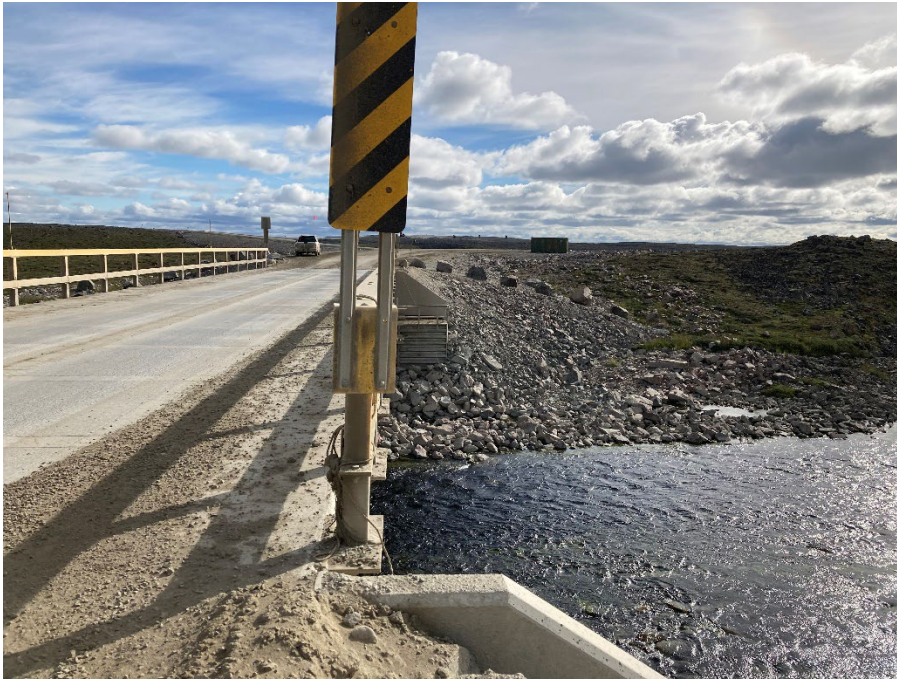
Photograph E2-15 Bridges 7 – km 148+300

Description: Looking at the south abutment.

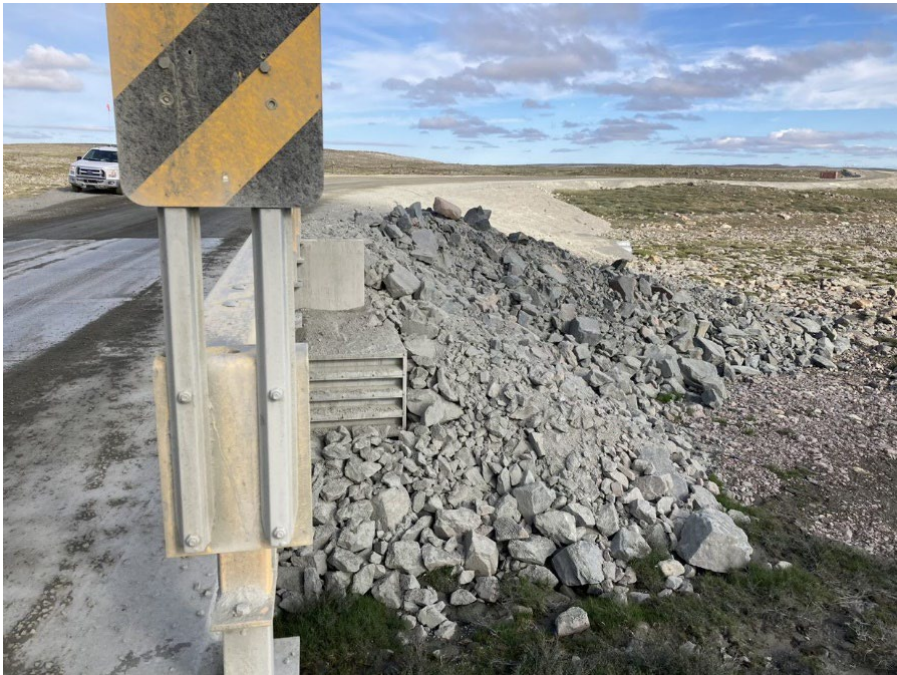
Photograph E2-16 Bridges 8 – km 159+500

Description: Looking at the north abutment.

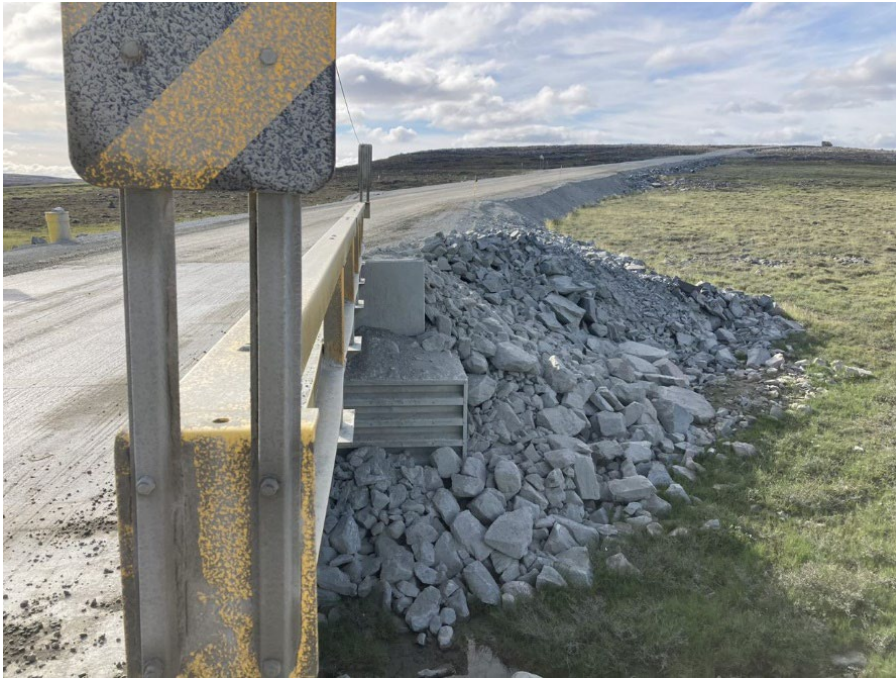
Photograph E2-17 Bridges 8 – km 159+500

Description: Looking at the south abutment.

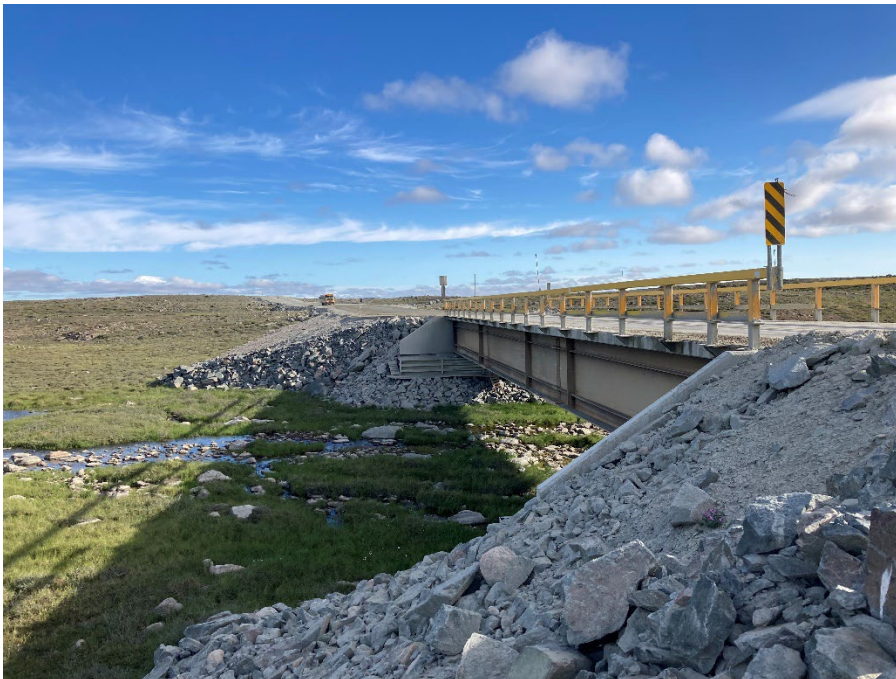
Photograph E2-18 Bridges 9 – km 160+800

Description: Looking at the north abutment.

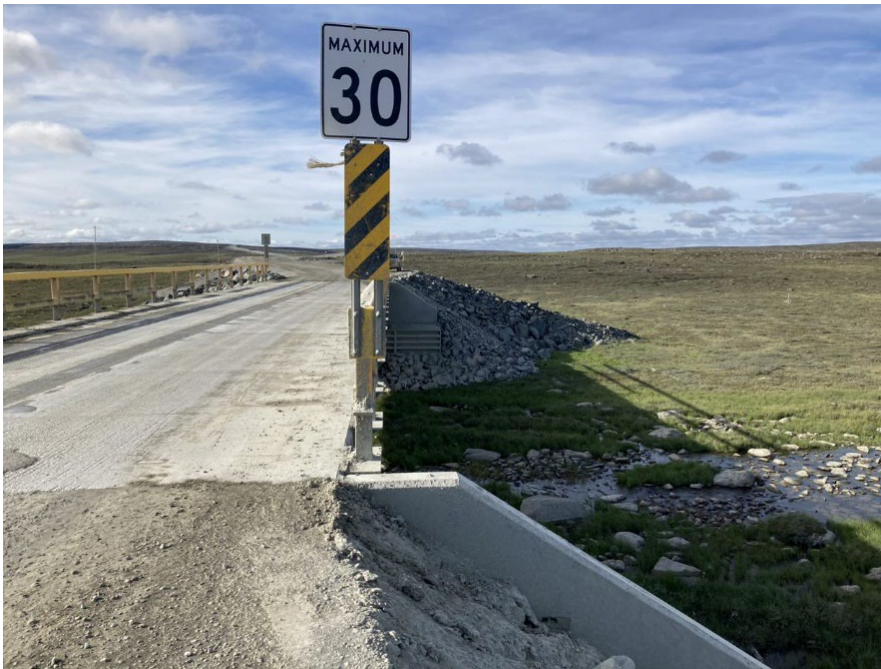
Photograph E2-19 Bridges 9 – km 160+800

Description: Looking at the south abutment.

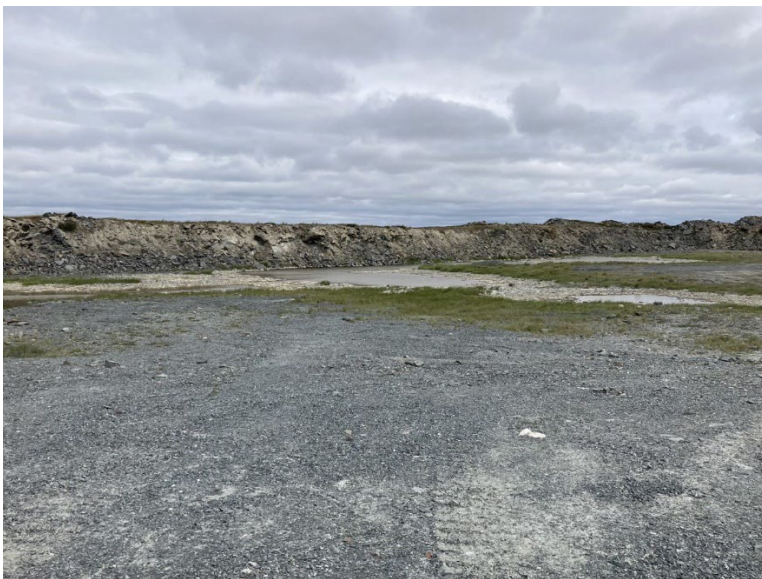
Photograph F-2: Quarry 13 – km 62+350

Description: View of north and west walls. Water ponding in the quarry.

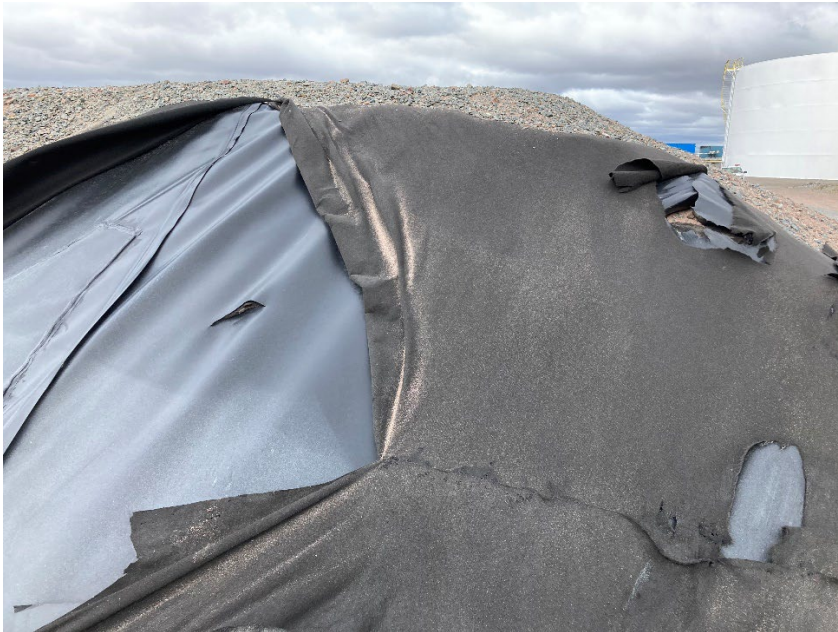
Photograph G1-5 Baker Lake Tank Farm

Description: Looking west. Presence of exposed and damaged geosynthetics in the slope.

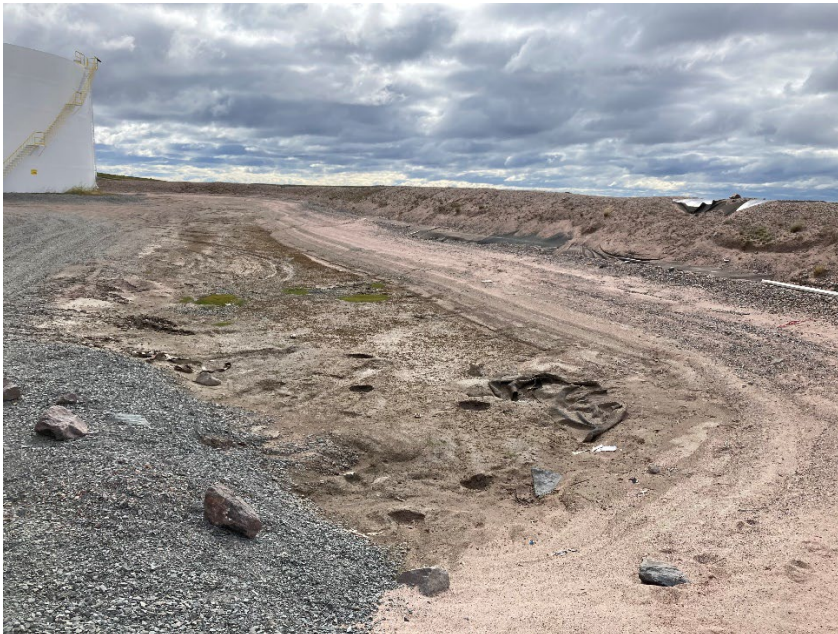
Photograph G1-6 Baker Lake Tank Farm

Description: From the southwestern corner of Tank 3 looking southeast. View of exposed geosynthetics.

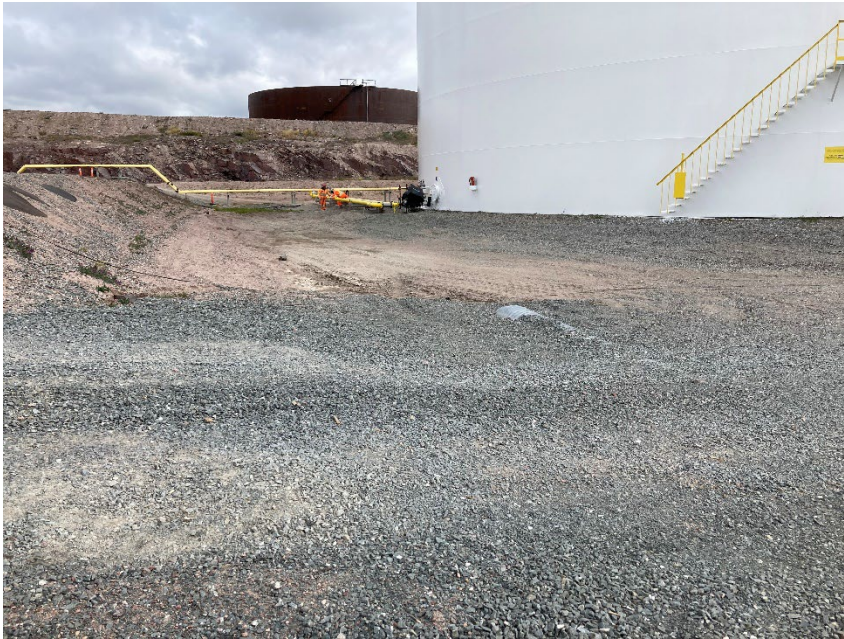
Photograph G1-7 Baker Lake Tank Farm

Description: From the southwestern corner of Tank 3 looking southeast. View of exposed geosynthetics.

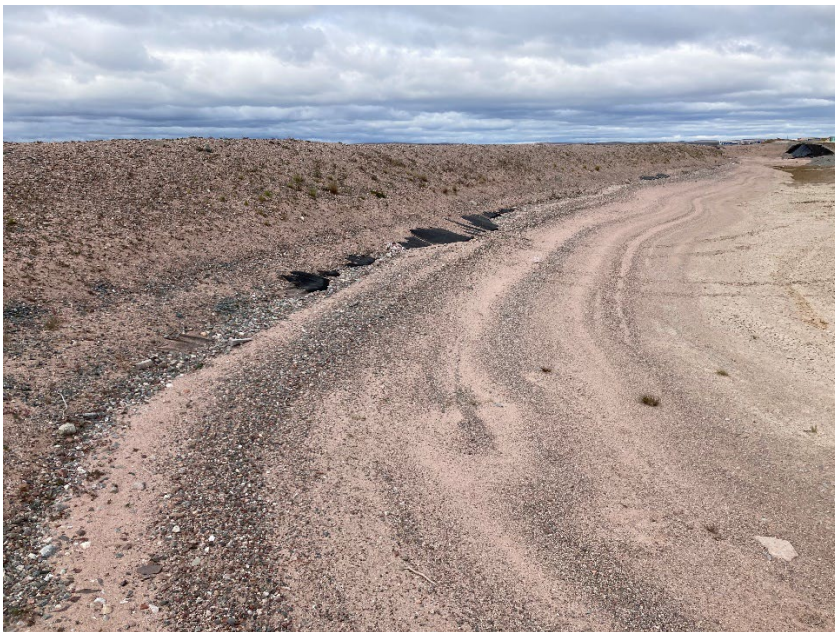
Photograph G1-8 Baker Lake Tank Farm

Description: From the south portion of the site looking northwest at the south side of Tank 3 and 4. View of exposed geosynthetics.

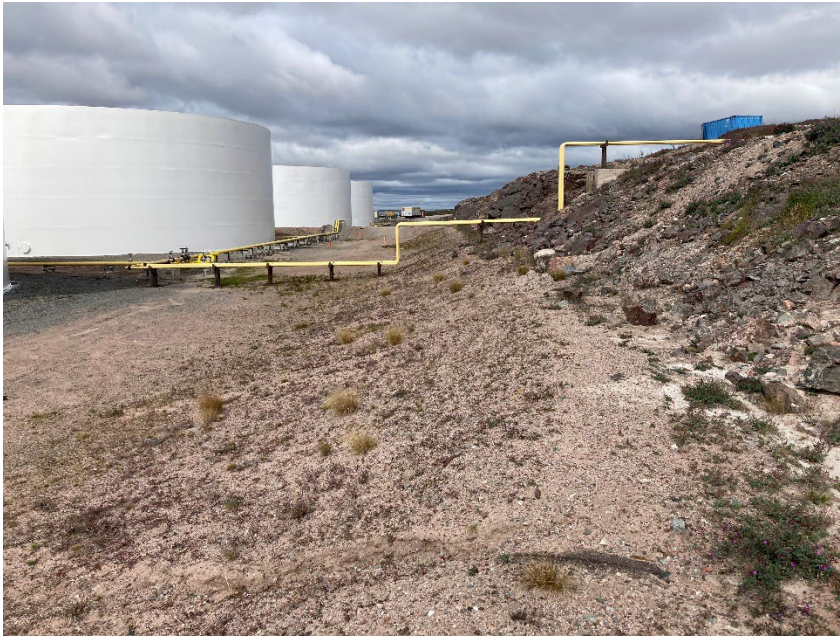
Photograph G1-11 Baker Lake Tank Farm

Description: From the northern side of Tank 4, looking northwest toward Tanks 4, 3, 2, and 1. Presence of exposed liner due to erosion of the granular cover.

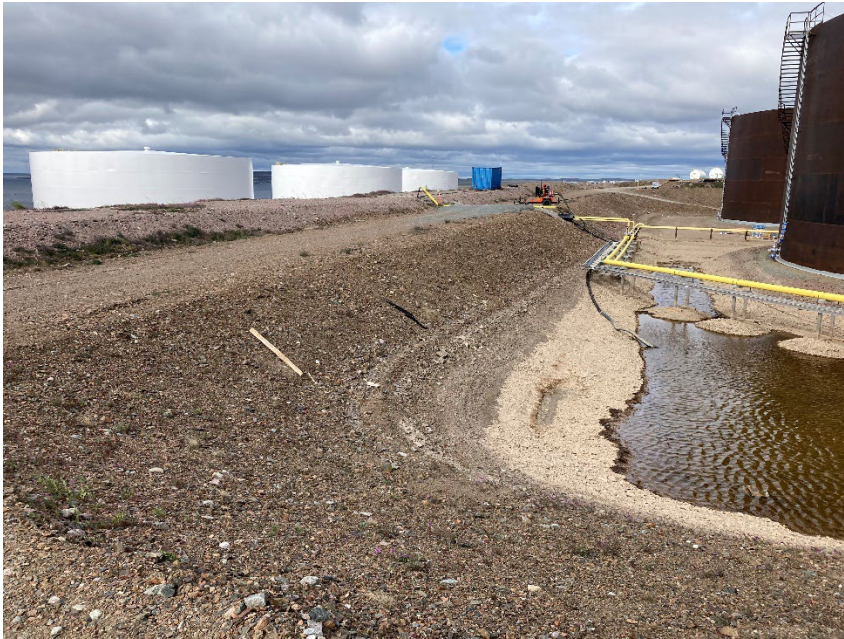
Photograph G1-15 Baker Lake Tank Farm

Description: From the southern corner of Tank 6, looking northeast at the southern side of Tanks 5 and 6. Presence of water ponding.

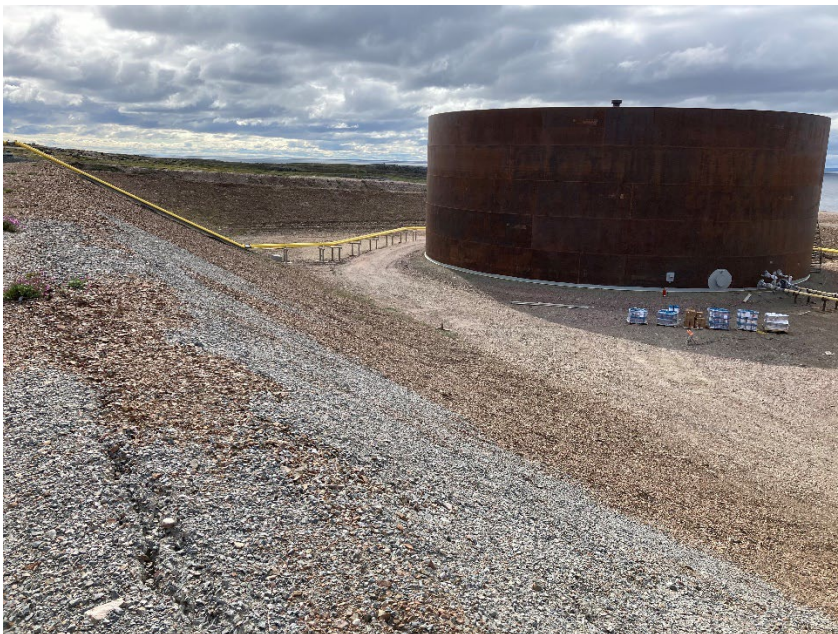
Photograph G1-16 Baker Lake Tank Farm

Description: Looking southeast at the northeastern side of Tank 6. Presence of old tension cracks.

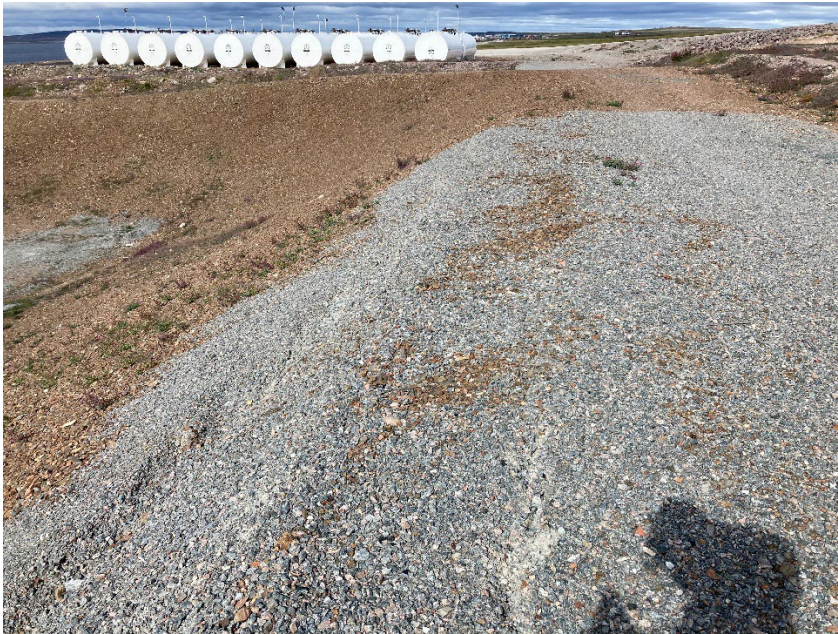
Photograph G1-17 Baker Lake Tank Farm

Description: Looking west at the crest on the northeastern side of Tank 5. Presence of old tension cracks.

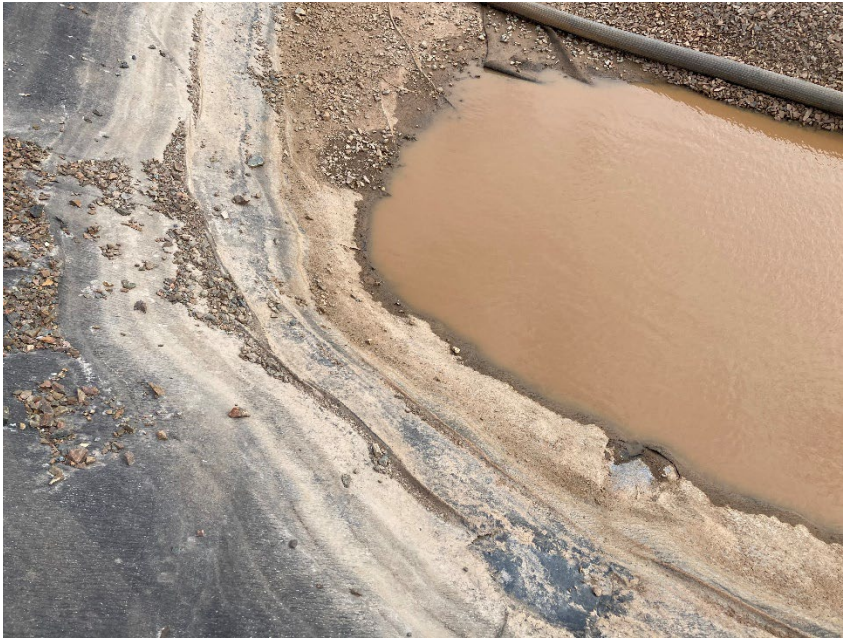
Photograph G1-21 Baker Lake Tank Farm

Description: From the southwestern corner of the Jet A fuel tanks looking northeast. Presence of exposed geomembrane with holes and water ponding.

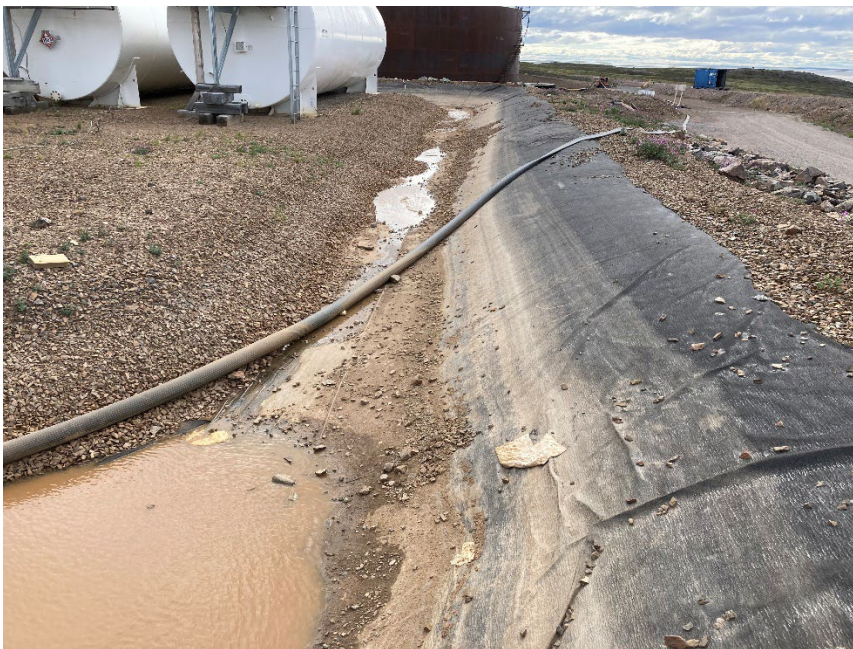
Photograph G1-22 Baker Lake Tank Farm

Description: From the southwestern corner of the Jet A fuel tanks looking east. Presence of exposed geomembrane and water ponding.

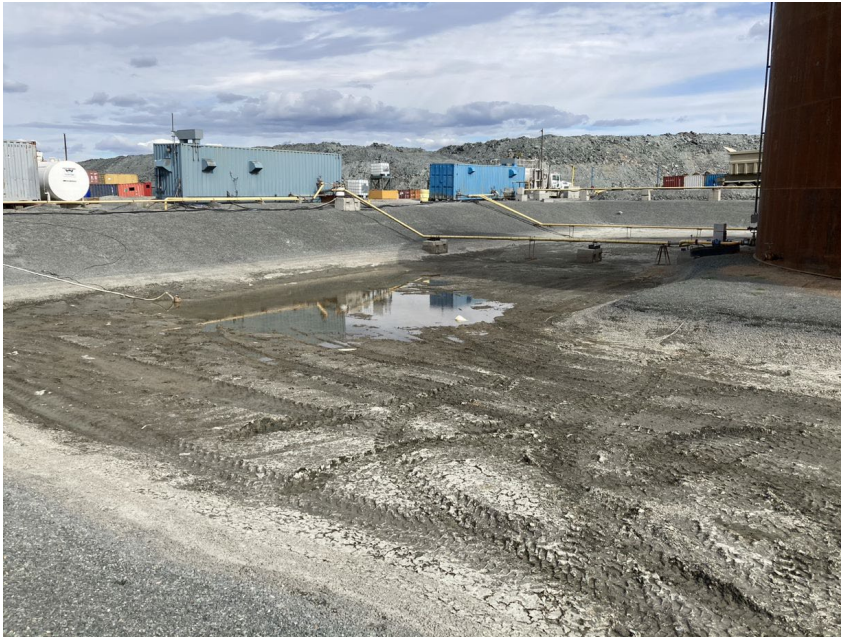
Photograph G2-5 Meadowbank Tank Farm

Description: Looking southeast from the northeastern side of the tank. Presence of water ponding.

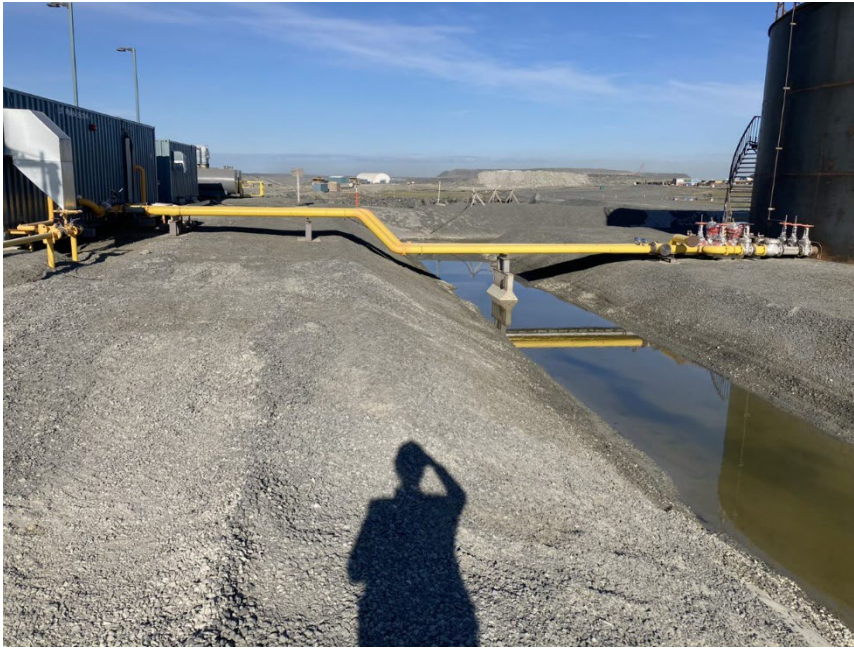
Photograph G3-1 Whale Tail Project Site Tank Farm

Description: From the fuelling pad, looking west at the Tank Farm. Presence of water ponding.

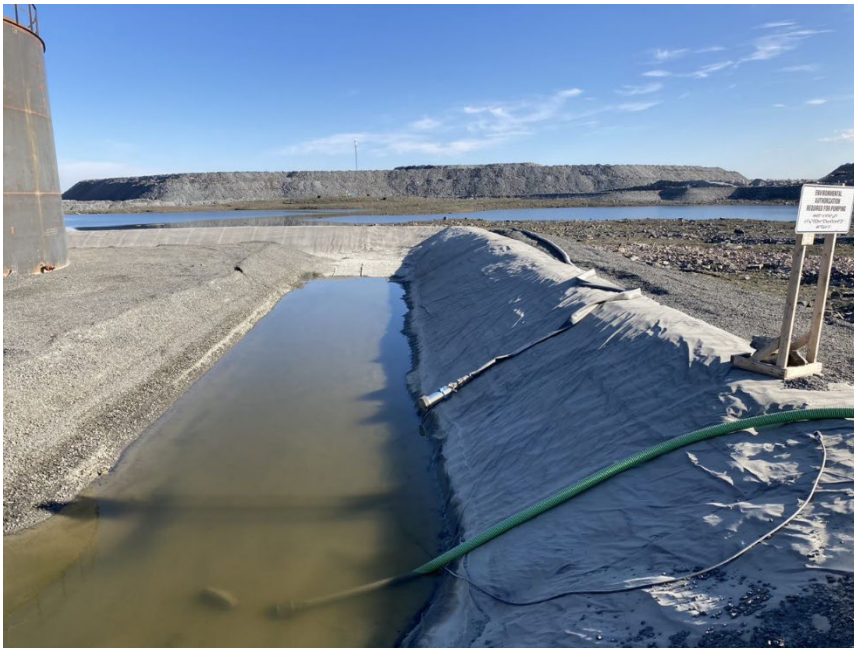
Photograph G3-2 Whale Tail Project Site Tank Farm

Description: From the fuelling pad, looking north at the Tank Farm. Presence of water ponding.

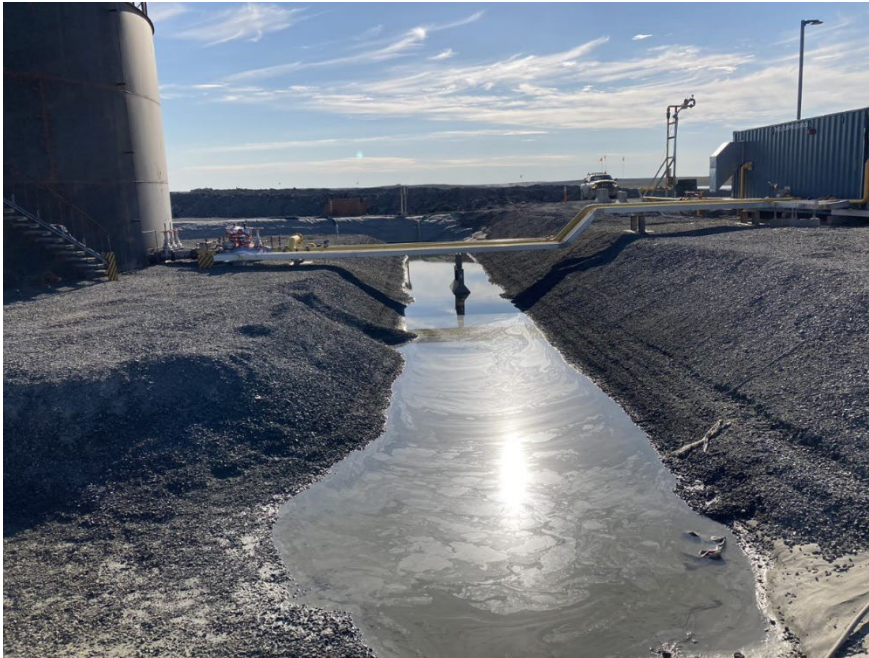
Photograph G3-7 Whale Tail Project Site Tank Farm

Description: From the southwest corner of the tank, looking east. Presence of water ponding.

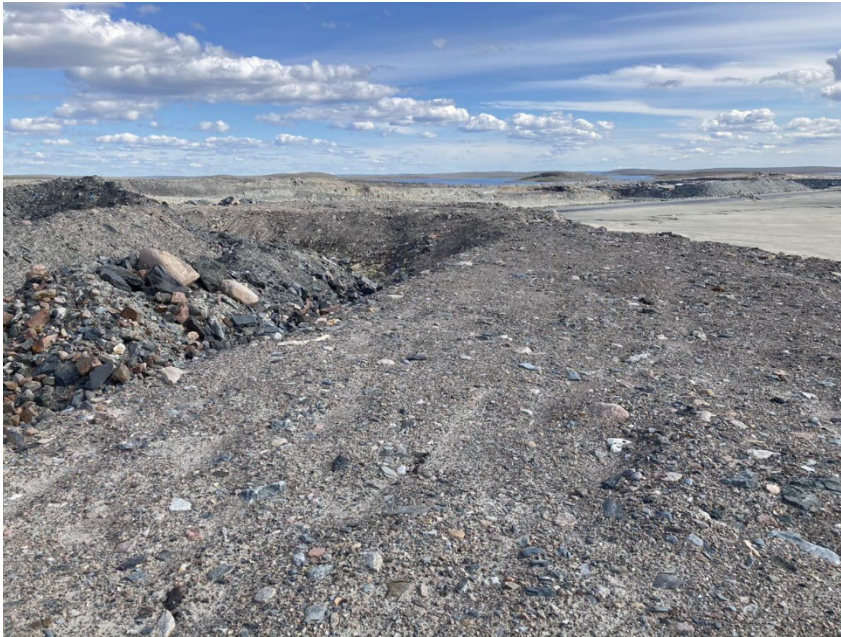
Photograph H5-1 Meadowbank Contaminated Soil Storage and Bioremedial Landfarm Facility

Description: From the eastern side of the Contaminated Soil Storage and Bioremedial Landfarm Facility, looking east at the containment berm. In good condition.

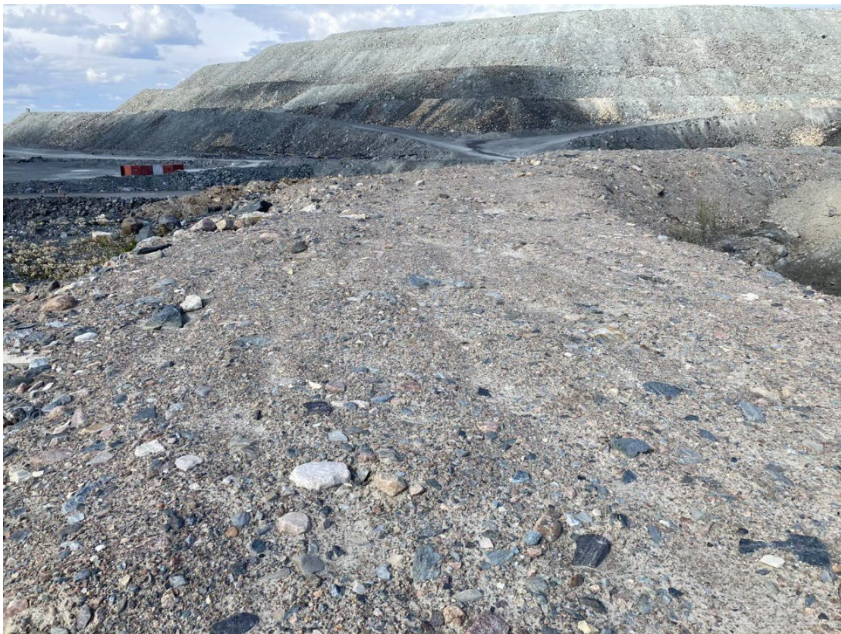
Photograph H5-2 Meadowbank Contaminated Soil Storage and Bioremedial Landfarm Facility

Description: From the northeast extremity of the South Cell, looking northeast at the Contaminated Soil Storage and Bioremedial Landfarm Facility. In good condition.

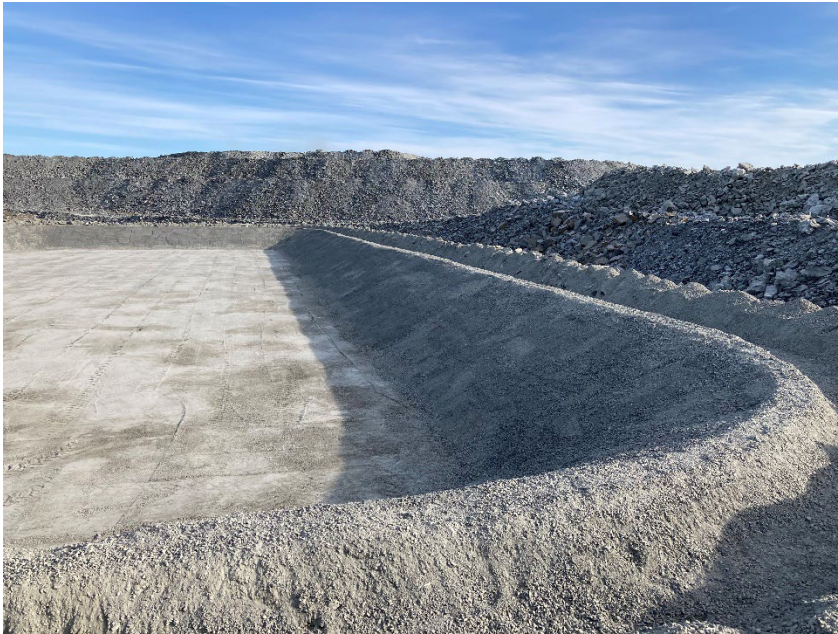
Photograph H5-3 Whale tail Project Contaminated Soil Storage and Bioremedial Landfarm Facility

Description: From the south extremity of the new Whale Tail Project facility, looking north. In good condition, not yet lined.

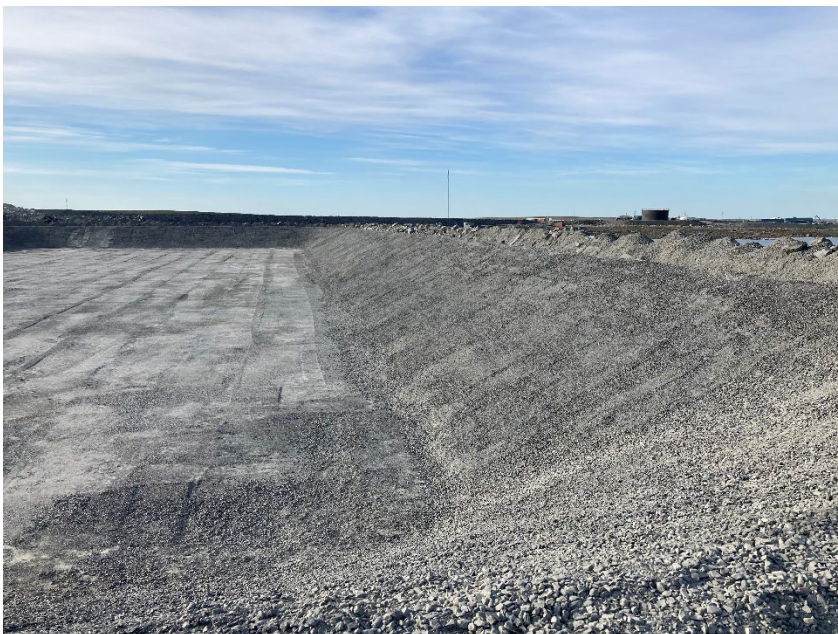
Photograph H5-4 Whale tail Project Contaminated Soil Storage and Bioremedial Landfarm Facility

Description: From the north extremity of the new Whale Tail Project facility, looking south. In good condition, not yet lined.

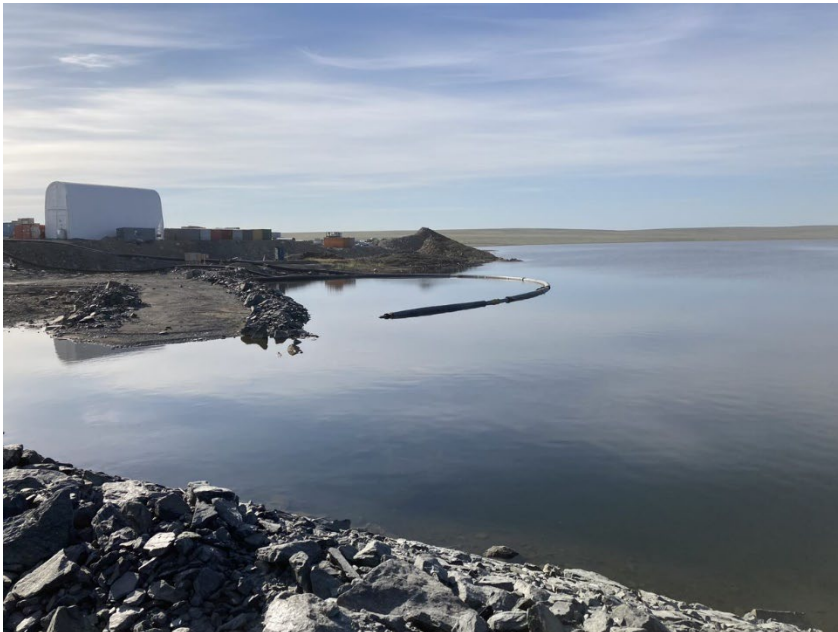
Photograph H9-2 Whale Tail South Diffuser

Description: From the east abutment of Whale Tail Dike, looking south. The diffuser present and working normally.

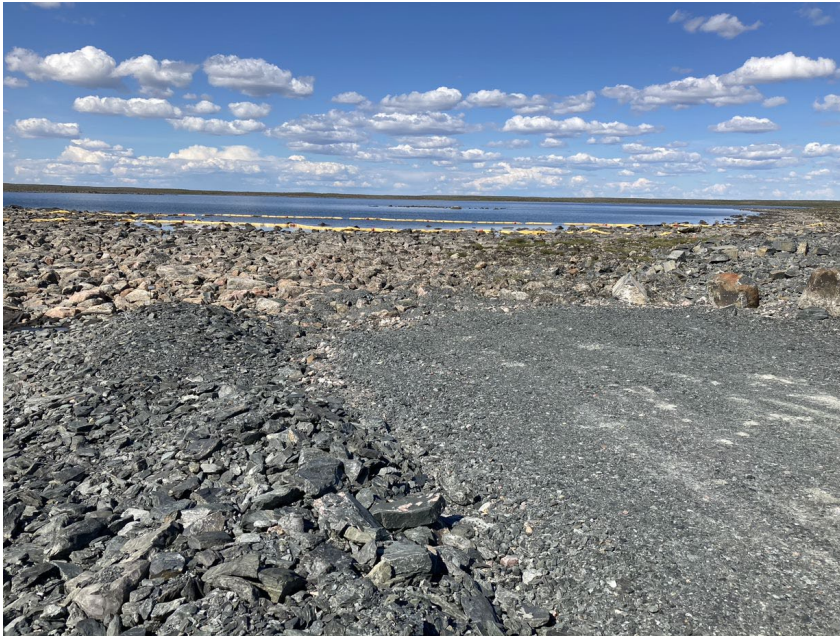
Photograph H10-1 South Whale Tail Channel

Description: From the outlet into Mammoth Lake, looking northwest. Two turbidity barriers are deployed in the lake.

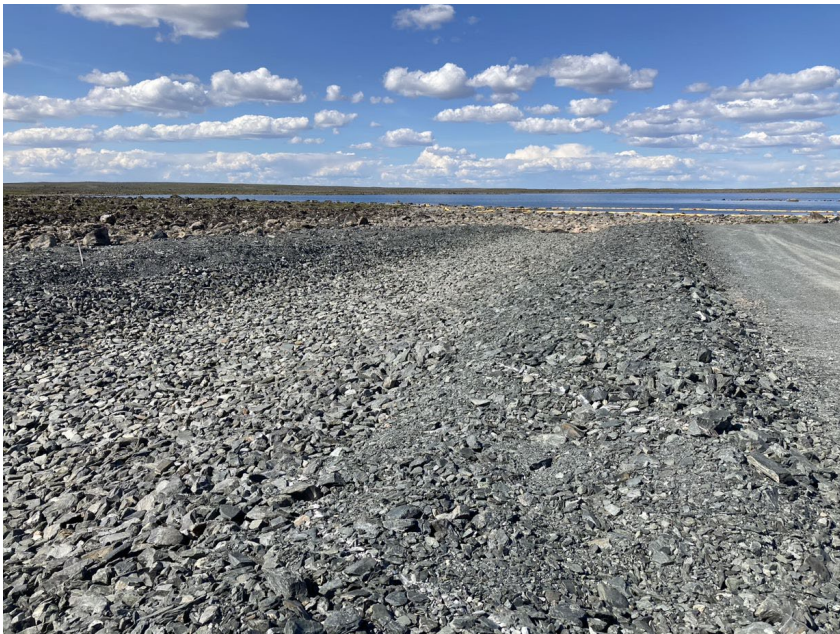
Photograph H10-2 South Whale Tail Channel

Description: From approx. Sta. 0+850, looking west. Settlement in the rockfill slope.

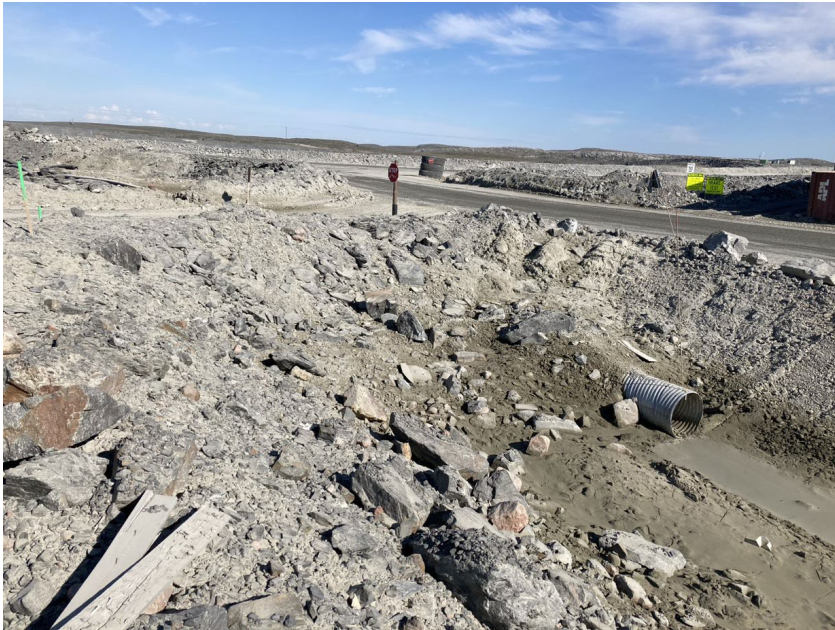
Photograph H11-1 Saline Ditch

Description: From the northern extremity of the Saline Ditch, looking west. The culvert is in good condition. Mud is accumulating in front of the inlet.

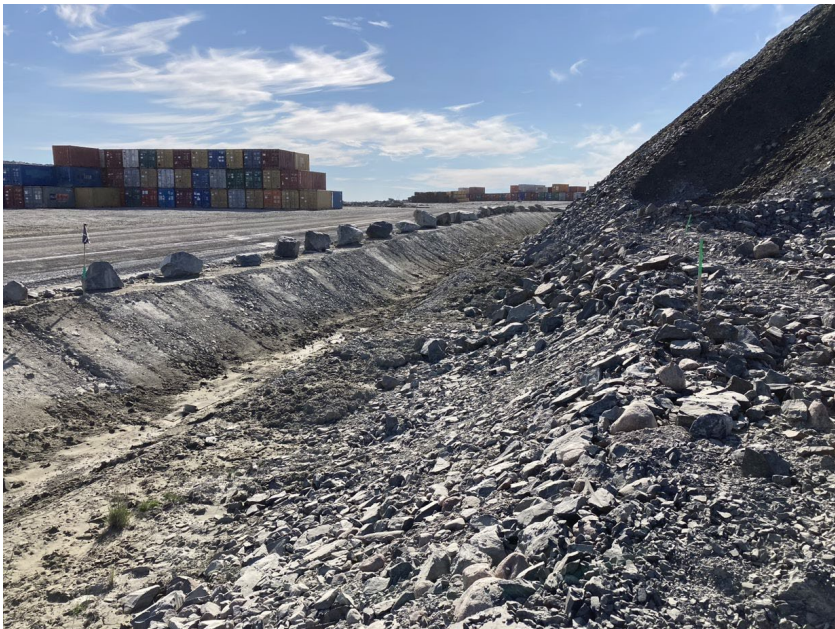
Photograph H11-2 Saline Ditch

Description: From the northern extremity of the Saline Ditch, looking east. Mud and gravel are present in the ditch.
