Whale Tail 2025 Annual Open Pit Geomechanical Inspection Report

March 10, 2026

RE: Meadowbank Complex - Amaruq Site - 2025 Annual Open Pit Geomechanical Inspection

2025 Annual Open Pit Geomechanical Inspection

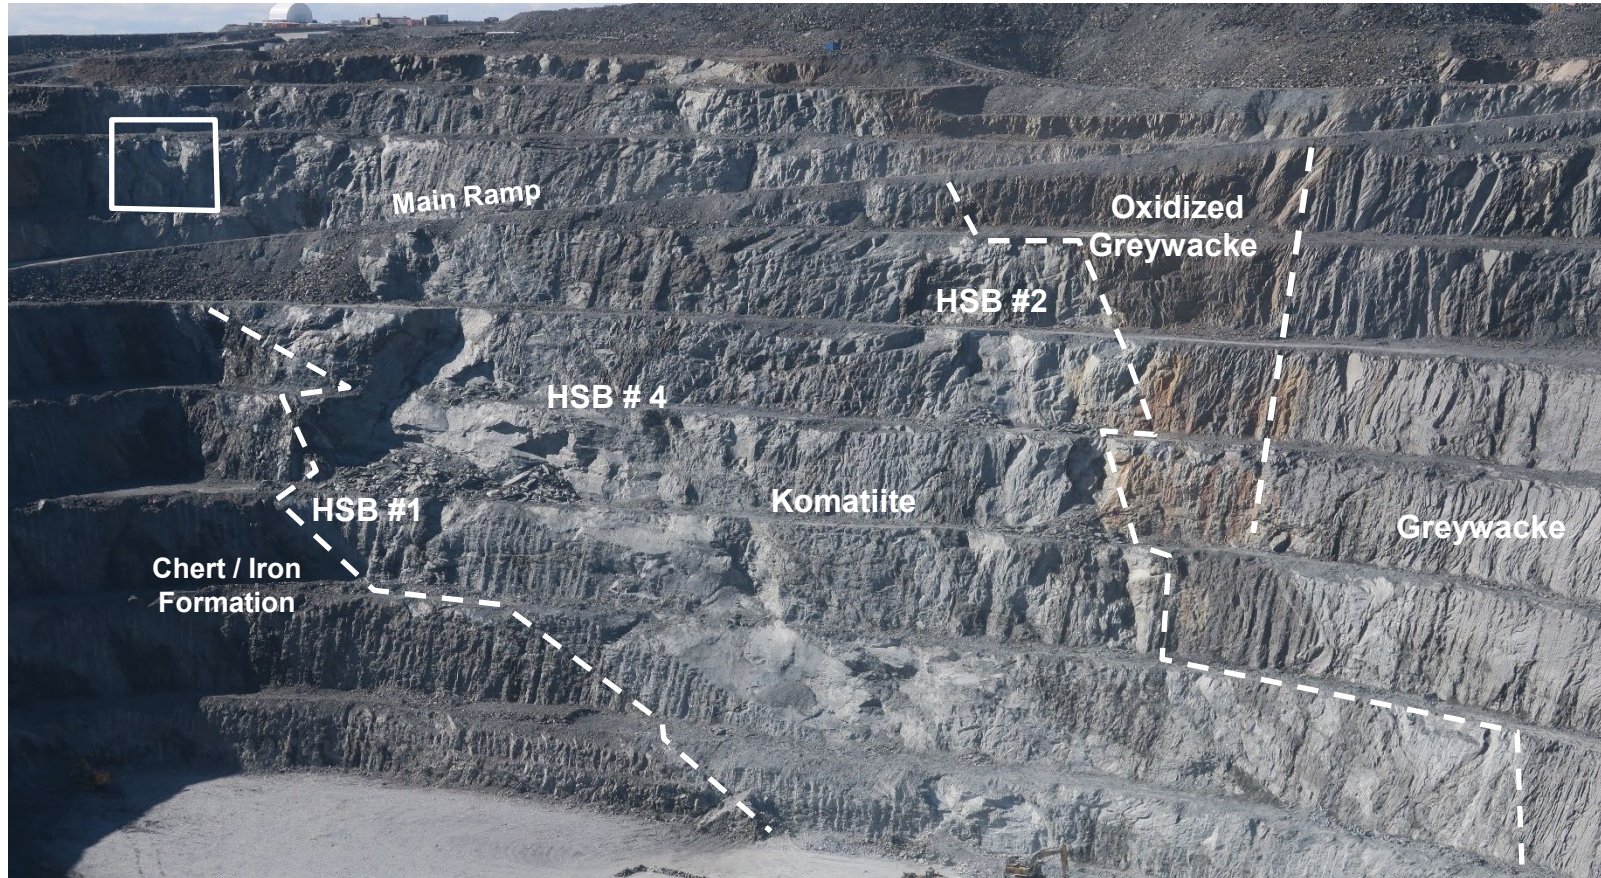
- Final wall in Design Sector A1/A1K.
- The benches in the Greywacke and Oxidized Greywacke are generally performing well.
- A series of bench-scale failures have occurred in the Komatiite along three High-Strain / Brittle Structures since September 2023, including 11 failures between August 2024 and August 2025. This is discussed further on the next slide. Elsewhere in the sector the Komatiite has performed well.
- A potential wedge is present above the ramp (white box). The wedge is discussed further on a subsequent slide.

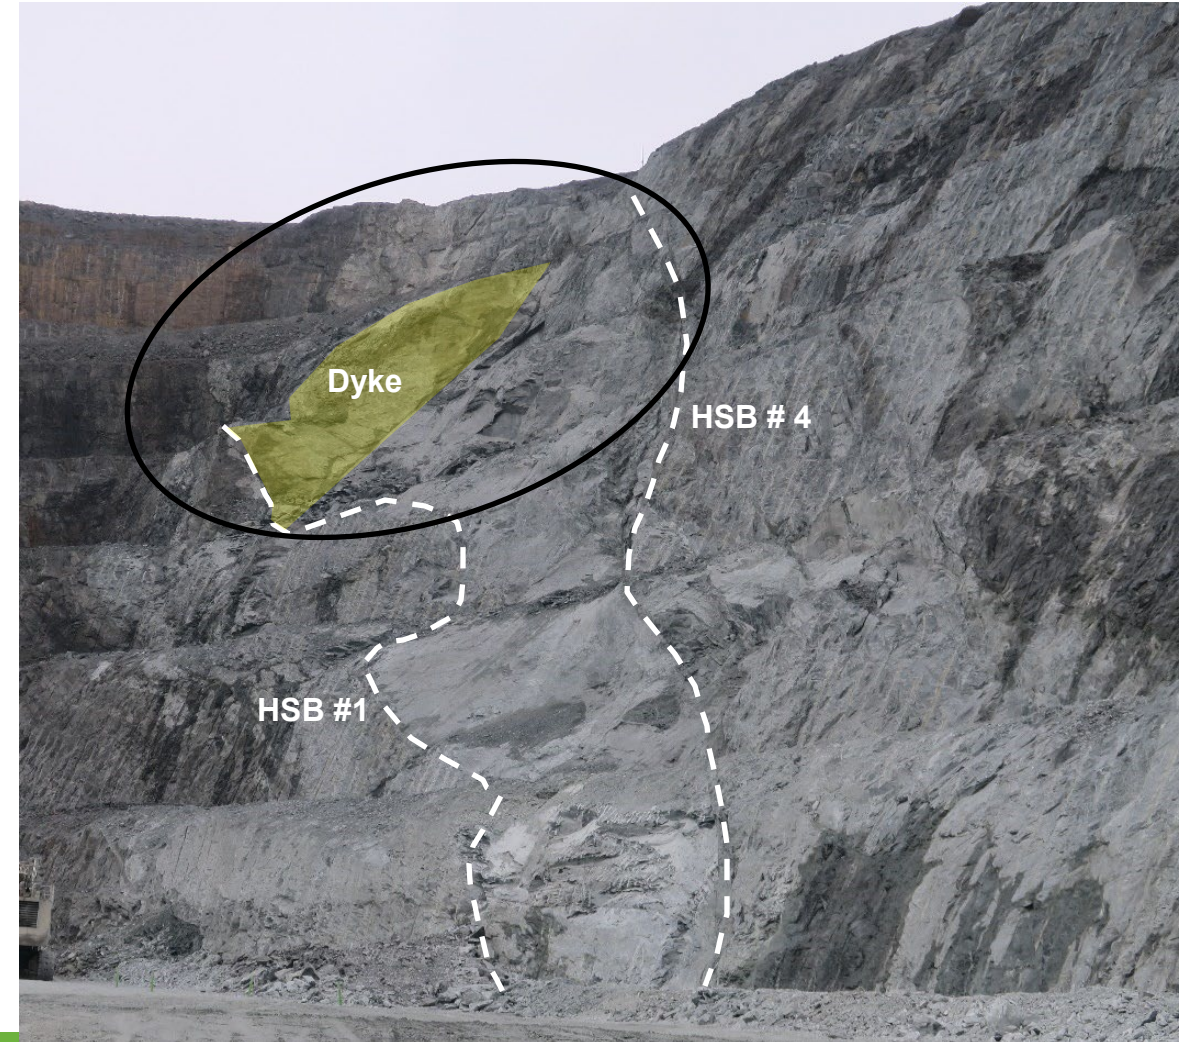
- A dyke appears to control the upper west side of the failure.
 - The structural control for the base of the failure is less clear. It may be the S3 foliation but could also be part of a family of sigmoidal structures between the two HSBs.

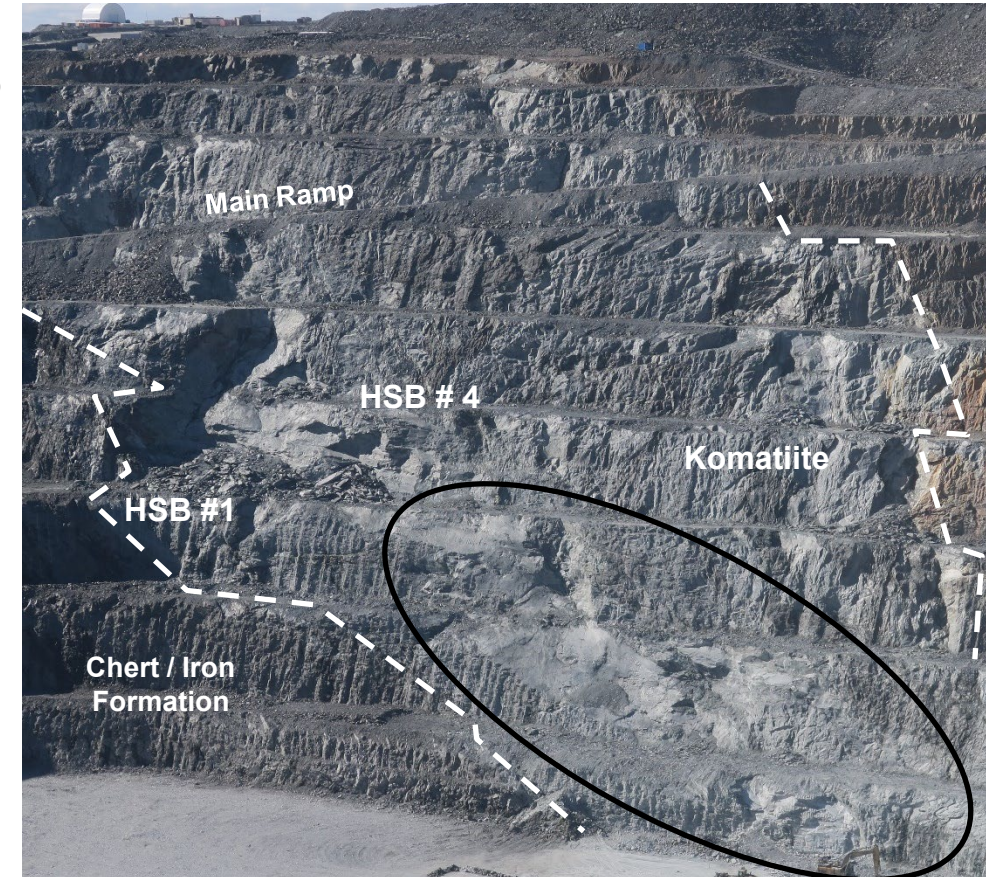
- These failures are expected to continue to occur as HSB #4 and #1 are exposed in new benches. Comments on managing these failures are provided on a subsequent slide.

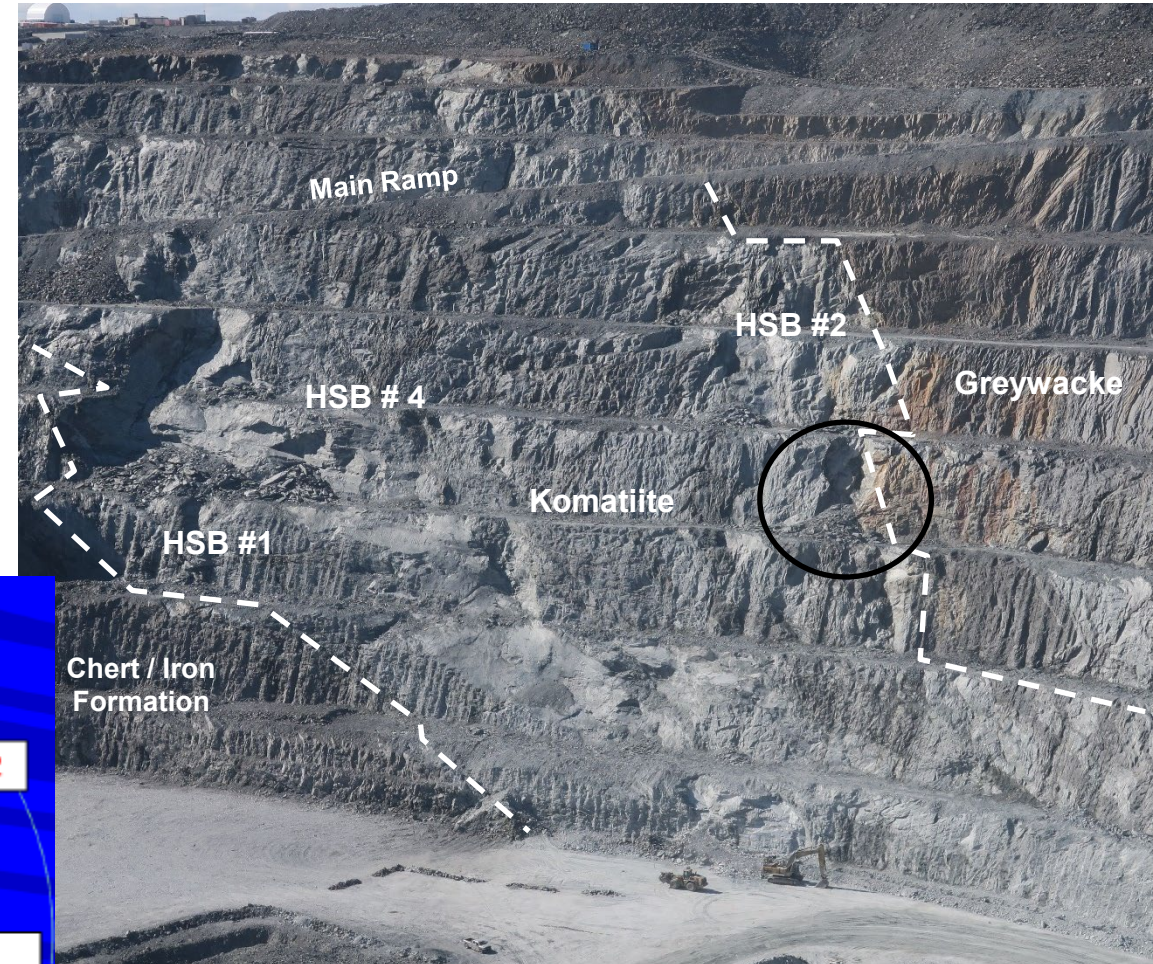
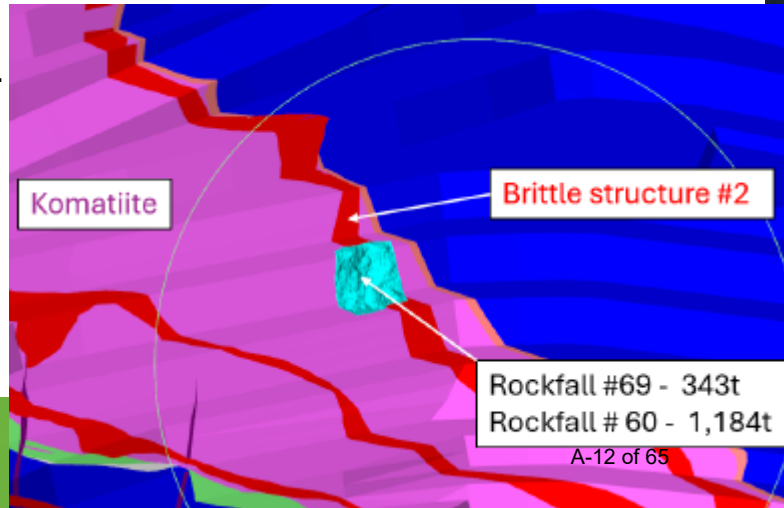
- Similar failures are expected to continue to occur along HSB#2. This area should continue to be a focus of scaling when establishing new benches.
- In some cases, trim blasting could be used to proactively remove the potential wedge.

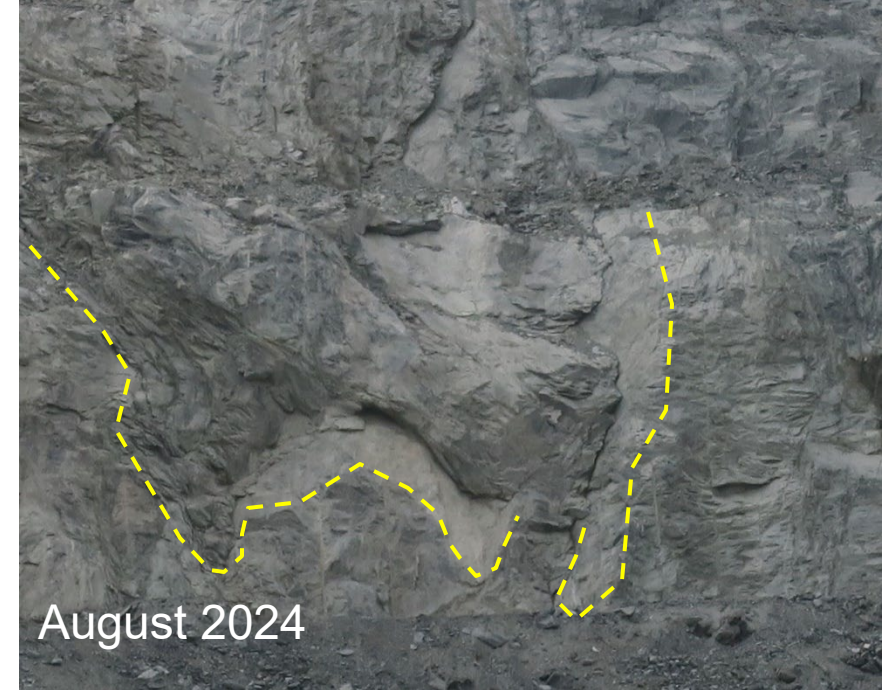
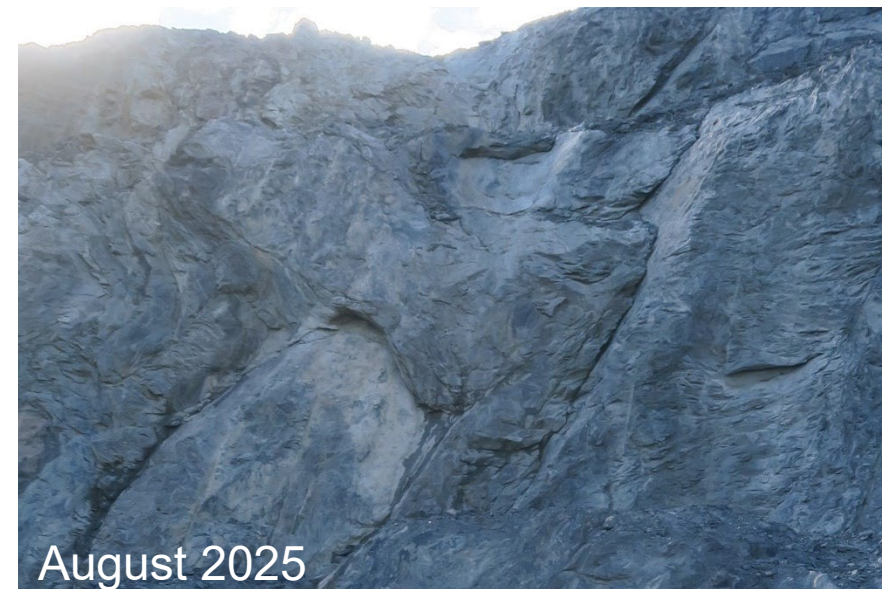
- The wedge was identified above the ramp in 2020.
- Ravelling of material over time has resulted in the wedge becoming more prominent. It is believed that most of the ravelling occurred when the Phase 2 Ramp was established below this area between December 2022 and January 2023.
- There is a partial bench between the wedge and the Phase 2 ramp. However, it is likely that material would reach the ramp if the wedge failed.
- The wedge is a focus of the regular visual inspections and the drone surveys.
- No significant changes in the condition of the wedge were observed between the 2023 and 2025 annual inspections.
- Continue to monitor this area closely, both from the ramp and the overlook above. If further deterioration is observed, further mitigation will be required (e.g., knocking down the wedge).

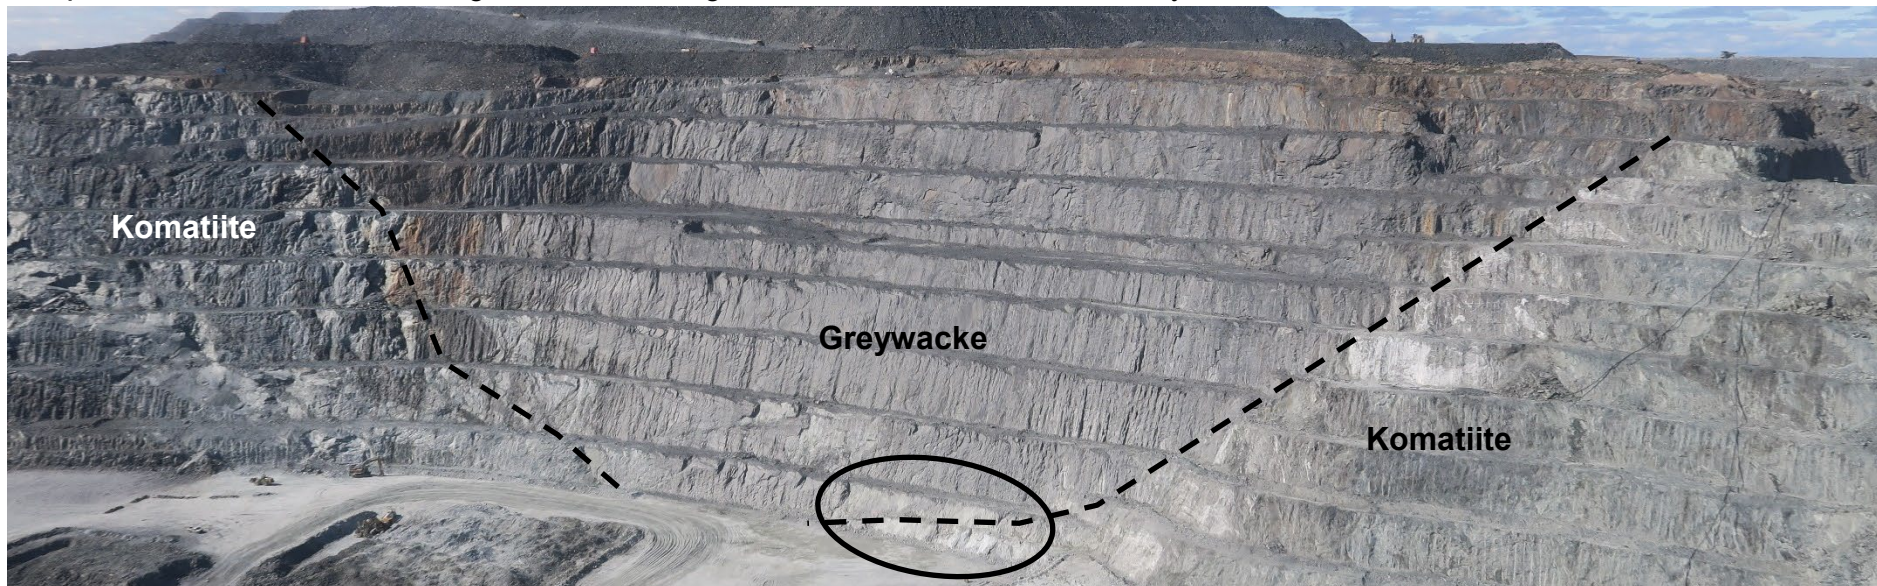
- Final wall in Design Sector B1.
- Approximately two benches have been mined on this wall since the last annual inspection.
- There have been no slope failures since the last annual inspection.
- To date, the benches have performed better than expected, with the bench face often standing steeper than the foliation in the Greywacke. As the wall transitions into Design Sectors B1K and B2K with depth, the bench faces are expected to more consistently break to the foliation. This is evident in the increased crest loss experienced at the eastern end of the most recent bench (circled below)
- There is a potential for localized wedge failures along the contact between the Greywacke and the Komatiite in the next few benches.

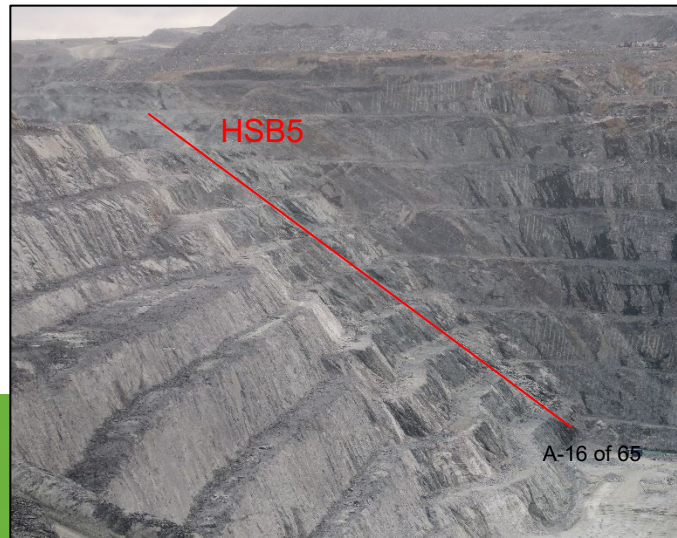
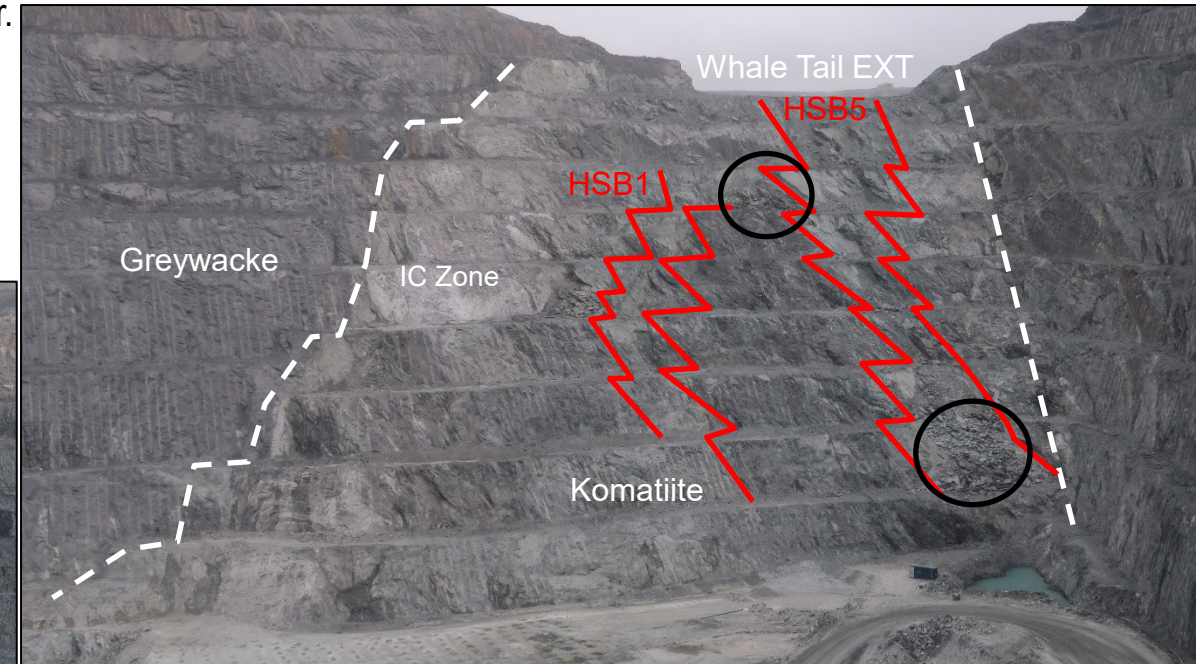
- Final wall in Design Sector D4K.
- This sector is within the Komatiite and has been characterized by a series of bench scale failures associated with the weak rock mass and the High-Strain / Brittle Structures (select structures are shown in red below). The slope design was revised in December 2021 and has been successful in managing the performance of the slope.

- It is expected that rockfalls and bench-scale failures will continue to occur. The wall continues to be a focus for the Rock Mechanics team. The Working with Komatiite Procedure is a key tool for managing the geotechnical risk in this sector.

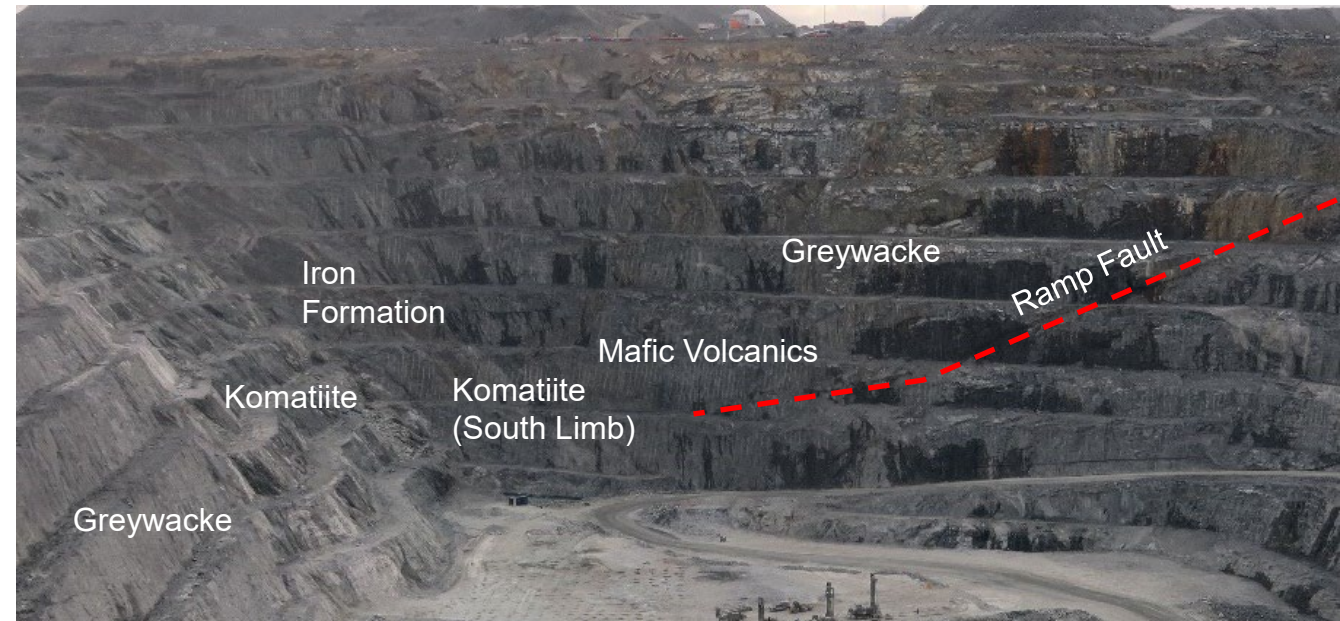
- Significant seepage was observed at the base of the East Wall. Intercepted groundwater from the South Wall is directed along a ditch on the inside of the ramp to a sump in the Northeast corner of the open pit. Water from the ditch is likely also flowing below the ramp and daylighting in the lower East Wall. It is expected that an ice wall will form below the ramp.

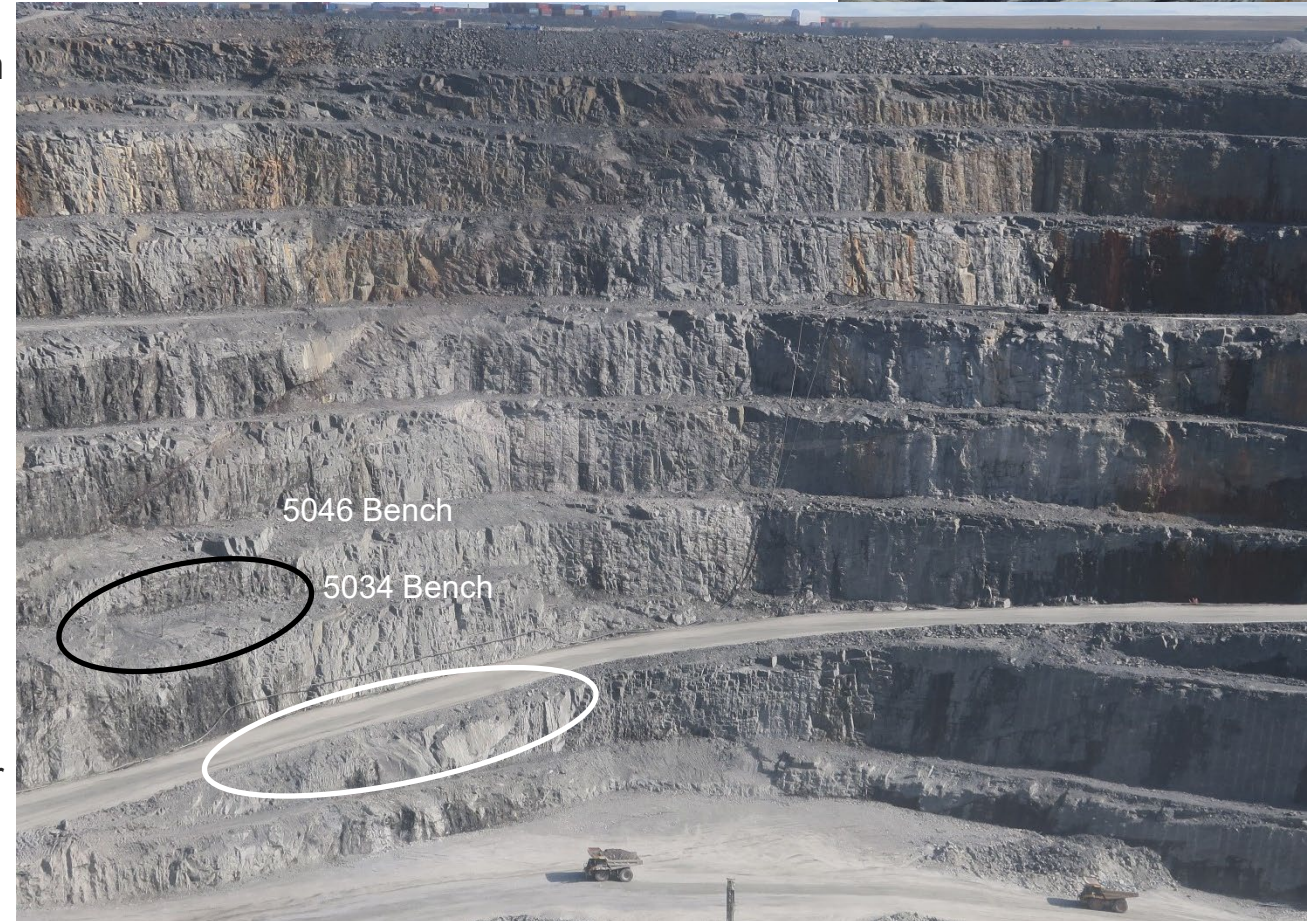
- Final wall in Design Sector F6, transitioning to G5.
- The slope geometry recommendations for this sector were adjusted in early 2023 by AEM to reduce the catch bench width from 16 m to 13 m based on the observed slope performance.

- The lower wall has now largely transitioned out of the Diorite (Design Sector F6) and into the Greywacke and Komatiite (Design Sector G5).
- The slope geometry recommendations for G5 are based on the expectation that Joint Set C will no longer control the bench geometry. This should be validated in the field as it is possible that Design Sector F6 extends deeper than currently believed.

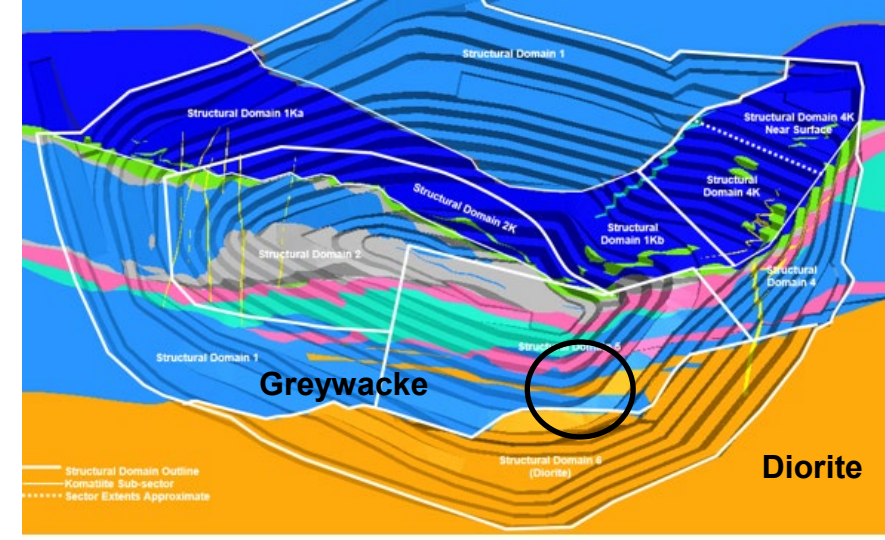
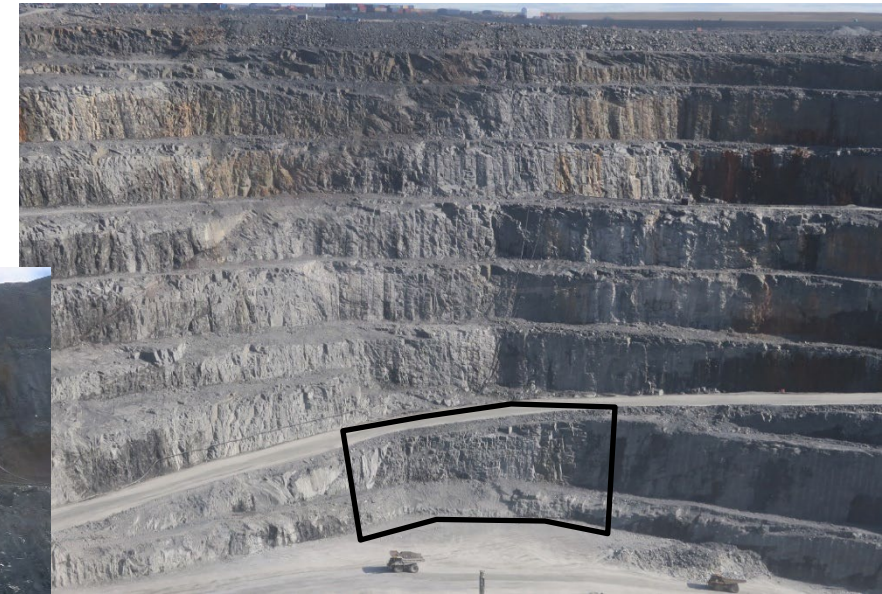
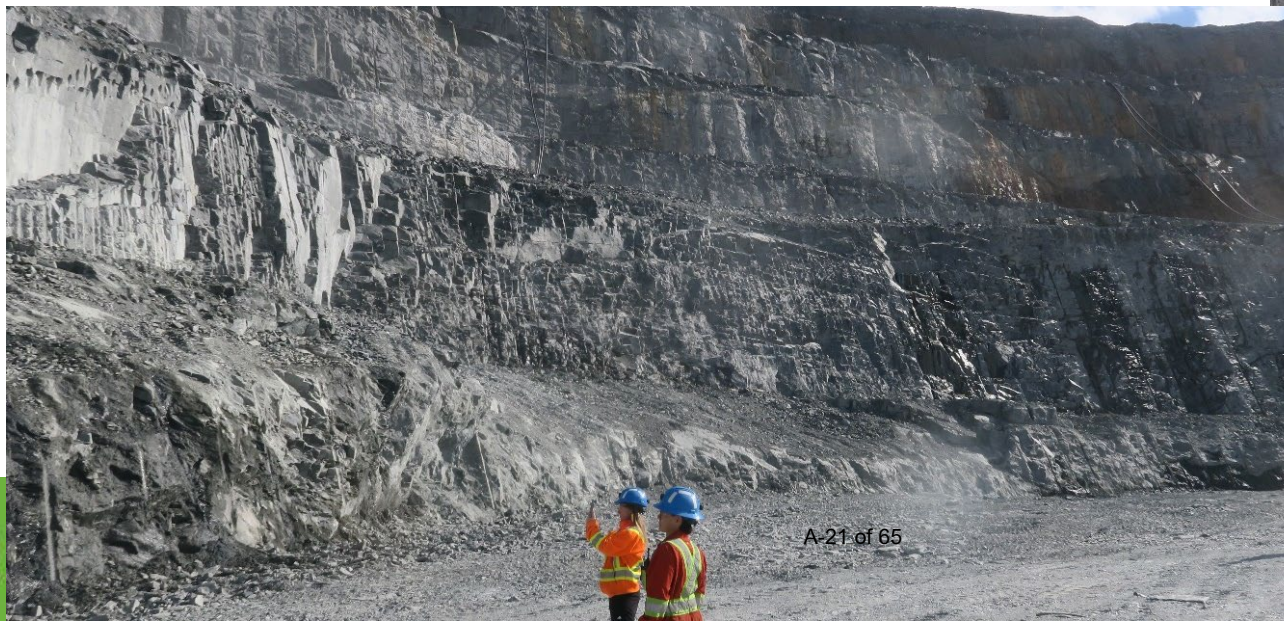
- A small intrusion of Diorite was expected below the ramp in this corner (circled area in plan at upper right).
- Inspection of the benches below the ramp suggest that the Diorite is more extensive than expected (outlined at lower right). Increased crest loss along Joint Set C within the Diorite has reduced the capacity of the catch benches. In addition, the blocky nature of the Diorite creates a rockfall hazard.
- The extents of the Diorite and the performance of the catch benches should be closely monitored in this area. The available infill drilling should be reviewed to assist with this. The catch bench width may need to be increased if the Diorite continues to extend to depth.
- Review the need for rockfall mitigation measures in this area, such as a rockfall berm or a rockfall barrier.

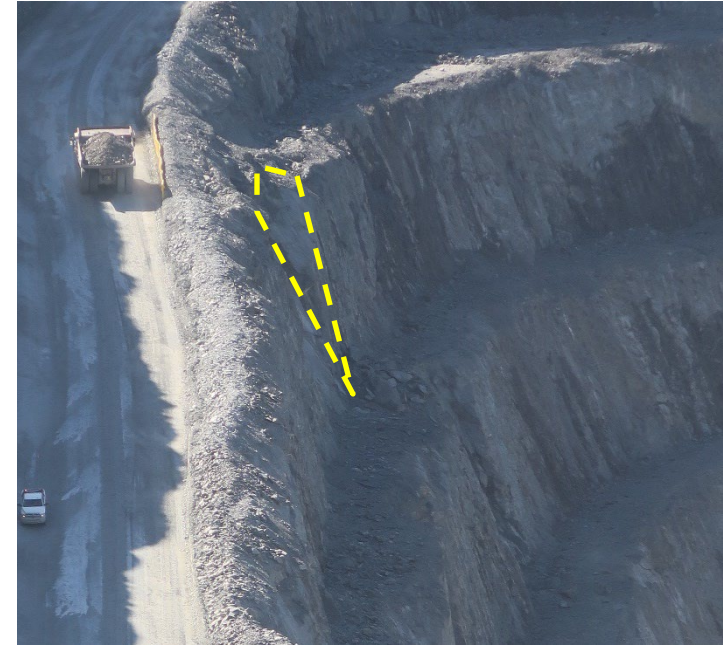
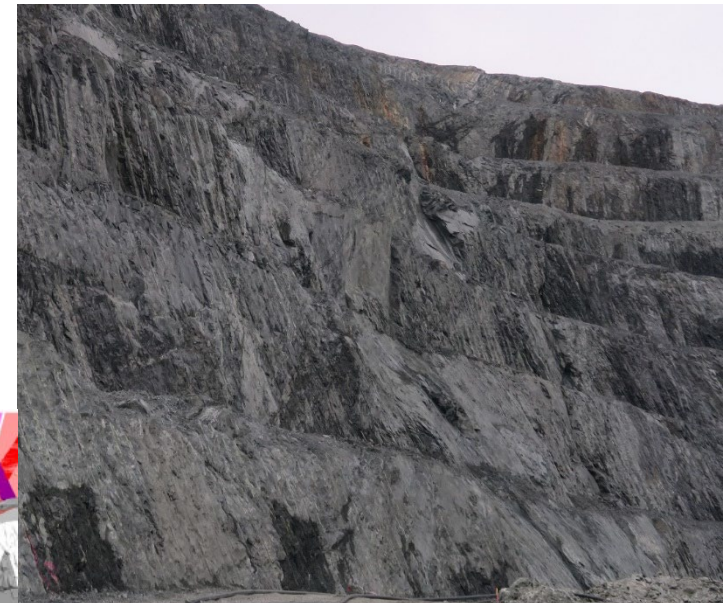
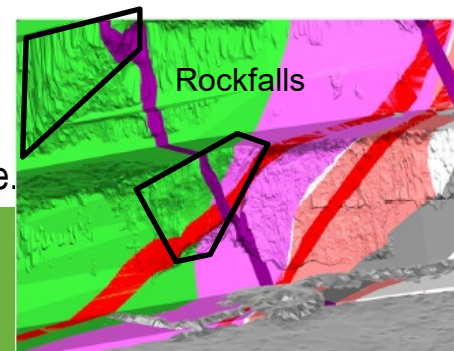
- These wedges are expected to continue to form as the open pit continues to depth.
- Alternative approaches for managing the wedges, include locally adjusting the bench design to mine out part or all of the wedge, taking a trim blast after the main blast to remove the wedge, ground support, and/or rockfall berms. The feasibility of these approaches should be reviewed in detail and implemented where possible.

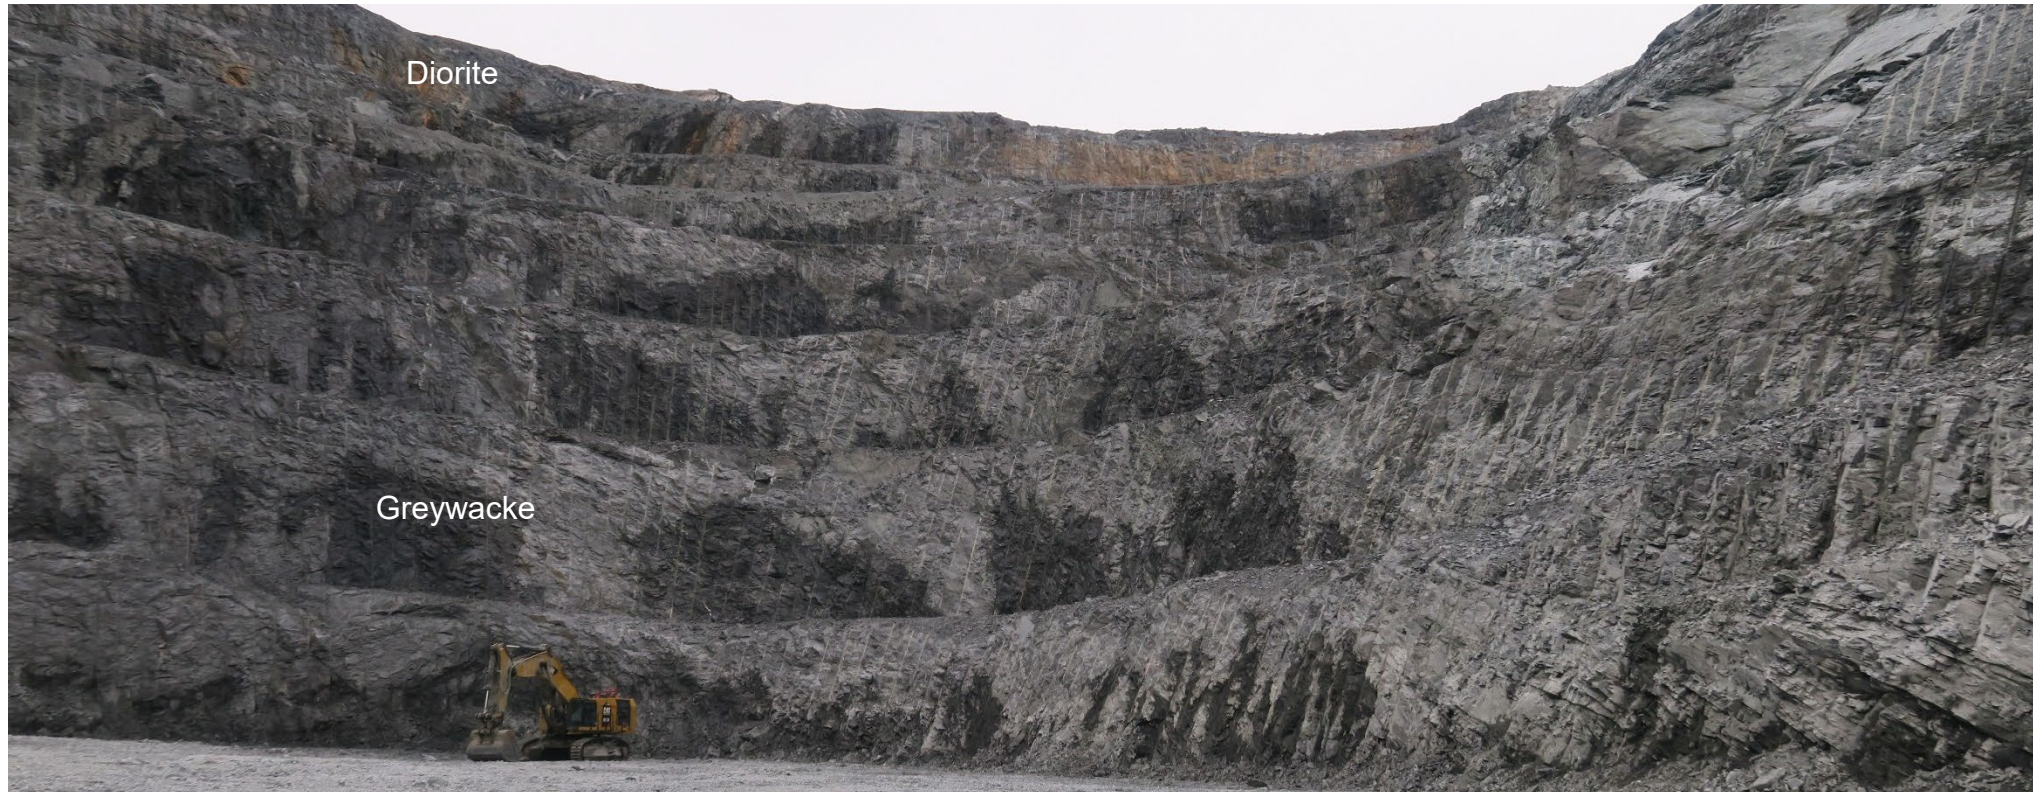
- Final wall in Design Sectors I6 (Diorite) and I1 (predominantly Greywacke).
- The wall is generally performing well. However, there continue to be challenges with drilling and blasting practices resulting in crest loss or hard toes on the benches.

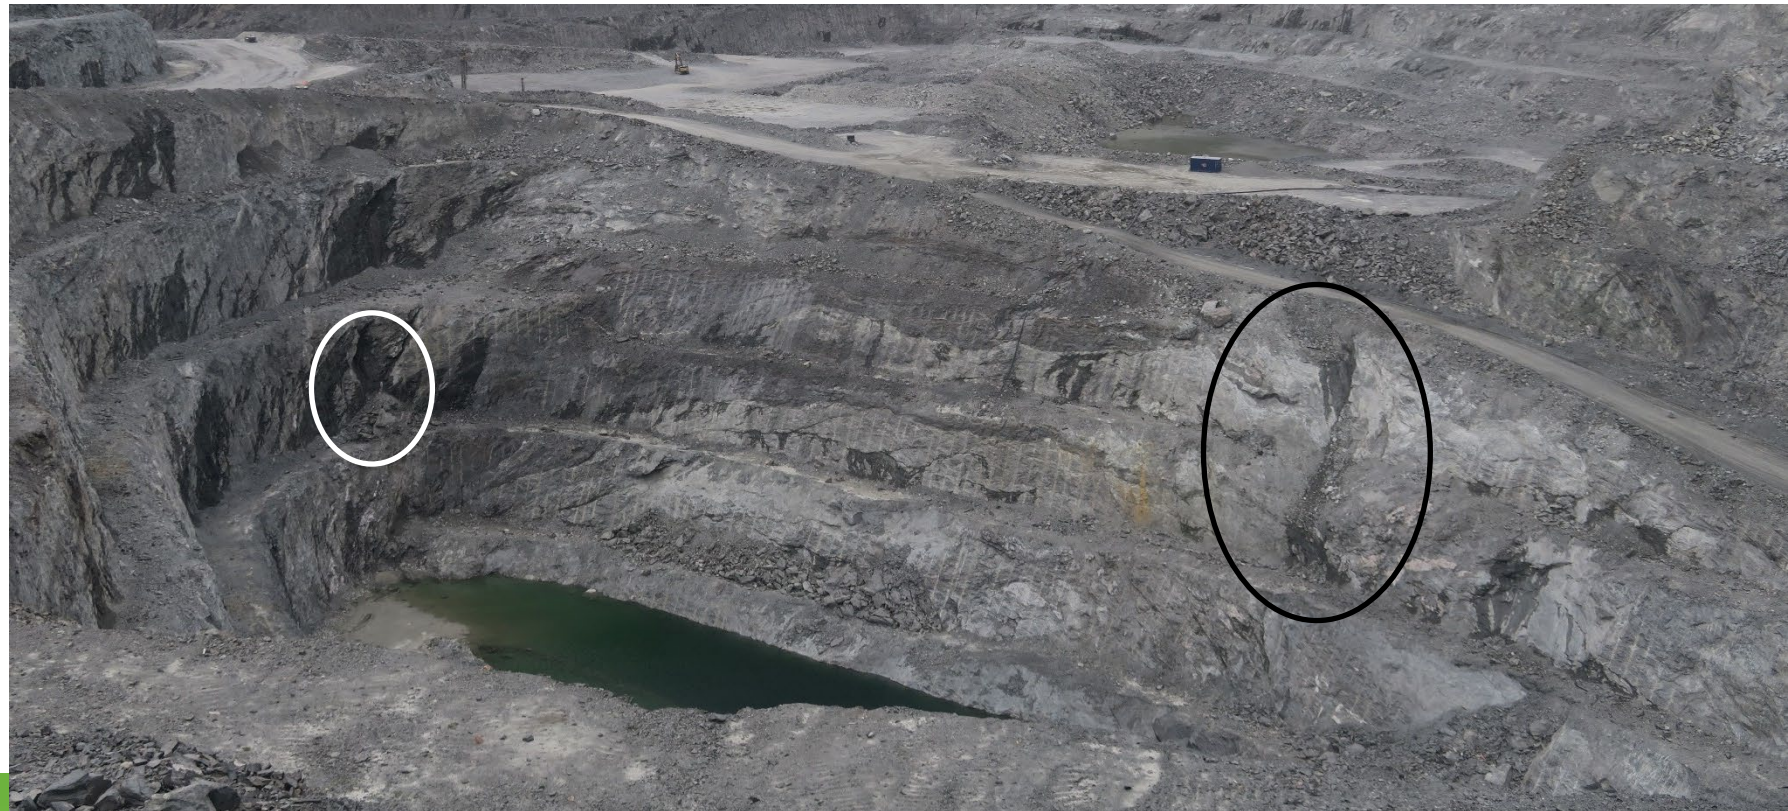
- The Northwest Wall is the footwall of the deposit and was established primarily within the Komatiite.
- Several bench scale failures and rockfalls have occurred over time on this wall, primarily associated with planar or wedge failures along the foliation. A progressive failure impacted the ramp in 2023 (circled in black below) and further failures are possible in this area.

- No particular concerns were noted for the other walls.
- Access to the open pit is prevented due to overspill from the blasting of the V2 open pit. Access is periodically re-established for water management purposes. The ramp is inspected by Rock Mechanics each time. However, a rockfall berm has not been re-established along the inside of the ramp. The berm should be re-established.

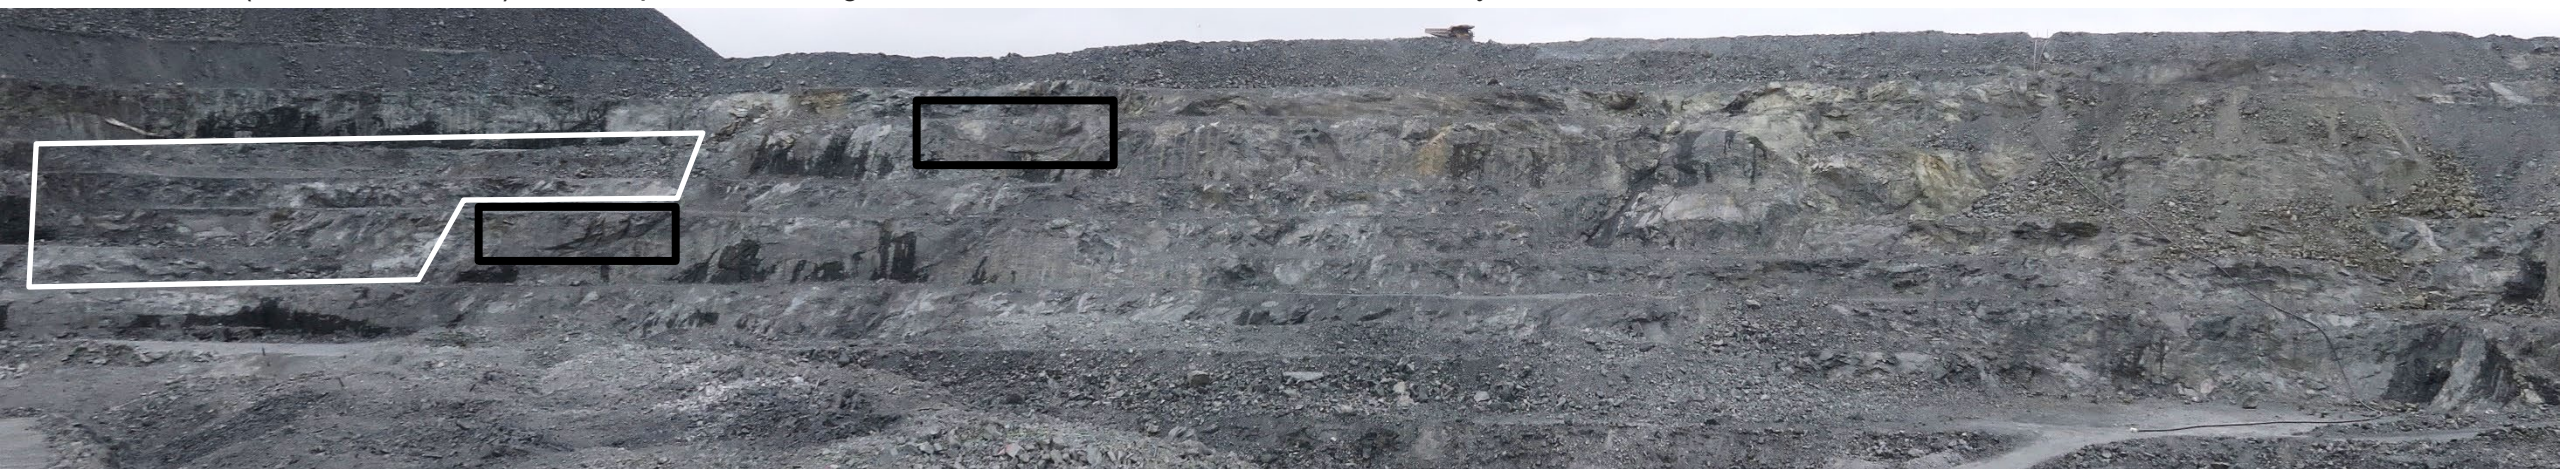
- Final wall established in the footwall of the deposit, primarily within the Mafic Volcanics. This wall has been extended due to the push backs of the East and West walls since the 2025 inspection but has not been advanced to depth.

- Several possible wedges formed by undulations in the foliation have been identified near the western end of the wall within the Mafic Volcanics (outlined in black). These possible wedges have not shown evidence of instability to date.

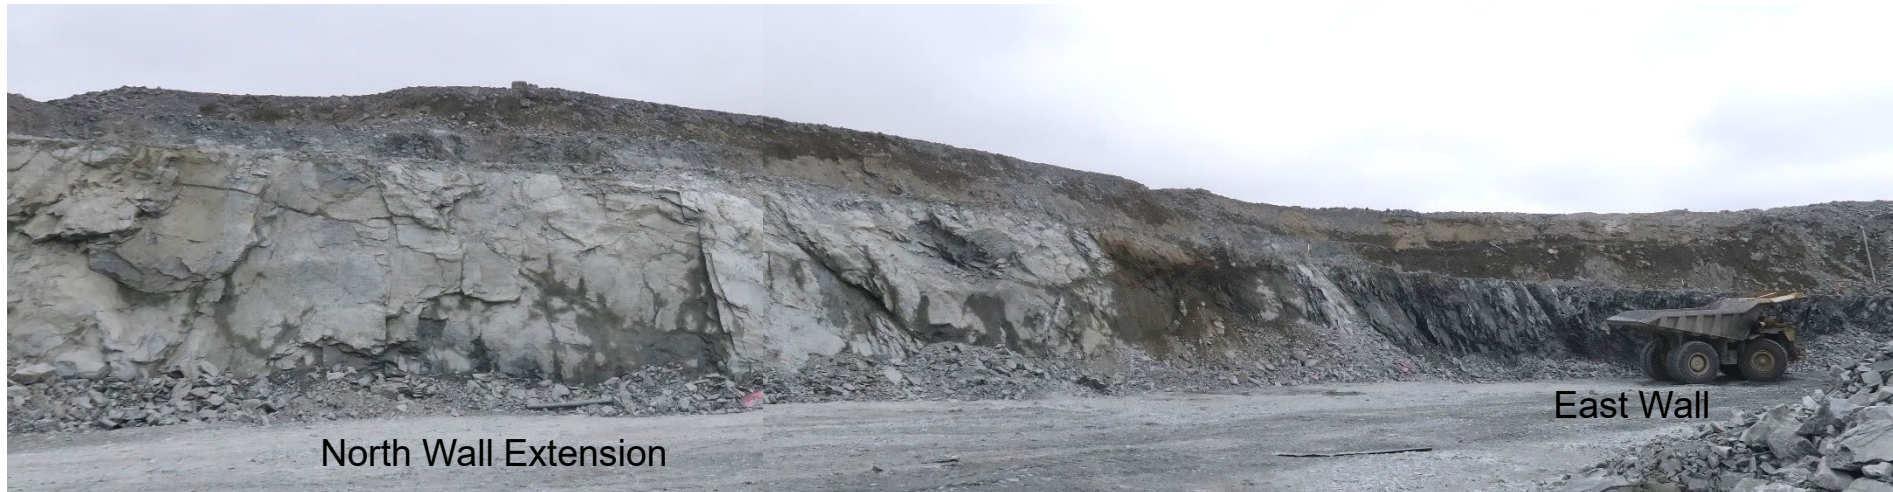
- The East Wall is being pushed back in anticipation of joining the IVR V2 and V1 open pits.
- At the time of the 2025 inspection, only a short interval of the East Wall was established and it had not yet been scaled. The East Wall below the pushback has not been advanced since the 2024 annual inspection and was largely obscured by overspill at the time of the 2025 inspection.
- The eastern extension of the North Wall has been exposed to a height of single bench and is shown below. The bench face is breaking back to the foliation, as expected. The orientation of the foliation and the lithologies forming the benches should be verified through mapping.
- The noses formed with the Turtlehead and with the IVR V1 open pit represent potential rockfall hazards. These will be mined out by the pushback, which is a favourable development from a geomechanical perspective.

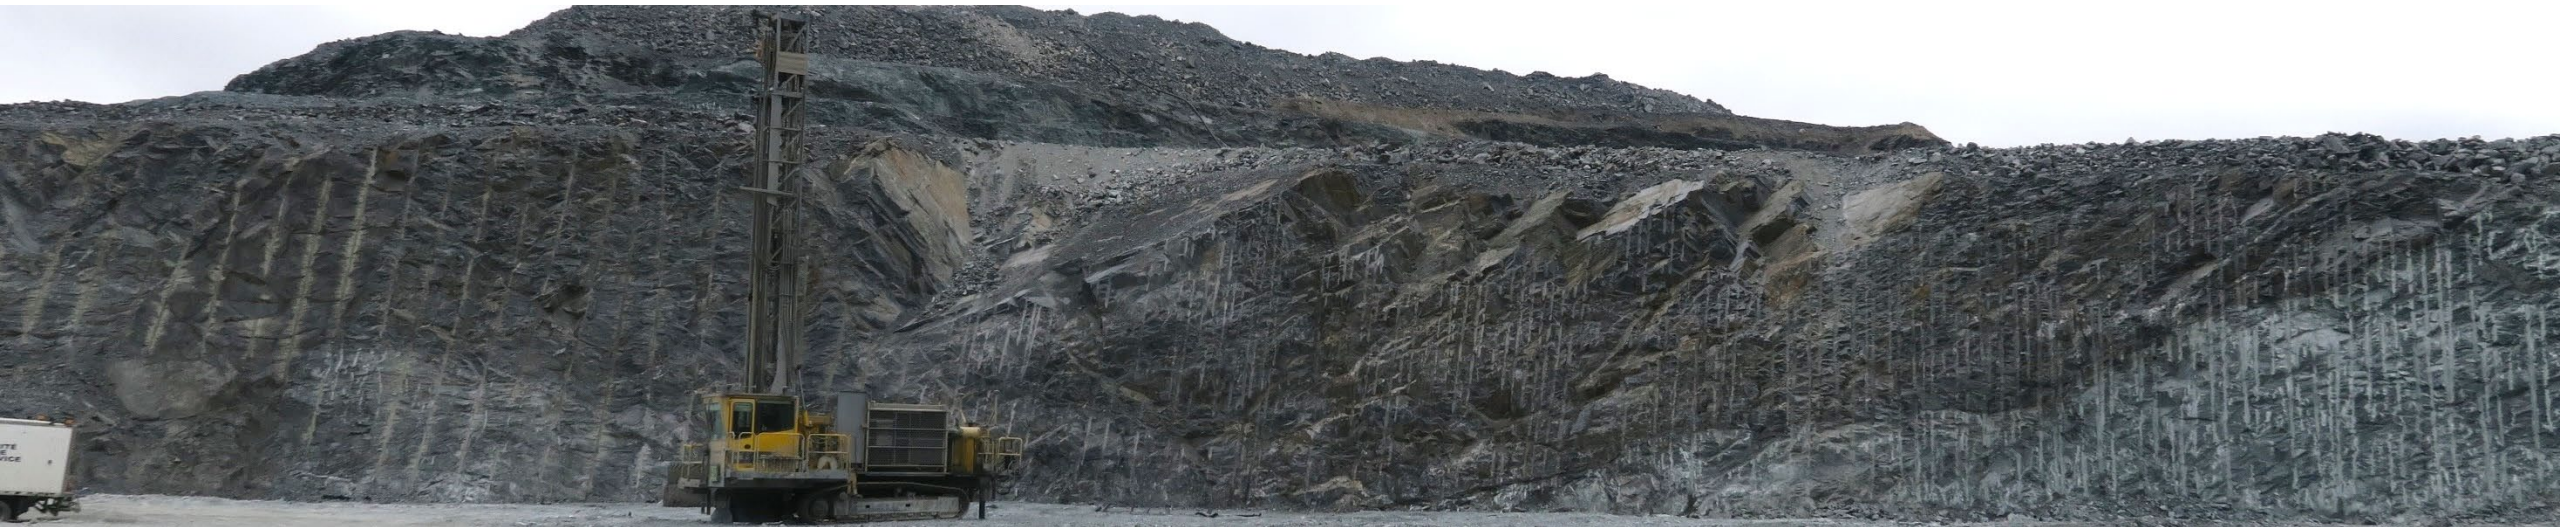
- The rock mass quality and rock mass structure in this wall are generally favourable and the performance of the initial bench has largely been consistent with expectations.
- However, a large potential wedge was identified in the initial flitch during mining and was proactively scaled out. Several smaller wedges formed by the same structures are present directly to the east of this area, at the crest.
- The joint sets that formed the wedge have not yet been confirmed. The sub-vertical set forming the eastern limit of the wedge may be Joint Set D while the shallower dipping set forming the western limit of the wedge may be Joint Set B. This should be confirmed and compared relative to the results of the stability analyses completed for this wall. If these features are more prominent than originally thought, the bench design may need to be adjusted.
