Whale Tail 2025 Annual Open Pit Geomechanical Inspection Report

March 10, 2026

RE: Meadowbank Complex - Amaruq Site - 2025 Annual Open Pit Geomechanical Inspection

2025 Annual Open Pit Geomechanical Inspection

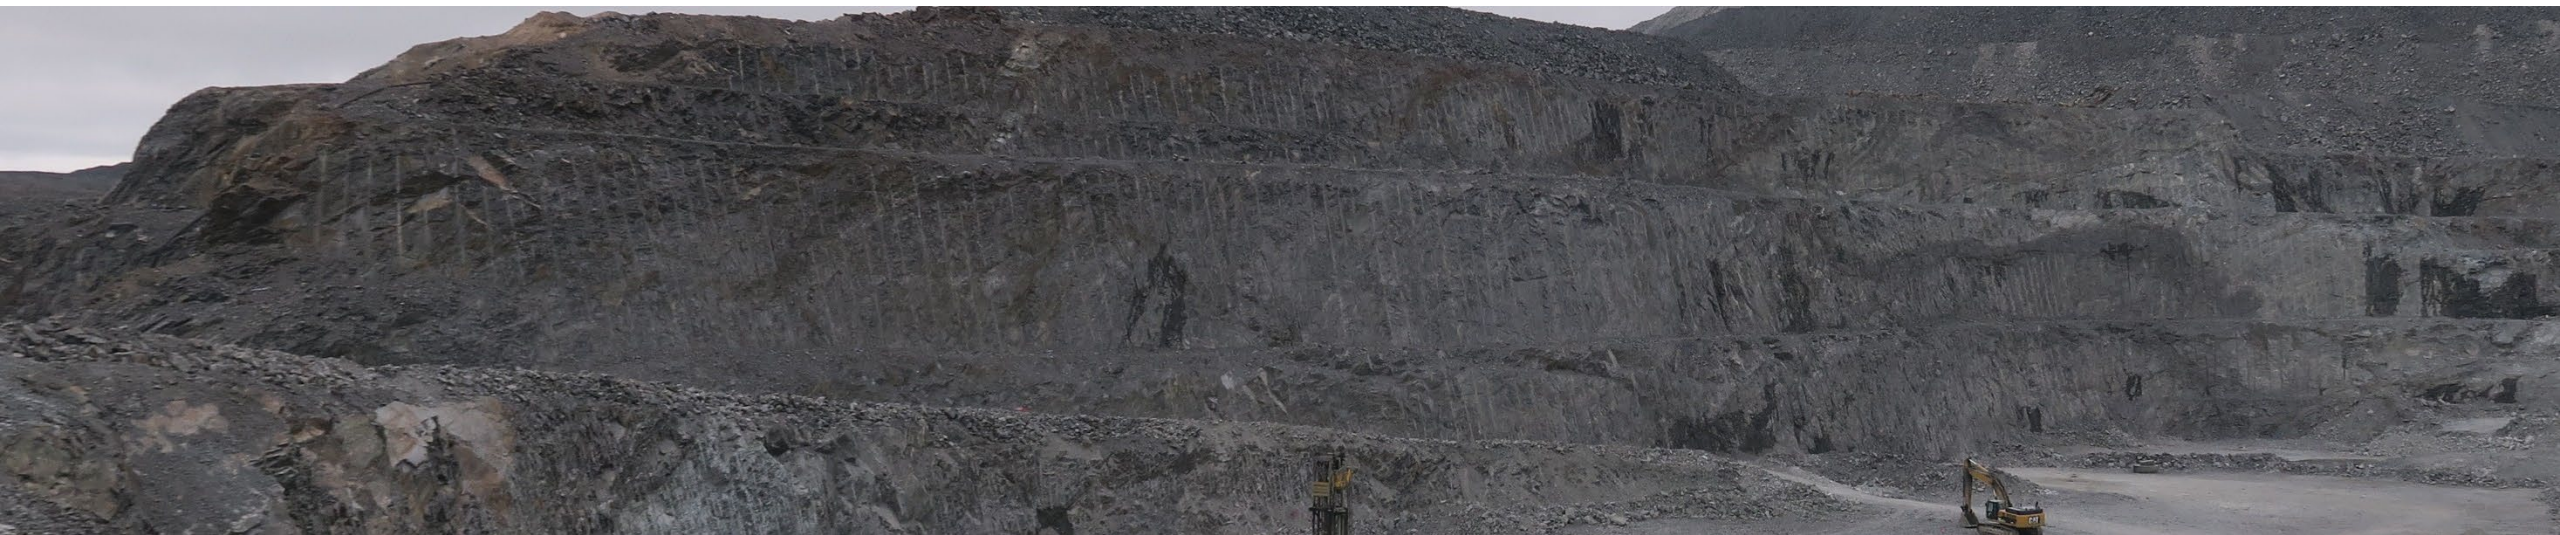
- The pushback of the west wall is complete and it has reached the current pit floor.
- The rock mass structure is favourable in this sector and the benches have performed well. The wall continues to benefit from the improvements to drilling and blasting practices in 2024. Half-barrels are regularly observed.

- Seepage has been consistently observed from the northwest corner when the IVR West 2 open pit is full of water. When it was dewatered, the seepage stopped. The IVR West 2 open pit is along strike from the IVR V2 open pit and this suggests that there are permeable, continuous, thawed structures connecting the two open pits despite the expected presence of permafrost. Consider keeping the IVR West 2 open pit dewatered to the extent practical.

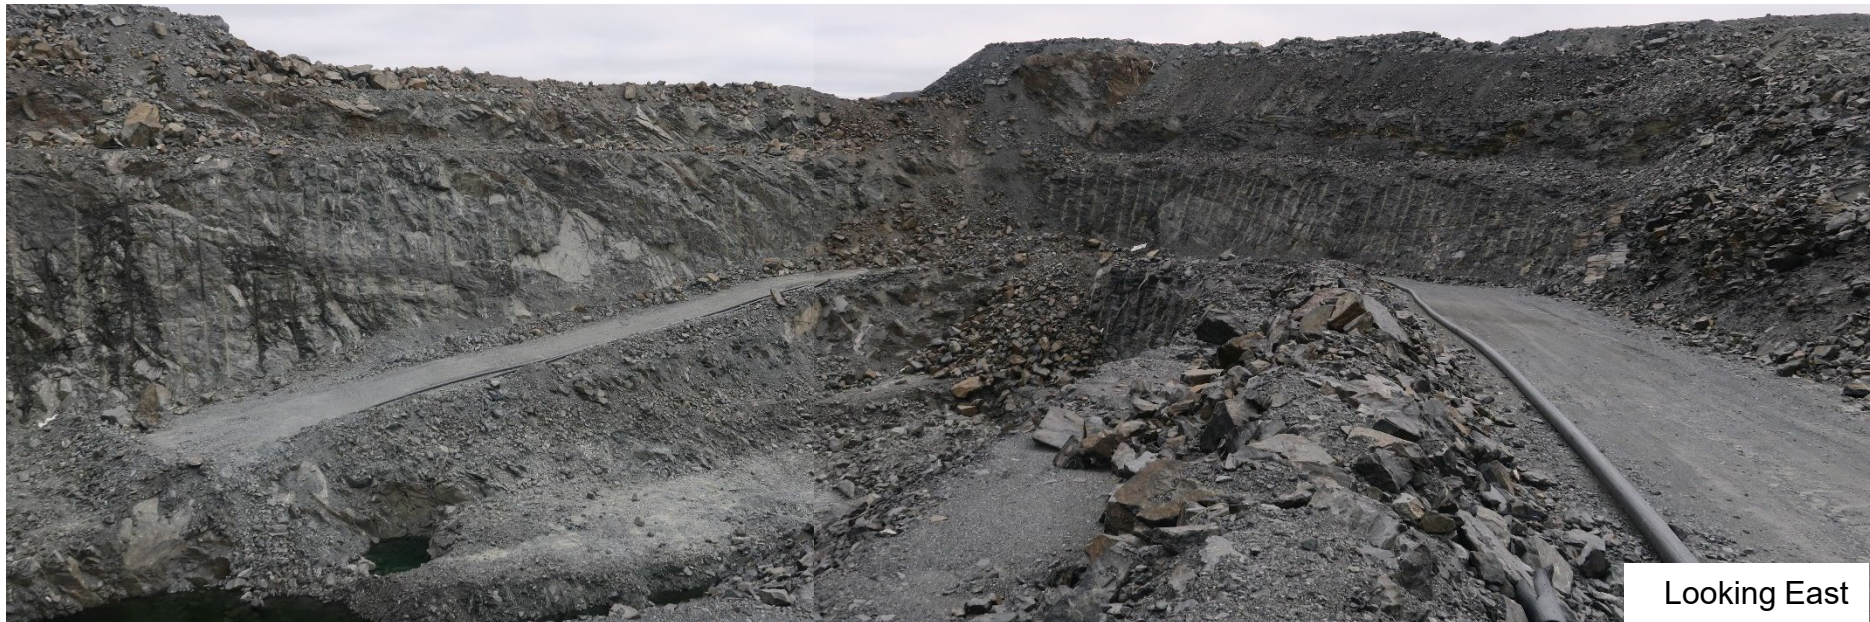
- Mining of the IVR West 2 pit is complete. Access to the ramp is restricted by candles. A berm is no longer present.
- It is understood that the pit is periodically used by dewatering personnel who travel along the ramp. A rock mechanics inspection is completed each time access is required. No dewatering infrastructure was present within the pit at the time of the annual inspection.
- Multiple rockfall hazards are present along the crest of the open pit above the ramp, typically associated with overspill. If access into the open pit continues to be required, these hazards need to be mitigated (e.g., by constructing a rockfall berm or removing the loose material on the slopes).

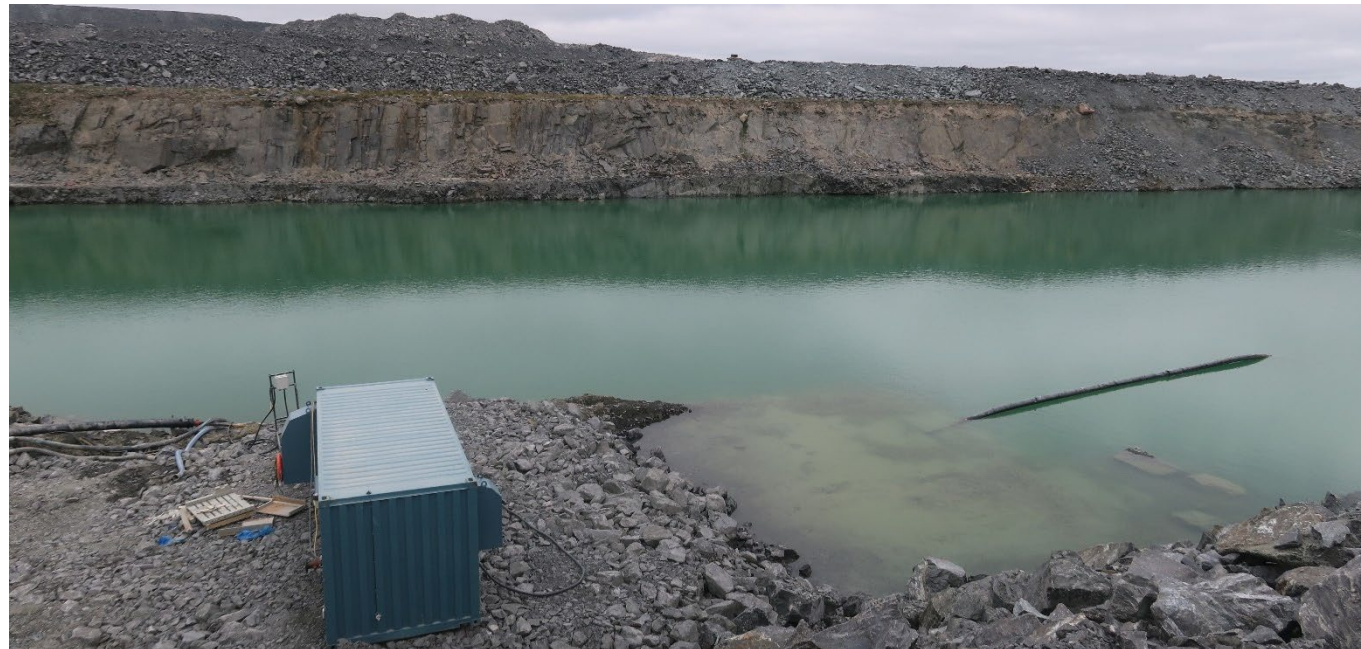
- Attenuation Pond 5 is a former quarry located to the east of the WHL open pit that is now used for water management. The pond was inspected on August 12, 2025.
- The pond is partially flooded, with one to two benches exposed above the pond water level. As a result, a detailed inspection could not be completed.
- No stability concerns were identified in the exposed slopes.
- Pumps were present at the time of the inspection.
