QA WEEKLY REPORT

DATE April 30th 2018 **Reference No.** 1897439-1577-TM-Rev0

QA WEEKLY REPORT FROM APRIL 23 TO 29 – TSF SOUTH CELL CONSTRUCTION MEADOWBANK (1897439)

QA WEEKLY REPORT FROM APRIL 30^{TH} TO MAY 6^{TH} – TSF SOUTH CELL CONSTRUCTION MEADOWBANK (1897439)

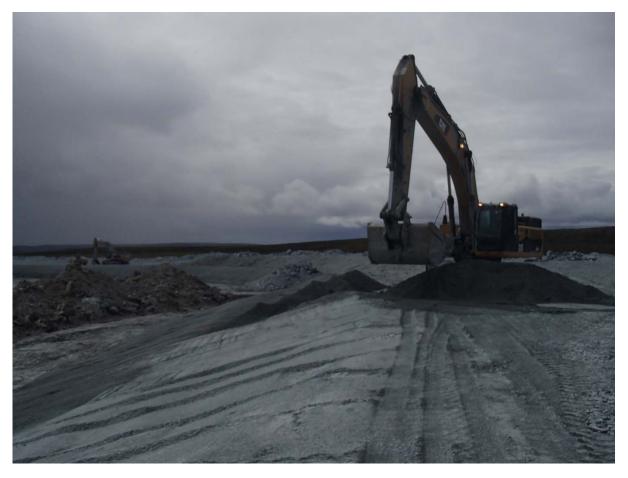
Photograph NCIS-135: From Sta. 1+860/-12 m (approx.), looking SW. Placement of a 0.5 m thick lift of fine filter in the upstream slope from El. 152 m to 154 m with an excavator from Sta. 1+830 m to 1+700 m.

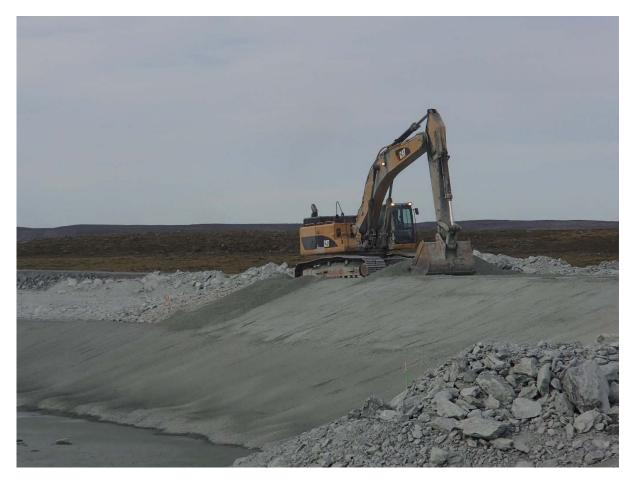
Photograph NCIS-136: From Sta. 1+800/-33 m (approx.), looking SW. Placement of a 0.5 m thick lift of fine filter in the upstream slope from El. 152 m to 154 m with an excavator from Sta. 1+700 m to 1+660 m.

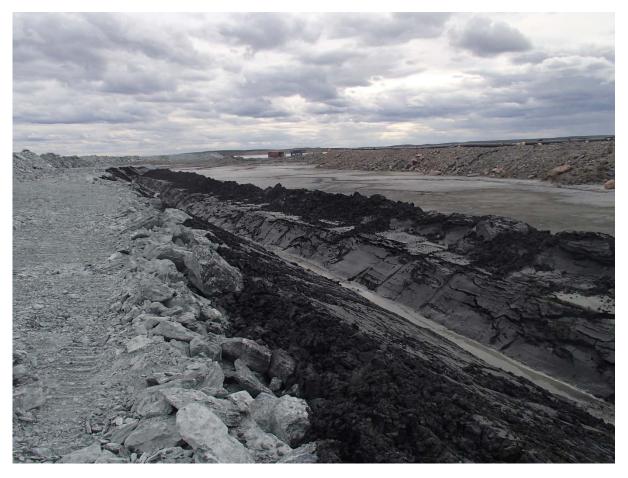
Photograph NCIS-137: From Sta. 1+380/+14 m (approx.), looking SW. Excavation of a 0.8 m (approx.) deep, 1 m wide shallow ditch in the tailings with an excavator from Sta. 1+300 m to 1+200 m.

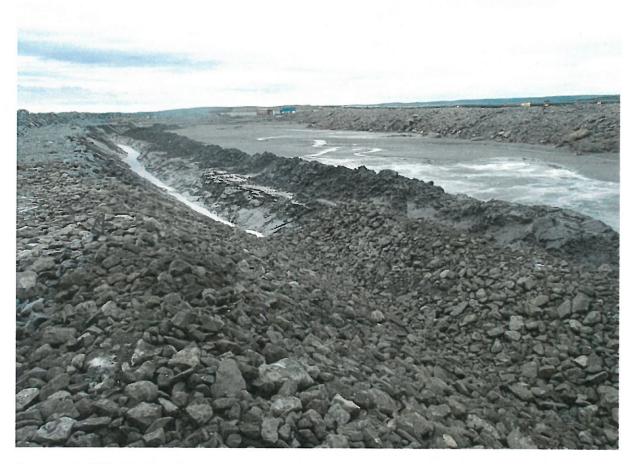
Photograph NCIS-138: From Sta. 1+365/+15 m (approx.), looking SW. Excavation of a 0.8 m (approx.) deep, 1 m wide shallow ditch in the tailings and placement of a 0.3 m thick (approx.) layer of till sieving reject material on the bottom

and on the slopes of the ditch from Sta. 1+200 m to 1+100 m.

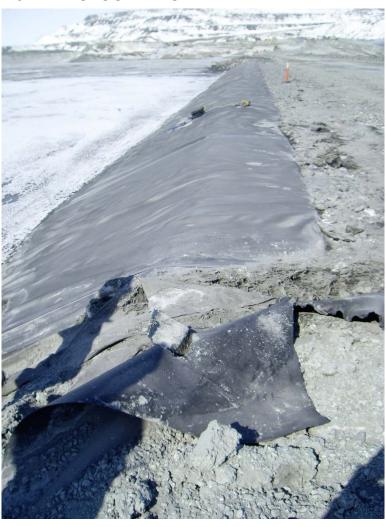
- The LLDPE liner installed on the upstream slope of Central Dike has been damaged near the deposition finger at approx. Sta. 0+650 m during snow removal operations. The amount of repairs required will be estimated when the deposition finger is removed entirely before installation of the new liner at El. 145 m.

Photograph CD-1796: From Sta. 0+650/-28 m, looking N. Damaged geomembrane near a deposition finger on Central Dike.

- Evaluate the LLDPE liner damages on the upstream slope of Central Dike.
- Inspect the LLDPE rolls stored on trailers outside once the snow has melted.

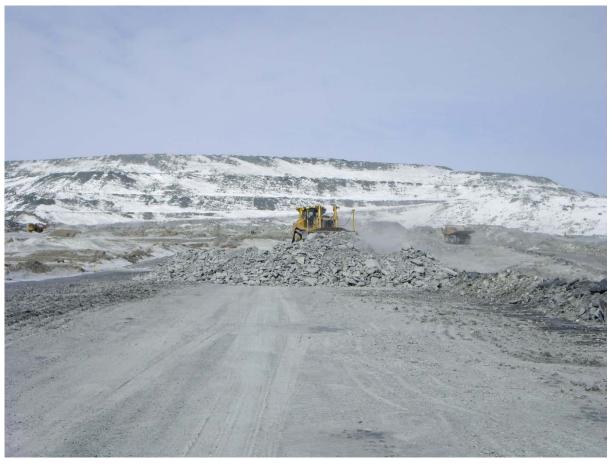
Photograph CD-1797: From Sta. 0+320/-20 m, looking N. Placement of a 2 m thick (approx.) lift of intermediate volcanic (IV) rockfill from El. 143 m to El. 145 m from 0+250 to 0+400 m (o.s. -28 to -18 m).

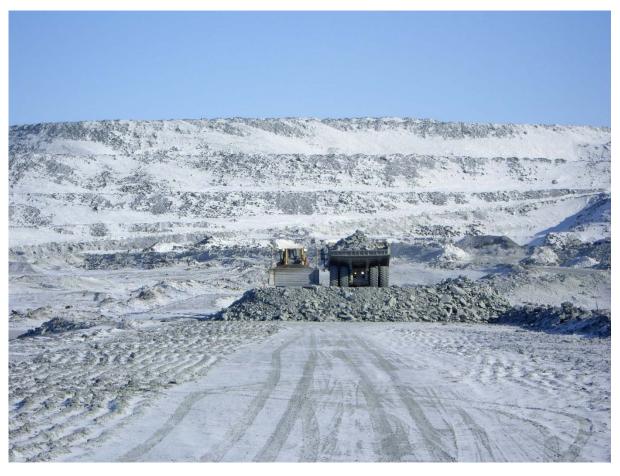
Photograph CD-1798: From Sta. 0+500/-15 m looking N. Placement of a 2 m thick (approx.) lift of intermediate volcanic (IV) rockfill from El. 143 m to El. 145 m from 0+340 to 0+435 m (o.s. -28 to -18 m).

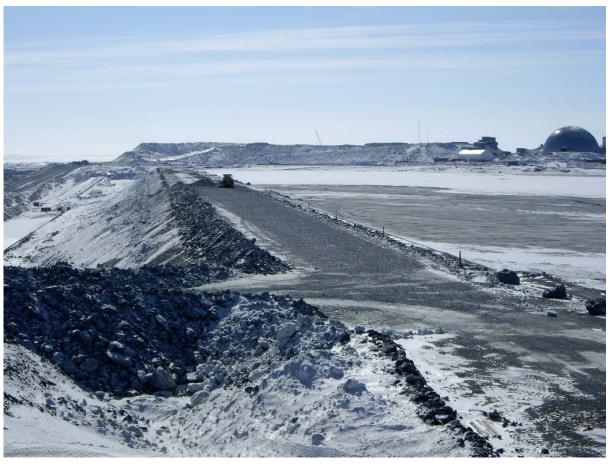
Photograph CD-1799: From Sta. 0+080/-25 m looking S. Placement of a 2 m thick (approx.) lift of intermediate volcanic (IV) rockfill from El. 143 m to El. 145 m from 0+340 to 0+435 m (o.s. -28 to -18 m).

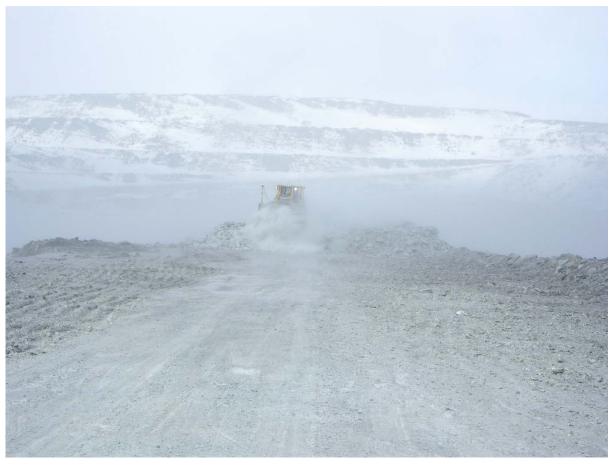
Photograph CD-1800: From Sta. 0+500/-14 m looking N. Placement of a 2 m thick (approx.) lift of intermediate volcanic (IV) rockfill from El. 143 m to El. 145 m from 0+435 to 0+535m (o.s. -28 to -18 m).

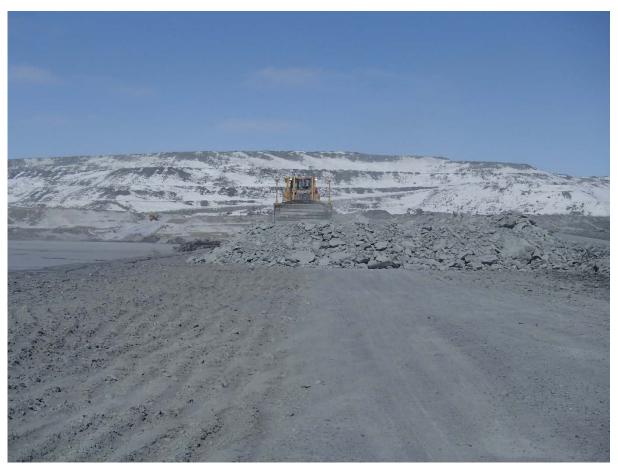
Photograph CD-1801: From Sta. 0+650/-10 m looking N. Placement of a 2 m thick (approx.) lift of intermediate volcanic (IV) rockfill from El. 143 m to El. 145 m from 0+535 to 0+625m (o.s. -28 to -18 m).

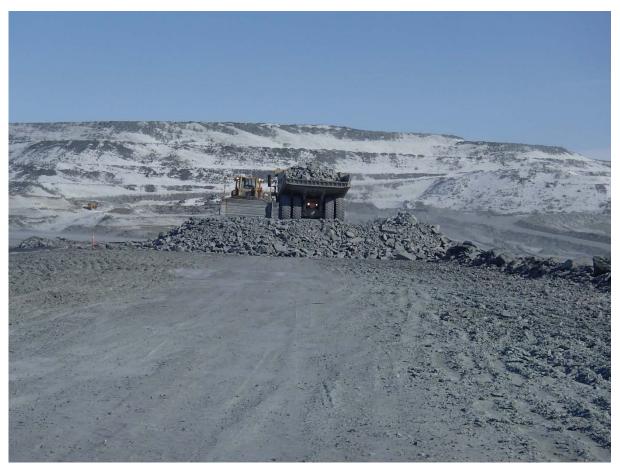
Photograph CD-1802: From Sta. 0+770/-16 m looking N. Placement of a 2 m thick (approx.) lift of intermediate volcanic (IV) rockfill from El. 143 m to El. 145 m from approx. Sta. 0+525 to 0+710 m (o.s. -28 to -18 m).

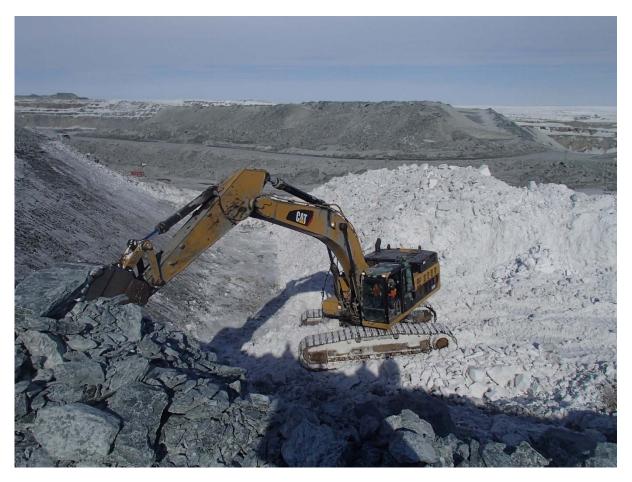
Photograph CD-1803: From Sta. 40+750/27 m looking NE. Removal of snow to expose the foundation bedrock with an excavator between approx. Sta. 40+780 and 40+800 m (o.s. 7 to 10 m).

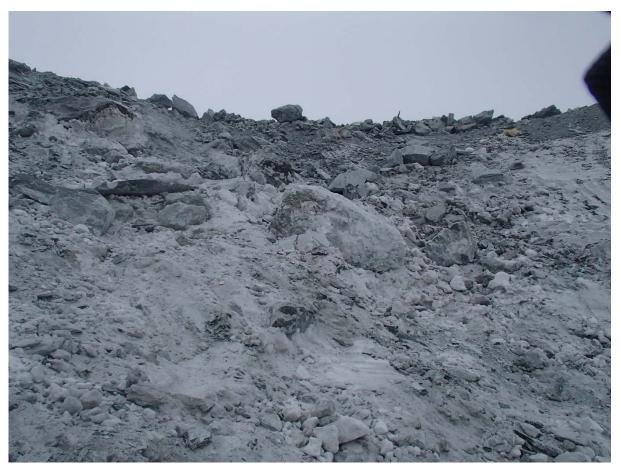
Photograph CD-1804: From Sta. 40+790/-2 m looking S. Presence of oversize boulders on the existing slope at the junction between SD5 and Central Dike.

- Following advice from the QA Engineer, some oversize boulders (>1.3 m in diameter) were removed from the slope of the dike before placement of rockfill at these elevations on the south part of Central Dike where the footprint was widened (see photograph in Section 7.0).

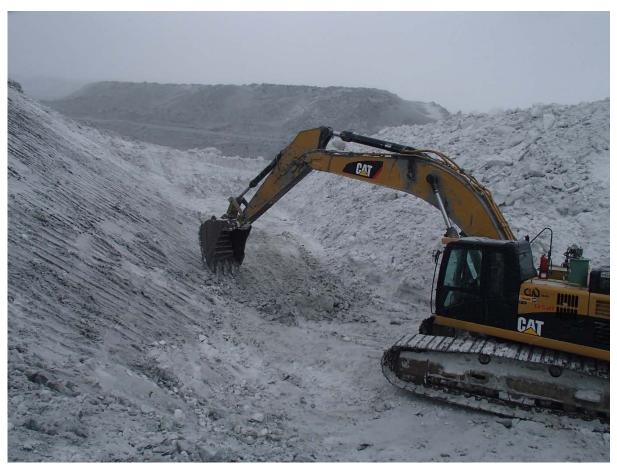
Photograph CD-1805: From Sta. 40+780/2 m looking NE. Final clean-up of footprint with an excavator to reach a good quality bedrock from Sta. 40+780 to 40+805 m (o.s. -6 to 9 m).

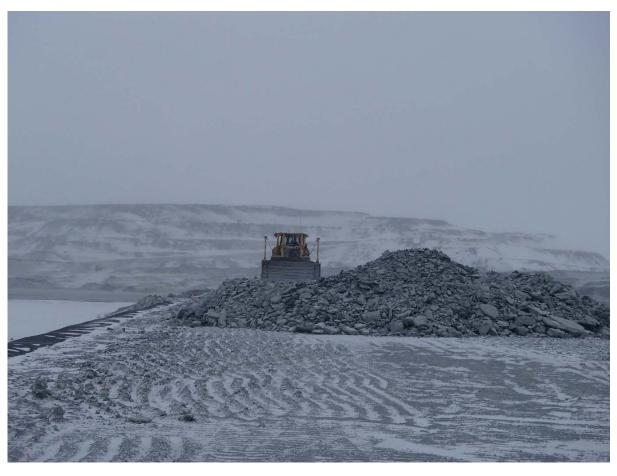
Photograph CD-1806: From Sta. 0+800/-27 m looking N. Placement a 2 m thick (approx.) lift of intermediate volcanic (IV) rockfill from El. 143 m to El. 145 m from approx. Sta. 0+710 to 0+760 m (o.s. -28 to 3 m).

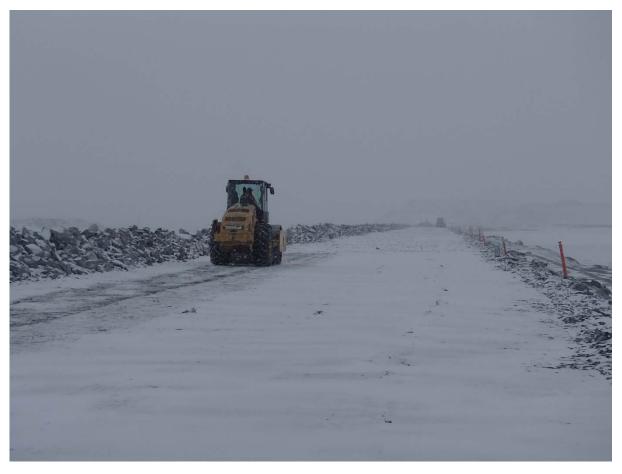
Photograph CD-1807: From Sta. 0+200/-15 m looking S. Compaction of the 2 m lift (approx.) of IV rockfill at El. 145 m with a 10-tonne smooth-drum compactor with vibration (6 passes) from Sta. 0+150 to 0+280 m (o.s. -21 to 11 m).

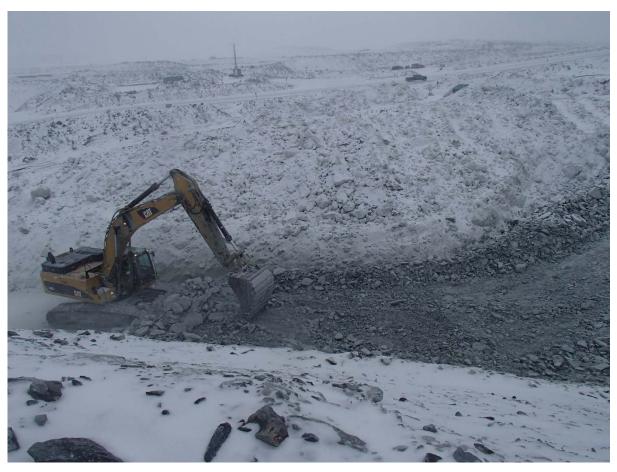
Photograph CD-1808: From Sta. 40+790/-14 m looking E. Placement of a 1.5 m thick (approx.) lift of intermediate volcanic (IV) rockfill from approx. Sta. 40+780 to 40+805 m (o.s. -6 to 9 m).

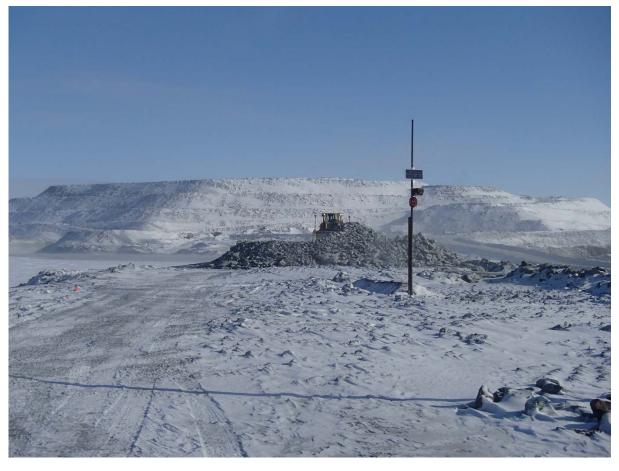
Photograph CD-1809: From Sta. 0+870/-16 m looking N. Placement of a 2 m thick (approx.) lift of intermediate volcanic (IV) rockfill from El. 143 m to El. 145 m from approx. Sta. 0+760 to 0+835 m (o.s. -28 to 3 m).

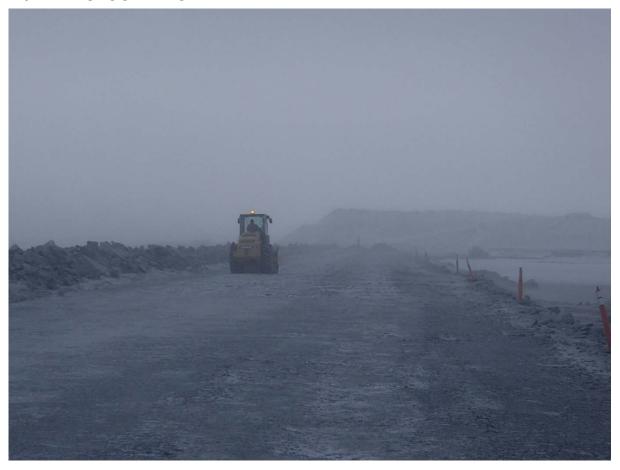
Photograph CD-1810: From Sta. 0+335/-15 m looking S. Compaction of the 2 m lift (approx.) of IV rockfill at El. 145 m with a 10-tonne smooth-drum compactor with vibration (6 passes) from Sta. 0+350 to 0+540 m (o.s. -19 to -7 m).

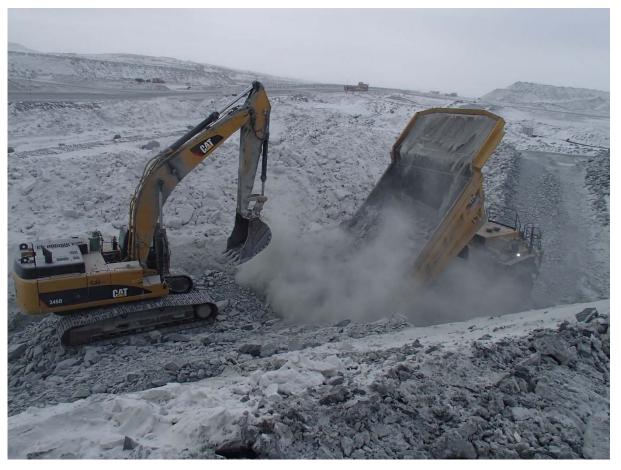
Photograph CD-1811: From Sta. 0+985/-11 m looking SE. Placement the second, third, fourth and fifth 1 m thick (approx.) lifts of intermediate volcanic (IV) rockfill from approx. Sta. 0+985 to 40+780 m (o.s. -8 to 8 m) with the excavator.

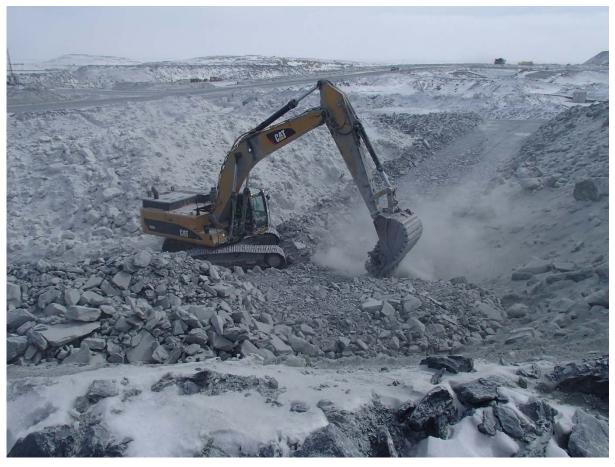
Photograph CD-1812: From Sta. 0+985/-11 m looking SE. Placement of intermediate volcanic (IV) rockfill on the existing downstream slope up to approx. El. 140 m, from approx. Sta. 0+985 to 40+780 m.

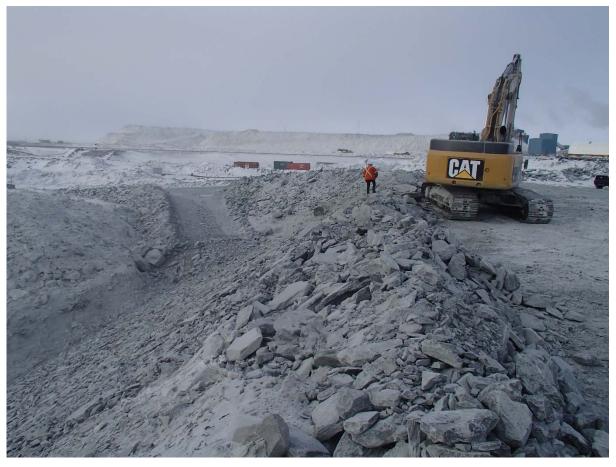
Photograph CD-1813: From Sta. 0+980/-2, looking S. Placement of intermediate volcanic (IV) rockfill on the existing downstream slope up to approx. El. 143 m, from approx. Sta. 0+980 to 40+780 m.

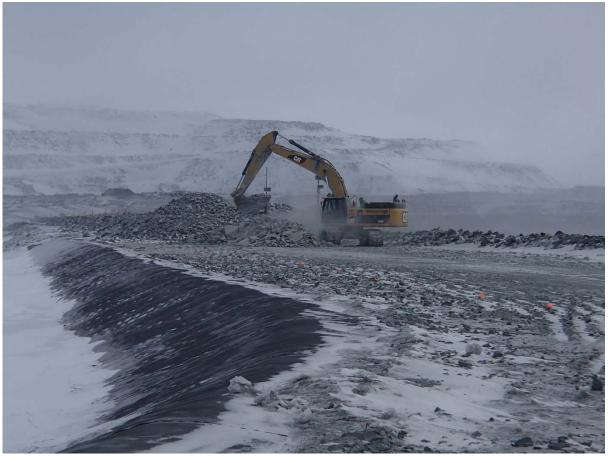
Photograph CD-1814: From Sta. 0+970/-10, looking NE. Placement of intermediate volcanic (IV) rockfill around the instruments at approx. Sta. 0+830 m with the excavator.

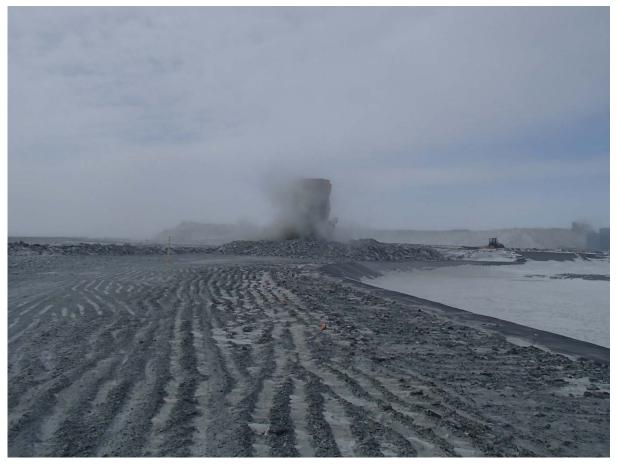
Photograph CD-1815: From Sta. 0+920/-25, looking S. Placement of a 2 m thick (approx.) lift of intermediate volcanic (IV) rockfill from El. 143 m to El. 145 m from approx. Sta. 40+740 to 0+980 m (o.s. -28 to -11 m).

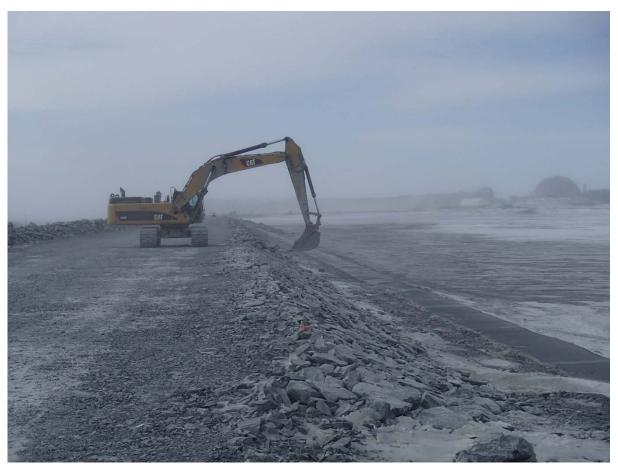
Photograph CD-1816: From Sta. 0+175/-27, looking S. Profiling of the upstream slope (2H:1V) from El. 143 to 145 m with an excavator between Sta. 0+175 and 0+560 m.

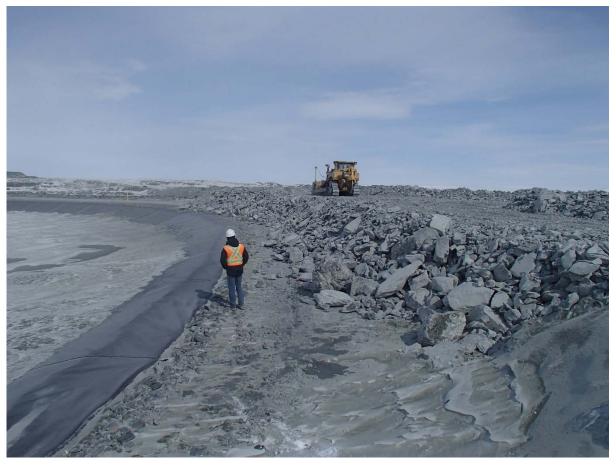
- It was observed that when using the D9 bulldozer, which does not have a GPS to monitor elevation, the intermediate volcanic (IV) rockfill lift thickness was slightly in excess of 2 m (approx. 2.5 m) on Central Dike, at the junction with Saddle Dam 5. The bulldozer was replaced with the GPS-equipped D8 bulldozer used in the previous days, which ensured that the elevation of the lift was at 145m.

Photograph CD-1817: From Sta. 40+700/-10, looking NE. View of the rockfill lift thickness at the junction of Saddle Dam 5 and Central Dike, approx. 2.5 m thick.

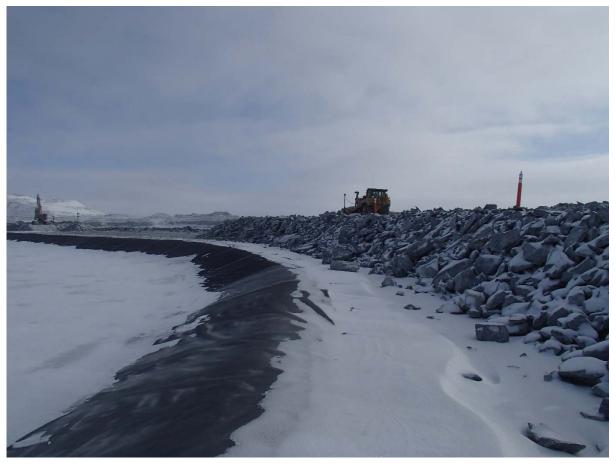
Photograph CD-1818: From Sta. 40+770/-25, looking NE. Placement of a 2 m thick (approx.) lift of intermediate volcanic (IV) rockfill from El. 143 m to El. 145 m from approx. Sta. 0+980 m to 0+880 m (o.s. -28 to -11 m).

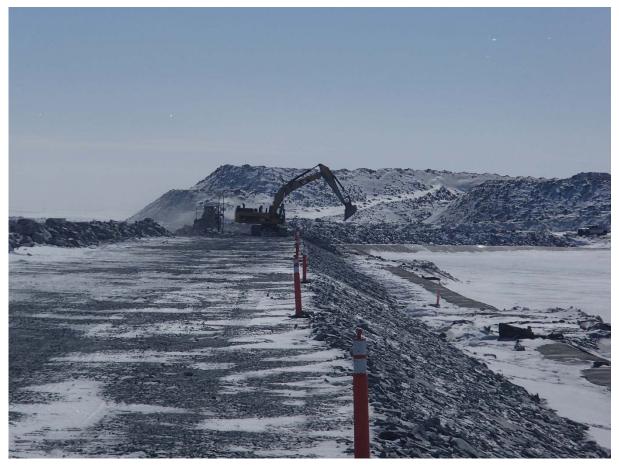
Photograph CD-1819: From Sta. 0+560/-21, looking S. Profiling of the upstream slope (2H:1V) from El. 143 to 145 m with an excavator between Sta. 0+560 m and 0+830 m.

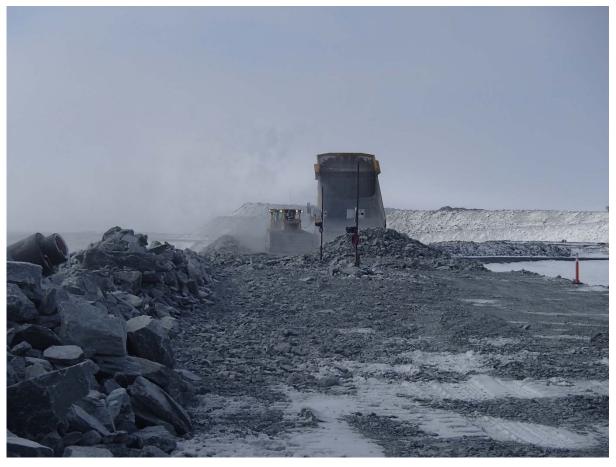
Photograph CD-1820: From Sta. 0+790/-7, looking S. Placement of a 2 m thick (approx.) lift of intermediate volcanic (IV) rockfill from El. 143 m to El. 145 m from approx. Sta. 0+880 m to 0+830 m (o.s. -28 to -11 m).

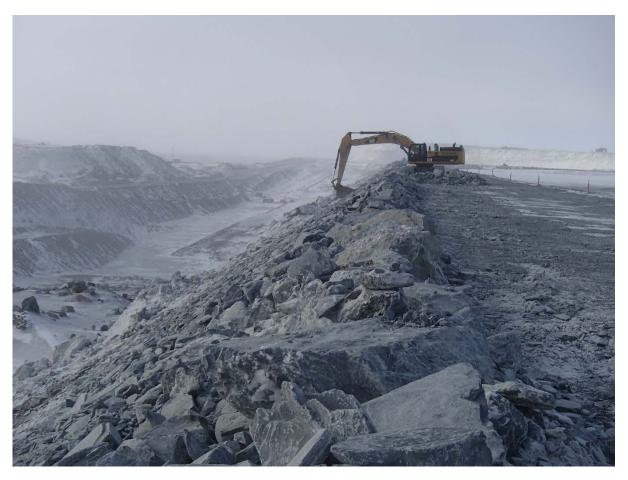
Photograph CD-1821: From Sta. 0+175/+3, looking S. Profiling of the downstream slope (1.5H:1V) from El. 143 to 145 m with an excavator between Sta. 0+250 m and 0+330 m.

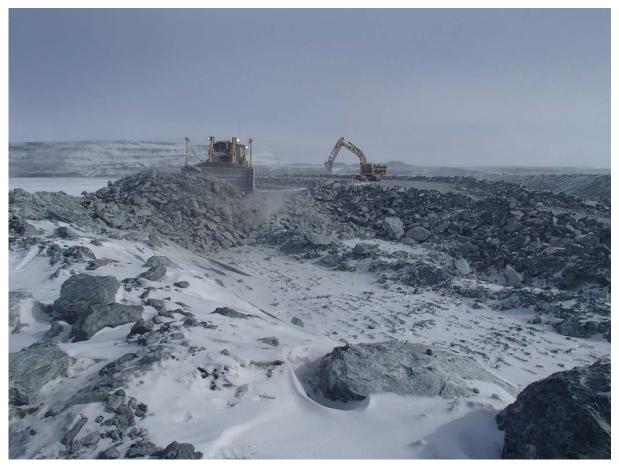
Photograph CD-1822: From Sta. 40+725/+7, looking N. Placement of two 2 m thick (approx.) lifts of intermediate volcanic (IV) rockfill from El. 141 m to El. 145 m from approx. Sta. 40+720 m to 40+750 m (o.s. -10 to +10 m) and profiling of the upstream slope (2H:1V) from El. 143 to 145 m with an excavator between Sta. 0+830 m and 0+980 m.

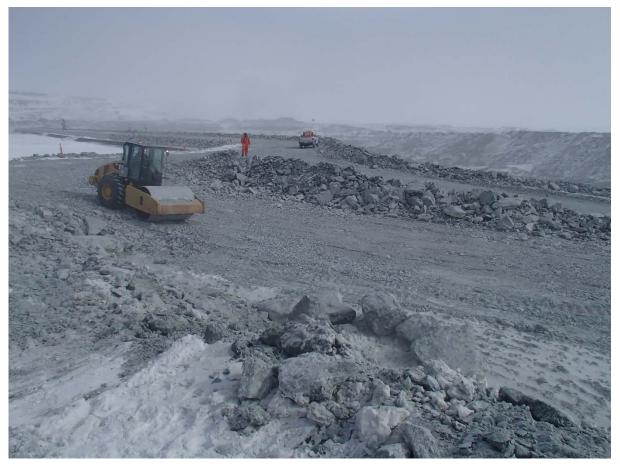
Photograph CD-1823: From Sta. 0+175/+8, looking NE. Compaction of the two 2 m lifts (approx.) of intermediate volcanic (IV) rockfill at El. 143 and at El. 145 m with a 10-tonne smooth-drum compactor with vibration (6 passes) from Sta. 40+720 m to 40+750 m (o.s. -10 to +10 m).

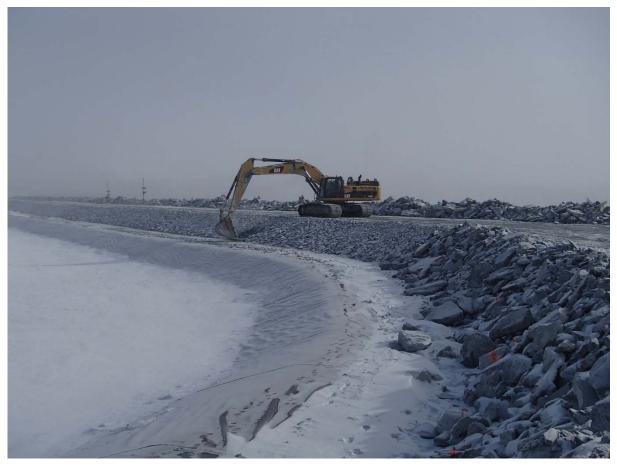
Photograph CD-1824: From Sta 40+760/-25 m, looking NE. Profiling of the upstream slope (2H:1V) from El. 143 to 145 m with an excavator between Sta. 0+830 m and 40+730 m.

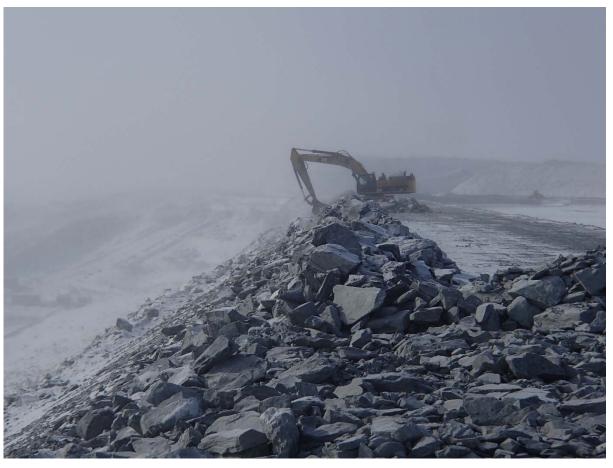
Photograph CD-1825: From Sta 0+430/+9 m, looking S. Profiling of the downstream slope (1.5H:1V) from El. 143 to 145 m with an excavator between Sta. 0+330 m and 0+440 m and between Sta. 0+530 m and 0+745 m.
