#### QA WEEKLY REPORT

**DATE** May 14th 2018 1897439-1577-TM-Rev0

# QA WEEKLY REPORT FROM MAY $7^{TH}$ TO MAY $13^{TH}$ – TSF SOUTH CELL CONSTRUCTION MEADOWBANK (1897439)

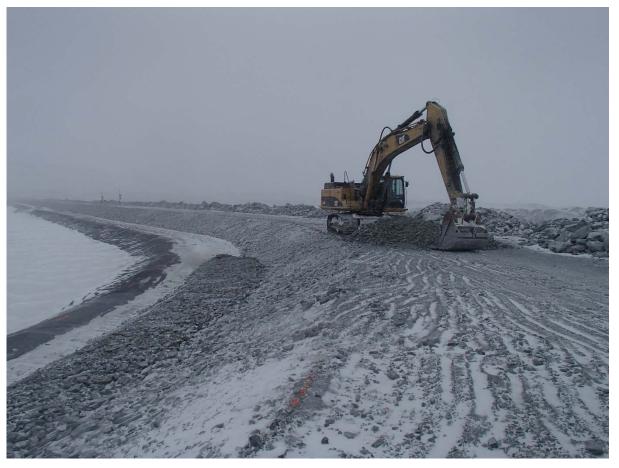
Photograph CD-1826: From Sta 40+770/-27 m, looking NE. Placement of a 0.5 m thick lift of coarse filter from El. 143 m to 143.5 m with an excavator from Sta. 40+730 m to 0+775 m.

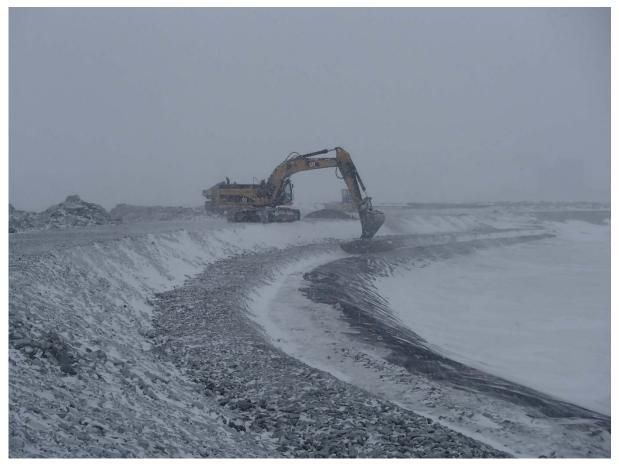
Photograph CD-1827: From Sta 0+940/-16 m, looking SW. Placement of a 0.5 m thick lift of fine filter from El. 143 m to 143.5 m with an excavator from Sta. 40+730 m to 0+835 m.

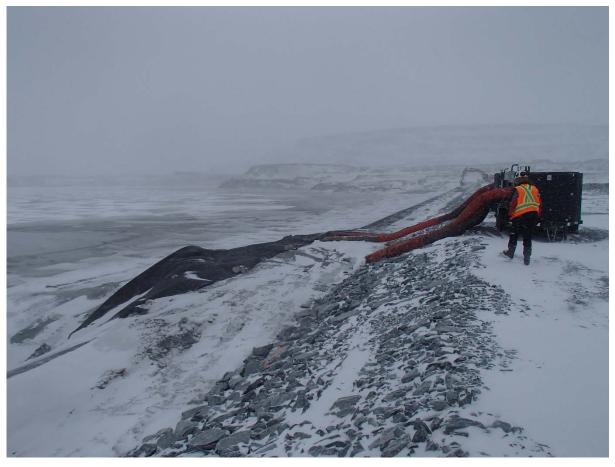
Photograph CD-1828: From Sta 0+410/-22 m, looking N. Defrosting of the deposition finger materials with two Frost Fighters at Sta. 0+390 m.

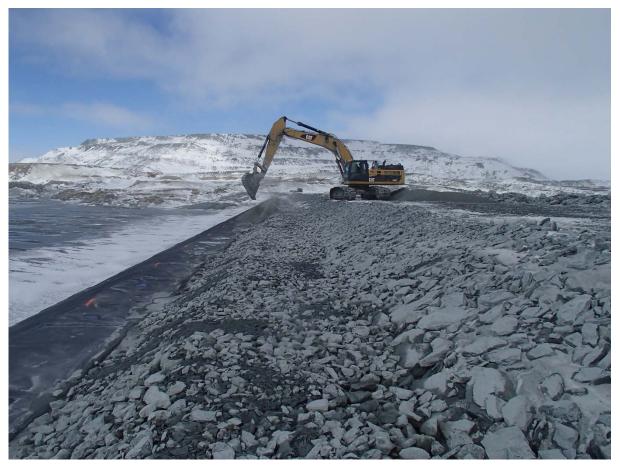
Photograph CD-1829: From Sta 0+410/-22 m, looking N. Placement of a 0.5 m thick lift of coarse filter from El. 143 m to 143.5 m with an excavator from Sta. 0+170 m to 0+460 m and placement of a 0.5 m thick lift of fine filter from Sta. 0+170 m to 0+380 m.

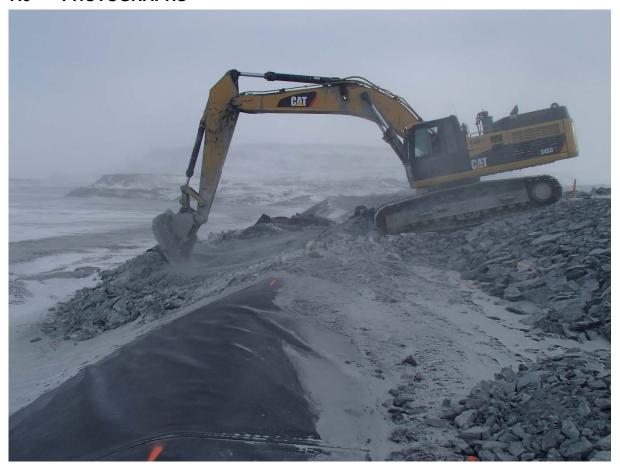
- The removal of the material on the four deposition fingers to expose 1 m of liner is complete. Only the first deposition finger materials at approx. Sta. 0+390 m were heated before their removal. It was noticed that the materials could be easily removed without heating, since a protection layer (Teranap) had been put in place prior to the construction of the deposition finger.

Photograph CD-1830: From Sta. 0+420/-26 m, looking N. Removal of the deposition point finger materials with an excavator at Sta. 0+390 m.

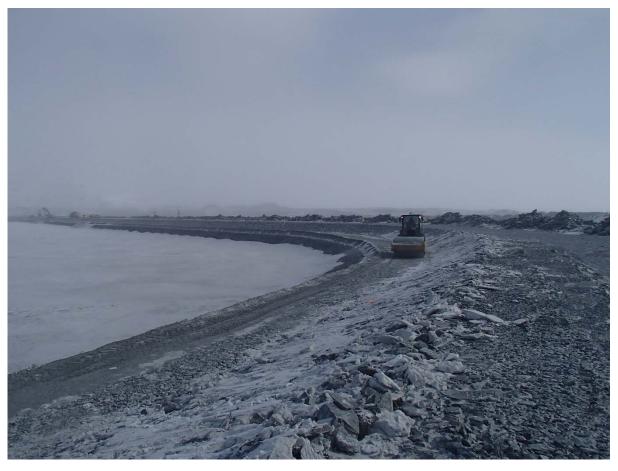
Photograph CD-1831: From Sta. 40+730/-24 m, looking NE. Compaction of the first 0.5 m lift (approx.) of fine and coarse filters material at El. 143.5 m with a 10-tonne smooth-drum compactor with vibration (6 passes) from Sta. 40+730 m to 0+830 m and from Sta. 0+175 m to 0+490 m.

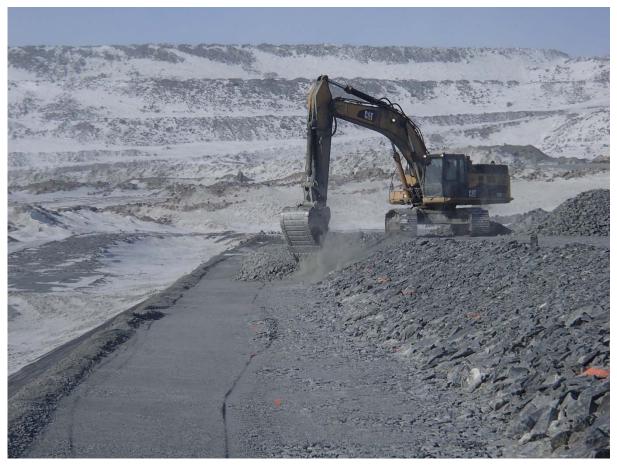
Photograph CD-1832: From Sta. 0+280/-25 m, looking N. Placement of a second 0.5 m thick lift of coarse filter from El. 143.5 m to 144 m with an excavator from Sta. 0+175 m to 0+280 m.

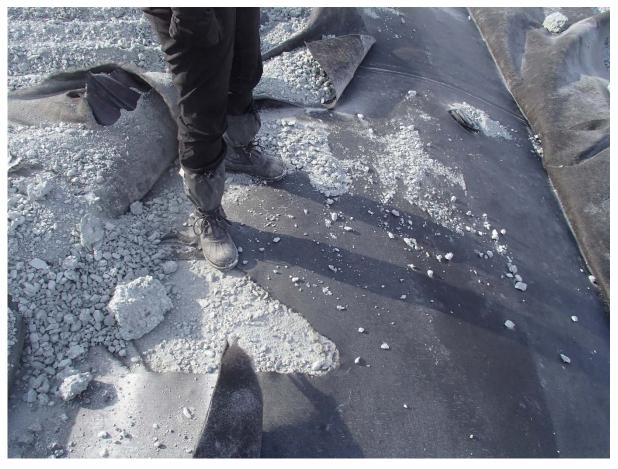
- Punctures were noticed on the top of the LLDPE liner around the four deposition fingers which were removed with the excavator. The holes all seem to be located above El. 142 m, where the horizontal extrusion weld for the raise of the liner is planned to be done. An inspection to assess the damages to the LLDPE liner on the upstream slope of Central Dike will be performed by the QA Manager.

Photograph CD-1833: From Sta. 0+390/-25 m, looking S. Damaged geomembrane near a deposition finger on Central Dike at Sta. 0+390 m.

- Evaluate the LLDPE liner damages on the upstream slope of Central Dike.
- Inspect the LLDPE rolls stored on trailers outside once the snow has melted.
- Make a decision regarding the design changes to apply to the SD3 LLDPE liner protection cover.

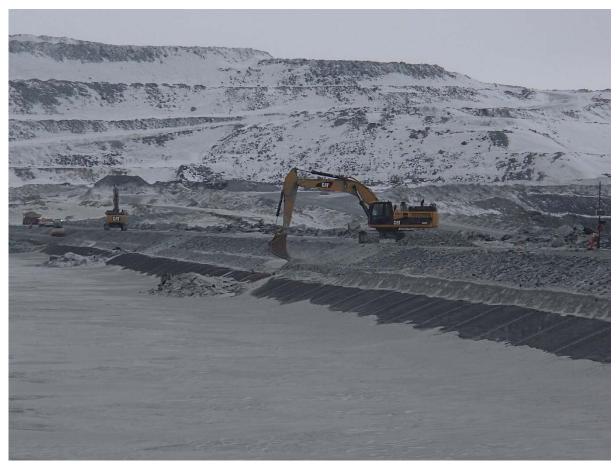
Photograph CD-1834: From Sta. 40+760/-23 m, looking NE. Placement of a first 0.5 m thick lift of coarse filter from El. 143 m to 143.5 m on length of approx. 5 m with an excavator at the location of the deposition finger at Sta. 0+520 m and 0+660 m.

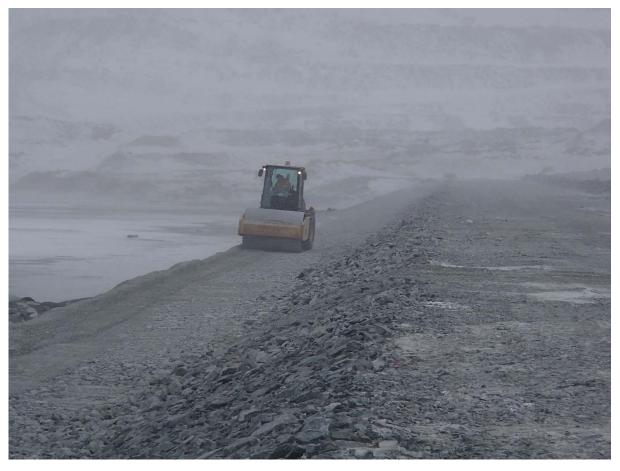
Photograph CD-1835: From Sta. 0+830/-20 m, looking N. Compaction of the first 0.5 m lift (approx.) of fine and coarse filters material at El. 143.5 m with a 10-tonne smooth-drum compactor with vibration (6 passes) from Sta. 0+490 to 0+835 m.

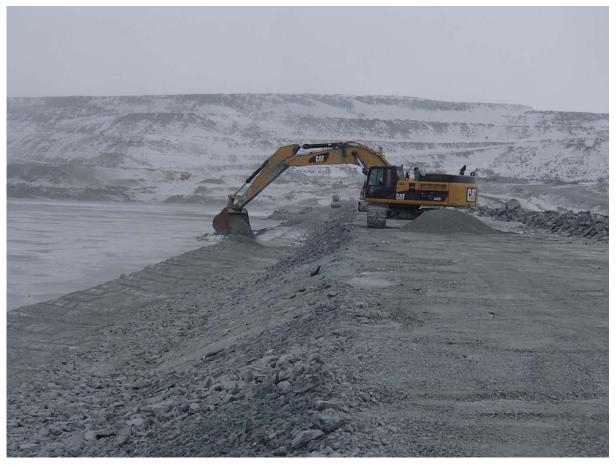
Photograph CD-1836: From Sta. 0+830/-20 m, looking N. Placement of a first 0.5 m thick lift of fine filter from El. 143 m to 143.5 m upstream of the coarse filter with an excavator from Sta. 0+490 to 0+835 m.

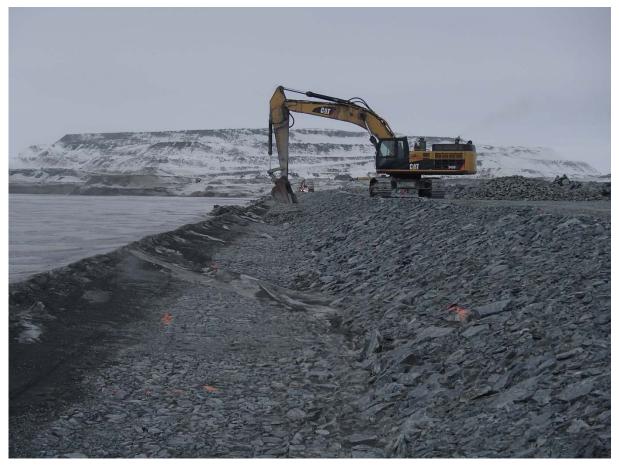
Photograph CD-1837: From Sta. 0+940/-25 m, looking N. Placement of a second 0.5 m thick lift of coarse filter from El. 143.5 m to 144 m with an excavator from Sta. 0+290 to 0+500 m and from Sta. 0+835 to 0+930 m.

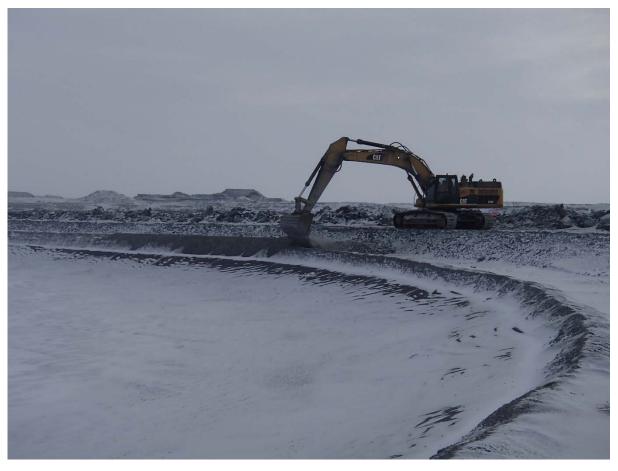
Photograph CD-1838: From Sta. 40+750/-31 m, looking NE. Placement of a second 0.5 m thick lift of fine filter from El. 143.5 m to 144 m upstream of the coarse filter with an excavator from Sta. 0+500 m to 0+835 m and from Sta. 0+930 to 40+730 m.

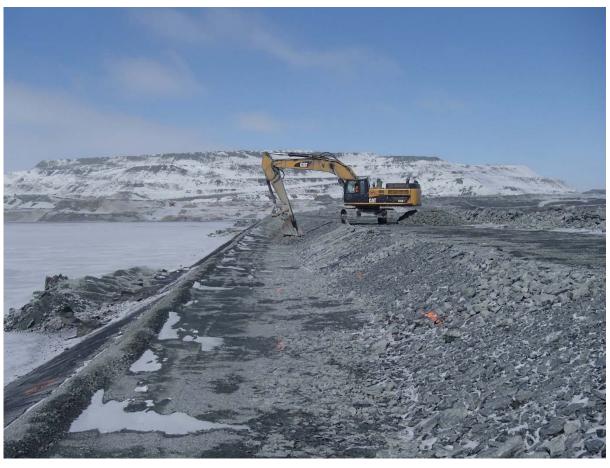
Photograph CD-1838: From Sta. 0+835/-20 m, looking N. Placement of a second 0.5 m thick lift of coarse filter from El. 143.5 m to 144 m with an excavator from Sta. 0+500 m to 0+835 m and from Sta. 0+930 to 40+730 m.

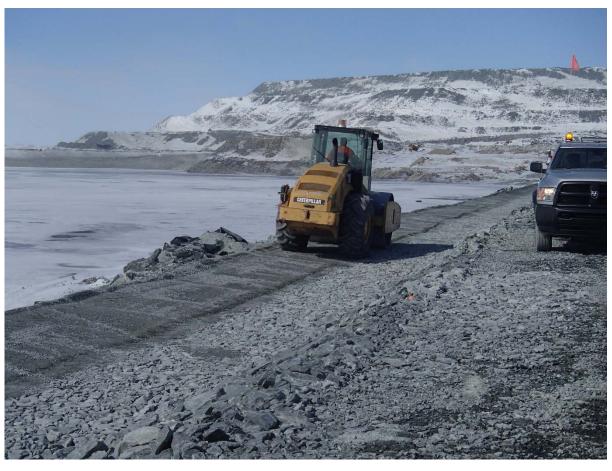
Photograph CD-1840: From Sta. 0+575/-15 m, looking NW. Compaction of the second 0.5 m lift (approx.) of fine and coarse filters material at El. 144 m with a 10-tonne smooth-drum compactor with vibration (4 passes) from Sta. 0+500 m to 40+730 m.

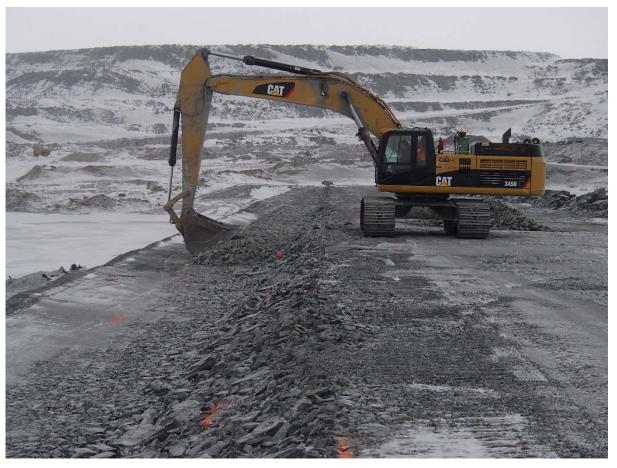
Photograph CD-1841: From Sta. 0+475/-14 m, looking N. Placement of a third 0.5 m thick lift of coarse filter from El. 144 m to 144.5 m with an excavator from Sta. 0+335 m to 40+730 m.

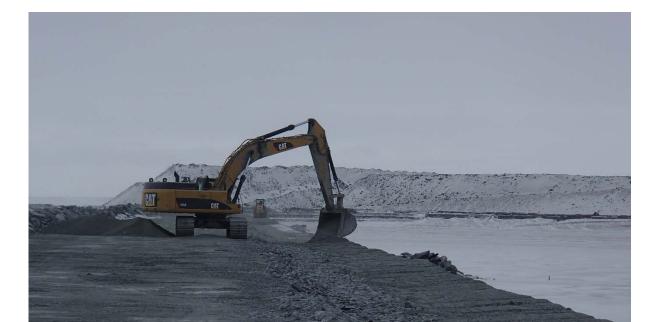
Photograph CD-1842: From Sta. 0+380/-16 m, looking S. Placement of a third 0.5 m thick lift of fine filter from El. 143.5 m to 144 m upstream of the coarse filter with an excavator from Sta. 0+335 m to 0+940 m.

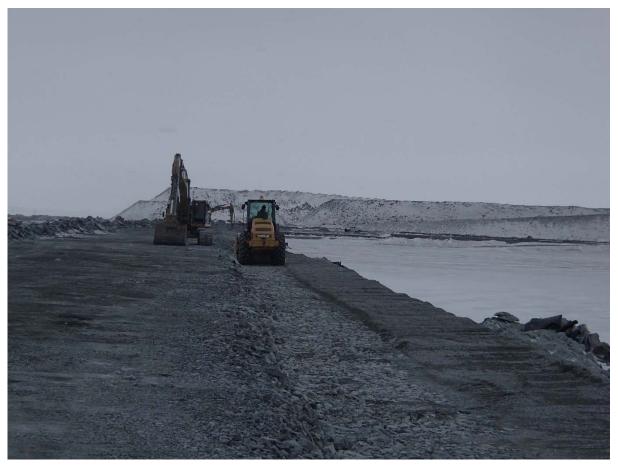
Photograph CD-1843: From Sta. 0+460/-23 m, looking S. Compaction of the third 0.5 m lift (approx.) of fine and coarse filters material at El. 144.5 m with a 10-tonne smooth-drum compactor with vibration (4 passes) from Sta 0+335m to 0+900 m.

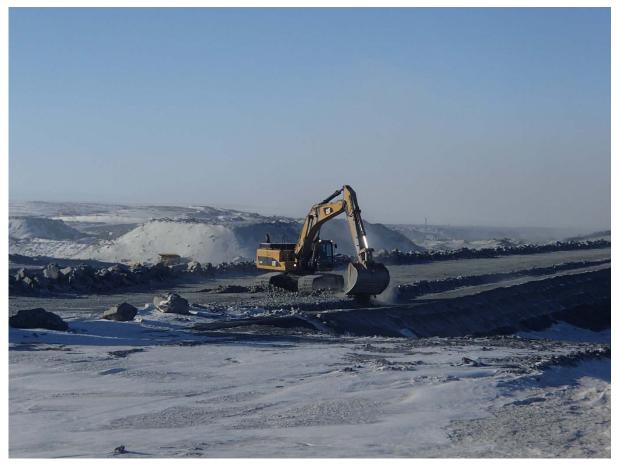
Photograph CD-1844: From Sta. 0+080/-49 m, looking SW. Placement of a fourth 0.5 m thick lift of coarse filter from El. 144.5 m to 145 m with an excavator from Sta. 0+170 m to 40+730 m.

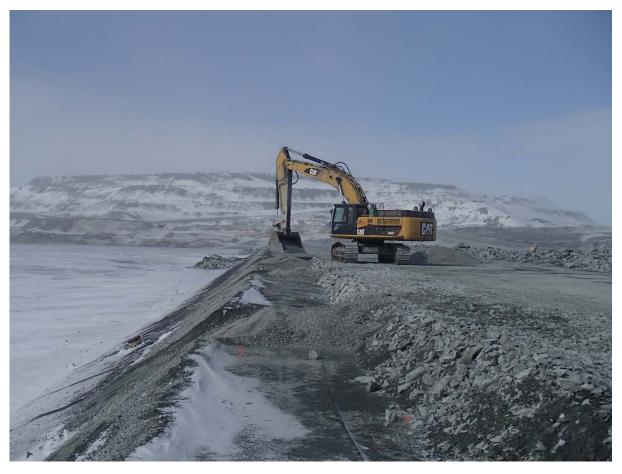
Photograph CD-1845: From Sta. 0+660/-20 m, looking N. Profiling of the upstream slope (2H:1V) from El. 143 to 145 m with an excavator between Sta. 0+175 and 0+330 m and between Sta. 0+600 m and 0+715 m. The removed material is placed on the fourth 0.5 m thick lift of fine filter from El. 144.5 m to 145 m upstream of the coarse filter with an excavator from Sta. 0+170 m to 0+330 m and between Sta. 0+600 m and 0+715 m.

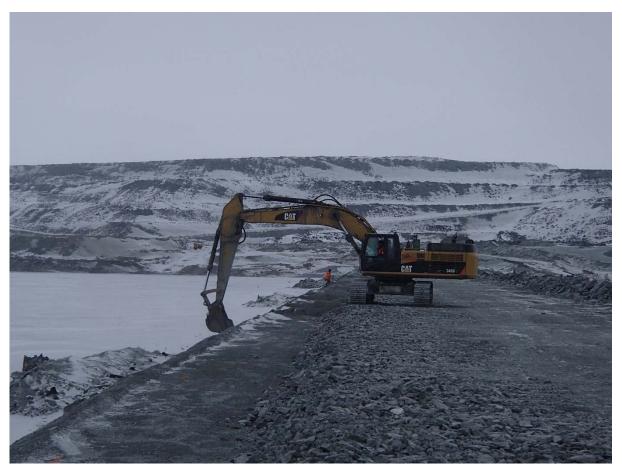
Photograph CD-1846: From Sta. 0+835/-25 m, looking N. Profiling of the upstream slope (2H:1V) from El. 143 to 145 m with an excavator between Sta. 0+330 and 0+600 m and between Sta. 0+715 m and 40+730 m. The removed material was placed with material from the fine filter stockpile on the fourth 0.5 m thick lift of fine filter from El. 144.5 m to 145 m upstream of the coarse filter with an excavator from Sta. 0+330 m to 0+600 m and between Sta. 0+715 m and 40+730 m.

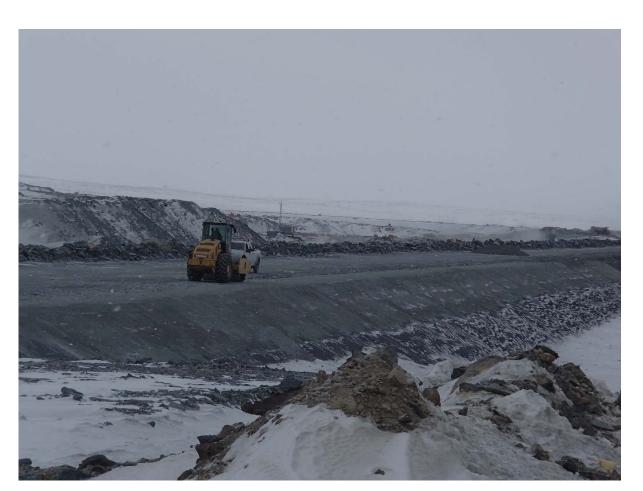
Photograph CD-1847: From Sta. 0+085/-48 m, looking SE. Compaction of the fourth 0.5 m lift (approx.) of fine and coarse filters material at El. 145 m with a 10-tonne smooth-drum compactor with vibration (4 passes) from Sta. 0+170 m to 40+730 m.

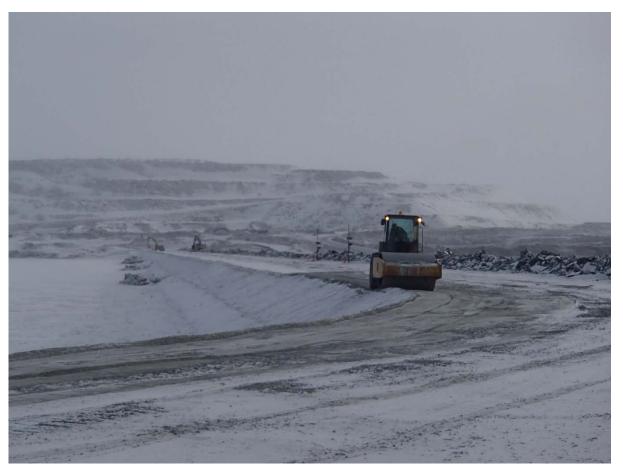
Photograph CD-1848: From Sta. 40+780/-15m, looking N. Compaction of the fourth 0.5 m lift (approx.) of fine and coarse filters material at El. 145 m with a 10-tonne smooth-drum compactor with vibration (4 passes) from Sta. 0+930 m to 40+730 m.

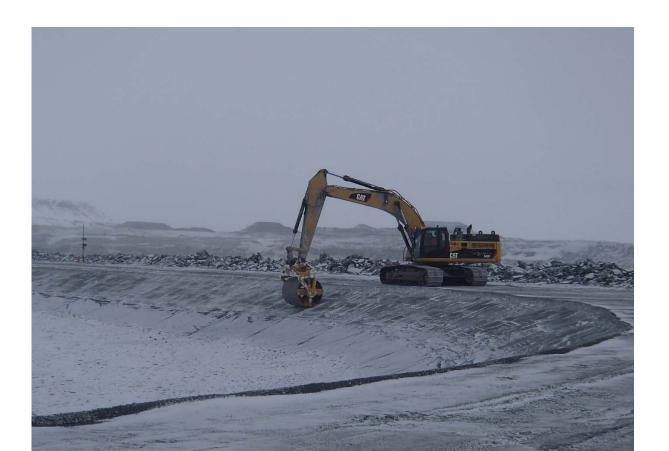
Photograph CD-1849: From Sta. 40+750/-17 m, looking NE. Final rolling of the upstream slope in view of the LLDPE geomembrane installation from Sta. 0+170 m to 40+730 m.

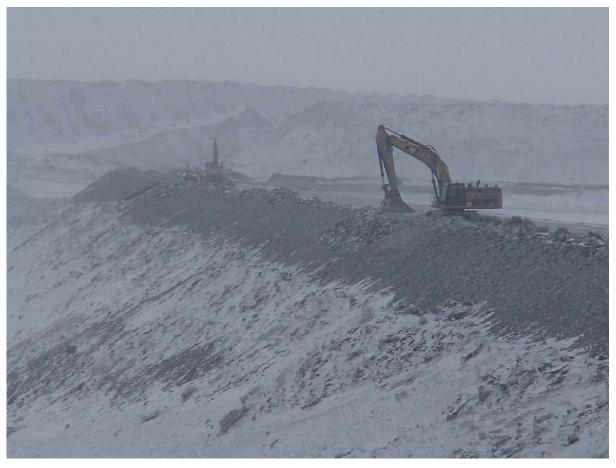
Photograph CD-1850: From Sta. 0+160/+20 m, looking SW. Profiling of the downstream slope (1.5H:1V) from El. 143 to 145 m with an excavator between Sta. 0+440 m and 0+530 m and between Sta. 0+745 m and 0+835 m.

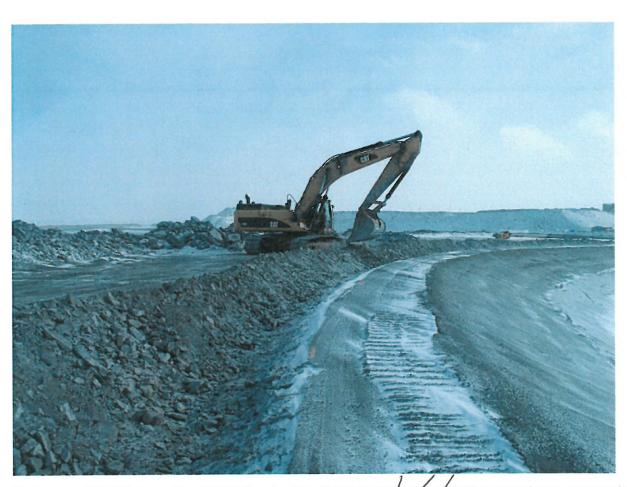
- The fine filter upstream surface was rolled in preparation for the LLDPE liner installation.
- The QA manager required that the LLDPE geomembrane crest anchoring trench be re-excavated from Sta. 40+730 m to 0+830 m, as it was shallower and less wide than intended in the design.

Photograph CD-1851: From Sta. 0+910/-18 m, looking S. Excavation of the LDPE geomembrane crest anchoring

trench from Sta. 40+730 m to 0+830 m.
