DATE May 21st 2018

1897439-1577-TM-Rev0

QA WEEKLY REPORT FROM MAY 14TH TO MAY 20TH – TSF SOUTH CELL CONSTRUCTION MEADOWBANK (1897439)

QA WEEKLY REPORT FROM MAY 21ST TO MAY 27TH – TSF SOUTH CELL CONSTRUCTION MEADOWBANK (1897439)

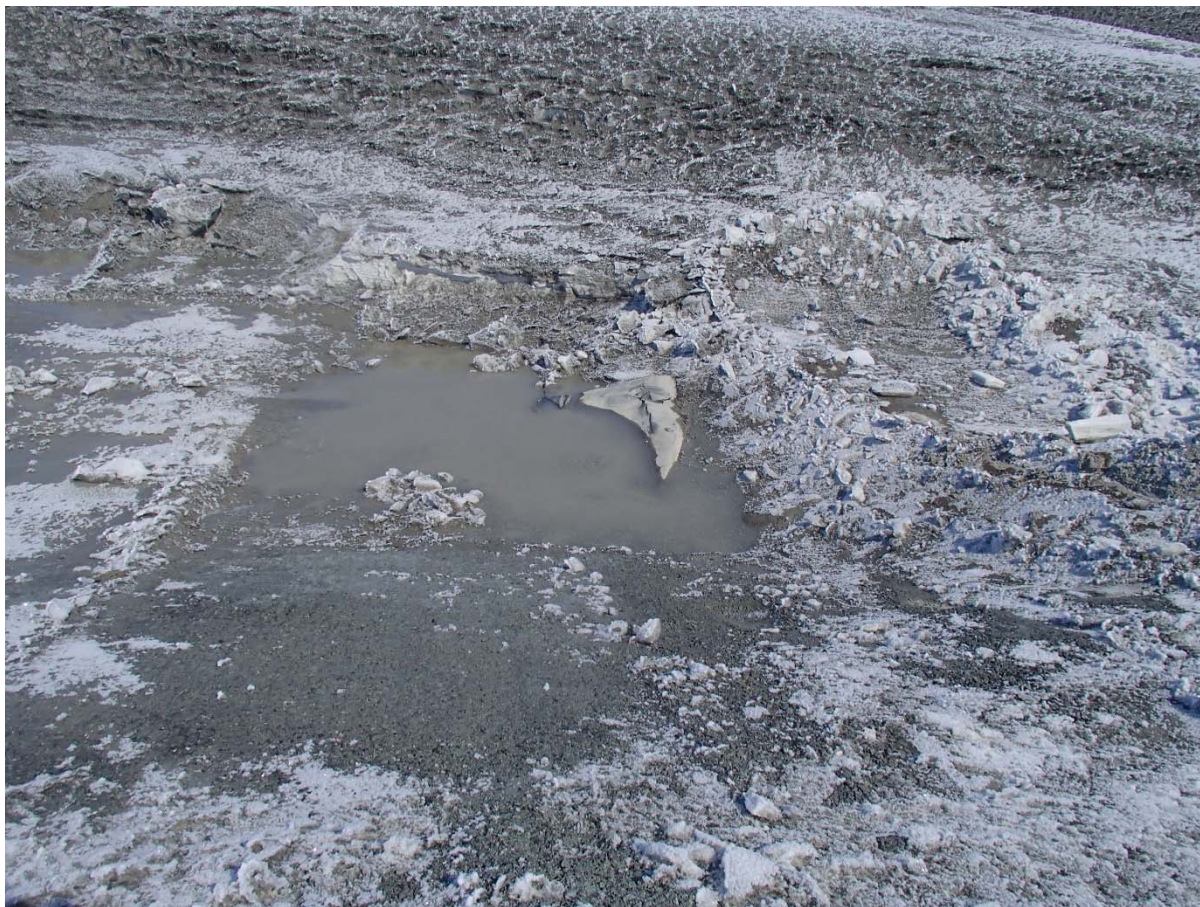
- Snow and ice are beginning to melt. As a result, some water is ponding on the upstream toe line tie-in on the east extremity of SD3 and will need to be pumped out before installation of the LLDPE liner next week. The QA Manager noticed that a horizontal portion of existing LLDPE liner in the upstream toe liner tie-in had been exposed and damaged during snow removal operations at approx. Sta. 20+595 m.

Photograph SD3-302: From Sta. 20+595/42 m, looking NE. View of water ponding on the first compacted sieved till layer of upstream toe liner tie-in. A portion of exposed damaged LLDPE liner is visible.

- The last panel of existing liner on the upstream slope at approx. Sta. 20+595 m is covered in finer filter. This fine filter will need to be removed to expose the liner for seaming of the next panel and prevent any contamination of the tie-in compacted sieved till;
- The portion of damaged liner needs to be exposed on at least 0.5 m on each side of the tear to allow for repairs and to ensure no further damage is encountered;
- The upstream slope of fine filter will need additional compaction with the roller attachment around the new upstream toe liner tie-ins at the extremities of the dike to ensure a smooth slope.

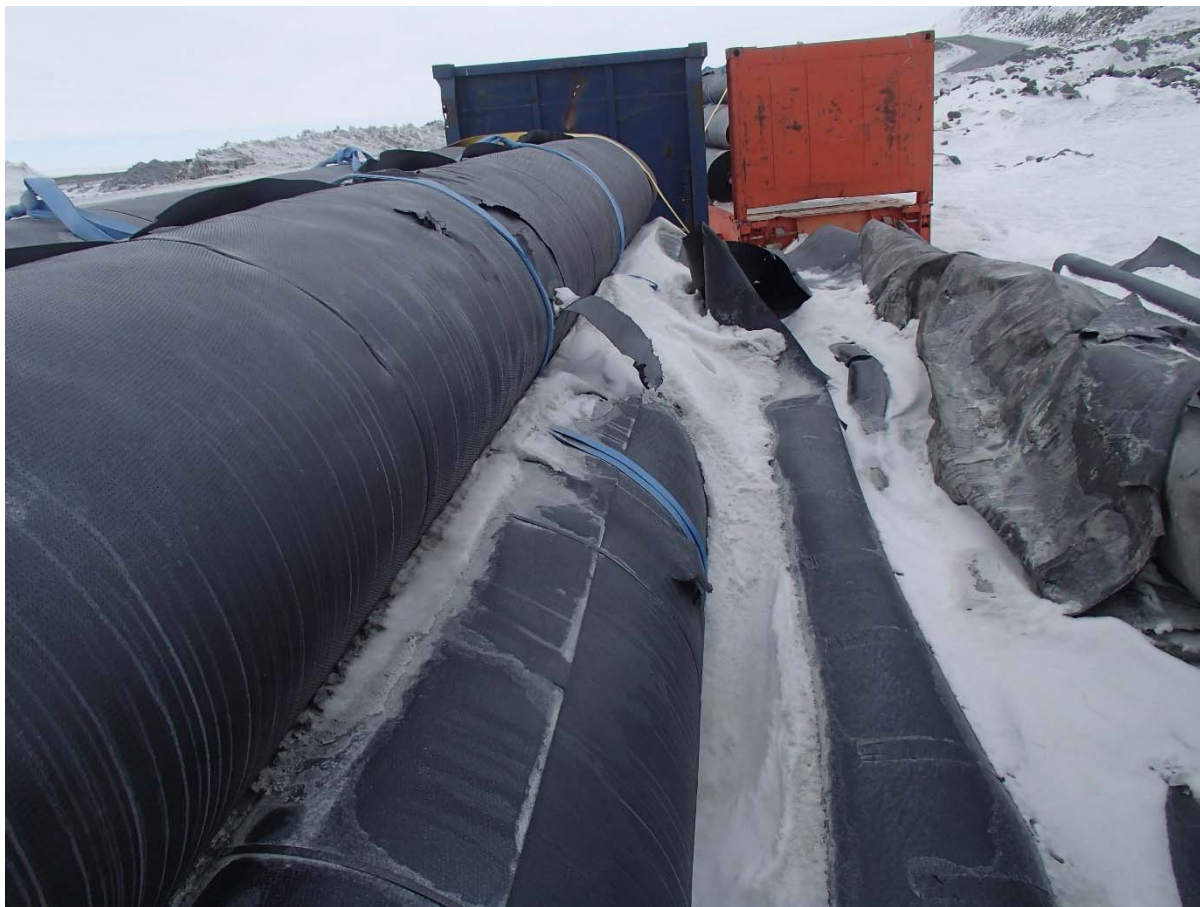
- From May 15th to May 17th, there was no AEM representative on site. The Dike Supervisor (Olivier Jacques) was in charge of the works.
- The QA Manager inspected visually the LLDPE rolls stored between Central Dike and the Rock Storage Facility. The new rolls are stored outside on 2 trailers, while old rolls are stored on the ground and are covered in snow. Those seem to be leftovers from last year's construction season and should not be used on the dikes this year. Most new rolls are in good condition, with some rolls on the blue trailer showing tears on their outer layers. It will be important before the LLDPE liner placement to discard the first few meters of the rolls to ensure that only intact, good quality material is used.
- The QA Manager reiterated that the liner must be dry and free of dust on at least 1 m from the top to allow for welding of the new LLDPE liner.

Photograph from the LLDPE storage site: View of new rolls stored on a trailer, showing tears.

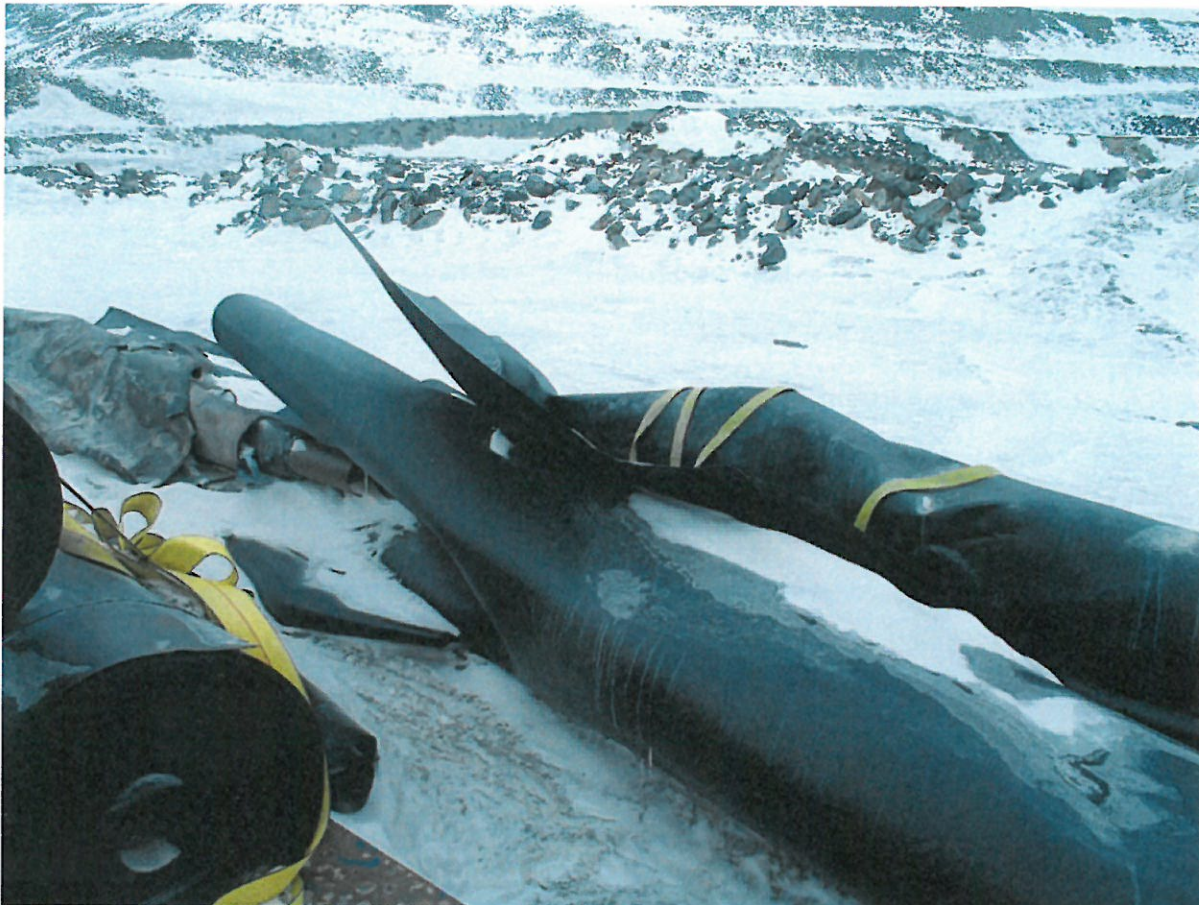
Photograph from the LLDPE storage site: View of old rolls stored on the ground.

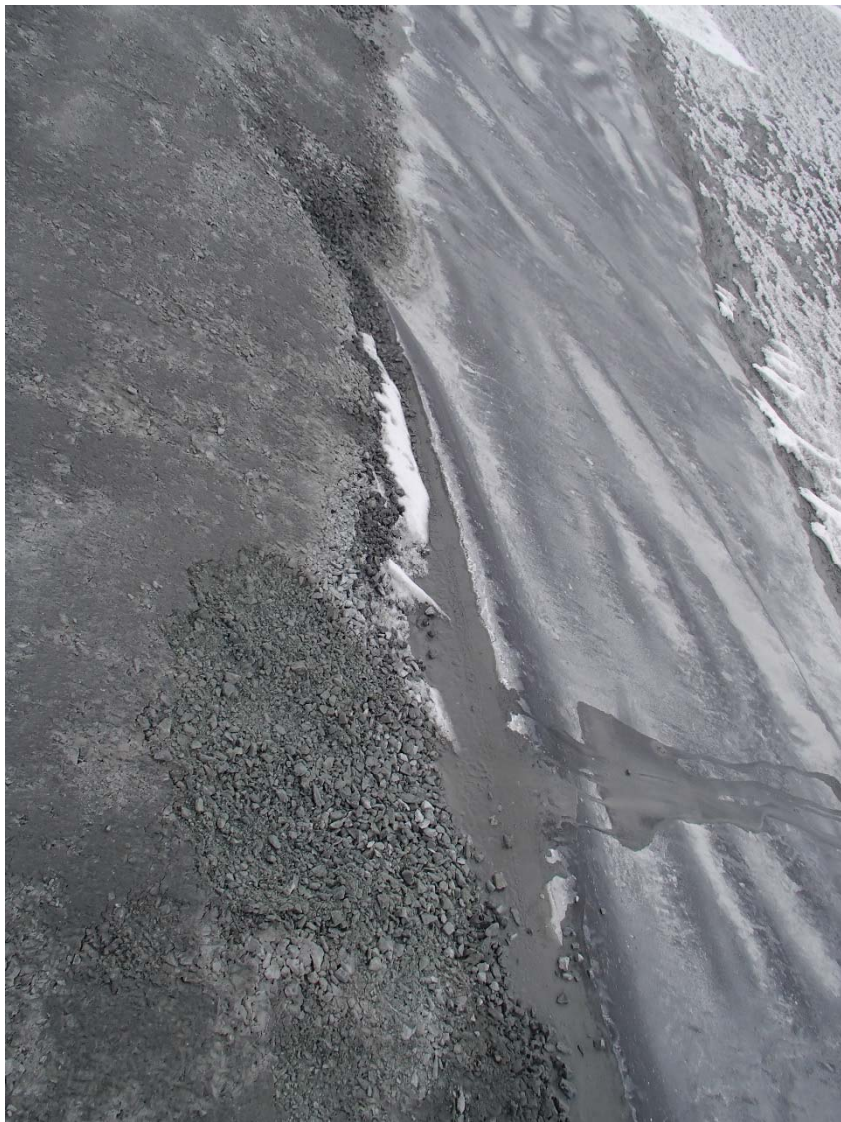
- Minor corrections to do at the bottom of the fine filter on the upstream slope of Central Dike were identified by the QA Manager (see photograph below) and completed. Some fine filter was missing to achieve a smooth slope and transition with the existing liner. It is likely that the combination of the thawing of the fine filter today and the recent cleaning operations using pressurized air accounts for the observed loss of material at the junction with the existing LLDPE liner.

Photograph CD-1858: From Sta. 0+970/-45 m, looking S. View of the bottom of the fine filter upstream slope. Some material is missing to achieve a smooth slope.

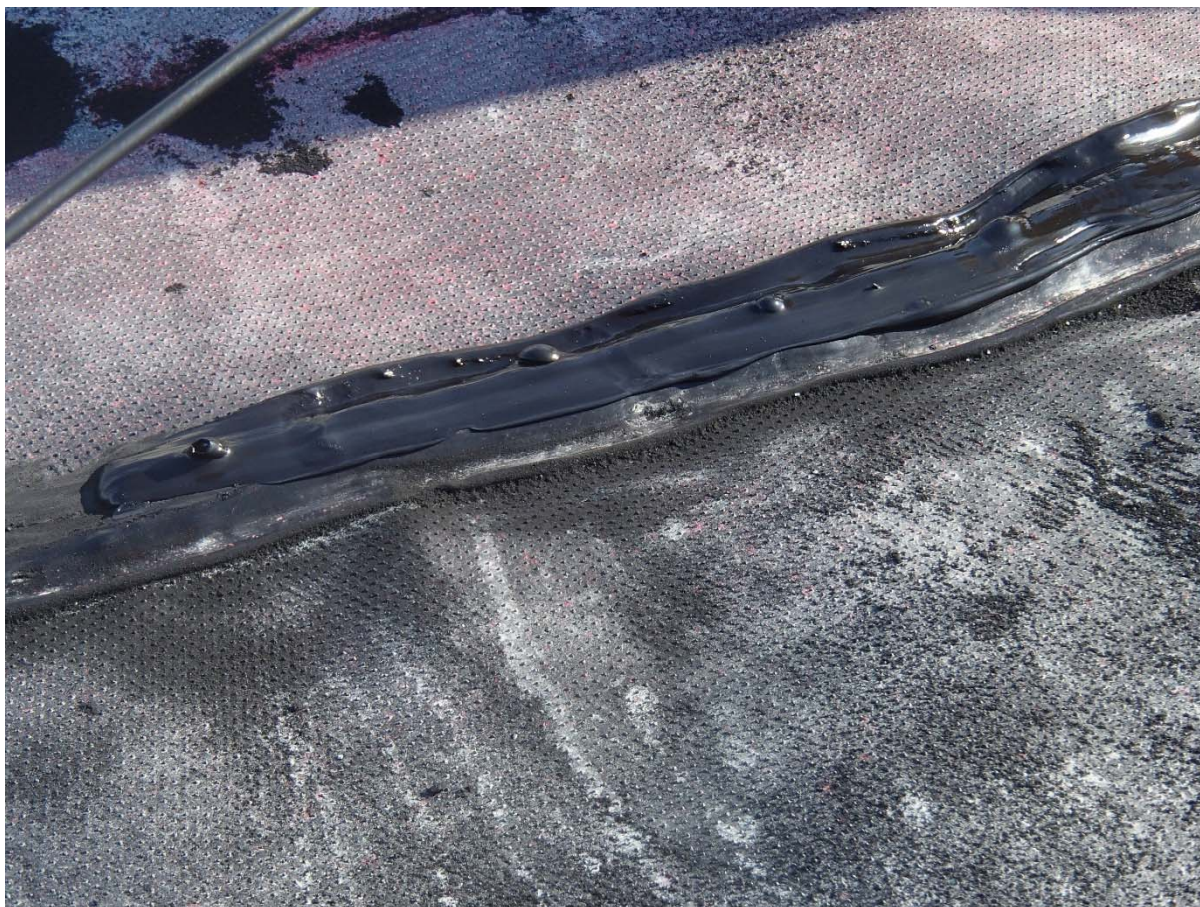
- Because of humidity (thawing slope underneath the geosynthetics), the extrusion weld at the bottom of the LLDPE liner panels needed additional repairs on some sections between Sta. 40+680 m and 0+950 m. Welding is difficult because of water flowing down the slope, which creates bubbles in the resin. The underlying liner has been cut at some places to drain the water and patches have been welded (see photograph CD-1864).

Photograph CD-1864: From Sta. 40+700/-38 m. View of bubbles formed in the extrusion weld because of humidity.
