QA WEEKLY REPORT

1897439-1577-TM-Rev0

QA WEEKLY REPORT FROM MAY 28TH TO JUNE 3RD – TSF SOUTH CELL CONSTRUCTION MEADOWBANK (1897439)

QA WEEKLY REPORT FROM JUNE 4TH TO JUNE 11TH – TSF SOUTH CELL CONSTRUCTION MEADOWBANK (1897439)

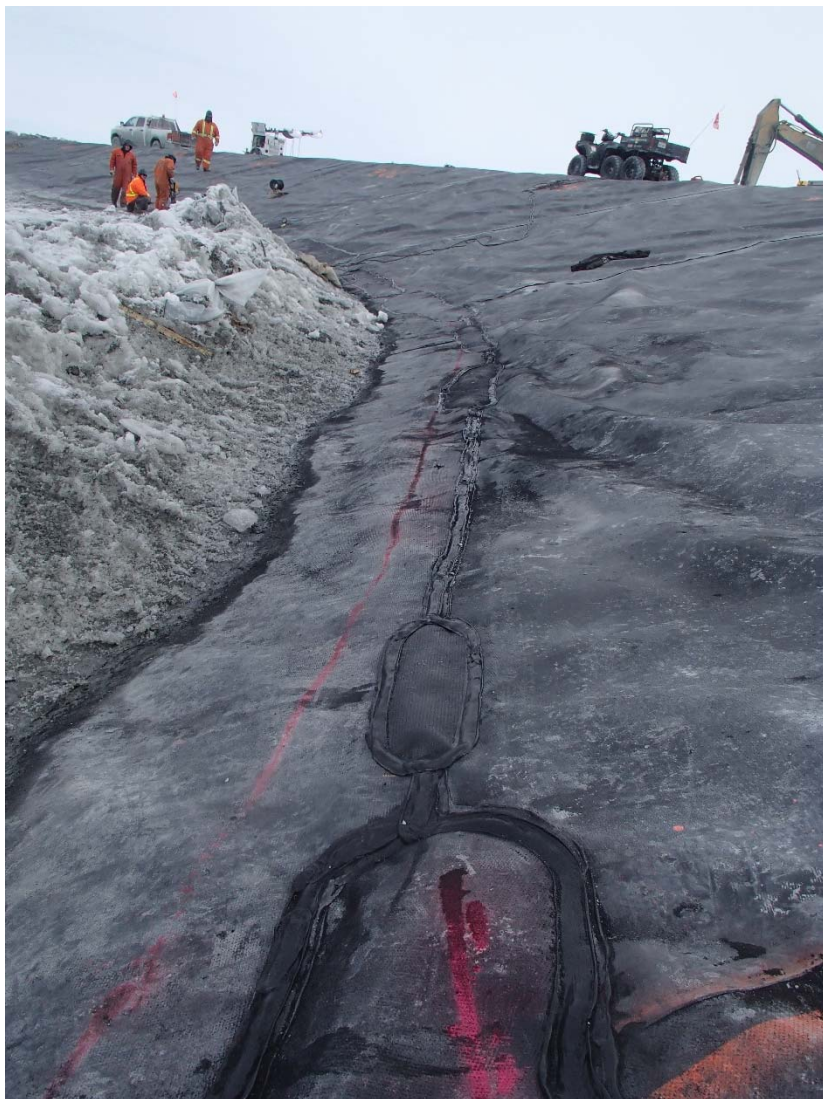
Photograph CD-1867: From Sta. 40+680/-37 m, looking E. View of repair patches on the extrusion weld at the bottom of the panels.

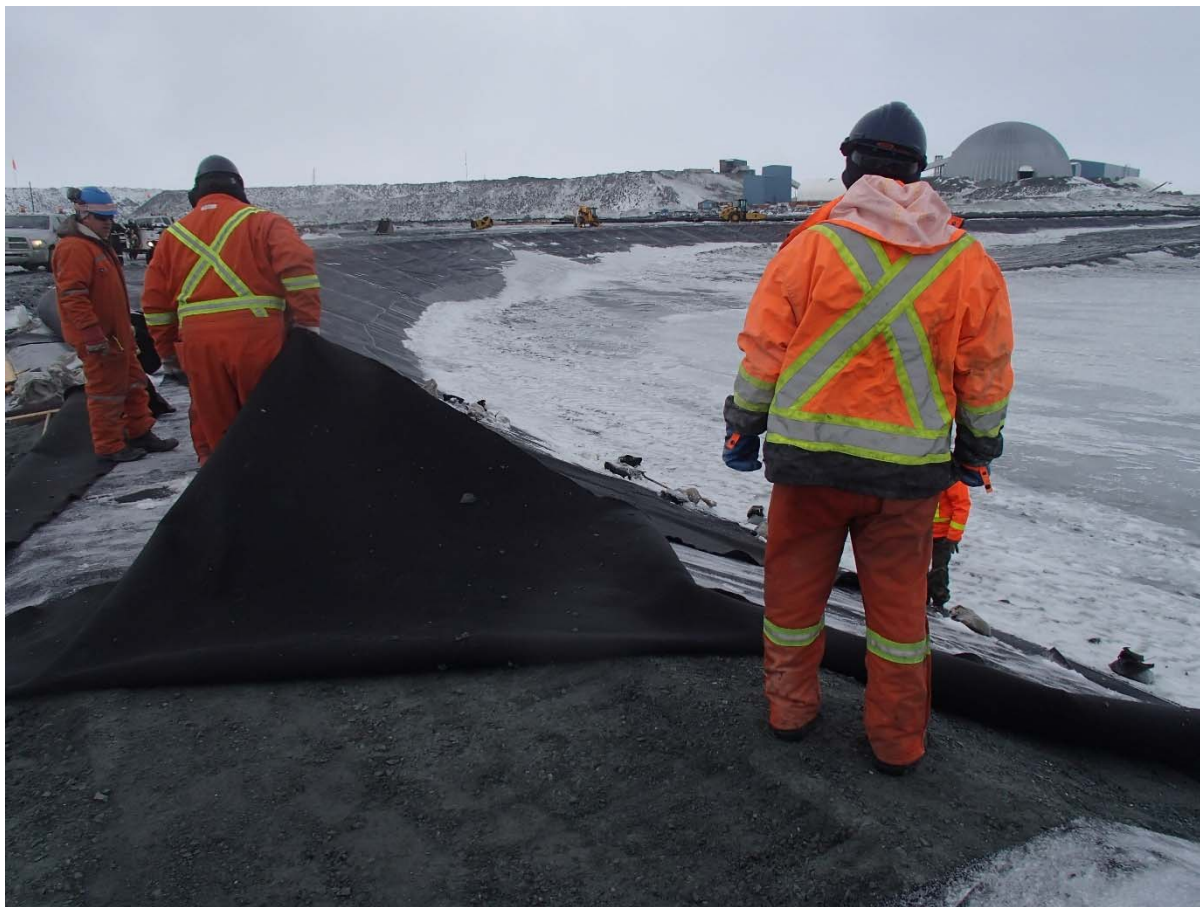
Photograph CD-1868: From Sta. 0+915/-24 m, looking S. Removal of the wet geotextile in place from Sta. 0+935 m to 0+900 m.

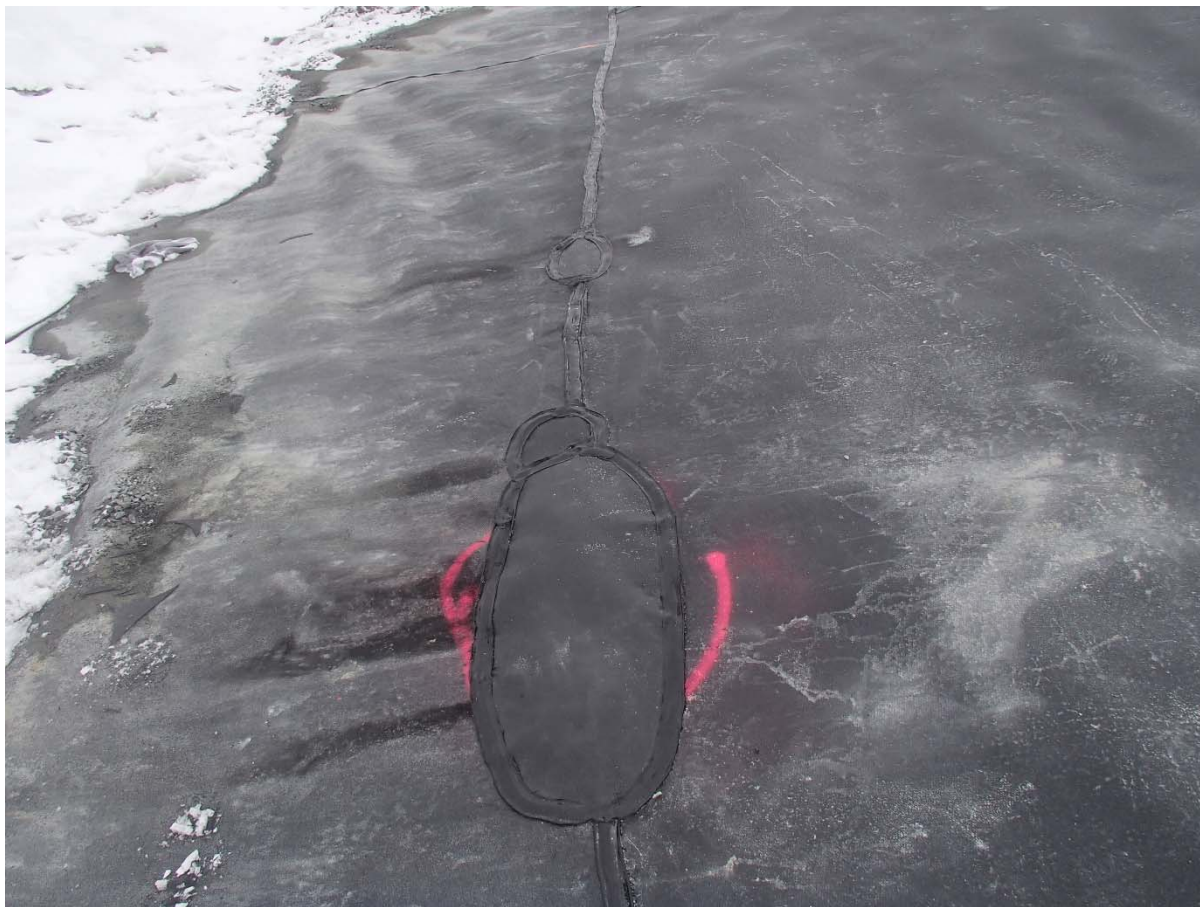
Photograph CD-1876: From Sta. 0+820/-26 m, looking N. View of repair patches on the extrusion weld at the bottom of panel 838.

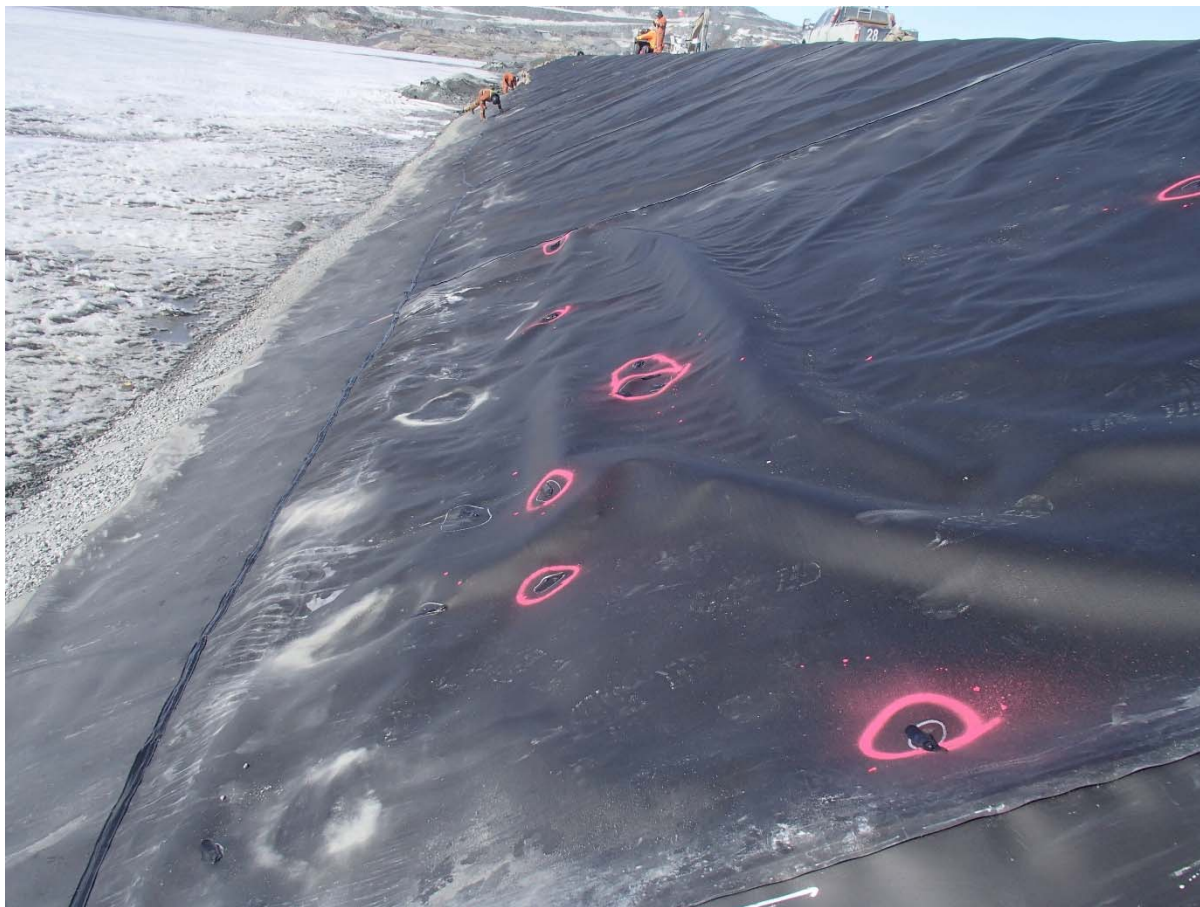
- Due to the adverse weather (strong winds), no geosynthetics could be installed from May 29th PM to May 31st. Geosynthetics installation resumed on June 1st.
- The QA Manager observed a few holes on LLDPE panel 850 after its installation and the fusion weld with panel 849. Panel 850 was the beginning of a new roll. The holes were repaired with extrusion welding. The QA Manager reminded to discard the first few metres of the rolls to ensure that only intact, good quality material is used.

Photograph CD-1879: From Sta. 0+735/-28 m, looking N. View of the repaired holes on panel 850.

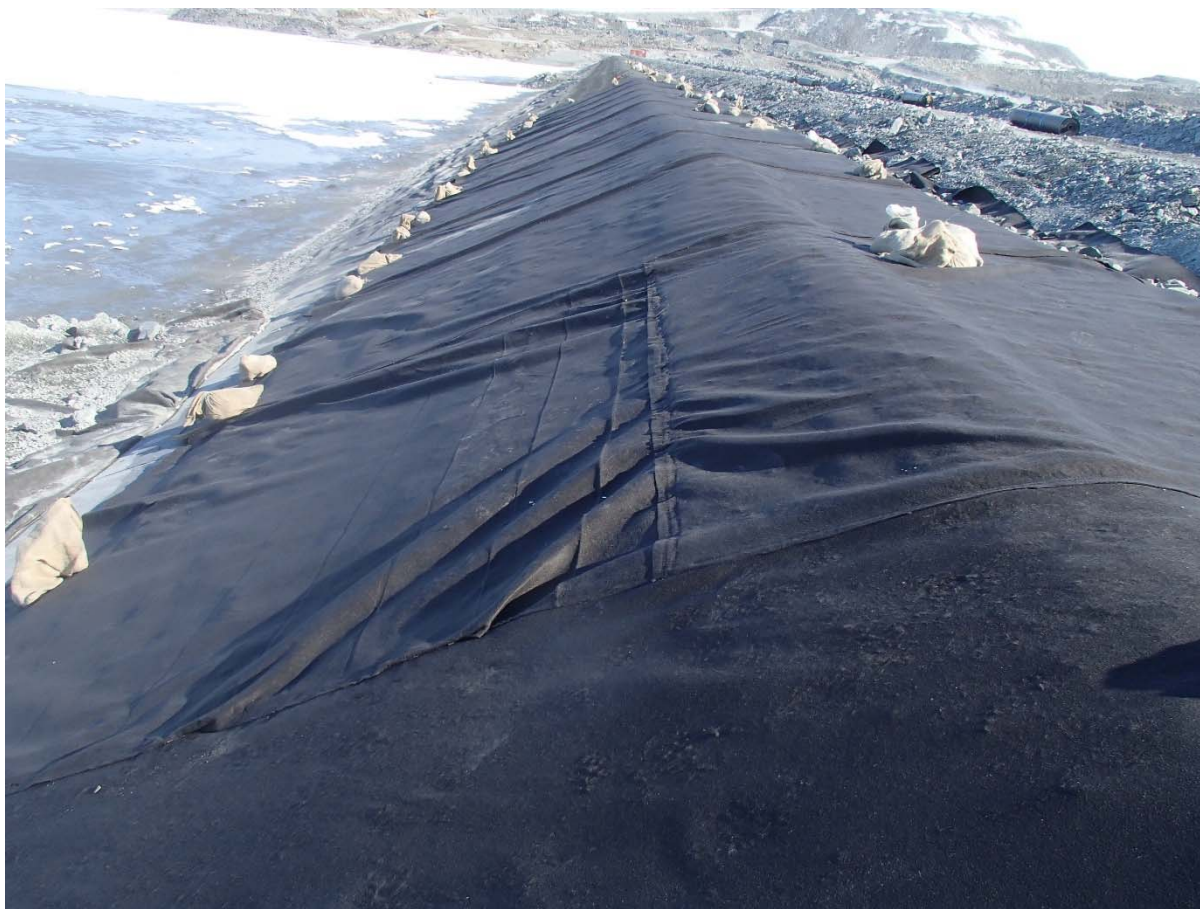
Photograph CD-1881: From Sta. 0+530/-27 m, looking N. View of a geotextile panel with a horizontal weld in the slope at Sta. 0+520 m before its removal.

- The QA Manager observed a geotextile panel with a horizontal weld in the slope at Sta. 0+520 m following its installation. The panel was removed and replaced by a new geotextile panel before installing the LLDPE liner panels.

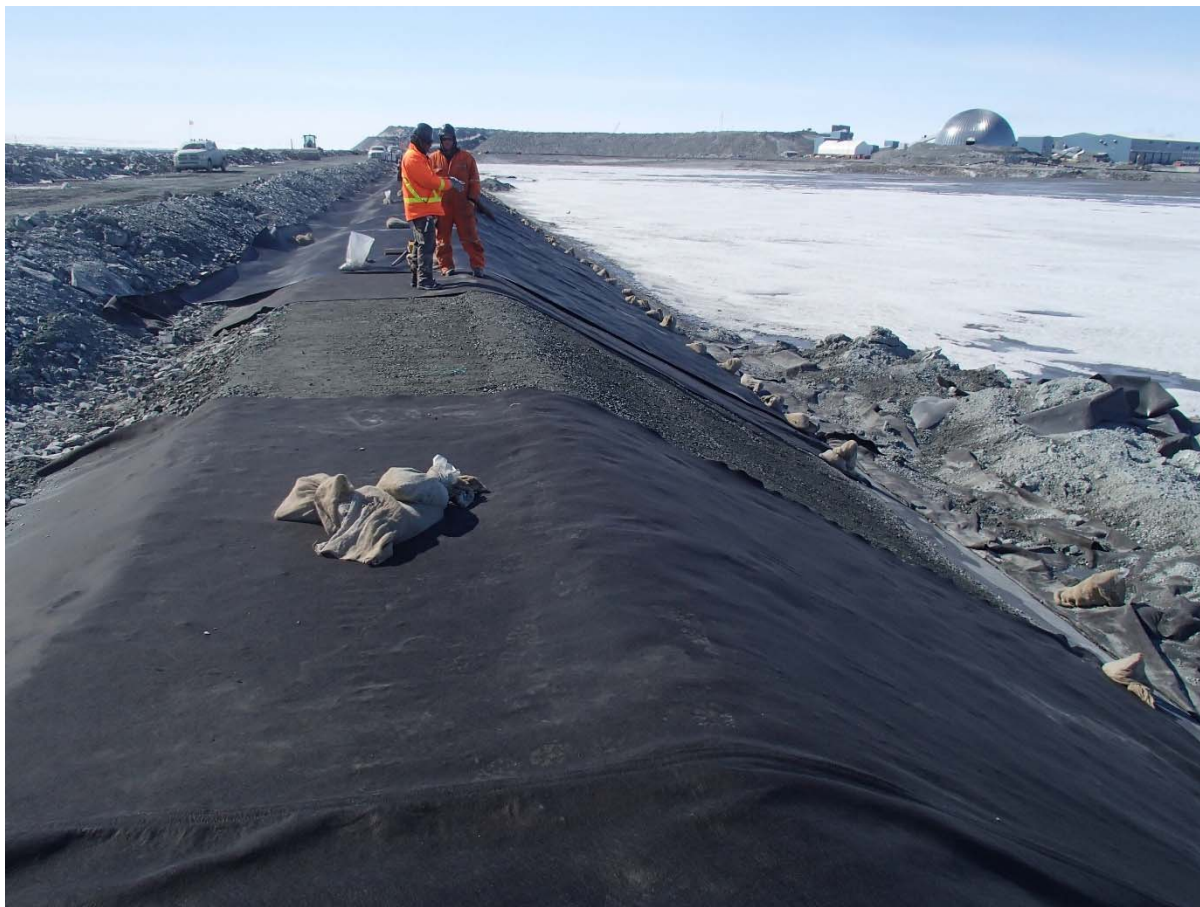
Photograph CD-1882: From Sta. 0+510/-25 m, looking S. View of the emplacement of the geotextile panel with a horizontal weld in the slope at Sta. 0+520 following its removal.

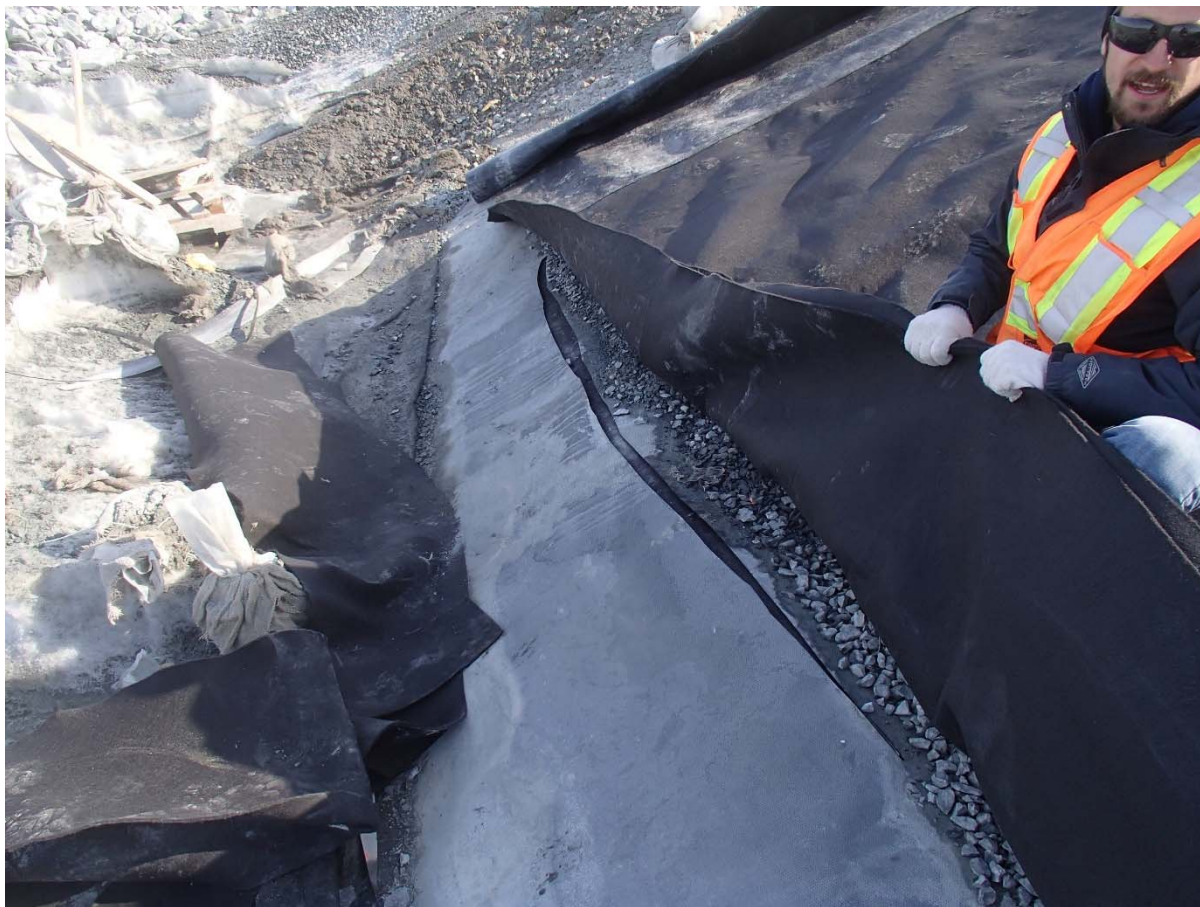
- An underlying liner has been cut at around Sta. 0+160 to drain the water (see photograph below) and is overlapped by the new panel 933.
- The QA Manager observed holes on the LLDPE liner panels 832, 833, 834, 879, 883 and 922. All holes were marked in paint, repaired and vacuum tested.
- Water leaking from extrusion fillet seams were noticed by the QA Manager at the bottom of panels 803, 807, 808, 810, 814, 815, 816 and 818. All leaks were marked with paint, repaired and vacuum tested.
- The installation of geosynthetics at Central Dike was completed on June 9th.

Photograph CD-1889: From Sta. 0+150/-28 m, looking N. View of the underlying liner that has been cut at around Sta. 0+160 m to drain the water.

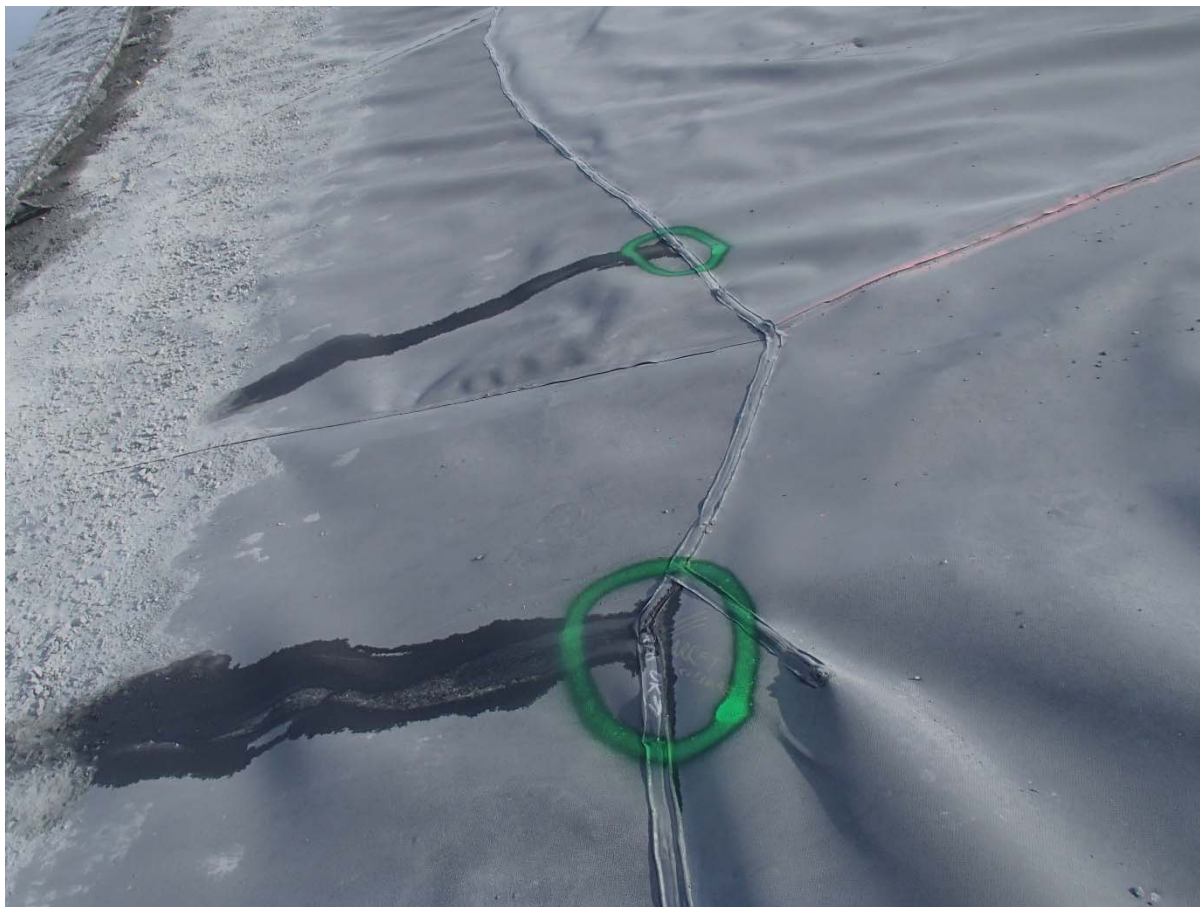
Photograph CD-1891: From Sta. 0+960/-28 m, looking N. View of leaking extrusion fillet seam before their repair on panels 816 and 818.

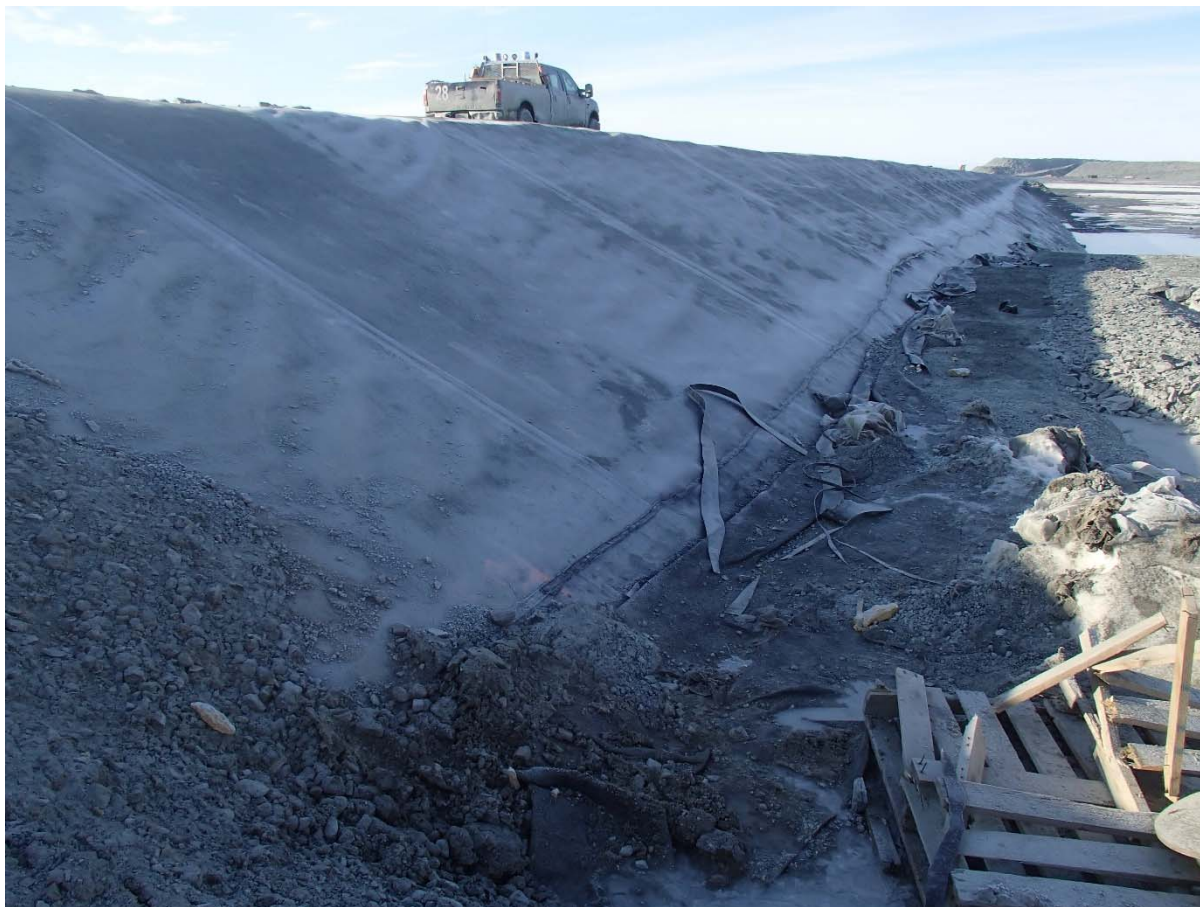
Photograph CD-1892: From Sta. 0+155/-32 m, looking S. View of the liner panel 933 overlapping the underlying liner that has been cut at around Sta. 0+160 m to drain the water.

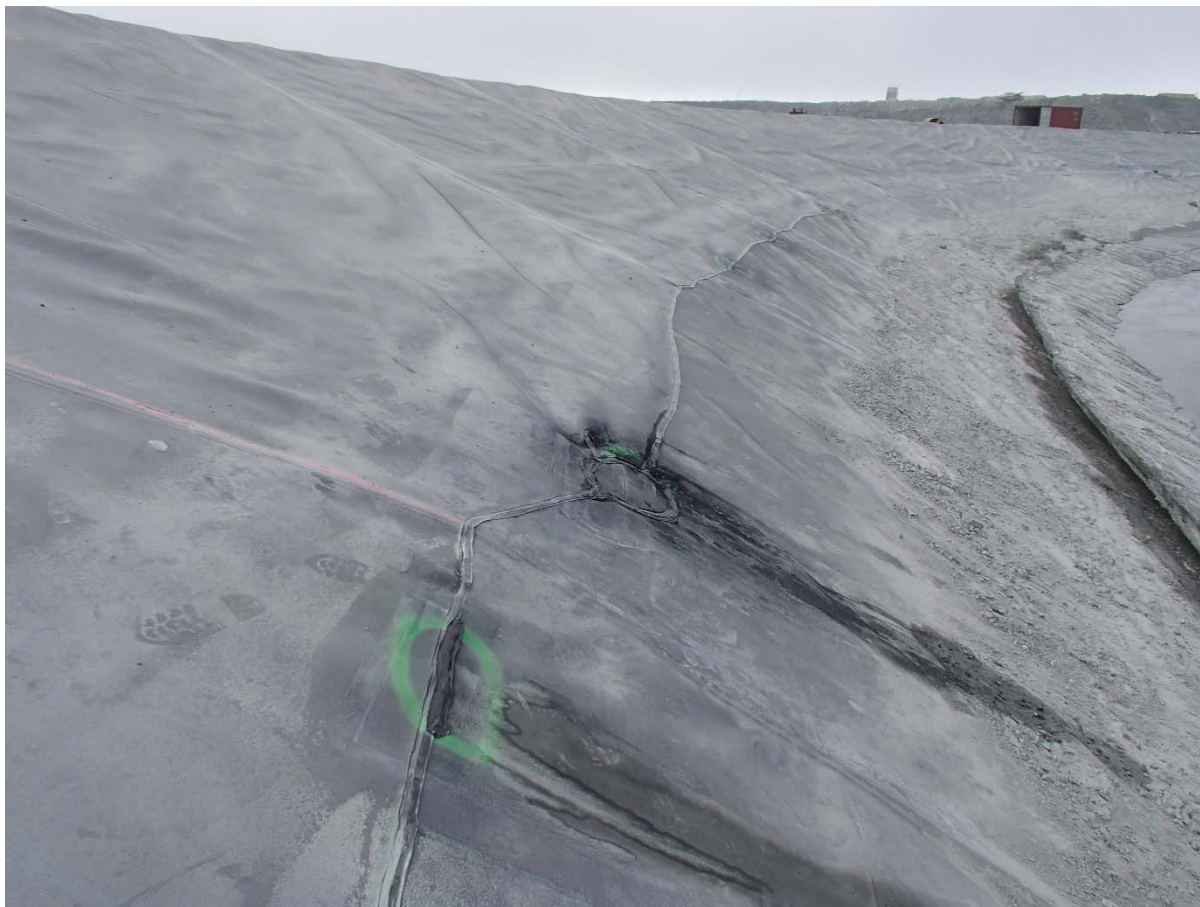
Photograph CD-1893: From Sta. 0+950/-27 m, looking SW. View of repair patches on the extrusion weld at the bottom of panels 803, 807, 808, 810, 814, 815, 816 and 818.

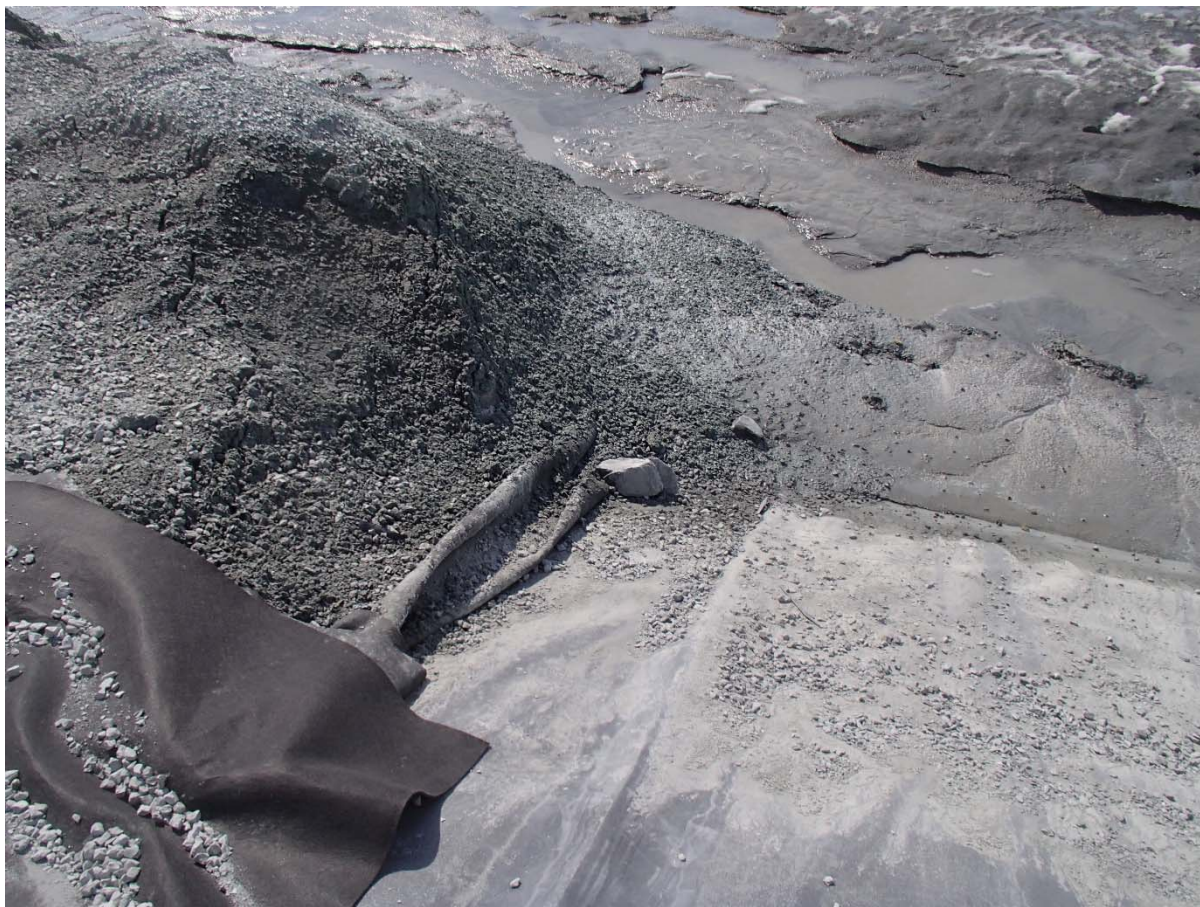
- The QA Manager observed a few rocks in direct contact with the liner following the construction of the deposition fingers on Central Dike and asked SANA's foreman to remove them.
- The QC Personnel observed that the compaction of the backfilling of the geosynthetics tie-in on Central Dike from approx. Sta 0+950 m to 1+050 m was inadequate and informed SANA's foreman. It will be compacted tomorrow.

Photograph CD-1894: From Sta. 0+800/-28 m, looking E. View of a rock in direct contact with the LLDPE liner following the construction of the deposition fingers on Central Dike.

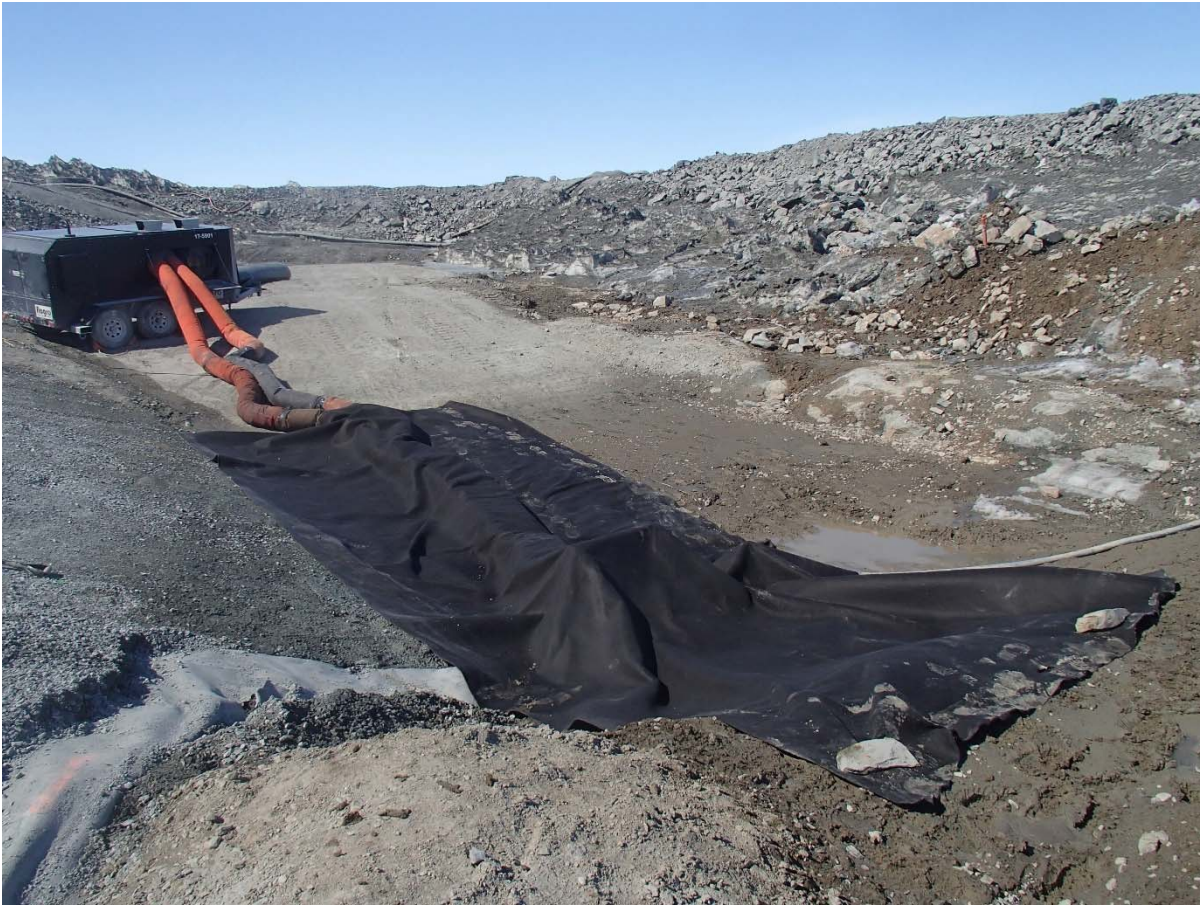
- The water runoff from a melting snow berm north of SD3 was flowing into the small pond on the first compacted sieved till layer of the upstream toe liner tie-in at approx. Sta. 20+595 m. A temporary trench was dug to deviate the water flow to allow for the dewatering of the pond before the installation of the LLDPE. The water ponding was then pumped out. A Genset Frost-fighter heated the sieved till layer and a pump evacuated the water.

Photograph SD3-305: From Sta. 20+610/-48 m, looking NW. Dewatering of the water ponding on the first compacted sieved till layer of upstream toe liner tie-in. A Genset Frost-fighter is heating the sieved till layer and a pump is evacuating the water.

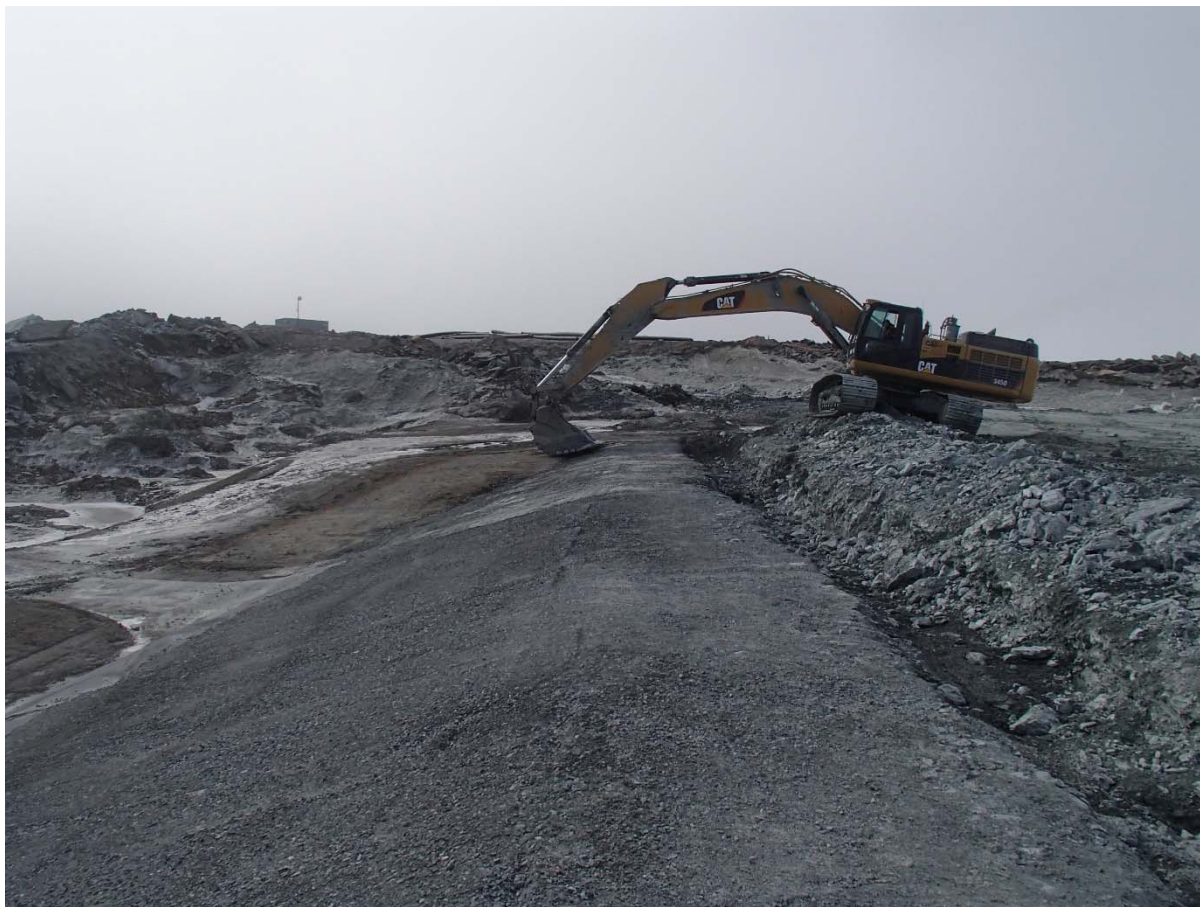
Photograph SD3-306: From Sta. 20+780/-25 m, looking S. Correction of the surface of the fine filter in the upstream slope and the top of the first class compacted sieved till layer with an excavator from Sta. 20+803 m to 20+793 m.
