## QA WEEKLY REPORT

1897439-1577-TM-Rev0

### QA WEEKLY REPORT FROM JULY 7<sup>TH</sup> TO JULY 15<sup>TH</sup> – TSF SOUTH CELL CONSTRUCTION MEADOWBANK (1897439)

This document summarizes QA activities performed by Golder from July 7<sup>th</sup> to June 15<sup>th</sup>, 2018 inclusively, related to the construction activities of Saddle Dam 3 (SD3) and Central Dike (CD) at the Meadowbank mine site.

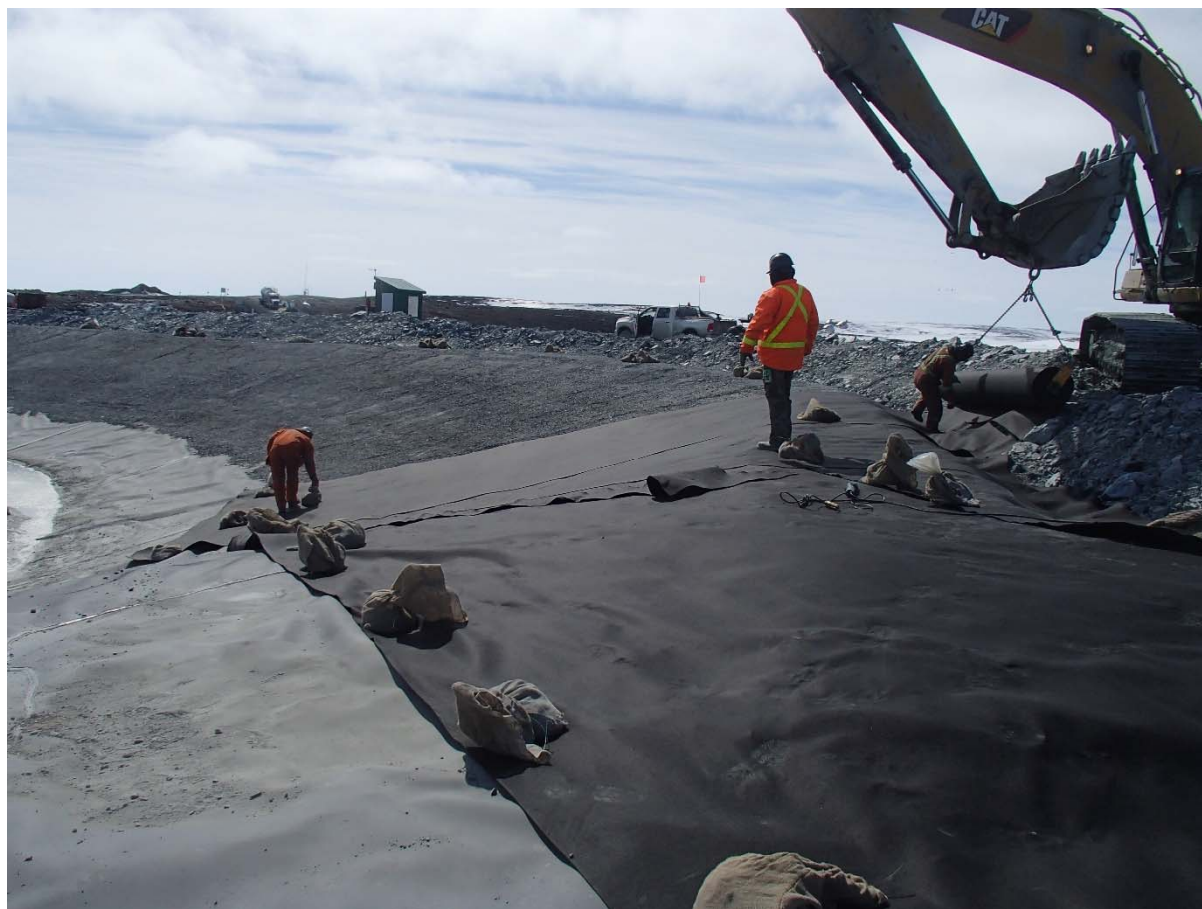
**Photograph SD3-308: From Sta. 20+620/-48 m, looking SW. Installation of the geotextile on the upstream slope 3H:1V between El. 143 m and 145 m from Sta. 20+610 m to 20+810 m.**

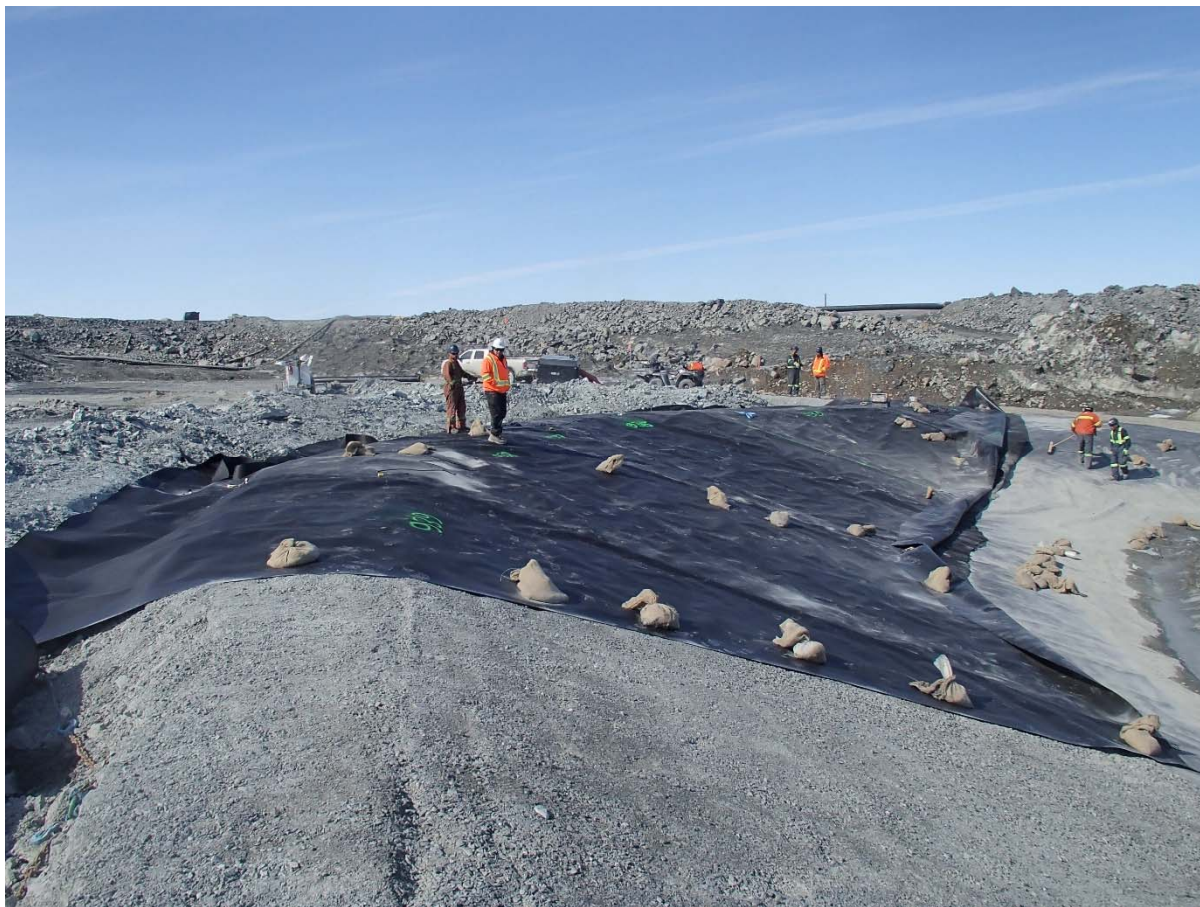
**Photograph SD3-309: From Sta. 20+640/-26 m, looking N. Installation of the LLDPE liner on the upstream slope 3H:1V between El. 143 m and 145 m from Sta. 20+610 m to 20+810 m (panel numbers 934 to 964).**

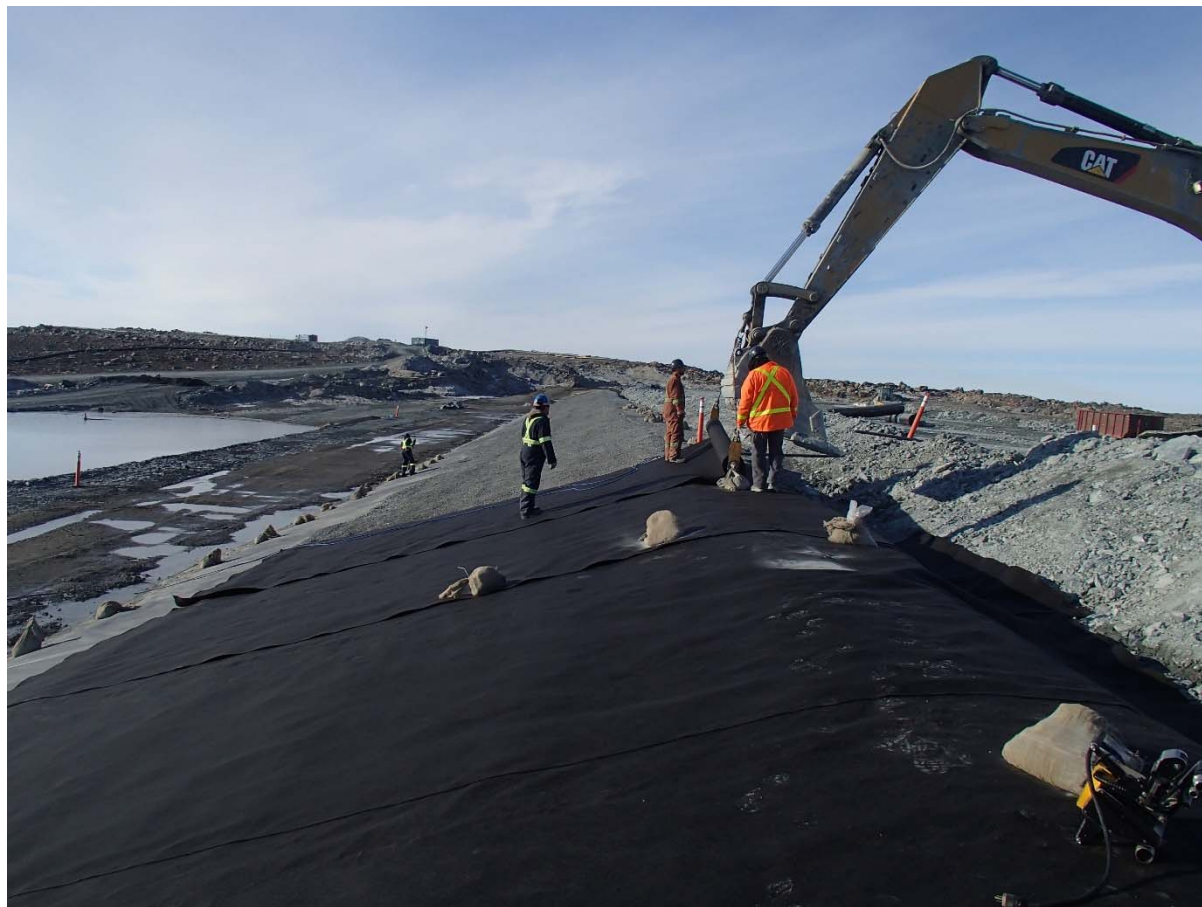
**Photograph SD3-310: From Sta. 20+635/-24 m, looking S. Installation of the geotextile on the upstream slope 3H:1V between El. 143 m and 145 m from Sta. 20+630 m to 20+800 m.**

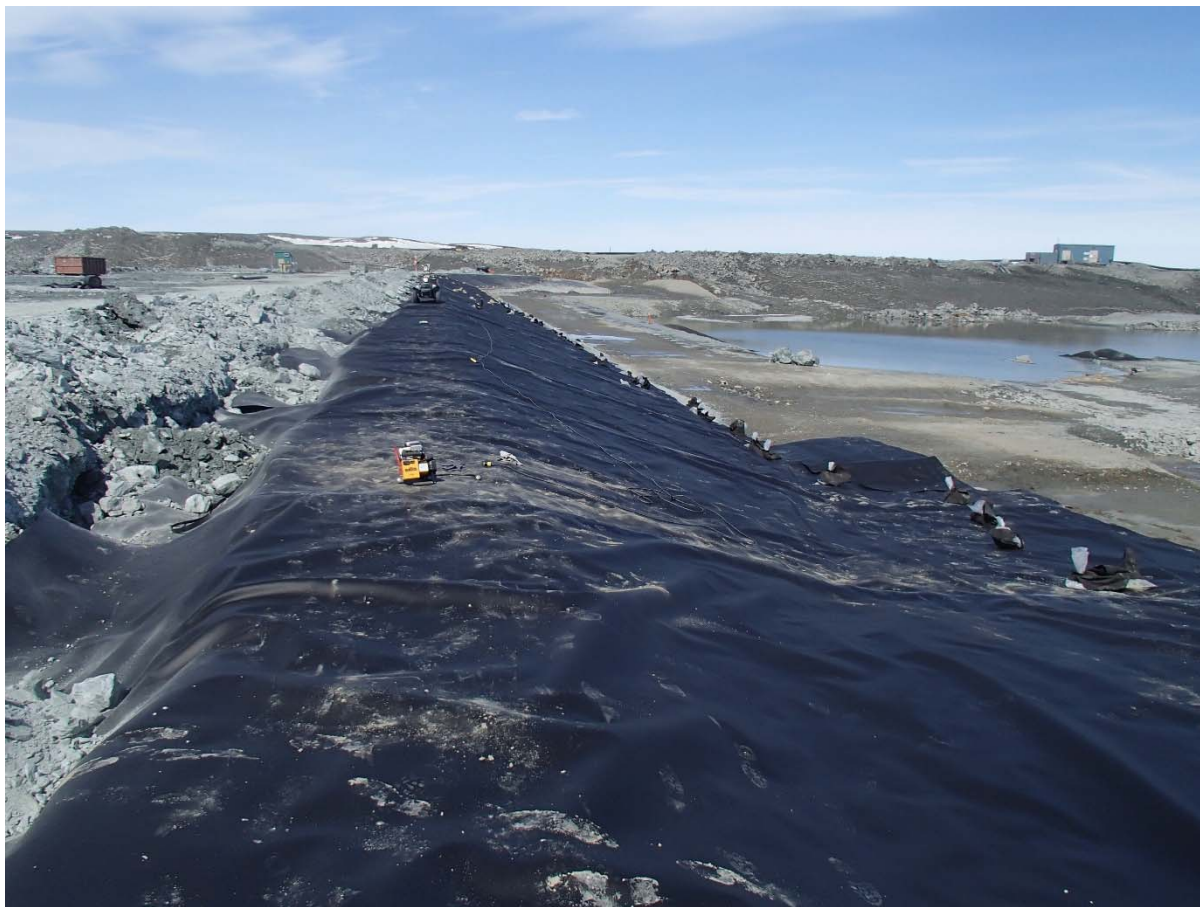
**Photograph SD3-311: From Sta. 20+810/-26 m, looking N. Installation of the LLDPE liner on the upstream slope 3H:1V between El. 143 m and 145 m from Sta. 20+630 m to 20+800 m (panel numbers 939 to 964).**

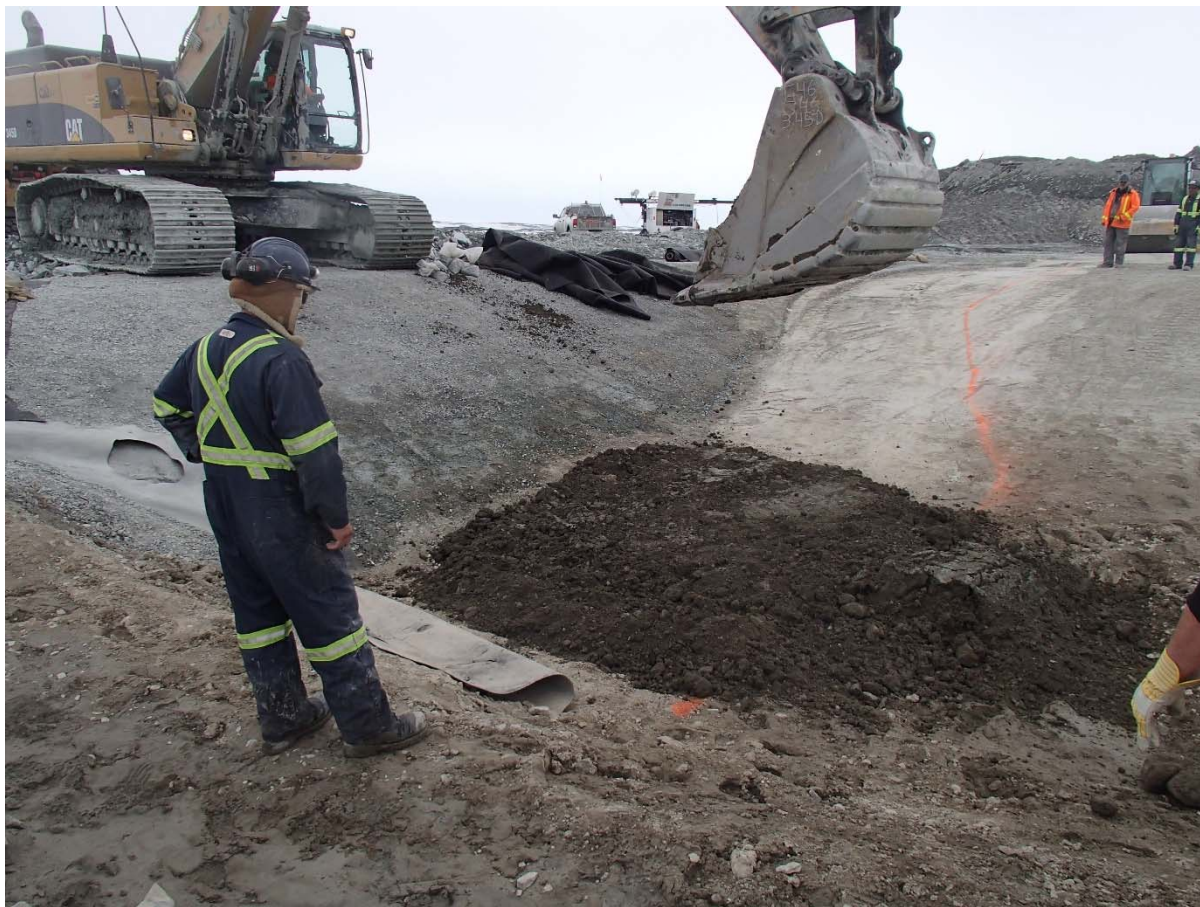
**Photograph SD3-312: From Sta. 20+610/-48 m, looking W. Placement of a 0.15 m thick lift of compacted sieved till from Sta. 20+596.4 m to 20+601.6 m (offset -42.6 to -46.3 m) to fill the depression in the compacted sieved till layer.**

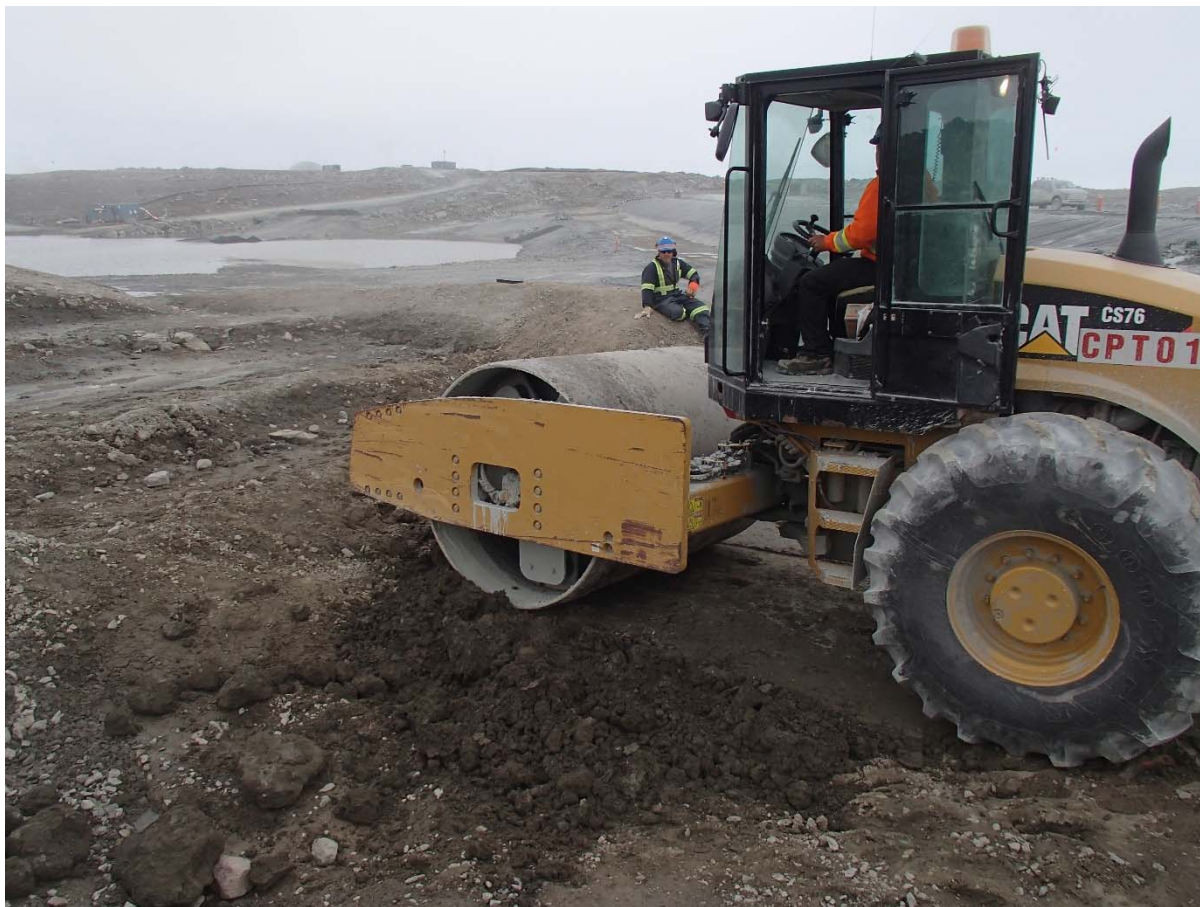
**Photograph SD3-313: From Sta. 20+600/-52 m, looking S. Compaction of the 0.15 m-thick lift of compacted sieved till with a 10-tonne smooth-drum compactor without vibration (4 passes) from Sta. 20+596 m to 20+601 m.**

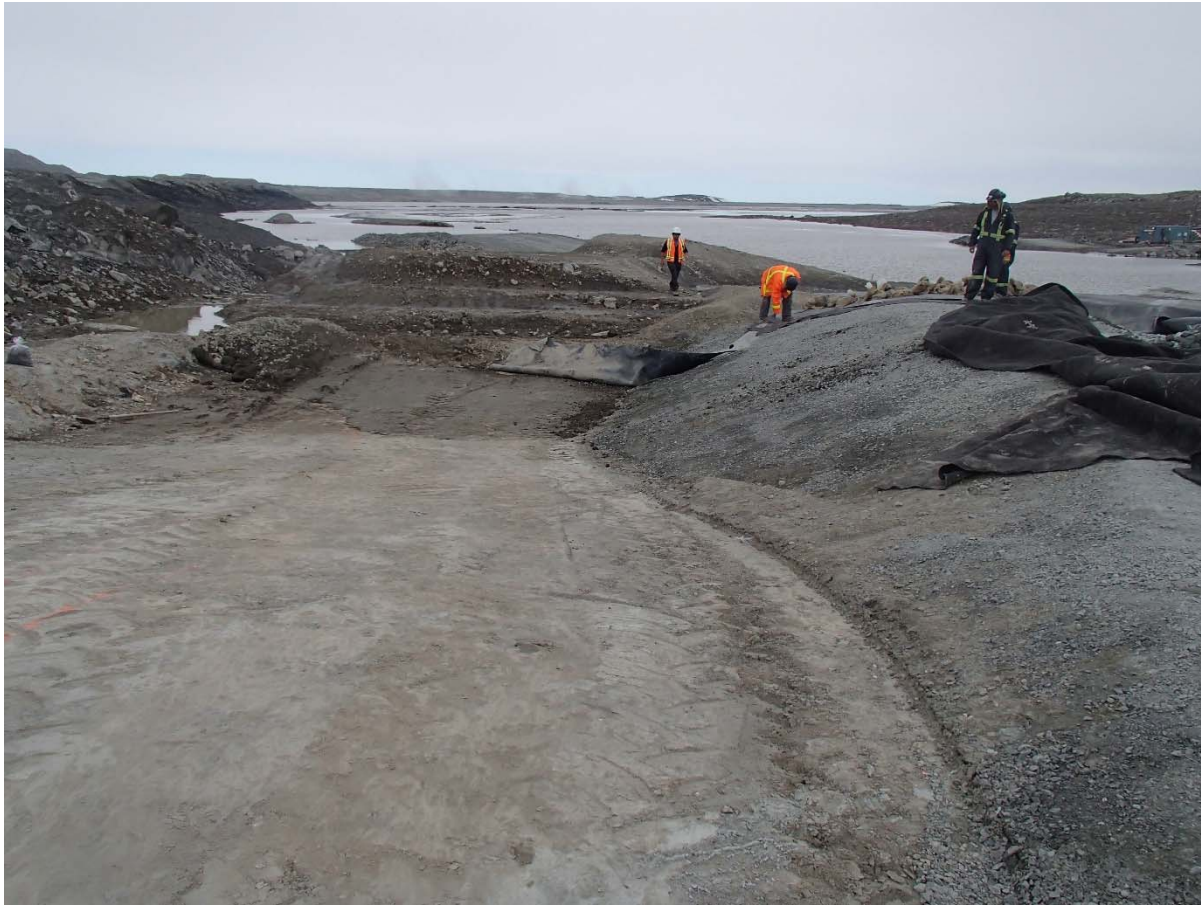
**Photograph SD3-314: From Sta. 20+590/-32 m, looking E. View of the liner bedding ready for geosynthetics installation.**

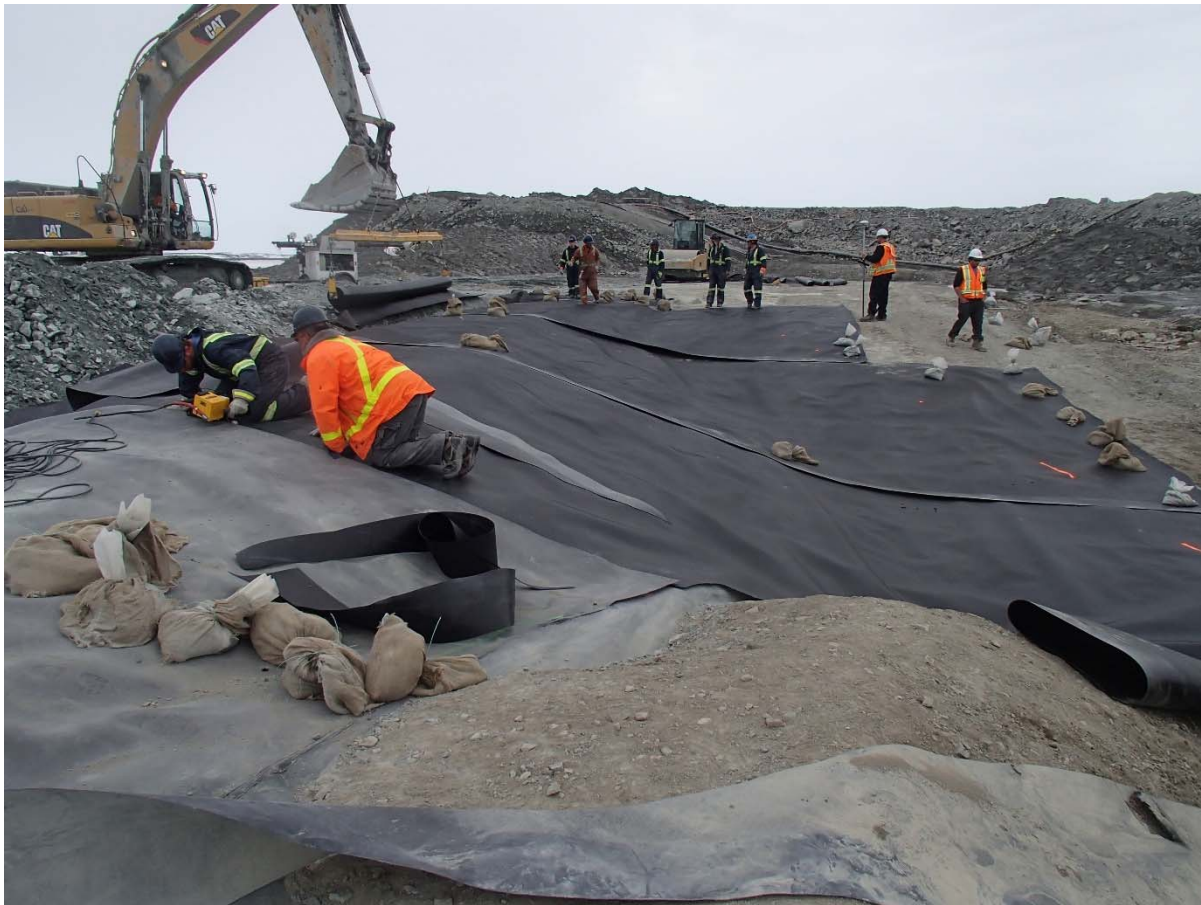
**Photograph SD3-315: From Sta. 20+615/-46 m, looking W. Installation of the geotextile on the upstream slope 3H:1V between El. 143 m and 145 m from Sta. 20+593 m to 20+610 m and installation of the LLDPE liner on the upstream slope 3H:1V between El. 143 m and 145 m from Sta. 20+593 m to 20+610 m (panel numbers 965 to 967).**

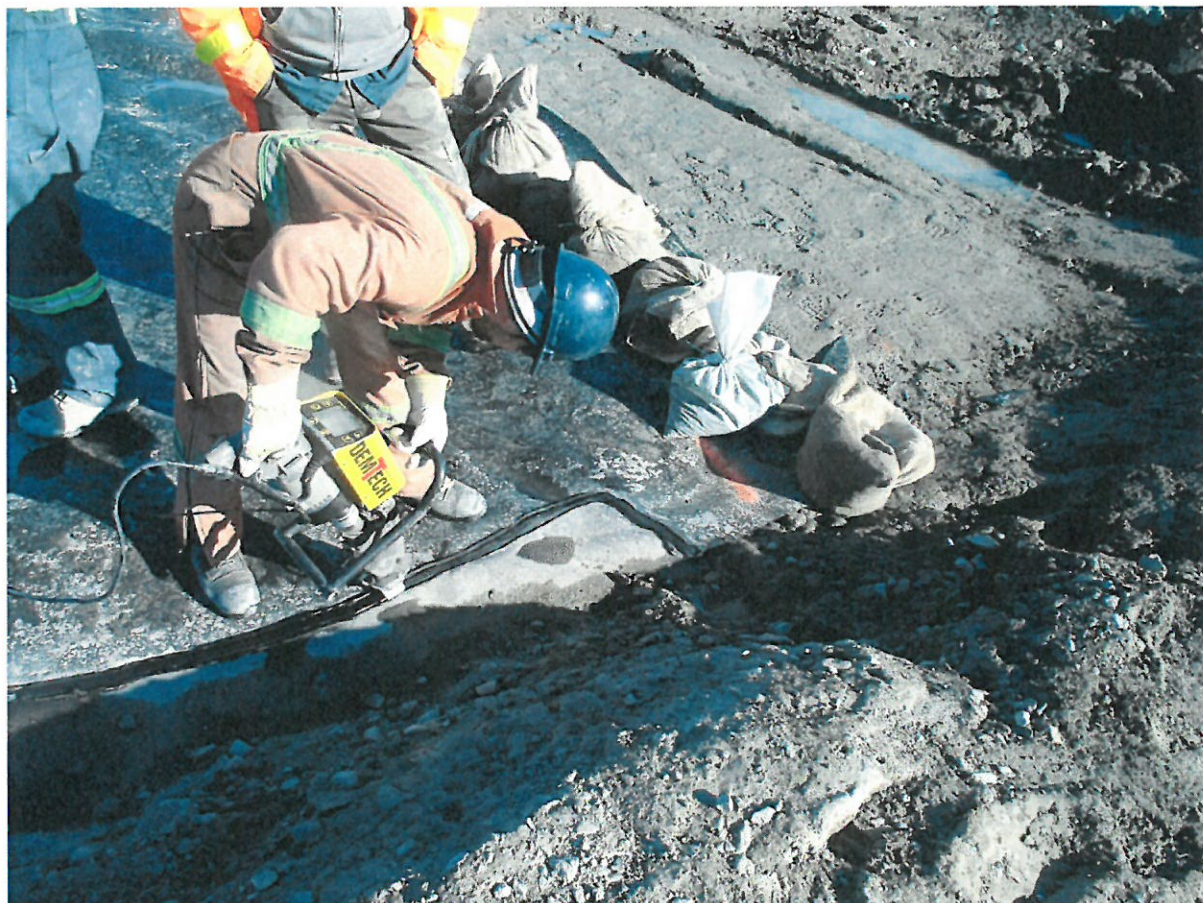
Photograph SD3-316: From Sta. 20+610/-45 m, looking NW. Repairs on the extrusion fillet seam between LLDPE panel 965 and the existing LLDPE panel at Sta. 20+600 m (approx.).

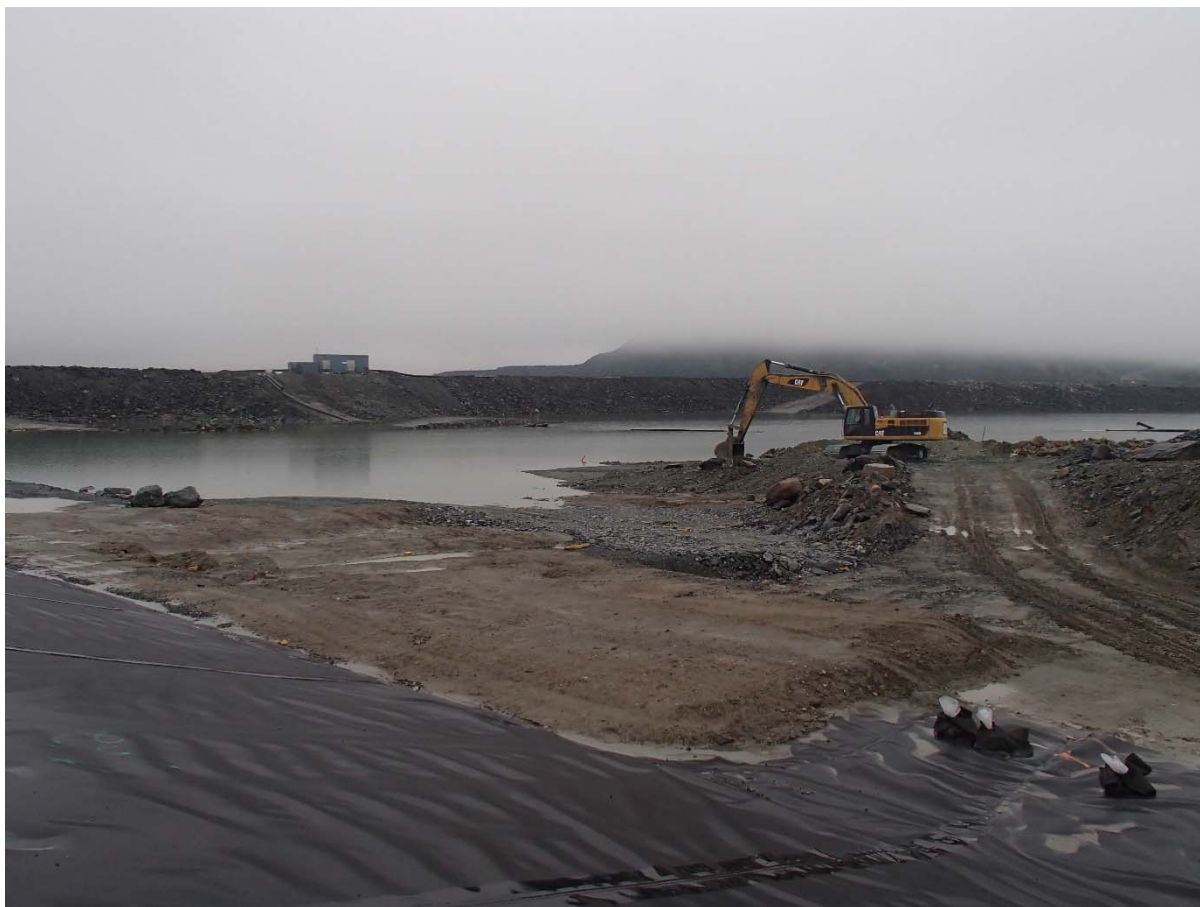
- Due to the level of the South Cell supernatant pond, it was impossible to access the upstream side of SD3 from the ground. The erosion protection offered a too narrow platform for the articulated trucks to access the work area. The rockfill layer was widened and the access road to SD3 was reworked before construction works on SD3 could resume.

Photograph SD3-317: From Sta. 20+800/-22 m, looking E. Reworking of the access to SD3.

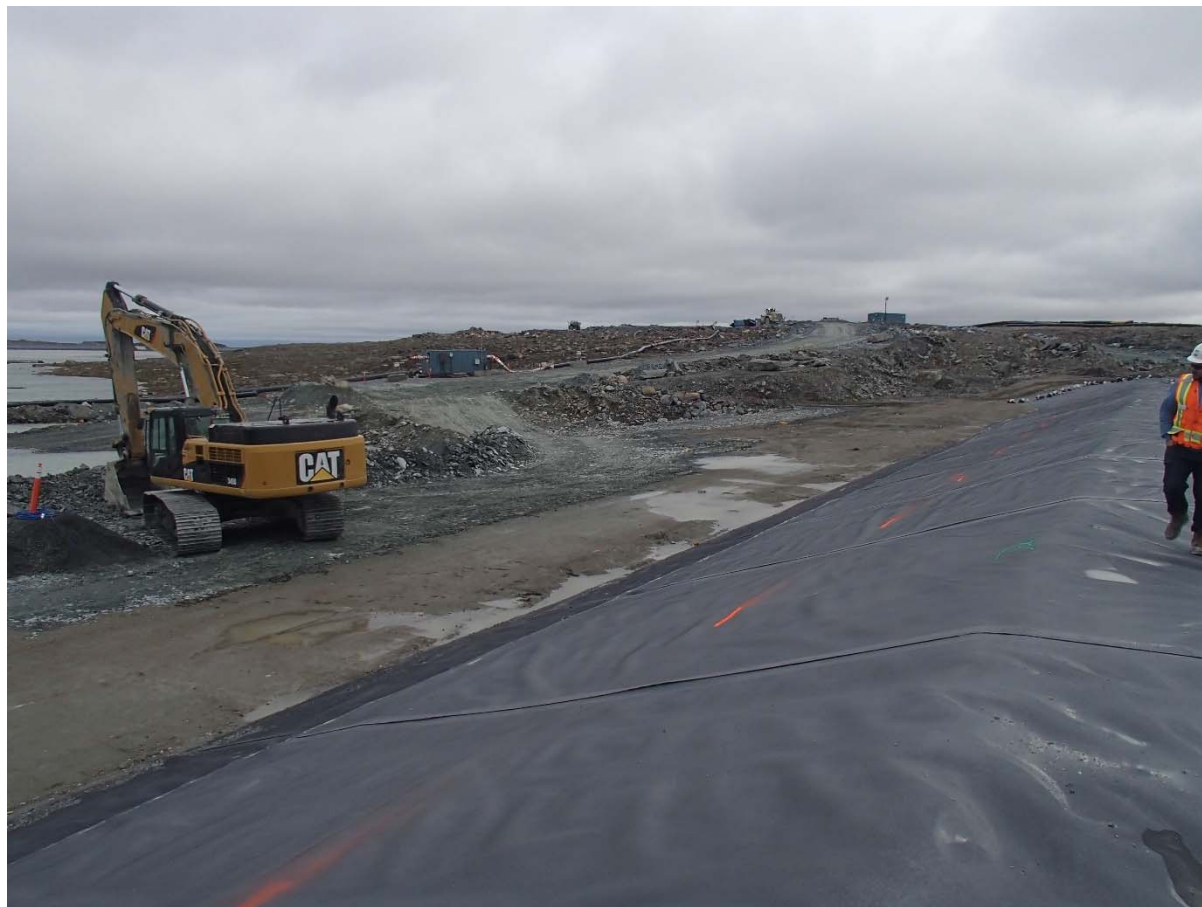
**Photograph SD3-318: From Sta. 20+710/-24 m, looking SE. Placement of IV rockfill in the water up to El. 142 m with an excavator from Sta. 20+785 m to 20+730 m, at the bottom of the upstream slope of SD3 to widen the rockfill layer and allow access to the erosion protection.**

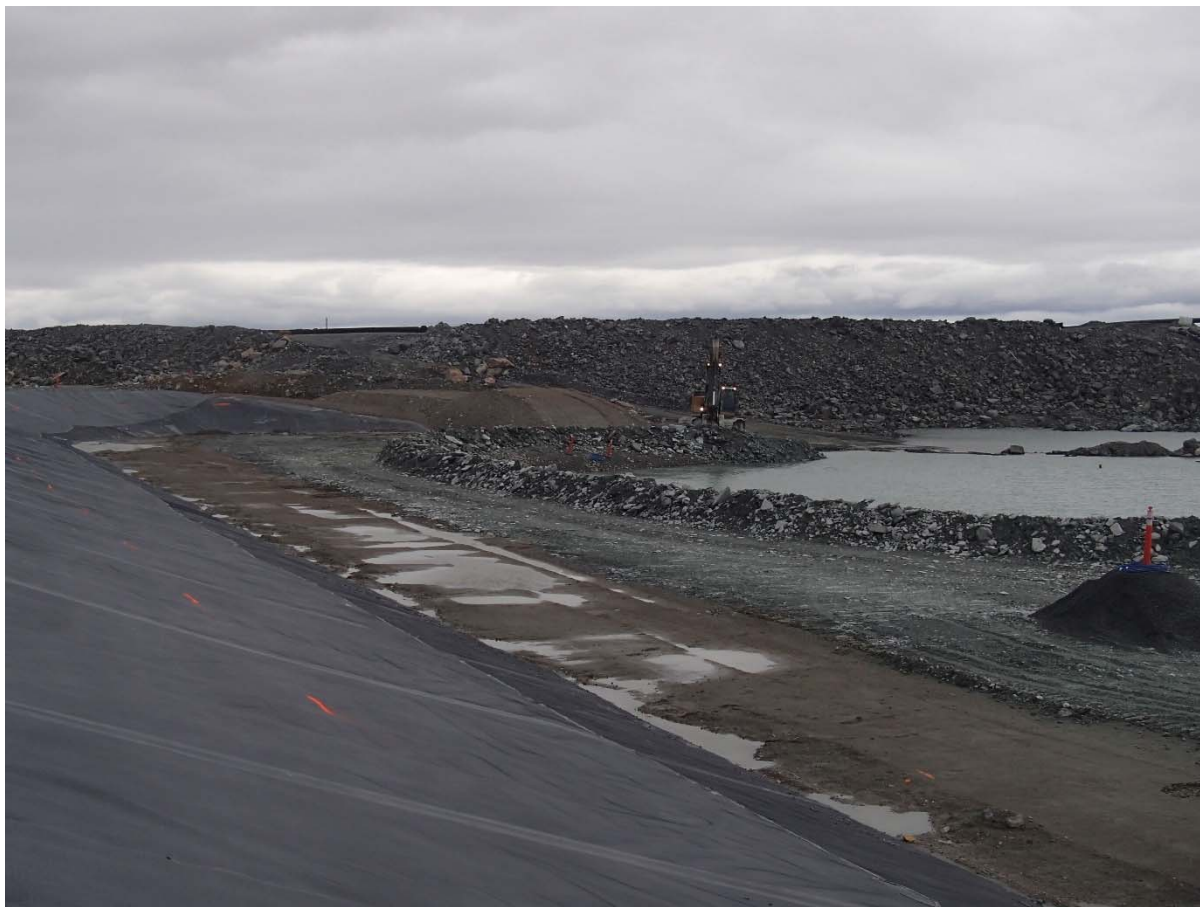
**Photograph SD3-319: From Sta. 20+740/-31 m, looking SE. Placement of IV rockfill in the water up to El. 142 m with an excavator from Sta. 20+730 m to 20+610 m, at the bottom of the upstream slope of SD3 to widen the rockfill layer and allow access to the erosion protection.**

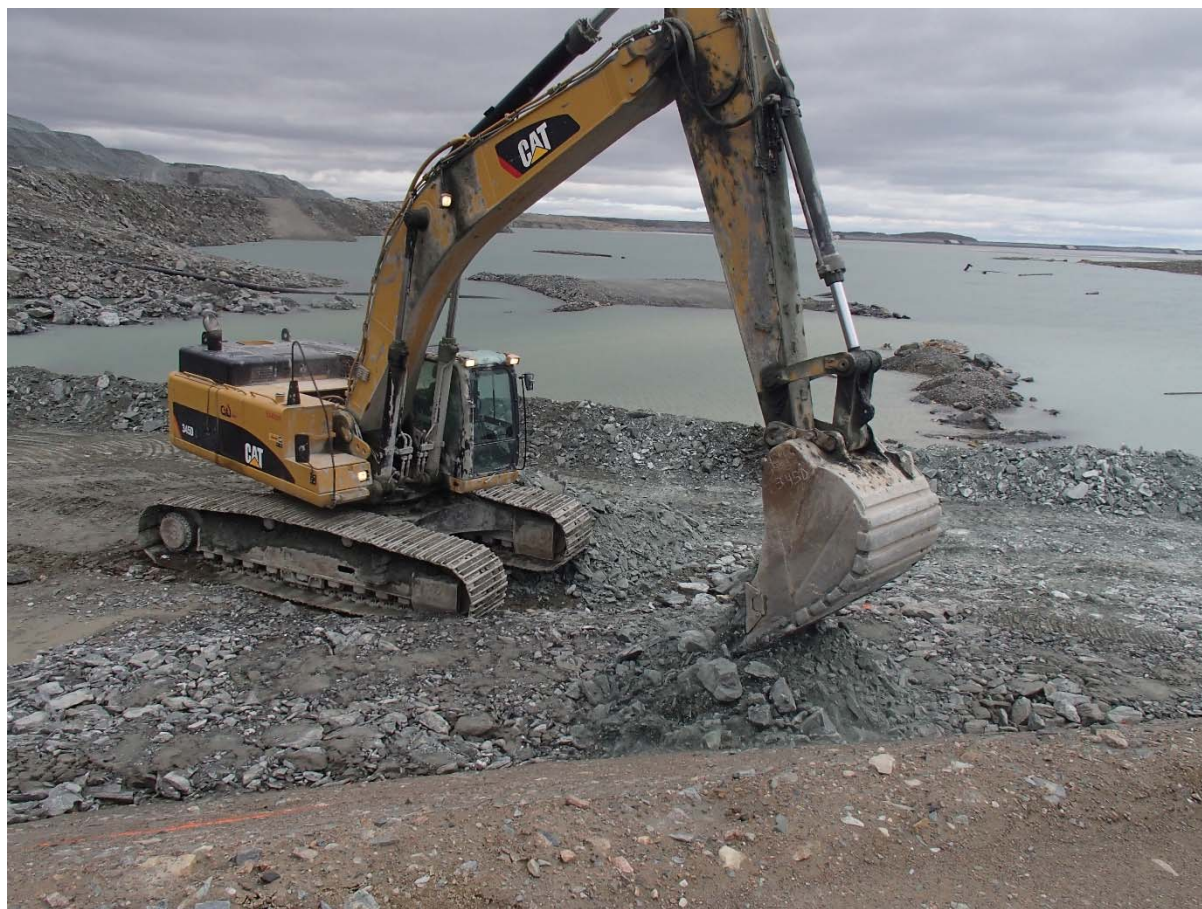
**Photograph SD3-320: From Sta. 20+620/-67 m, looking E. Placement of a 1 m thick (approx.) lift of fine IV rockfill over the compacted till in the upstream slope from El. 142 m to 144 m with an excavator from Sta. 20+600 m to 20+610 m.**

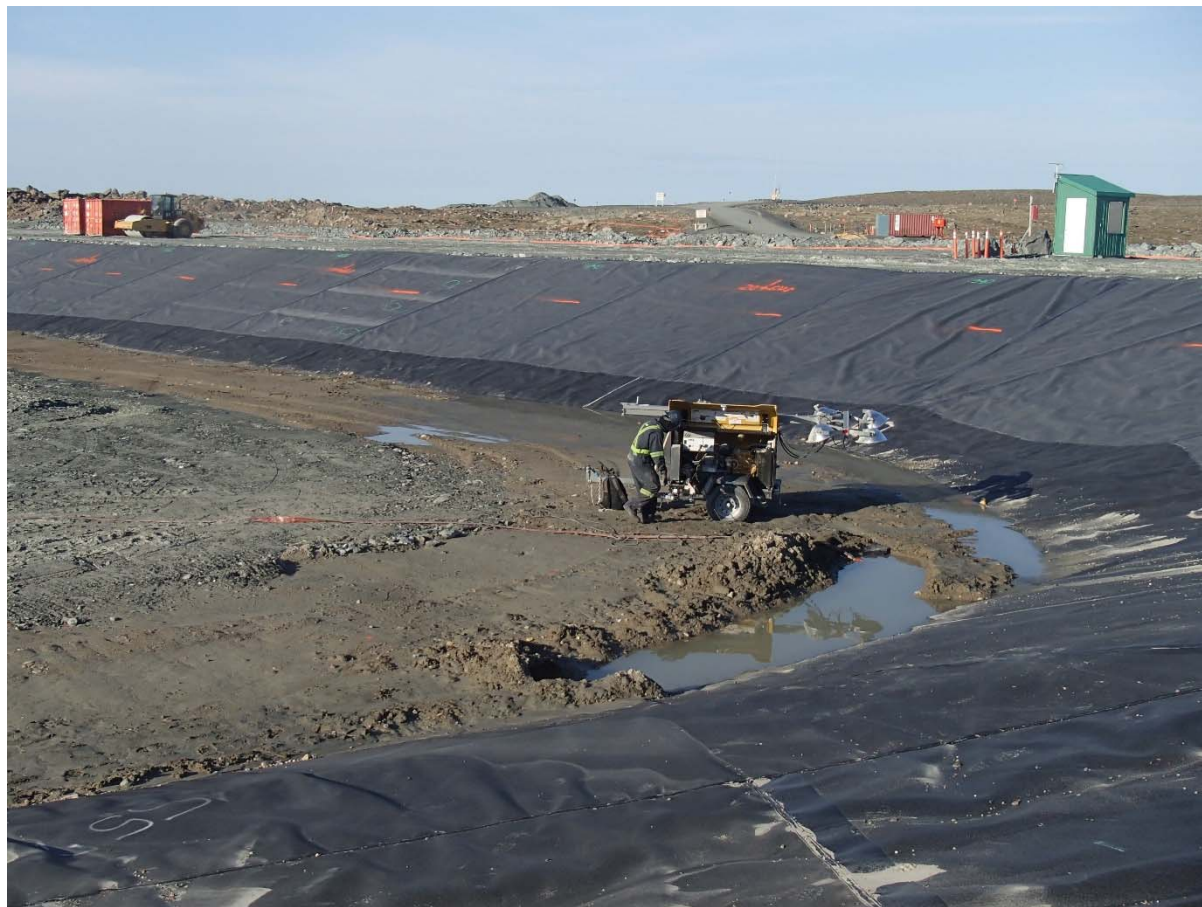
**Photograph SD3-321: From Sta. 20+610/-56 m, looking SW. Water ponding at El. 142m on the compacted sieved till layer of the upstream toe liner tie-in at approx. Sta. 20+620 m to 20+630 m was pumped.**

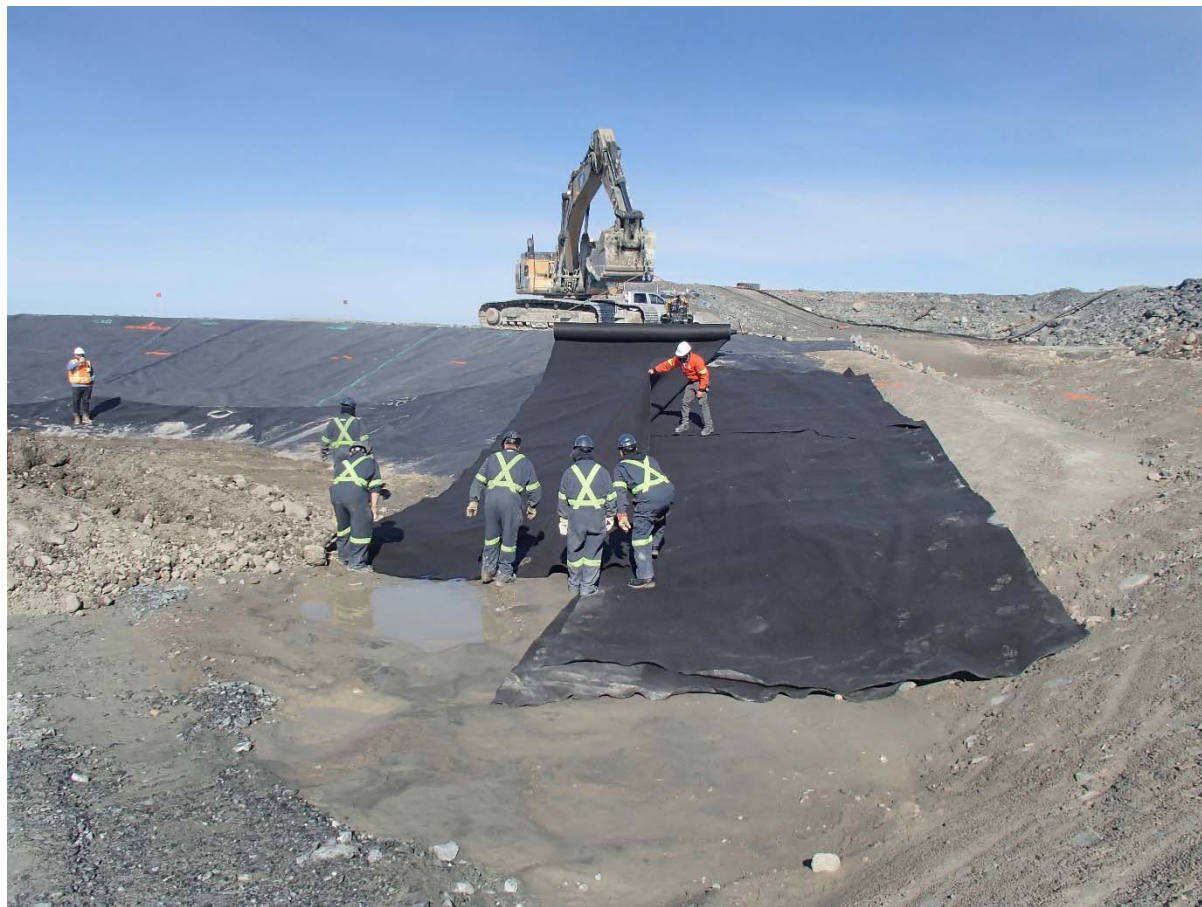
- The design change for the erosion protection cover on SD3 required geotextile type Texel 934 or equivalent. Given that the mechanical properties of the only geotextile available on site, TenCate Mirafi S1600, are inferior to those of Texel 934, an alternative of two layers of TenCate Mirafi S1600 was accepted. It should be noted that the use of two layers of geotextile is generally not a recommended practice as the two layers may slip on each other. The acceptance is based on the fact that the dike would likely not be built to its final initially planned elevation. Should the dike be raised further, this aspect of the design will need to be reviewed.

**Photograph SD3-322: From Sta. 20+625/-63 m, looking W. Installation of two layers of geotextile on the upstream slope 3H:1V between El. 142 m and 143 m (approx.) from Sta. 20+610 m to 20+800 m.**

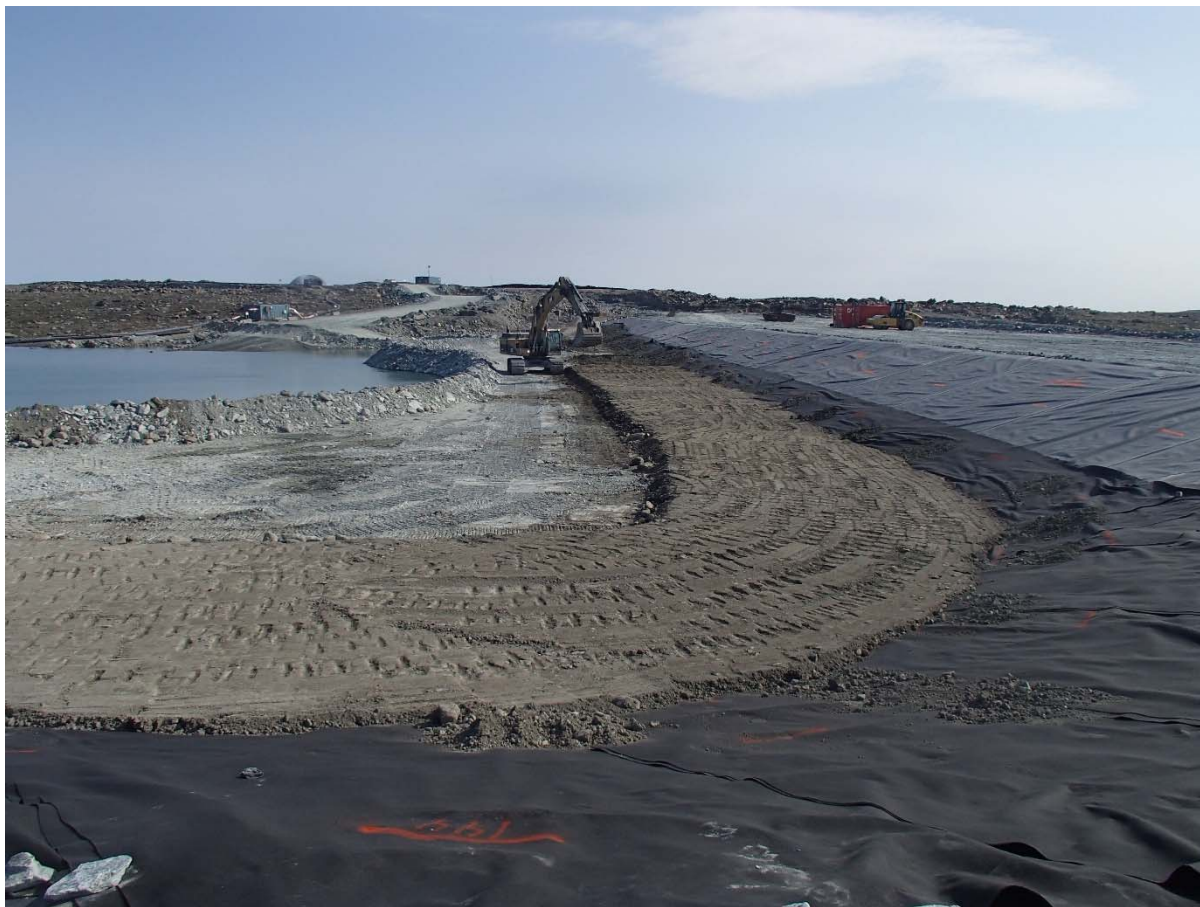
- The QA Manager observed many particles larger than 300 mm in the low quality till sieved with the bucket of the excavator (0-150 mm) on SD3 at the beginning of the construction of the first lift. It was reiterated that the sieving operation aims to remove particles of size over 150 mm. The bigger particles were removed with an excavator on SD3. The SANA foreman forwarded the information to the operator of the excavator sieving and loading the till at the E5 stockpile.

**Photograph SD3-323: From Sta. 20+610/-43 m, looking S. Placement of the first lift of low quality till (0-150 mm) from El. 142 m to 142.5 m from Sta. 20+610 m to 20+715 m.**

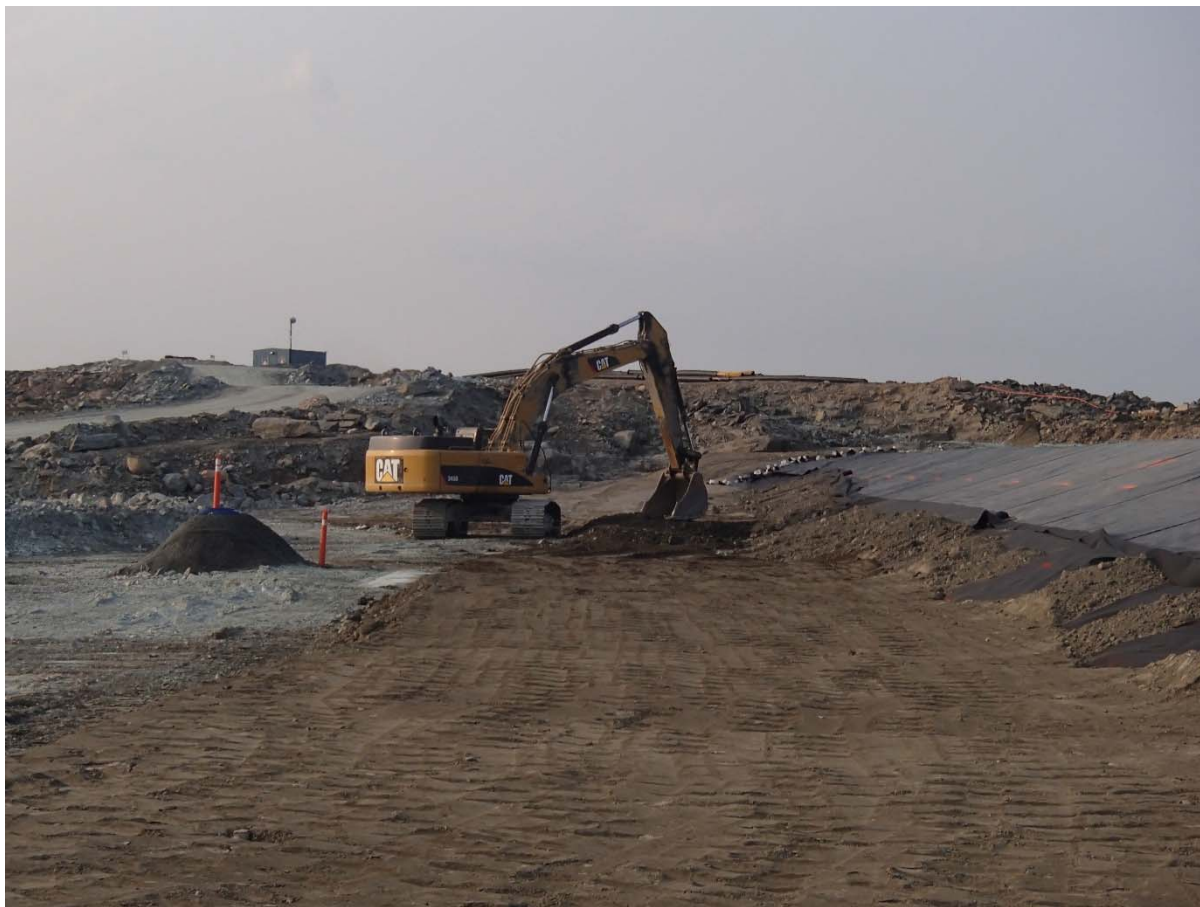
- Following discussions with AEM's representative, the thermistors upstream of SD3 were unplugged and the cables were moved temporarily at the base of SD3, for placement of the erosion protection layer. The cables were protected with crusher reject material before placement of the rockfill for the access road and the end of the cables that comes out of the reject was installed on a crusher reject mound to assure that no articulated truck would circulate over it. The crusher reject mound is visible on photograph SD3-324.

**Photograph SD3-324: From Sta. 20+680/-39m, looking S. Placement of a 0.5 m thick lift of low quality till (0-150 mm) from El. 142 m to 142.5 m from Sta. 20+715 m to 20+760 m.**

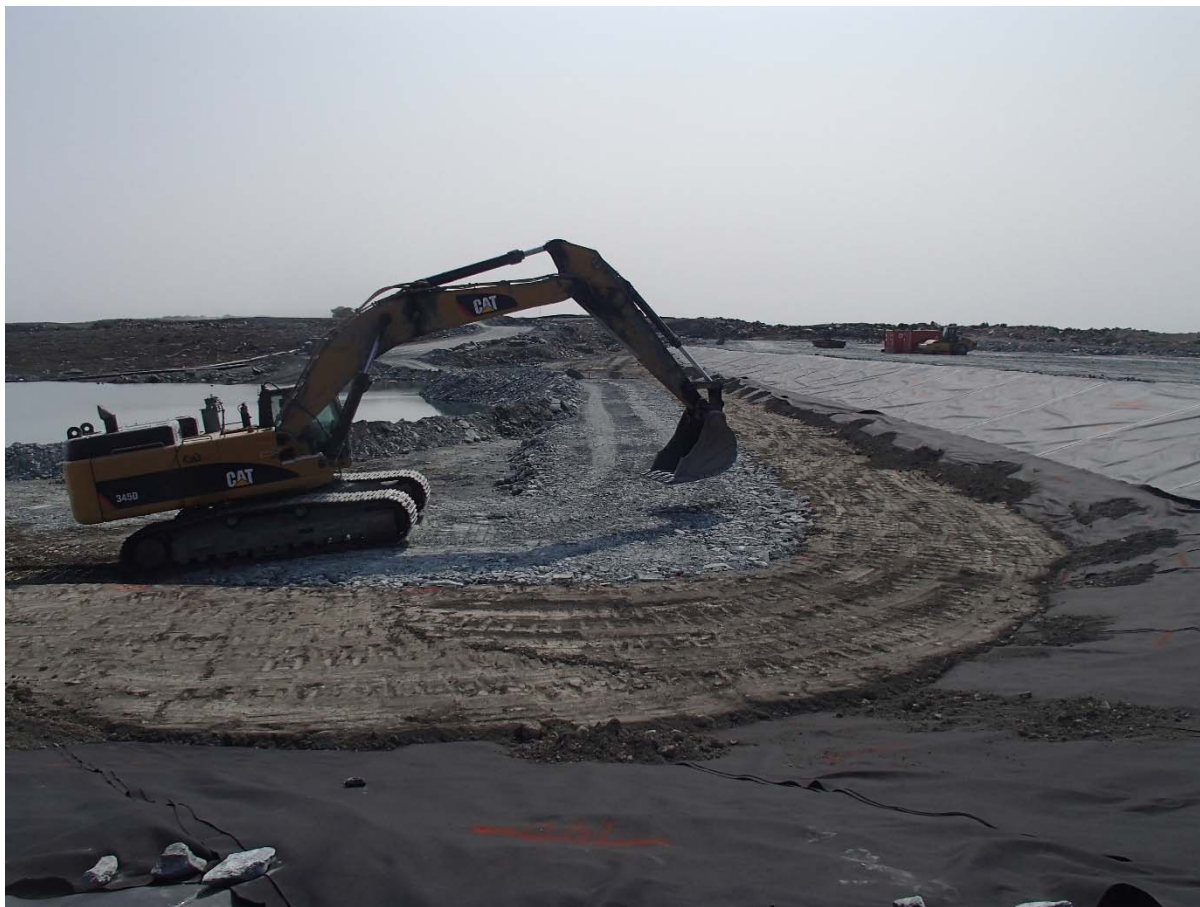
**Photograph SD3-325: From Sta. 20+610/-43 m, looking S. Placement of a first 0.5 m thick lift of fine rockfill (0-500 mm) upstream of the low quality till from El. 142 m to 142.5 m from Sta. 20+610 m to 20+760 m.**

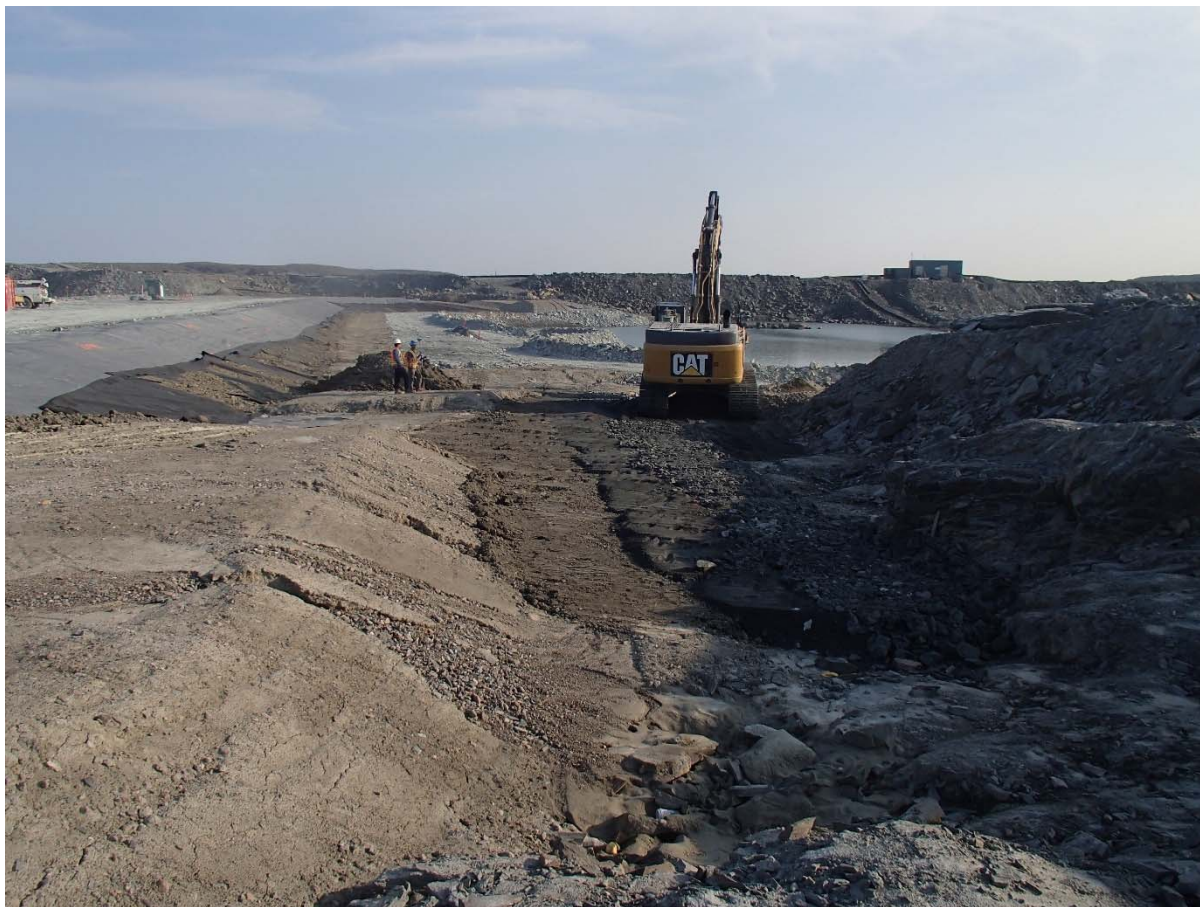
**Photograph SD3-326: From Sta. 20+820/-34 m, looking N. Placement of the 0.5 m thick lift of low class till, fine filter, coarse filter and fine rockfill on the upstream slope of the upstream toe liner tie-in with an excavator from Sta. 20+780 to 20+810 m.**
