## QA WEEKLY REPORT

1897439-1577-TM-Rev0

### QA WEEKLY REPORT FROM JULY 7<sup>TH</sup> TO JULY 15<sup>TH</sup> – TSF SOUTH CELL CONSTRUCTION MEADOWBANK (1897439)

This document summarizes QA activities performed by Golder from July 7<sup>th</sup> to June 15<sup>th</sup>, 2018 inclusively, related to the construction activities of Saddle Dam 3 (SD3) and Central Dike (CD) at the Meadowbank mine site.

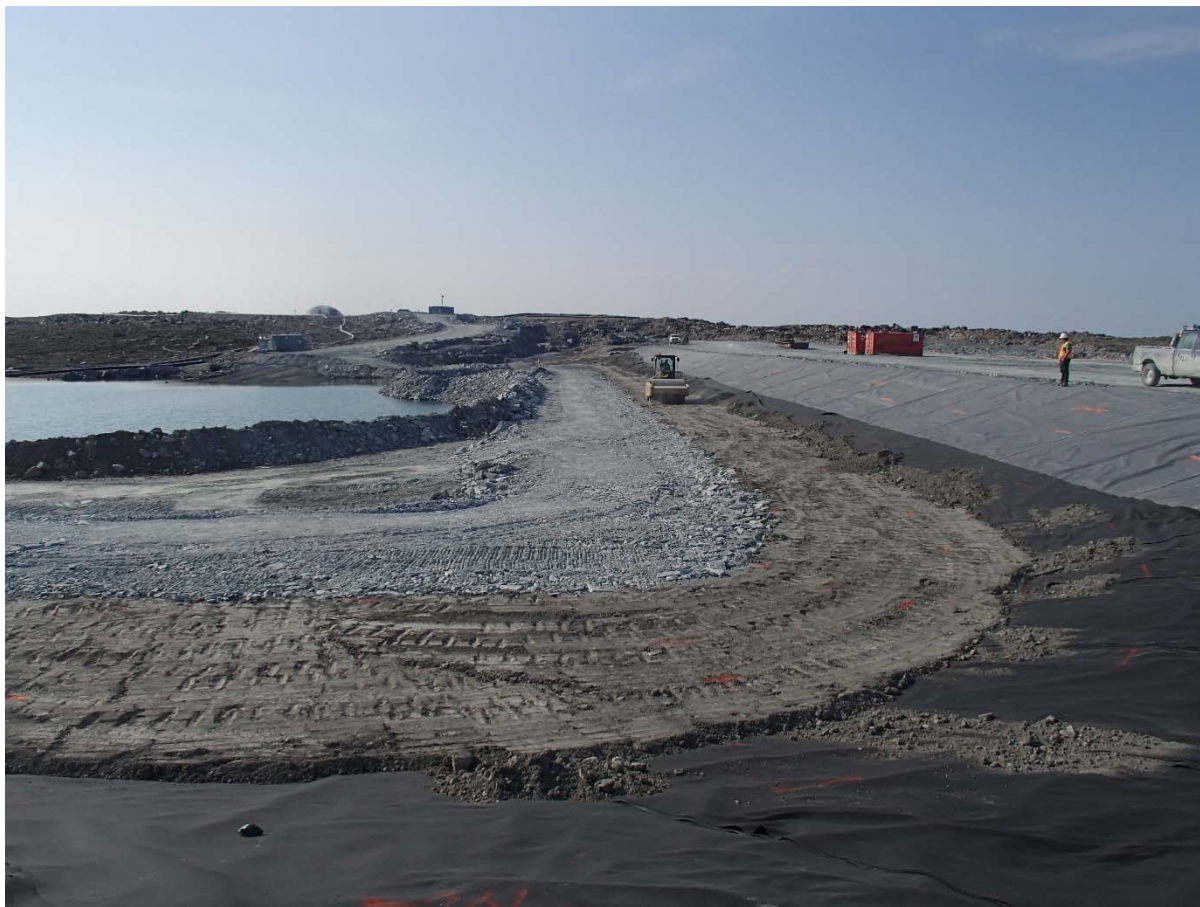
**Photograph SD3-327: From Sta. 20+610/-43 m, looking S. Compaction of the 0.5 m lift of low quality till (0-150 mm) at El. 142.5 m with a 10-tonne smooth-drum compactor with vibration (4 passes) from Sta. 20+610 m to 20+615 m and from Sta. 20+635 m to 20+760 m.**

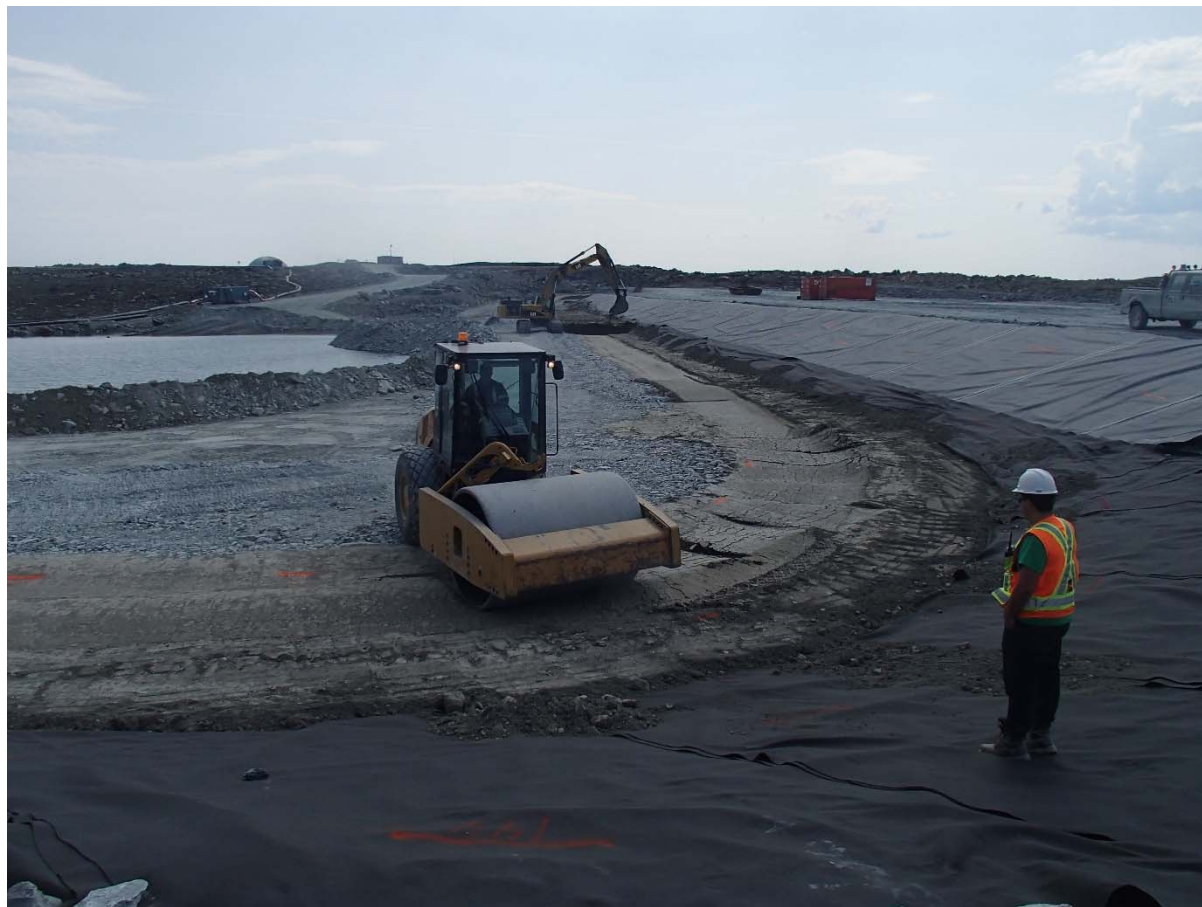
- The compactor was sinking in the low quality till at El. 142.5 m from Sta. 20+615 m to 20+635 m, when turning to follow the curve of Saddle Dam 3. As the water content measured with the portable nuclear gauge indicated a 6.1% water content, it was assumed that it was the underlying compacted sieved till layer that

**Photograph SD3-328: From Sta. 20+610/-43 m, looking S. Compaction perpendicularly to the longitudinal axis of Saddle Dam 3 of the 0.5 m lift of low quality till (0-150 mm) at El. 142.5 m with a 10-tonne smooth-drum compactor without vibration (4 passes) from Sta. 20+615m to 20+635 m.**

was too soft. Following discussion with the Designer, it was decided not to excavate the underlying till layer to prevent damaging the LLDPE geomembrane below the compacted sieved till. The surface of the low quality till at El. 142.5 m was corrected with the excavator and was then compacted with a 10-tonne smooth-drum compactor without vibration. The compaction was carried out perpendicularly to the longitudinal axis of Saddle Dam 3 from Sta. 20+615 m to 20+635 to avoid the necessity to turn on the low quality till for the compactor.

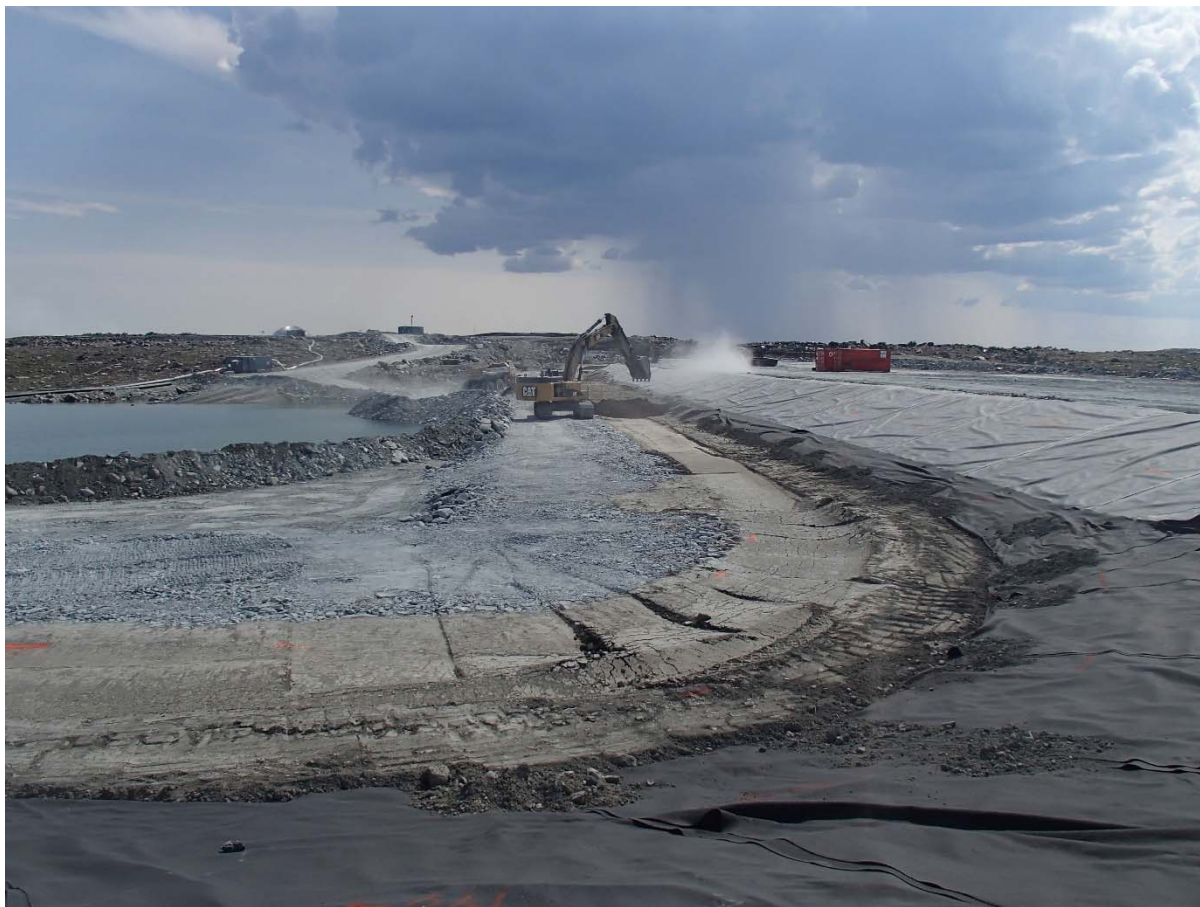
**Photograph SD3-329: From Sta. 20+610/-43 m, looking S. Placement of a 0.5 m thick lift of low quality till (0-150 mm) from El. 142.5 m to 143 m from Sta. 20+610 m to 20+760 m.**

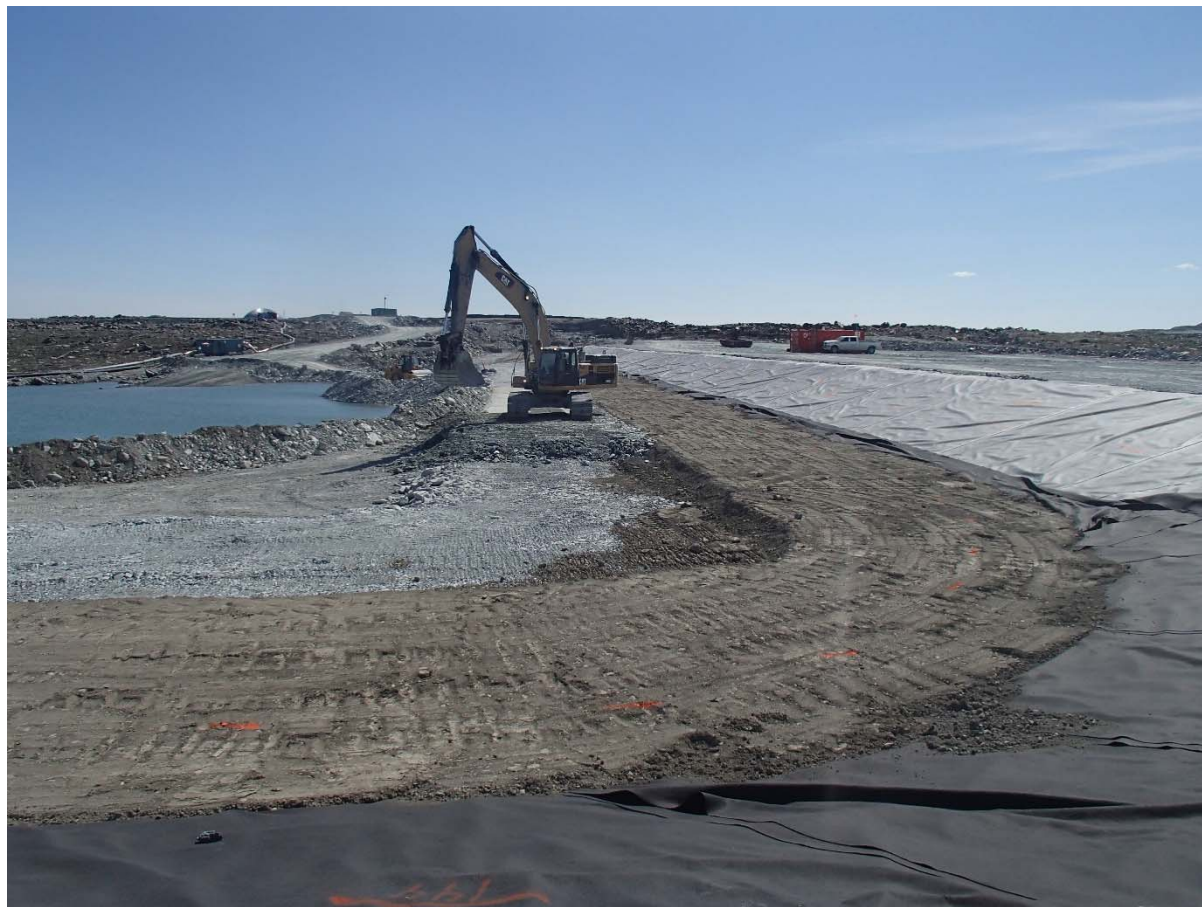
**Photograph SD3-330: From Sta. 20+610/-43 m, looking S. Placement of a second 0.5 m thick lift of fine rockfill (0-500 mm) upstream of the low quality till (0-150 mm) from El. 142.5 m to 143 m from Sta. 20+610 m to 20+760 m.**

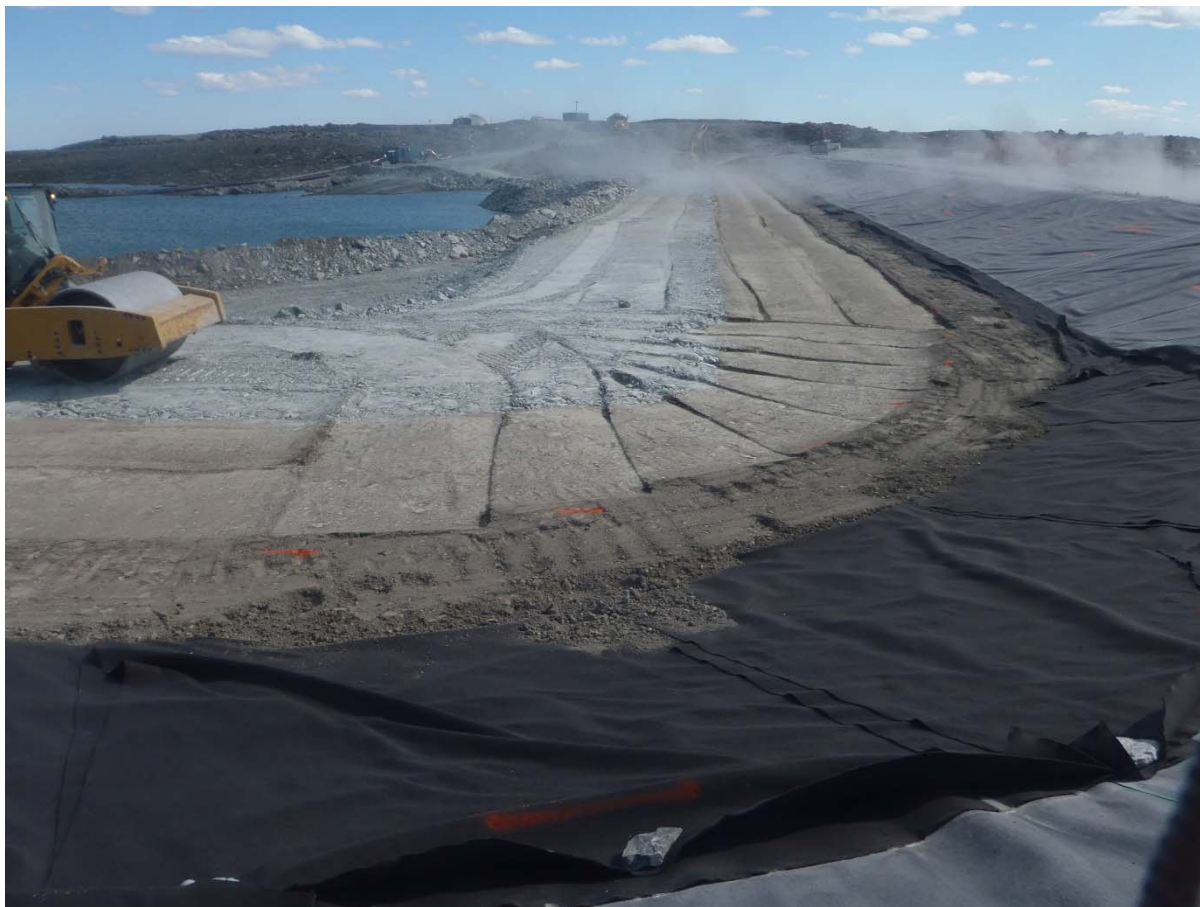
**Photograph SD3-331: From Sta. 20+610/-43 m, looking S. Compaction of the 0.5 m lift of low quality till (0-150 mm) at El. 143 m with a 10-tonne smooth-drum compactor with vibration (4 passes) from Sta. 20+610 m to 20+760 m.**

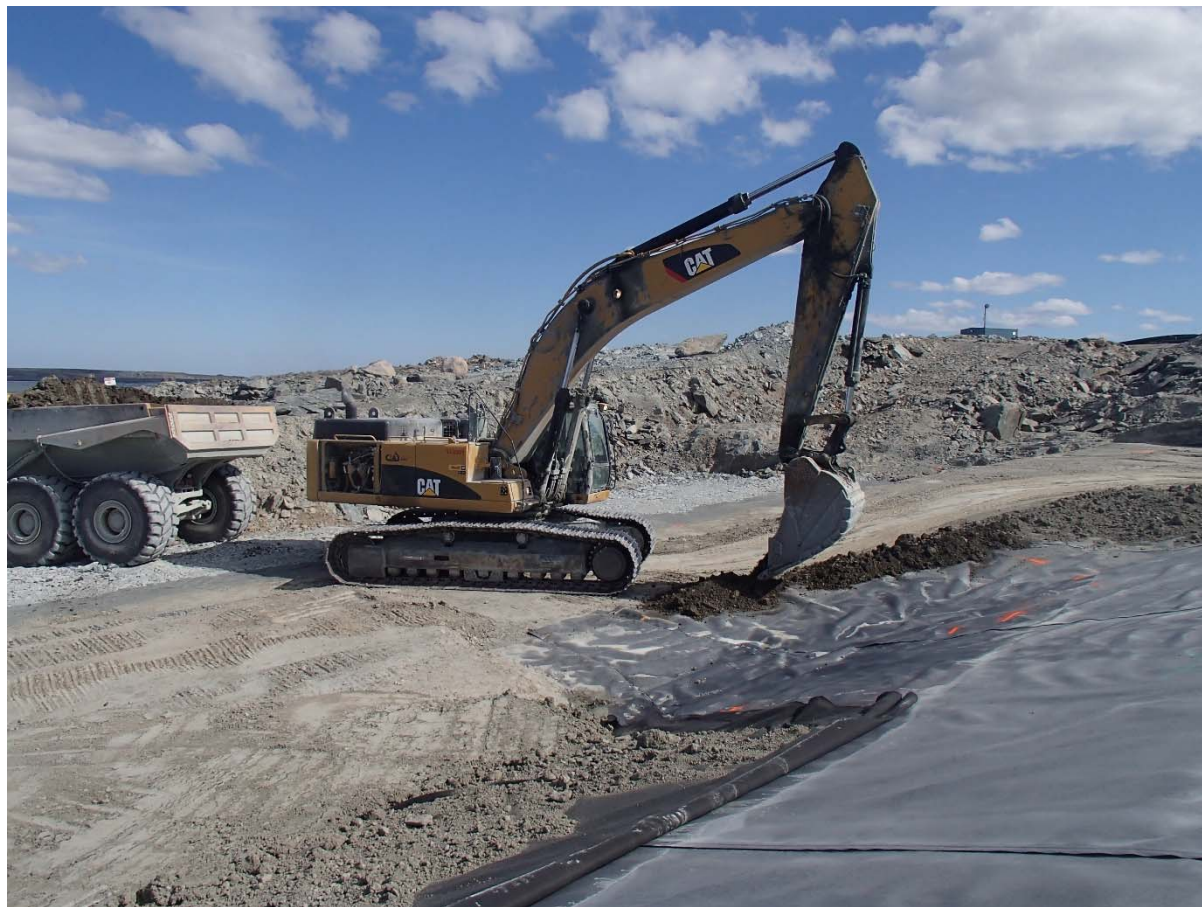
**Photograph SD3-332: From Sta. 20+775/-23 m, looking SE. Placement of a first 0.5 m thick lift of compacted sieved till over the LLDPE geomembrane on the upstream toe liner tie-in with an excavator from Sta. 20+775 m to 20+800 m.**

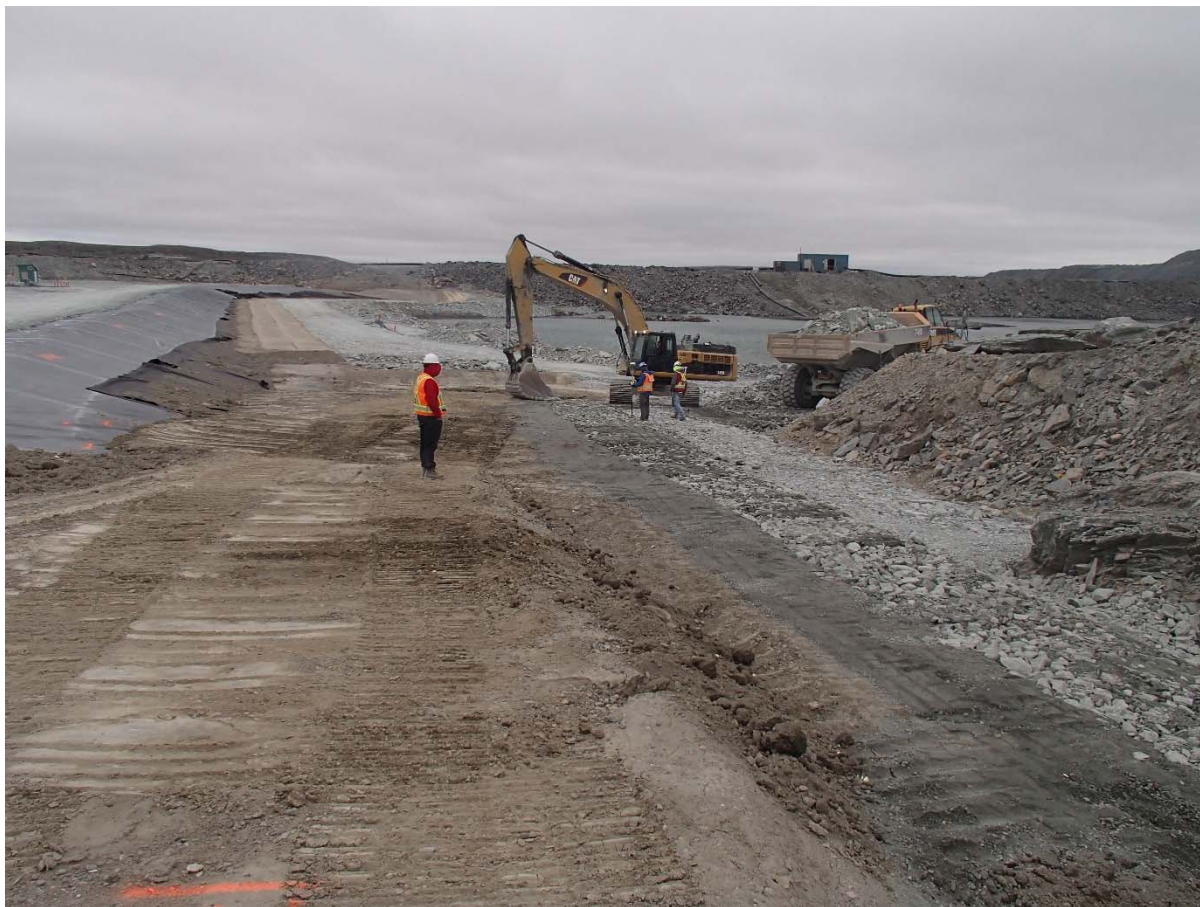
**Photograph SD3-333: From Sta. 20+817/-29 m, looking N. Placement of a second 0.5 m thick lift of fine rockfill on the upstream slope of the upstream toe liner tie-in with an excavator from Sta. 20+775 m to 20+800 m.**

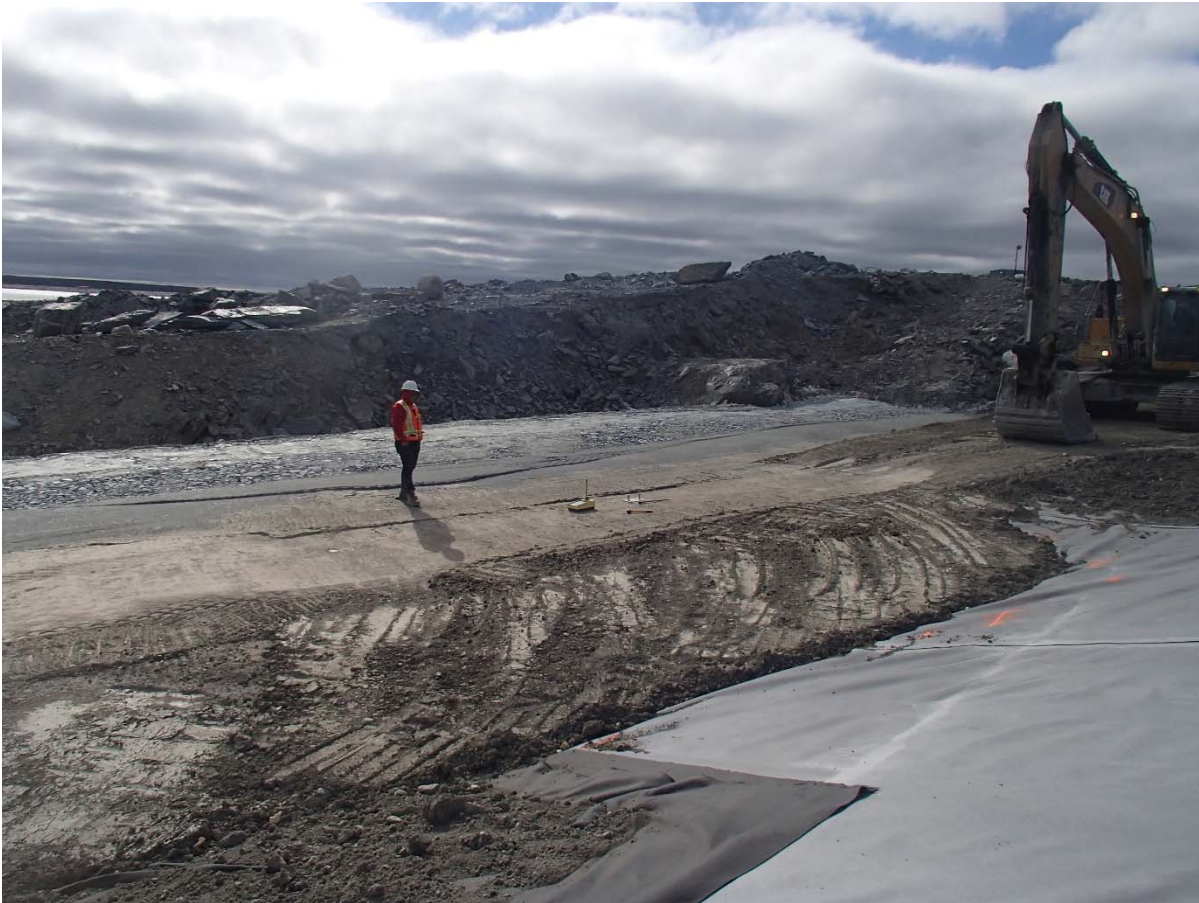
**Photograph SD3-334: From Sta. 20+780/-26 m, looking SE. Compaction of the second 0.5 m thick lift of compacted sieved till and third lift of fine filter, coarse filter and fine rockfill of the upstream toe liner tie-in with a 10-tonne smooth-drum compactor with vibrations from Sta. 20+770 m to 20+800 m.**

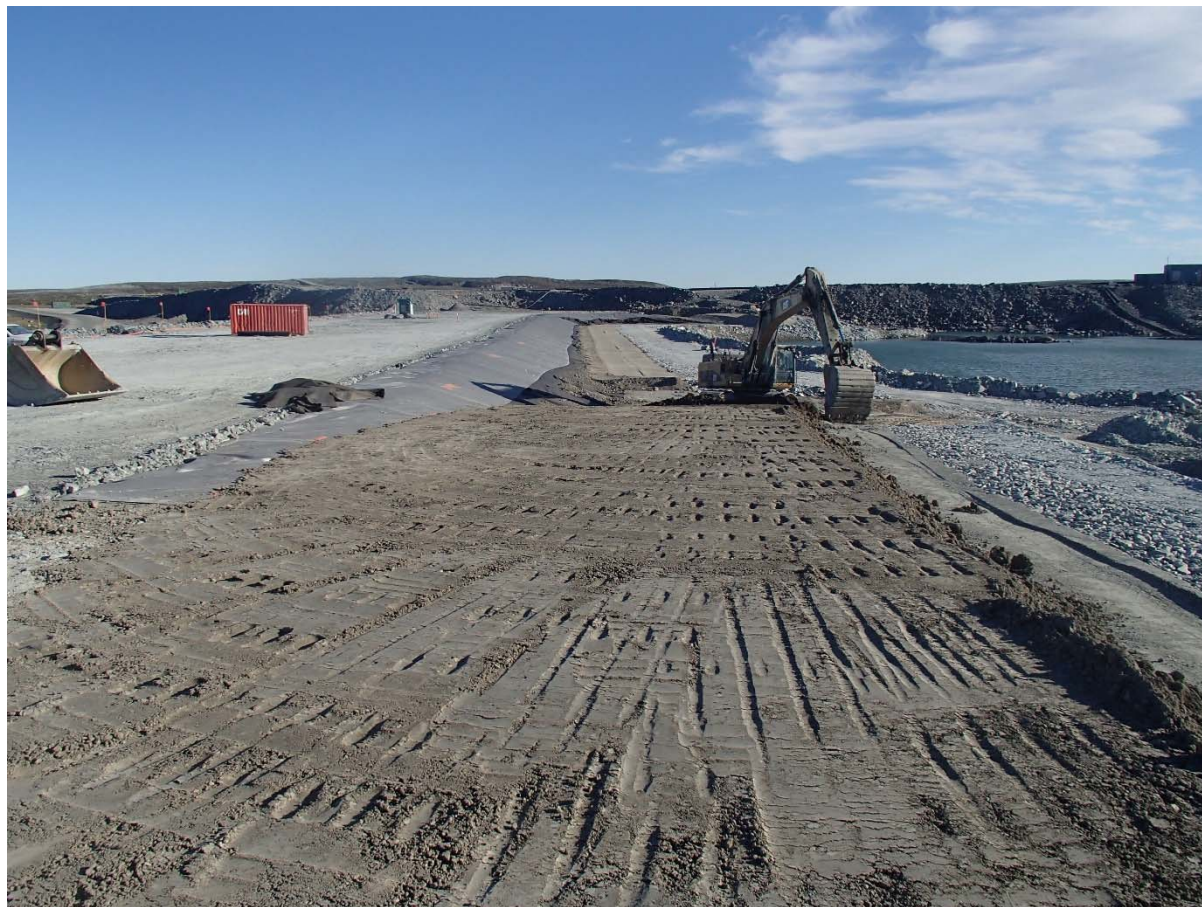
**Photograph SD3-335: From Sta. 20+815/-27 m, looking N. Placement of a third 0.5 m thick lift of compacted sieved till on the upstream toe liner tie-in with an excavator from Sta. 20+760 m to 20+810 m.**

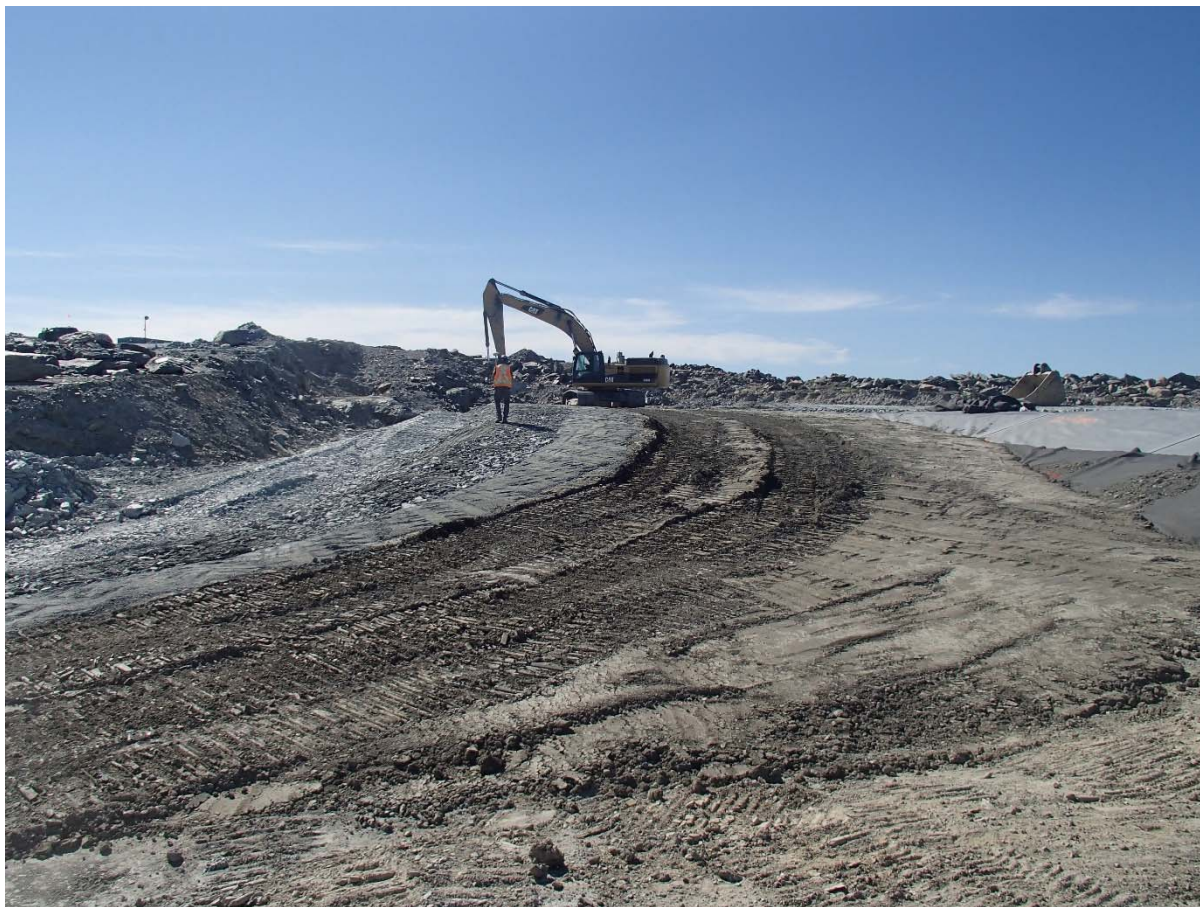
**Photograph SD3-336: From Sta. 20+755/-48 m, looking S. Placement of a fourth 0.5 m thick lifts of fine filter, coarse filter and fine rockfill on the upstream slope of the upstream toe liner tie-in with an excavator from Sta. 20+770 to 20+800 m.**

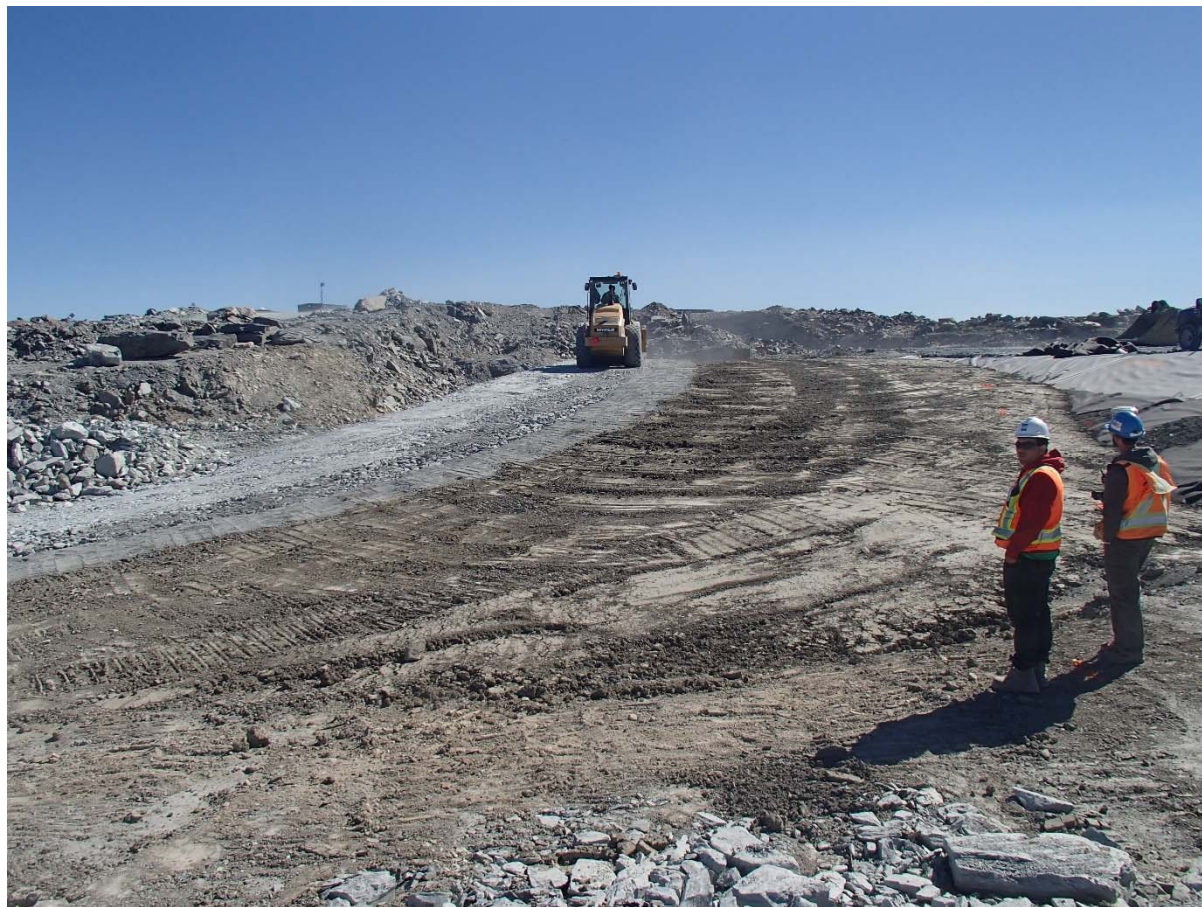
**Photograph SD3-337: From Sta. 20+760/-37 m, looking S. Compaction of the fourth 0.5 m thick lifts of fine filter, coarse filter and fine rockfill on the upstream slope of the upstream toe liner tie-in with a 10-tonne smooth-drum compactor with vibrations (4 passes) from Sta. 20+770 to 20+800 m.**
