QA WEEKLY REPORT

QA WEEKLY REPORT FROM JULY 16TH TO JULY 22ND – TSF SOUTH CELL CONSTRUCTION MEADOWBANK (1897439)

QA DAILY REPORT FOR APRIL 23RD, 2018 – TSF SOUTH CELL CONSTRUCTION - MEADOWBANK (1897439)

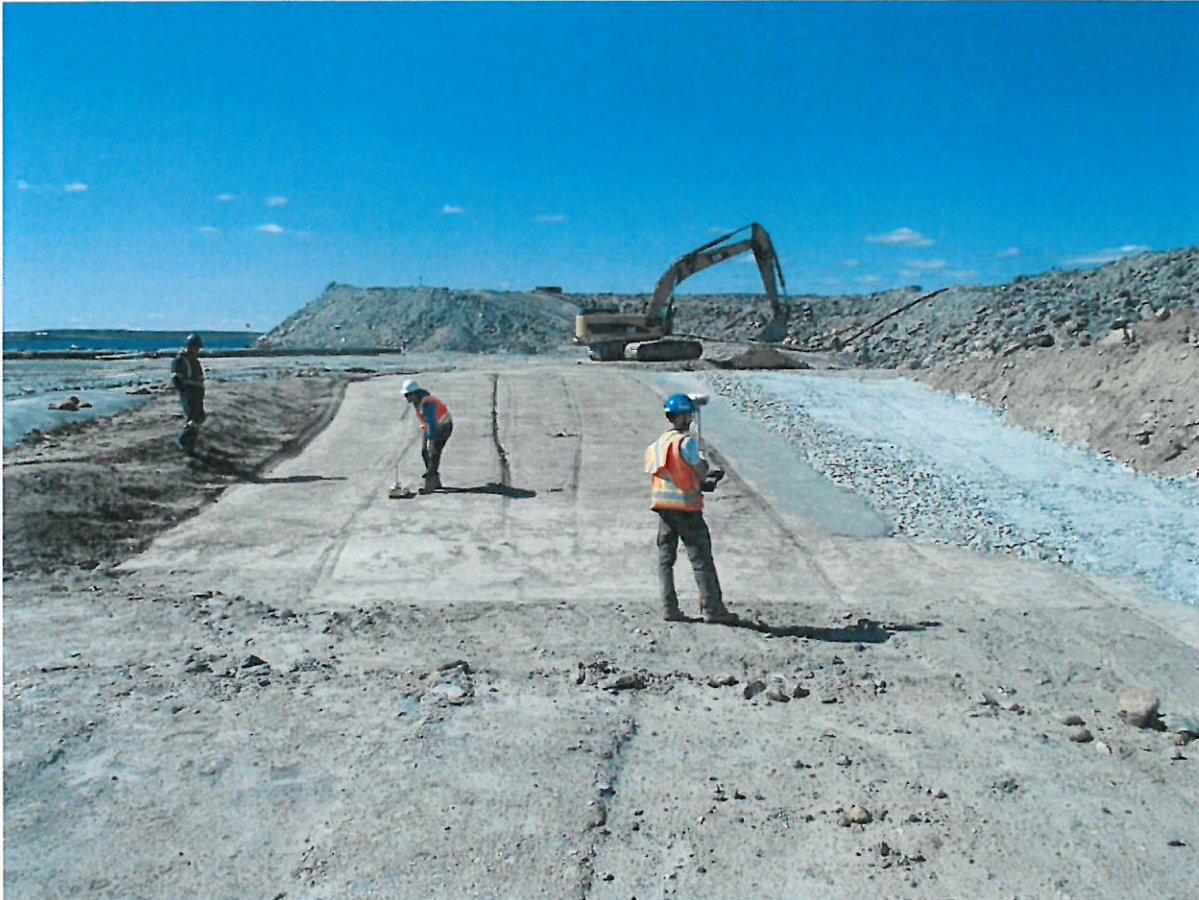
Photograph SD3-342: From Sta. 20+600/-57 m, looking W. View of the compaction test and view of the filling of the depression between SD2 and SD3 with low quality till up to El. 145 m

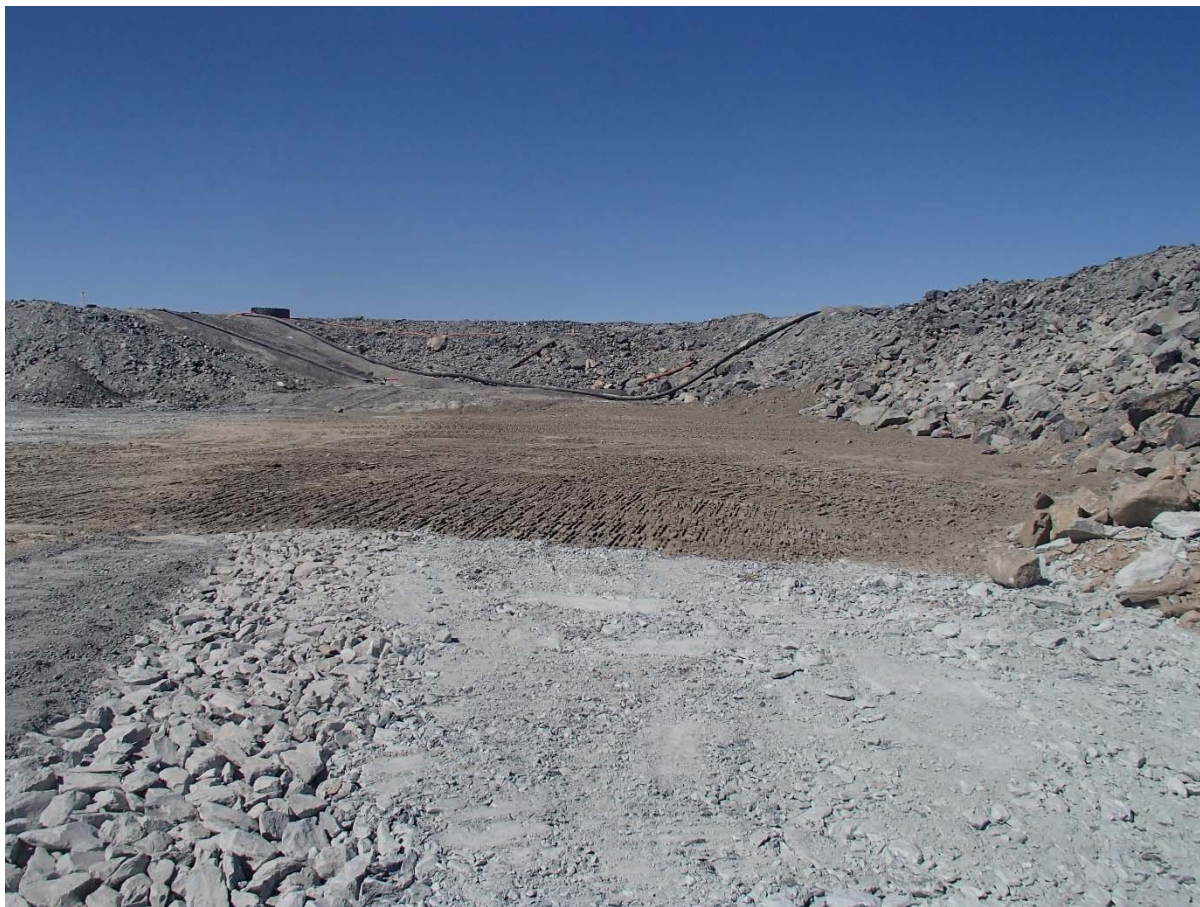
Photograph SD3-343: From Sta. 20+590/-40 m, looking NW. View of the depression between SD2 and SD3 backfilled with low quality till up to El. 145 m.

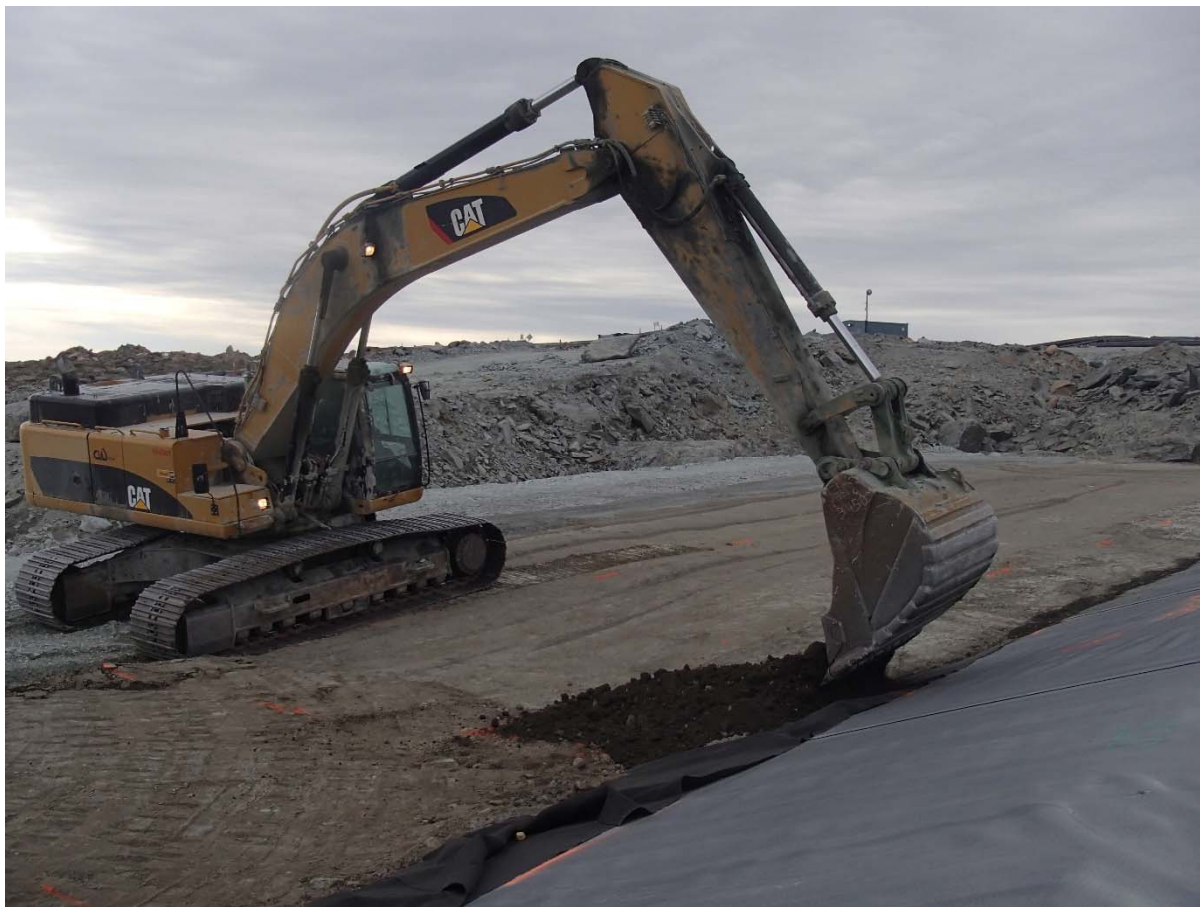
- The sieved till used against the LLDPE liner on the upstream slope of SD3 as part on the granular protection of the south upstream toe liner tie-in contained many rocks larger than 50 mm, probably picked up during loading at the stockpile. Therefore, the QA and QC personnel supervised the placement of the till to ensure no large rock was placed against the line.

Photograph SD3-348: From Sta. 20+760/-25 m, looking E. Placement of a 0.5 m thick layer of compacted sieved till on the upstream slope of SD3 with an excavator from Sta. 20+777 m to 20+807 m. No large rock was allowed to be placed against the LLDPE liner.

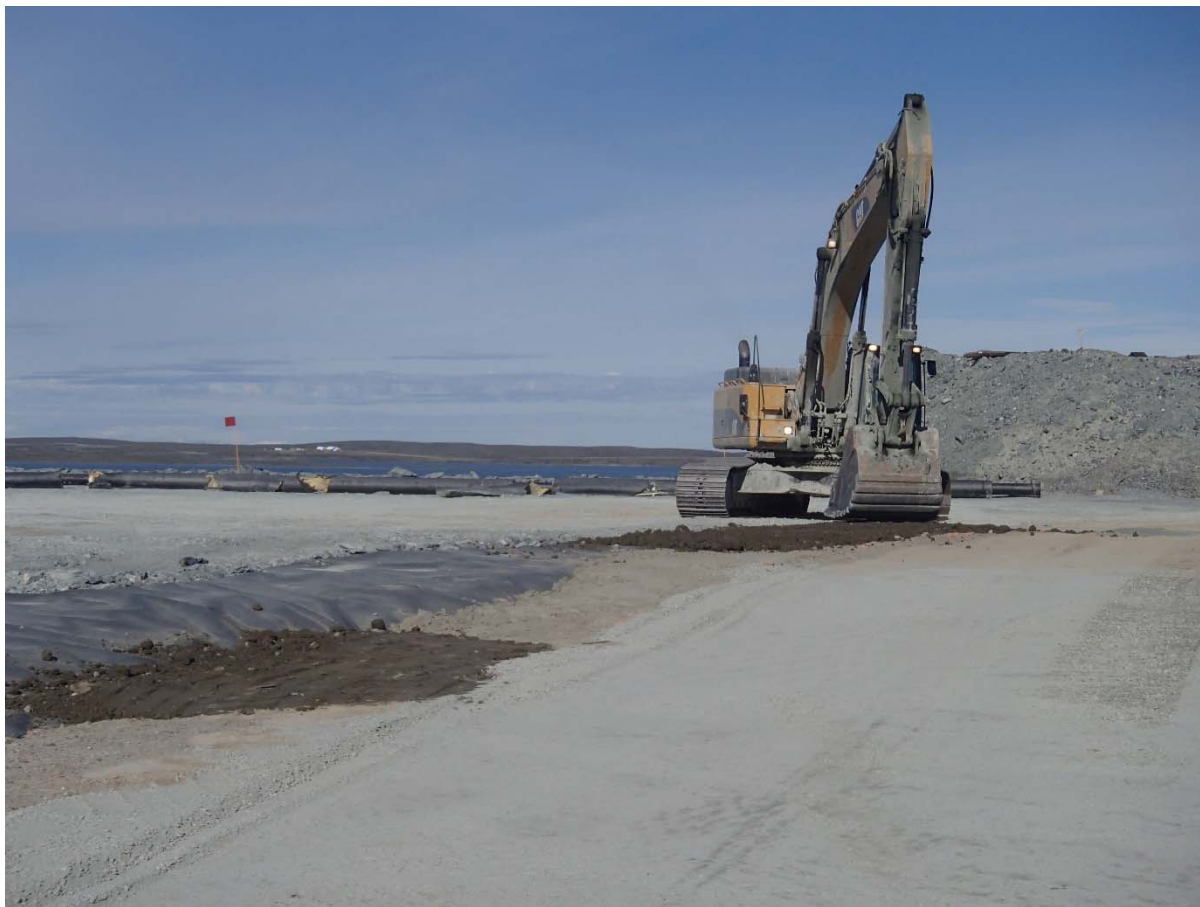
Photograph SD3-352: From Sta. 20+600/-59 m, looking SW. Corrections to the layer of compacted sieved till placed against the upstream slope from Sta. 20+599 m to 20+613 m.
