## QA DAILY REPORT

1897439-1576-TM-Rev0

### QA DAILY REPORT FOR APRIL 29<sup>TH</sup>, 2018 – TSF SOUTH CELL CONSTRUCTION - MEADOWBANK (1897439)

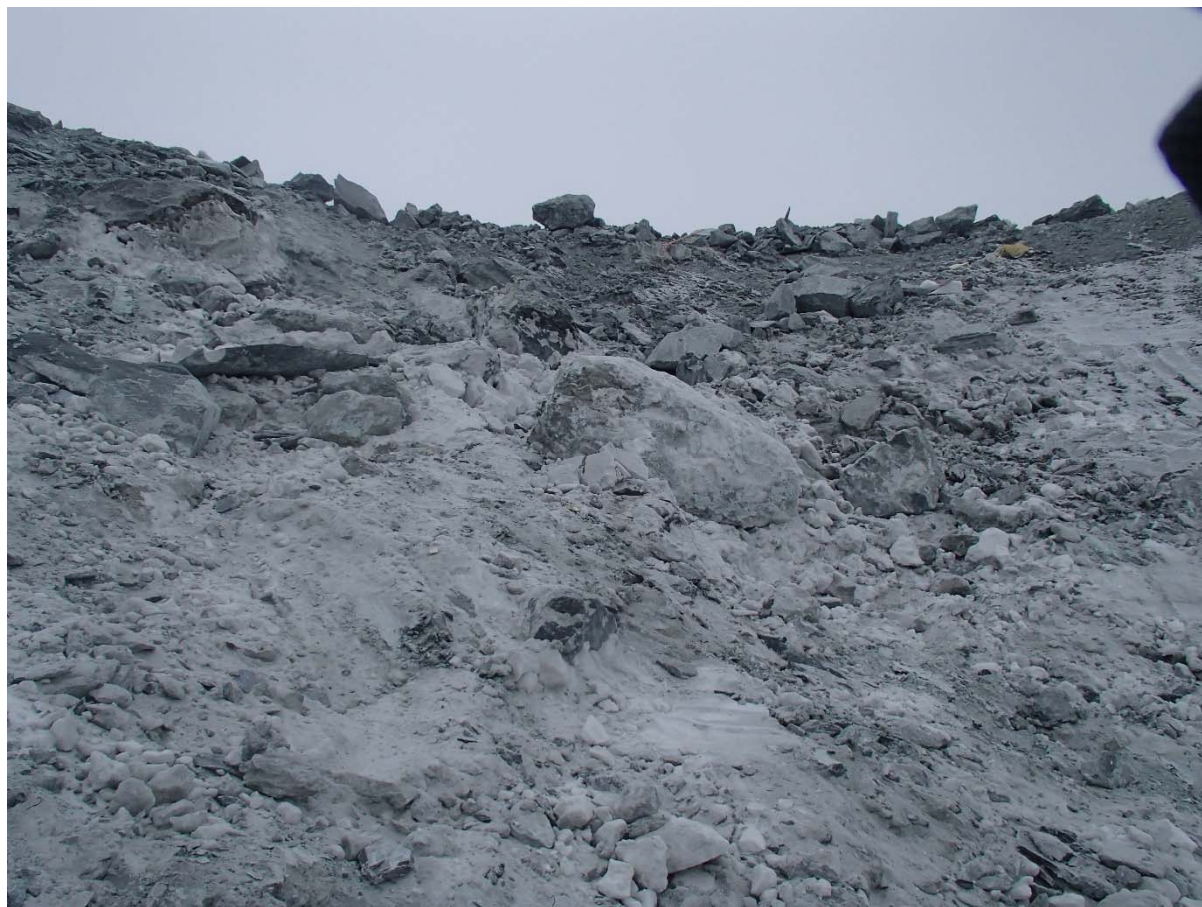
*Photograph CD-1804: From Sta. 40+790/-2 m looking S. Presence of oversize boulders on the existing slope at the junction between SD5 and Central Dike.*

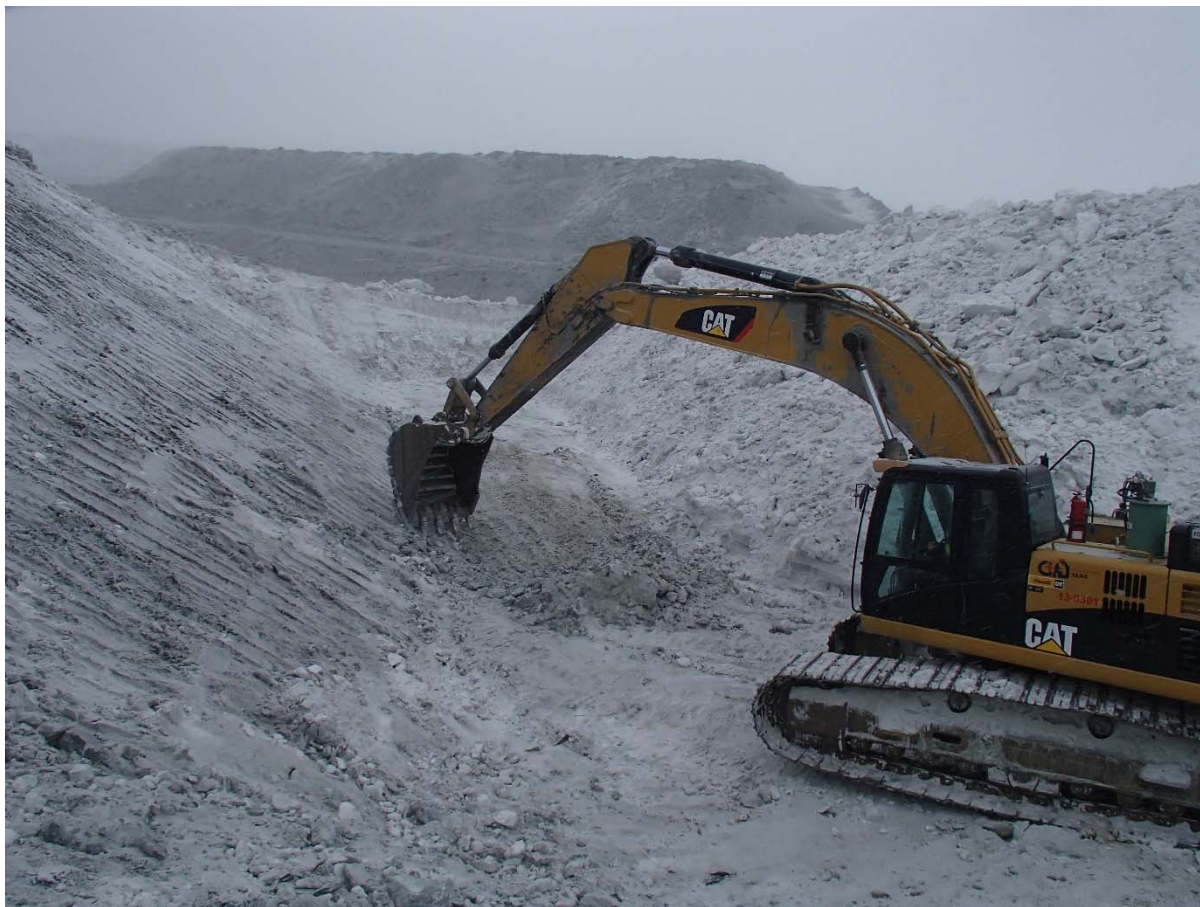
*Photograph CD-1805: From Sta. 40+780/2 m looking NE. Final clean-up of footprint with an excavator to reach a good quality bedrock from Sta. 40+780 to 40+805 m (o.s. -6 to 9 m).*

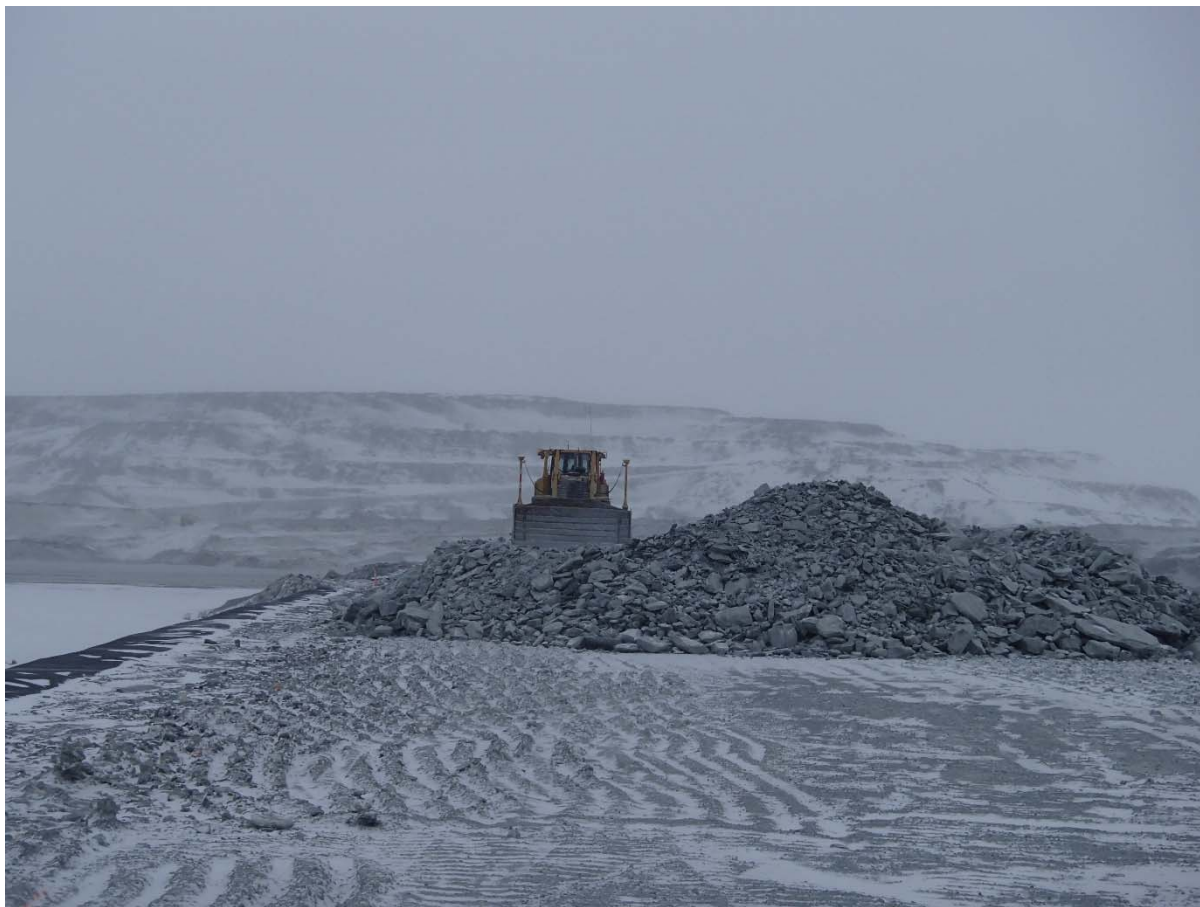
*Photograph CD-1806: From Sta. 0+800/-27 m looking N. Placement a 2 m thick (approx.) lift of intermediate volcanic (IV) rockfill from El. 143 m to El. 145 m from approx. Sta. 0+710 to 0+760 m (o.s. -28 to 3 m).*

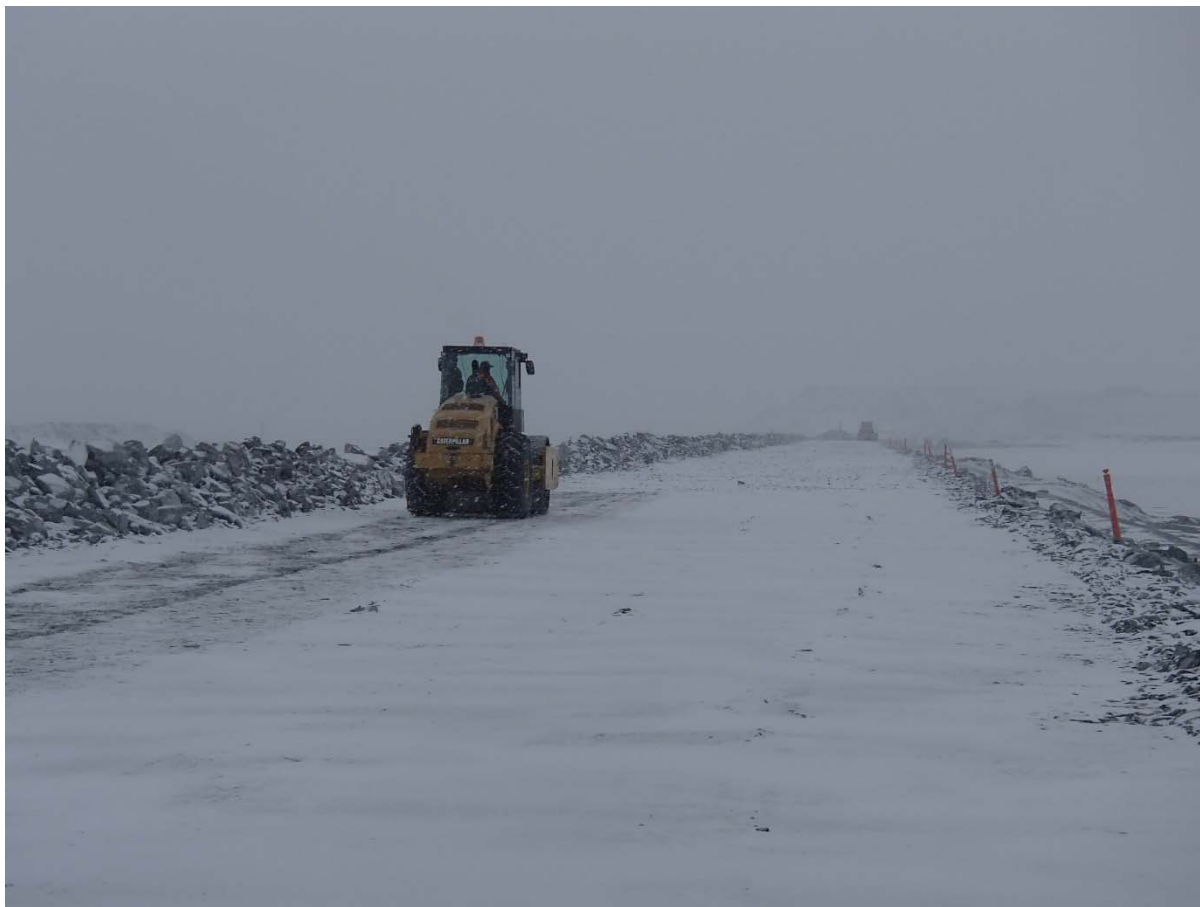
*Photograph CD-1807: From Sta. 0+200/-15 m looking S. Compaction of the 2 m lift (approx.) of IV rockfill at El. 145 m with a 10-tonne smooth-drum compactor with vibration (6 passes) from Sta. 0+150 to 0+280 m (o.s. -21 to 11 m).*

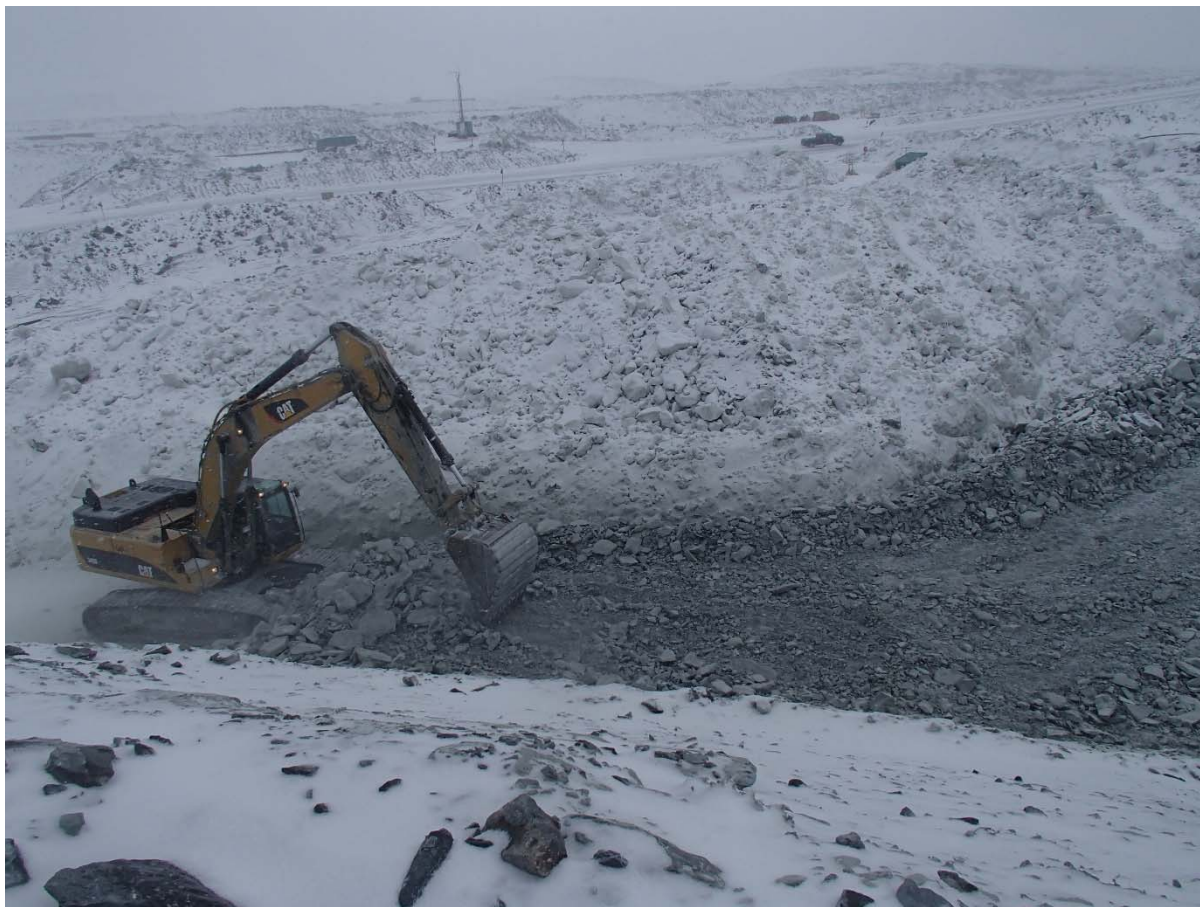
*Photograph CD-1808: From Sta. 40+790/-14 m looking E. Placement a 1.5 m thick (approx.) lift of intermediate volcanic (IV) rockfill from approx. Sta. 40+780 to 40+805 m (o.s. -6 to 9 m).*

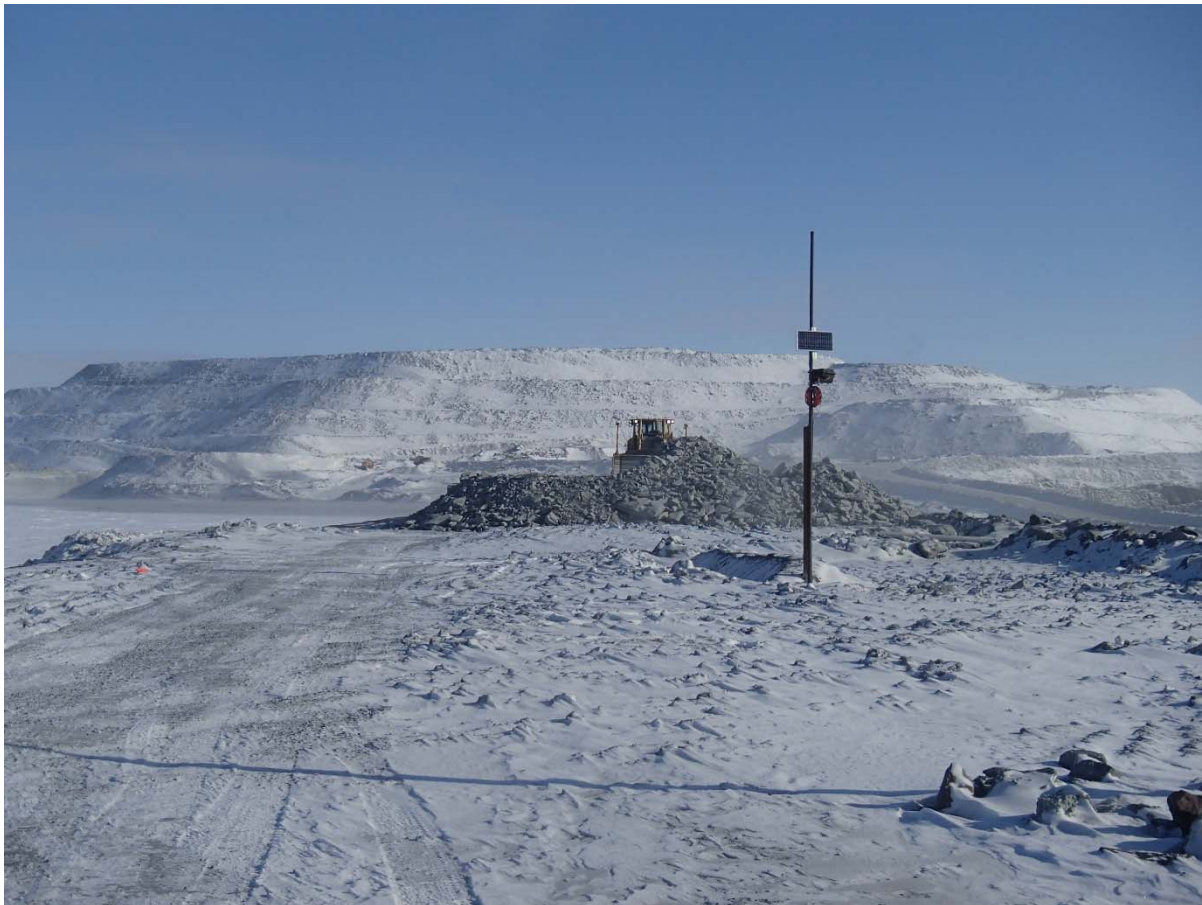
*Photograph CD-1809: From Sta. 0+870/-16 m looking N. Placement a 2 m thick (approx.) lift of intermediate volcanic (IV) rockfill from El. 143 m to El. 145 m from approx. Sta. 0+760 to 0+835 m (o.s. -28 to 3 m).*

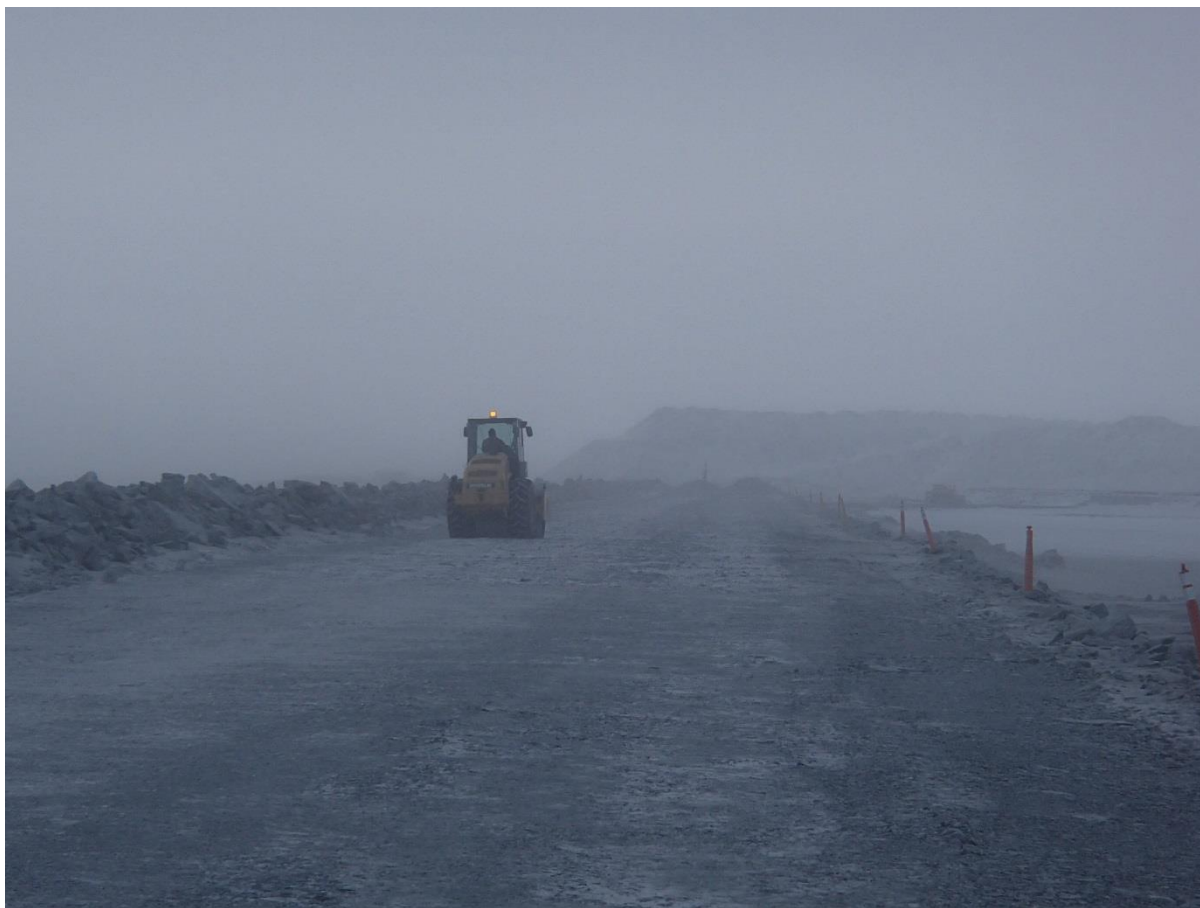
*Photograph CD-1810: From Sta. 0+335/-15 m looking S. Compaction of the 2 m lift (approx.) of IV rockfill at El. 145 m with a 10-tonne smooth-drum compactor with vibration (6 passes) from Sta. 0+350 to 0+540 m (o.s. -19 to -7 m).*

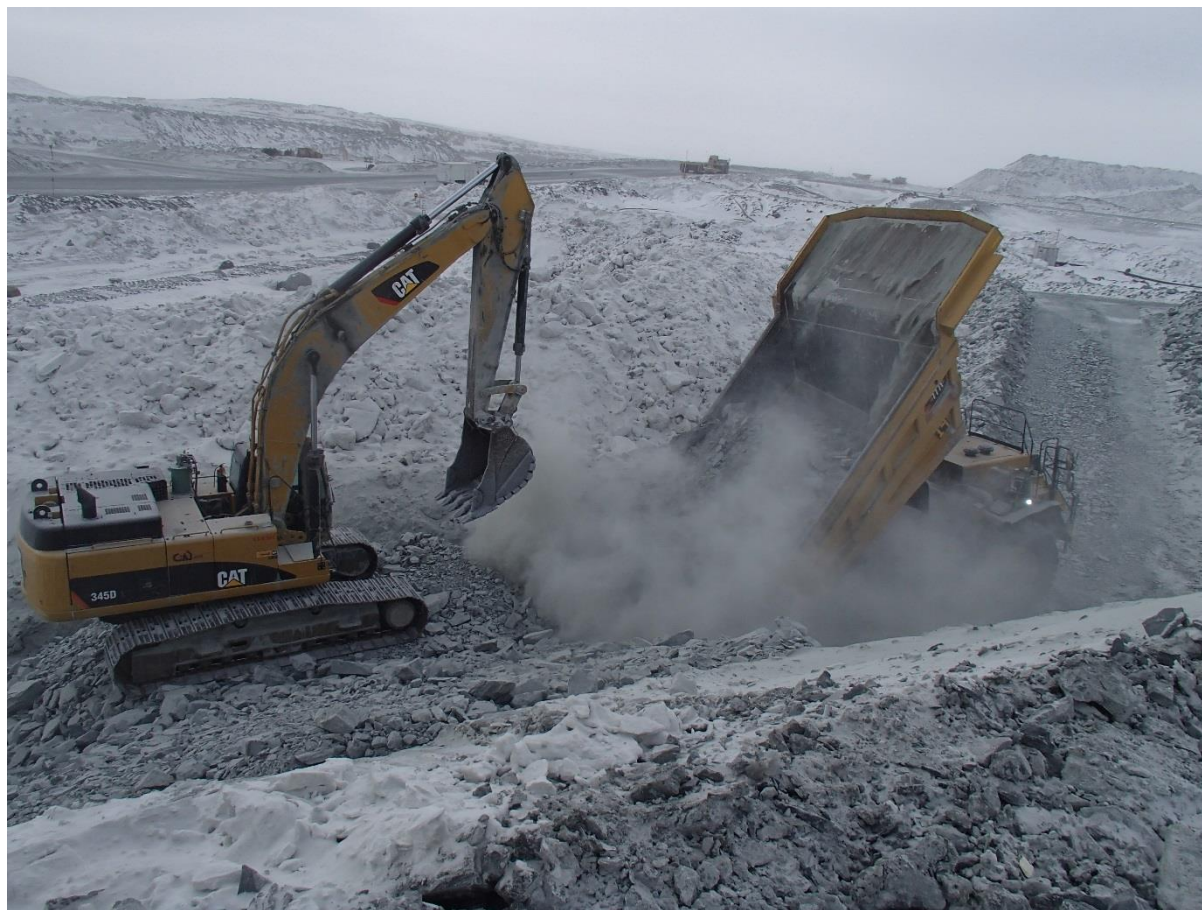
*Photograph CD-1811: From Sta. 0+985/-11 m looking SE. Placement the second, third, fourth and fifth 1 m thick (approx.) lifts of intermediate volcanic (IV) rockfill from approx. Sta. 0+985 to 40+780 m (o.s. -8 to 8 m) with the excavator.*

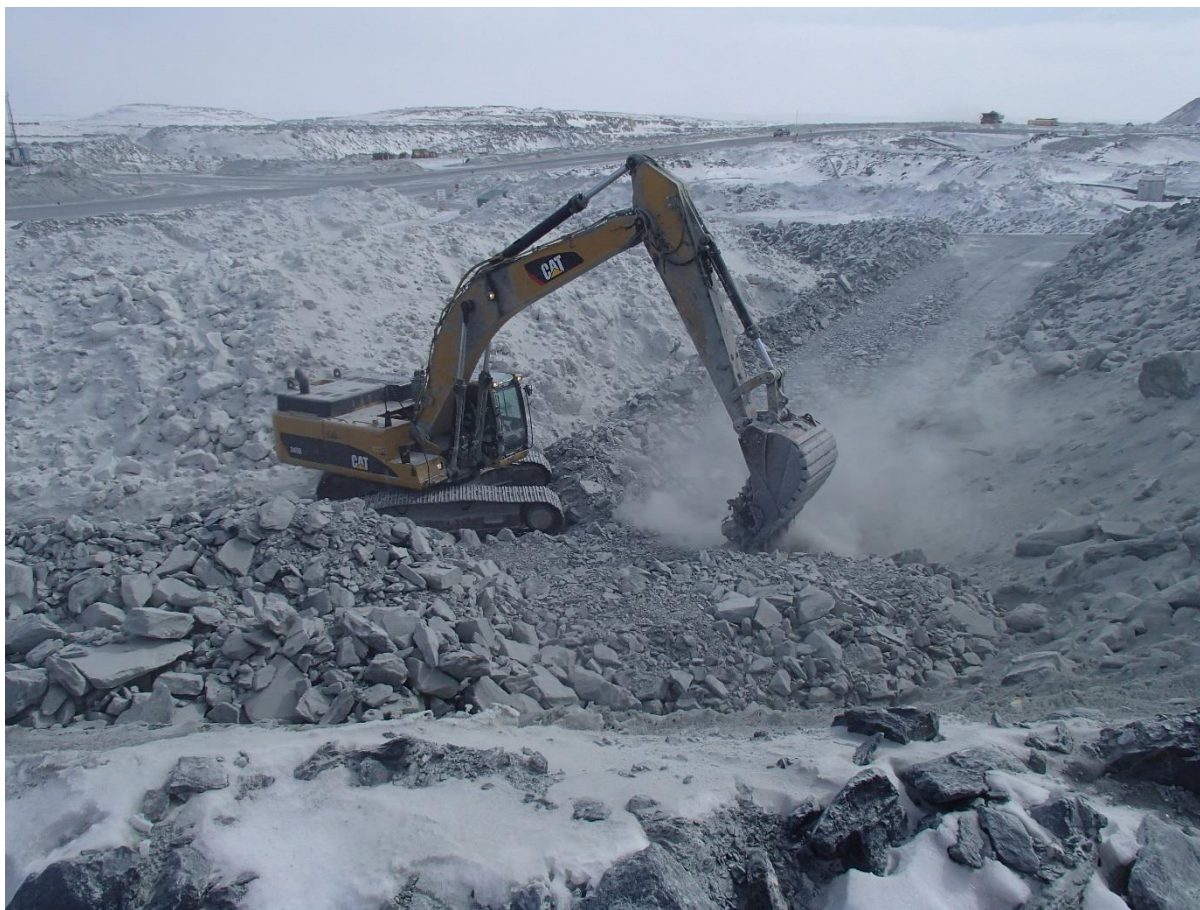
*Photograph CD-1812: From Sta. 0+985/-11 m looking SE. Placement of intermediate volcanic (IV) rockfill on the existing downstream slope up to approx. El. 140 m, from approx. Sta. 0+985 to 40+780 m.*

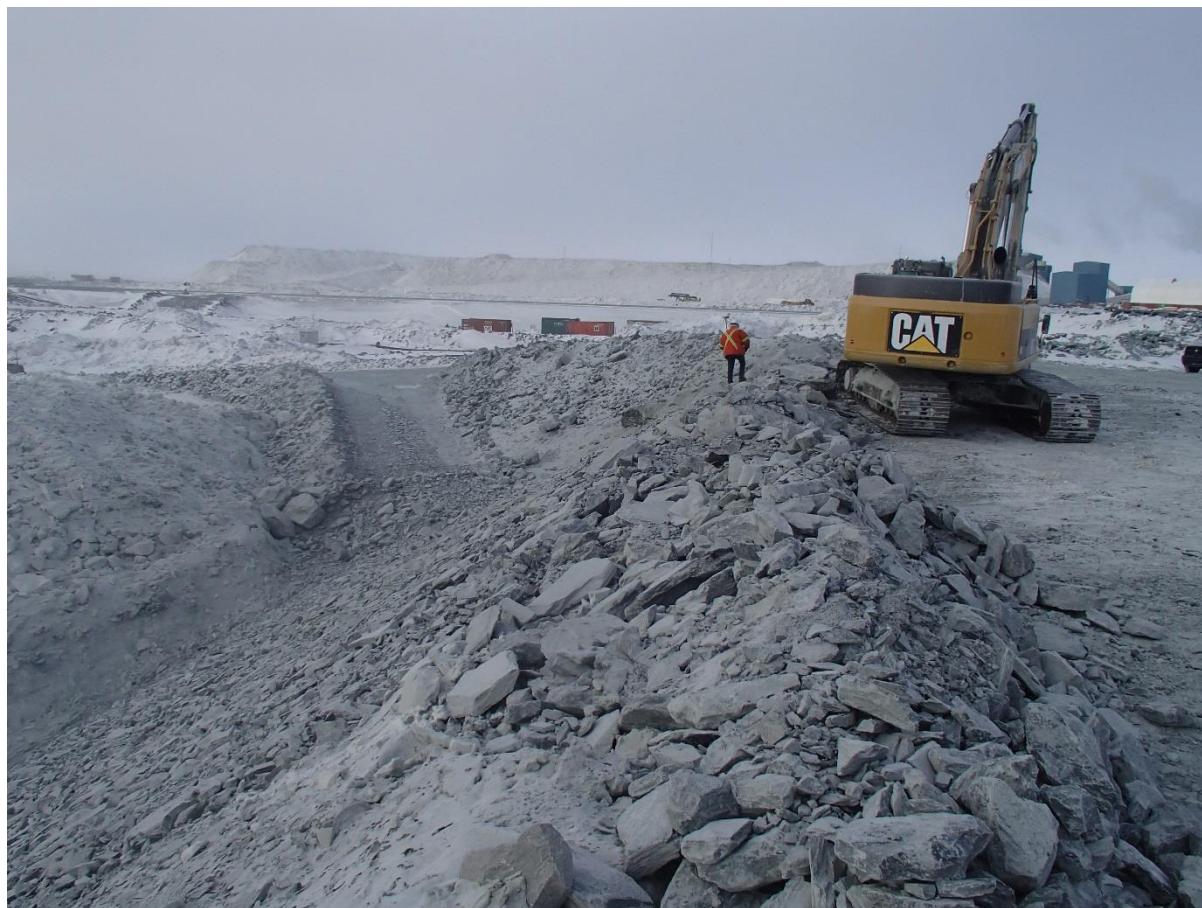
*Photograph CD-1813: From Sta. 0+980/-2, looking S. Placement of intermediate volcanic (IV) rockfill on the existing downstream slope up to approx. El. 143 m, from approx. Sta. 0+980 to 40+780 m.*

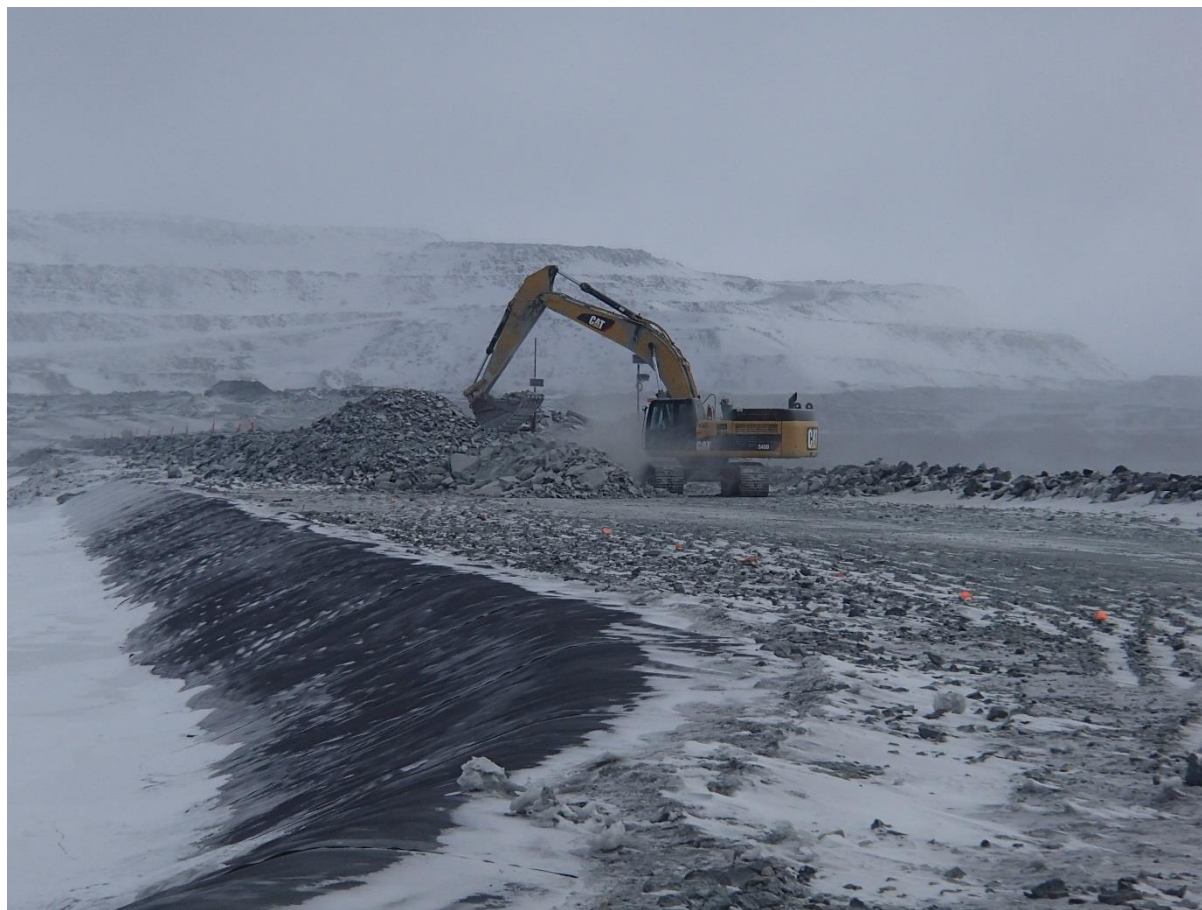
*Photograph CD-1814: From Sta. 0+970/-10, looking NE. Placement of intermediate volcanic (IV) rockfill around the instruments at approx. Sta. 0+830 m with the excavator.*

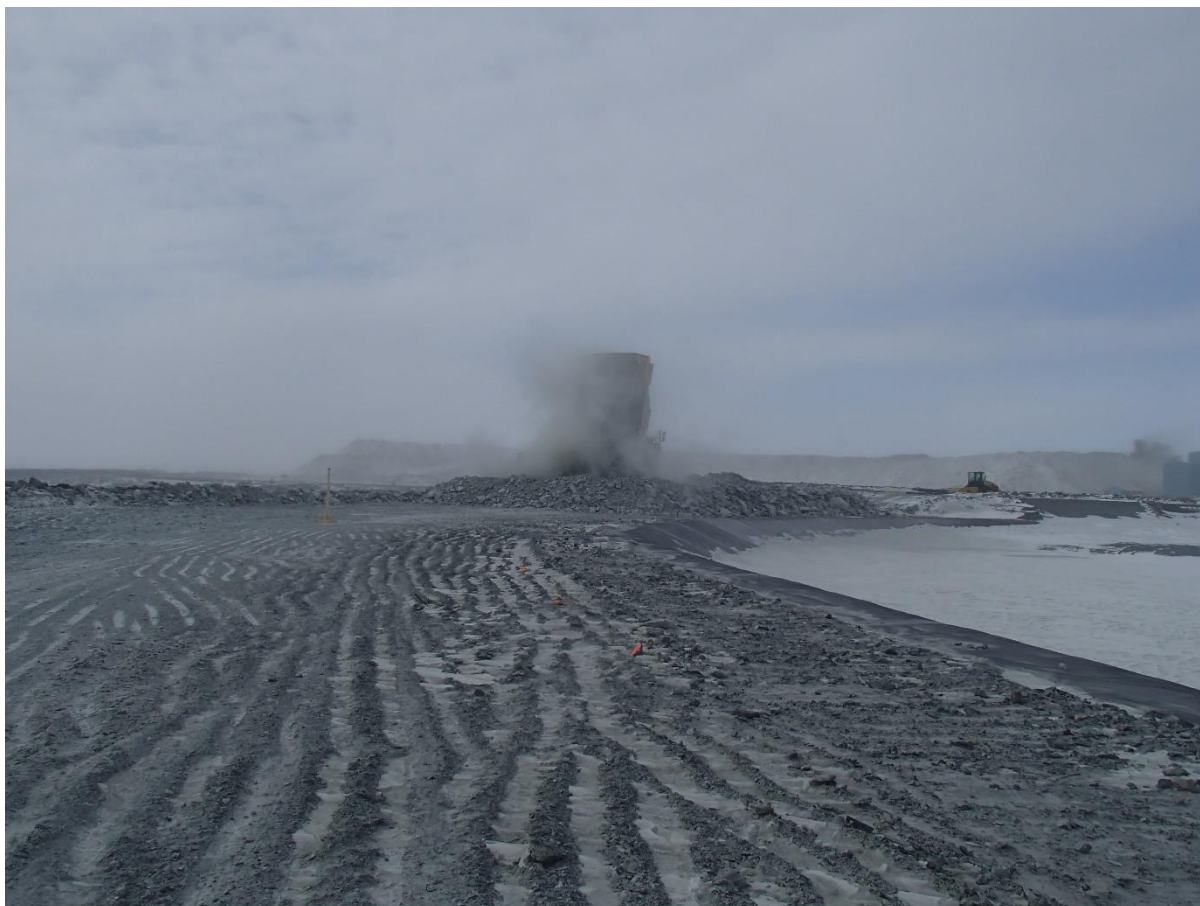
Photograph CD-1815: From Sta. 0+920/-25, looking S. Placement of a 2 m thick (approx.) lift of intermediate volcanic (IV) rockfill from El. 143 m to El. 145 m from approx. Sta. 40+740 to 0+980 m (o.s. -28 to -11 m).

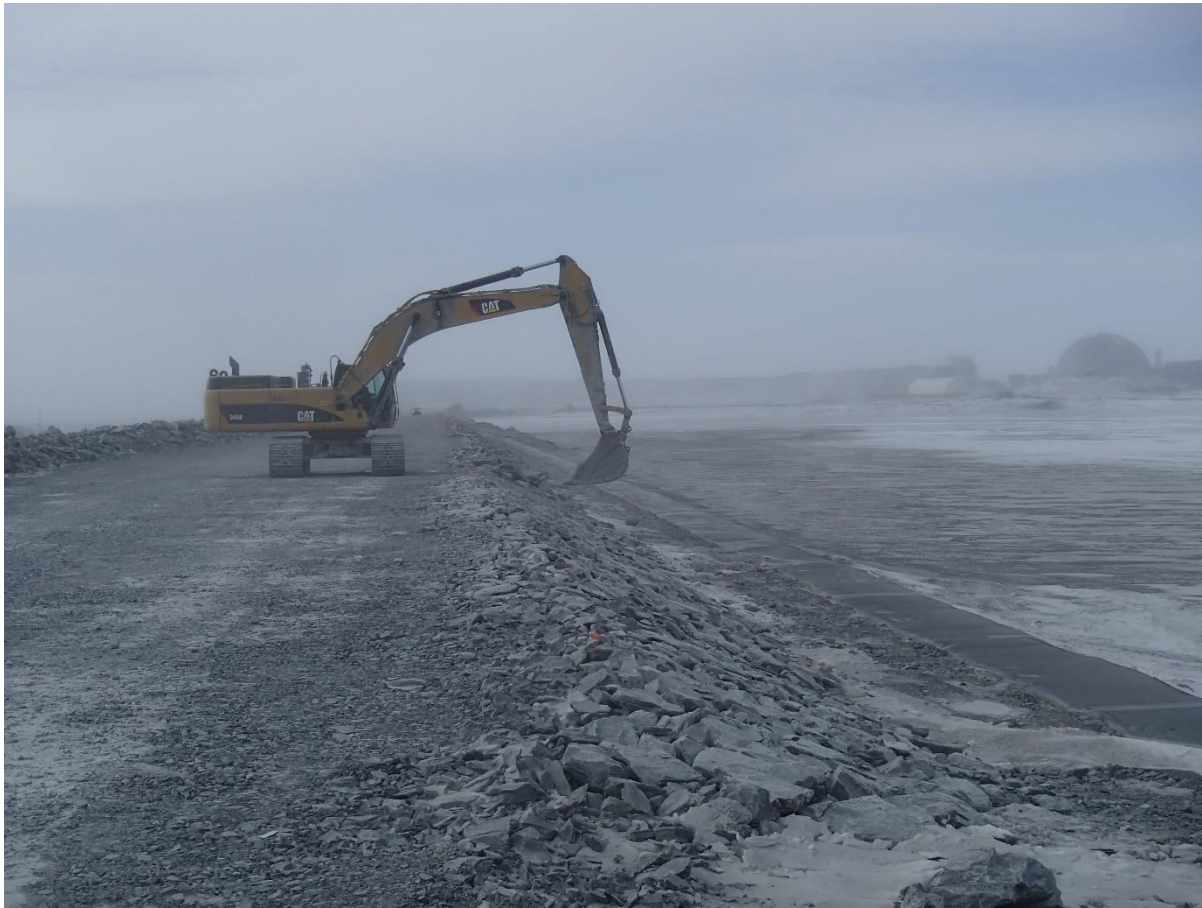
**Photograph CD-1816: From Sta. 0+175/-27, looking S. Profiling of the upstream slope (2H:1V) from El. 143 to 145 m with an excavator between Sta. 0+175 and 0+560 m.**

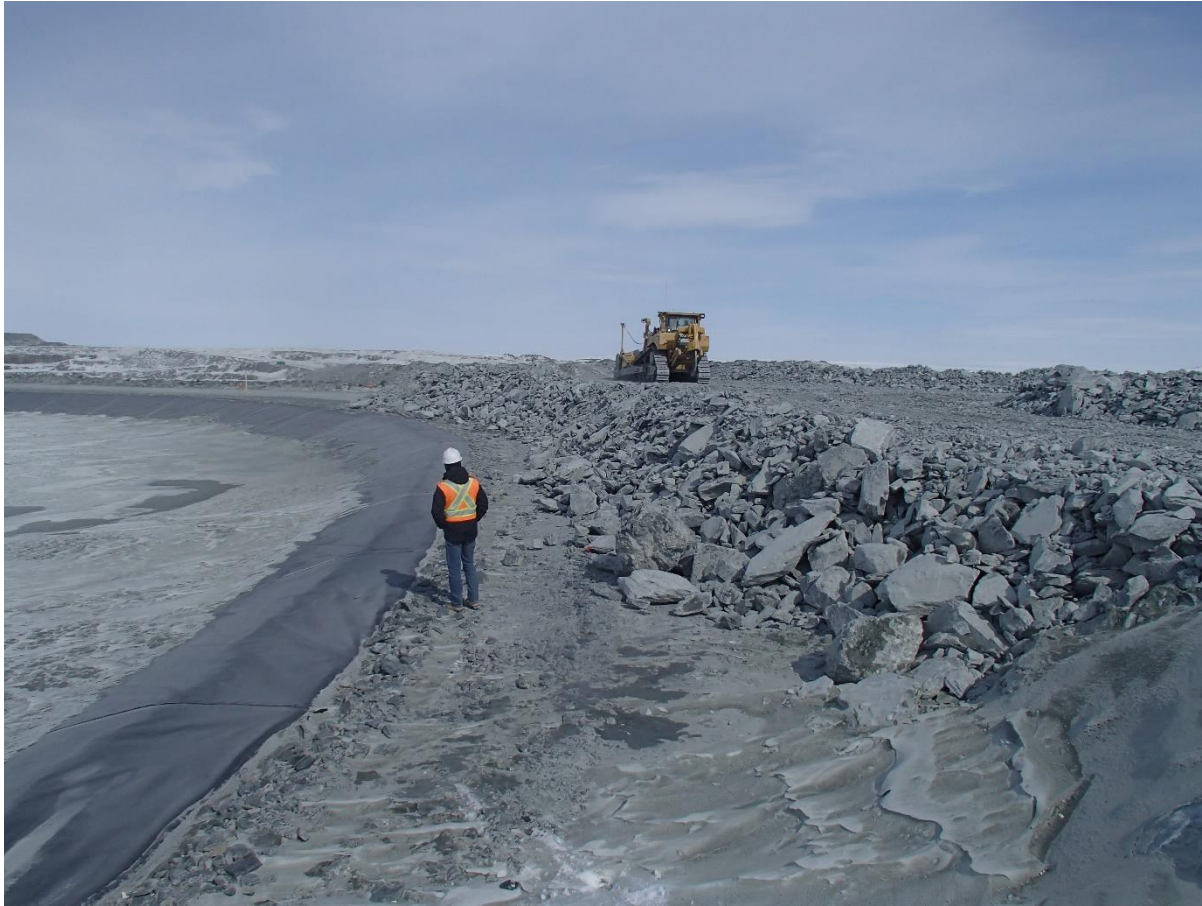
**Photograph CD-1817: From Sta. 40+700/-10, looking NE. View of the rockfill lift thickness at the junction of Saddle Dam 5 and Central Dike, approx. 2.5 m thick.**

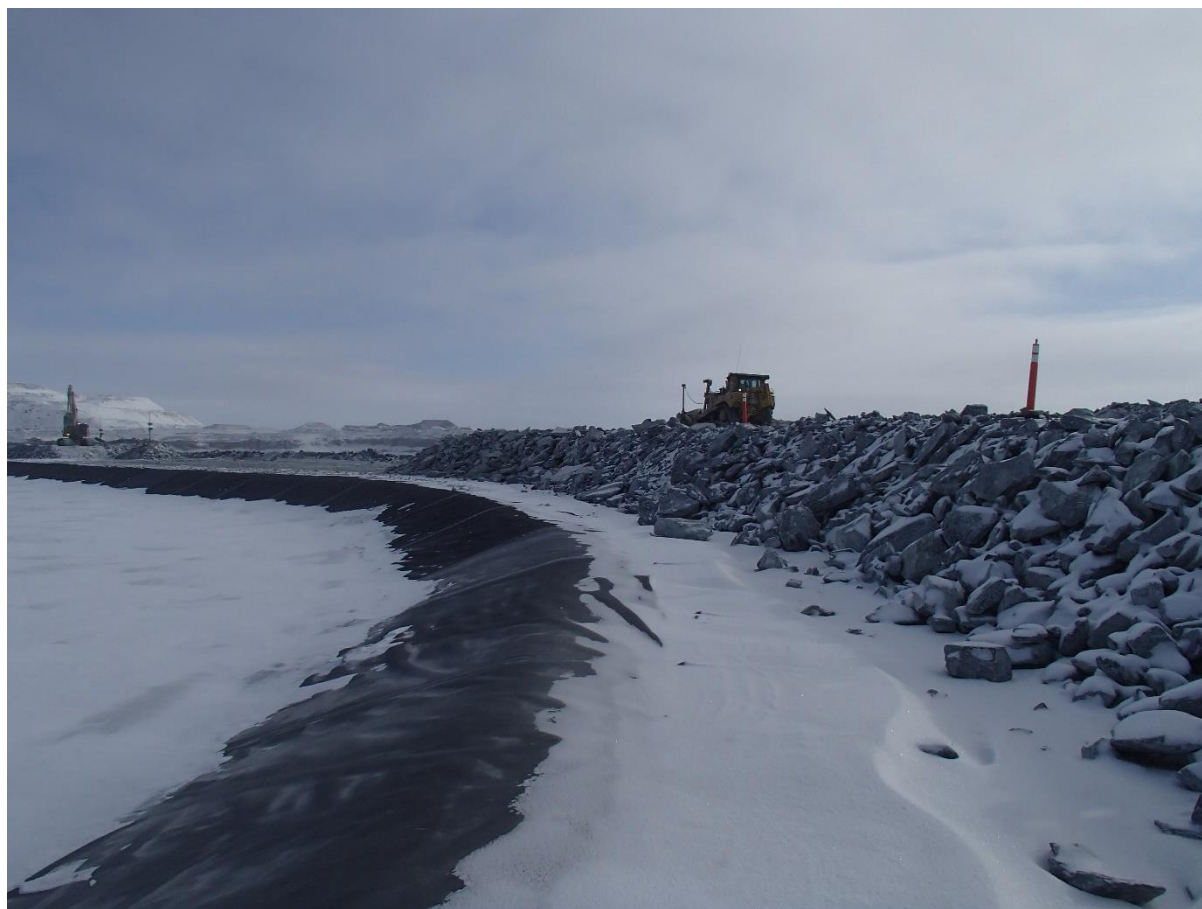
**Photograph CD-1818: From Sta. 40+770/-25, looking NE. Placement of a 2 m thick (approx.) lift of intermediate volcanic (IV) rockfill from El. 143 m to El. 145 m from approx. Sta. 0+980 m to 0+880 m (o.s. -28 to -11 m).**

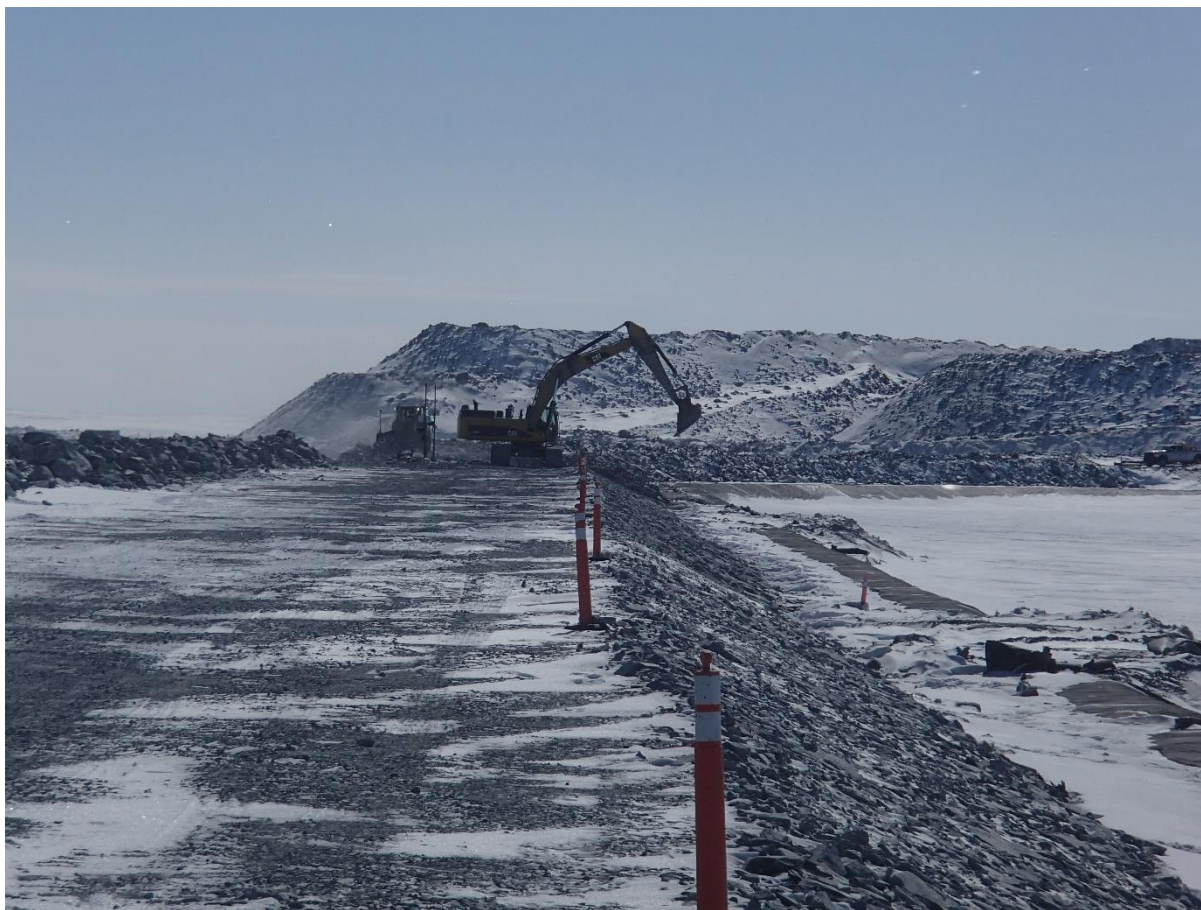
**Photograph CD-1819: From Sta. 0+560/-21, looking S. Profiling of the upstream slope (2H:1V) from El. 143 to 145 m with an excavator between Sta. 0+560 m and 0+830 m.**

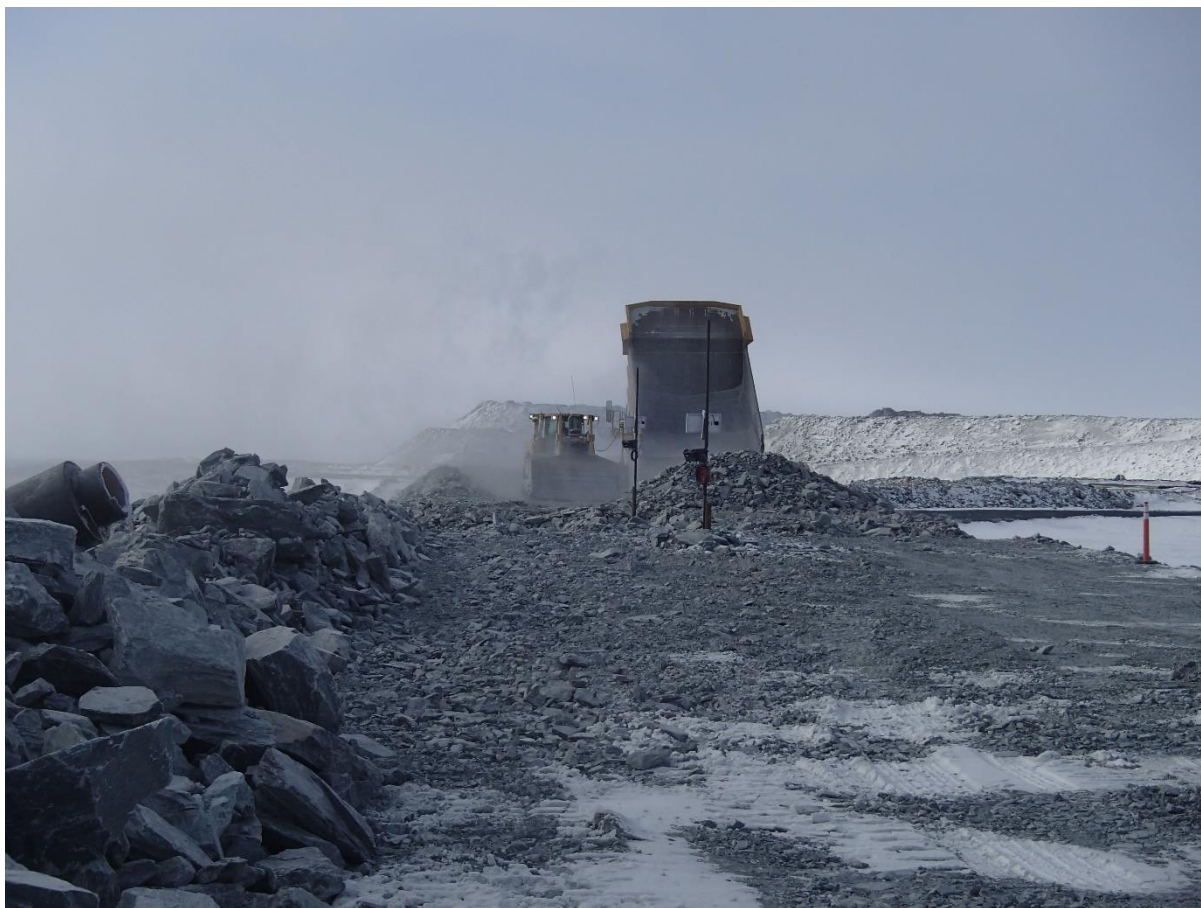
**Photograph CD-1820: From Sta. 0+790/-7, looking S. Placement of a 2 m thick (approx.) lift of intermediate volcanic (IV) rockfill from El. 143 m to El. 145 m from approx. Sta. 0+880 m to 0+830 m (o.s. -28 to -11 m).**

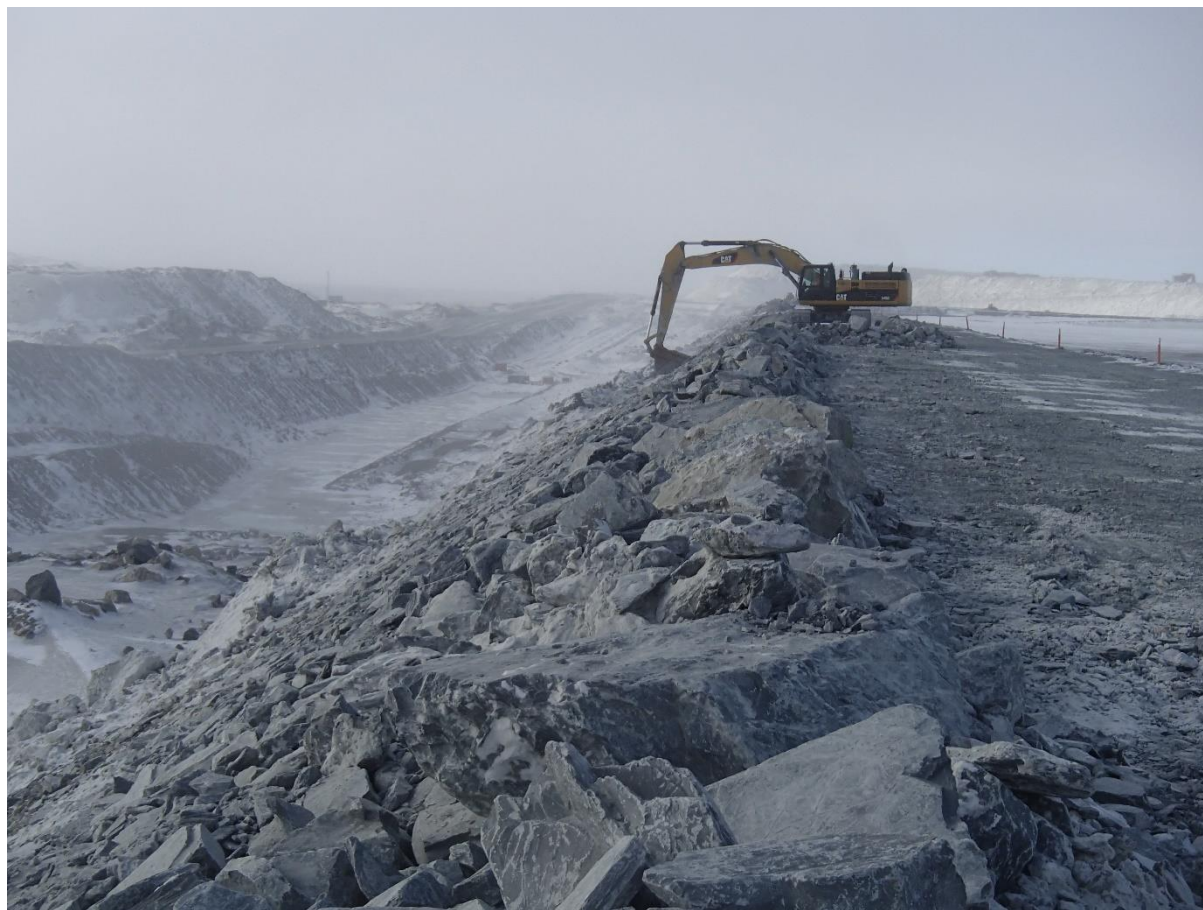
**Photograph CD-1821: From Sta. 0+175/+3, looking S. Profiling of the downstream slope (1.5H:1V) from El. 143 to 145 m with an excavator between Sta. 0+250 m and 0+330 m.**

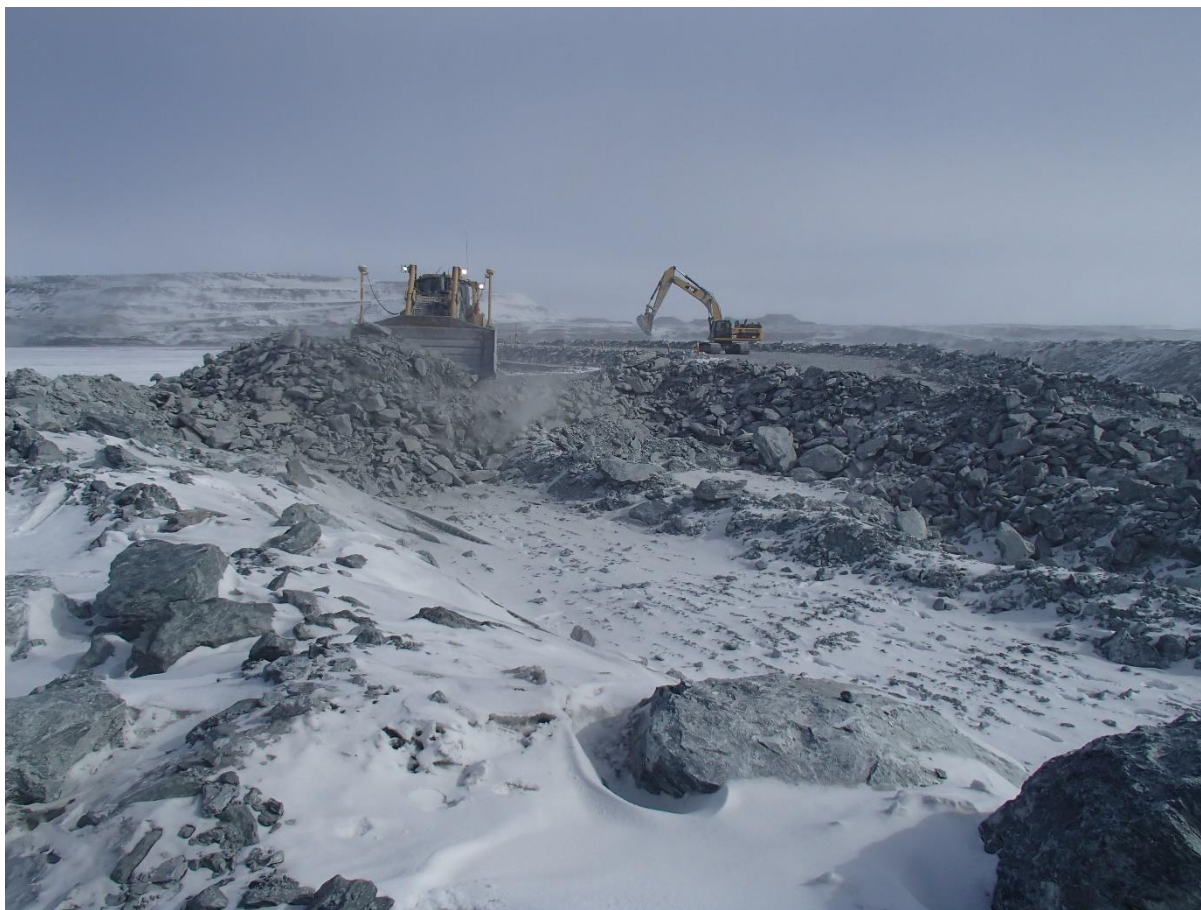
**Photograph CD-1822: From Sta. 40+725/+7, looking N. Placement of two 2 m thick (approx.) lifts of intermediate volcanic (IV) rockfill from El. 141 m to El. 145 m from approx. Sta. 40+720 m to 40+750 m (o.s. -10 to +10 m) and profiling of the upstream slope (2H:1V) from El. 143 to 145 m with an excavator between Sta. 0+830 m and 0+980 m.**

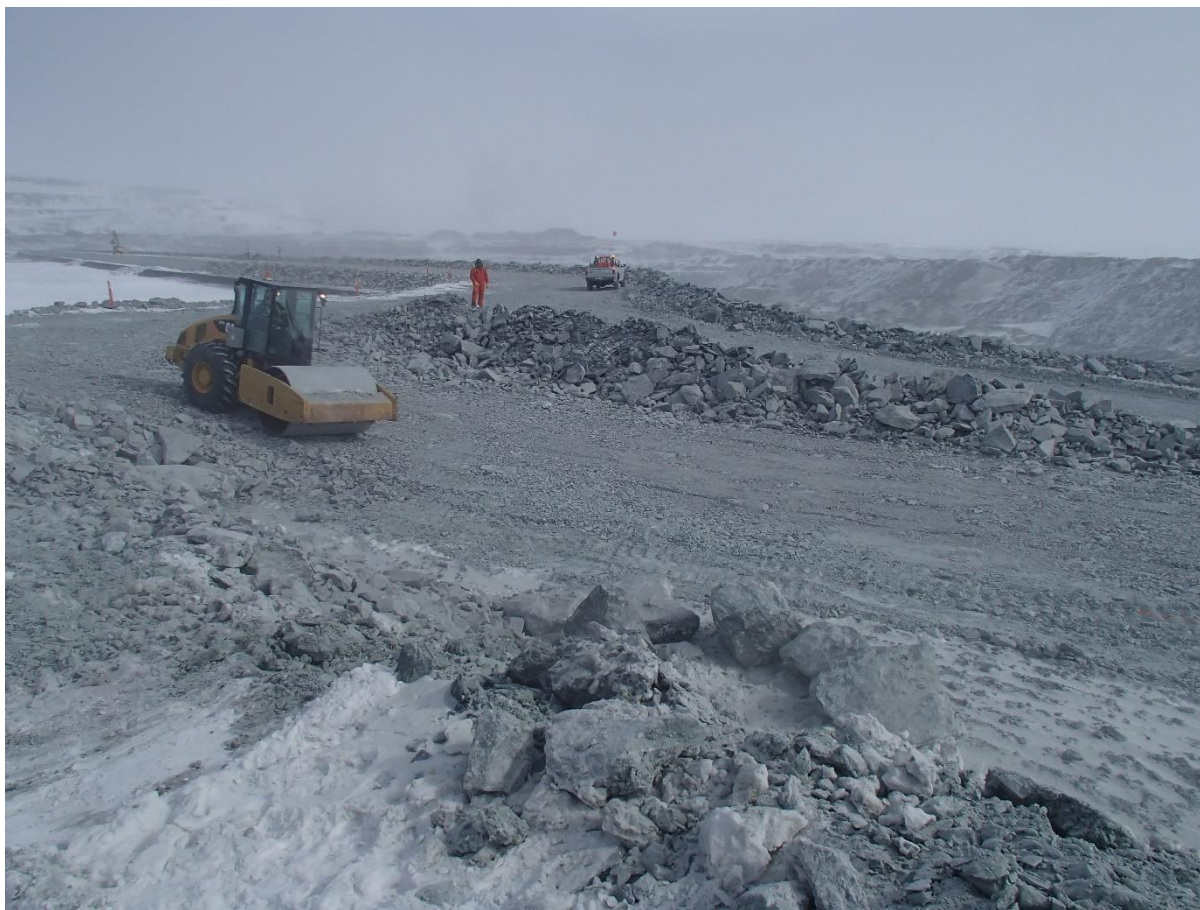
**Photograph CD-1823: From Sta. 0+175/+8, looking NE. Compaction of the two 2 m lifts (approx.) of intermediate volcanic (IV) rockfill at El. 143 and at El. 145 m with a 10-tonne smooth-drum compactor with vibration (6 passes) from Sta. 40+720 m to 40+750 m (o.s. -10 to +10 m).**
