## QA DAILY REPORT

1897439-1576-TM-Rev0

### QA DAILY REPORT FOR APRIL 29<sup>TH</sup>, 2018 – TSF SOUTH CELL CONSTRUCTION - MEADOWBANK (1897439)

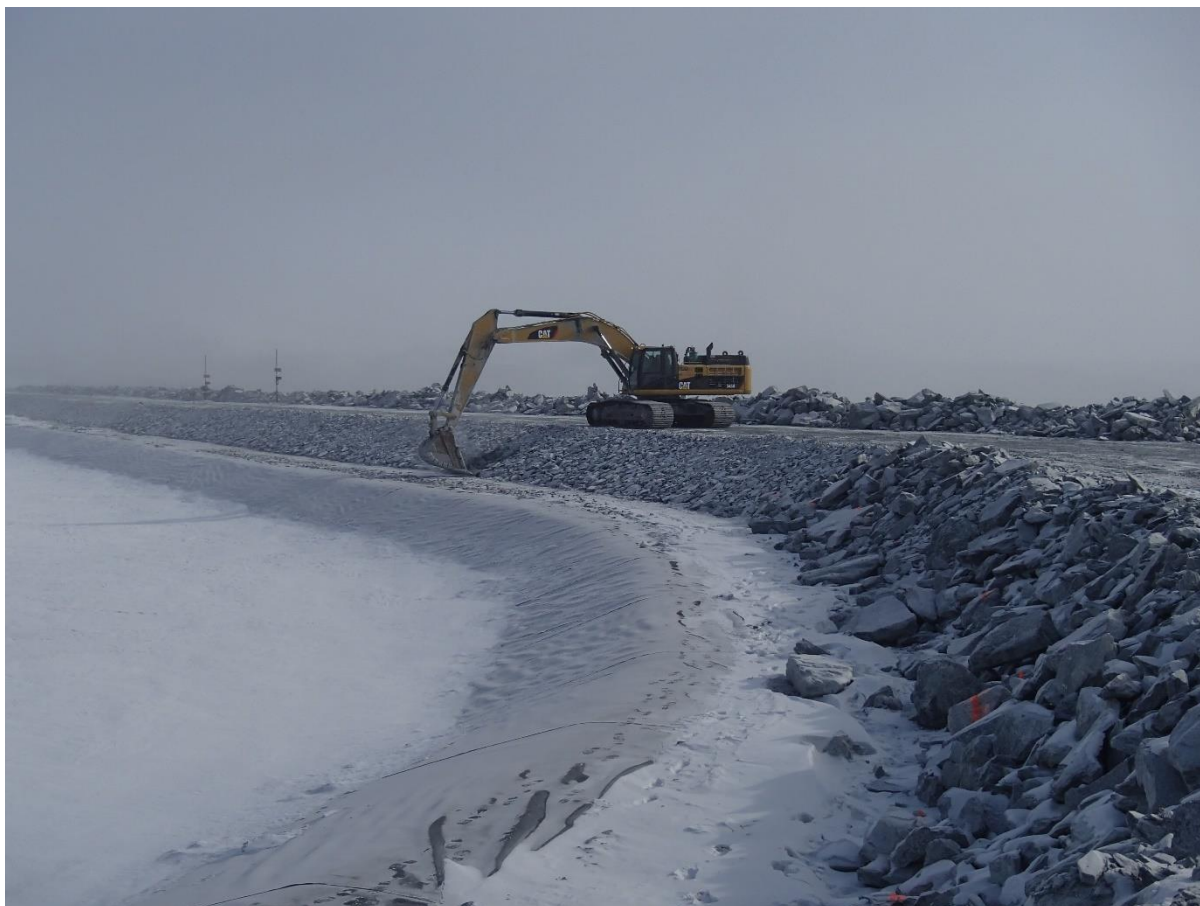
**Photograph CD-1824: From Sta 40+760/-25 m, looking NE. Profiling of the upstream slope (2H:1V) from El. 143 to 145 m with an excavator between Sta. 0+830 m and 40+730 m.**

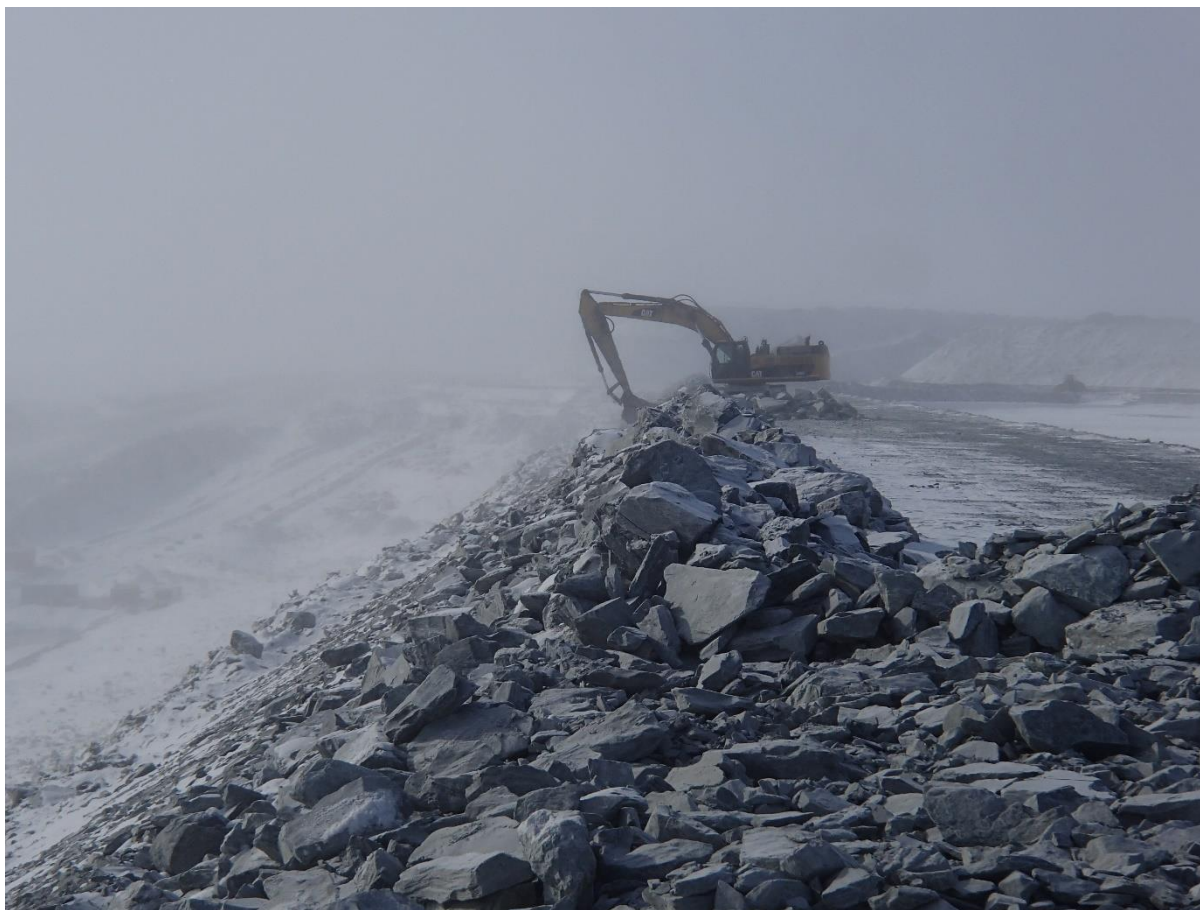
**Photograph CD-1825: From Sta 0+430/+9 m, looking S. Profiling of the downstream slope (1.5H:1V) from El. 143 to 145 m with an excavator between Sta. 0+330 m and 0+440 m and between Sta. 0+530 m and 0+745 m.**

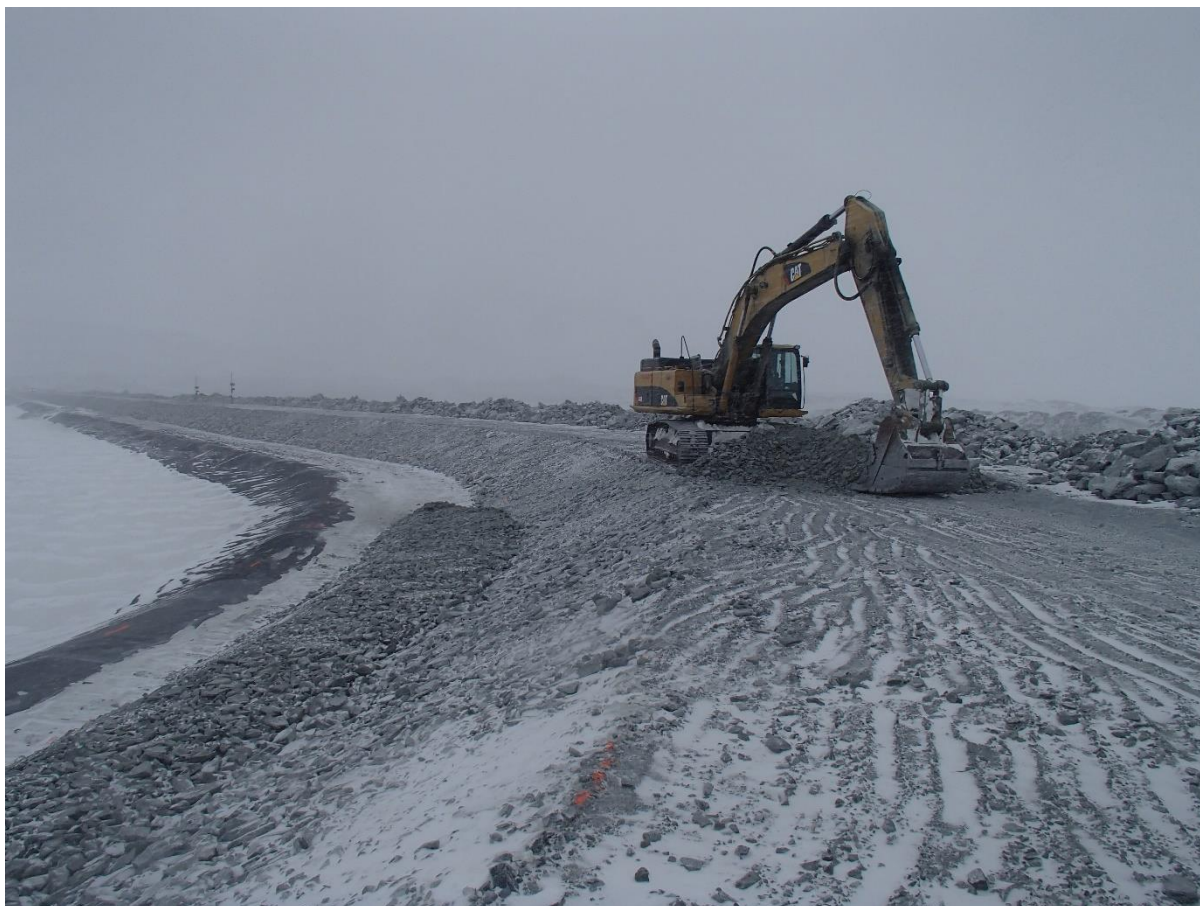
**Photograph CD-1826: From Sta 40+770/-27 m, looking NE. Placement of a 0.5 m thick lift of coarse filter from El. 143 m to 143.5 m with an excavator from Sta. 40+730 m to 0+ 775 m.**

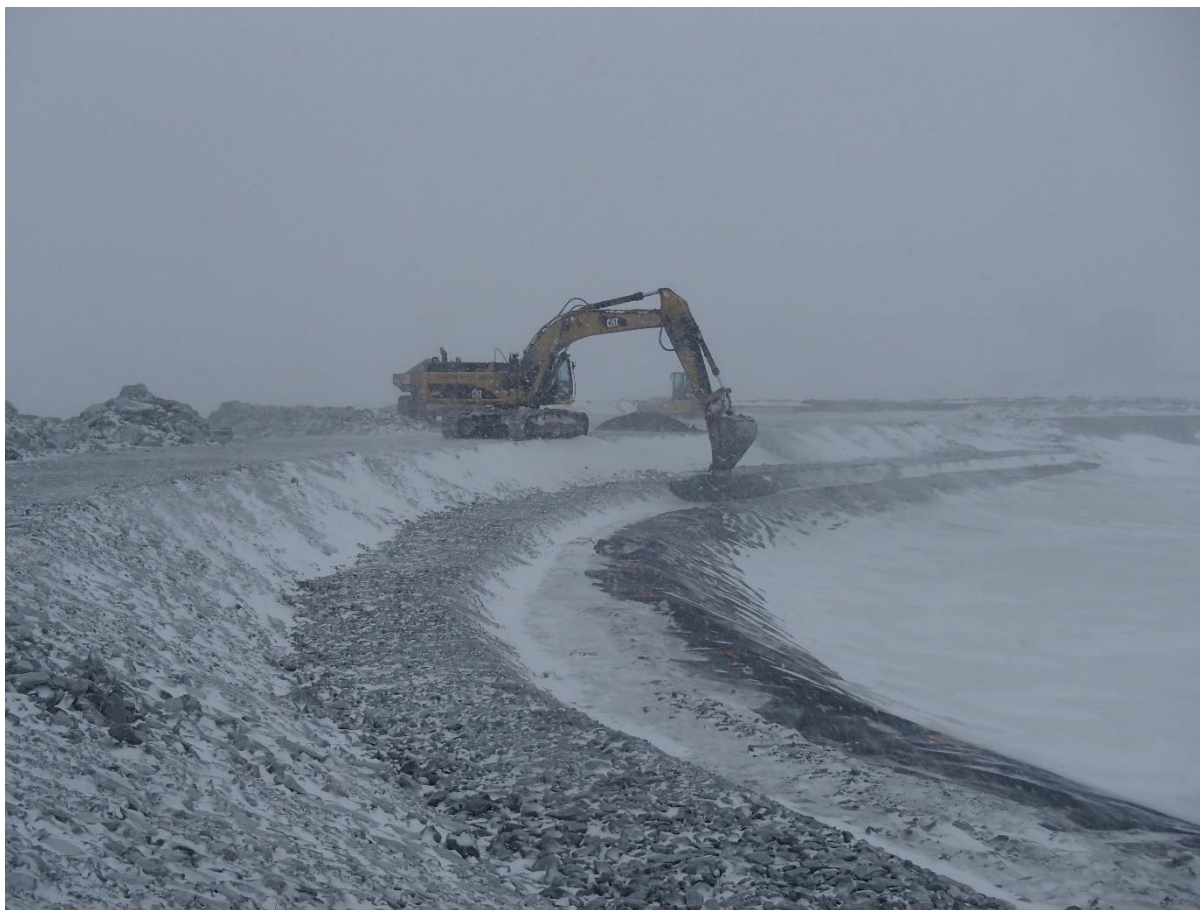
**Photograph CD-1827: From Sta 0+940/-16 m, looking SW. Placement of a 0.5 m thick lift of fine filter from El. 143 m to 143.5 m with an excavator from Sta. 40+730 m to 0+ 835 m.**

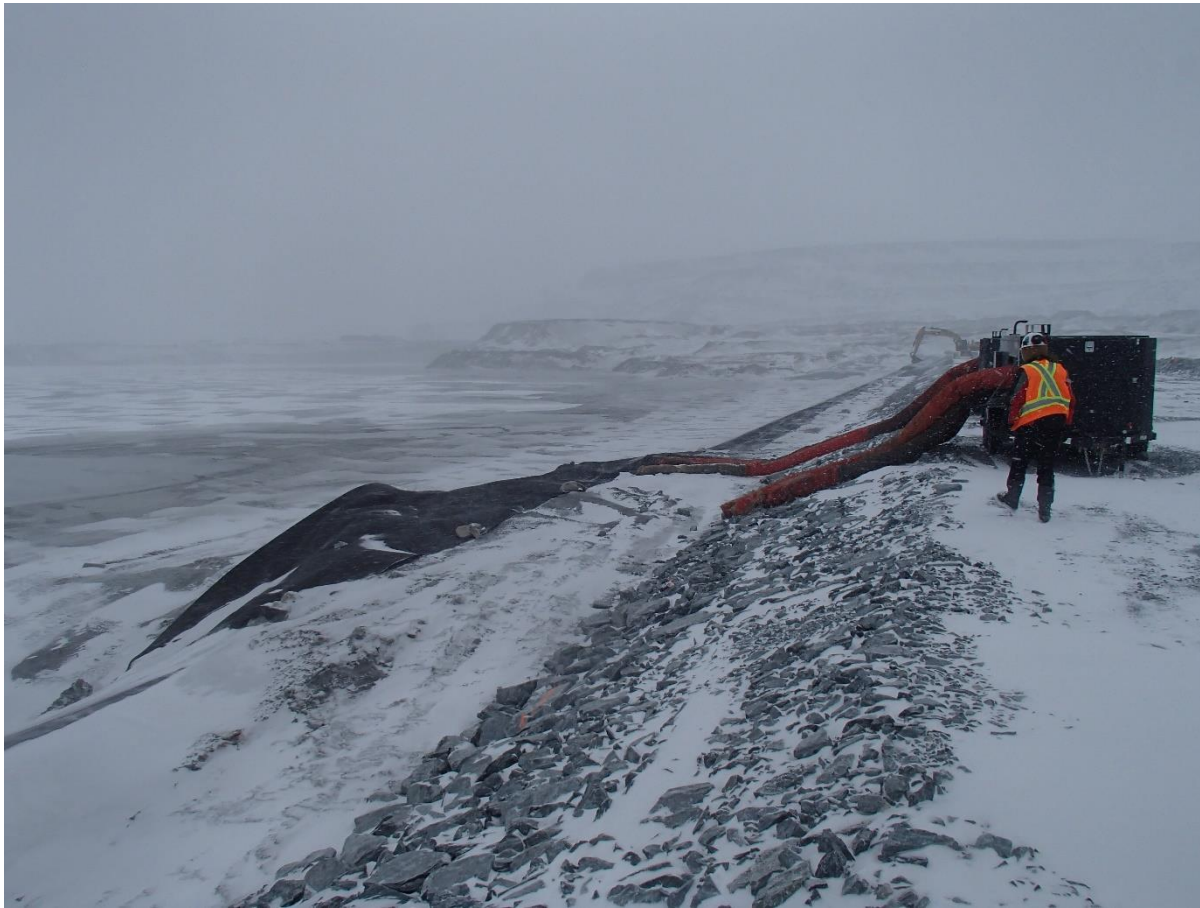
**Photograph CD-1828: From Sta 0+410/-22 m, looking N. Defrosting of the deposition finger materials with two Frost Fighters at Sta. 0+390 m.**

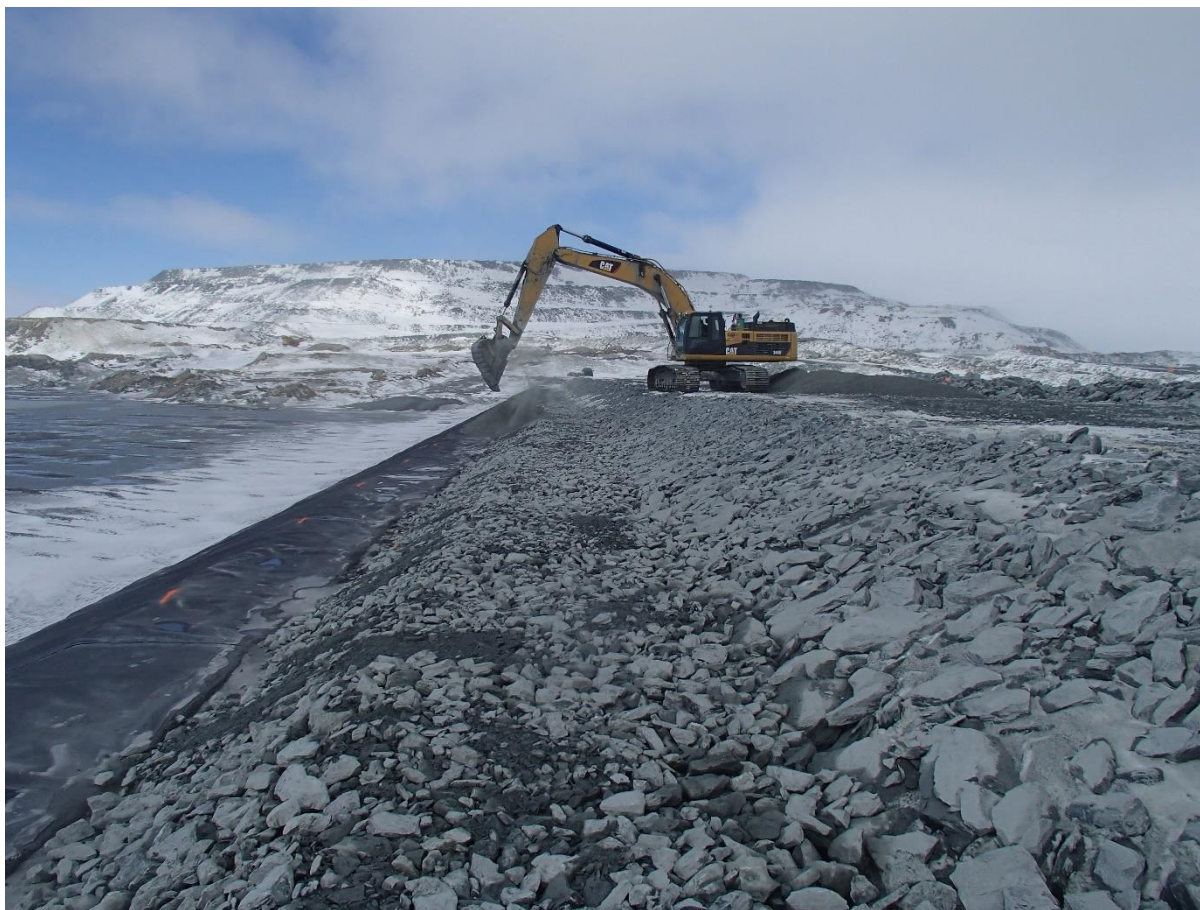
**Photograph CD-1829: From Sta 0+410/-22 m, looking N. Placement of a 0.5 m thick lift of coarse filter from El. 143 m to 143.5 m with an excavator from Sta. 0+170 m to 0+460 m and placement of a 0.5 m thick lift of fine filter from Sta. 0+170 m to 0+380 m.**

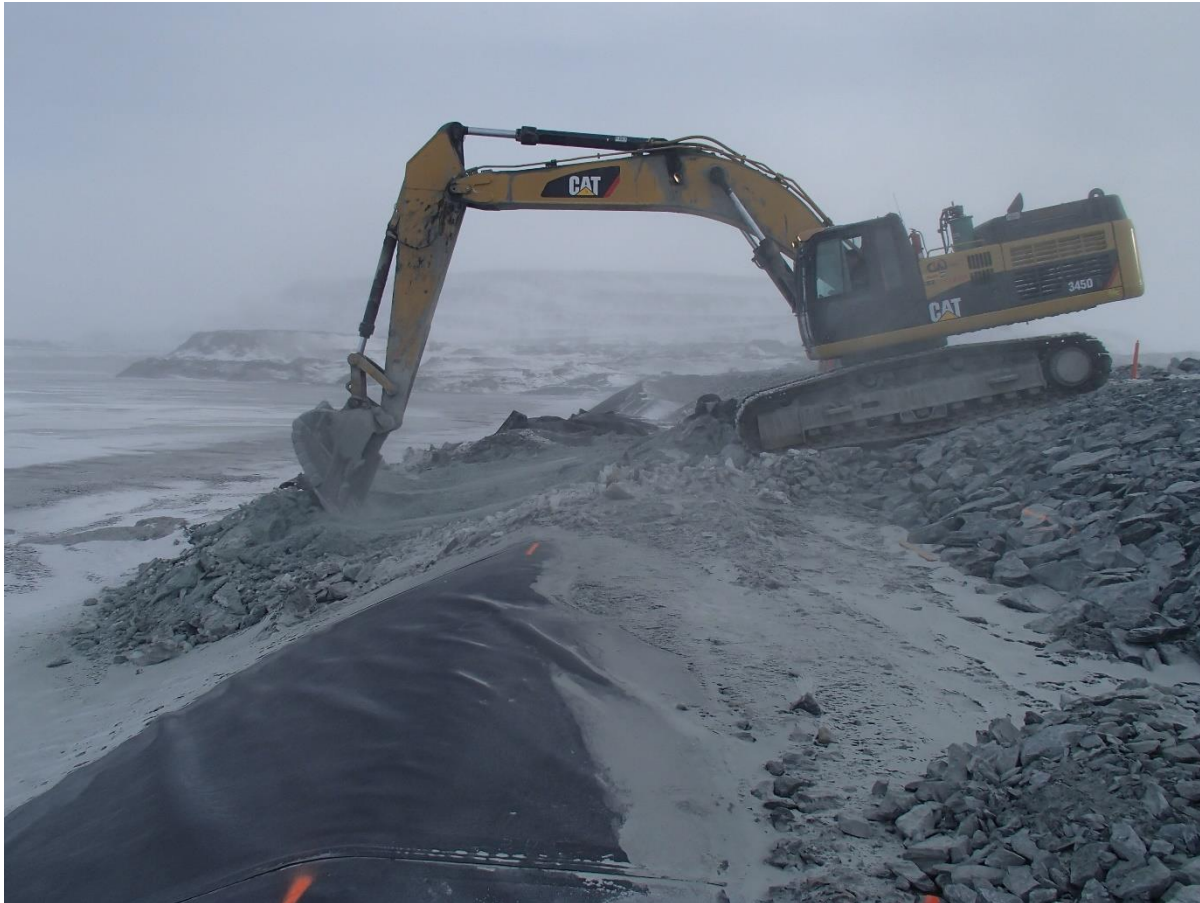
**Photograph CD-1830: From Sta 0+420/-26 m, looking N. Removal of the deposition point finger materials with an excavator at Sta. 0+390 m.**
