QA DAILY REPORT

1897439-1576-TM-Rev0

QA DAILY REPORT FOR MAY 8TH, 2018 – TSF SOUTH CELL CONSTRUCTION - MEADOWBANK (1897439)

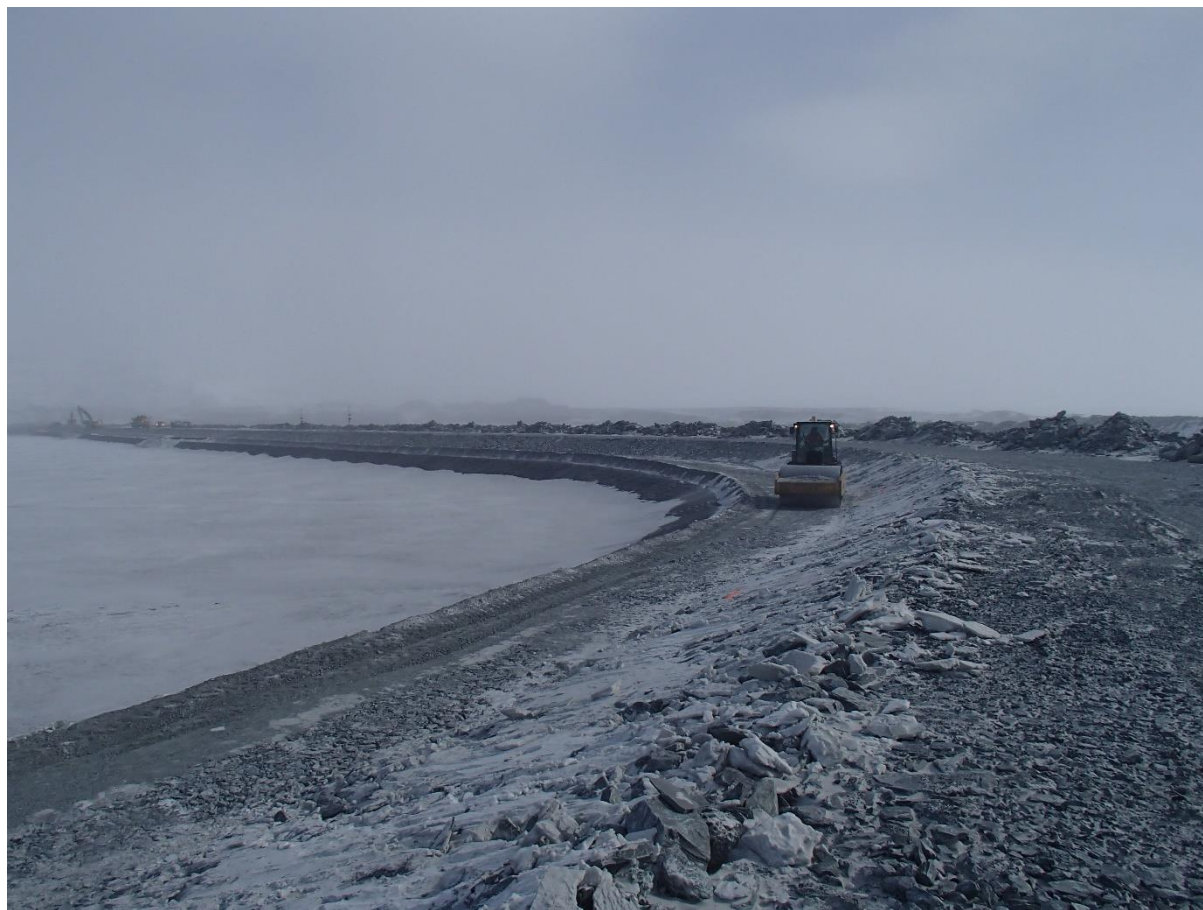
Photograph CD-1831: From Sta 40+730/-24 m, looking NE. Compaction of the first 0.5 m lift (approx.) of fine and coarse filters material at El. 143.5 m with a 10-tonne smooth-drum compactor with vibration (6 passes) from Sta. 40+730 m to 0+830 m and from Sta. 0+175 m to 0+490 m.

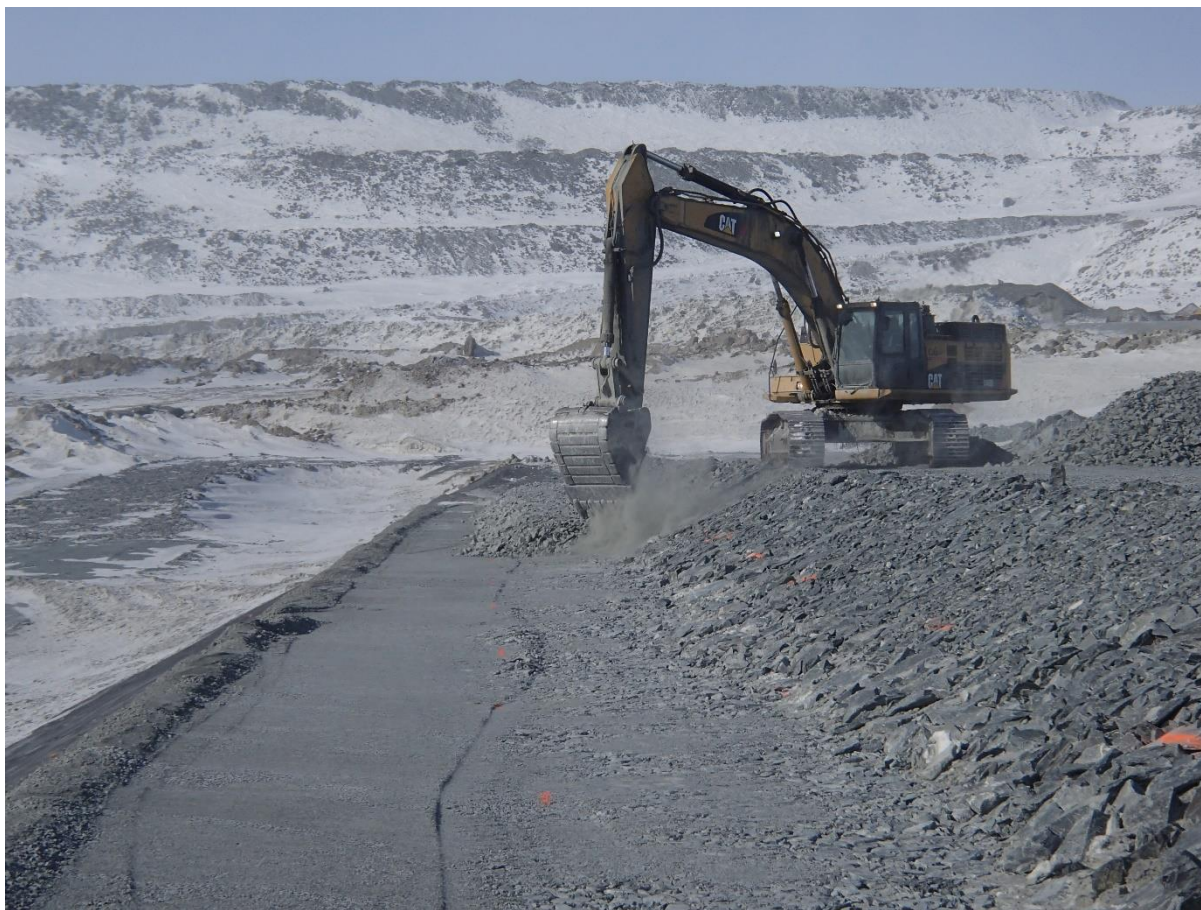
Photograph CD-1832: From Sta 0+280/-25 m, looking N. Placement of a second 0.5 m thick lift of coarse filter from El. 143.5 m to 144 m with an excavator from Sta. 0+175 m to 0+280 m.

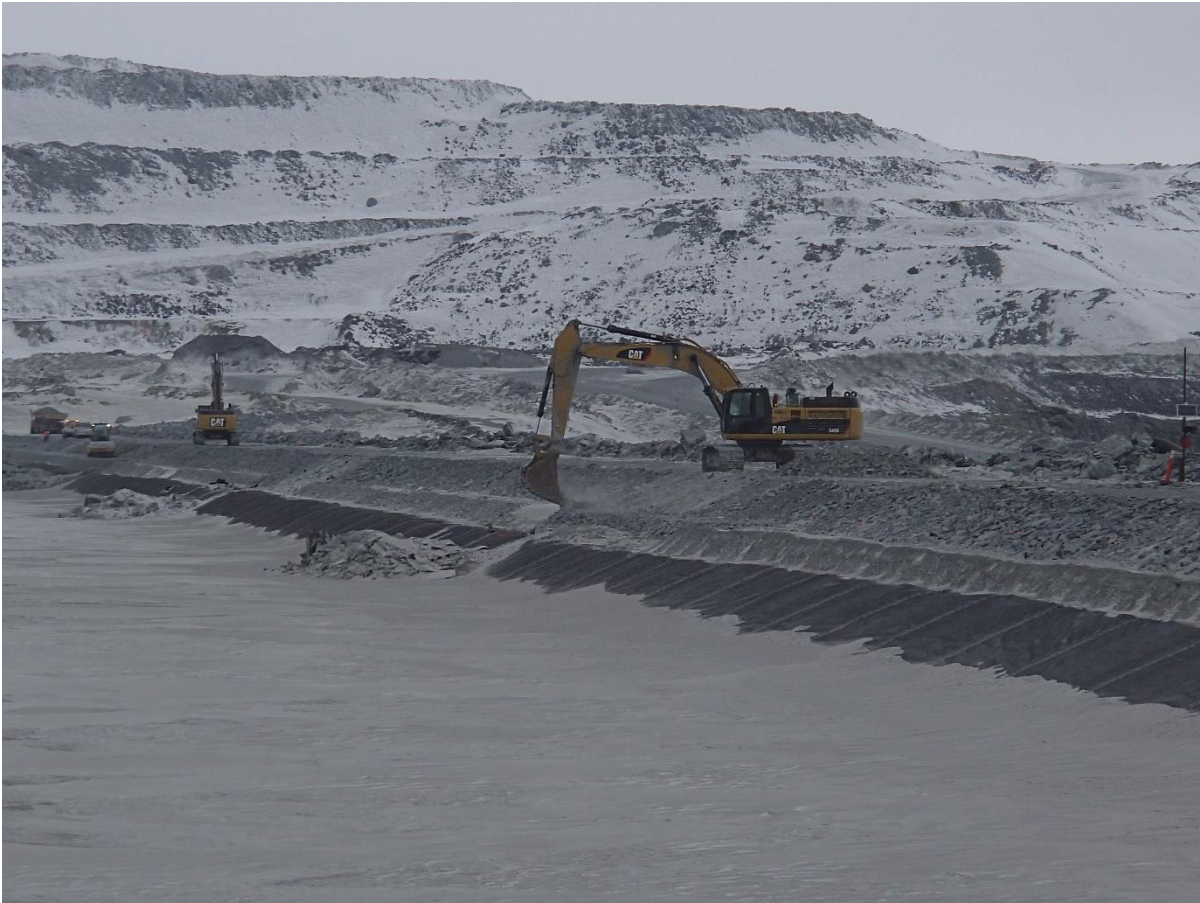
Photograph CD-1834: From Sta 40+760/-23 m, looking NE. Placement of a first 0.5 m thick lift of coarse filter from El. 143 m to 143.5 m on length of approx. 5 m with an excavator at the location of the deposition finger at Sta 0+520 m and 0+660 m.

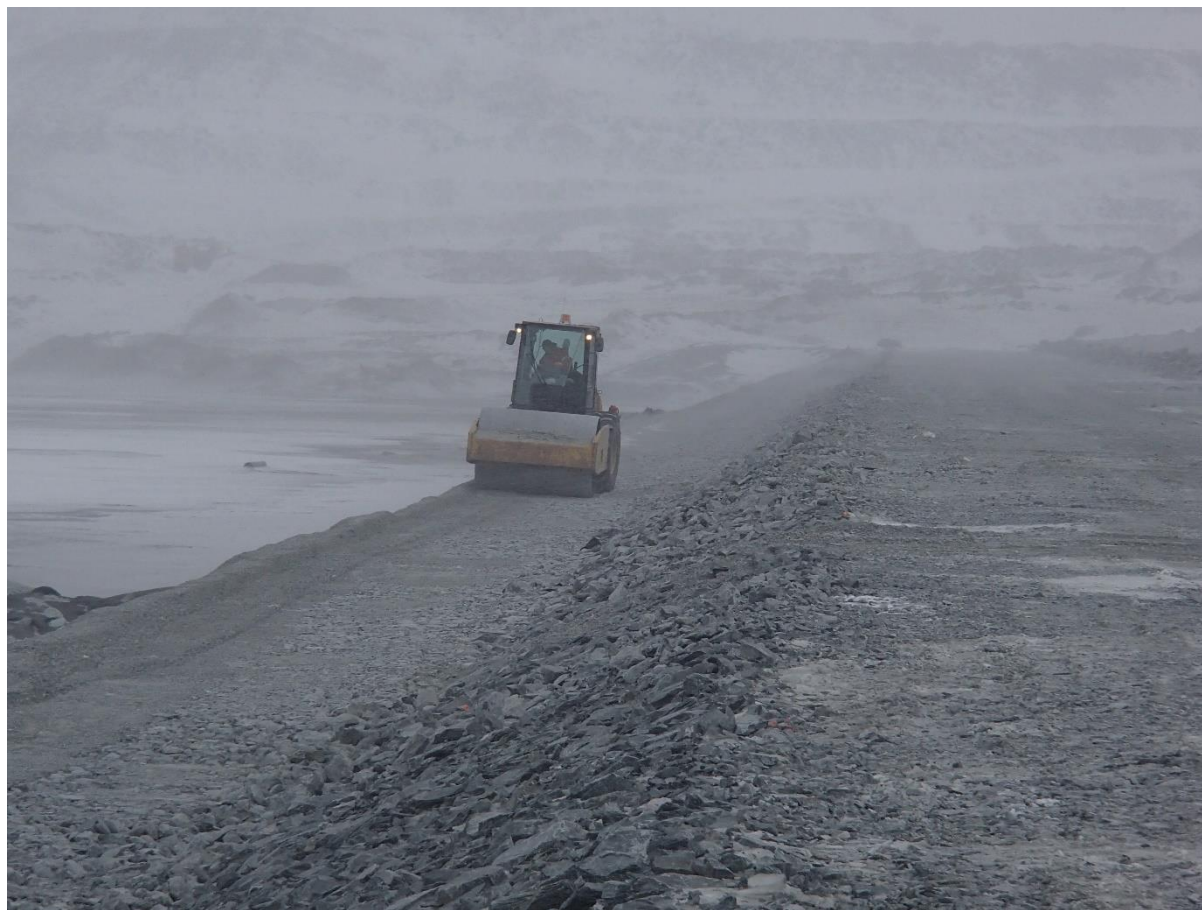
Photograph CD-1835: From Sta 0+830/-20m, looking N. Compaction of the first 0.5 m lift (approx.) of fine and coarse filters material at El. 143.5 m with a 10-tonne smooth-drum compactor with vibration (6 passes) from Sta 0+490 to 0+835 m.

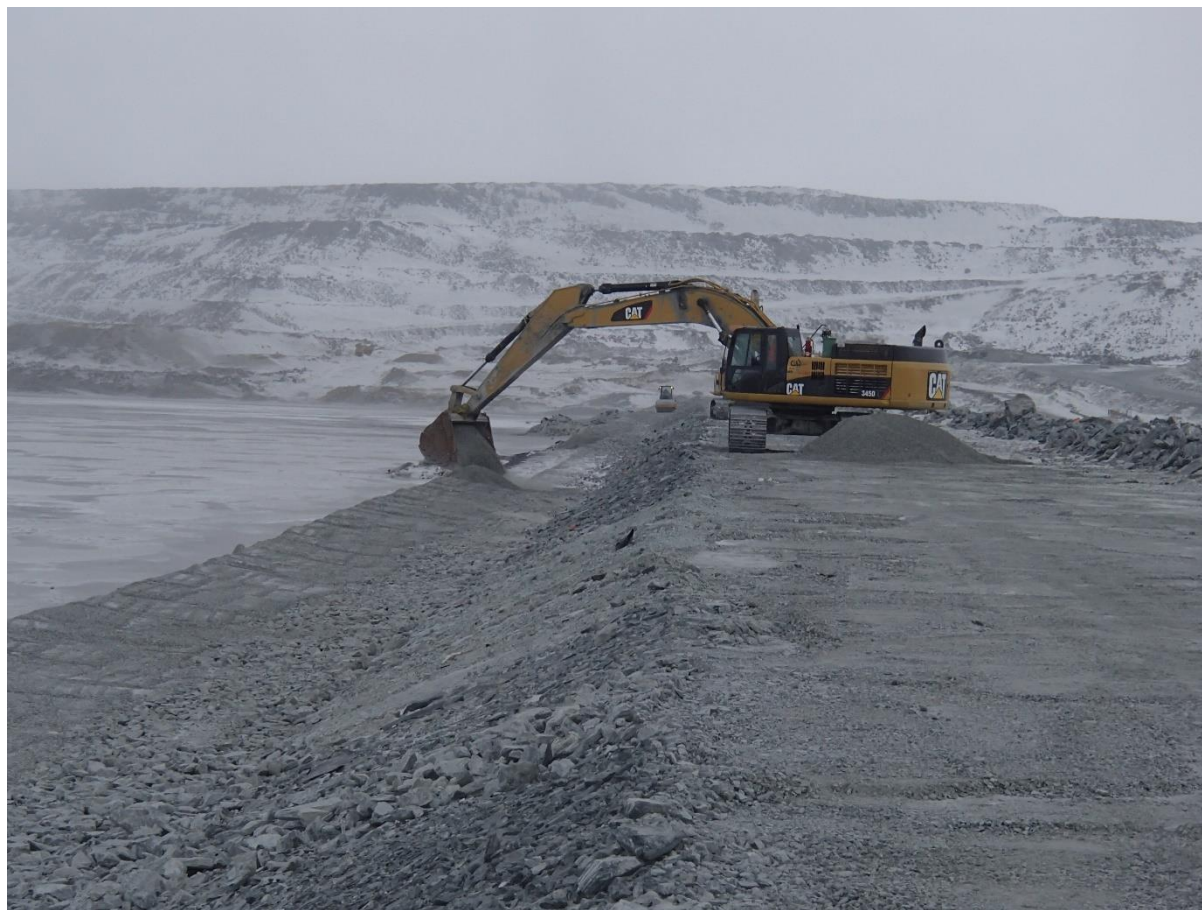
Photograph CD-1836: From Sta 0+830/-20m, looking N. Placement of a first 0.5 m thick lift of fine filter from El. 143 m to 143.5 m upstream of the coarse filter with an excavator from Sta. 0+490 to 0+835 m.

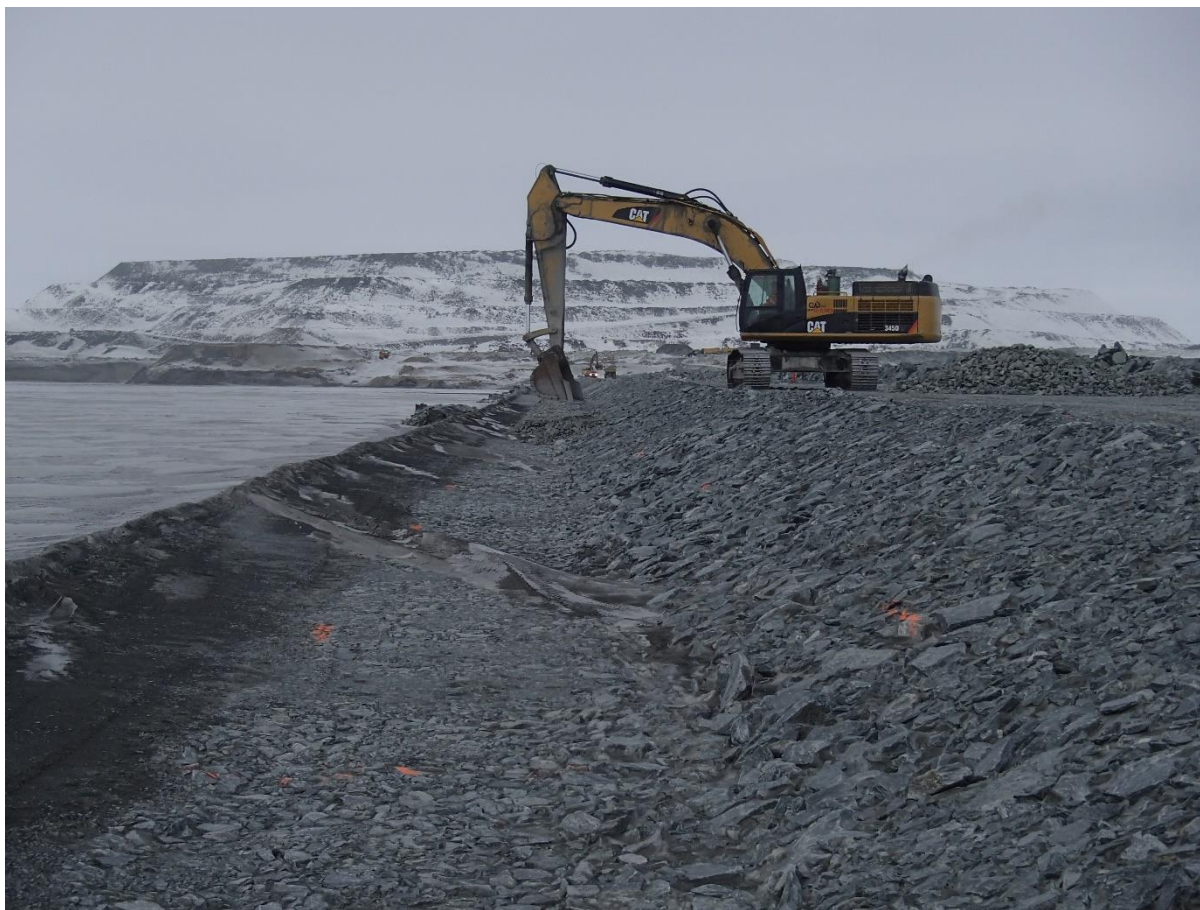
Photograph CD-1837: From Sta 0+940/-25m, looking N. Placement of a second 0.5 m thick lift of coarse filter from El. 143.5 m to 144 m with an excavator from Sta. 0+290 to 0+500 m and from Sta. 0+835 to 0+930 m.

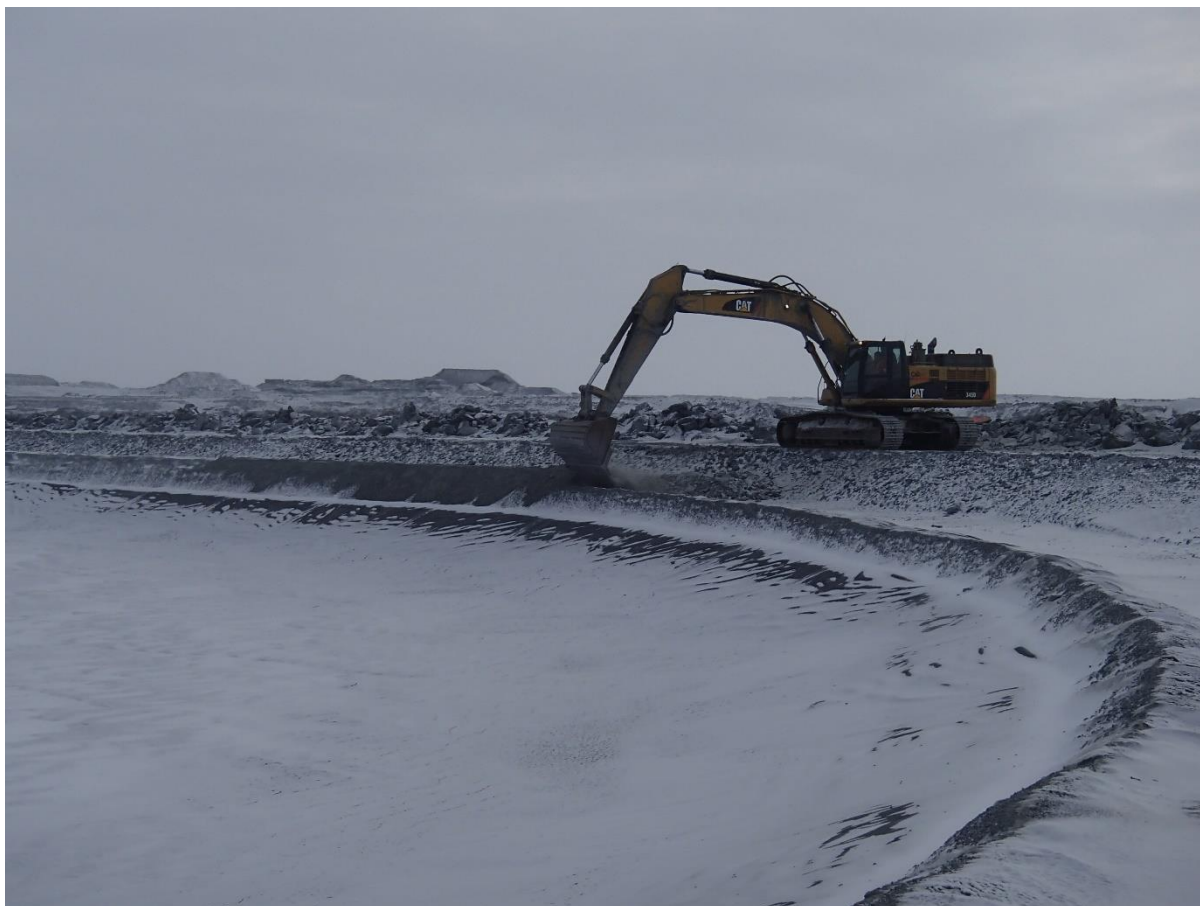
Photograph CD-1838: From Sta 40+750/-31 m, looking NE. Placement of a second 0.5 m thick lift of fine filter from El. 143.5 m to 144 m upstream of the coarse filter with an excavator from Sta. 0+500 m to 0+835 m and from 0+930 to 40+730 m.

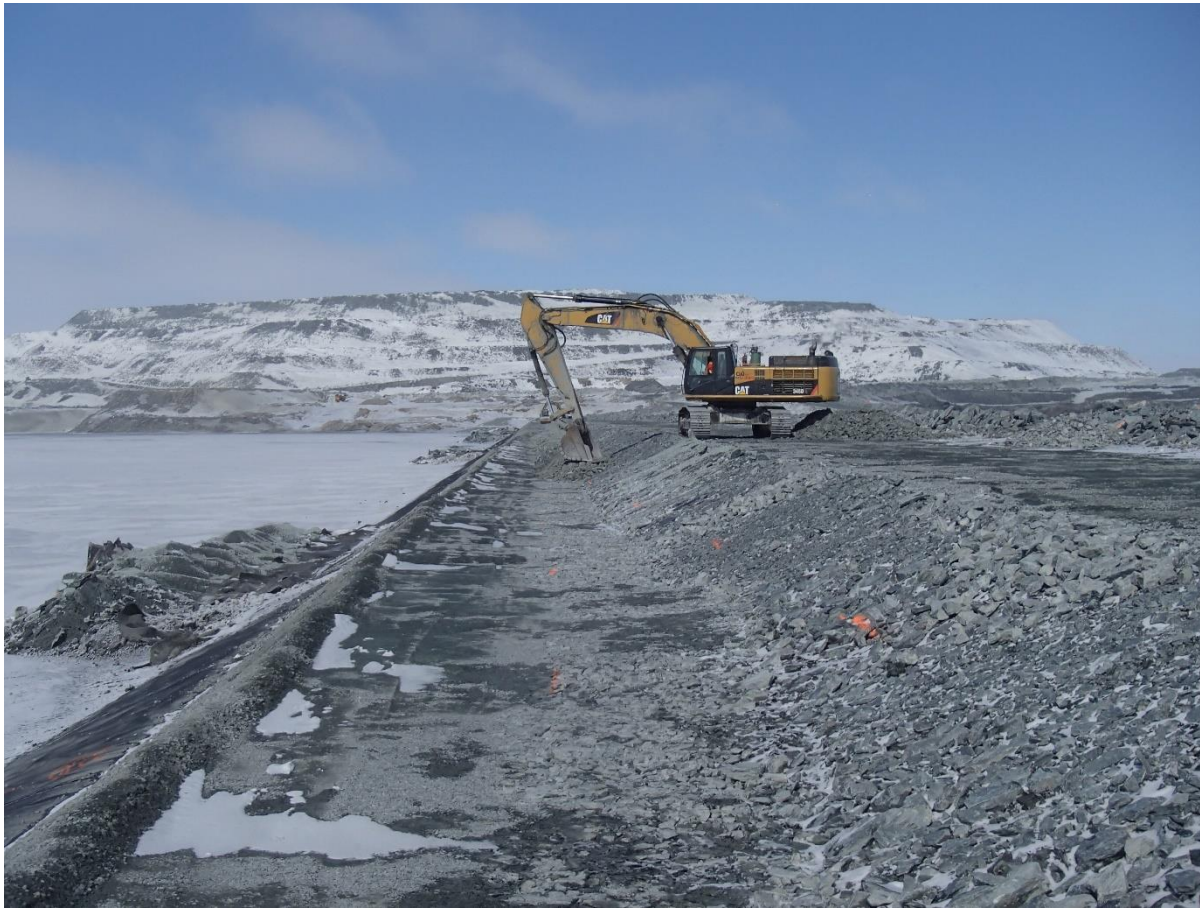
Photograph CD-1838: From Sta 0+835/-20 m, looking N. Placement of a second 0.5 m thick lift of coarse filter from El. 143.5 m to 144 m with an excavator from Sta. 0+500 m to 0+835 m and from 0+930 to 40+730 m.

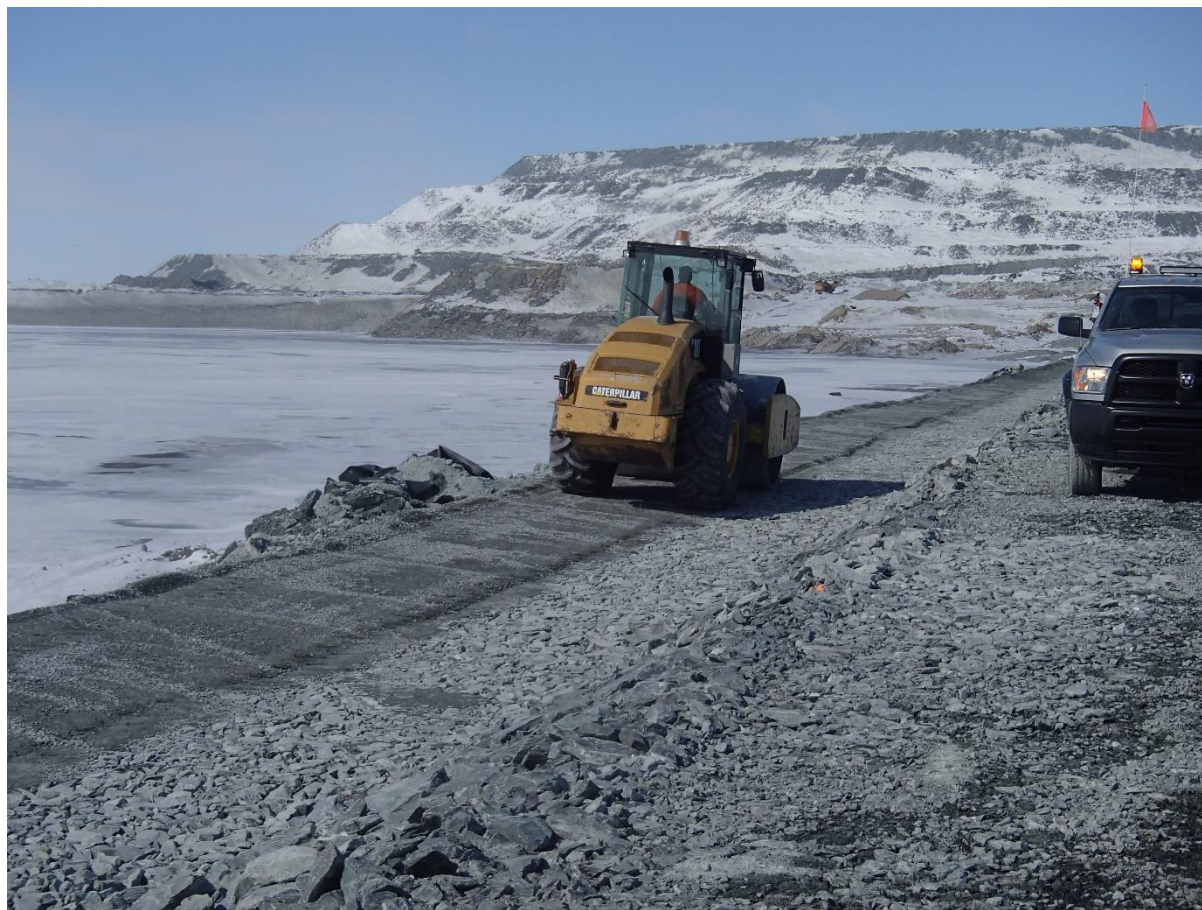
Photograph CD-1840: From Sta 0+575/-15 m, looking NW. Compaction of the second 0.5 m lift (approx.) of fine and coarse filters material at El. 144 m with a 10-tonne smooth-drum compactor with vibration (4 passes) from Sta 0+500 m to 40+730 m.

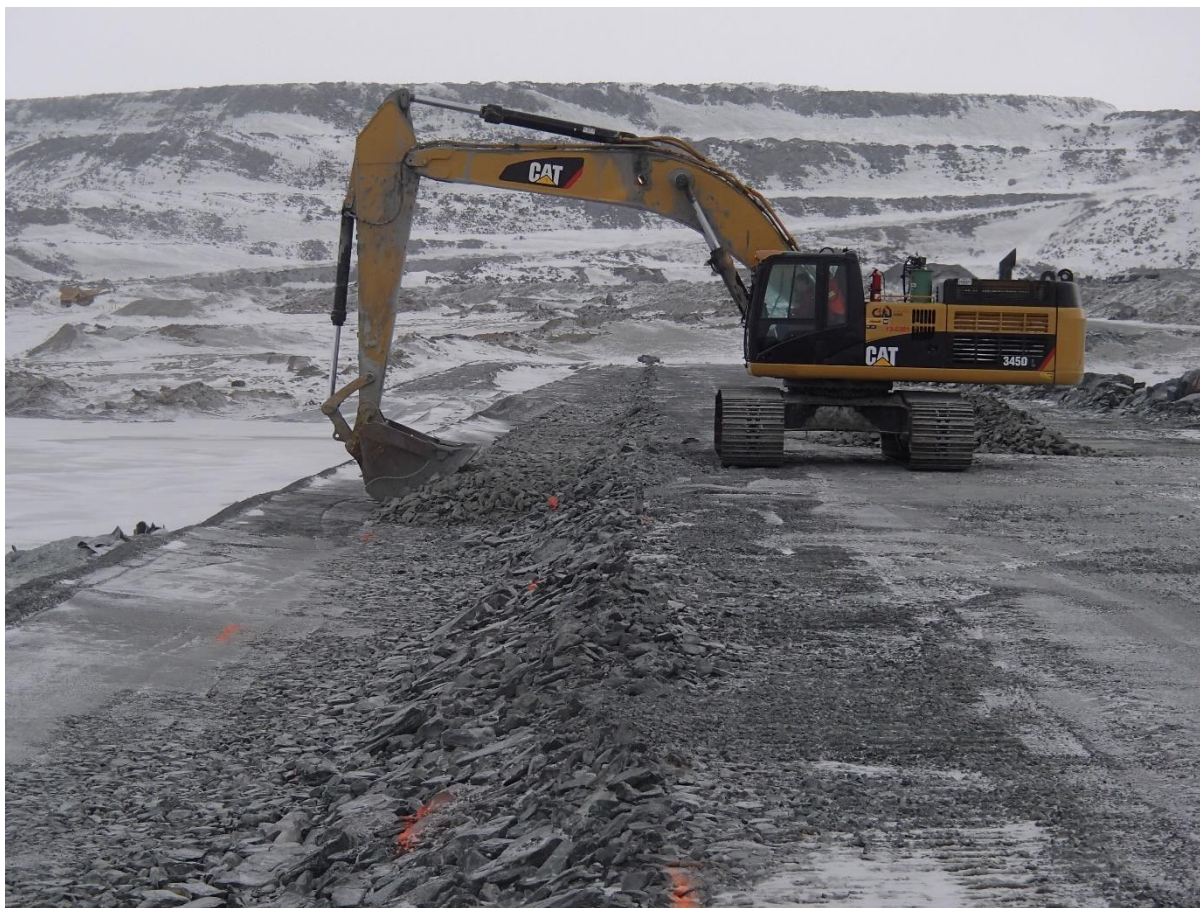
Photograph CD-1841: From Sta 0+475/-14 m, looking N. Placement of a third 0.5 m thick lift of coarse filter from El. 144 m to 144.5 m with an excavator from Sta. 0+335 m to 40+730 m.

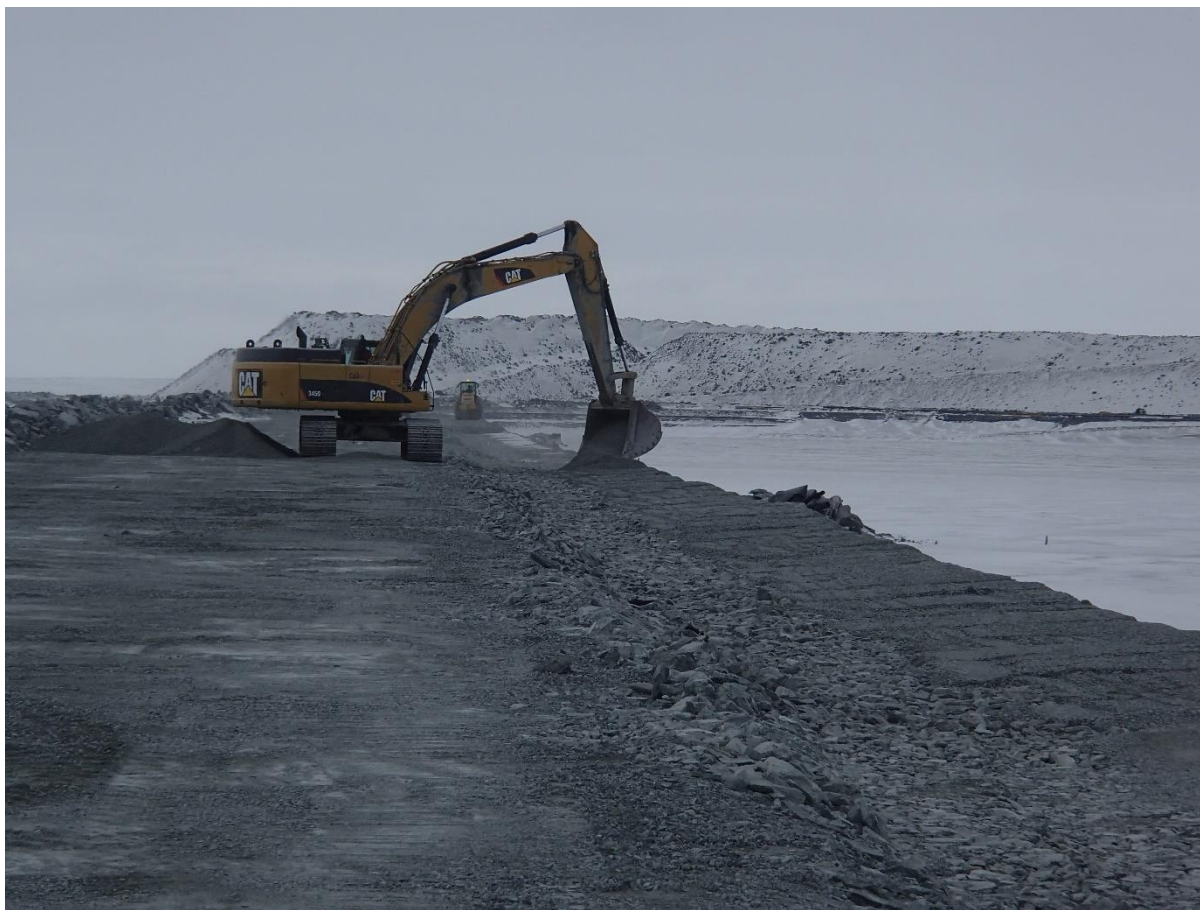
Photograph CD-1842: From Sta 0+380/-16 m, looking S. Placement of a third 0.5 m thick lift of fine filter from El. 143.5 m to 144 m upstream of the coarse filter with an excavator from Sta. 0+335 m to 0+940 m.

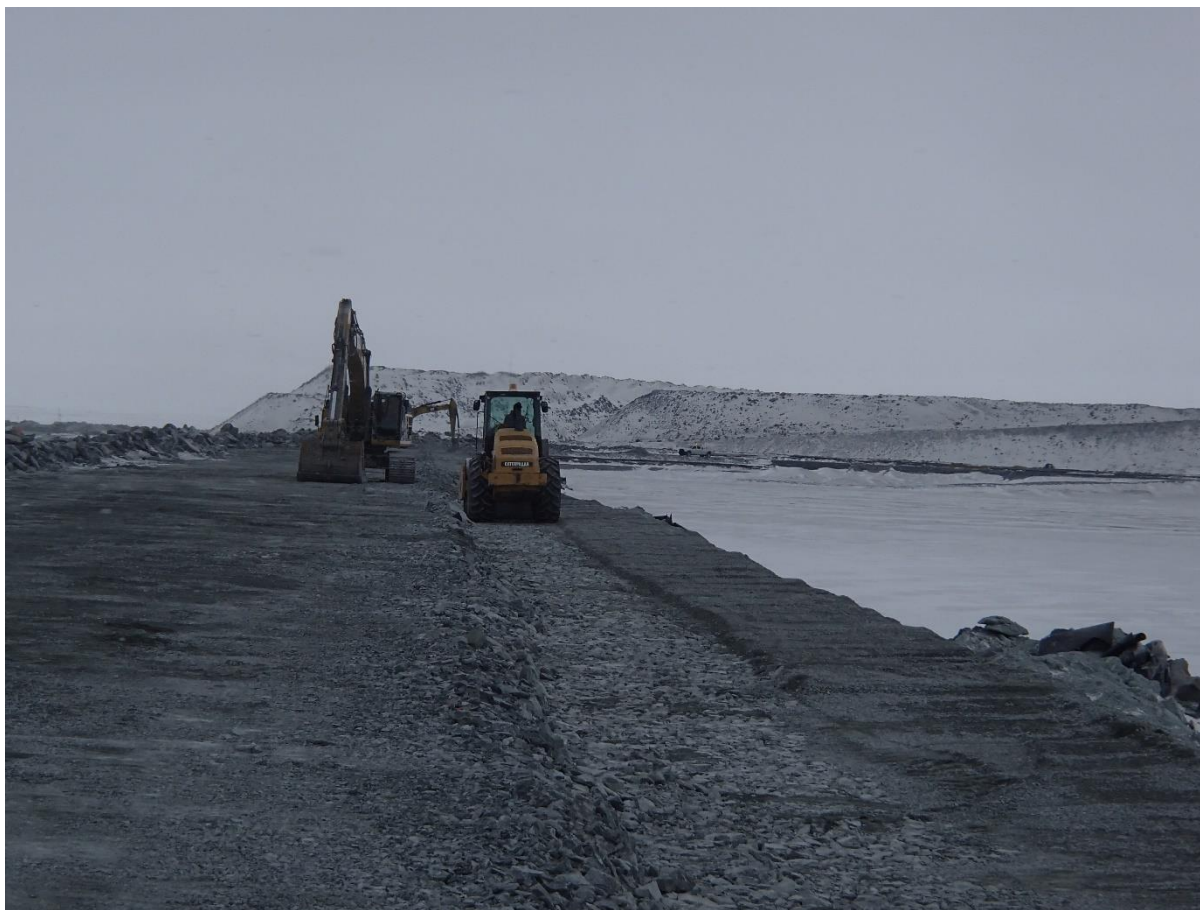
Photograph CD-1843: From Sta 0+460/-23 m, looking S. Compaction of the third 0.5 m lift (approx.) of fine and coarse filters material at El. 144.5 m with a 10-tonne smooth-drum compactor with vibration (4 passes) from Sta 0+335m to 0+900 m.

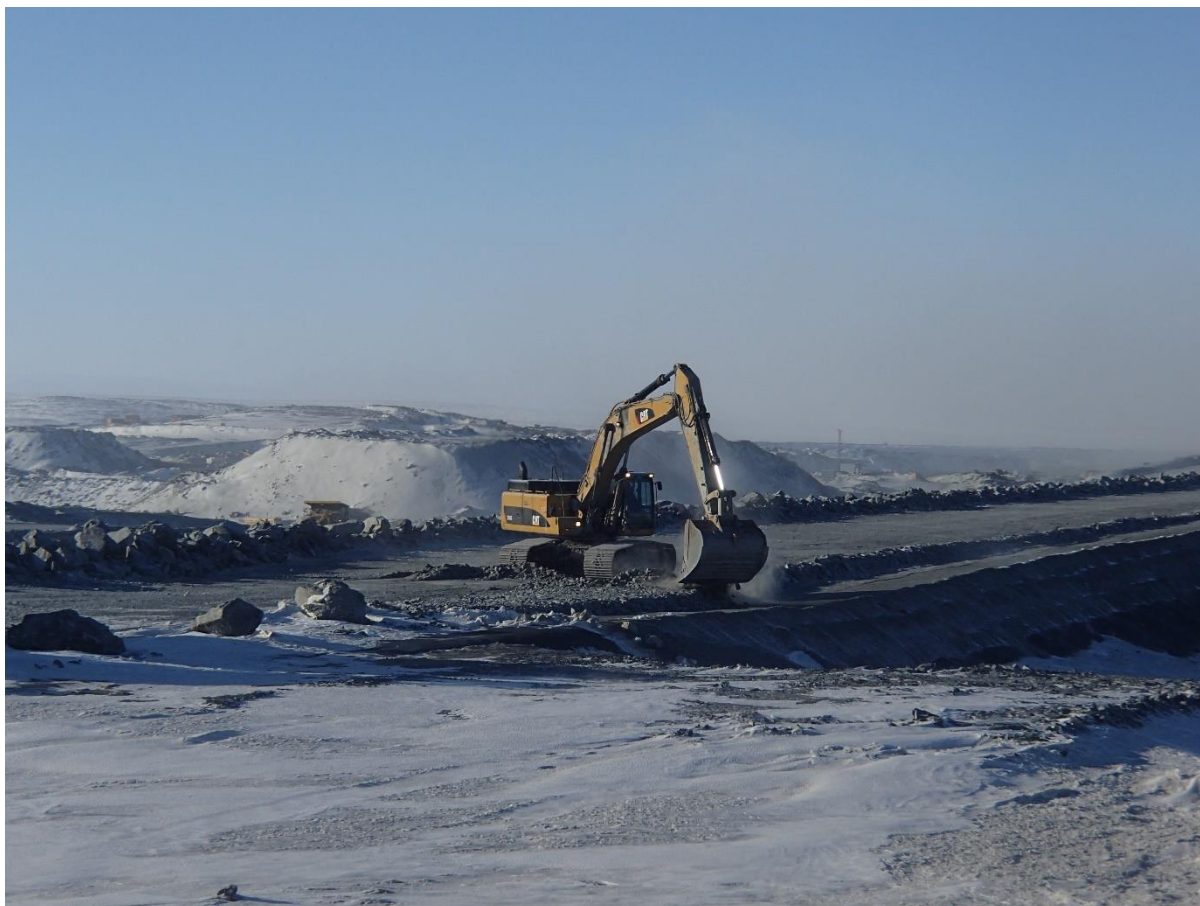
Photograph CD-1844: From Sta 0+080/-49 m, looking SW. Placement of a fourth 0.5 m thick lift of coarse filter from El. 144.5 m to 145 m with an excavator from Sta. 0+170 m to 40+730 m.

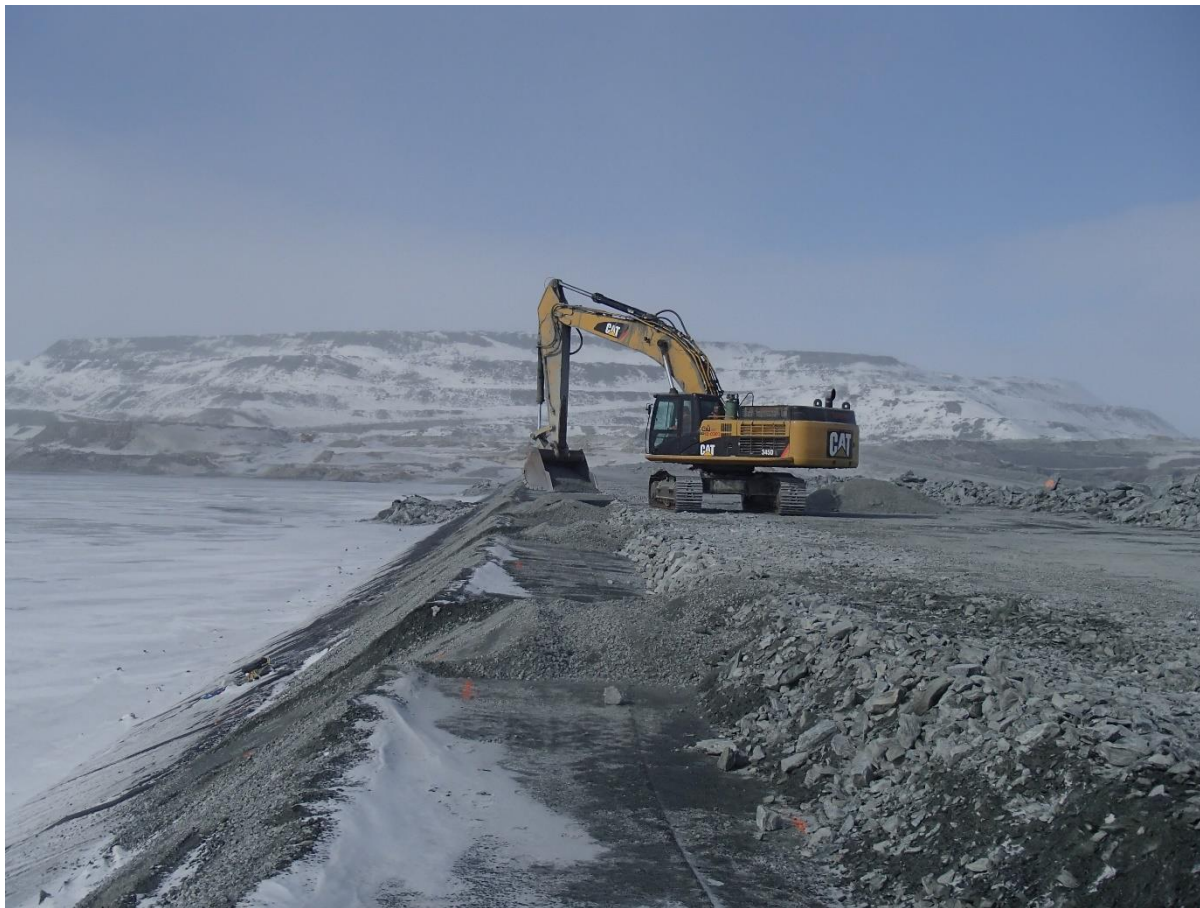
Photograph CD-1845: From Sta 0+660/-20 m, looking N. Profiling of the upstream slope (2H:1V) from El. 143 to 145 m with an excavator between Sta. 0+175 and 0+330 m and between Sta. 0+600 m and 0+715 m. The removed material is placed on the fourth 0.5 m thick lift of fine filter from El. 144.5 m to 145 m upstream of the coarse filter with an excavator from Sta. 0+170 m to 0+330 m and between Sta. 0+600 m and 0+715 m.

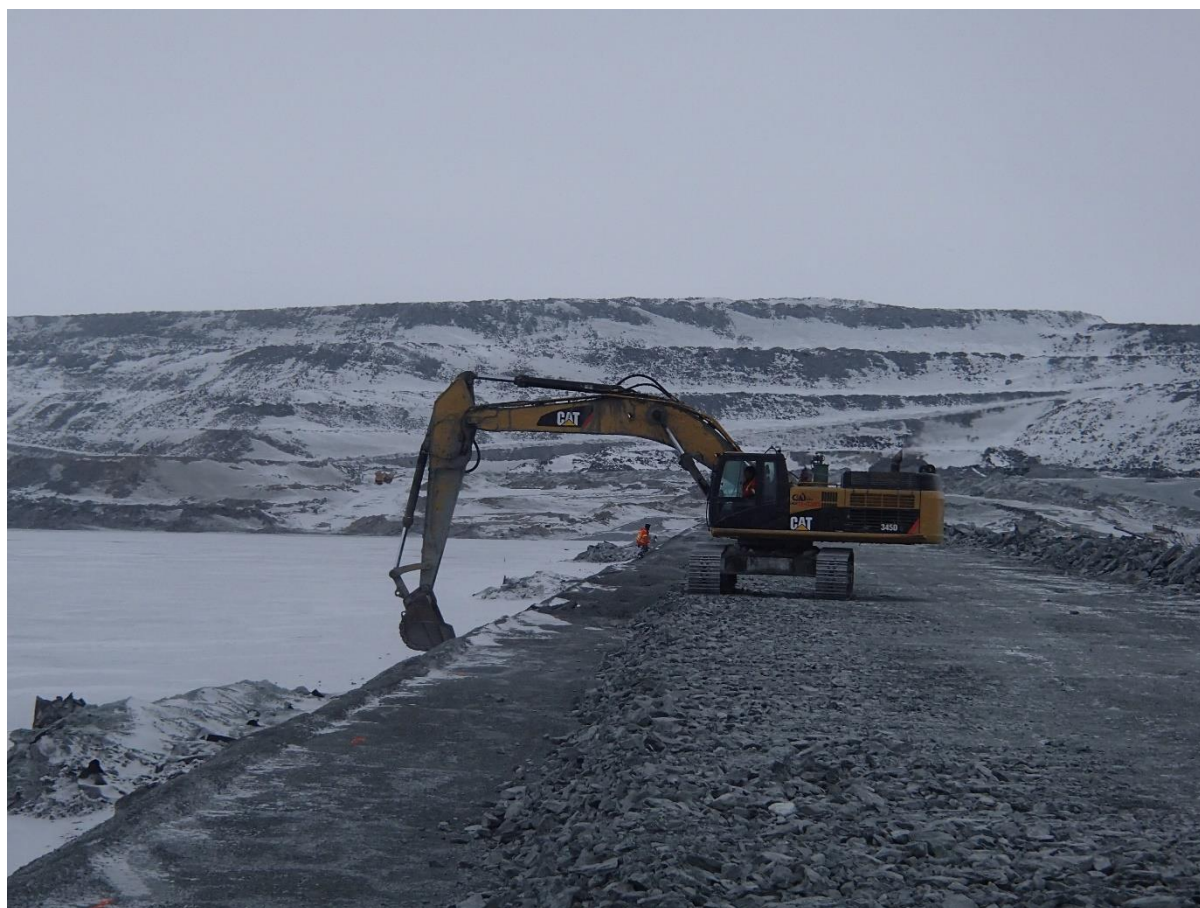
Photograph CD-1846: From Sta 0+835/-25 m, looking N. Profiling of the upstream slope (2H:1V) from El. 143 to 145 m with an excavator between Sta. 0+330 and 0+600 m and between Sta. 0+715 m and 40+730 m. The removed material was placed with material from the fine filter stockpile on the fourth 0.5 m thick lift of fine filter from El. 144.5 m to 145 m upstream of the coarse filter with an excavator from Sta. 0+330 m to 0+600 m and between Sta. 0+715 m and 40+730 m.

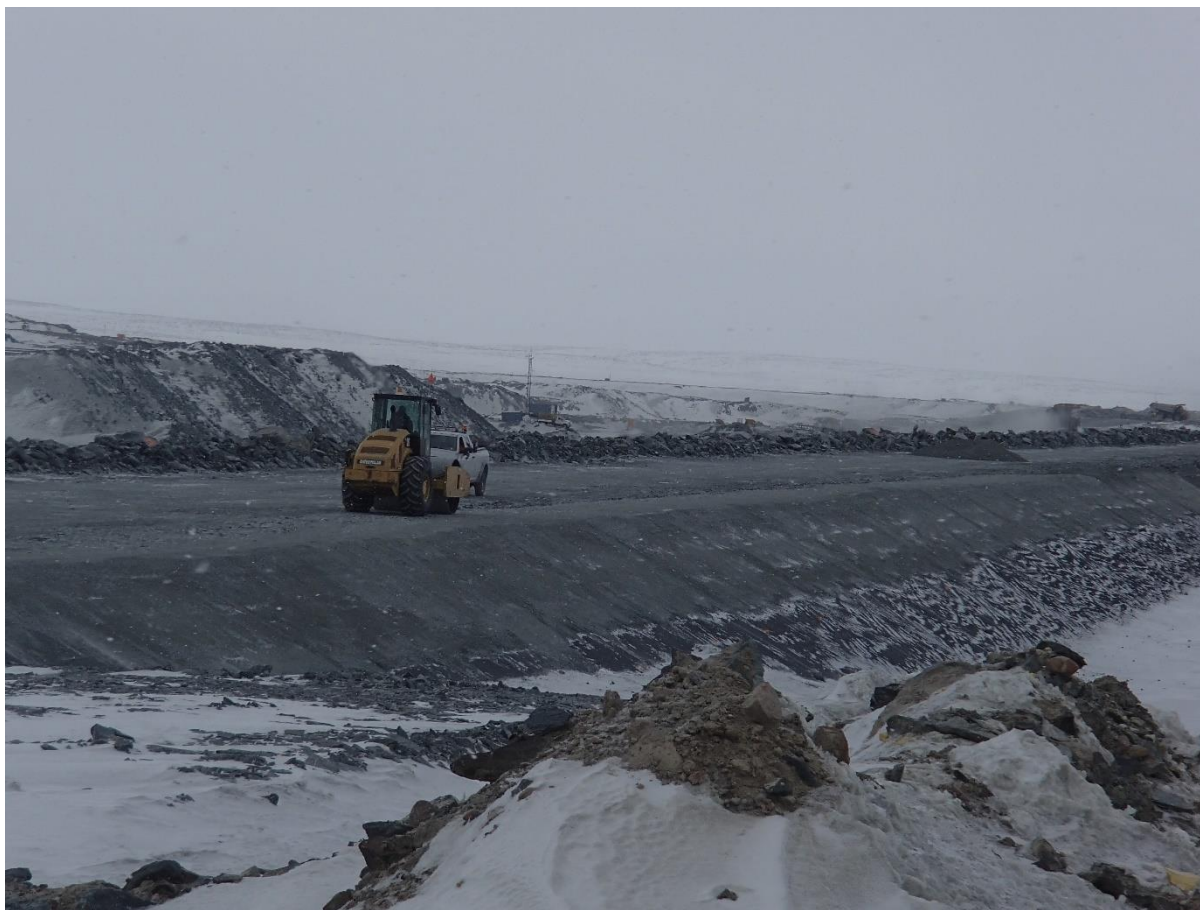
Photograph CD-1847: From Sta 0+085/-48 m, looking SE. Compaction of the fourth 0.5 m lift (approx.) of fine and coarse filters material at El. 145 m with a 10-tonne smooth-drum compactor with vibration (4 passes) from Sta 0+170 m to 0+930 m.

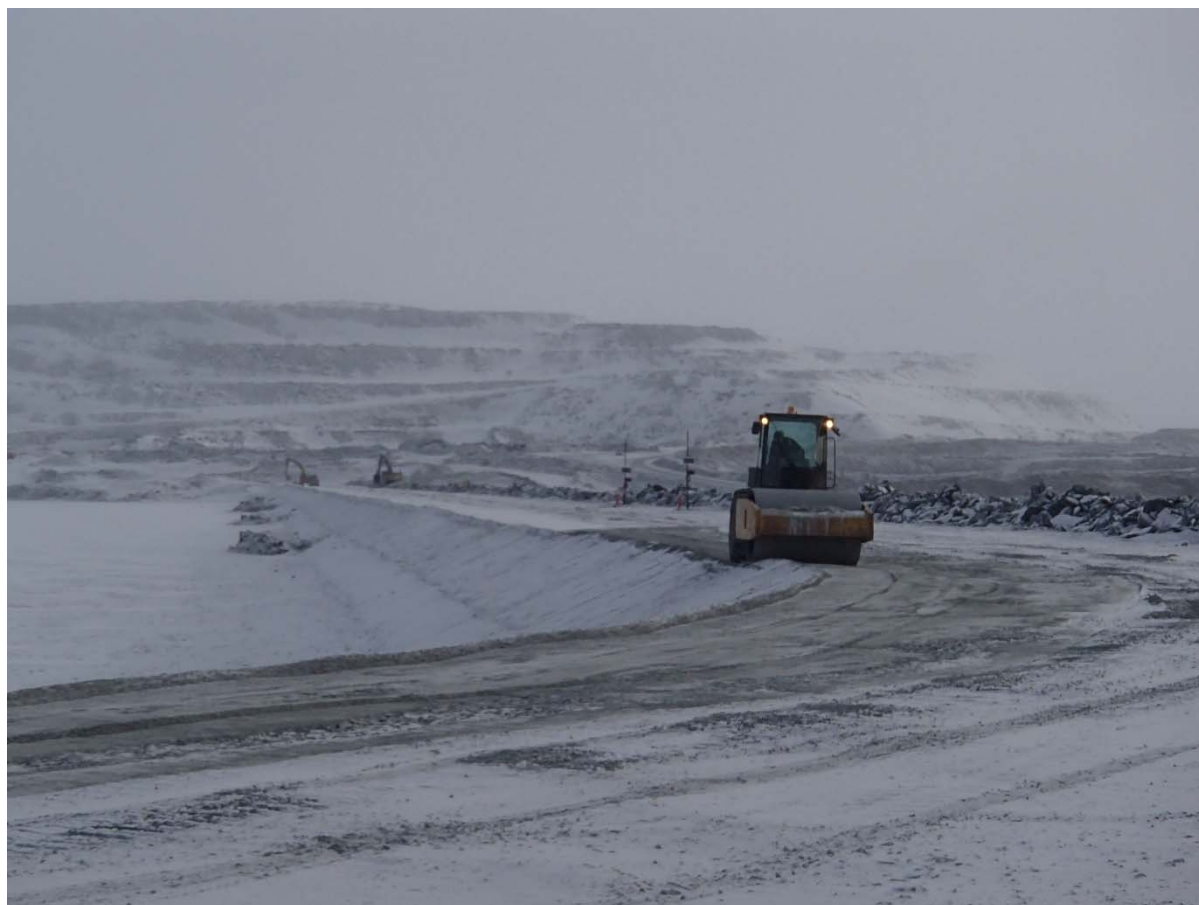
Photograph CD-1848: From Sta. 40+780/-15 m, looking N. Compaction of the fourth 0.5 m lift (approx.) of fine and coarse filters material at El. 145 m with a 10-tonne smooth-drum compactor with vibration (4 passes) from Sta 0+930 m to 40+730 m.

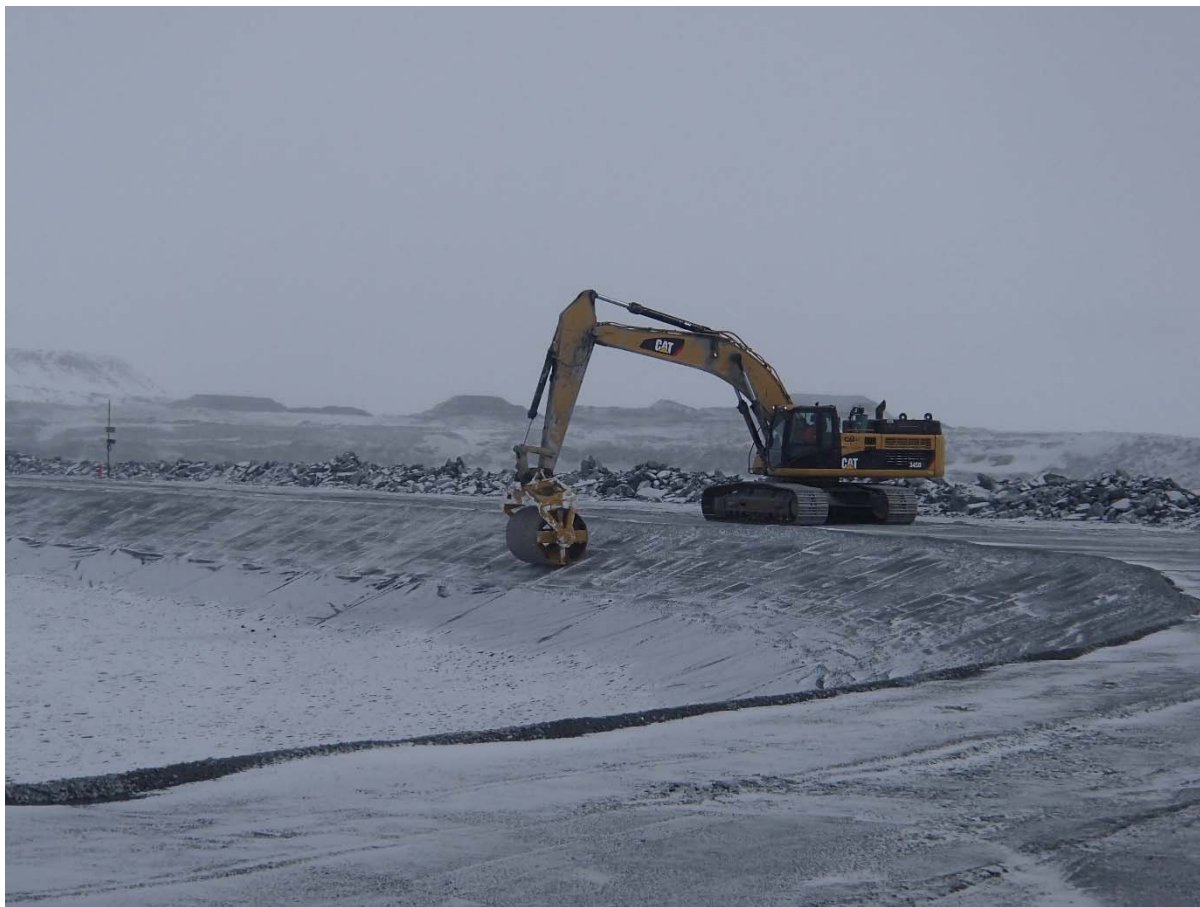
Photograph CD-1849: From Sta. 40+750/-17 m, looking NE. Final rolling of the upstream slope in view of the LLDPE geomembrane installation from Sta. 0+170 m to 40+730 m.

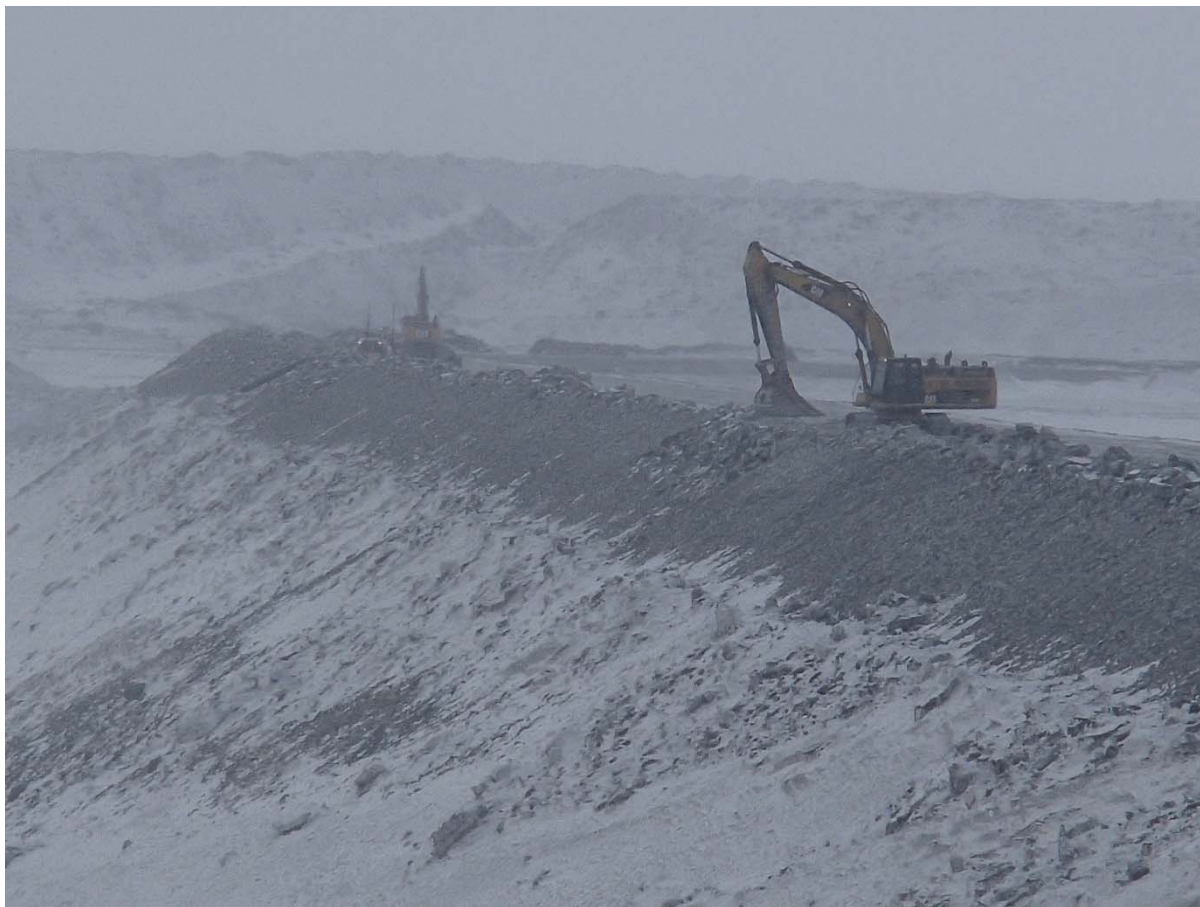
Photograph CD-1850: From Sta. 0+160/+20 m, looking SW. Profiling of the downstream slope (1.5H:1V) from El. 143 to 145 m with an excavator between Sta. 0+440 m and 0+530 m and between Sta. 0+745 m and 0+835 m.

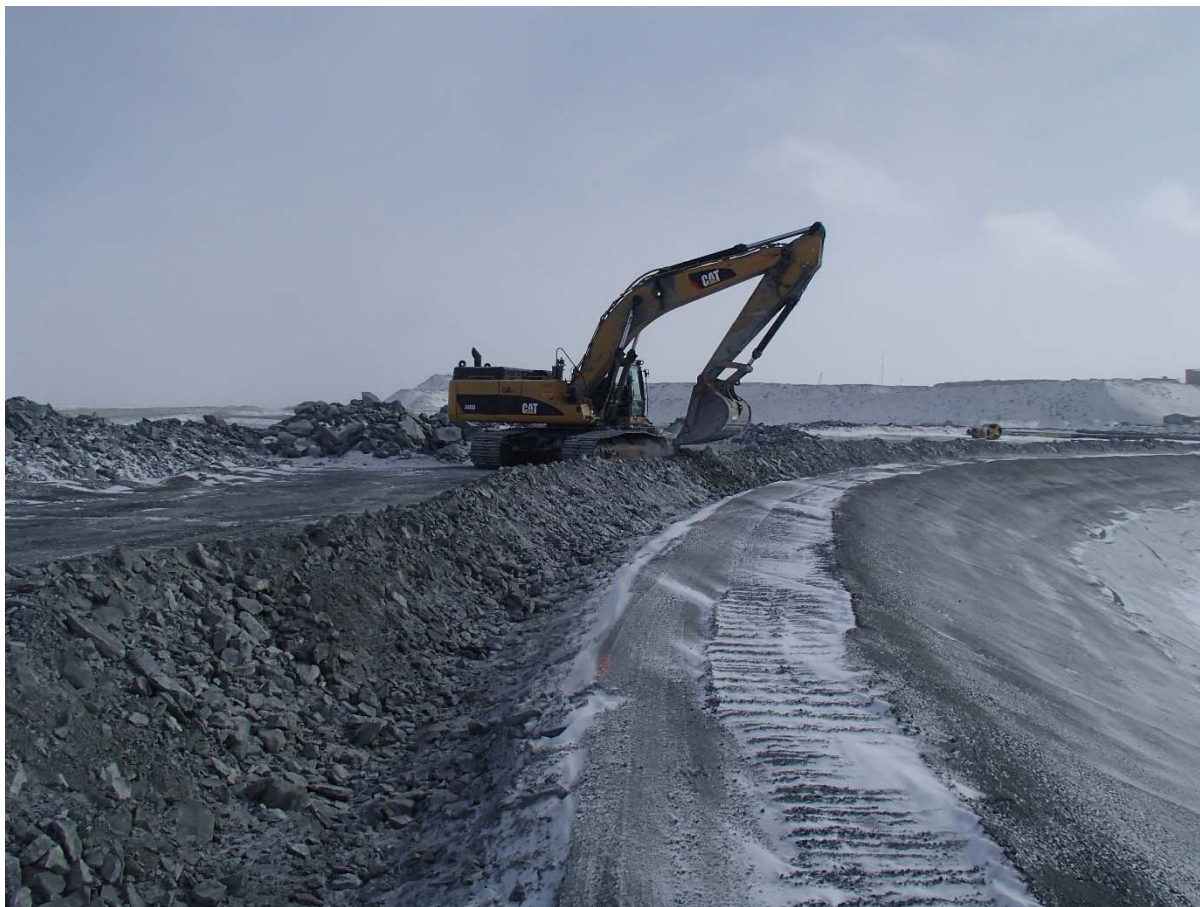
Photograph CD-1851: From Sta. 0+910/-18 m, looking S. Excavation of the LLDPE geomembrane crest anchoring trench from Sta. 40+730 m to 0+830 m.
