QA DAILY REPORT

1897439-1576-TM-Rev0

QA DAILY REPORT FOR MAY 8TH, 2018 – TSF SOUTH CELL CONSTRUCTION - MEADOWBANK (1897439)

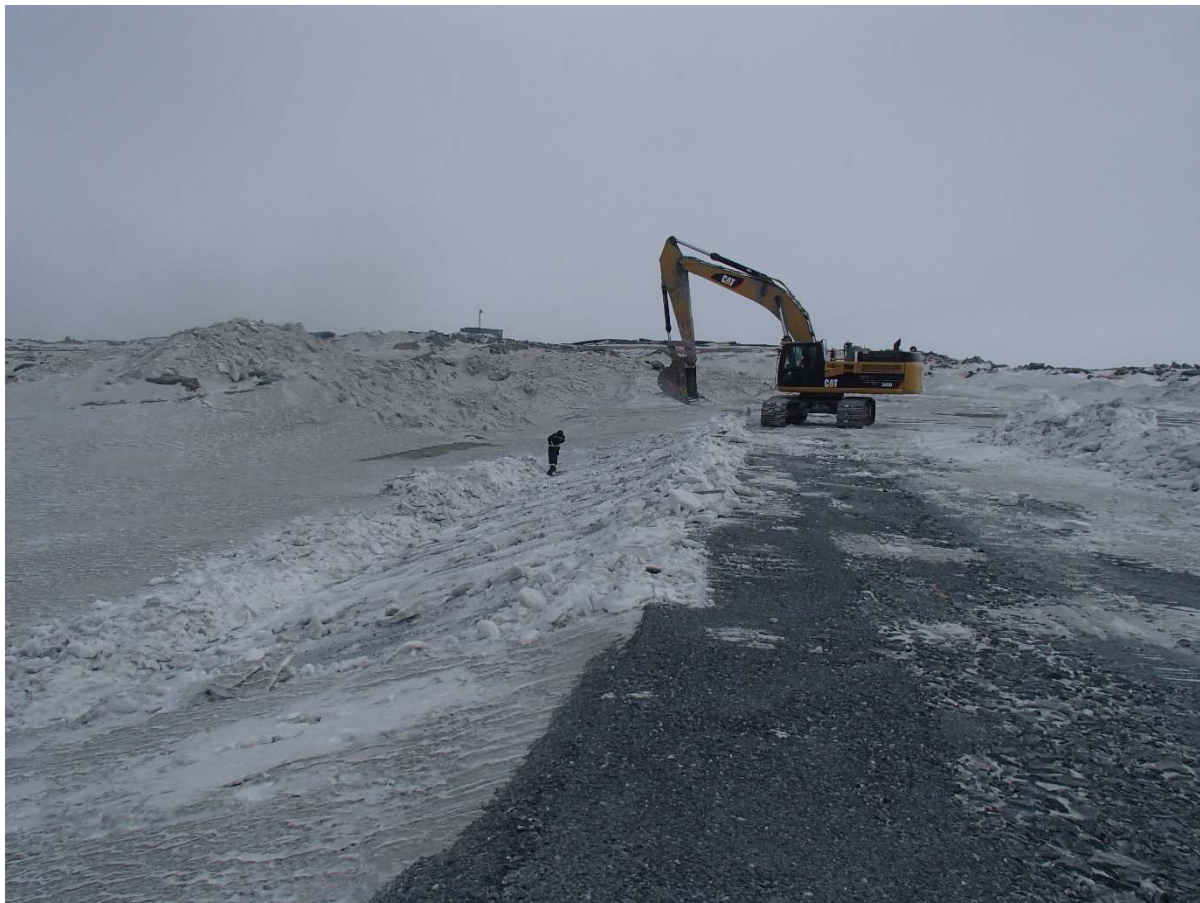
Photograph SD-297: From Sta. 20+730/-10 m, looking SE. Removal of snow on the upstream slope of SD3 with an excavator, from Sta. 20+640 to 20+760 m.

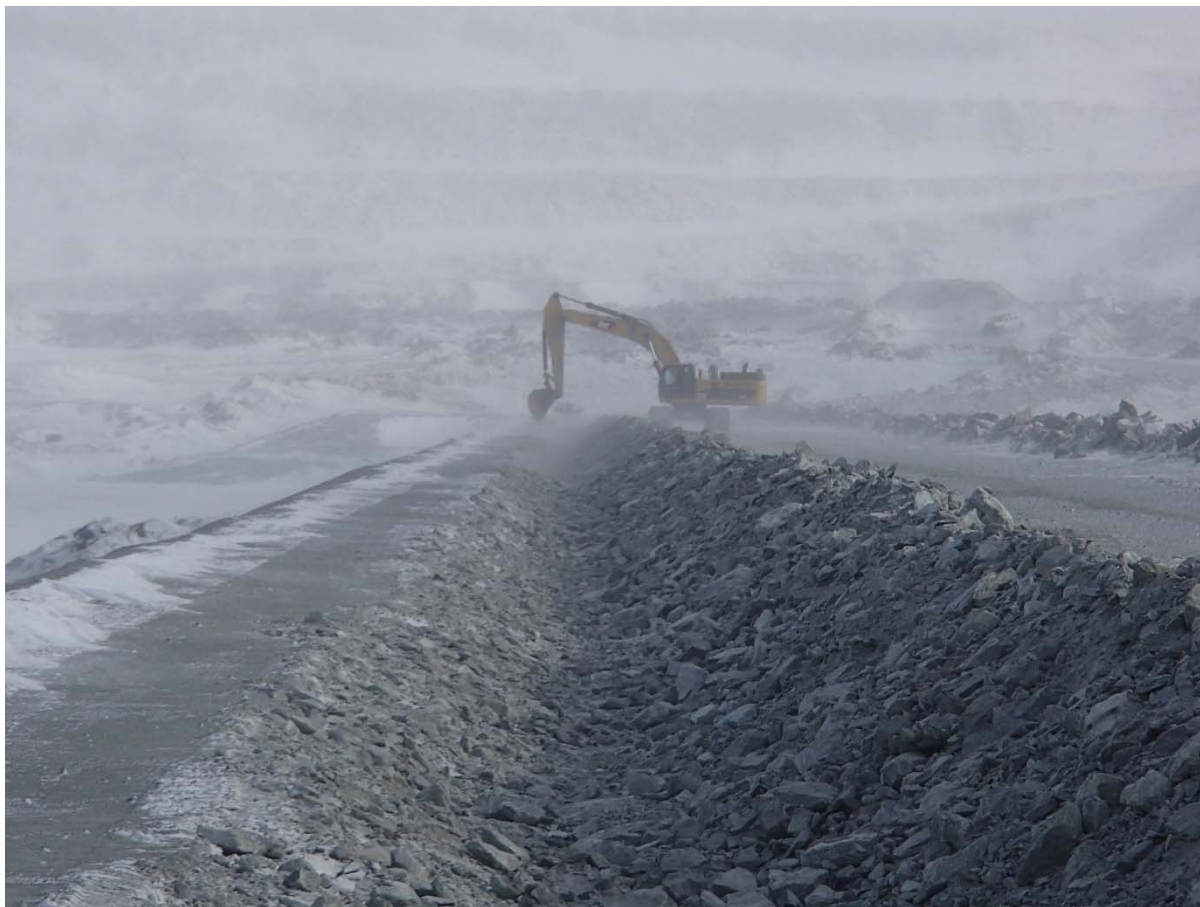
Photograph CD-1852: From Sta. 0+500/-25 m, looking N. Excavation of the LLDPE geomembrane crest anchoring trench from Sta. 0+830 m to 0+170 m.

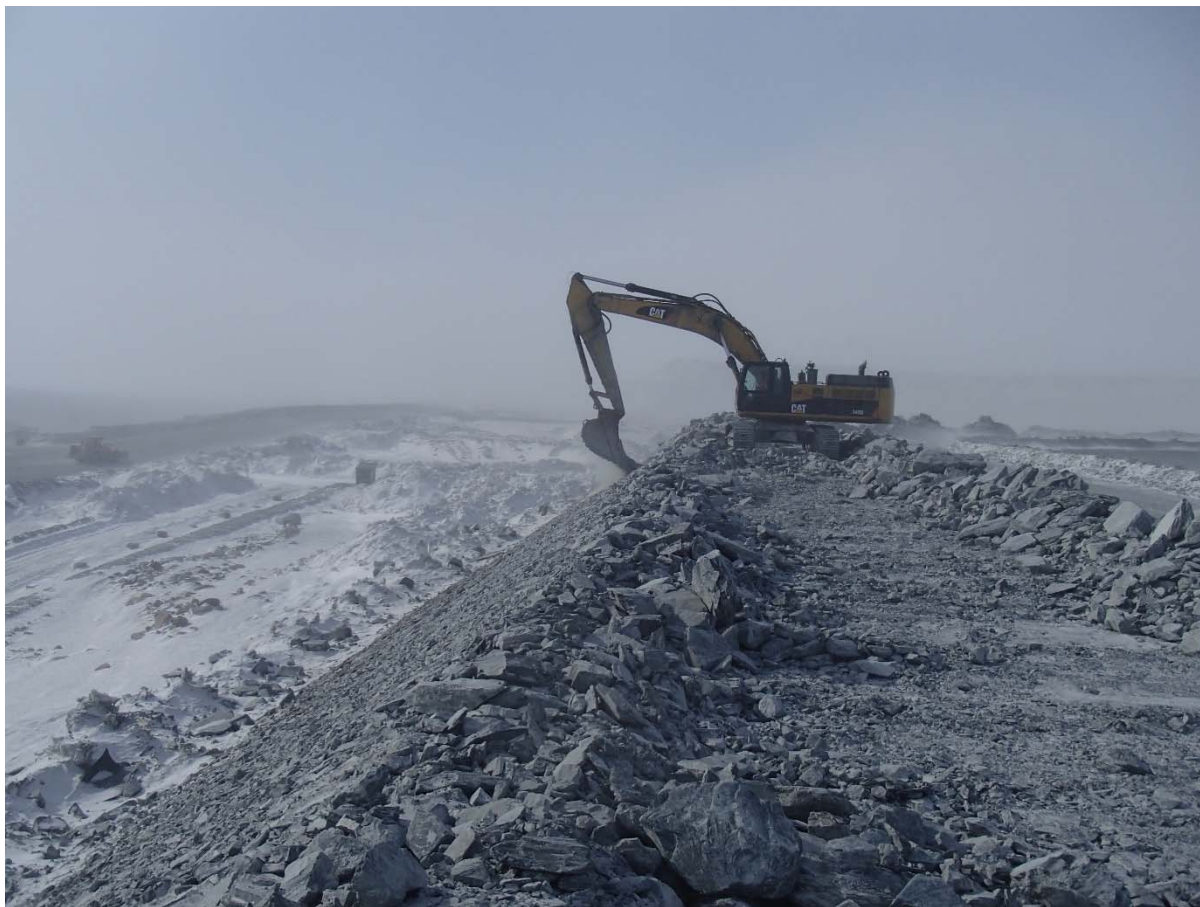
Photograph CD-1853: From Sta. 0+850/+3 m, looking S. Profiling of the downstream slope (1.5H:1V) from El. 143 to 145 m with an excavator between Sta. 0+835 m and 0+940 m.

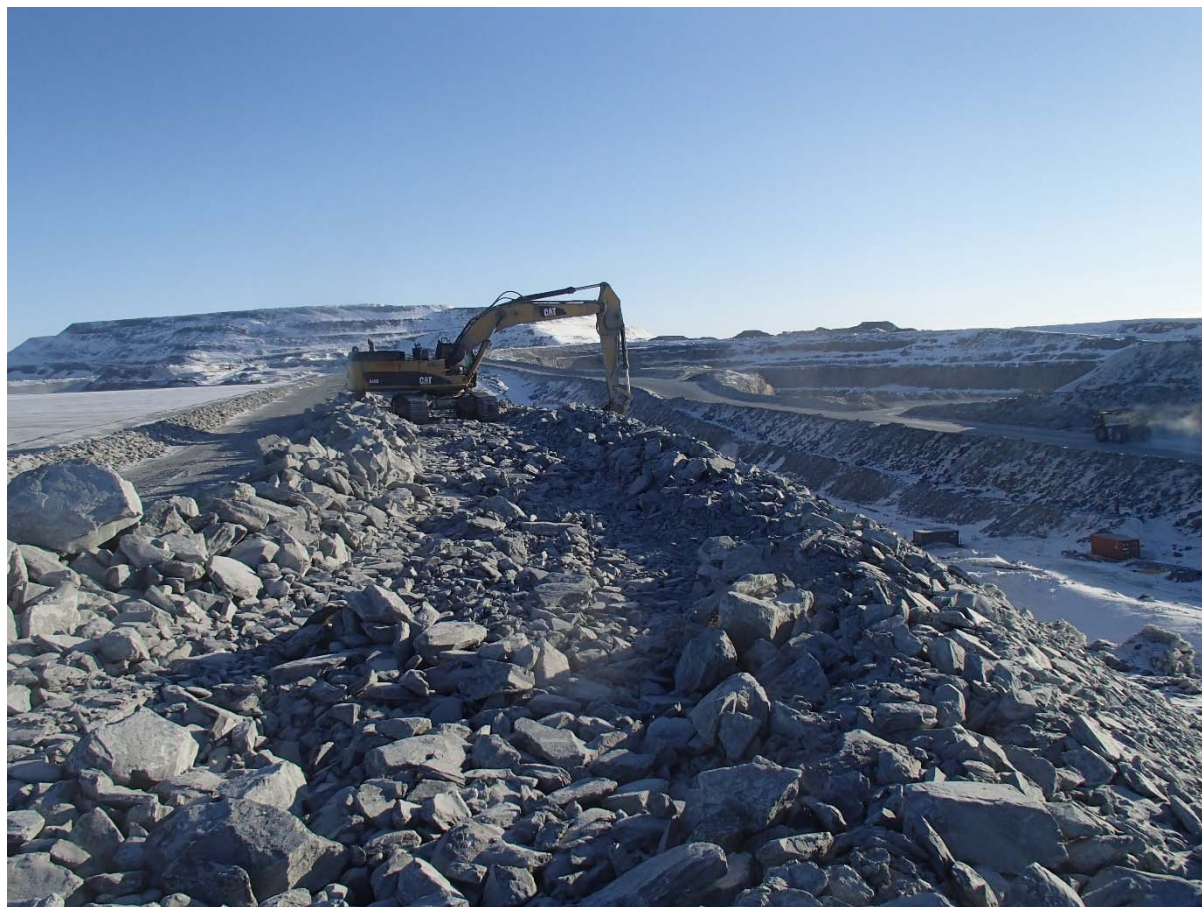
Photograph CD-1854: From Sta. 0+960/-13 m, looking N. Profiling of the downstream slope (1.5H:1V) from El. 143 to 145 m with an excavator between Sta. 0+940 m and 0+990 m.

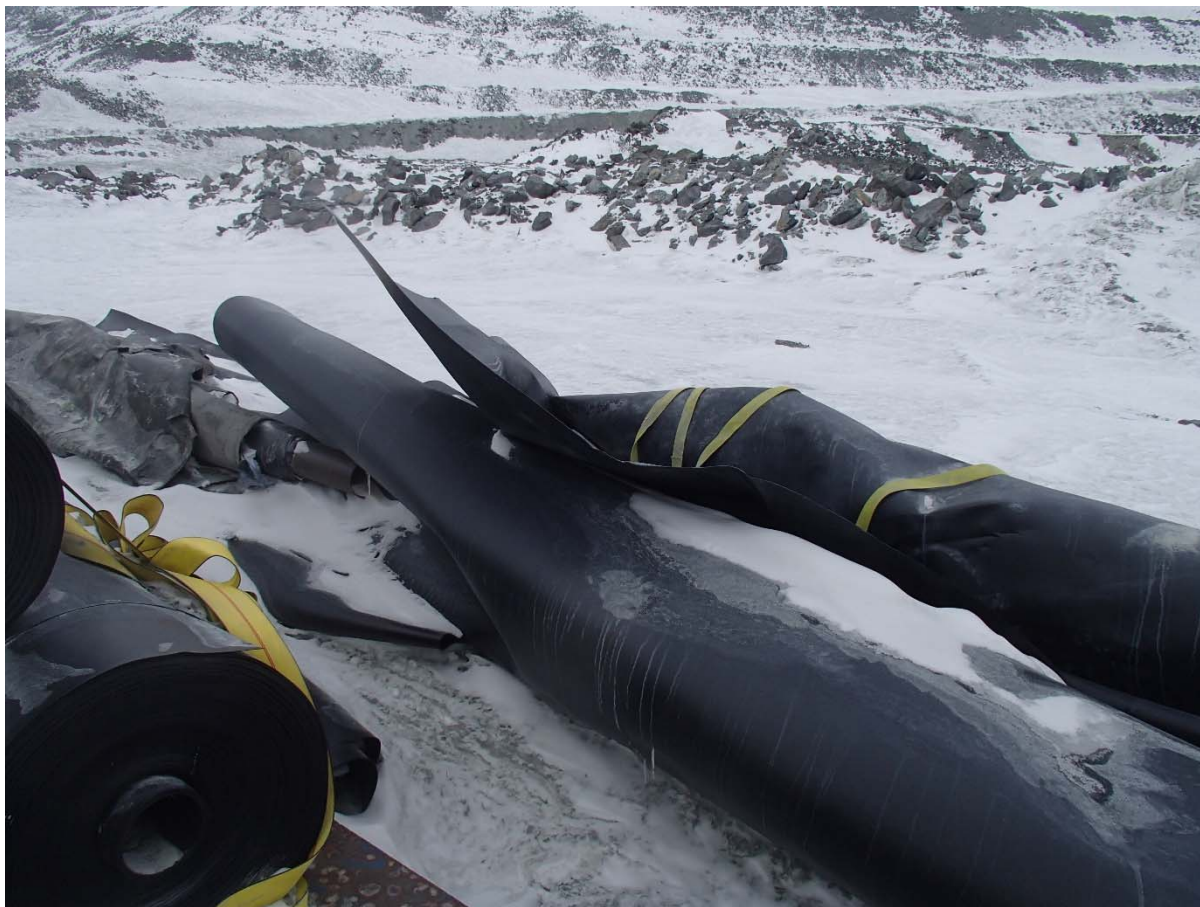
Photograph from the LLDPE storage site: View of old rolls stored on the ground.
