QA DAILY REPORT

QA DAILY REPORT FOR MAY 17TH, 2018 – TSF SOUTH CELL CONSTRUCTION - MEADOWBANK (1897439)

QA DAILY REPORT FOR MAY 18TH, 2018 – TSF SOUTH CELL CONSTRUCTION - MEADOWBANK (1897439)

QA DAILY REPORT FOR MAY 19TH, 2018 – TSF NORTH CELL CONSTRUCTION - MEADOWBANK (1897439)

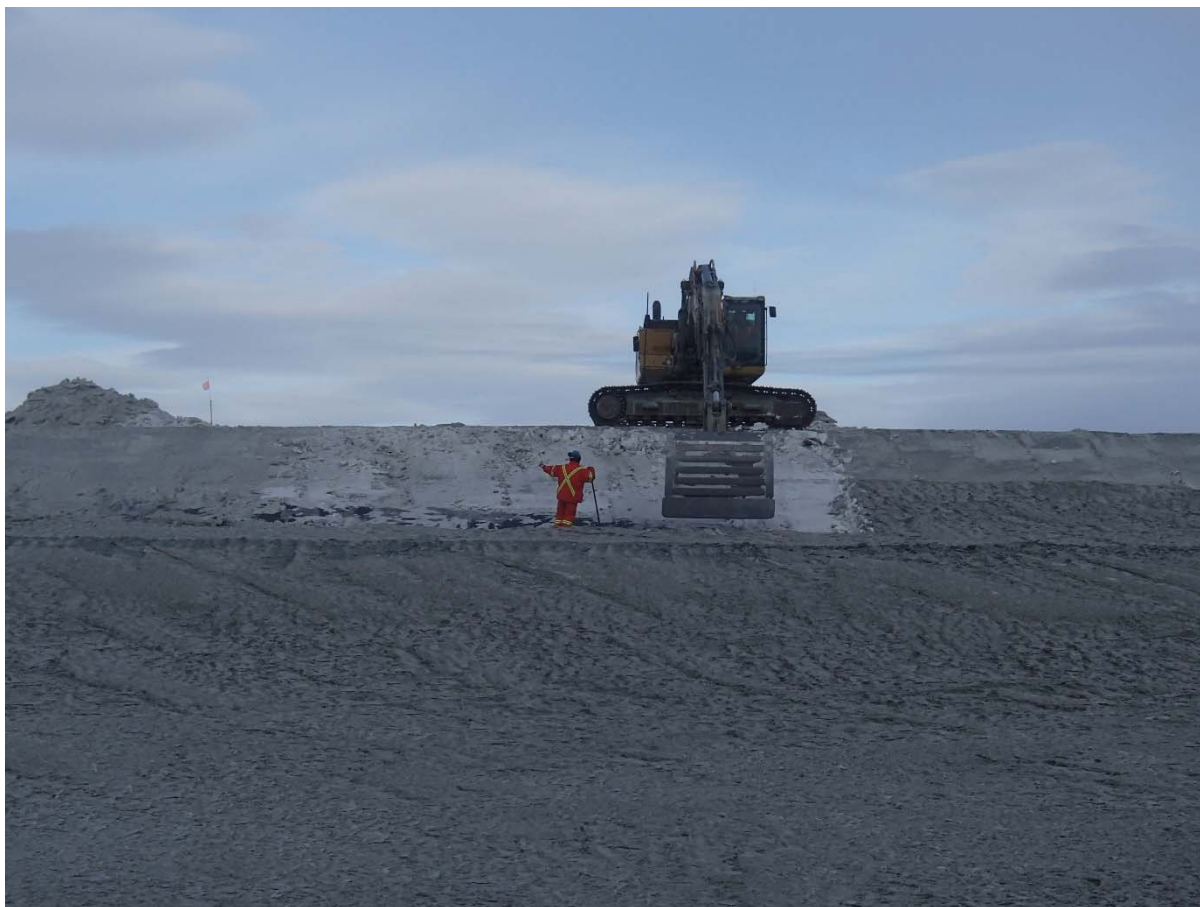
Photograph SD3-298: From Sta. 20+680/-88 m, looking S. Removal of snow on the upstream slope of SD3 above El. 142 m, from Sta. 20+620 m to 20+780 m.

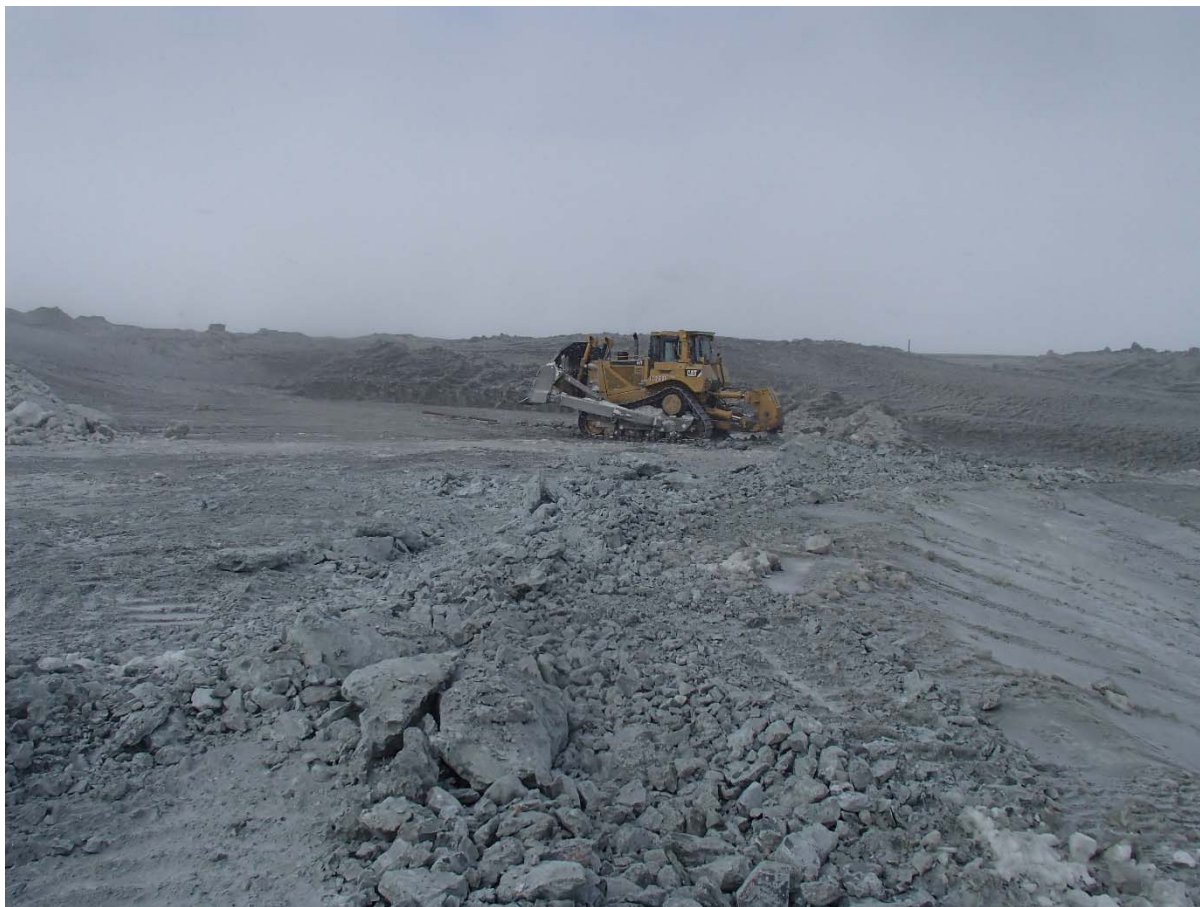
Photograph SD3-299: From Sta. 20+620/-26 m, looking NW. Scarification of the frozen ultramafic volcanic (UM) rockfill on the crest with a dozer for the anchoring trench excavation between Sta. 20+605 m and 20+780 m.

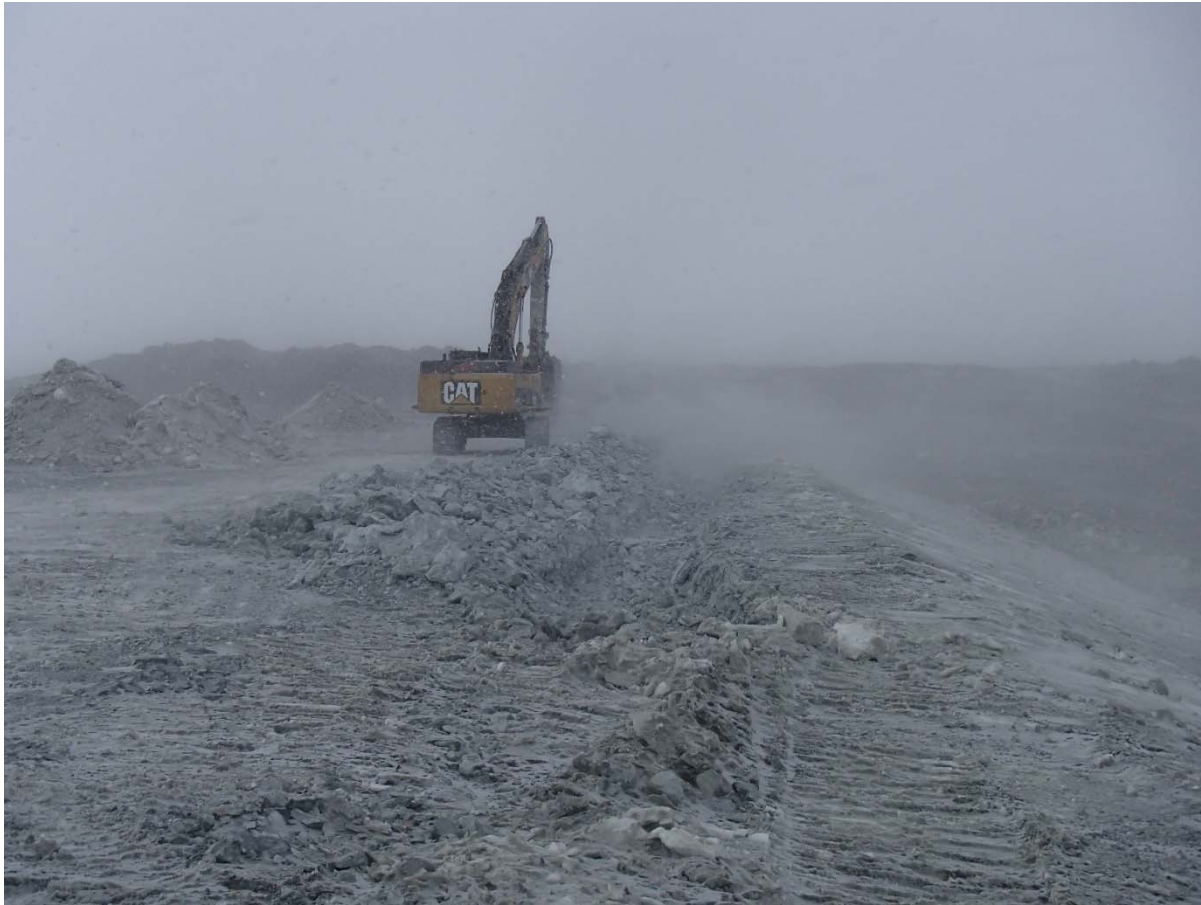
Photograph SD3-300: From Sta. 20+790/-33 m, looking NW. Excavation of the LLDPE geomembrane crest anchoring trench with an excavator from Sta. 20+675 m to 20+780 m.

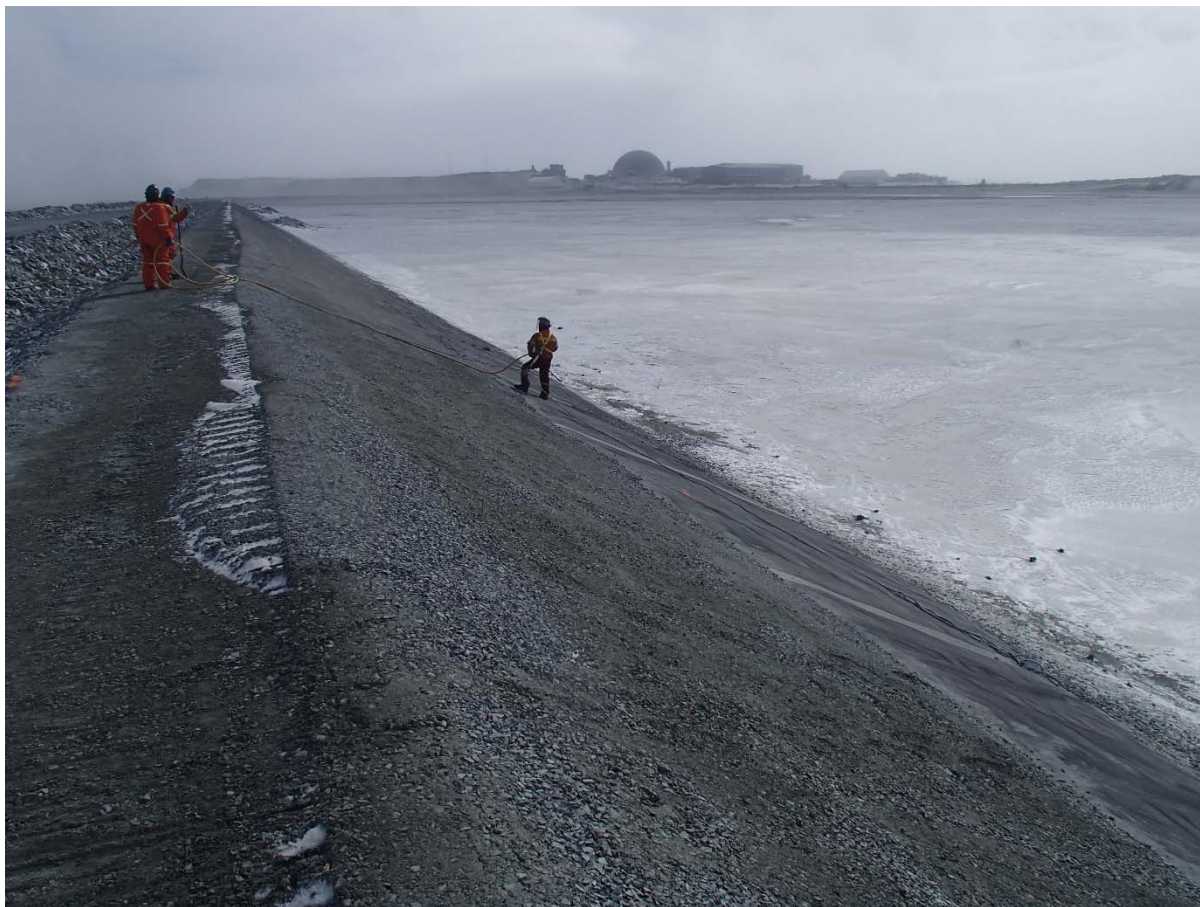
Photograph CD-1855: From Sta. 0+230/-22 m, looking S. Clean-up of the existing LLDPE with pressurized air stream in preparation for liner installation between Sta. 0+170 m and 40+780 m

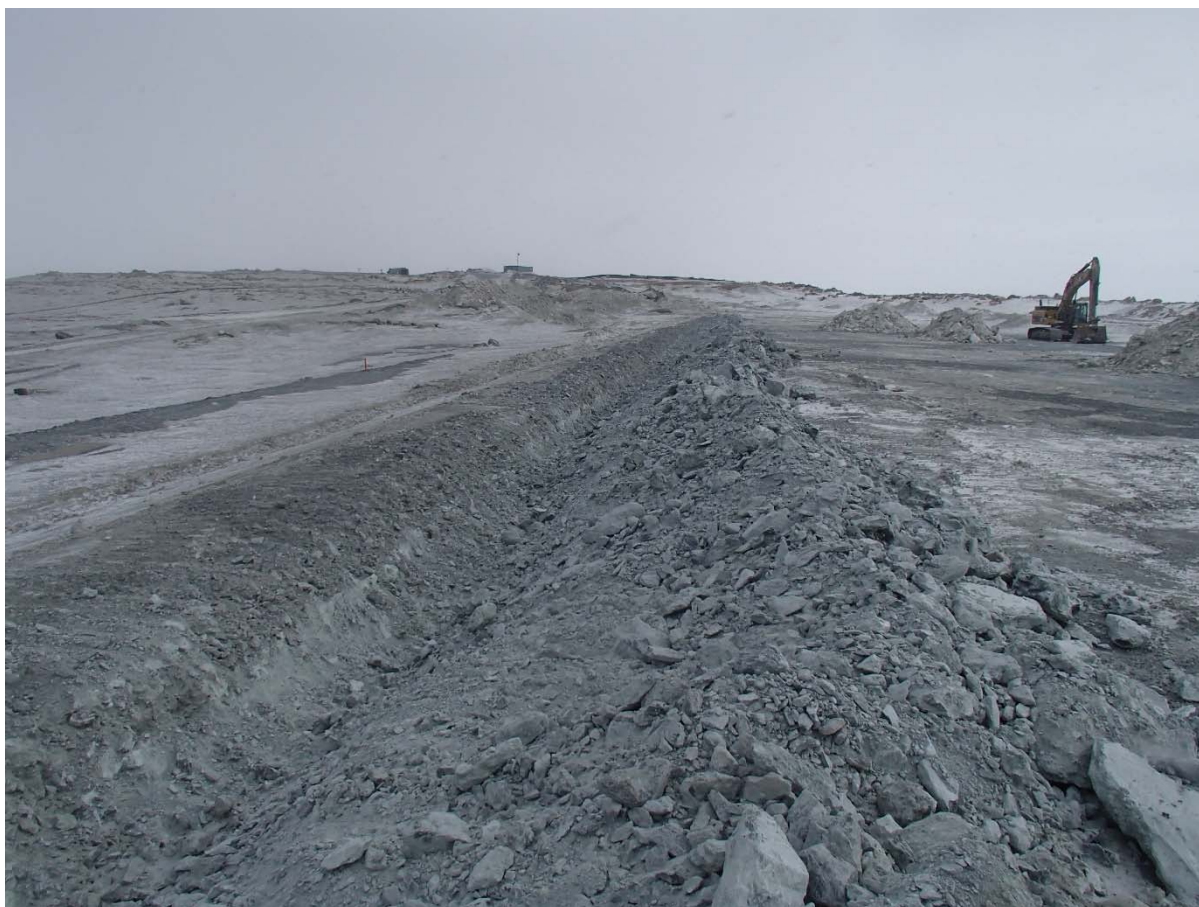
Photograph SD3-301: From Sta. 20+660/-22 m, looking SE. Excavation of the LLDPE geomembrane crest anchoring trench with an excavator from Sta. 20+655 m to 20+675 m.

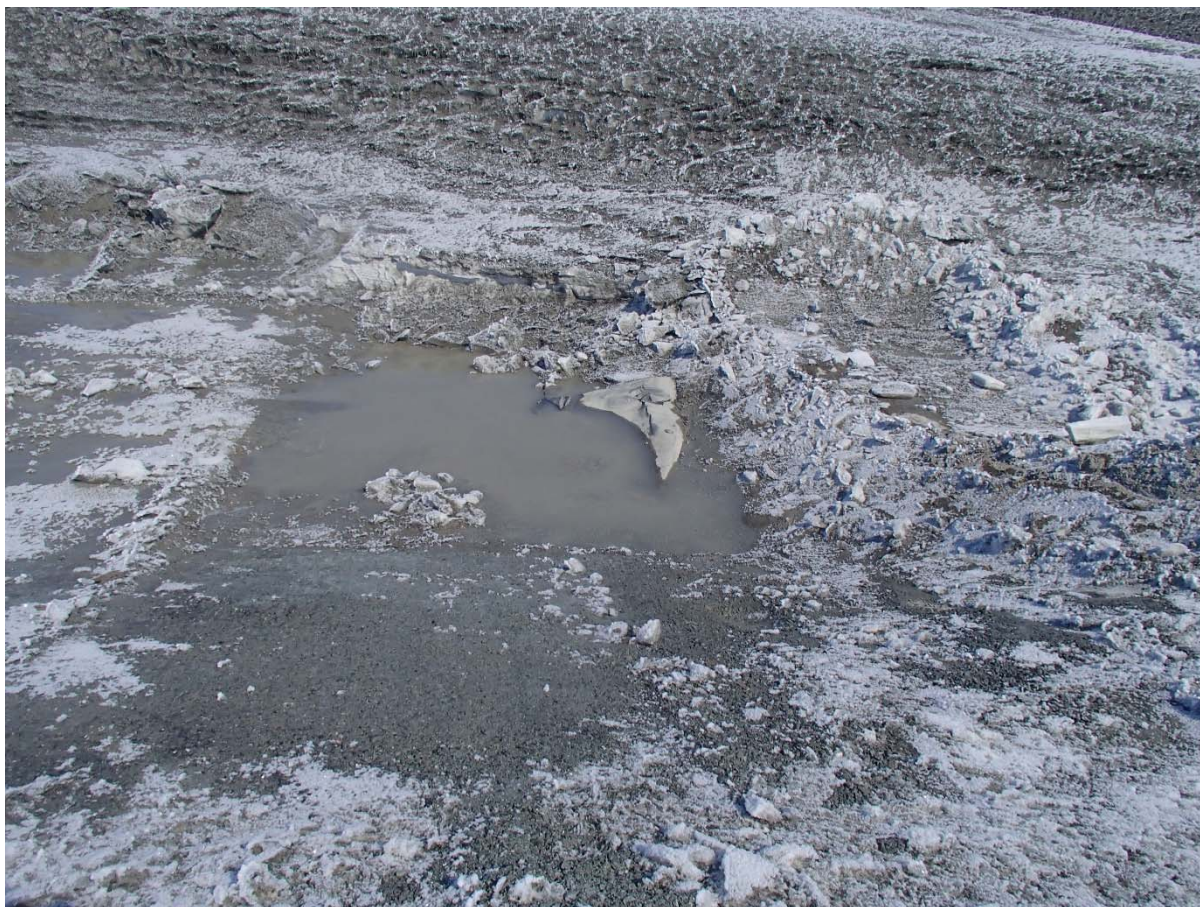
Activity or Area	Comments
Water management	<ul style="list-style-type: none"> ■ Water is ponding on the first compacted sieved till layer of the upstream toe liner tie-in at approx. Sta. 20+595 m.

Photograph SD3-302: From Sta. 20+595/42 m, looking NE. View of water ponding on the first compacted sieved till layer of upstream toe liner tie-in. A portion of exposed damaged LLDPE liner is visible.

- The portion of damaged liner needs to be exposed on at least 0.5 m on each side of the tear to allow for repairs and to ensure no further damage is encountered;

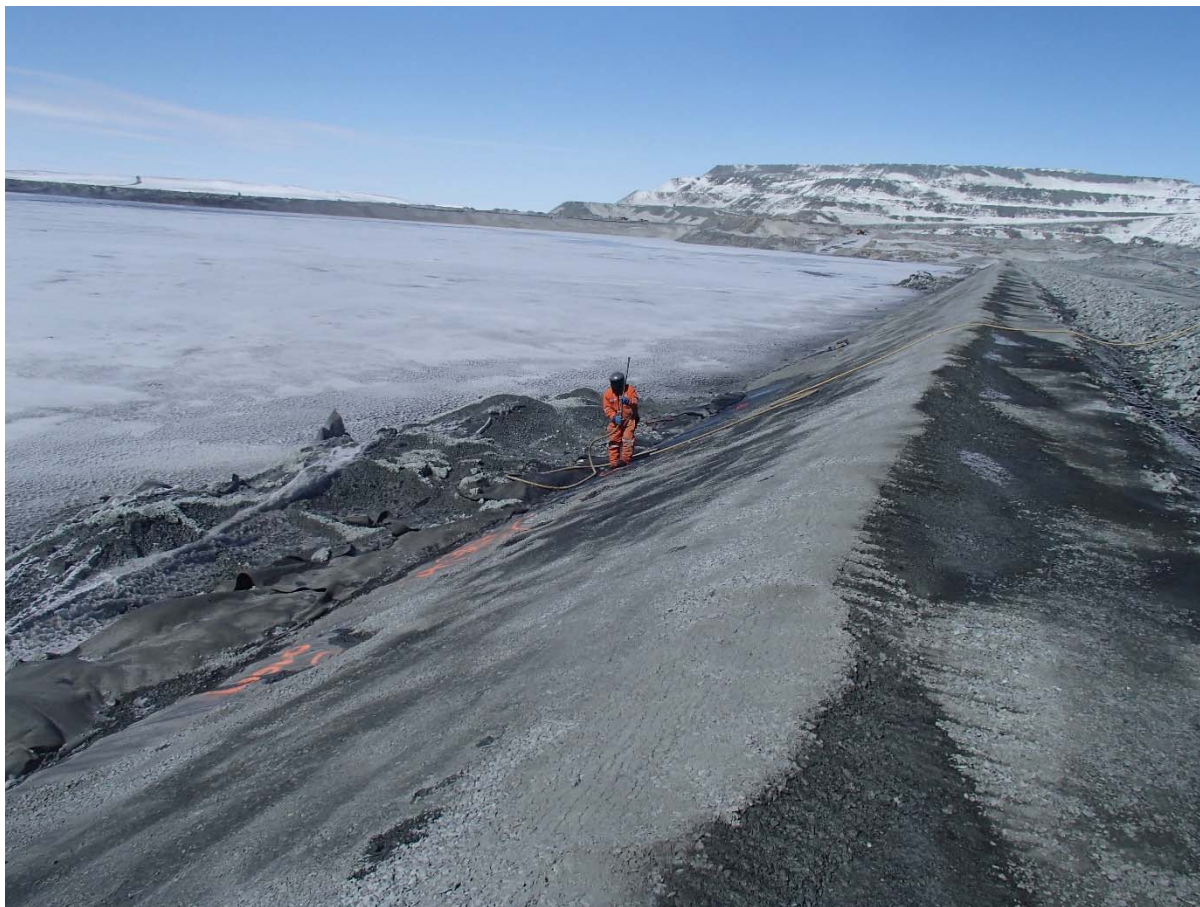
Photograph CD-1586: From Sta. 0+670/-24 m, looking N. Clean-up of the fine filter placed against the slope at the deposition finger at approx. Sta. 0+670 m with pressurized air stream to expose 1 m of LLDPE liner, in preparation for the new liner installation.

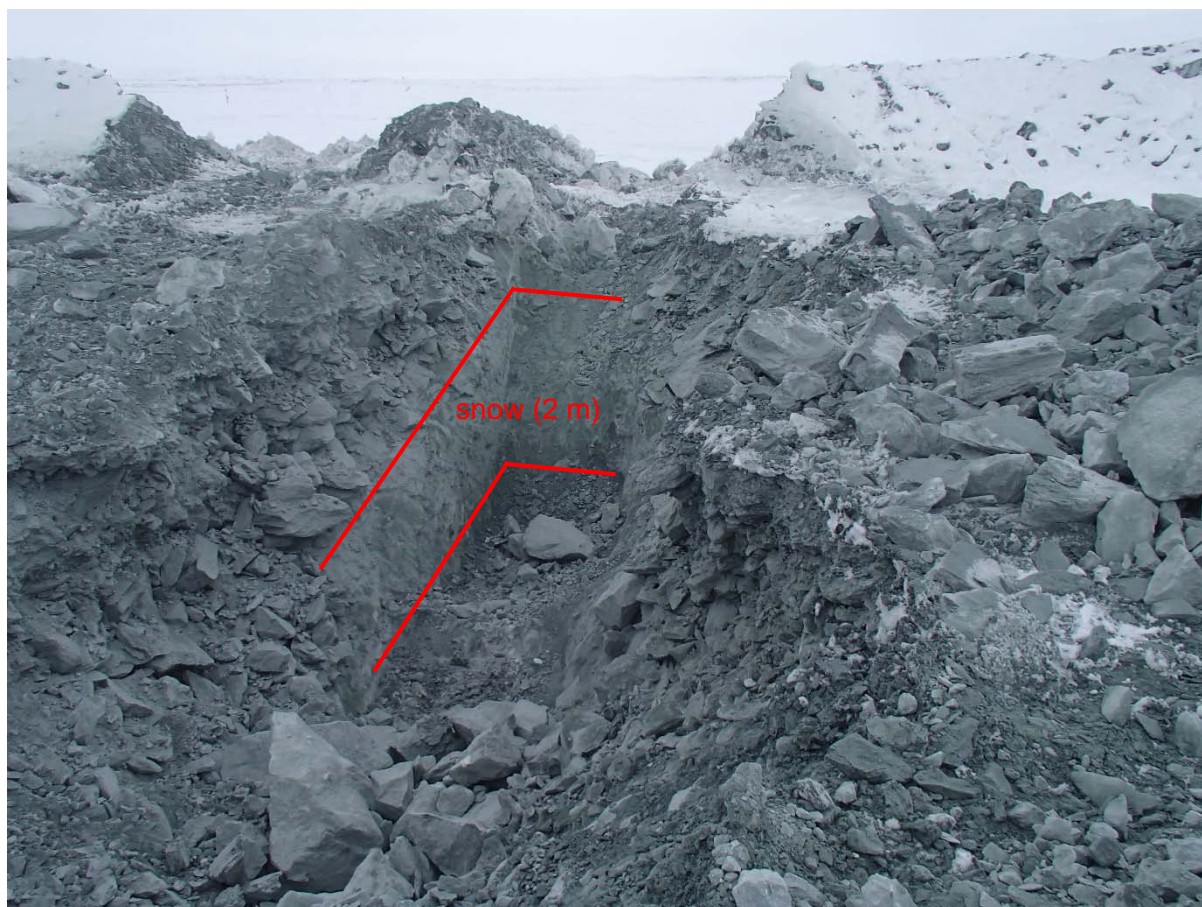
- Test pits were excavated to identify the extent of the snow layer. Since snow was not observed in the northern part of the UM rockfill lift, which appears to be built directly on the North Cell capping, it was decided to move the operations there and progress towards the north. The excavator removes the snow-rich toe of the UM rockfill lift until snow is no longer observed (a 2-3 m wide zone in average), and a dozer pushes the excavated material (UM rockfill mixed with snow) toward the center of the North Cell to clear the upstream toe.

Photograph NCIS-001: View of a test pit in the UM rockfill lift at El. 152 m: a thick layer (2 m) of snow underlies the rockfill.

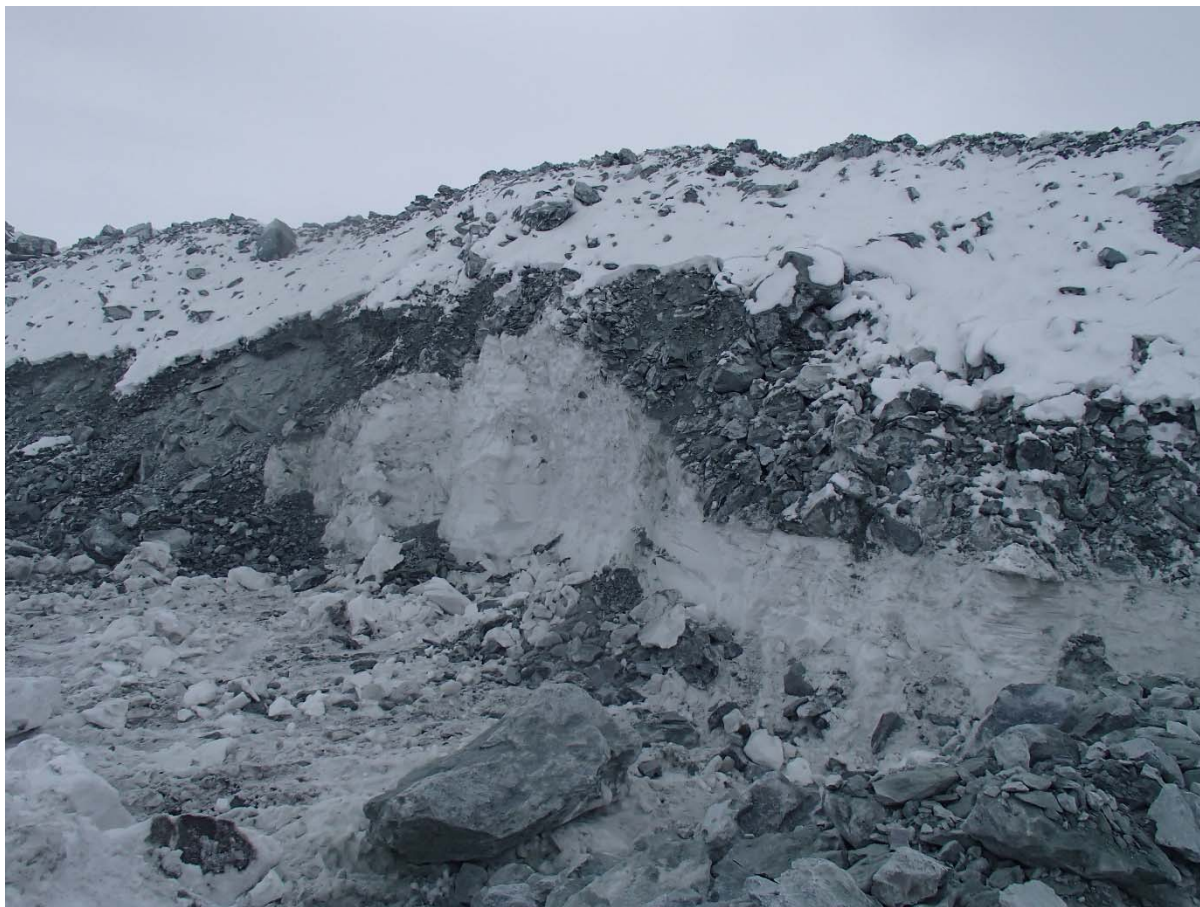
Photograph NCIS-002: View of the scraped upstream side of the UM rockfill lift at El. 152 m: a thick layer of snow (1.5 m) underlies the rockfill.

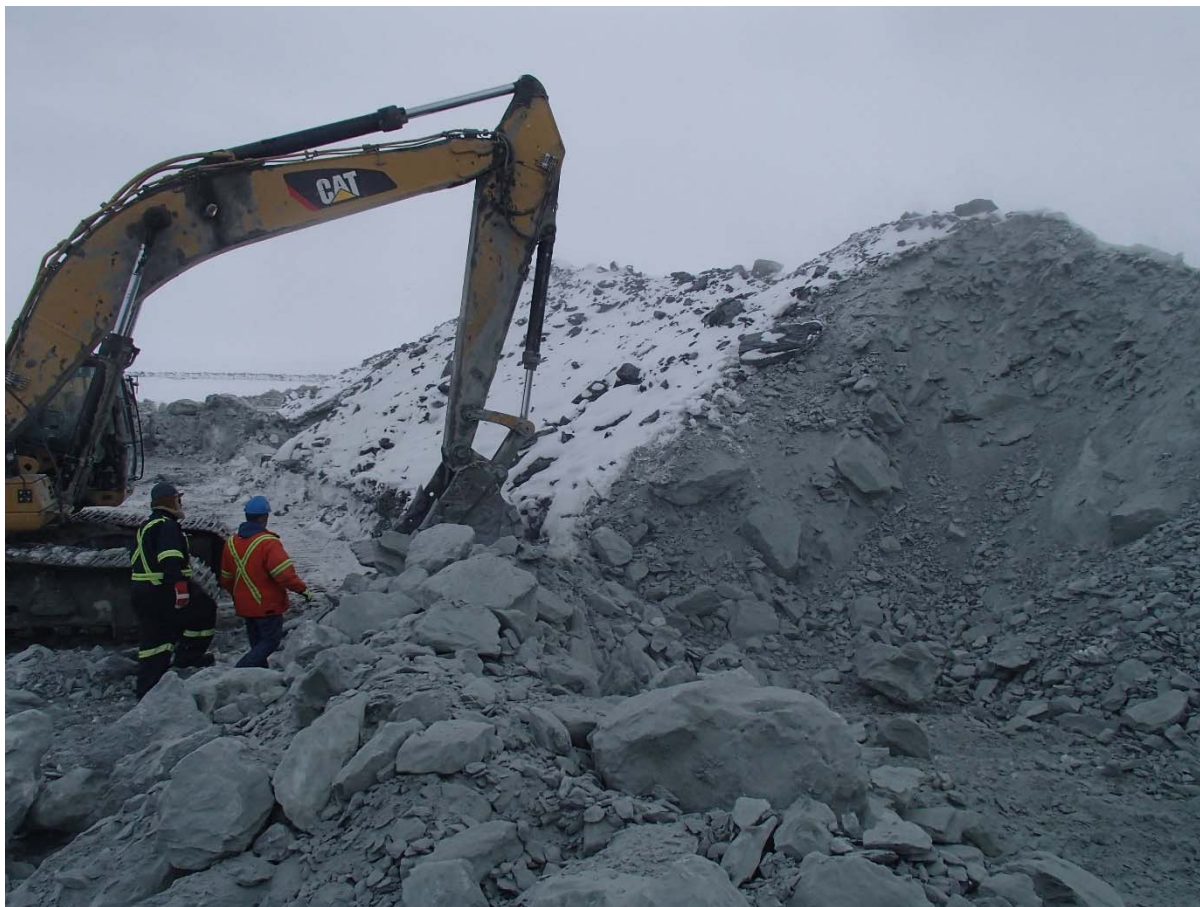
Photograph NCIS-003: Excavation of the snow-rich upstream toe material on an average width of 2 to 3 m with an excavator.

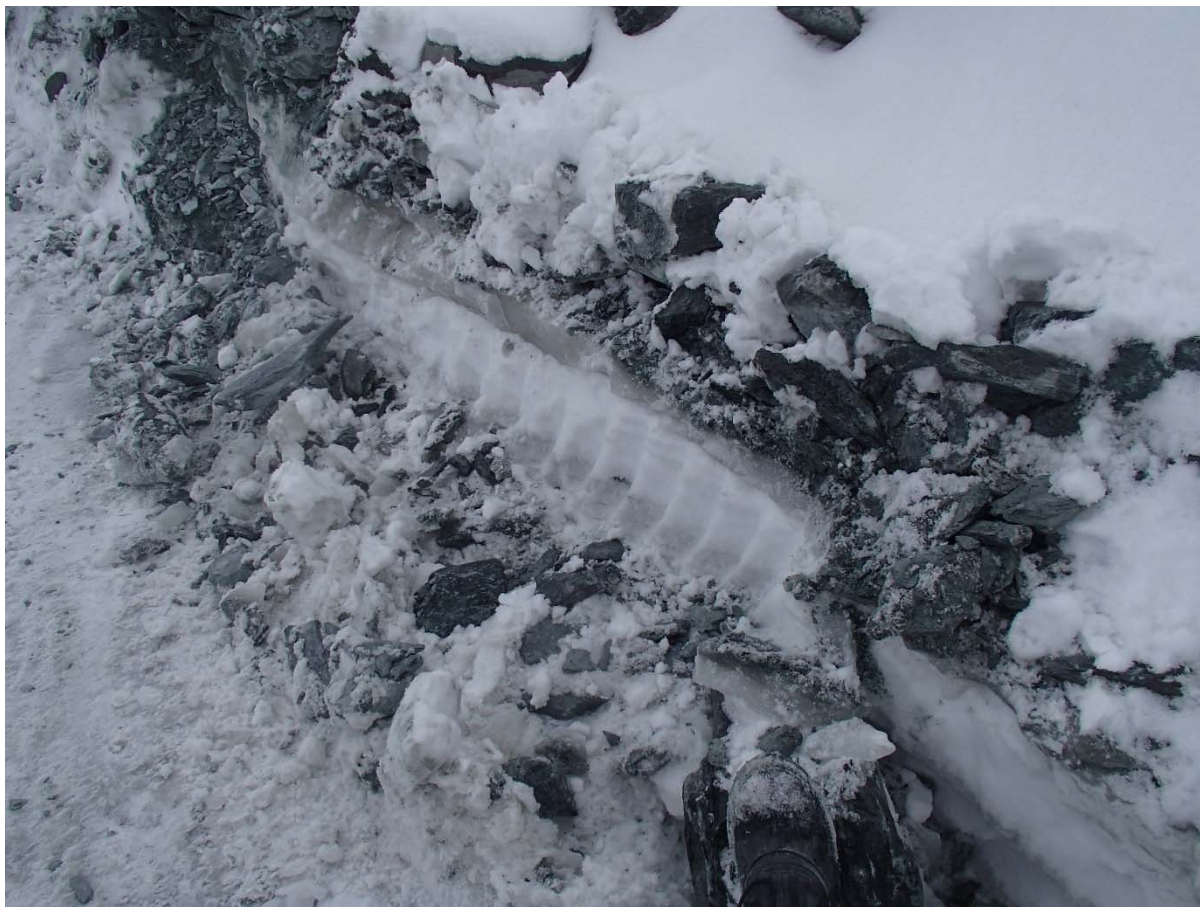
Photograph NCIS-004: View of the scraped upstream side of the UM rockfill lift at El. 152 m further to the north: the snow layer is only observed at the toe and is approximately 0.5 m thick.

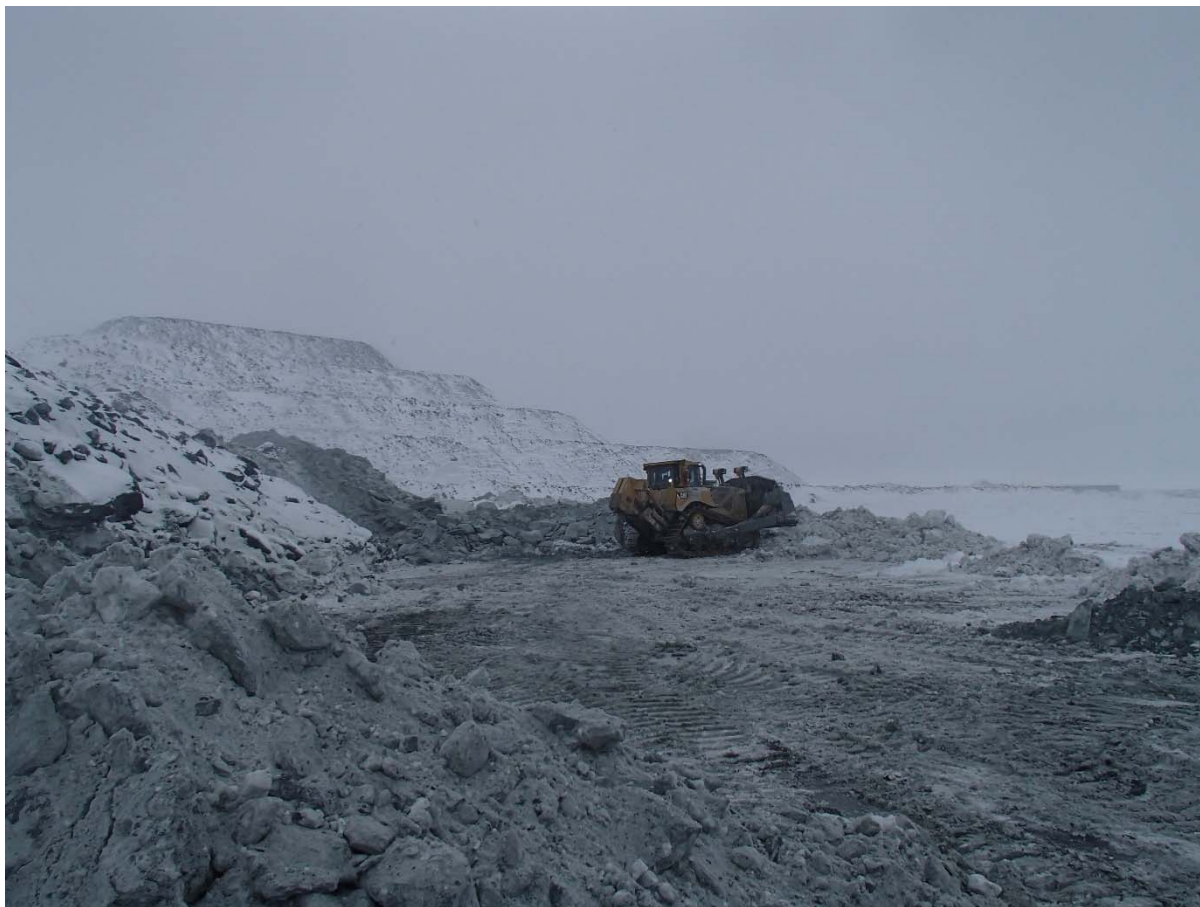
Photograph NCIS-005: Removal of the excavated material, pushed with a dozer towards the center of the North Cell to clear the upstream toe.

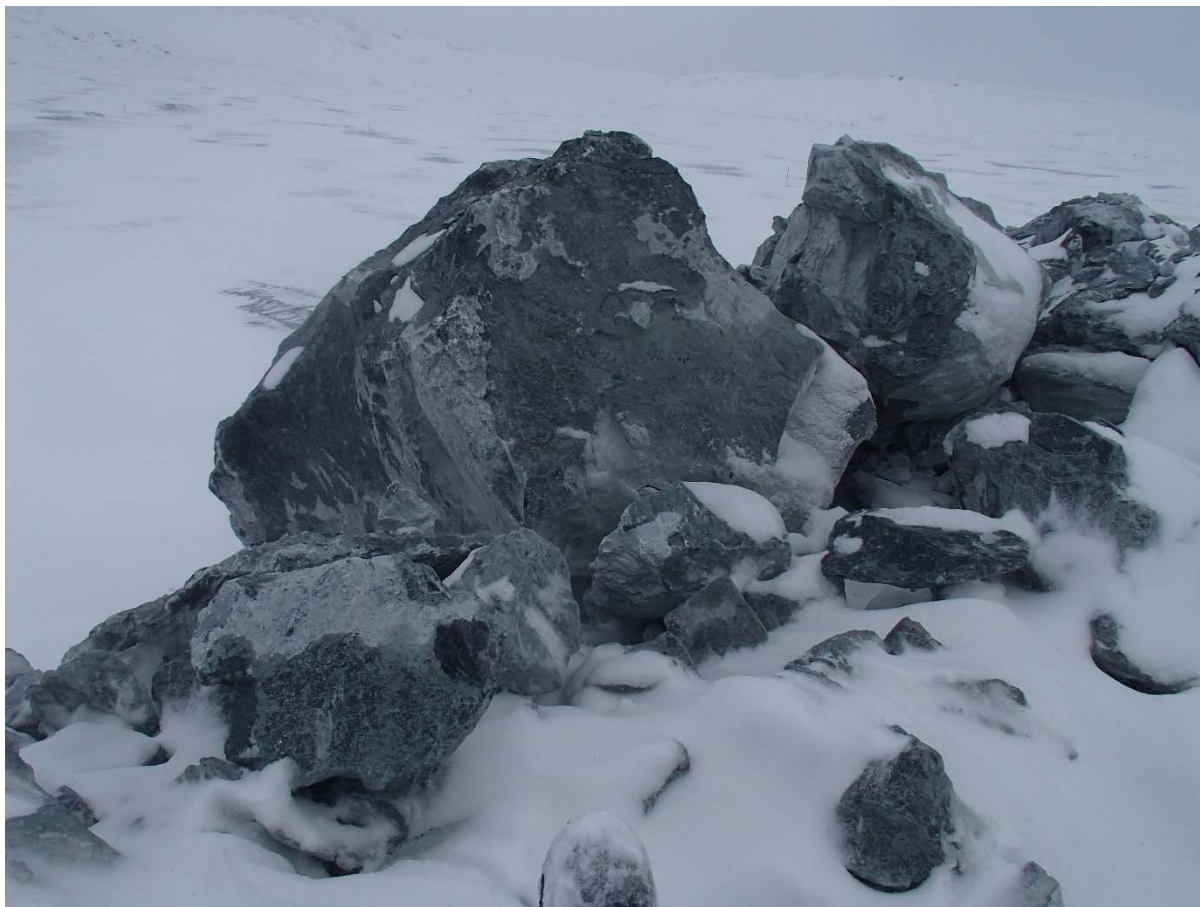
- The QA Manager noticed several oversize boulders on the UM rockfill lift at El. 152 m and reiterated that the maximum allowable size on the dikes is 1.3 m. AEM forwarded the information to the operators in the pit and on the dikes. If an oversize boulder is delivered on the dikes, it will be pushed aside in the downstream slope by the dozer during placement.

Photograph NCIS-006: View of oversize boulders on the UM rockfill lift at El. 152 m.

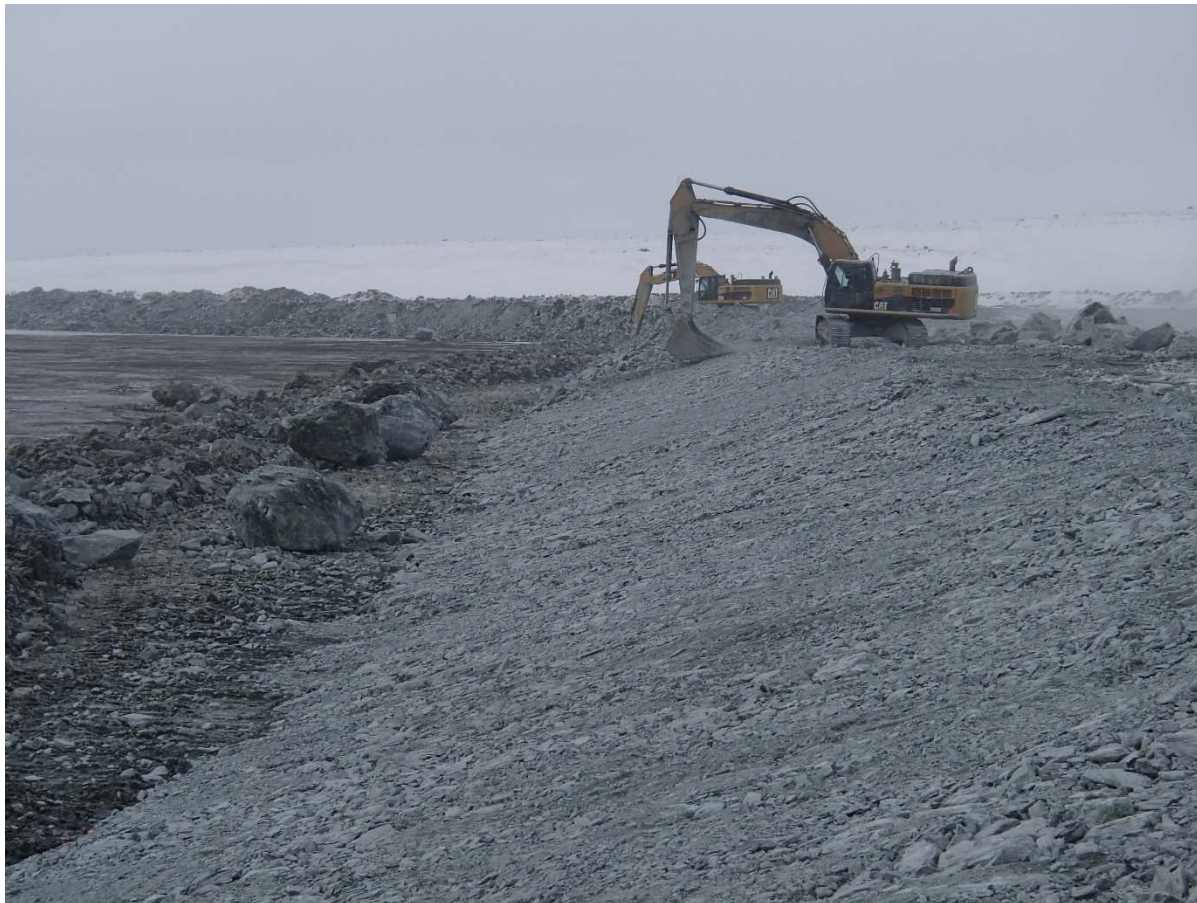
Photograph NCIS-007: Profiling of the upstream slope (3H:1V) from El. 150 to 152 m with an excavator.

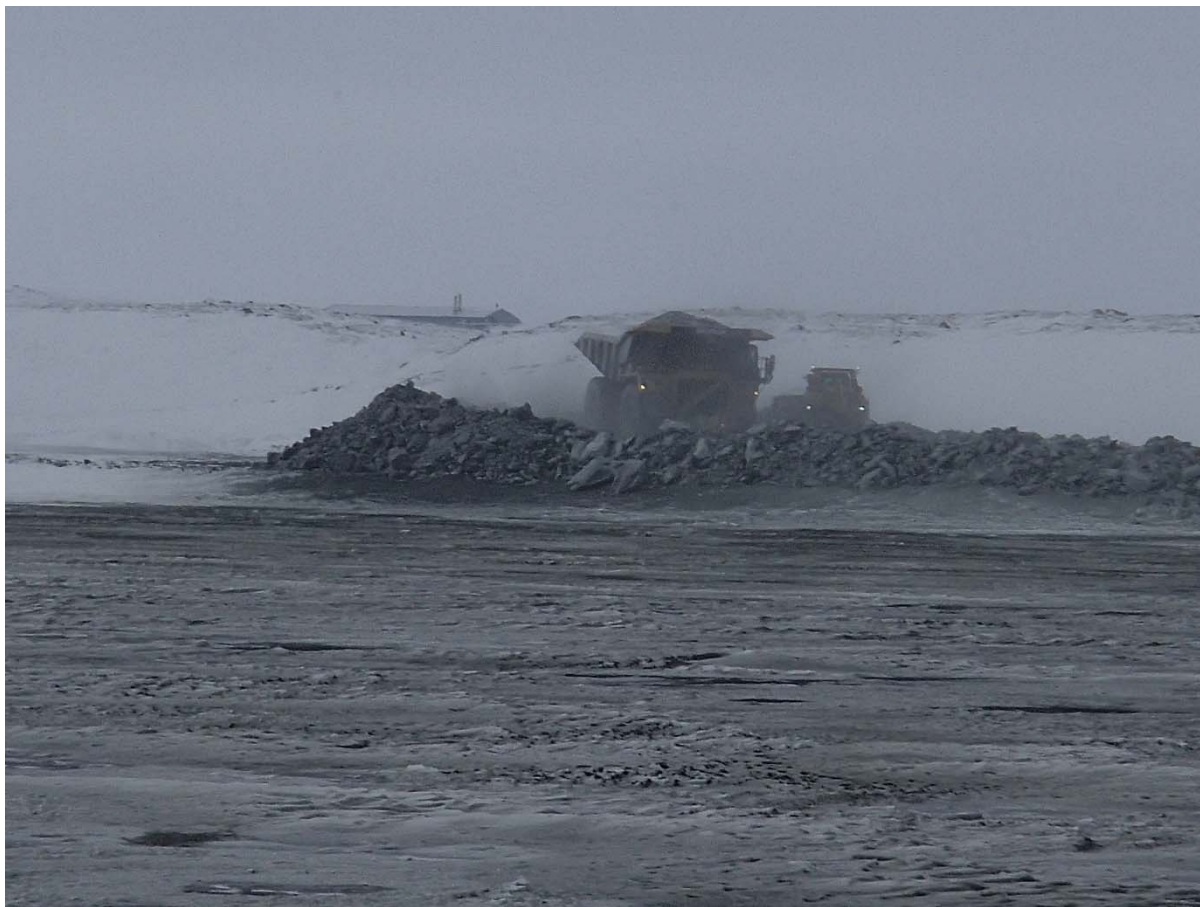
Photograph NCIS-008: Placement a 2 m thick (approx.) lift of UM rockfill from El. 150 m to El. 152 m (approx.) with a dozer. The material is of good quality and is well graded.

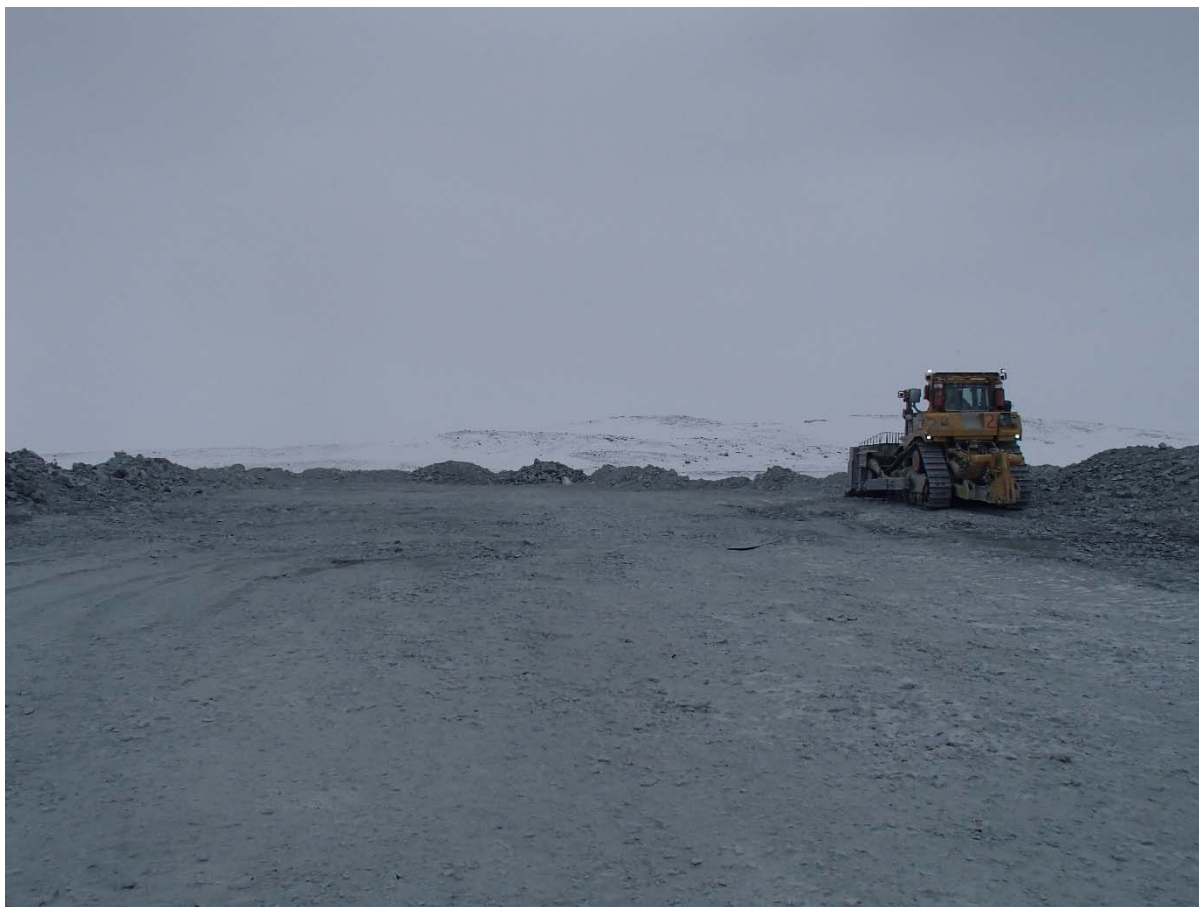
Photograph NCIS-009: Placement a 2 m thick (approx.) lift of UM rockfill from El. 150 m to El. 152 m (approx.) with a dozer from Sta. 1+880 m to 1+825 m (o.s. unavailable).

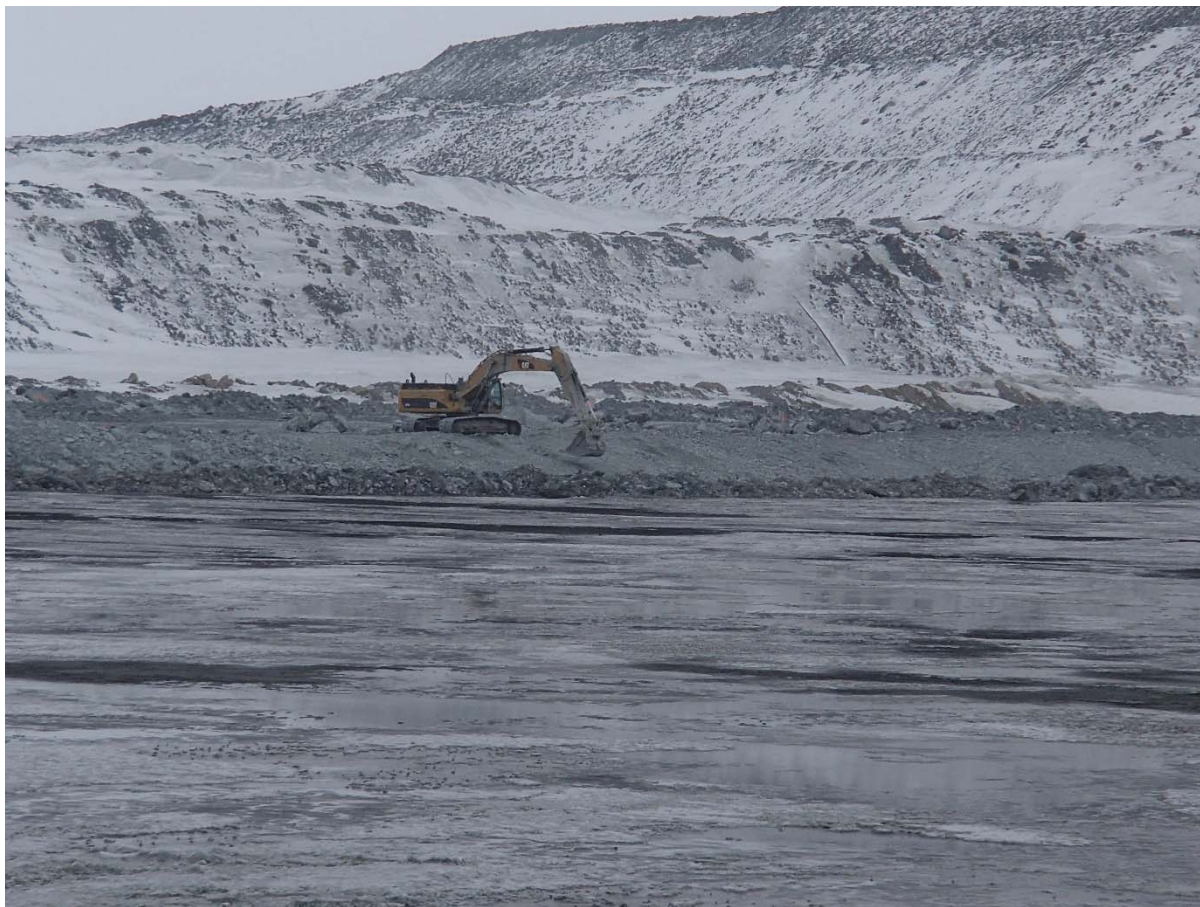
Photograph NCIS-010: Profiling of the upstream slope (3H:1V) from El. 150 to 152 m with an excavator from Sta. 2+777 m to 2+400 m (approx.).

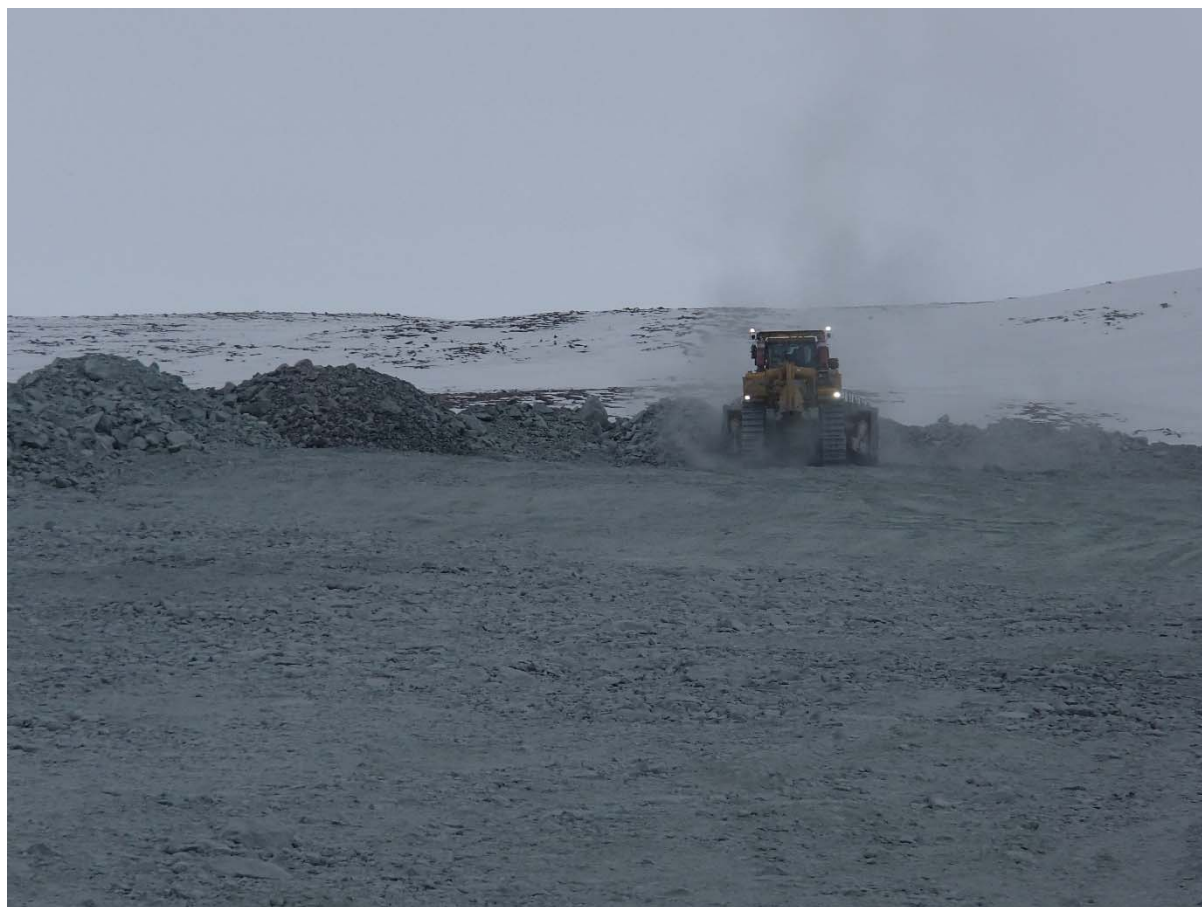
Photograph NCIS-011: From Sta. 2+000 m (approx.), looking SW. Placement a 2 m thick (approx.) lift of UM rockfill from El. 150 m to El. 152 m (approx.) with a dozer from Sta. 1+880 m to 1+767 m (o.s. unavailable).

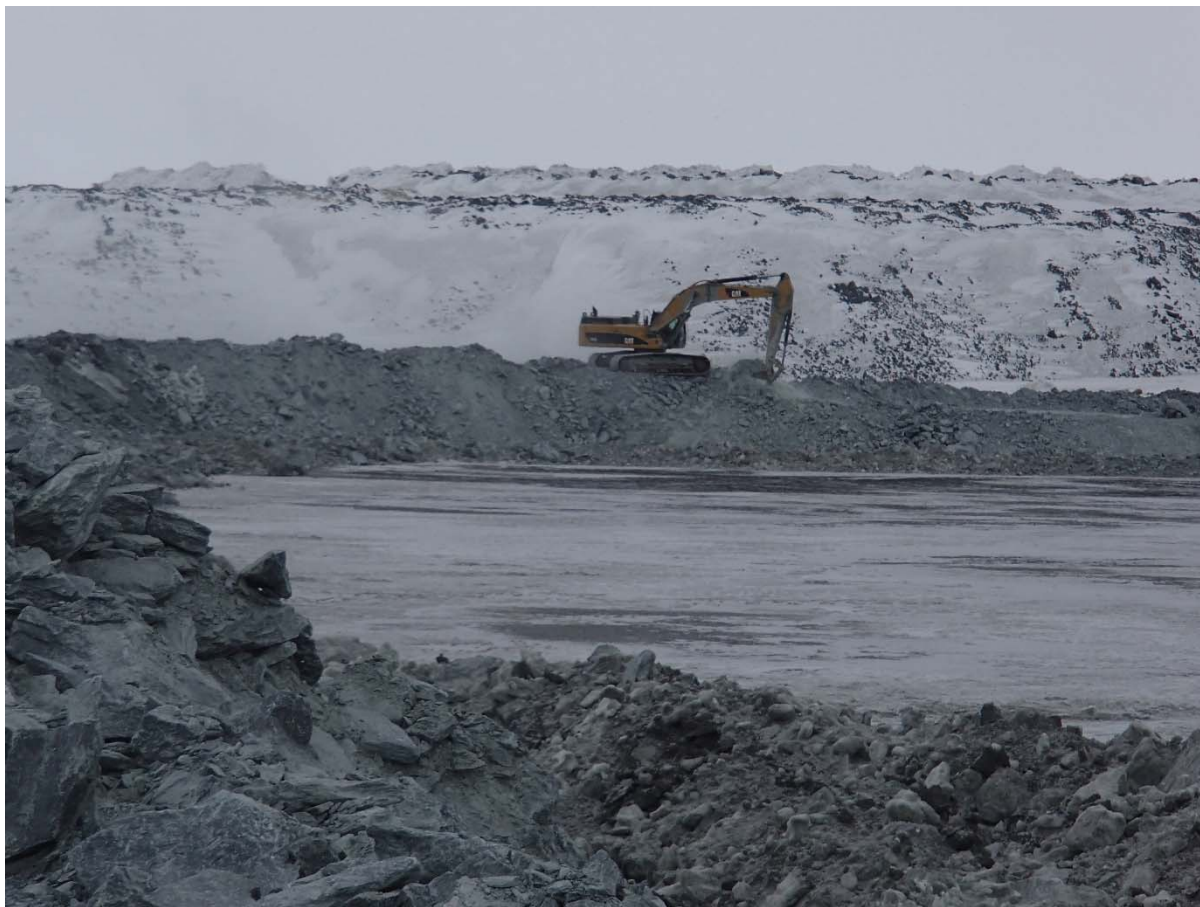
Photograph NCIS-012: From Sta. 2+000 m (approx.), looking NW. Profiling of the upstream slope (3H:1V) from El. 150 to 152 m with an excavator from Sta. 2+325 m to 2+275 m (approx.).

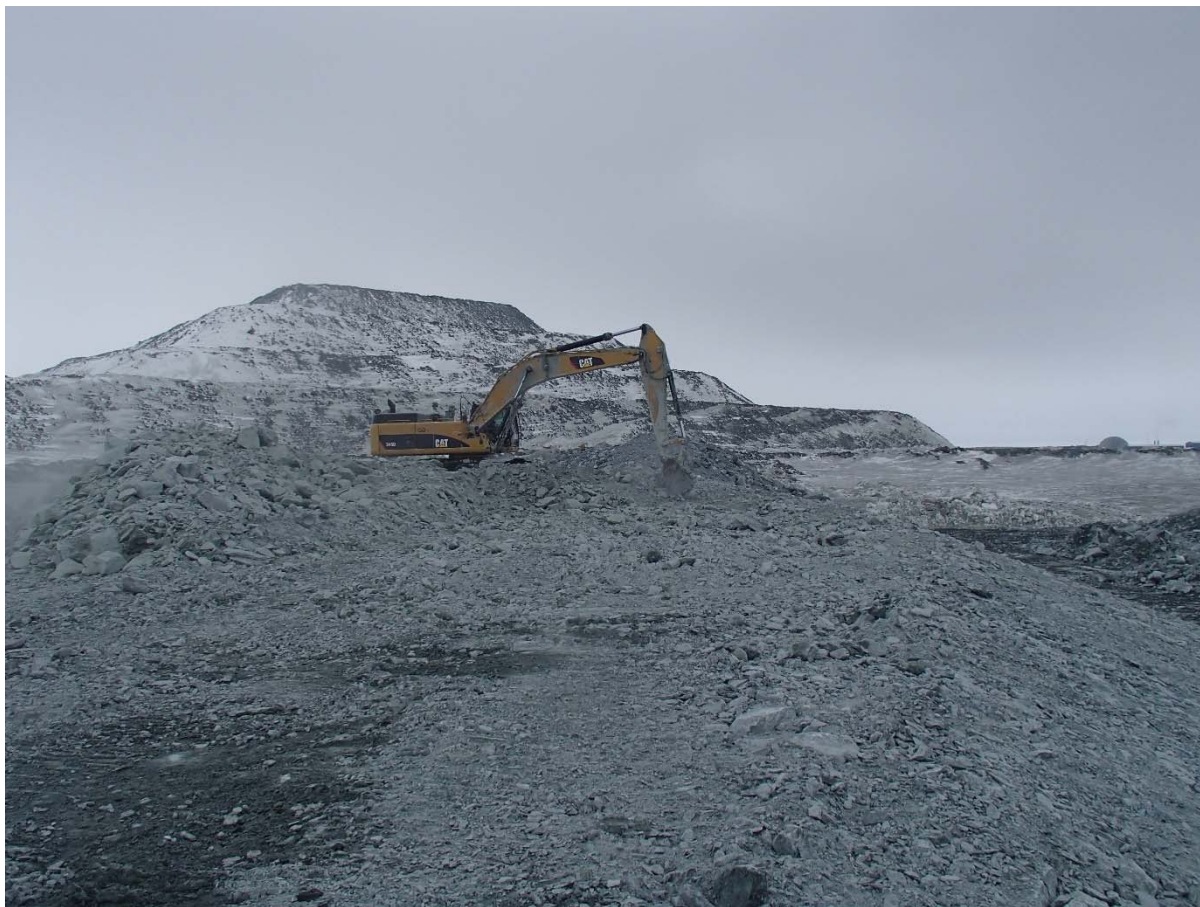
Photograph NCIS-013: From Sta. 2+600 m (approx.), looking NE. Correction of the crest elevation with an excavator to achieve a closer elevation to 152 m around Sta. 2+650 m.
