QA DAILY REPORT

QA DAILY REPORT FOR MAY 17TH, 2018 – TSF SOUTH CELL CONSTRUCTION - MEADOWBANK (1897439)

QA DAILY REPORT FOR MAY 18TH, 2018 – TSF SOUTH CELL CONSTRUCTION - MEADOWBANK (1897439)

QA DAILY REPORT FOR MAY 19TH, 2018 – TSF NORTH CELL CONSTRUCTION - MEADOWBANK (1897439)

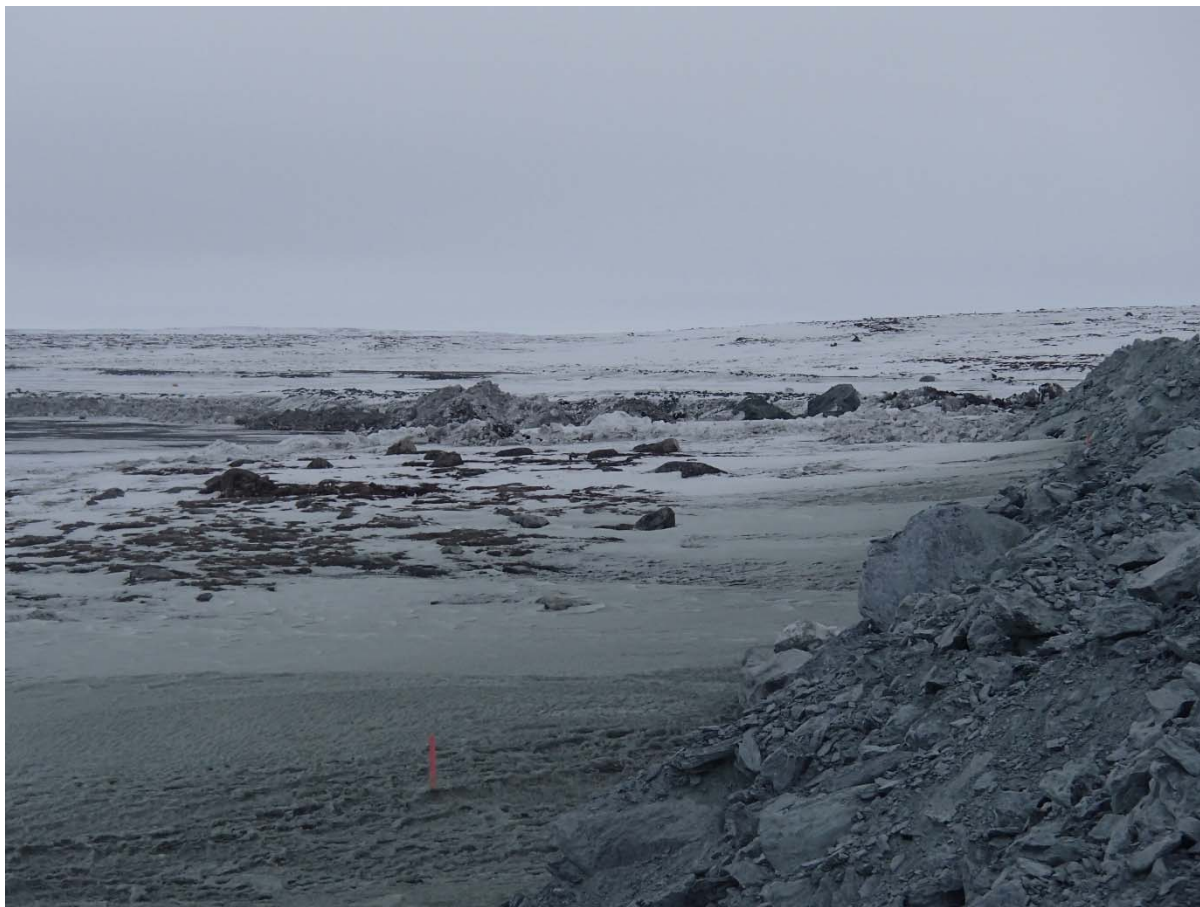
- The UM rockfill lift at El. 152 m has reached a location where the 2015 rockfill capping is built on the natural soil (thin layer of organic soil overlying till), between Sta. 1+800 m and 1+900 m approximately. The toe of the UM rockfill lift placed today seems to reach beyond the toe of the capping, meaning the dike is partially founded on unprepared natural soil. The filter zone is also expected to extend on the natural soil. A test pit has been excavated to estimate the thickness of the soil layer, however the frozen conditions prevented the excavator from reaching deeper than about 200 mm (see photograph below). The QA Manager asked that the surveyor estimate the width of the lift that lies beyond the capping. Further discussions will follow regarding actions to take.

Photograph NCIS-014: From Sta. 1+900 m (approx.), looking SE. View of the natural soil on which the 2015 capping is built.

- A decision has to be made as soon as possible by AEM with the support of the QA Manager regarding the rockfill lift founded on unprepared natural soil (Sta. 1+800 m to 1+900 m, approx.), as the structure may soon be raised to El. 154 m in this section.
- Updated material quantities will be issued with the new alignment of the North Cell Internal Structure.
- SANA's surveyor will mark the limits of the downstream slope of the lift at El. 154 m to evaluate whether they are within the lift at El. 152 m or whether safety berms need to be removed for compaction.
- The top of the upstream slope of the lift at El. 152 m will also be marked on the section where the snow foundation was encountered to evaluate the best corrective measure to take.

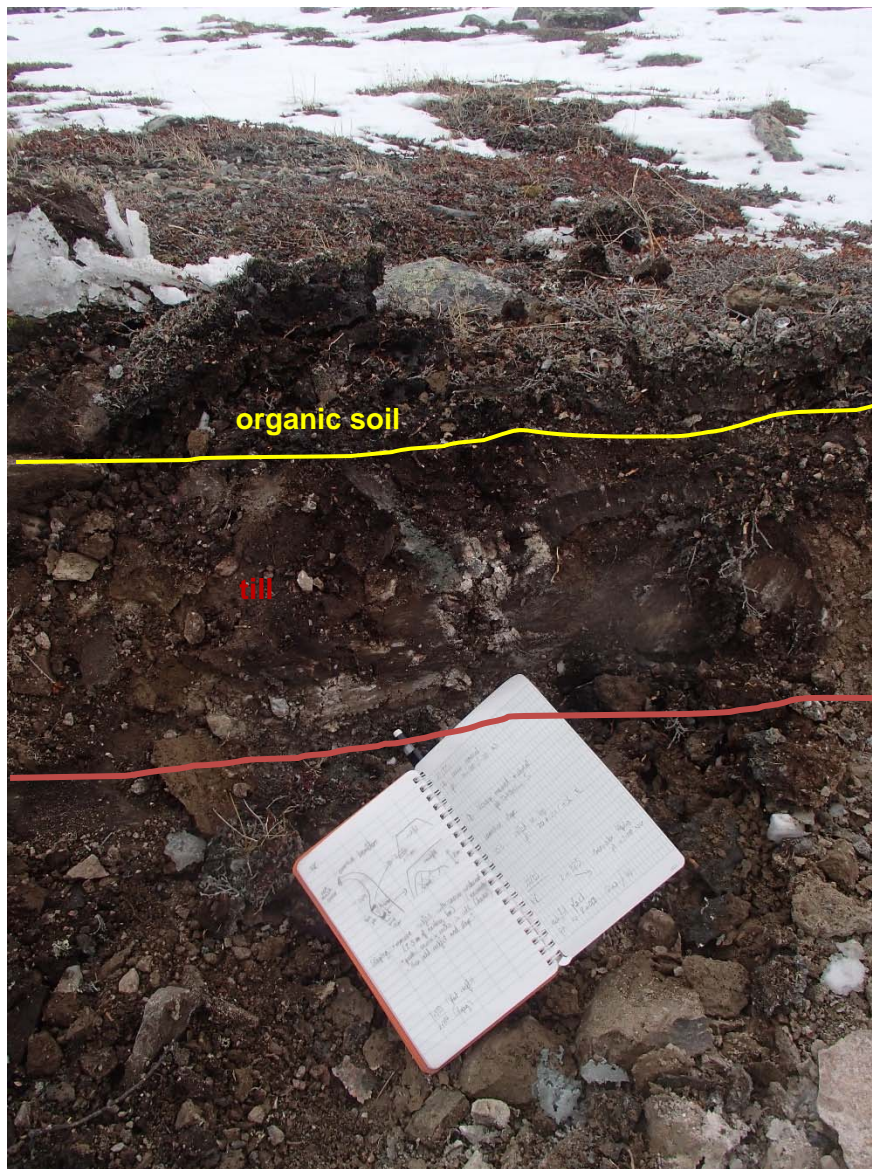
Photograph NCIS-015: From Sta. 1+850 m (approx.), looking S. View of the 200 mm deep test pit excavated into the natural soil. A thin layer or organic soil overlies frozen till.

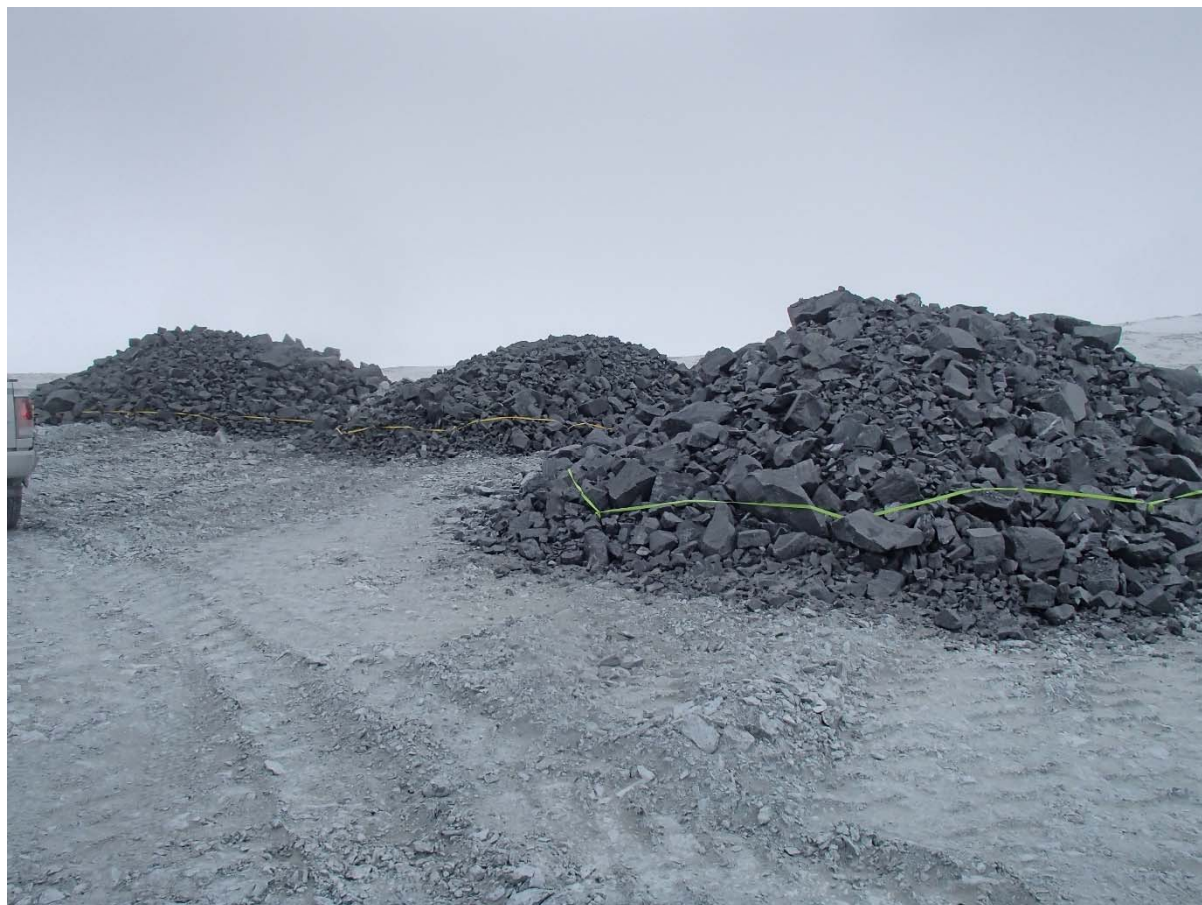
Photograph NCIS-016: From Sta. 1+750 m (approx.), looking SE. View of the Iron Formation rockfill (PAG material) piles on the North Cell Internal Structure.

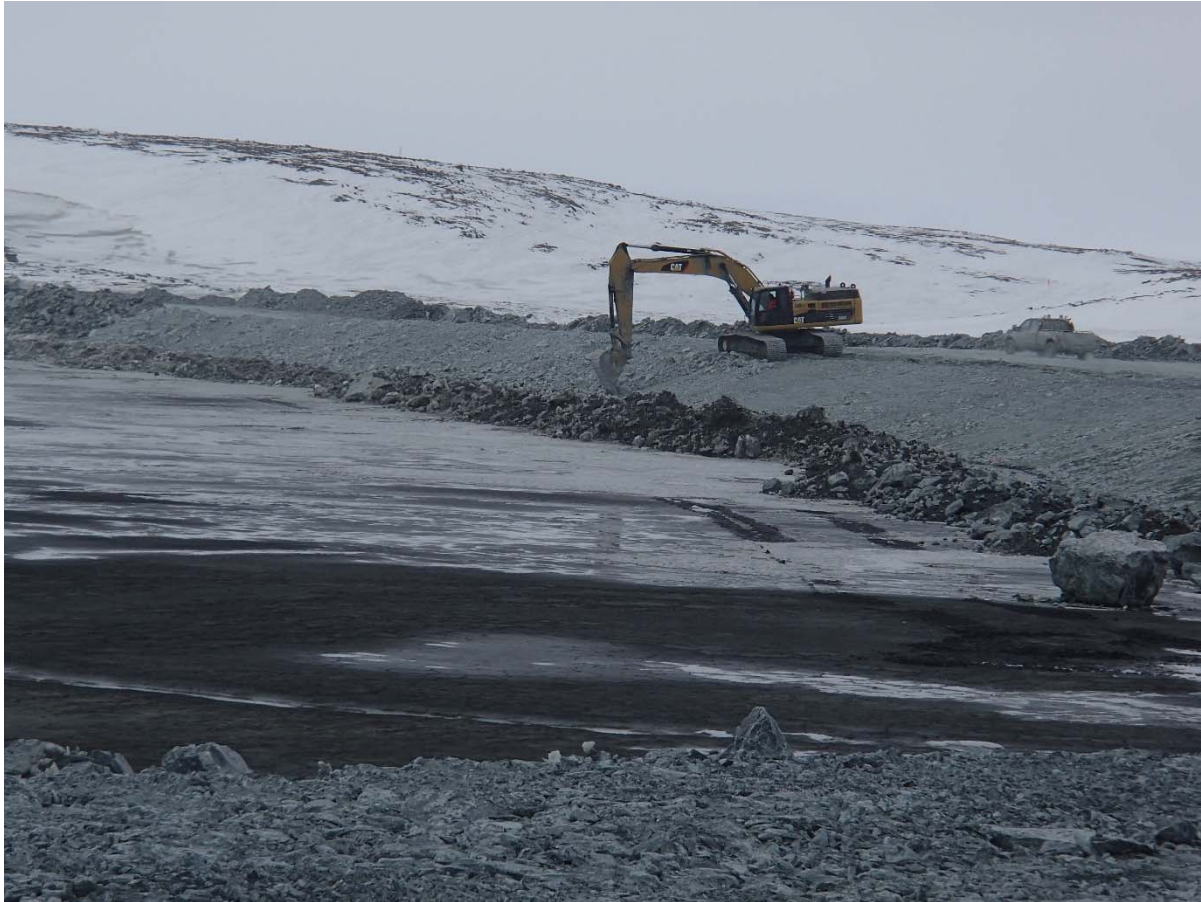
Photograph NCIS-017: From Sta. 2+290 m (approx.), looking SW. Profiling of the upstream slope (3H:1V) from El. 150 to 152 m with an excavator from Sta. 2+138 m to 1+989 m.

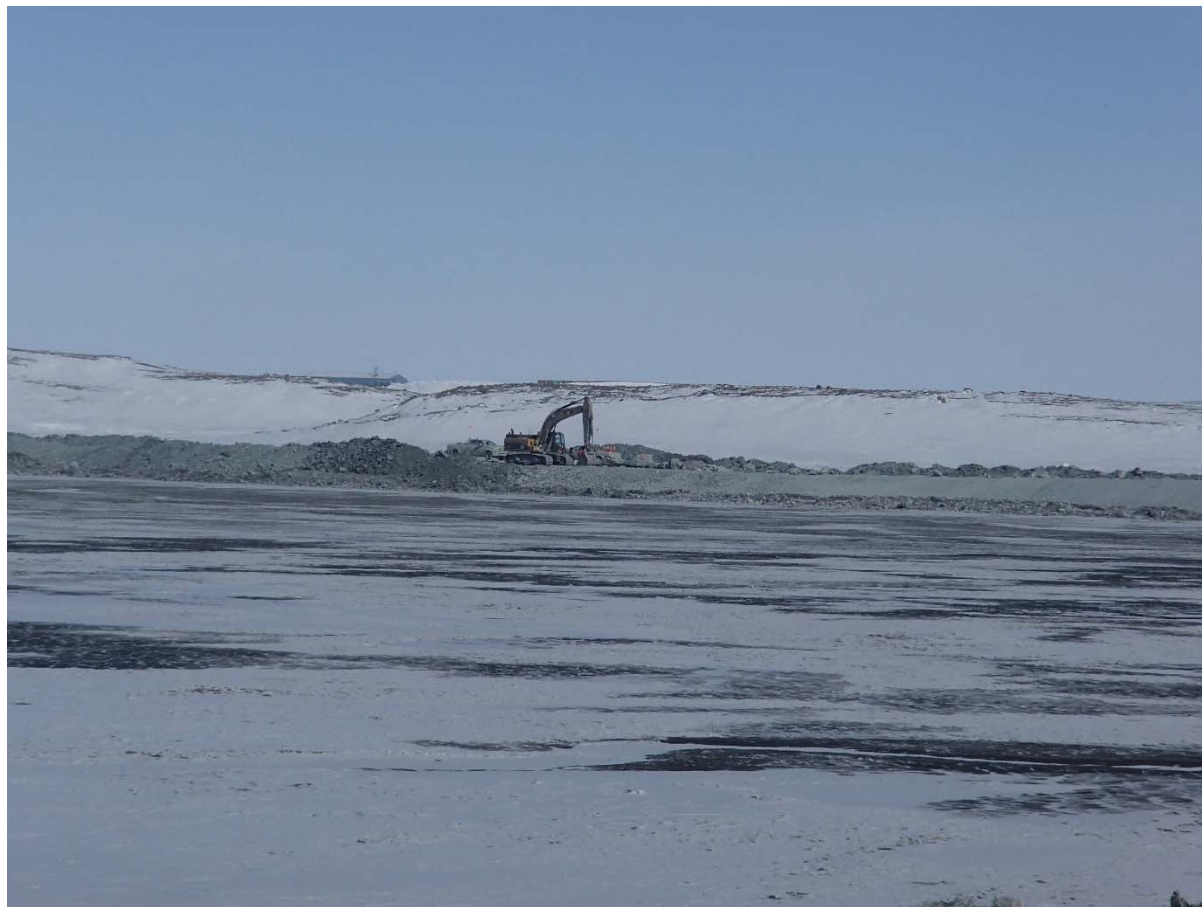
Photograph NCIS-018: From Sta. 2+310 m (approx.), looking NW. Profiling of the upstream slope (3H:1V) from El. 150 to 152 m with an excavator from Sta. 1+989 m to 1+860 m.

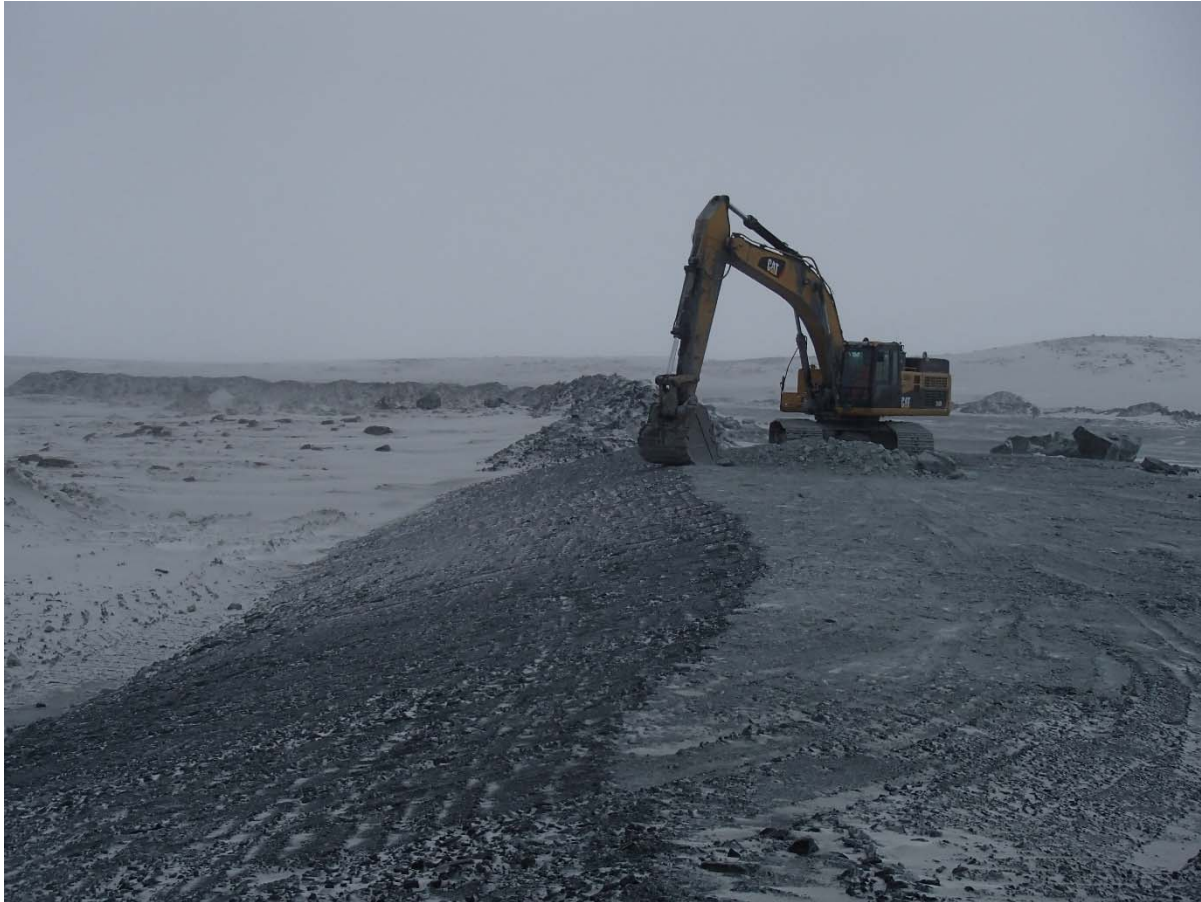
Photograph NCIS-019: From Sta. 2+100 m (approx.), looking SW. Profiling of the upstream slope (3H:1V) from El. 150 to 152 m with an excavator from Sta. 1+860 m to 1+678 m. The portion between Sta. 1+900 m and 1+800 m, where the structure is built on the natural ground, was not profiled.

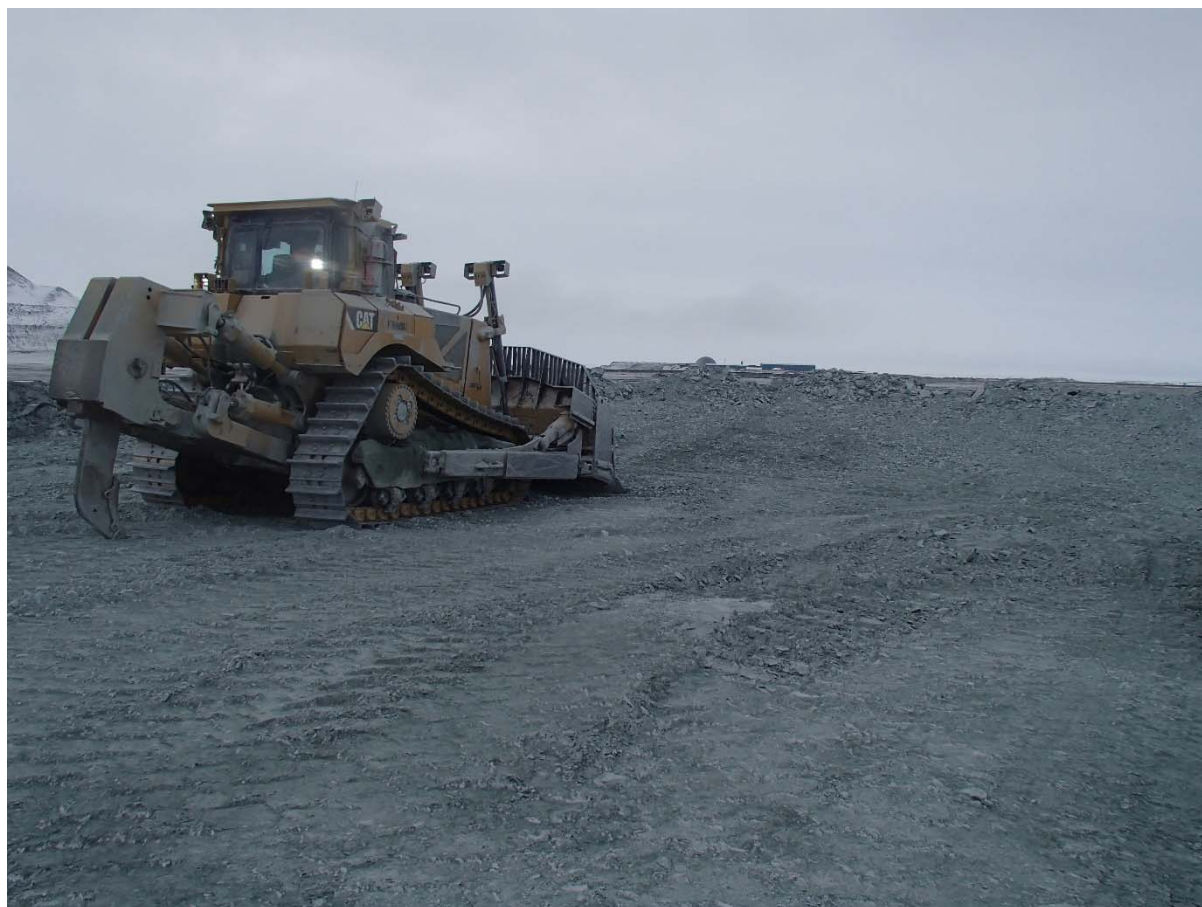
Photograph NCIS-020: From Sta. 1+570 m (approx.), looking S. Placement a 2 m thick (approx.) lift of UM rockfill from El. 150 m to El. 152 m (approx.) with a dozer from Sta. 1+564 m to 1+535 m (o.s. unavailable).

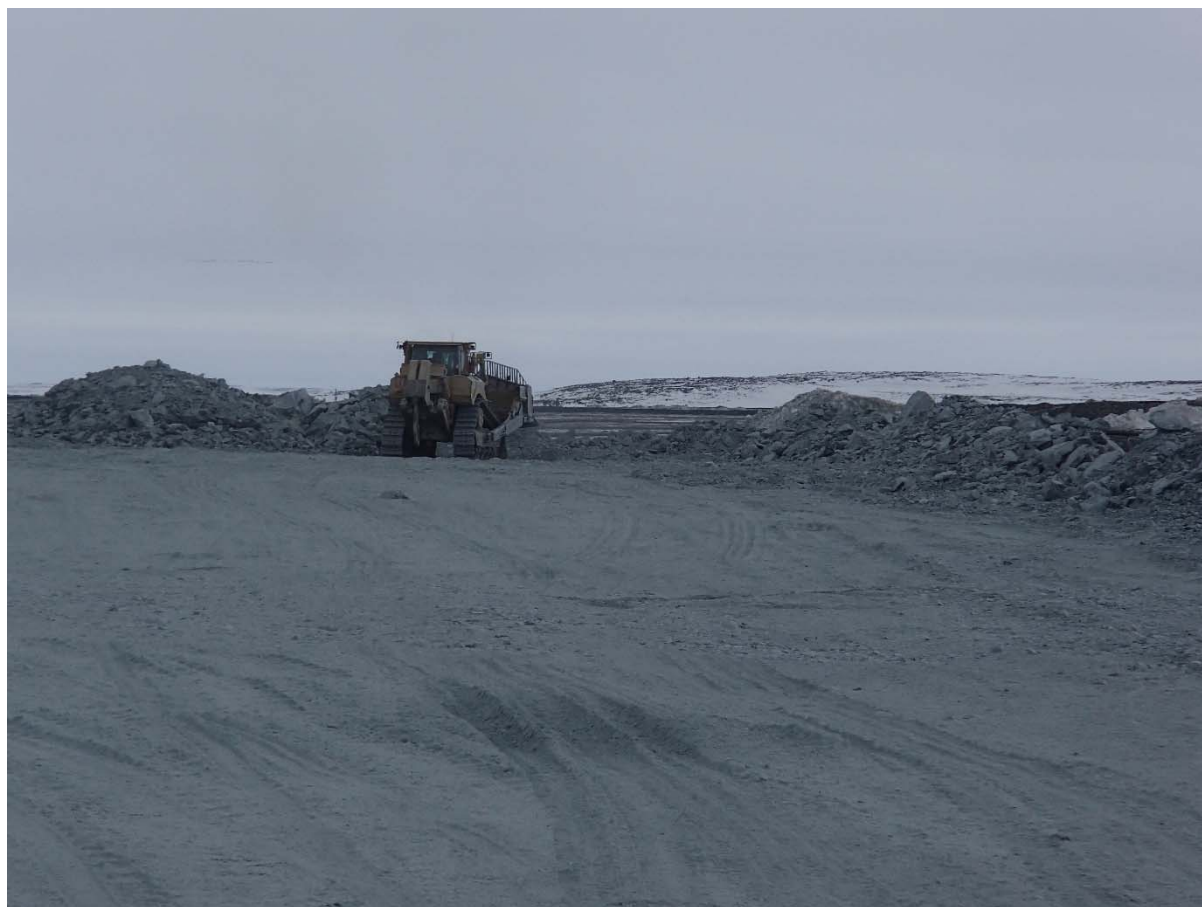
Photograph NCIS-021: From Sta. 1+550 m (approx.), looking S. Placement a 2 m thick (approx.) lift of UM rockfill from El. 150 m to El. 152 m (approx.) with a dozer from Sta. 1+535 m to 1+500 m (o.s. unavailable).

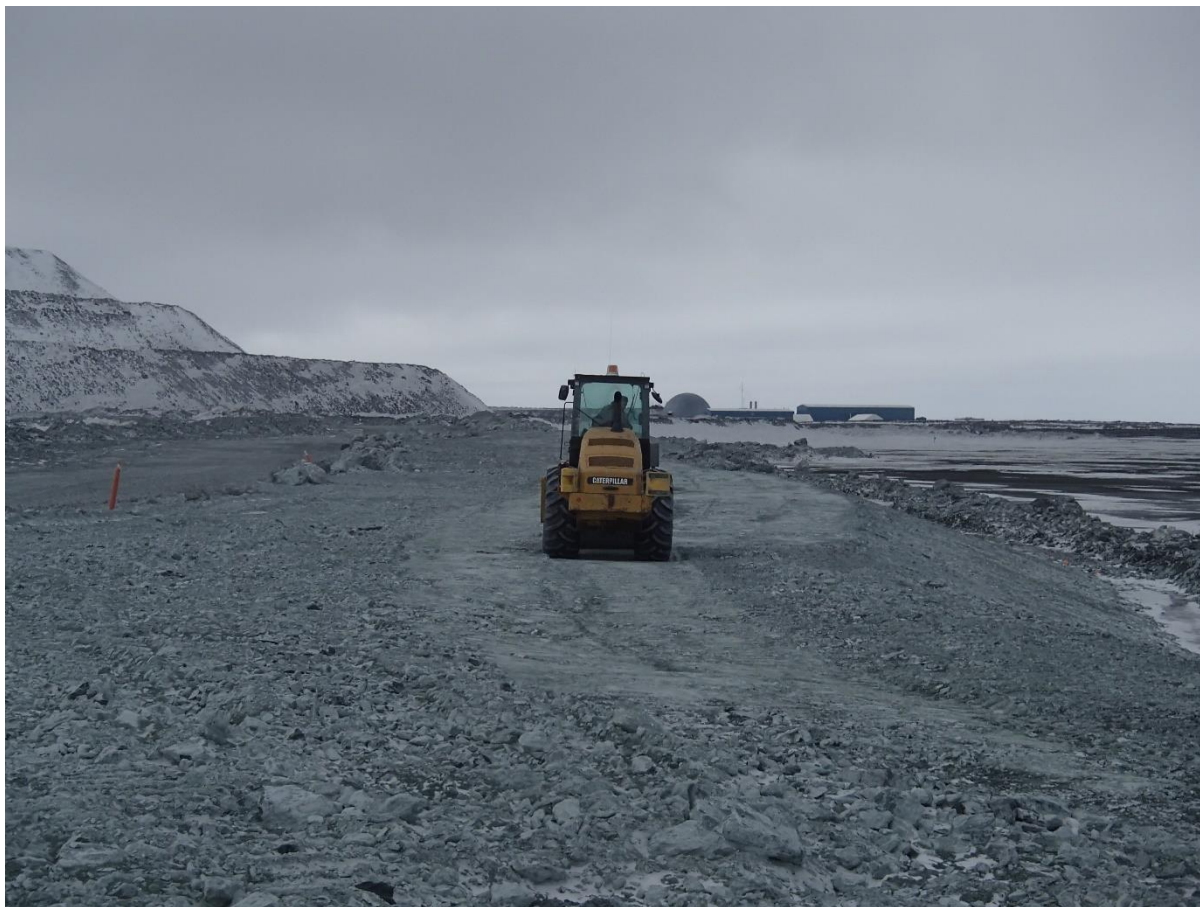
Photograph NCIS-022: From Sta. 2+245 m (approx.), looking SE. Compaction of the 2 m lift (approx.) of ultramafic (UM) rockfill at El. 152 m with a 10-tonne smooth-drum compactor with vibration (6 passes) between the haul truck traffic lane and the upstream slope from Sta. 2+625 to 1+625 m (o.s. unavailable).

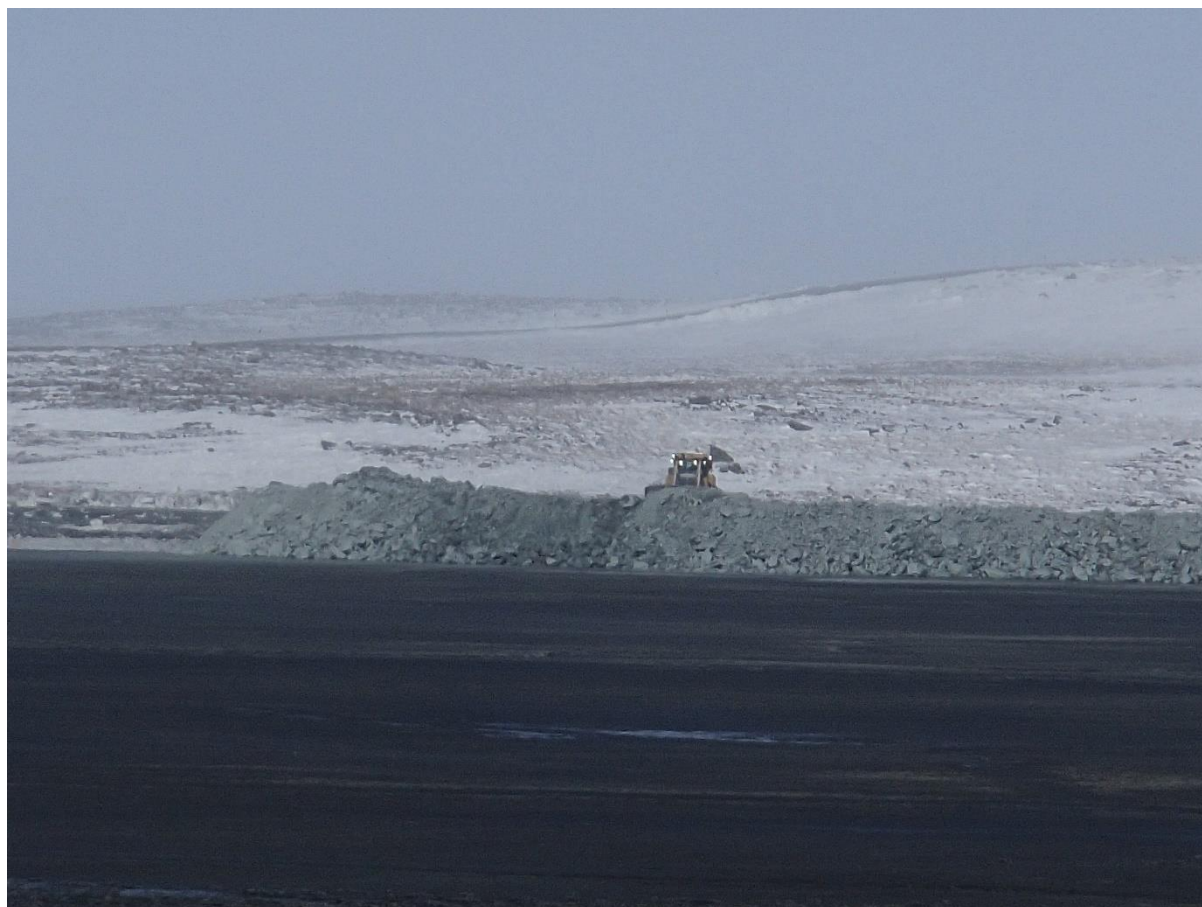
Photograph NCIS-023: From Sta. 2+570 m (approx.), looking W. Placement of a 2 m thick (approx.) lift of UM rockfill from El. 150 m to El. 152 m (approx.) with a dozer from Sta. 1+500 m to 1+450 m (o.s. unavailable). The material is of good quality and is well graded.

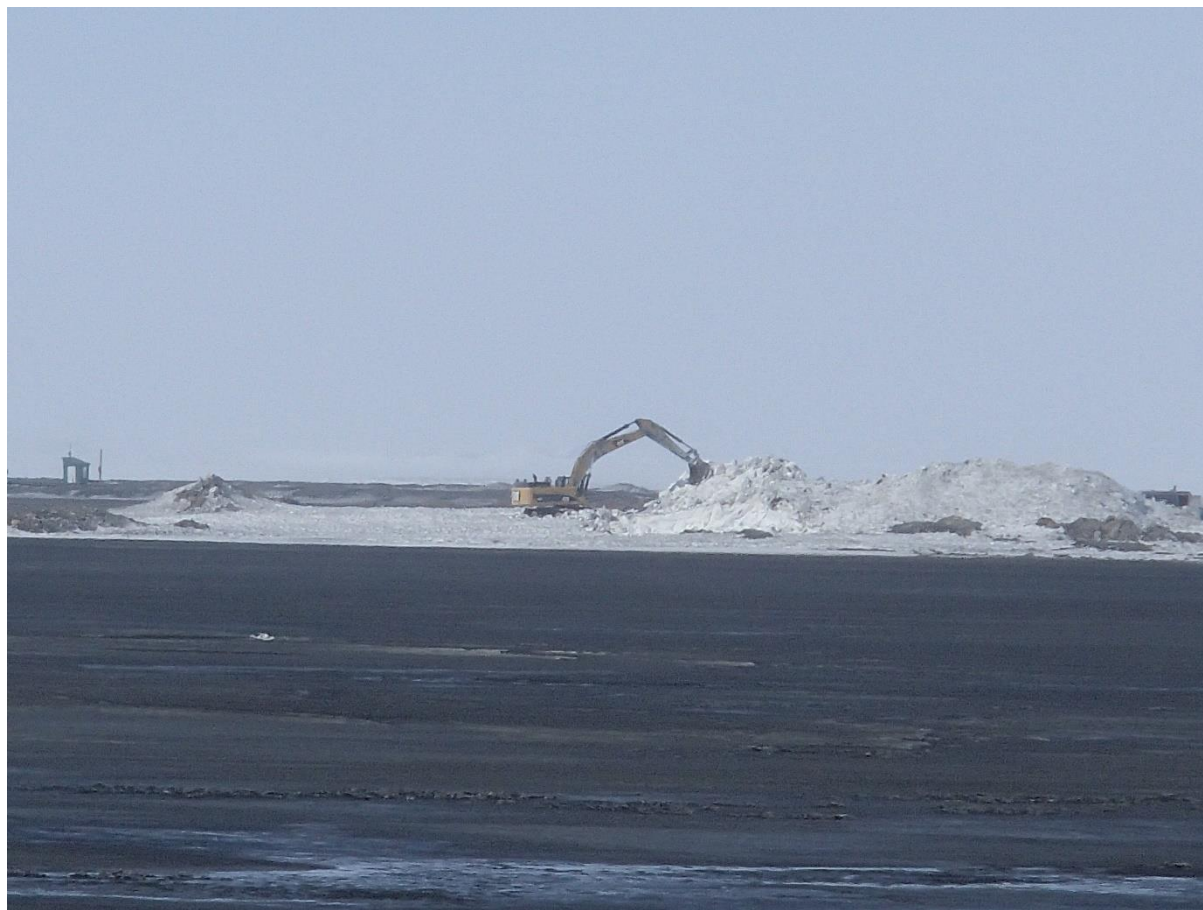
Photograph NCIS-024: From Sta. 2+570 m (approx.), looking SW. Removal of the snow bank in the footprint with an excavator from Sta. 1+160 m to 1+120 m (approx.).
