**DATE** July 14th 2018 1897439-1576-TM-Rev0

TO Patrice Gagnon, Pier-Éric McDonald

Agnico Eagle Mines Ltd, Meadowbank Division

## QA DAILY REPORT FOR JULY $13^{TH}$ , 2018 - TSF NORTH CELL CONSTRUCTION - MEADOWBANK (1897439)

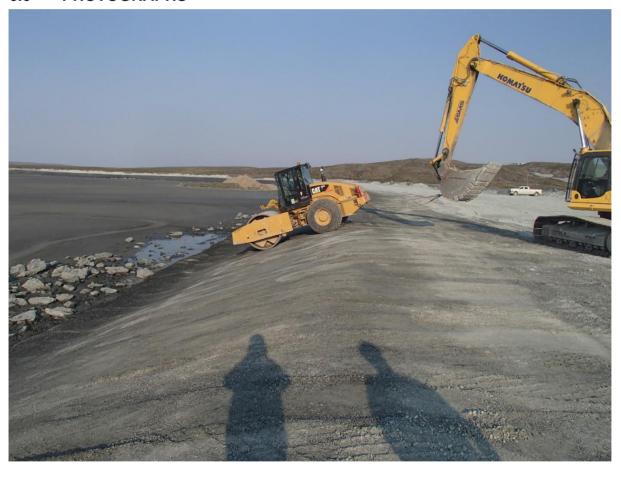
Photograph NCIS-088: From Sta 2+000/-35 m (approx.), looking W. Compaction of the 0.5 m lift (approx.) of fine filter between El. 150 m and 152 m with a 10-tonne smooth-drum compactor (4 passes) in the upstream slope from Sta. 2+028 m to 1+650 m.

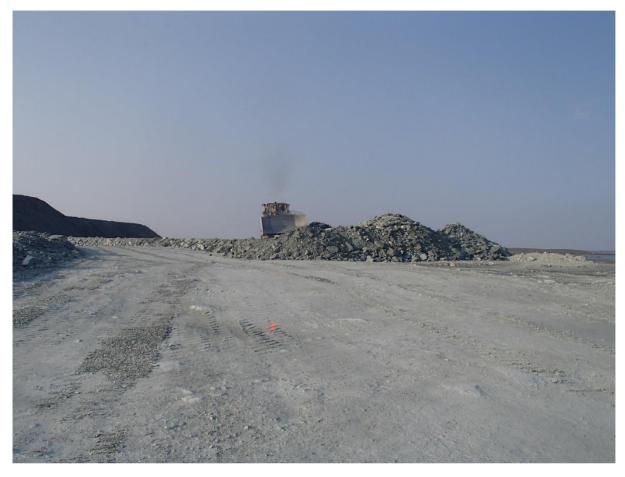
Activity or Area	Comments
Crest	■ Placement of a 2 m thick (approx.) lift of UM rockfill from El. 152 m to El. 154 m (approx.) with a dozer from Sta. 2+605 m to 2+455 m (+3 m to -23 m). The material is of good quality and is well graded.
	Compaction of the 0.5 m lift (approx.) of fine filter between El. 150 m and 152 m with a 10-tonne smooth-drum compactor (4 passes) in the upstream slope from Sta. 2+028 m to 1+650 m. Vibration is used except for the first pass down the slope in order to stabilize the material and limit deformation of the lift.

Photograph NCIS-089: From Sta 2+525/+4 m (approx.), looking S. Placement of a 2 m thick (approx.) lift of UM rockfill from El. 152 m to El. 154 m (approx.) with a dozer from Sta. 2+605 m to 2+455 m (+3 m to -23 m).

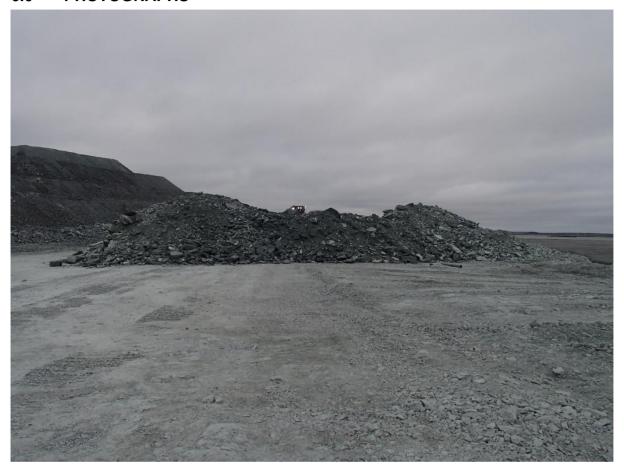
Activity or Area	Comments
Crest	■ Placement of a 2 m thick (approx.) lift of UM rockfill from El. 152 m to El. 154 m (approx.) with a dozer from Sta. 2+455 m to 2+370 m (+4 m to -24 m). The material is of good quality and is well graded.

Photograph NCIS-090: From Sta 2+440/-1 m (approx.), looking SE. Placement of a 2 m thick (approx.) lift of UM rockfill from El. 152 m to El. 154 m (approx.) with a dozer from Sta. 2+455 m to 2+370 m (+4 m to -24 m).

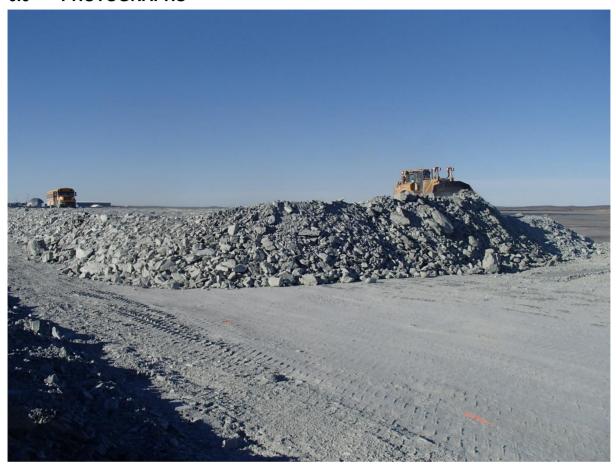
- The UM rockfill lift installed yesterday was thicker than required by 300 mm to 700 mm even if the surveyor installed guide pickets. SANA Surveyor will increase the frequency of the follow-ups with the bulldozer operator from the Mine, as the Non-AG rockfill quantities are low and limited. The elevation will be corrected to 154 m by an excavator to have a smooth surface for the compactor as well as to limit the extent of the filters.
- Boulders acting as a berm on the North Cell Internal Structure were move by mistake on the top of the upstream slope at El 152 m. They were scattered with an excavator to prevent honeycombing.

Photograph NCIS-091: From Sta 2+330/+13 m (approx.), looking S. Placement of a 2 m thick (approx.) lift of UM rockfill from El. 152 m to El. 154 m (approx.) with a dozer from Sta. 2+370 m to 2+290 m (+9 m to -22 m). The material is of good quality and is well graded.

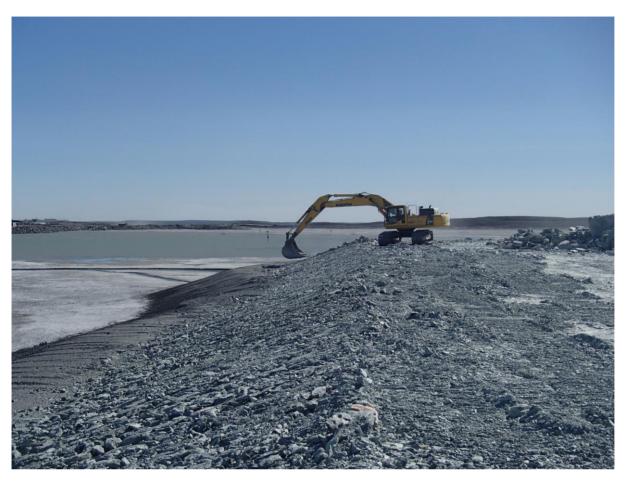
Photograph NCIS-092: From Sta 1+160/-77 m (approx.), looking S. Profiling of the upstream slope (3H:1V) from El. 150 to 152 m with an excavator from Sta. 1+185 m to 1+135 m.

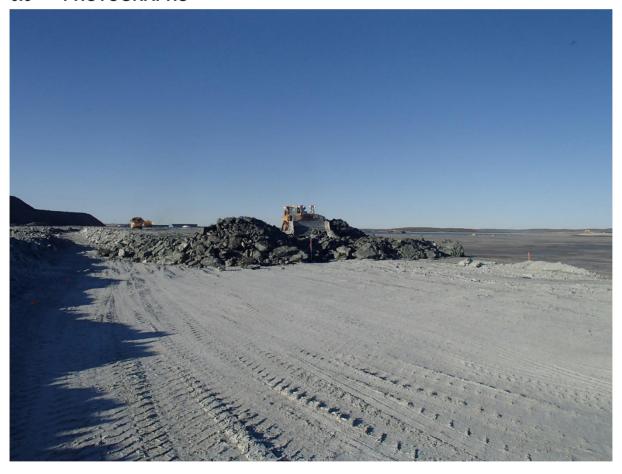
Photograph NCIS-093: From Sta 2+260/+12 m (approx.), looking S. Placement of a 2 m thick (approx.) lift of UM rockfill from El. 152 m to El. 154 m (approx.) with a dozer from Sta. 2+290 m to 2+280 m (+9 m to -22 m).

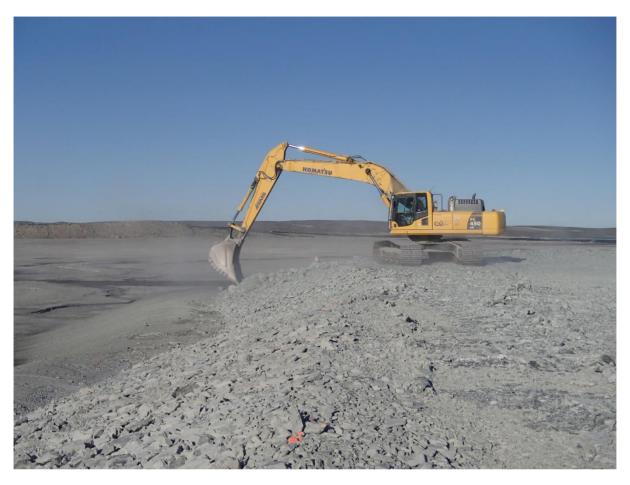
Photograph NCIS-094: From Sta 1+125/-109 m (approx.), looking SW. Profiling of the upstream slope (3H:1V) from El. 150 to 152 m with an excavator from Sta. 1+135 m to 1+100 m.

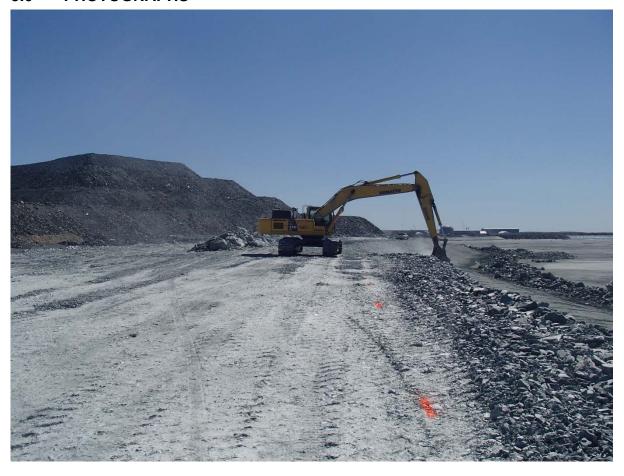
Activity or Area	Comments
Upstream	■ Profiling of the upstream slope (3H:1V) from El. 152 to 154 m with an excavator from Sta. 2+545 m to 2+410 m.

Photograph NCIS-095: From Sta 2+375/-18 m (approx.), looking S. Profiling of the upstream slope (3H:1V) from El. 152 to 154 m with an excavator from Sta. 2+545 m to 2+410 m.

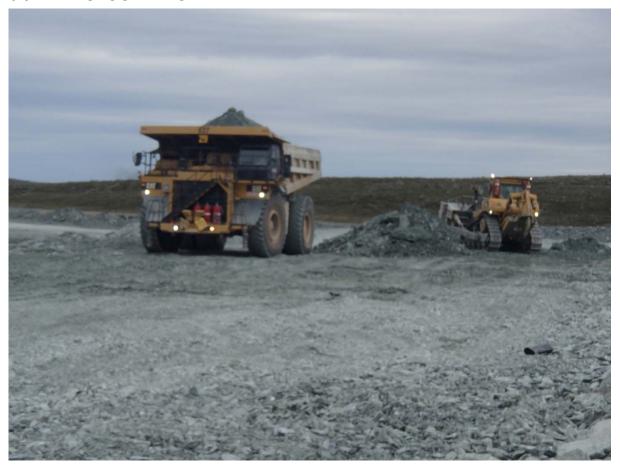
Photograph NCIS-096: From Sta 2+355/+9 m (approx.), looking N. Placement of a 2 m thick (approx.) lift of UM rockfill from El. 152 m to El. 154 m (approx.) with a dozer from Sta. 2+190 m to 2+103 m (+7 m to -22 m). The material is of good quality and is well graded.

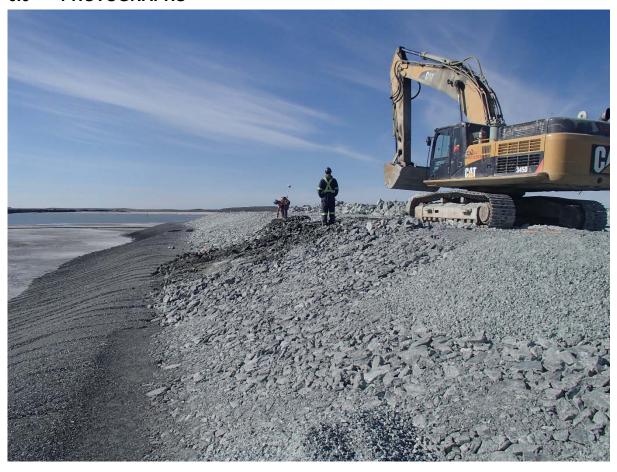
Photograph NCIS-097: From Sta. 1+180/-75 m (approx.), looking SW. Placement of a 0.5 m thick lift of coarse filter in the upstream slope from El. 150 m to 152 m with an excavator from Sta. 1+200 m to 1+113 m.

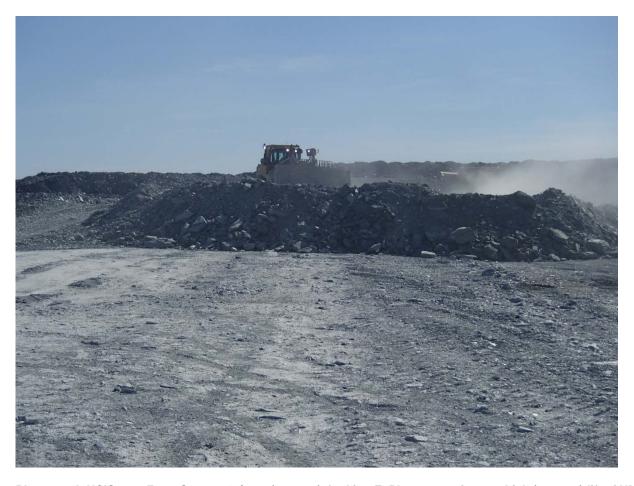
Photograph NCIS-098: From Sta. 2+040/-9 m (approx.), looking E. Placement of a 2 m thick (approx.) lift of UM rockfill from El. 152 m to El. 154 m (approx.) with a dozer from Sta. 2+103 m to 1+984 m (+7 m to -22 m). The material is of good quality and is well graded.

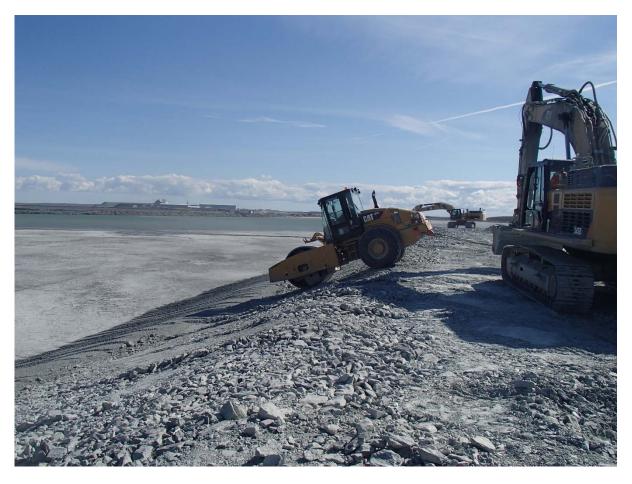
Photograph NCIS-099: From Sta. 1+180/-76 m (approx.), looking SE. Compaction of the 0.5 m lift (approx.) of coarse filter between El. 150 m and 152 m with a 10-tonne smooth-drum compactor with vibration (4 passes) in the upstream slope from Sta. 1+200 m to 1+170 m.

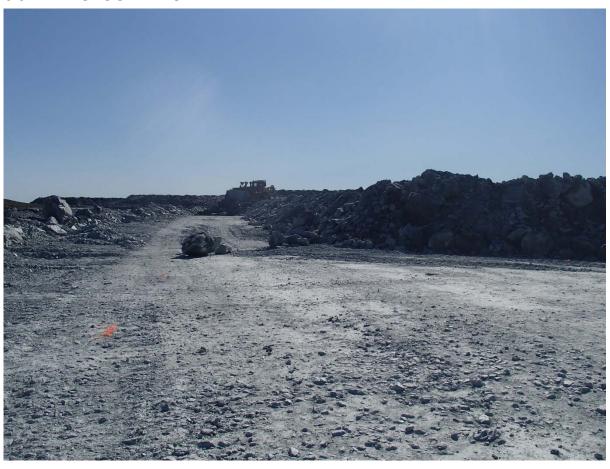
Photograph NCIS-100: From Sta. 1+960/+10 m (approx.), looking E. Placement of a 2 m thick (approx.) lift of UM rockfill from El. 152 m to El. 154 m (approx.) with a dozer from Sta. 1+984 m to 1+947 m (+14 m to -26 m). The material is of good quality and is well graded.

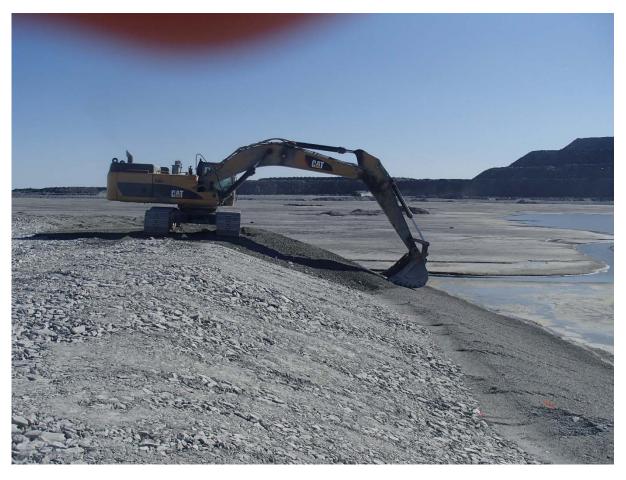
Photograph NCIS-101: From Sta. 1+120/-89 m (approx.), looking N. Placement of a 0.5 m thick lift of fine filter in the upstream slope from El. 150 m to 152 m with an excavator from Sta. 1+113 m to 1+205 m.

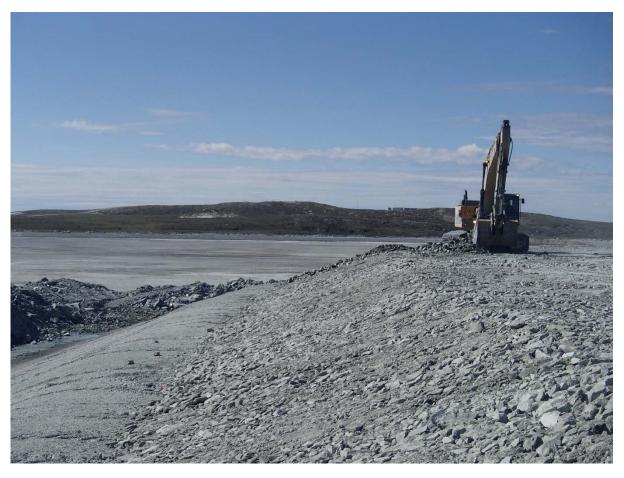
Photograph NCIS-102: From Sta. 2+680/-21 m (approx.), looking W. Placement of a 0.5 m thick lift of coarse filter in the upstream slope from El. 152 m to 154 m with an excavator from Sta. 2+575 m to 2+710 m and from Sta. 2+411 m to 2+460 m.

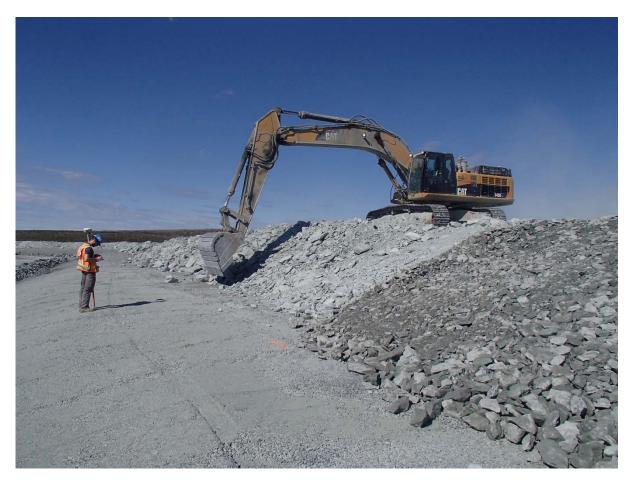
Photograph NCIS-103: From Sta. 2+420/-27 m (approx.), looking NE. Profiling of the upstream slope (3H:1V) from El. 152 to 154 m with an excavator from Sta. 2+400 m to 2+410 m. Oversize boulders were removed.

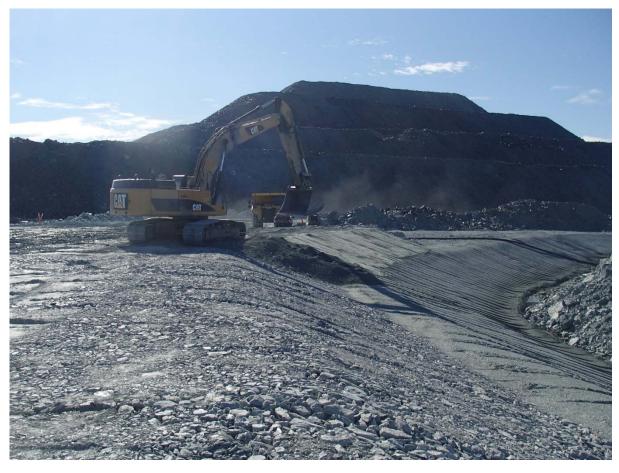
Photograph NCIS-104: From Sta. 2+650/-23 m (approx.), looking SE. Placement of a 0.5 m thick lift of fine filter in the upstream slope from El. 152 m to 154 m with an excavator from Sta. 2+710 m to 2+445 m.

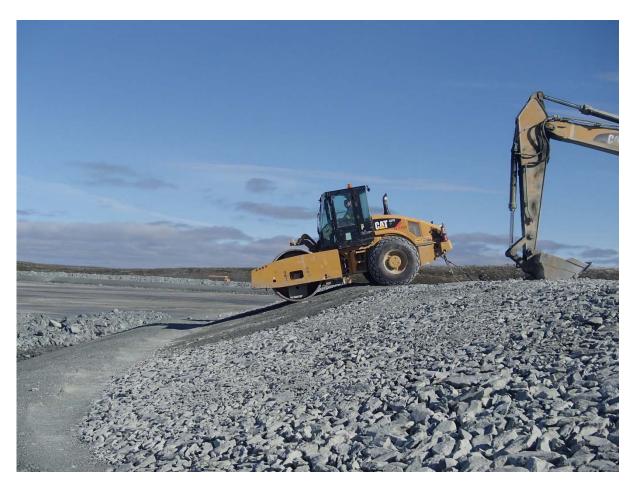
Photograph NCIS-105: From Sta. 2+630/-34 m (approx.), looking NW. Compaction of the 0.5 m lift (approx.) of coarse filter between El. 152 m and 154 m with a 10-tonne smooth-drum compactor with vibration (4 passes) in the upstream slope from Sta. 2+710 m to 2+411 m.

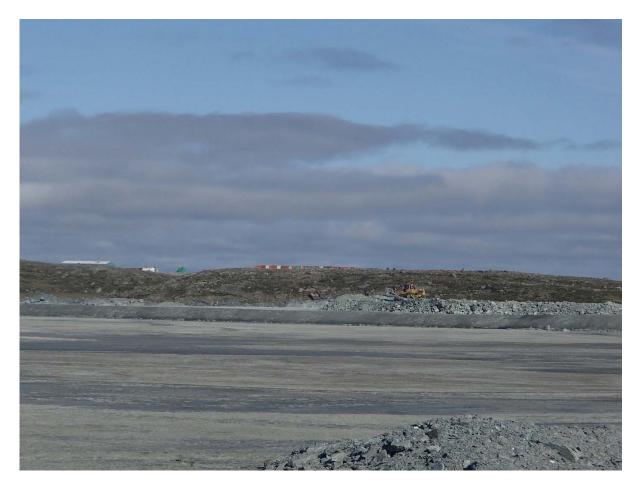
Photograph NCIS-106: From Sta. 2+620/-35 m (approx.), looking NW. Placement of a 2 m thick (approx.) lift of UM rockfill from El. 152 m to El. 154 m (approx.) with a dozer from Sta. 1+947 m to 1+863 m (+14 m to -26 m). The material is of good quality and is well graded.

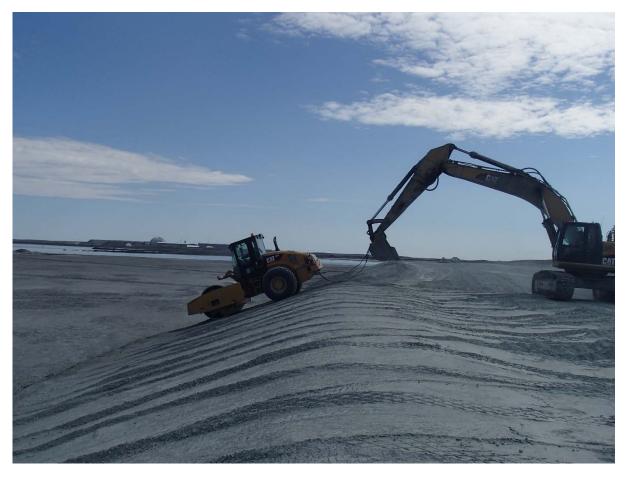
Photograph NCIS-107: From Sta. 1+380/-38 m (approx.), looking S. Compaction of the 0.5 m lift (approx.) of fine filter between El. 150 m and 152 m with a 10-tonne smooth-drum compactor with vibration (4 passes) in the upstream slope from Sta. 1+251 m to 1+660 m.

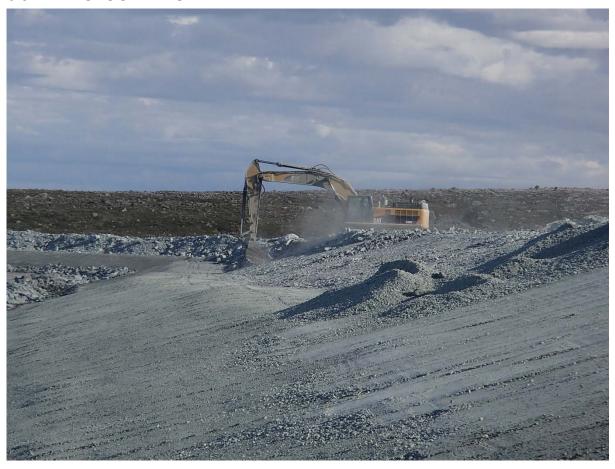
Photograph NCIS-108: From Sta. 2+490/-32 m (approx.), looking N. Profiling of the upstream slope (3H:1V) from El. 152 to 154 m with an excavator from Sta. 2+159 m to 2+409 m.

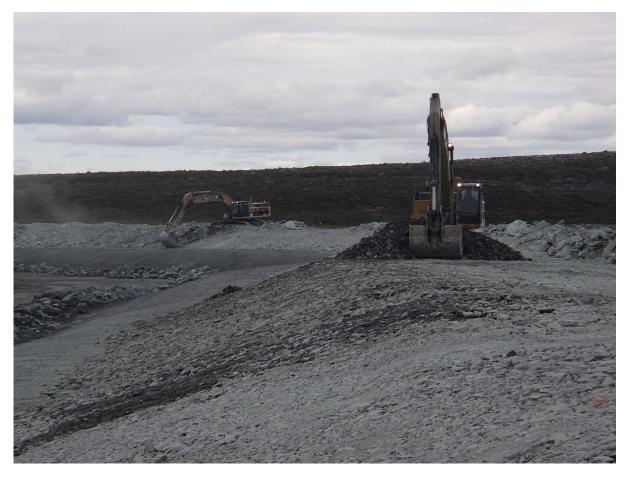
Photograph NCIS-109: From Sta. 2+450/-21 m (approx.), looking N. Placement of a 0.5 m thick lift of coarse filter in the upstream slope from El. 152 m to 154 m with an excavator from Sta. 2+293 m to 2+411 m.

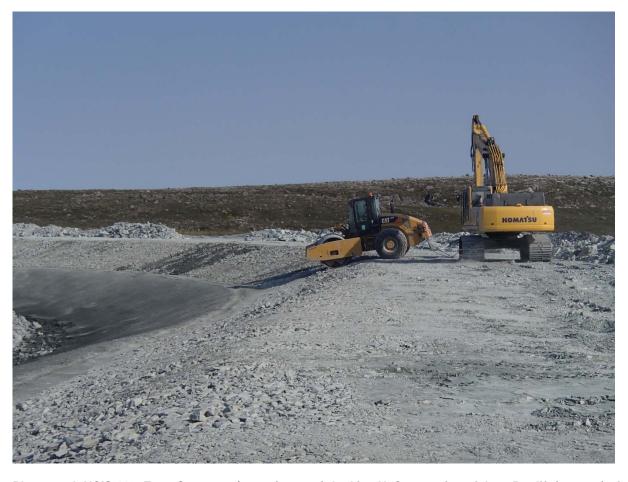
Photograph NCIS-110: From Sta. 2+320/-22 m (approx.), looking N. Compaction of the 0.5 m lift (approx.) of coarse filter between El. 152 m and 154 m with a 10-tonne smooth-drum compactor with vibration (4 passes) in the upstream slope from Sta. 2+293 m to 2+080 m.

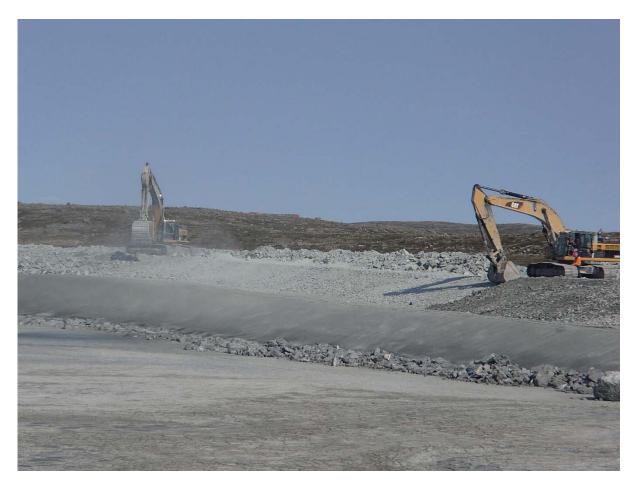
Photograph NCIS-111: From Sta. 2+320/-22 m (approx.), looking NW. Profiling of the upstream slope (3H:1V) from EI. 152 to 154 m with an excavator from Sta. 2+159 m to 2+000 m and placement of a 0.5 m thick lift of coarse filter in the upstream slope from EI. 152 m to 154 m with an excavator from Sta. 2+293 m to 2+080 m.

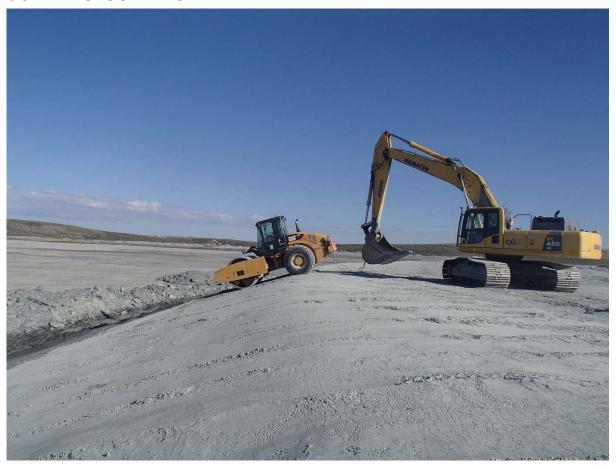
Photograph NCIS-112: From Sta. 2+610/-29 m (approx.), looking N. Compaction of the 0.5 m lift (approx.) of coarse filter between El. 152 m and 154 m with a 10-tonne smooth-drum compactor with vibration (4 passes) in the upstream slope from Sta. 2+080 m to 2+000 m.

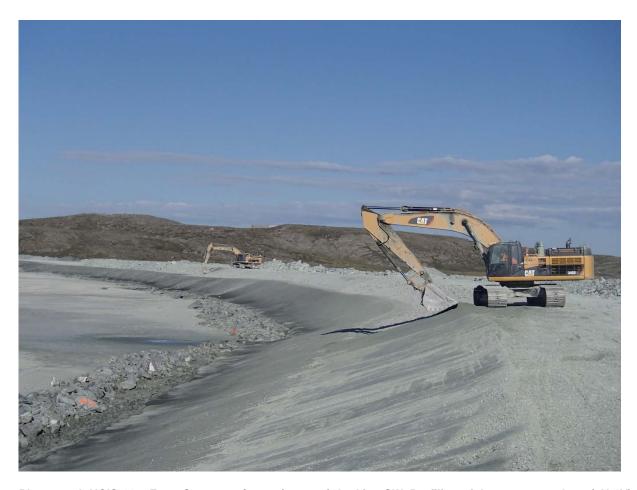
Photograph NCIS-113: From Sta. 2+220/-26 m (approx.), looking SW. Profiling of the upstream slope (3H:1V) from El. 152 to 154 m with an excavator from Sta. 2+000 m to 1+185 m and placement of a 0.5 m thick lift of fine filter in the upstream slope from El. 152 m to 154 m with an excavator from Sta. 2+300 m to 2+090 m.

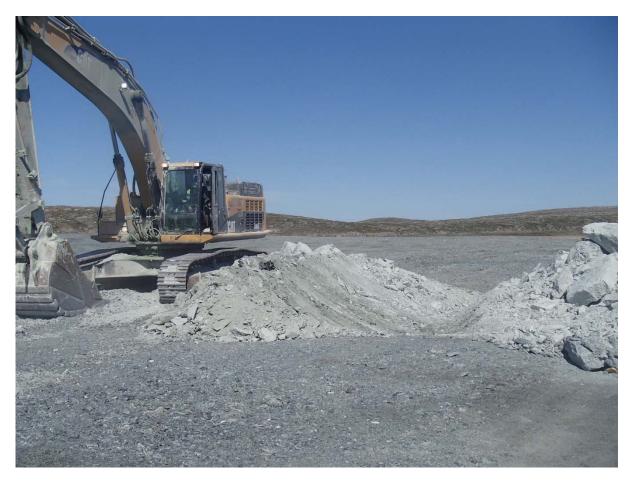
Photograph NCIS-114: From Sta. 1+700/-34 m (approx.), looking N. Excavation of a 0.8 m (approx.) deep, 1 m wide shallow ditch in the rockfill capping with an excavator from Sta. 1+500 m to 1+650 m.
