QA DAILY REPORT

1897439-1576-TM-Rev0

QA DAILY REPORT FOR JULY 25TH, 2018 – TSF NORTH CELL CONSTRUCTION - MEADOWBANK (1897439)

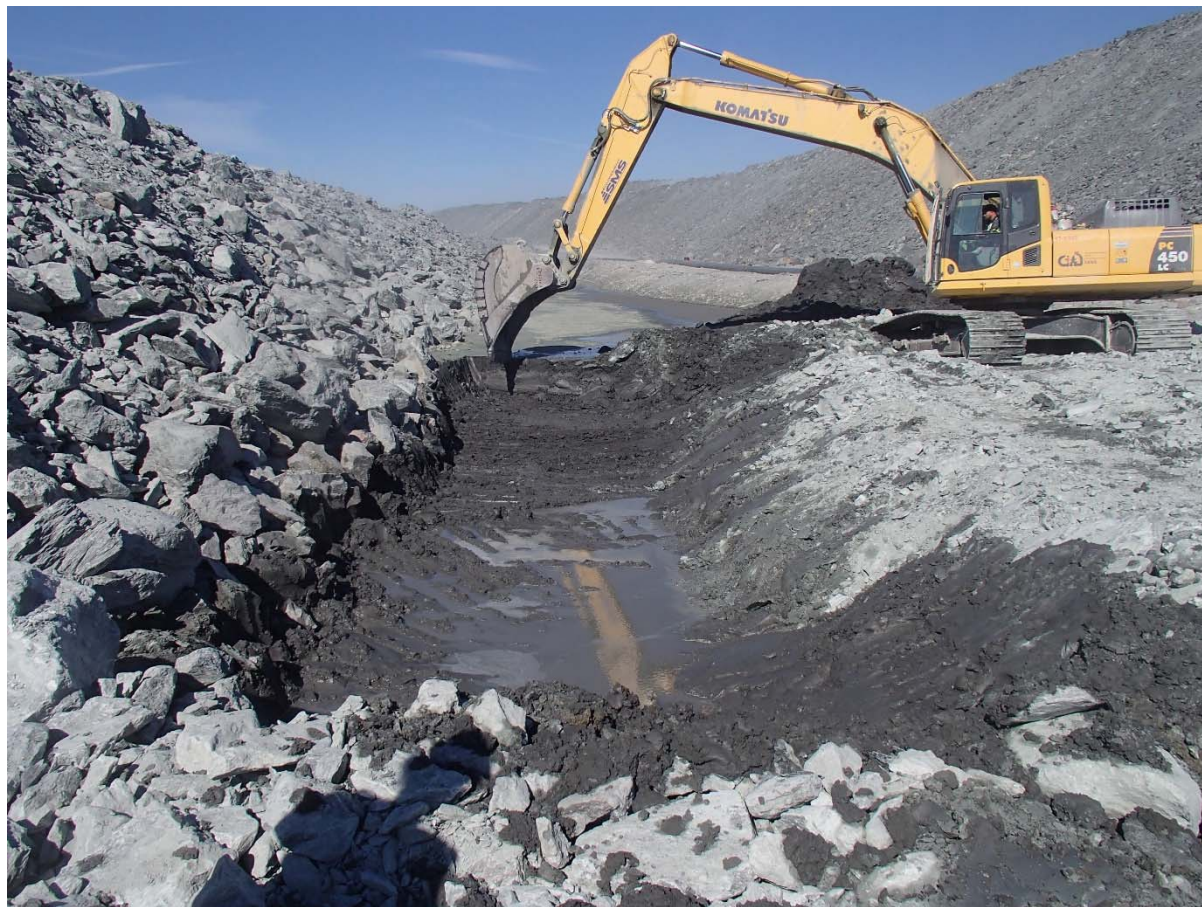
Photograph NCIS-115: From Sta. 3+040/-33 m (approx.), looking NE. Excavation of a 1 m (approx.) sump in the tailings with an excavator from Sta. 3+010 m to 3+030 m (o.s. +27 to +30 m). The bottom of the excavation was frozen.

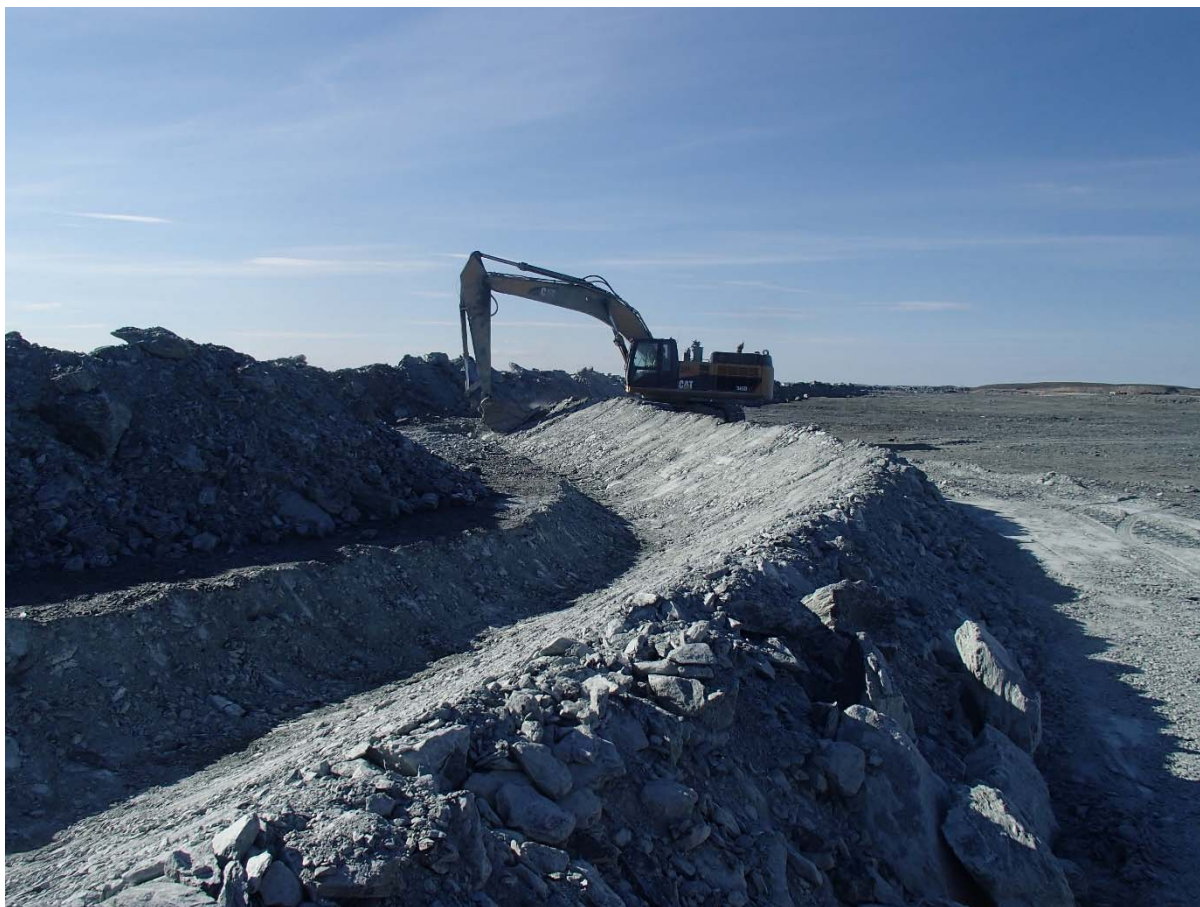
Photograph NCIS-116: From Sta. 1+700/+37 m (approx.), looking SE. Excavation of a 0.8 m (approx.) deep, 1 m wide shallow ditch in the rockfill capping with an excavator from Sta. 1+500 m to 1+455 m.

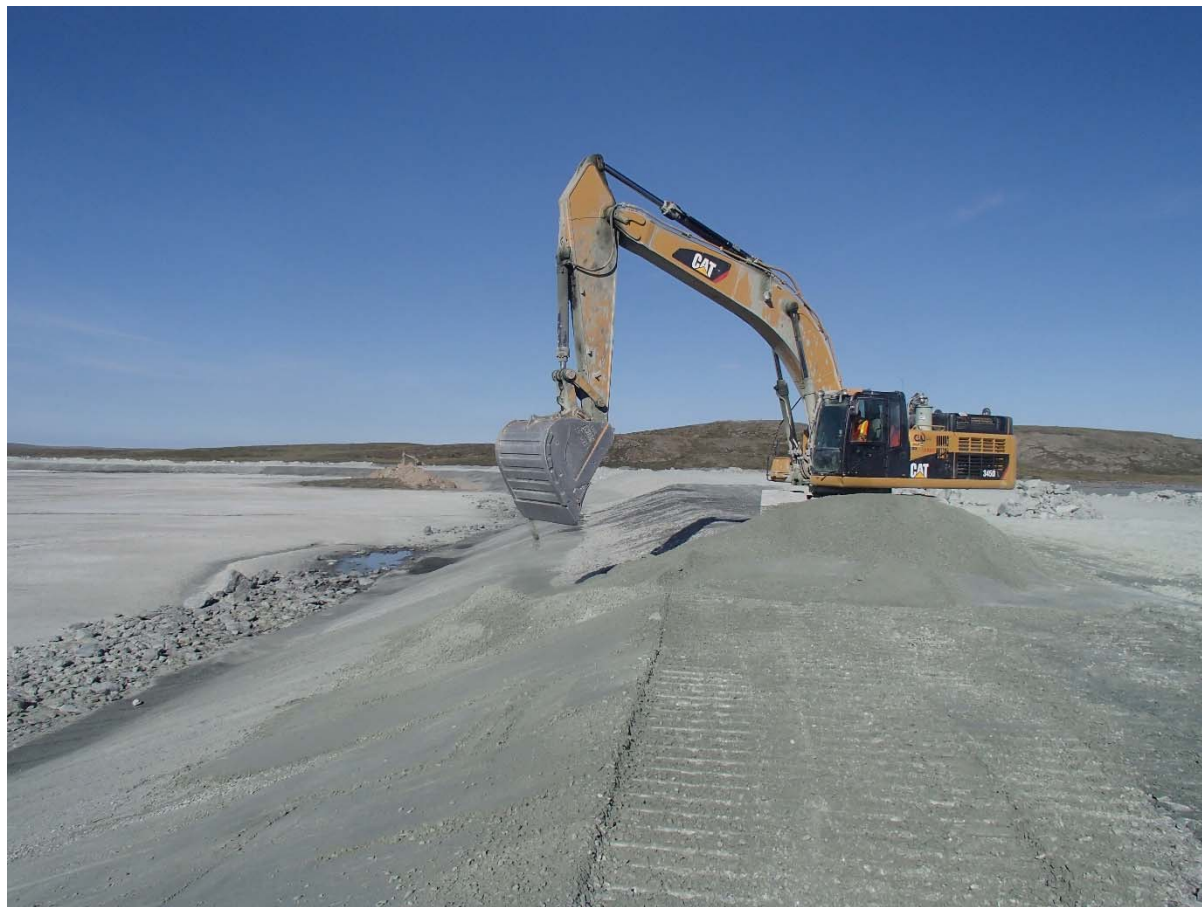
Photograph NCIS-117: From Sta. 2+050/-25 m (approx.), looking SW. Placement of a 0.5 m thick lift of fine filter in the upstream slope from El. 152 m to 154 m with an excavator from Sta. 2+090 m to 1+890 m.

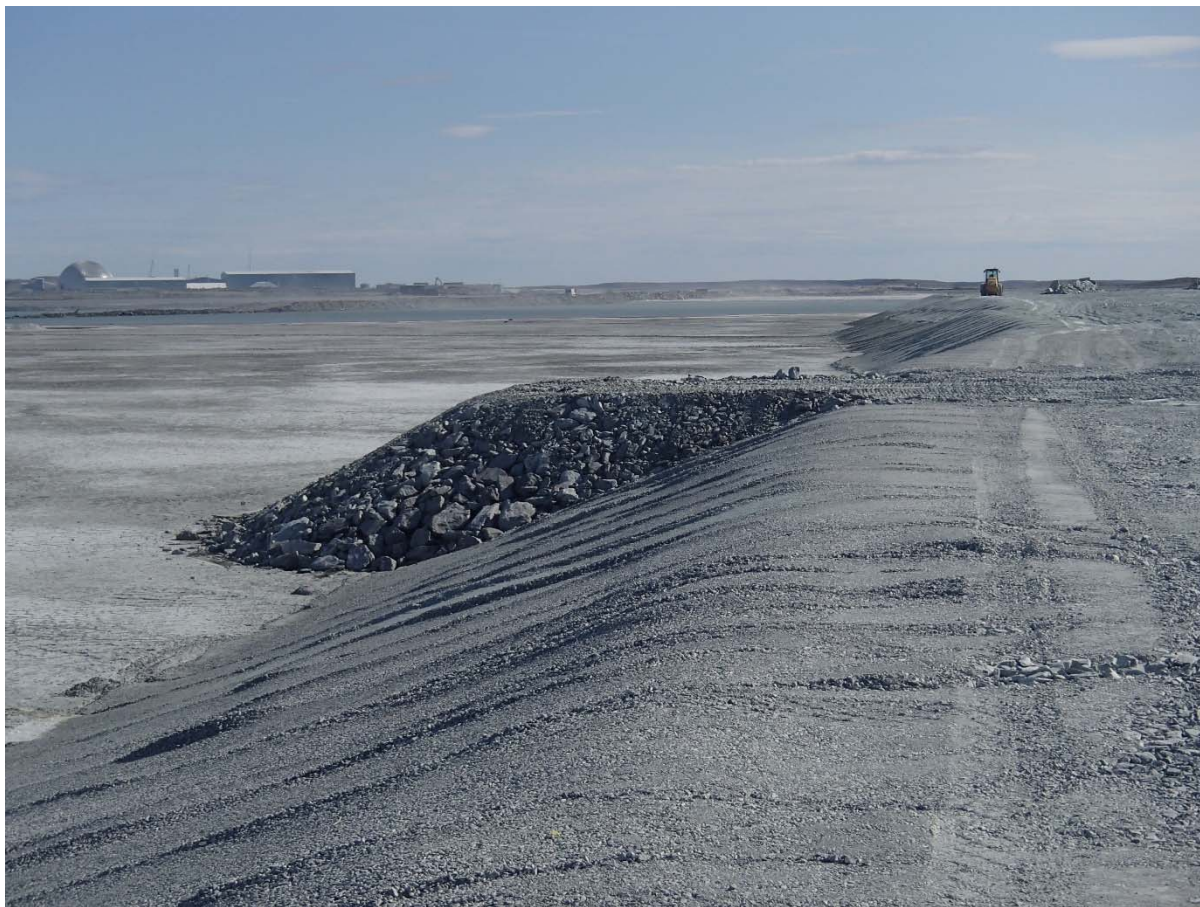
Photograph NCIS-118: From Sta. 1+500/-37 m (approx.), looking S. View of a deposition point.

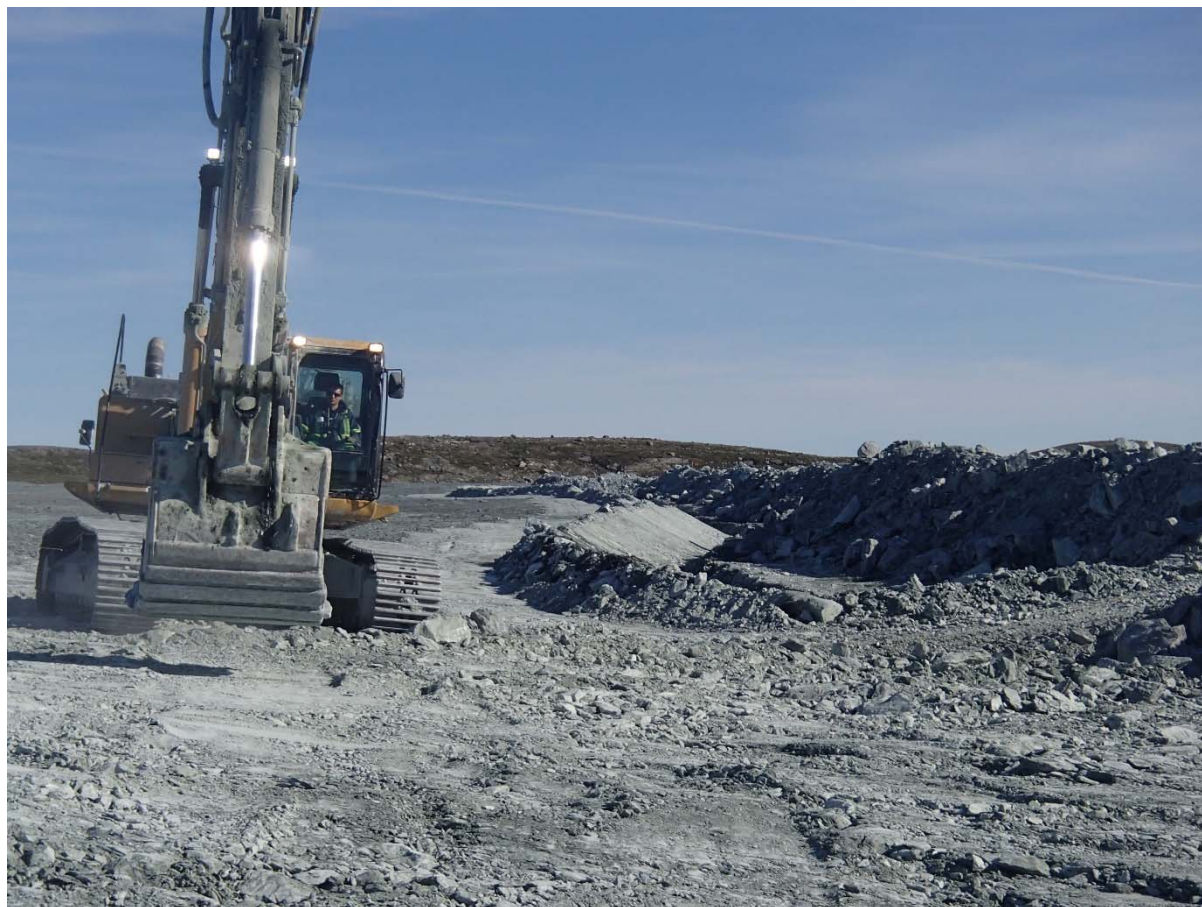
Photograph NCIS-119: From Sta. 1+430/-22 m (approx.), looking N. Excavation of a 0.8 m (approx.) deep, 1 m wide shallow ditch in the rockfill capping with an excavator from Sta. 1+455 m to 1+400 m.

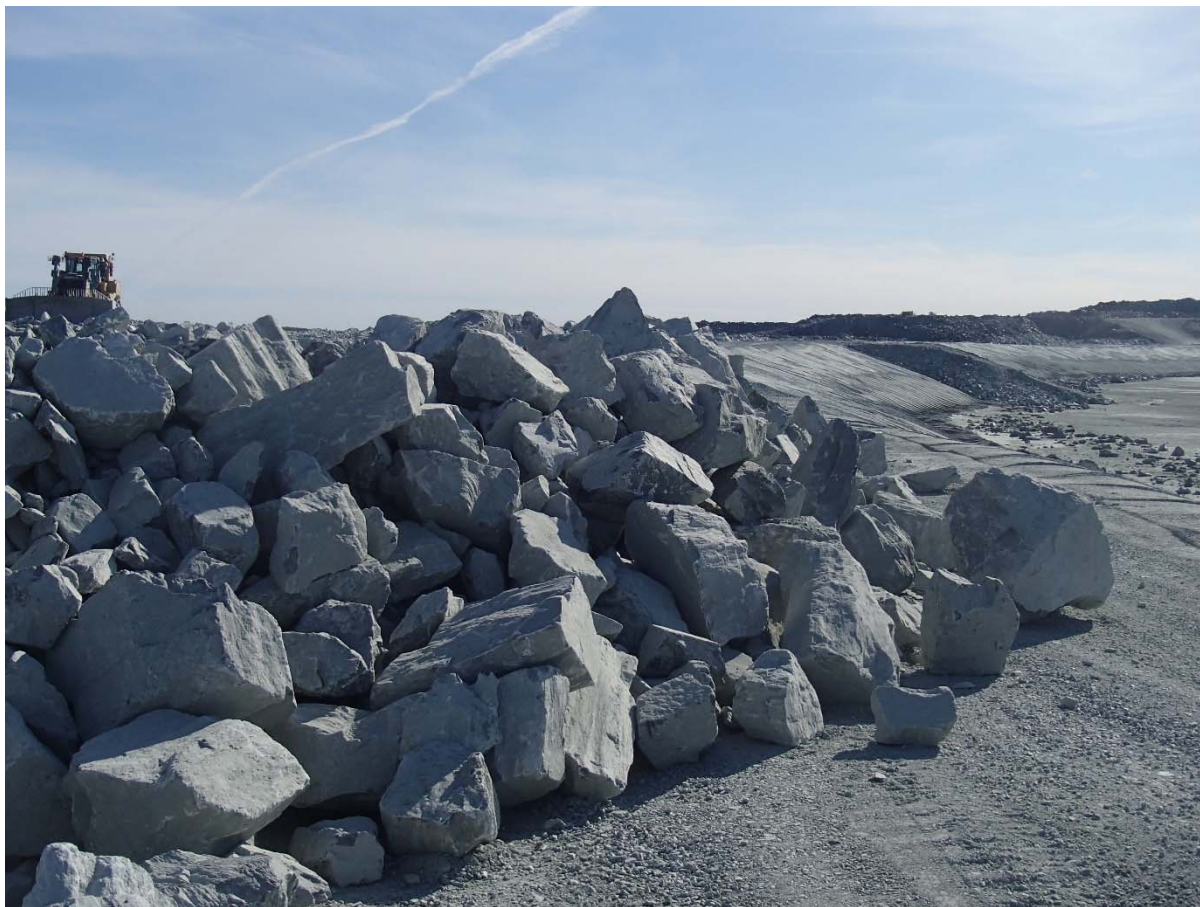
Photograph NCIS-120: From Sta. 1+830/-27 m (approx.), looking NE. View of an accumulation of boulders on the upstream slope of the NCIS.

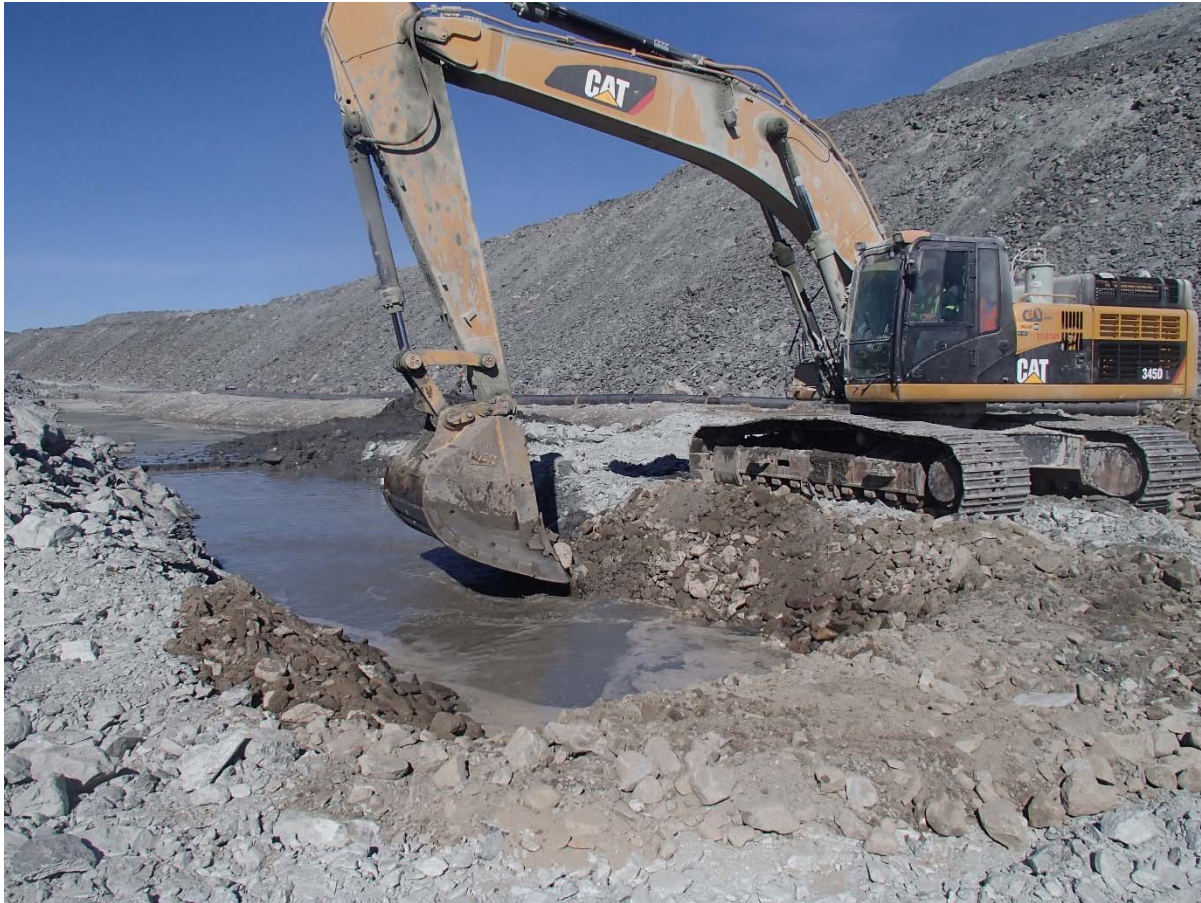
- Till sieving reject material is used in place of the coarse filter as the protective layer in the ditch excavated in the tailings (see photograph below). This material is considered good quality for this use, and this adjustment will save some coarse filter material.
- The QA Manager noticed boulder nests on the upstream slope of the rockfill around Sta. 1+830 m (see photograph below). Fine material will be mixed in during slope profiling of this section.

Photograph NCIS-121: From Sta.3+050/+26 m (approx.), looking NE. Placement of a 0.3 m thick (approx.) layer of till sieving reject material on the bottom and on the slopes of the sump.

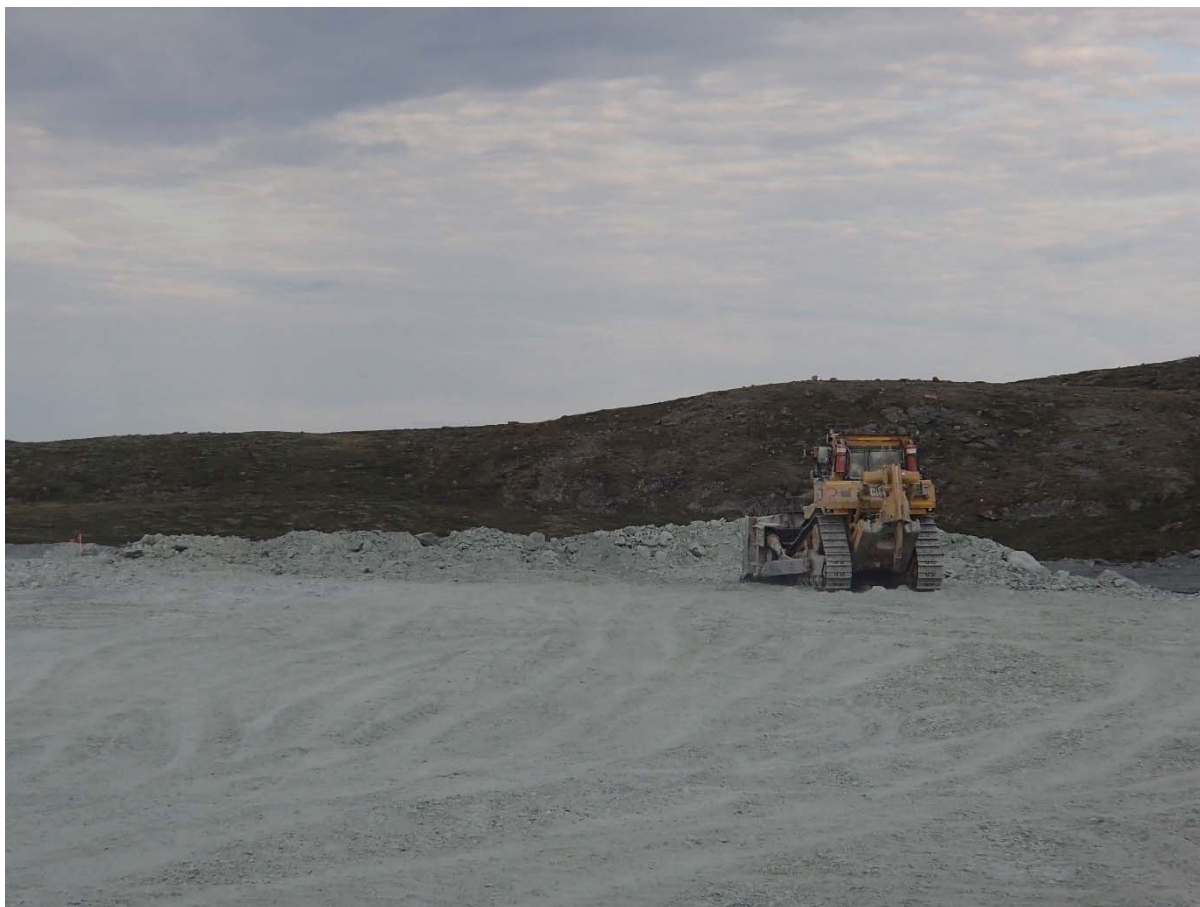
Photograph NCIS-122: From Sta. 1+960/-6 m (approx.), looking W. Placement of a 2 m thick (approx.) lift of UM rockfill from El. 152 m to El. 154 m (approx.) with a dozer from Sta. 1+830 m to 1+860 m (+8 m to -23 m).

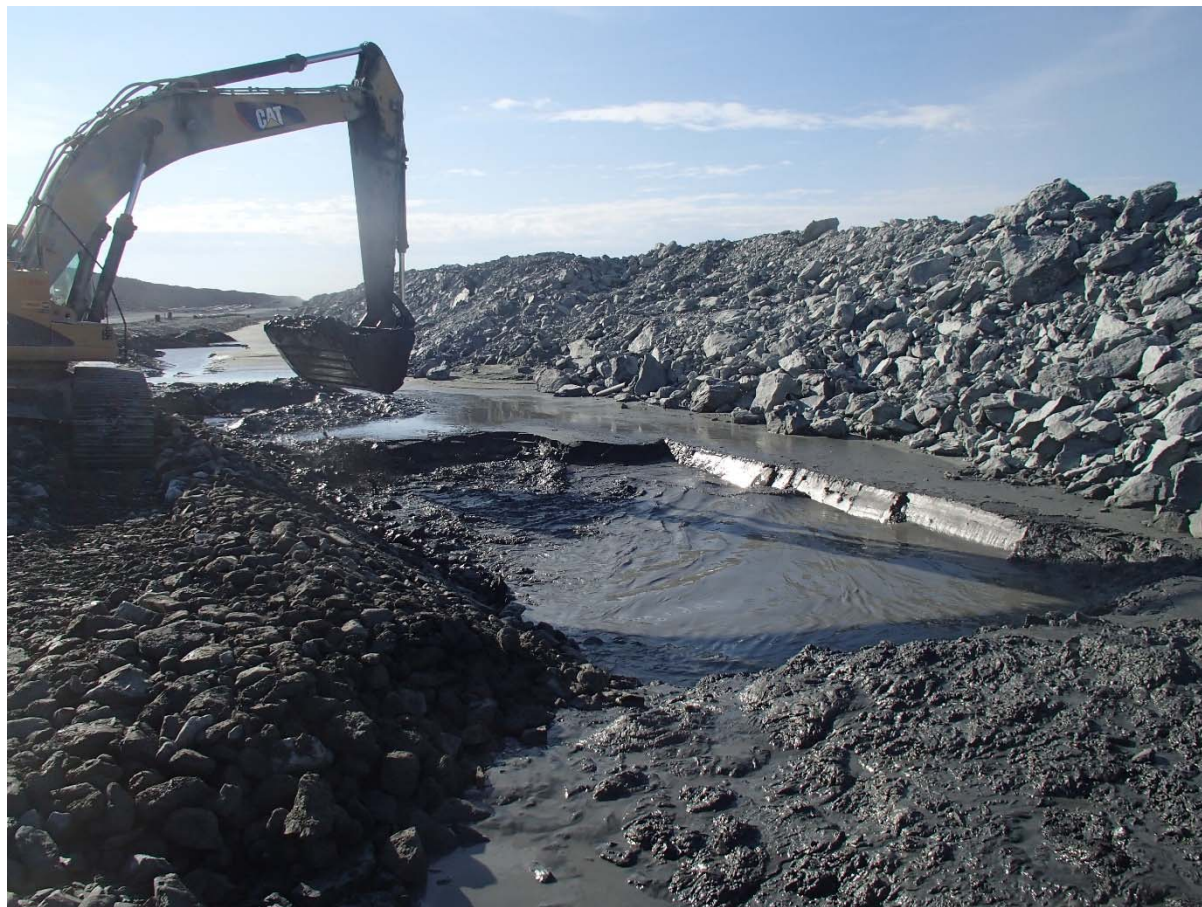
Photograph NCIS-123: From Sta. 3+340/+33 m (approx.), looking S. Excavation of a 1 m (approx.) deep sump (south sump) in the tailings with an excavator from Sta. 3+345 m to 3+365 m (o.s. +24 to +32 m). The bottom of the excavation was frozen.

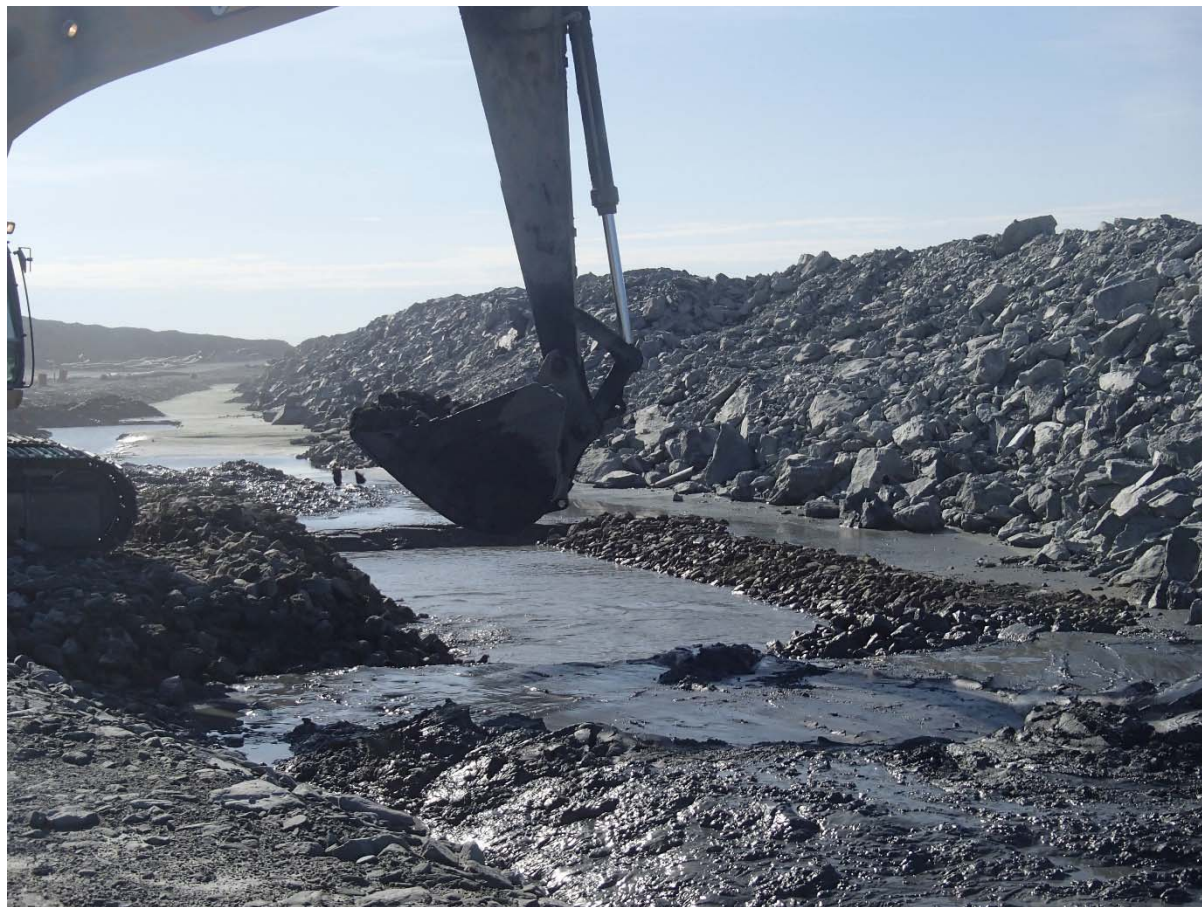
Photograph NCIS-124: From Sta. 3+340/+33 m (approx.), looking S. Placement of a 0.3 m thick (approx.) layer of till sieving reject material on the bottom and on the slopes of the south sump.

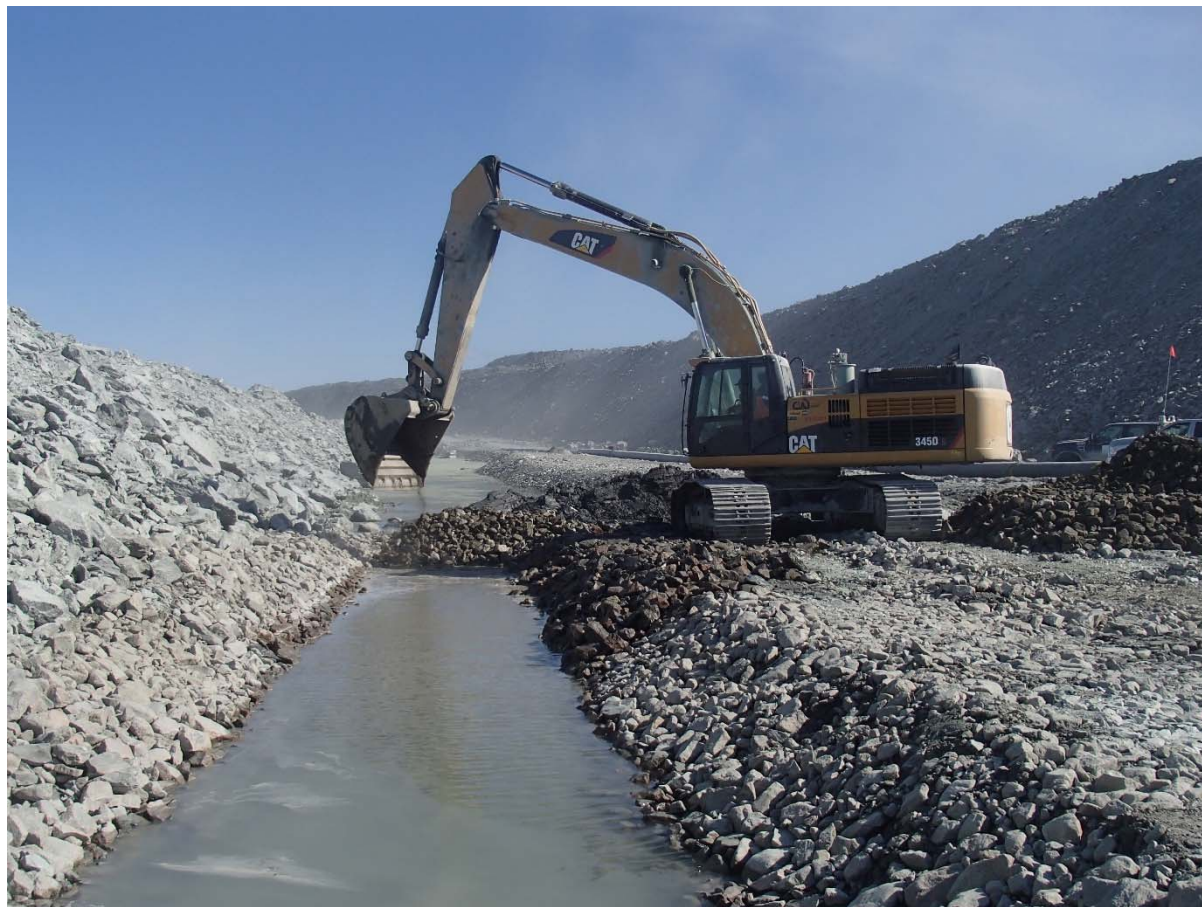
- The first sump dug yesterday was not deep enough due to thawing tailings movement and an excessive thickness of the till sieving reject material layer. The sump was reworked today to gain depth.
- The pipe which crosses the North Cell Internal Structure will not be moved, instead the deposition will be slightly adjusted to avoid raising this section of the dike to El. 154 m.

Photograph NCIS-125: From Sta. 3+050/+26 m (approx.), looking NE. Corrections to the north sump: removal of approx. 0.5 m of tailing and till sieving reject material on the bottom of the excavation. The erosion protection material was replaced.

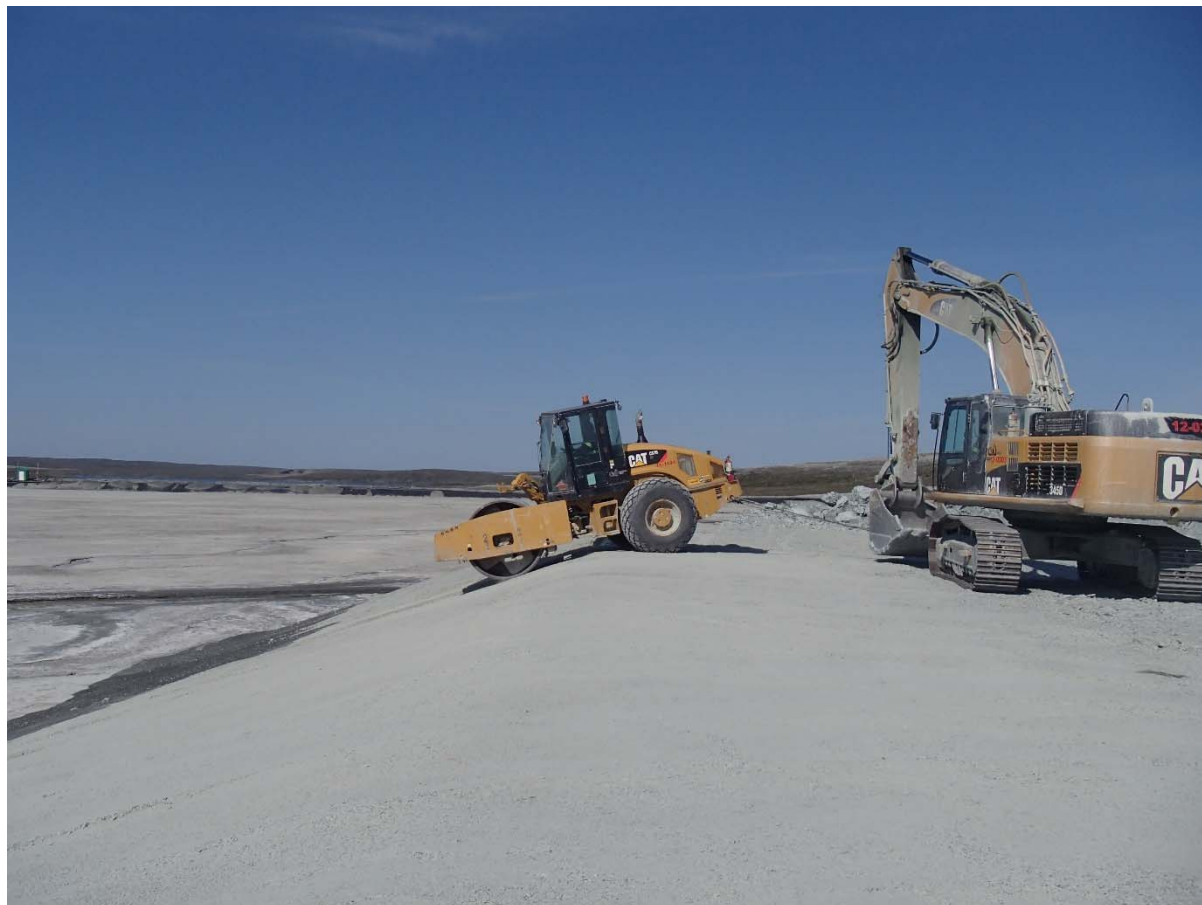
Photograph NCIS-126: From Sta. 1+140/-98 m (approx.), looking W. Compaction of the 0.5 m lift (approx.) of fine filter between El. 150 m and 152 m with a 10-tonne smooth-drum compactor with vibration (4 passes) in the upstream slope from Sta. 1+240 m to 1+100 m.

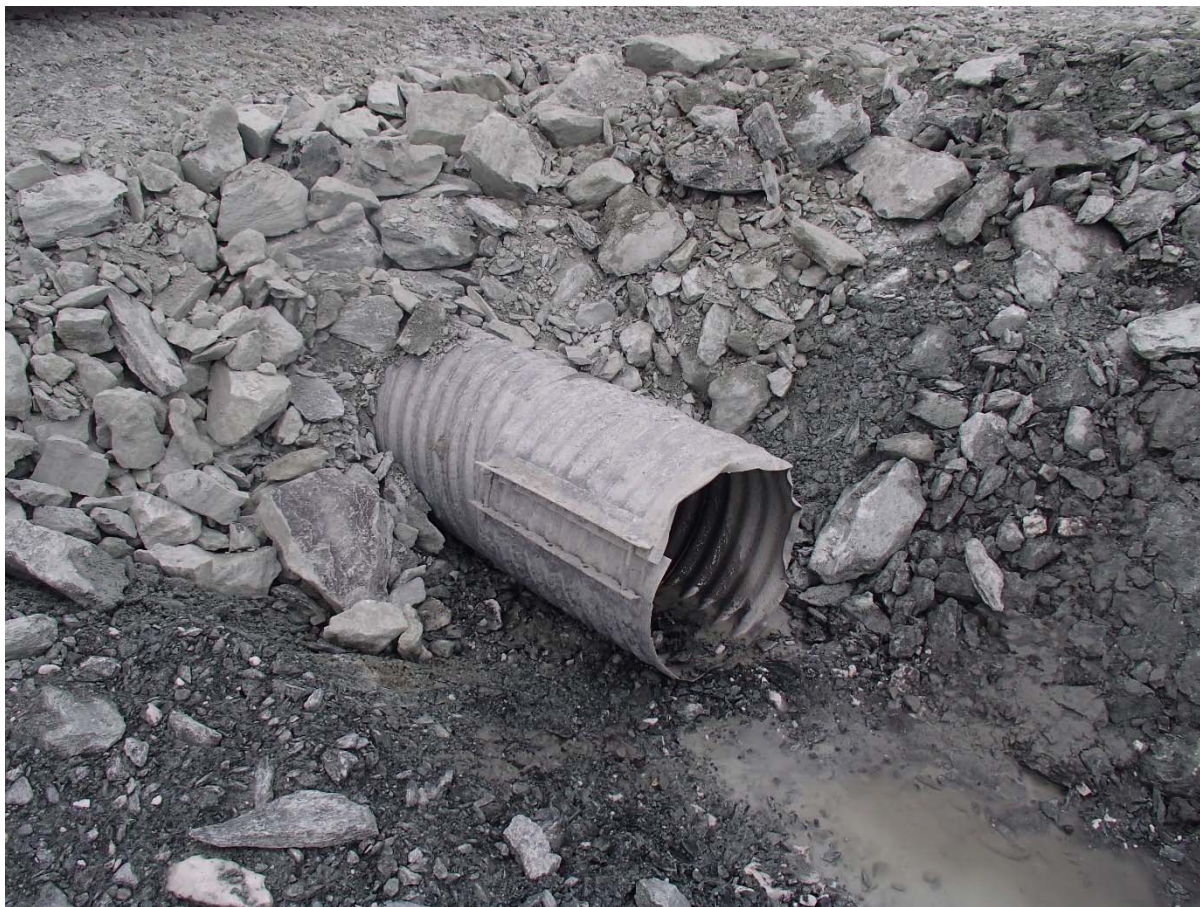
Photograph NCIS-127: From Sta. 1+470/+20 m (approx.), looking SW. View of the culvert installed in the ditch at Sta. 1+460 m.

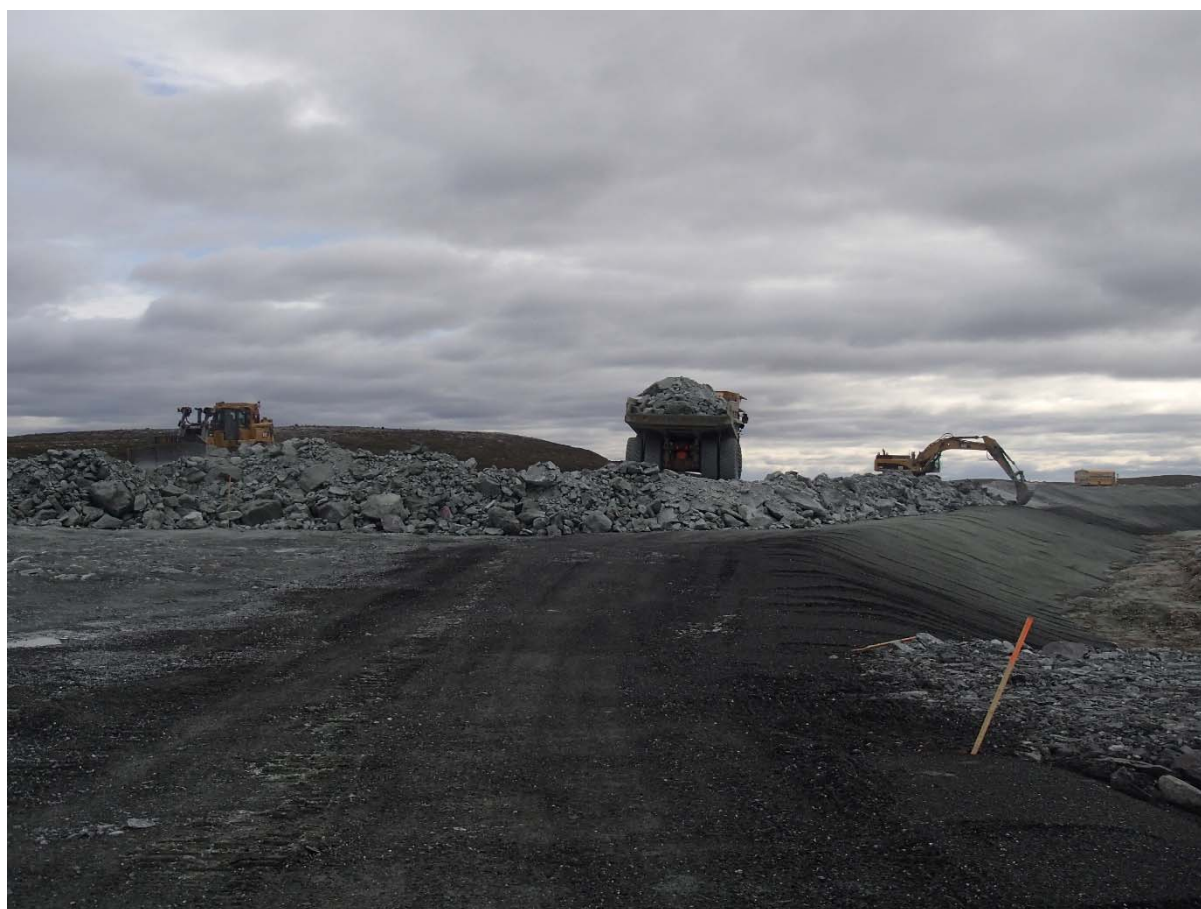
Photograph NCIS-128: From Sta. 1+680/-42 m (approx.), looking NE. Placement of a 2 m thick (approx.) lift of UM rockfill from El. 152 m to El. 154 m (approx.) with a dozer from Sta. 1+830 m to 1+660 m (+8 m to -31 m) and profiling of the upstream slope (3H:1V) from El. 152 to 154 m with an excavator from Sta. 1+880 m to 1+780 m.

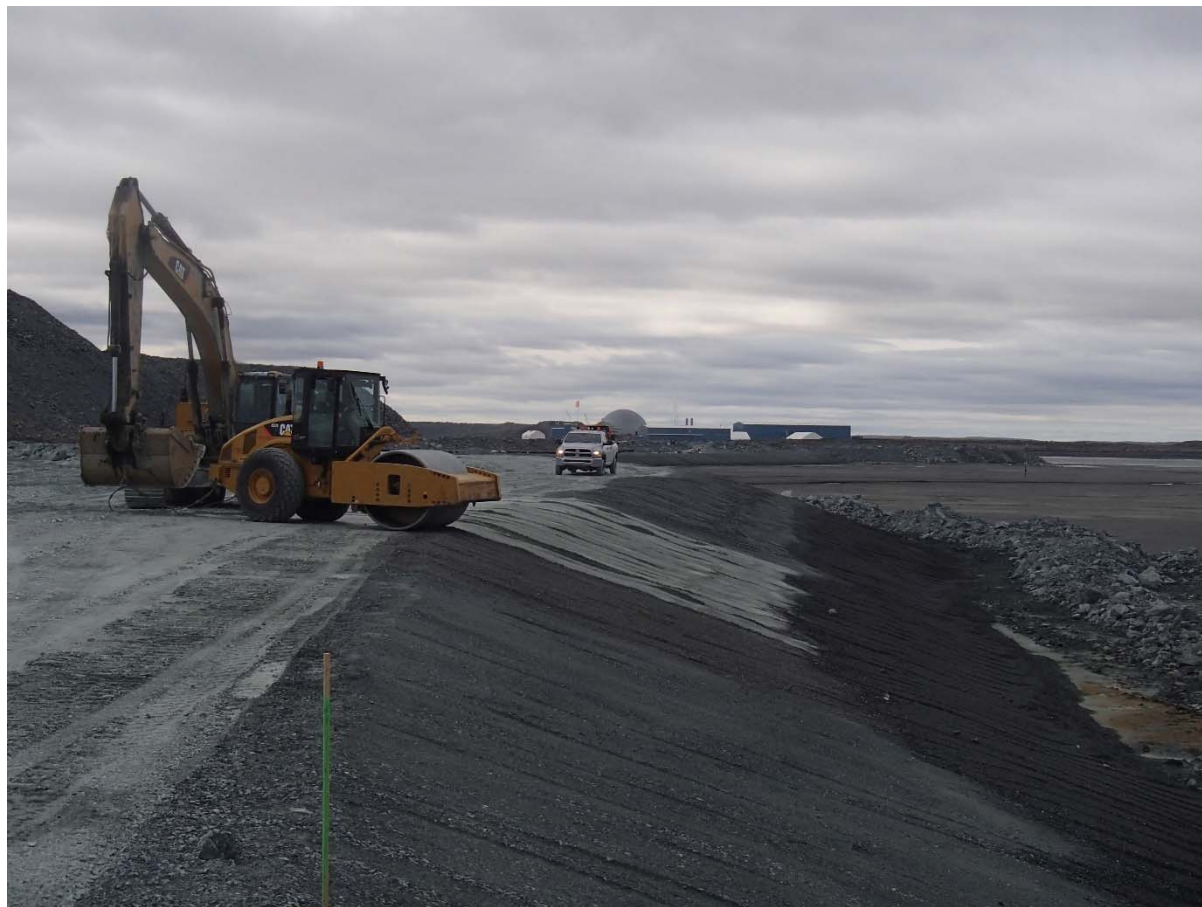
Photograph NCIS-129: From Sta. 2+450/-21 m (approx.), looking S. Compaction of the 0.5 m lift (approx.) of fine filter between El. 152 m and 154 m with a 10-tonne smooth-drum compactor with vibration (4 passes) in the upstream slope from Sta. 2+220 m to 1+940 m.

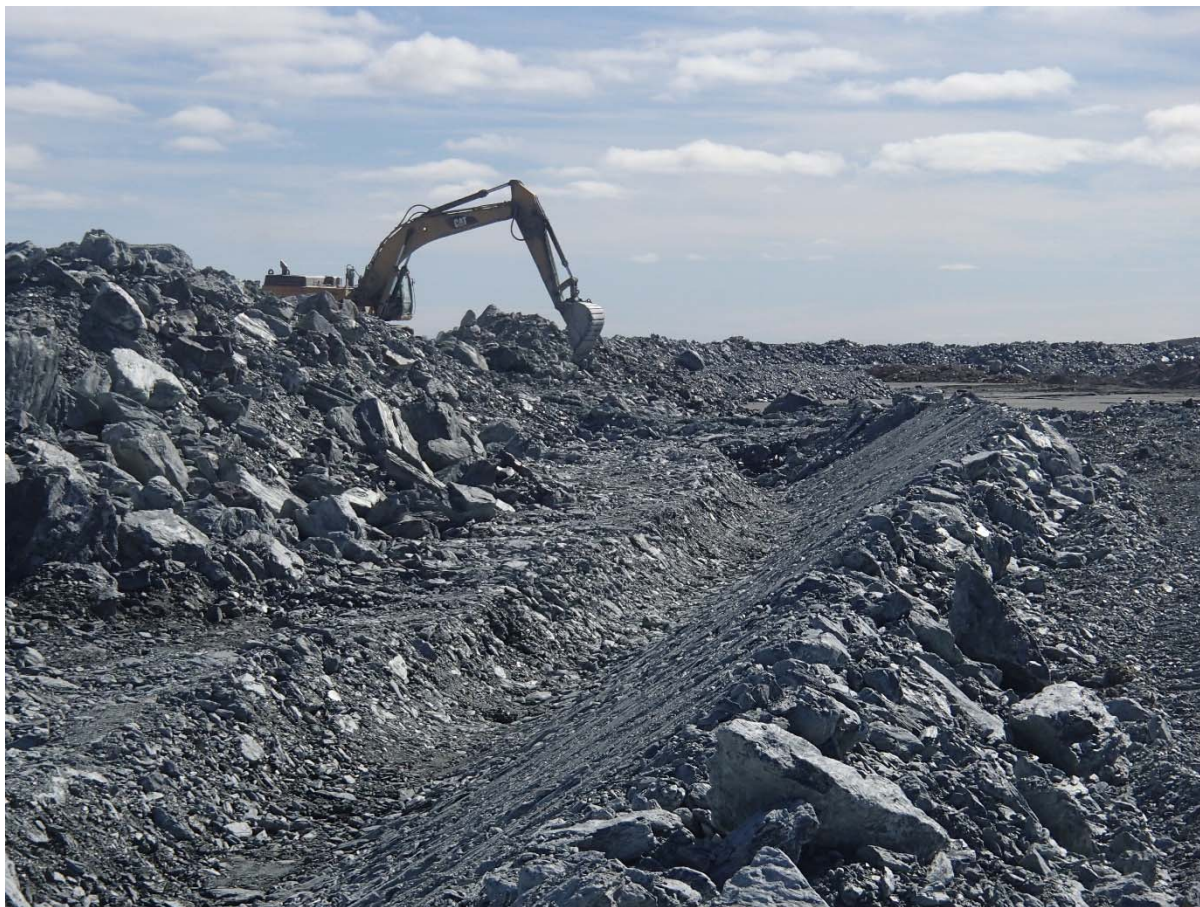
Photograph NCIS-130: From Sta. 1+446/+16 m (approx.), looking S. Excavation of a 0.8 m (approx.) deep, 1 m wide shallow ditch in the rockfill capping with an excavator from Sta. 1+380 m to 1+300 m.

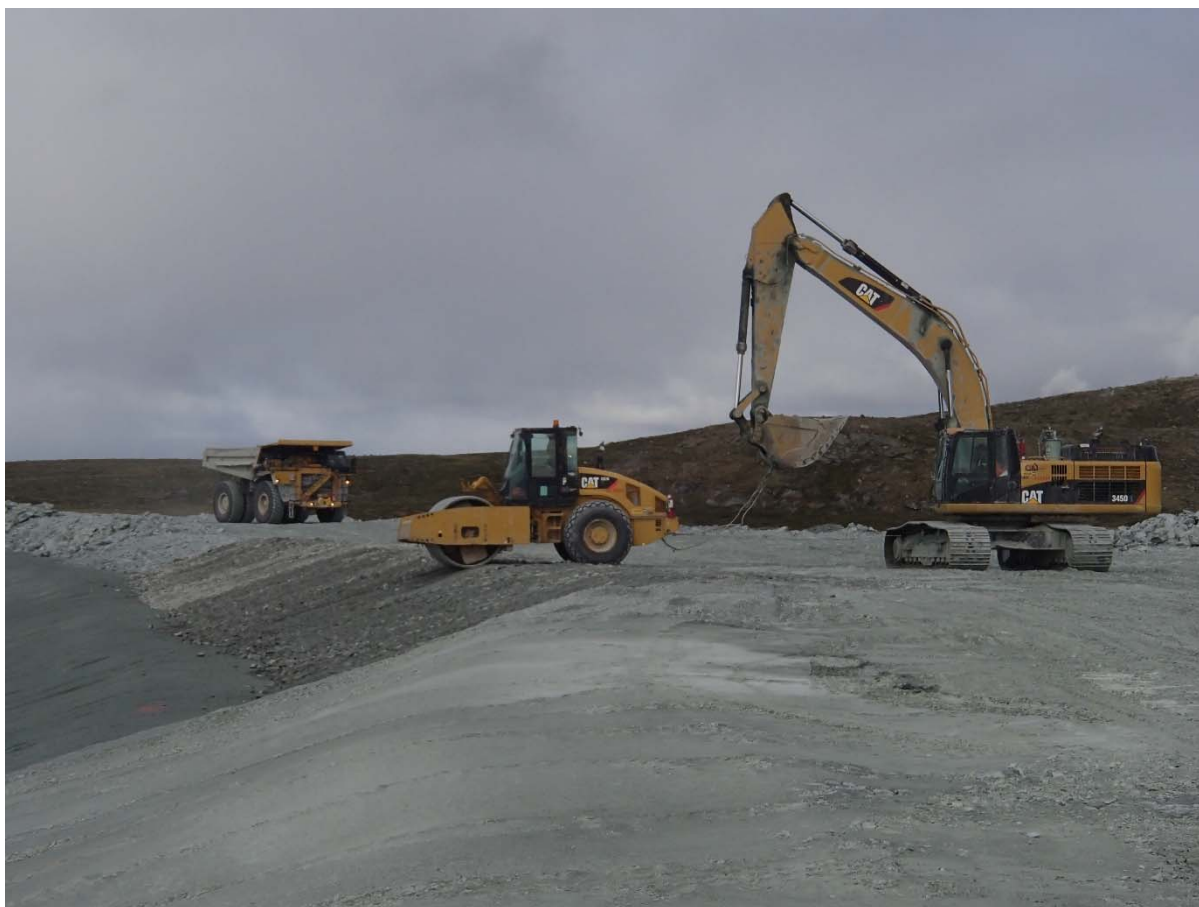
Photograph NCIS-131: From Sta. 1+940/-20 m (approx.), looking W. Compaction of the 0.5 m lift (approx.) of coarse filter between El. 152 m and 154 m with a 10-tonne smooth-drum compactor with vibration (4 passes) in the upstream slope from Sta. 1+890 m to 1+826 m.

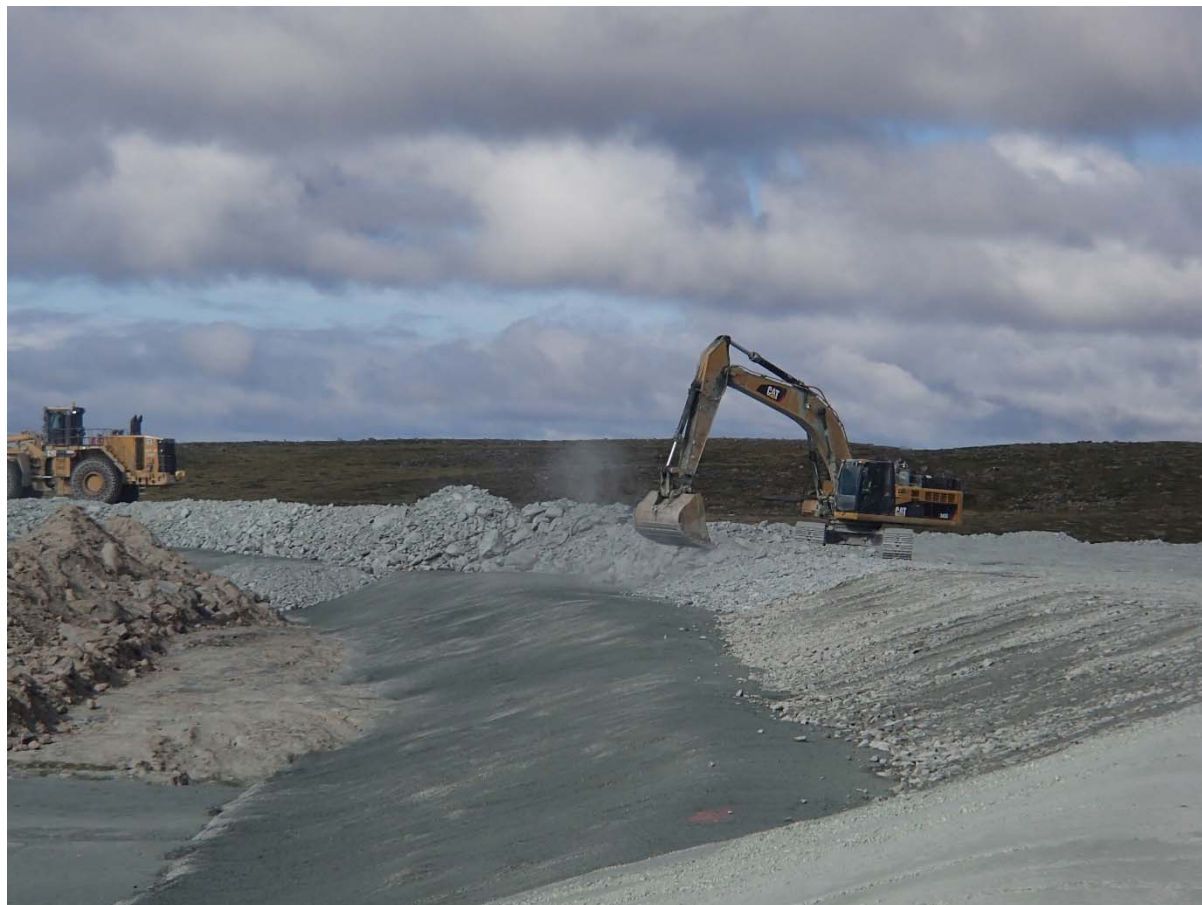
Photograph NCIS-132: From Sta. 1+940/-20 m (approx.), looking W. Profiling of the upstream slope (3H:1V) from El. 152 to 154 m with an excavator from Sta. 1+780 m to 1+660 m.

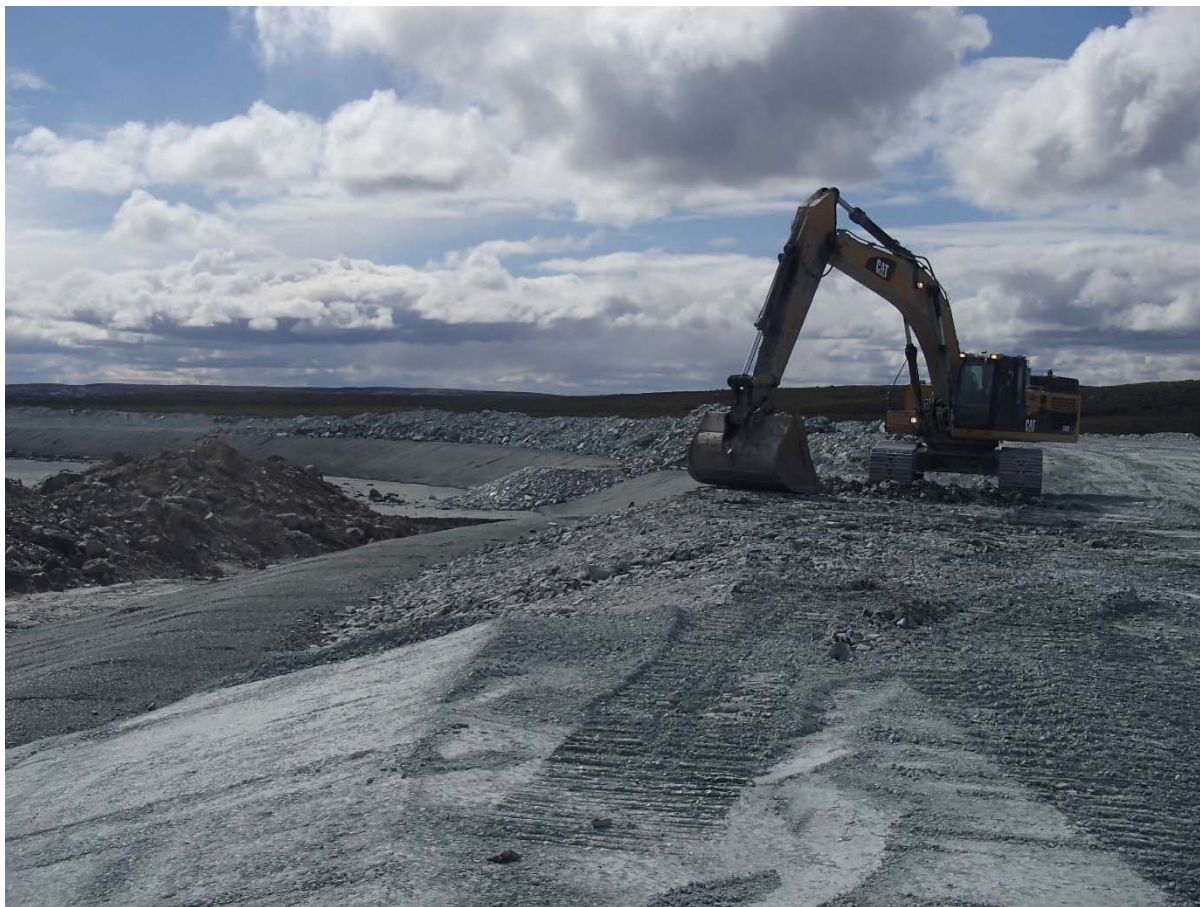
Photograph NCIS-133: From Sta. 1+820/-28 m (approx.), looking W. Placement of a 0.5 m thick lift of coarse filter in the upstream slope from El. 152 m to 154 m with an excavator from Sta. 1+890 m to 1+826 m.

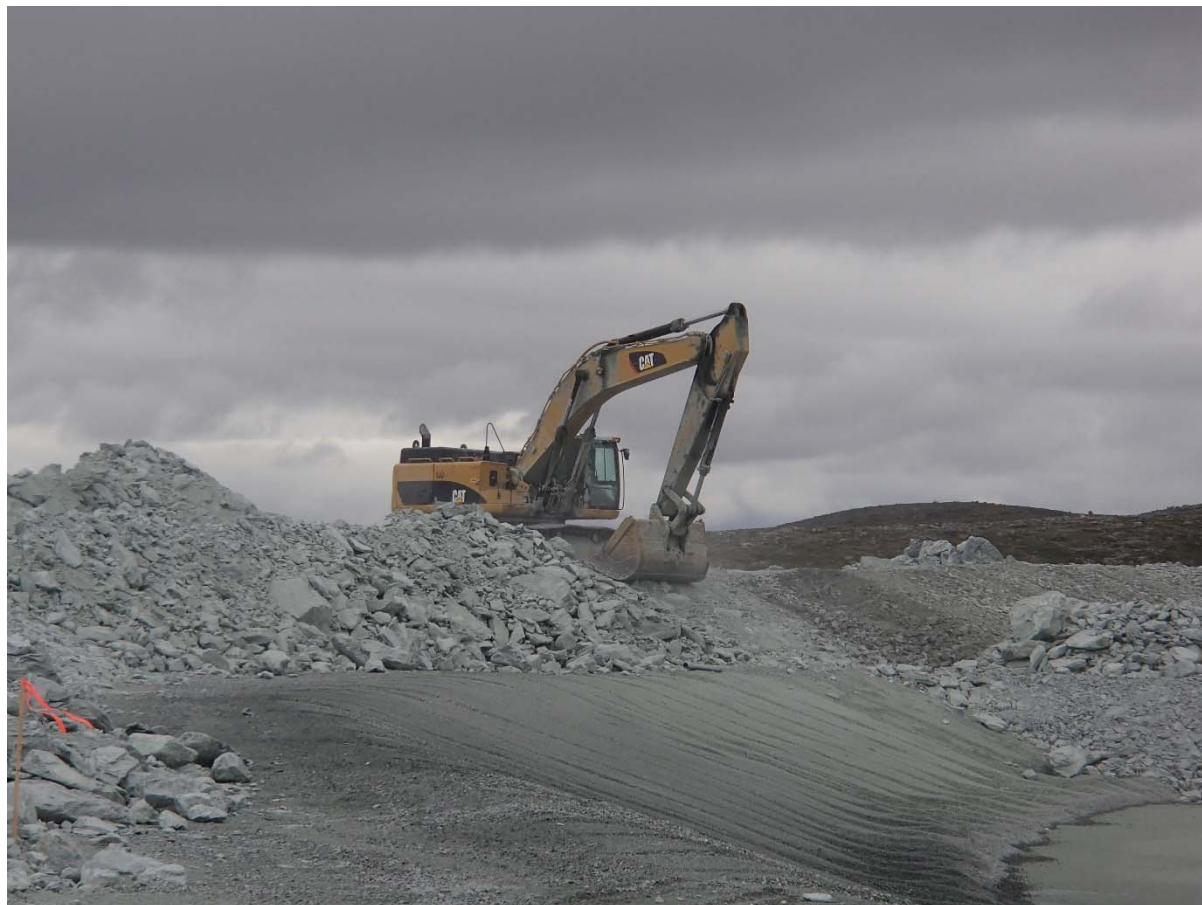
Photograph NCIS-134: From Sta. 1+630/-32 m (approx.), looking NE. Completion of the profiling of the upstream slope (3H:1V) from El. 152 to 154 m with an excavator from Sta. 1+700 m to 1+660 m.
