QA DAILY REPORT

1897439-1576-TM-Rev0

QA DAILY REPORT FOR JULY 25TH, 2018 – TSF NORTH CELL CONSTRUCTION - MEADOWBANK (1897439)

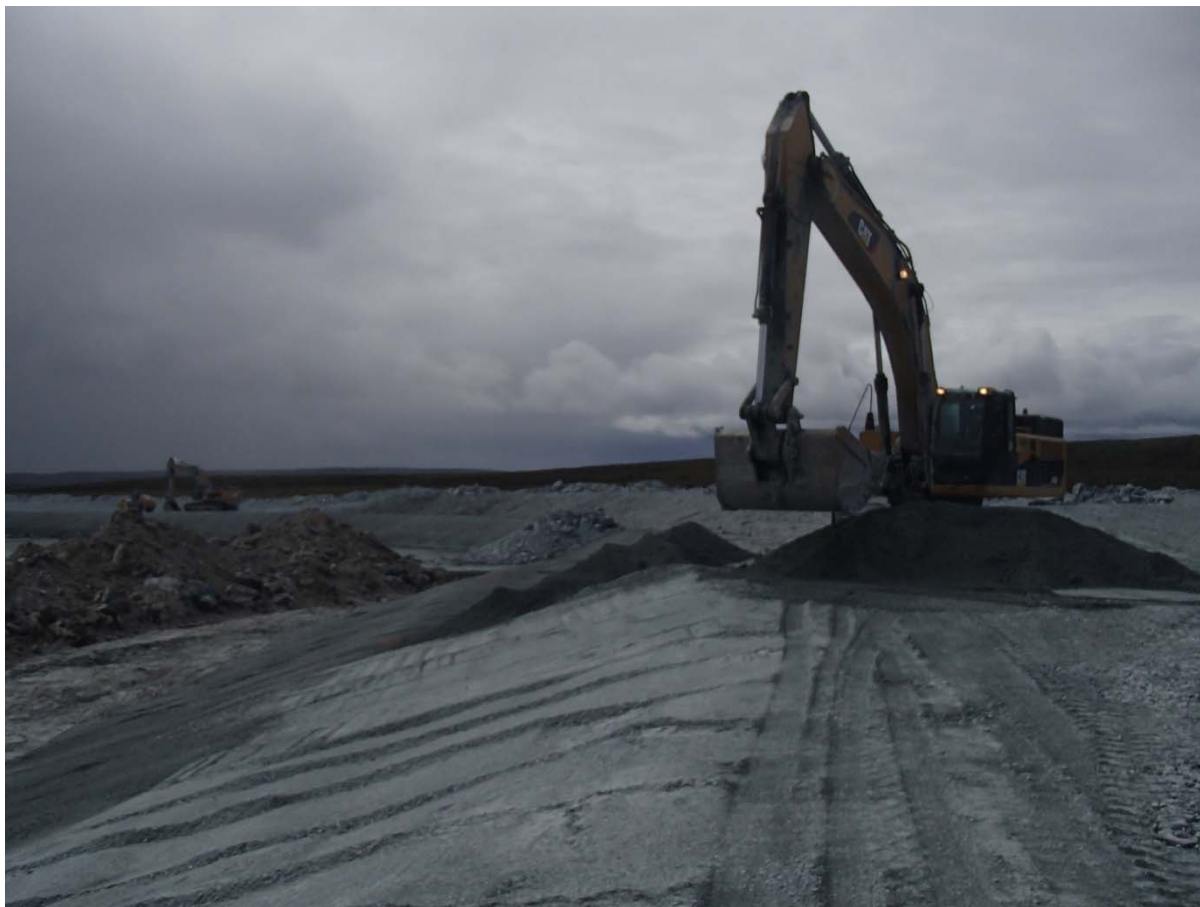
Photograph NCIS-135: From Sta. 1+860/-12 m (approx.), looking SW. Placement of a 0.5 m thick lift of fine filter in the upstream slope from El. 152 m to 154 m with an excavator from Sta. 1+830 m to 1+700 m.

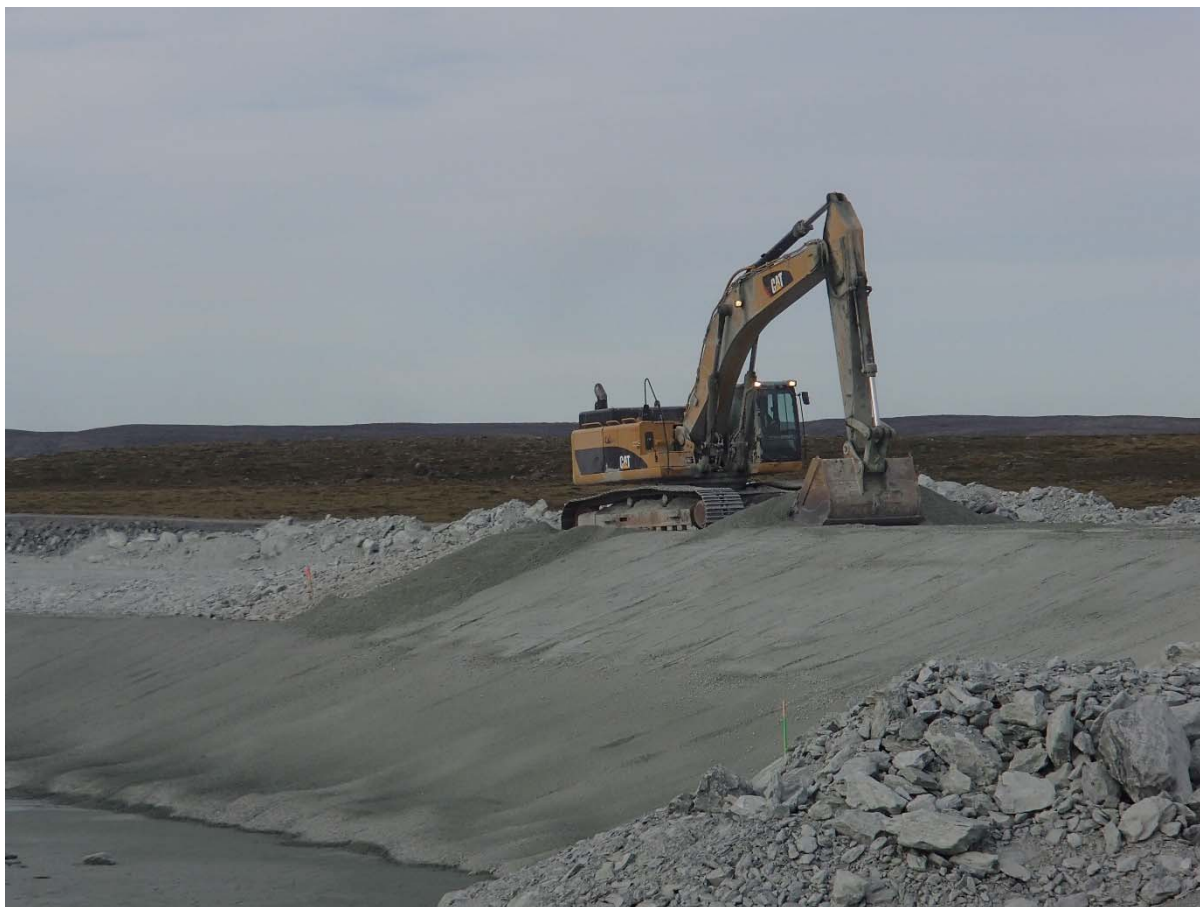
Photograph NCIS-136: From Sta. 1+800/-33 m (approx.), looking SW. Placement of a 0.5 m thick lift of fine filter in the upstream slope from El. 152 m to 154 m with an excavator from Sta. 1+700 m to 1+660 m.

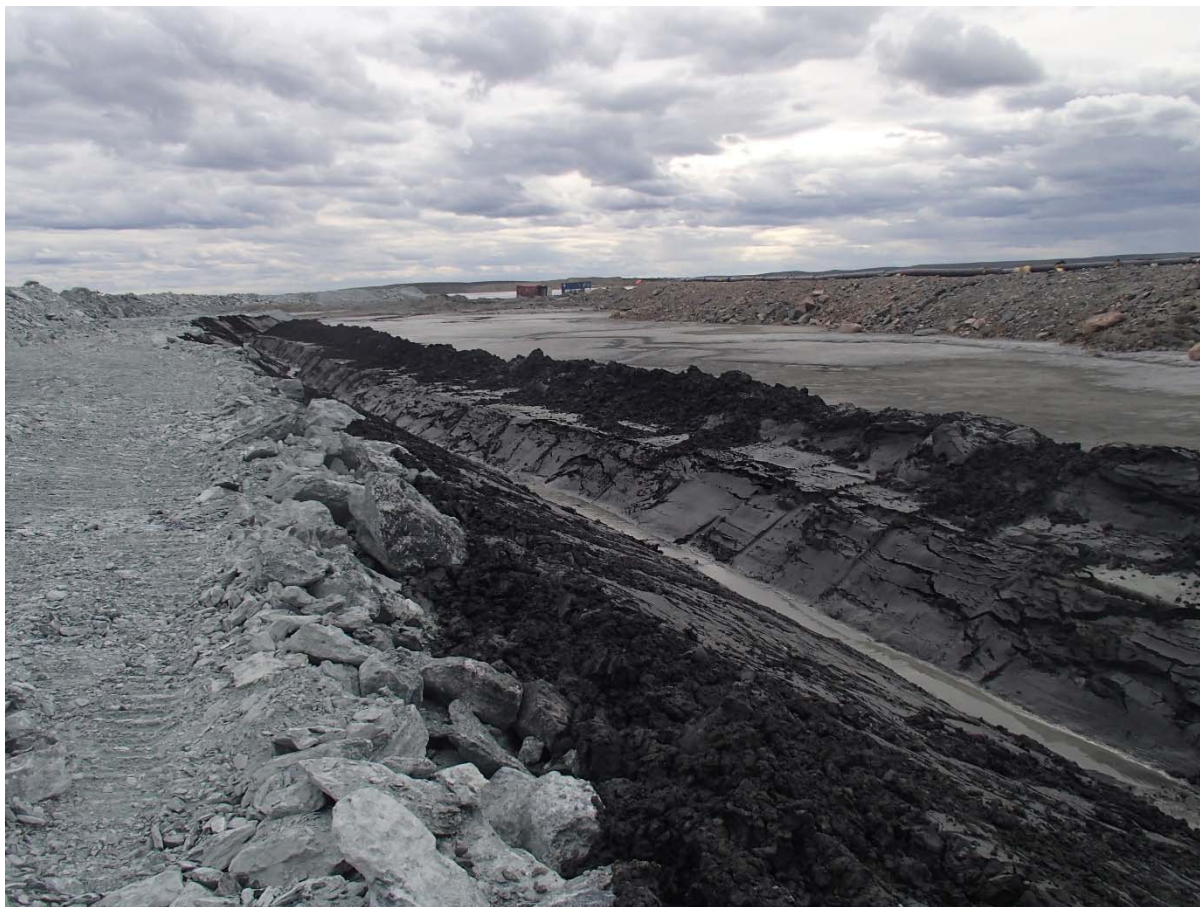
Photograph NCIS-137: From Sta. 1+380/+14 m (approx.), looking SW. Excavation of a 0.8 m (approx.) deep, 1 m wide shallow ditch in the tailings with an excavator from Sta. 1+300 m to 1+200 m.

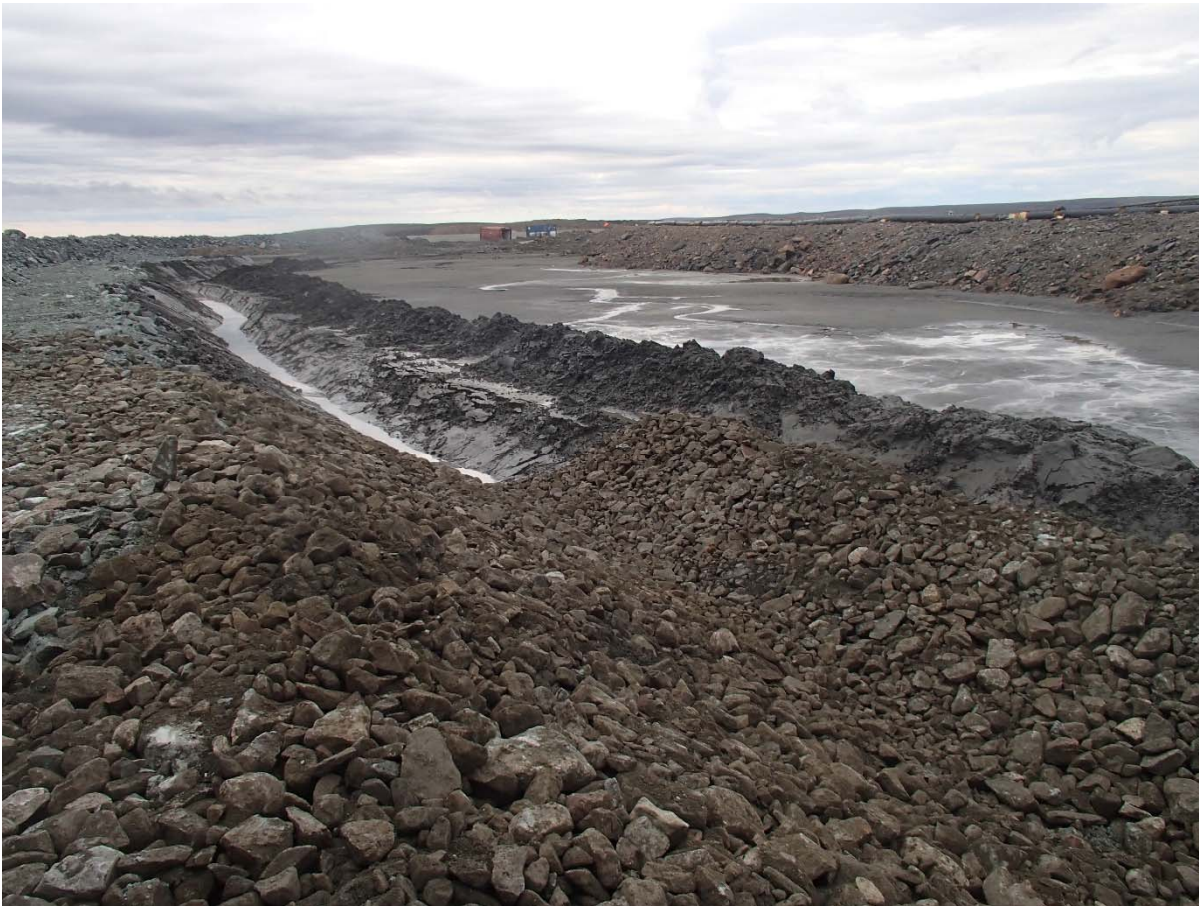
Photograph NCIS-138: From Sta. 1+365/+15 m (approx.), looking SW. Excavation of a 0.8 m (approx.) deep, 1 m wide shallow ditch in the tailings and placement of a 0.3 m thick (approx.) layer of till sieving reject material on the bottom and on the slopes of the ditch from Sta. 1+200 m to 1+100 m.

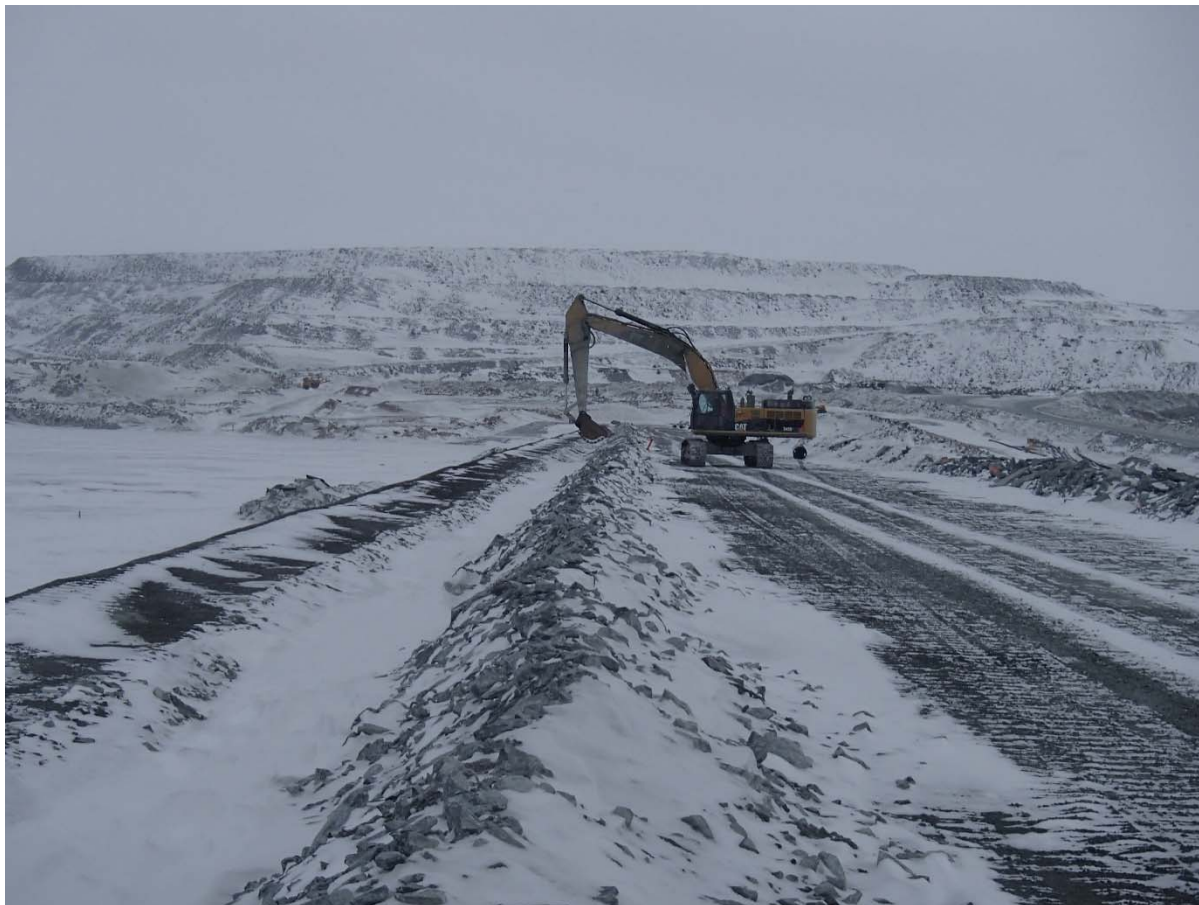
Photograph CD-1857: From Sta. 0+700/-20 m, looking N. Snow removal in the anchoring trench with an excavator between Sta. 0+170 m and 40+780 m.

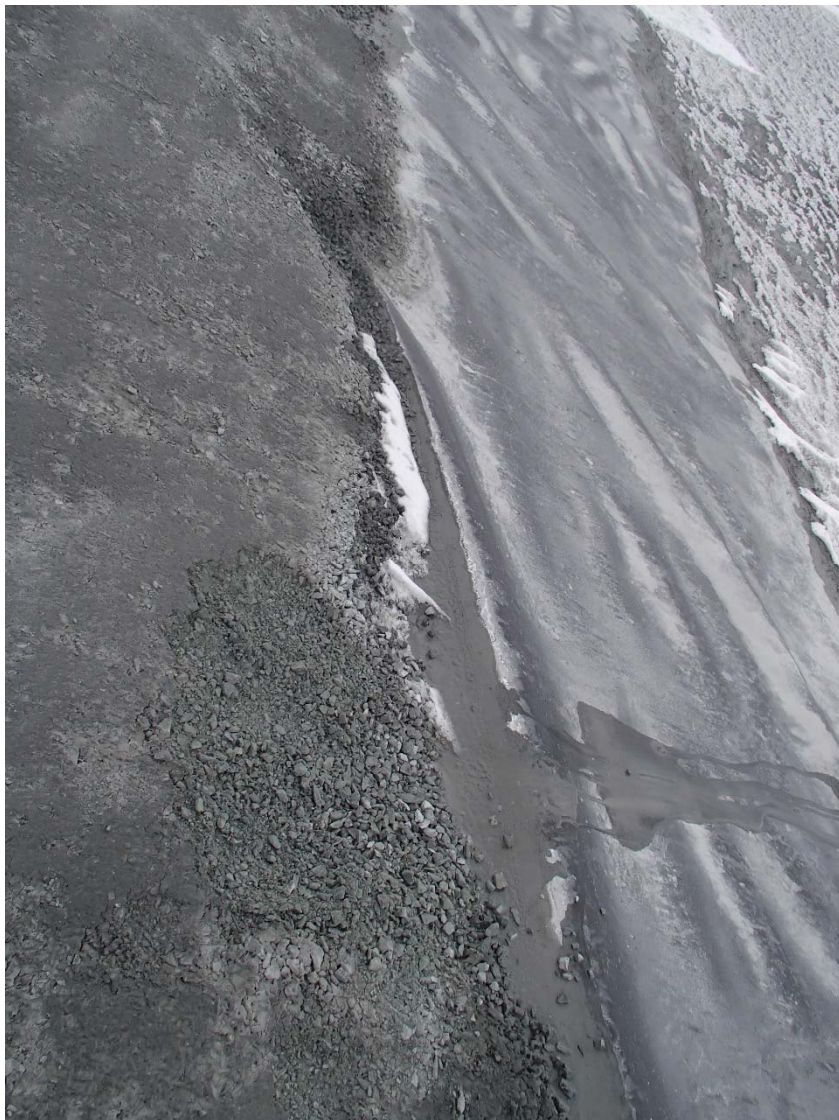
- Minor corrections to do at the bottom of the fine filter on the upstream slope of Central Dike have been identified by the QA Manager (see photograph below). Some fine filter is missing to achieve a smooth slope and transition with the existing liner. It is likely that the combination of the thawing of the fine filter today and the recent cleaning operations using pressurized air accounts for the observed loss of material at the junction with the existing LLDPE liner.

Photograph CD-1858: From Sta. 0+970/-45 m, looking S. View of the bottom of the fine filter upstream slope. Some material is missing to achieve a smooth slope.

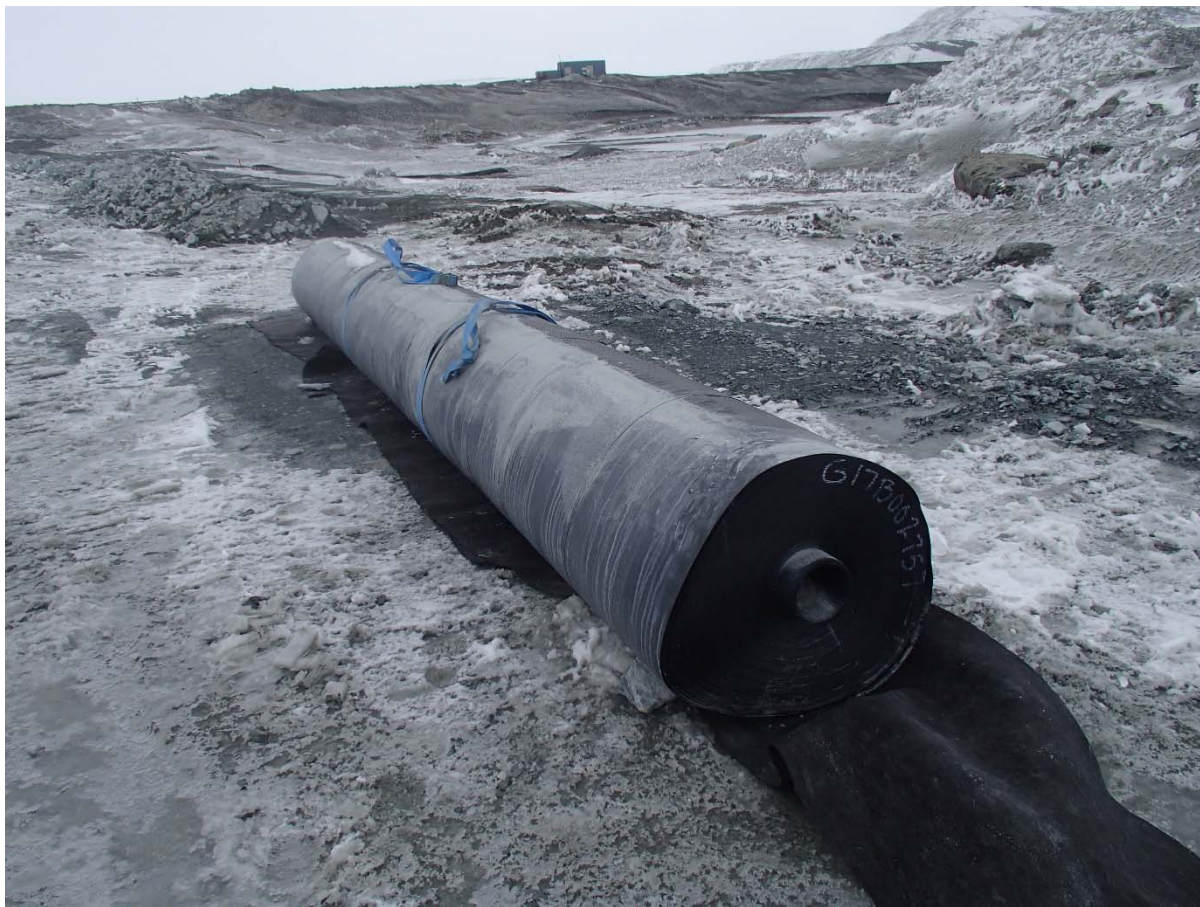
Photograph SD3-303: From Sta. 20+780/-15 m, looking N. View of a LLDPE liner roll stored on geotextile.

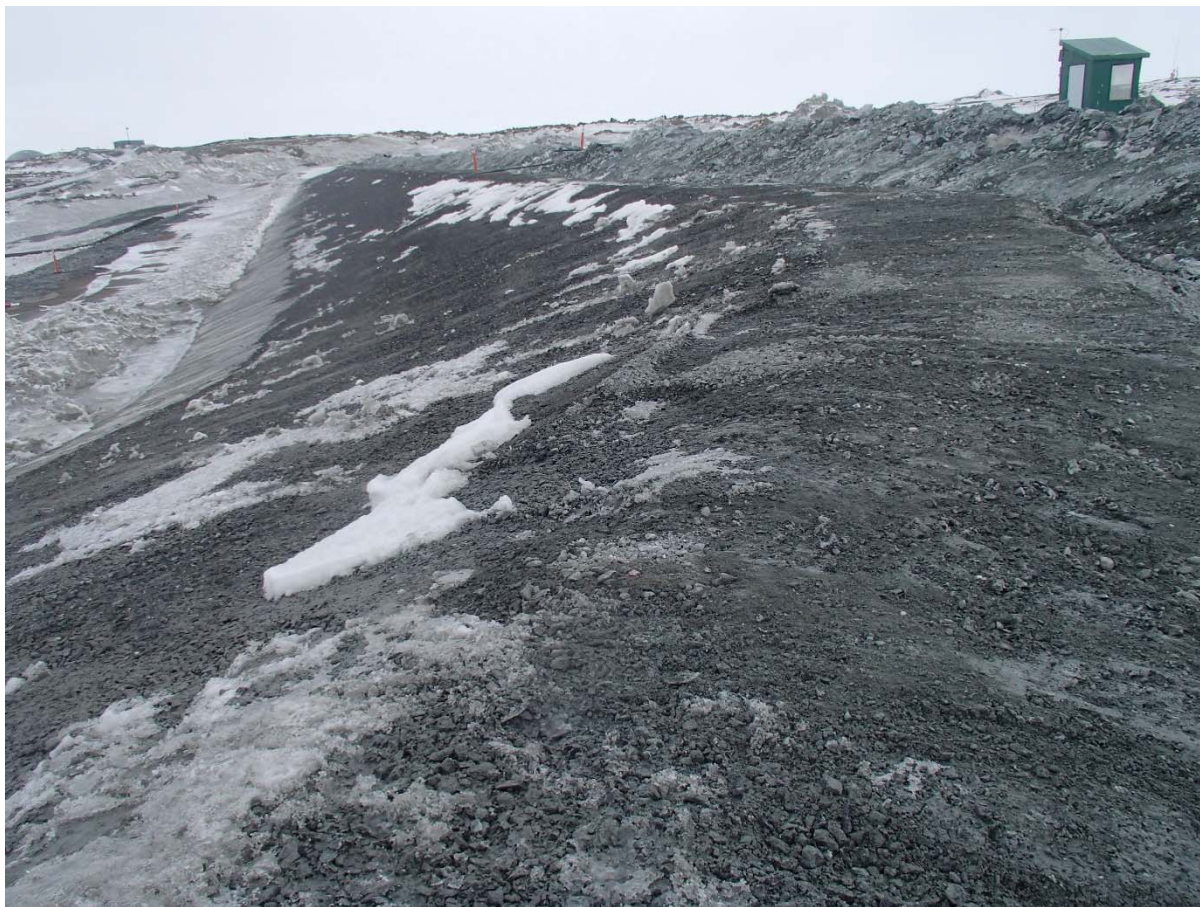
Photograph SD3-304: From Sta. 20+620/-36 m, looking SE. Smoothing of the surface of the fine filter with an excavator on top of the upstream slope from Sta. 20+600 m to 20+780 m.

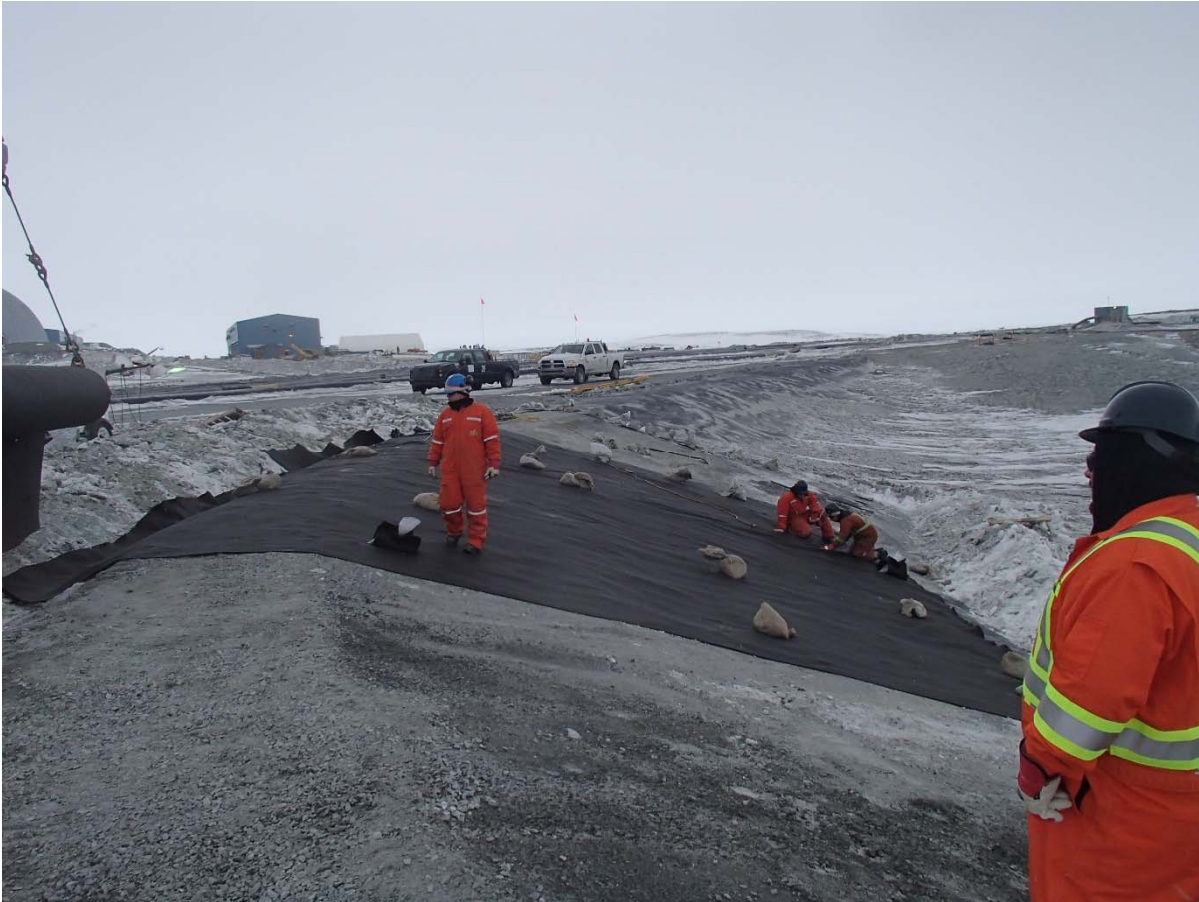
Photograph CD-1859: From Sta. 40+780/-38 m, looking SW. Installation of the geotextile on the upstream slope 3H:1V (SD5 side) to 2H:1V (Central Dike side) between El. 143 m and 145 m from Sta. 40+640 m to 0+830 m.

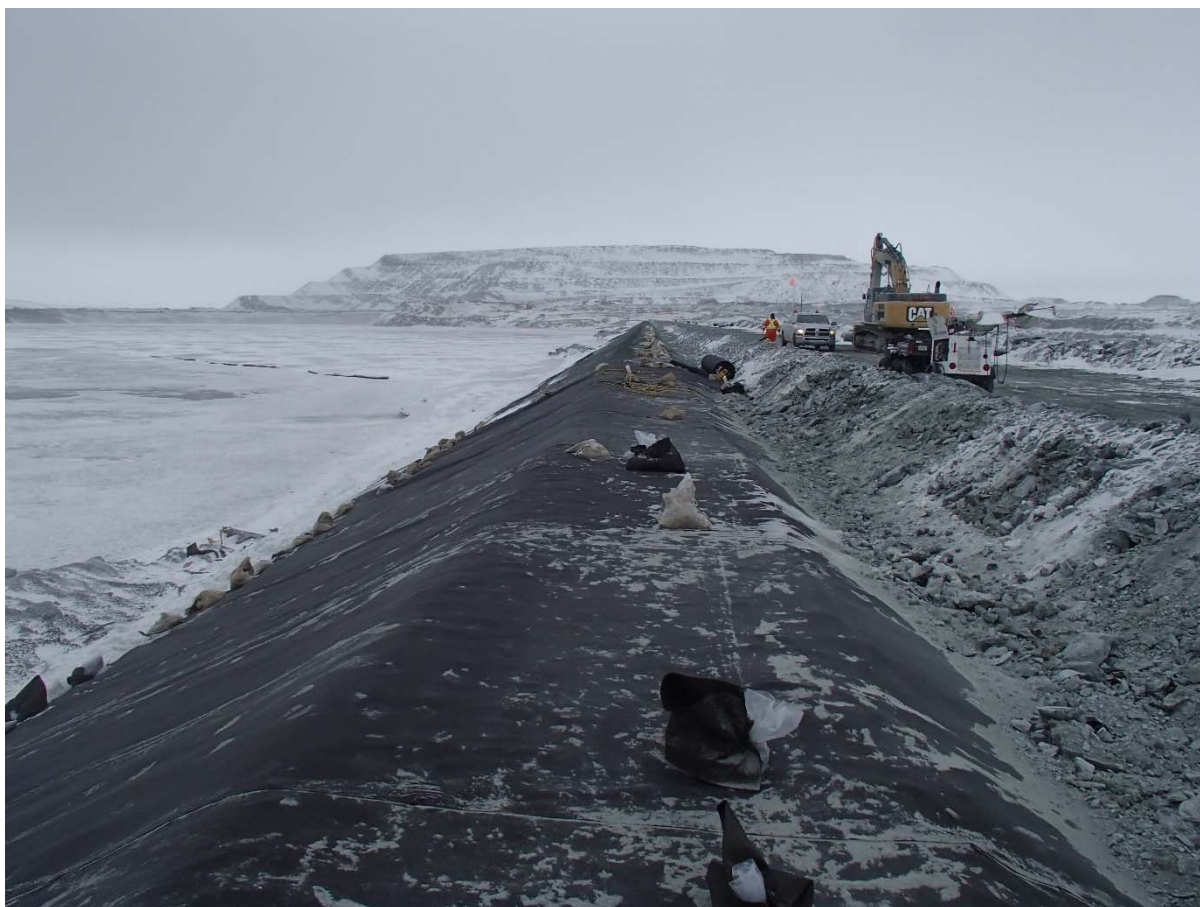
Photograph CD-1860: From Sta. 0+790/-26 m, looking N. Installation of the geotextile on the upstream slope 2H:1V between El. 143 m and 145 m from Sta. 0+830 m to 0+750 m.
