QA DAILY REPORT

1897439-1576-TM-Rev0

QA DAILY REPORT FOR MAY 25TH, 2018 – TSF SOUTH CELL CONSTRUCTION - MEADOWBANK (1897439)

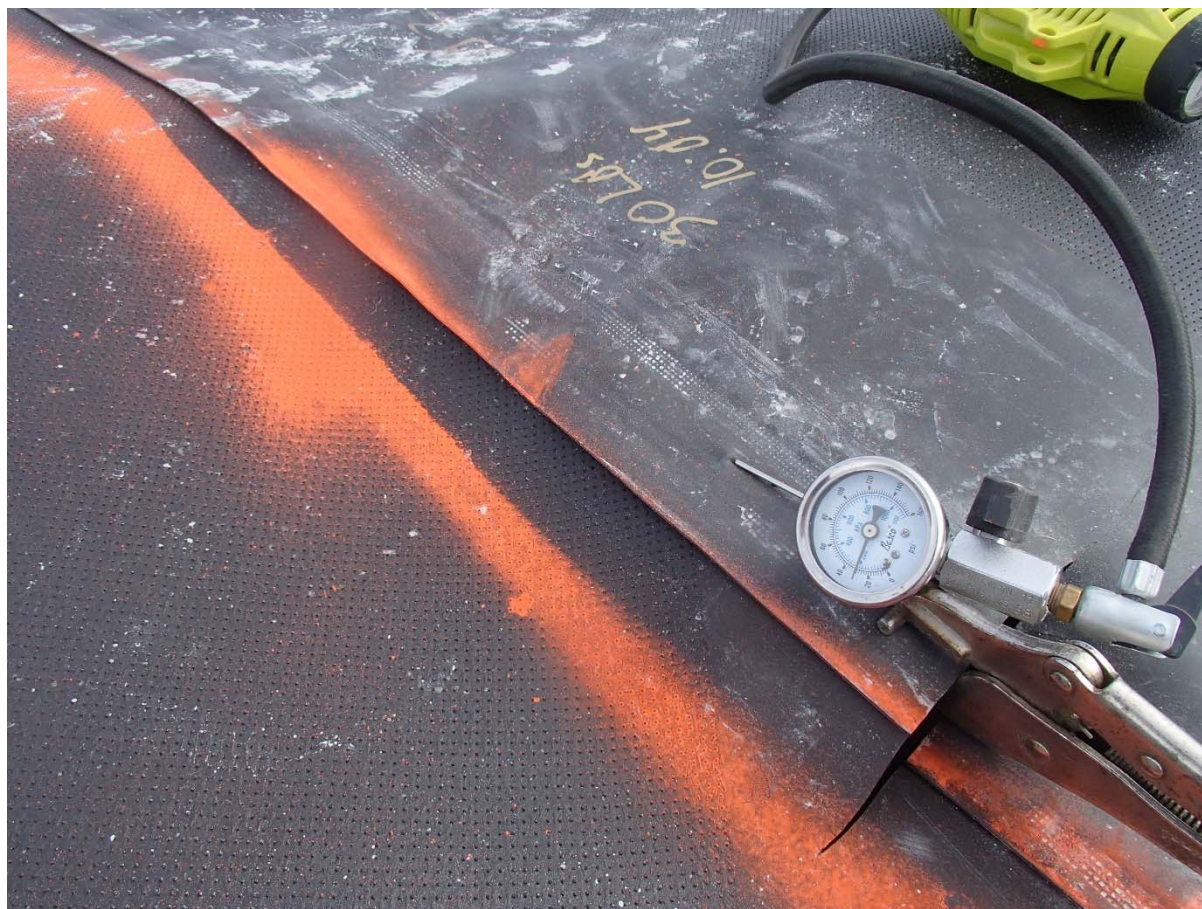
Photograph CD-1862: From Sta. 40+960/-24 m. View of an air channel test.

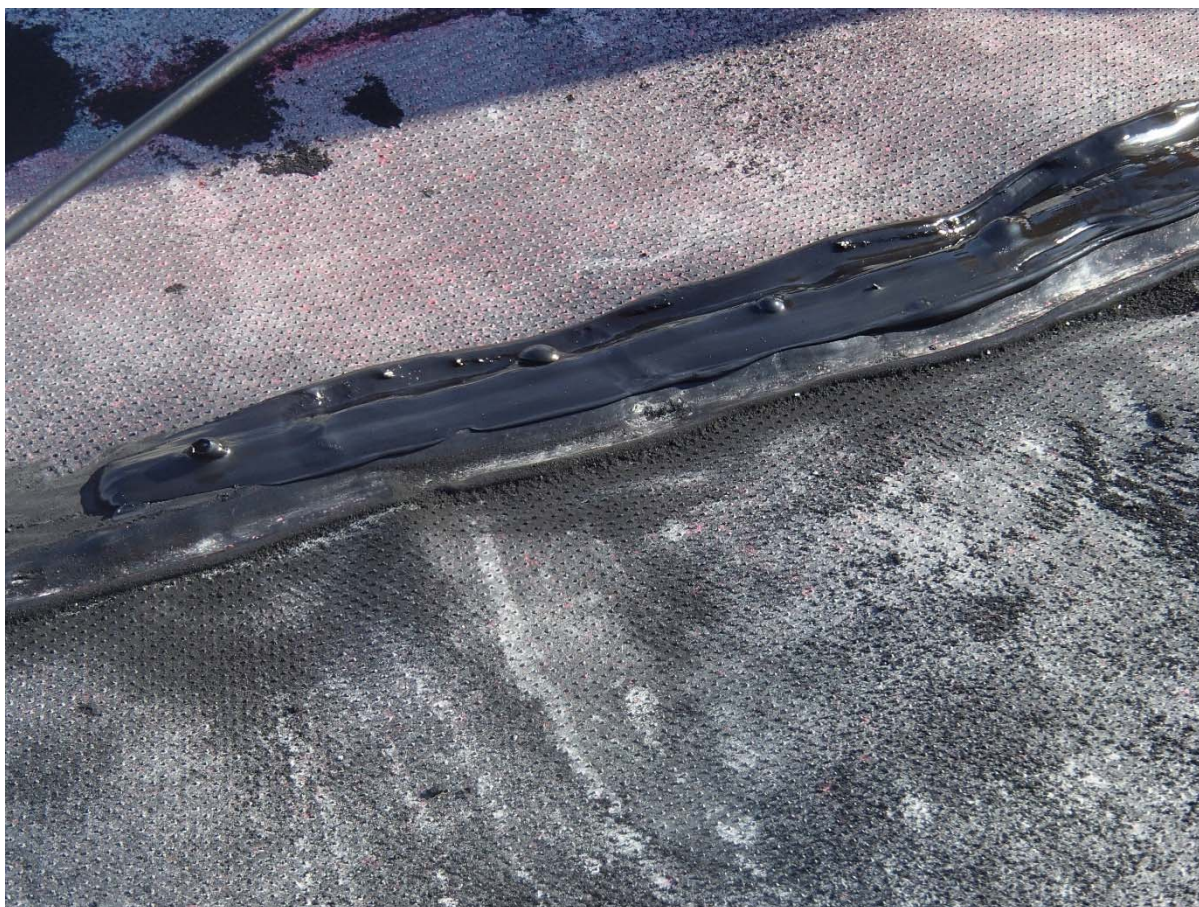
- The QA Manager reiterated that the LLDPE liner anchoring trench on the crest of the dike must be compacted after being backfilled with 4 passes of the compactor.
- Because of humidity (thawing slope underneath the geosynthetics), the extrusion weld at the bottom of the LLDPE liner panels needs additional repairs on some sections. Welding is difficult because of water flowing down the slope which creates bubbles in the resin. The underlying liner has been cut at some places to drain the water and patches have been welded (see photographs).

Photograph CD-1864: From Sta. 40+700/-38 m. View of bubbles formed in the extrusion weld because of humidity.

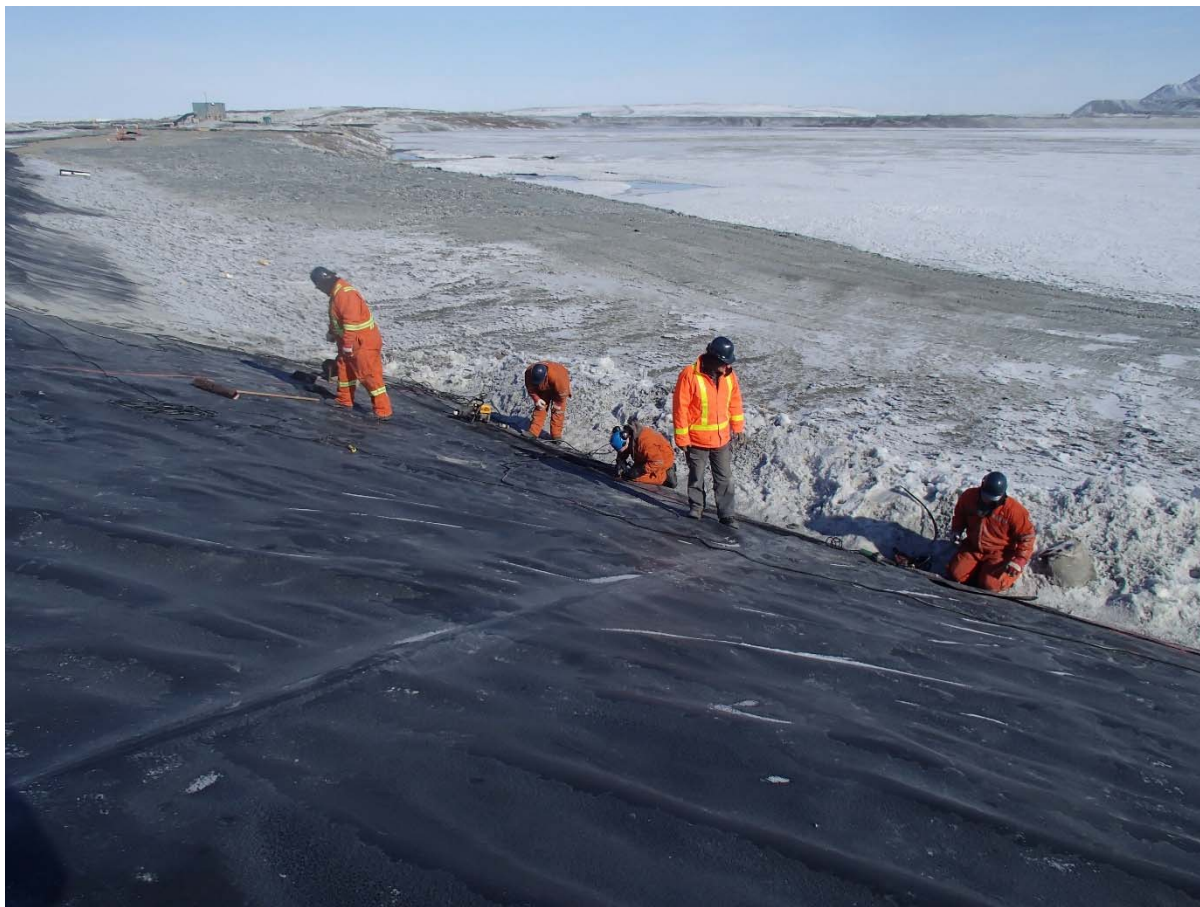
Photograph CD-1865: From Sta. 40+740/-35 m, looking NW. Repairs on the extrusion fillet seam at the bottom of the LLDPE liner panels between Sta. 40+680 m and 0+950 m, on panels 802 to 807, and 811 to 813.

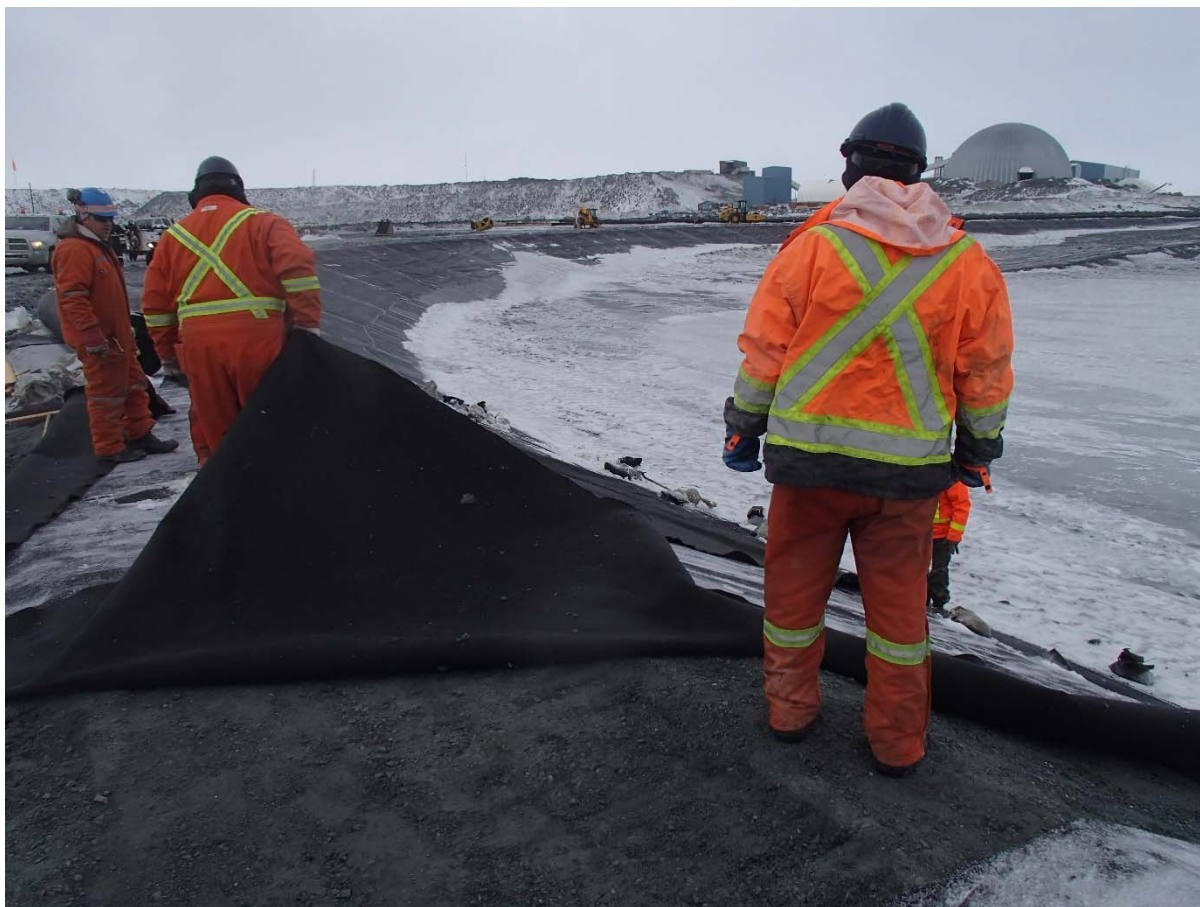
- The uncovered geotextile in place is wet and frozen. In order to avoid welding issues, geotextile panels from Sta. 0+935 m to 0+900 m were removed and replaced with new geotextile before LLDPE liner installation.
- Starting today, the geotextile panels are welded together with the dual hot wedge instrument. The overlap is about 150 mm. This type of welding yields a more regular and stronger bond than the heat gun.
- Due to strong winds, geosynthetics installation was interrupted at 12:00.

Photograph CD-1868: From Sta. 0+915/-24 m, looking S. Removal of the wet geotextile in place from Sta. 0+935 m to 0+900 m.

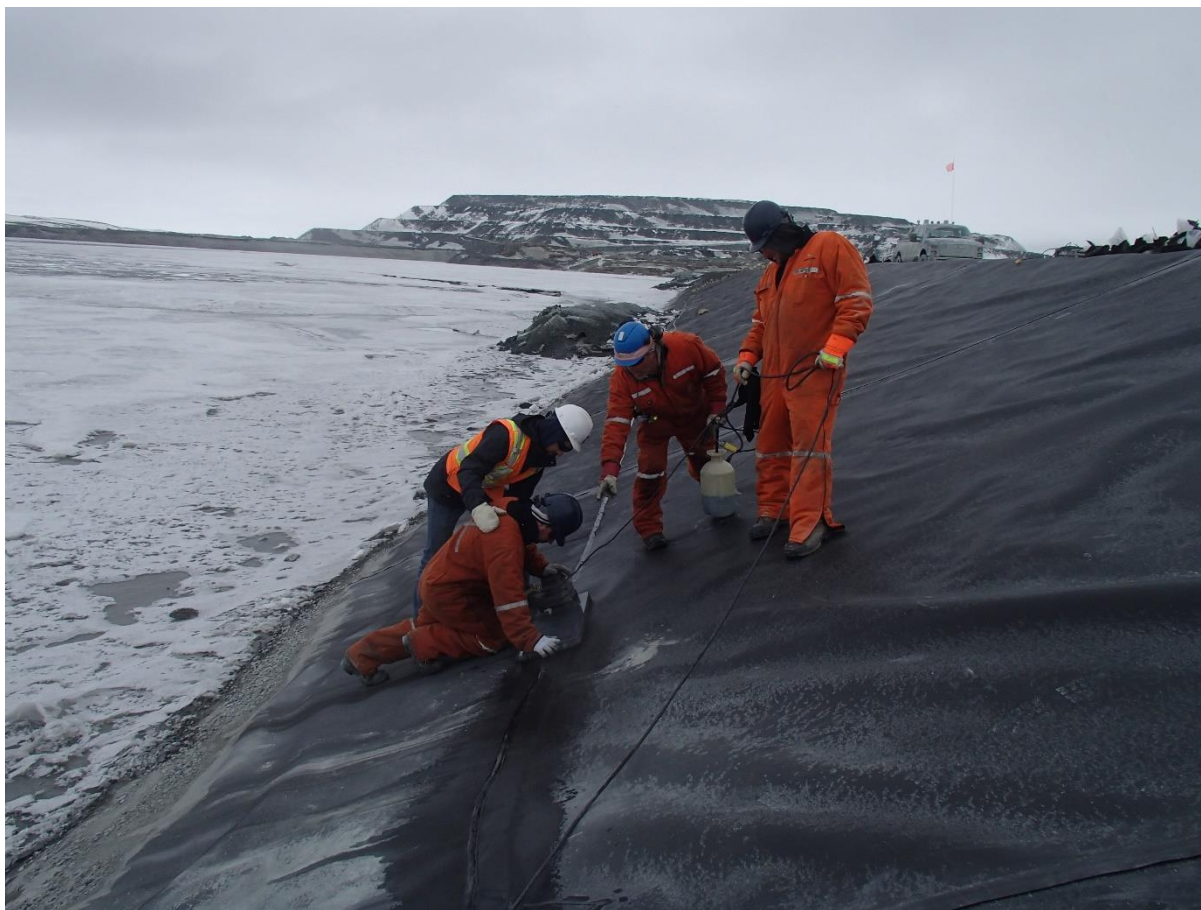
Photograph CD-1875: From Sta. 0+835/-26 m, looking N. View of a vacuum box testing.

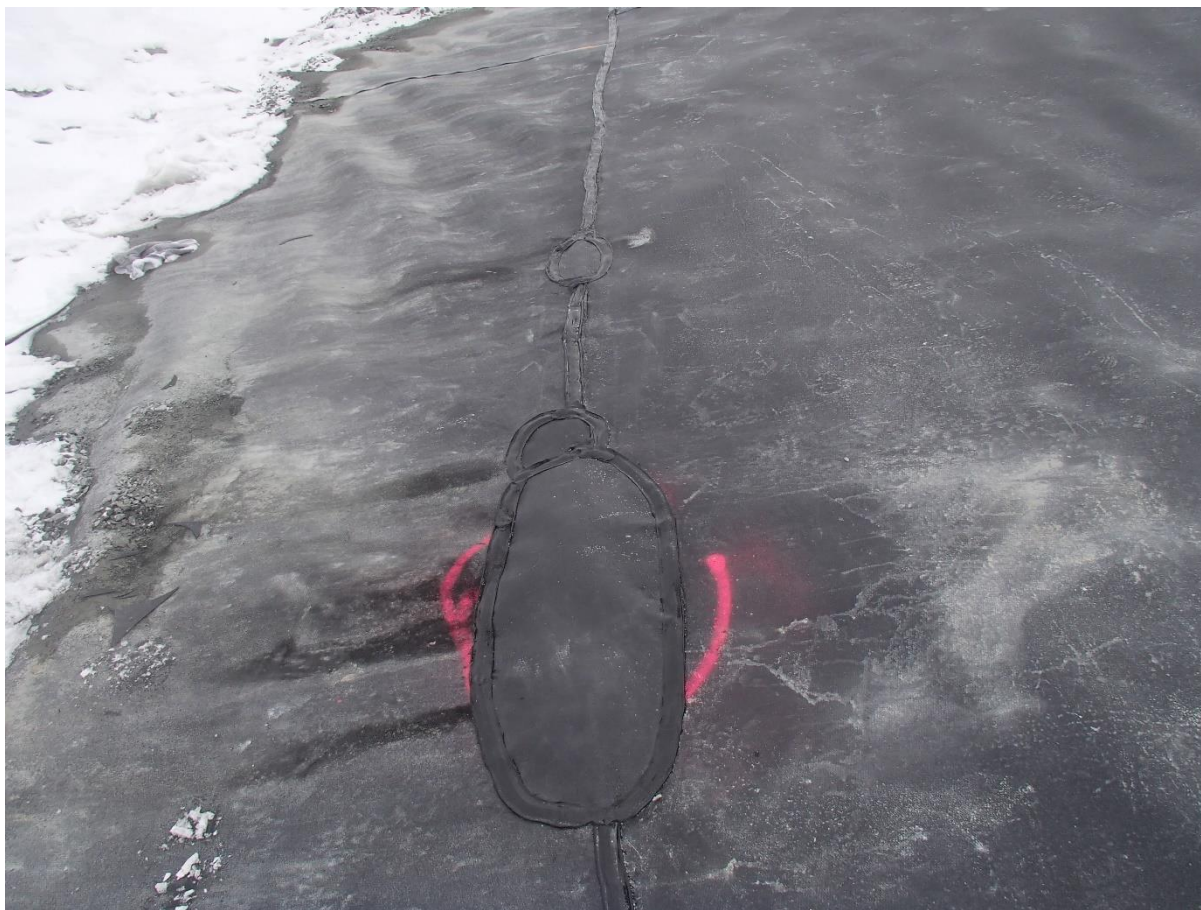
Photograph CD-1876: From Sta. 0+820/-26 m, looking N. View of repair patches on the extrusion weld at the bottom of panel 838.

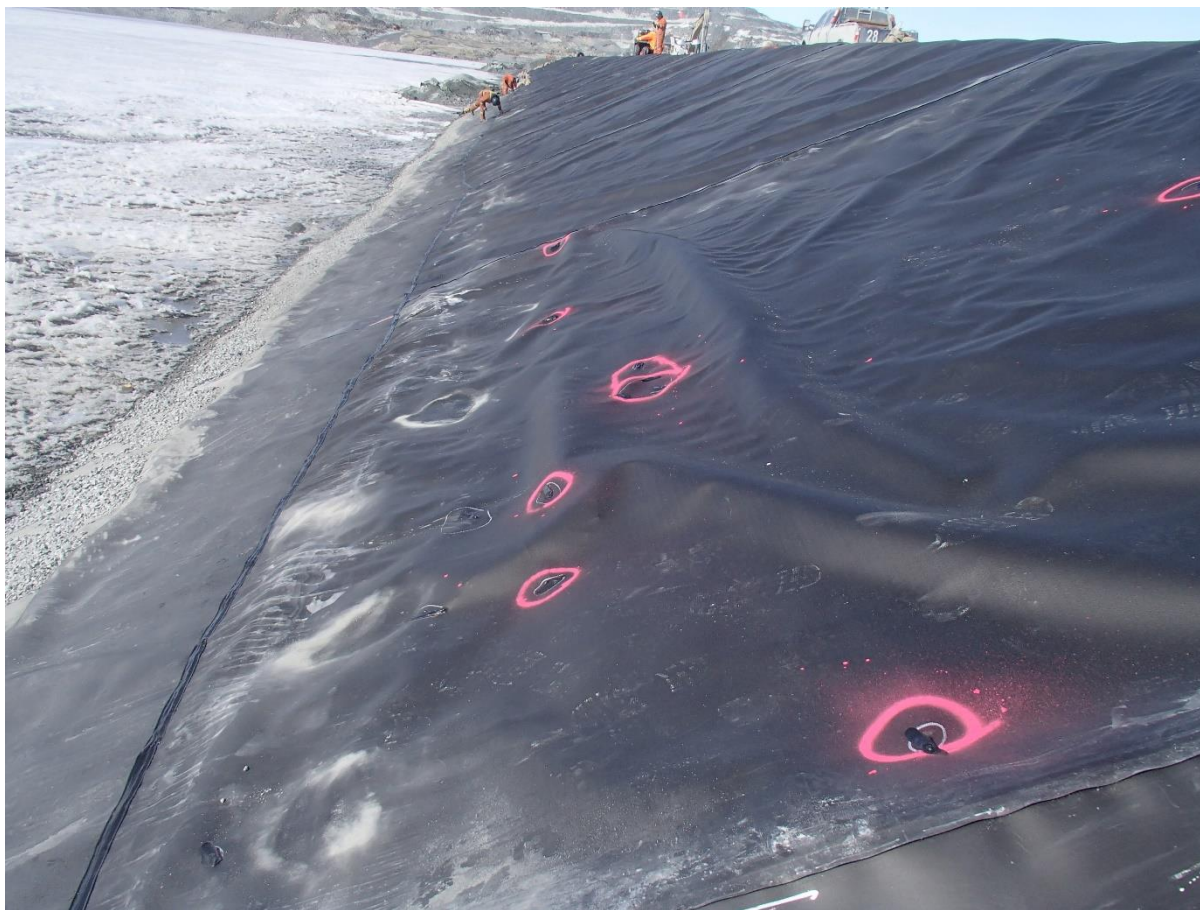
- In order to take advantage of the good weather, priority was given to installing LLDPE liner panels. The extrusion was weld up to Sta. 0+660 m and vacuum box testing will be performed tomorrow.
- The QA Manager observed a few holes on LLDPE panel 850 after its installation and the fusion weld with panel 849. Panel 850 was the beginning of a new roll. The holes were repaired with extrusion welding. The QA Manager reminded to discard the first few meters of the rolls to ensure that only intact, good quality material is used.

Photograph CD-1879: From Sta. 0+735/-28 m, looking N. View of the repaired holes on panel 850.

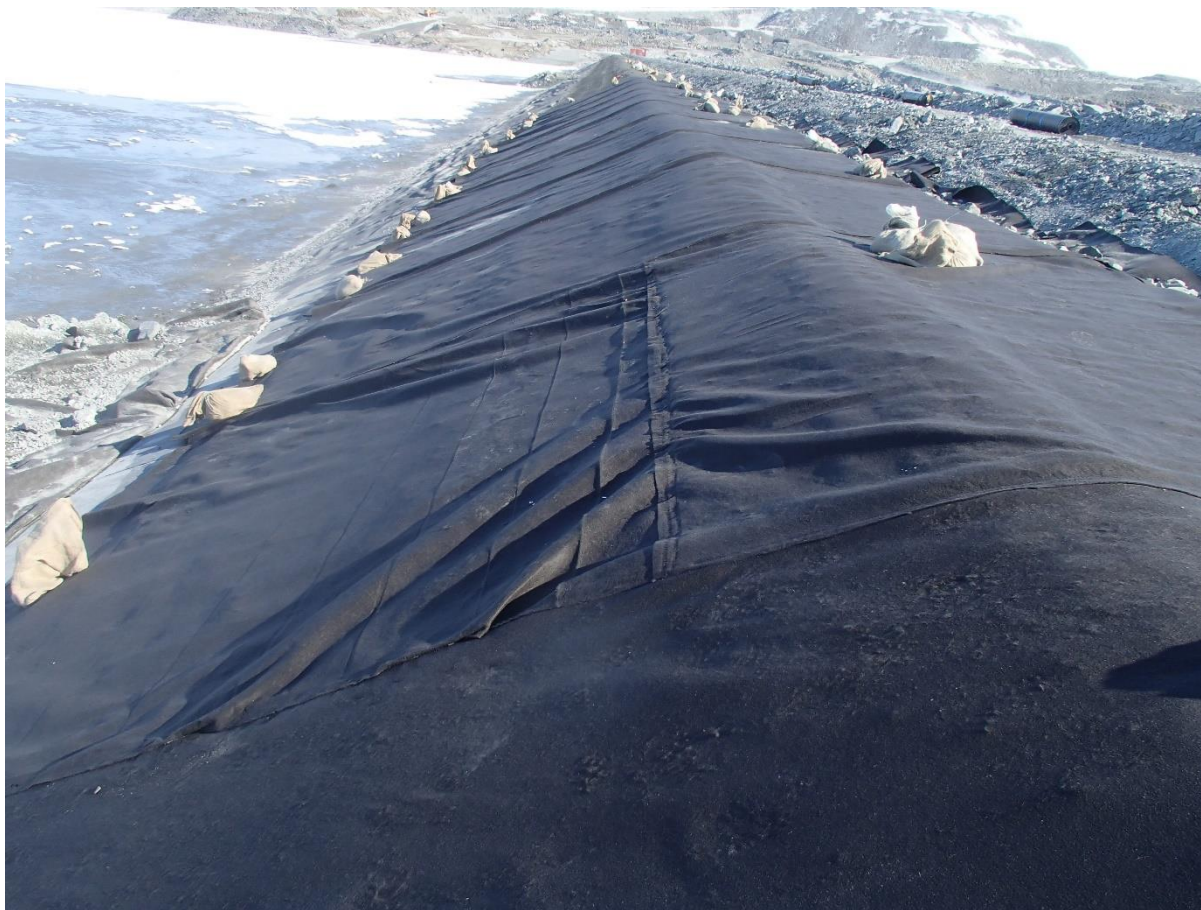
- In order to take advantage of the good weather, priority was given to installing LLDPE liner panels. The extrusion was weld up to Sta. 0+550 m and vacuum box testing will be performed latter.
- The QA Manager observed a geotextile panel with a horizontal weld in the slope at Sta. 0+520 m following its installation. The panel was removed and replaced it by a new geotextile panel before installing the LLDPE liner panels.

Photograph CD-1881: From Sta. 0+530/-27 m, looking N. View of a geotextile panel with a horizontal weld in the slope at Sta. 0+520 m before its removal.

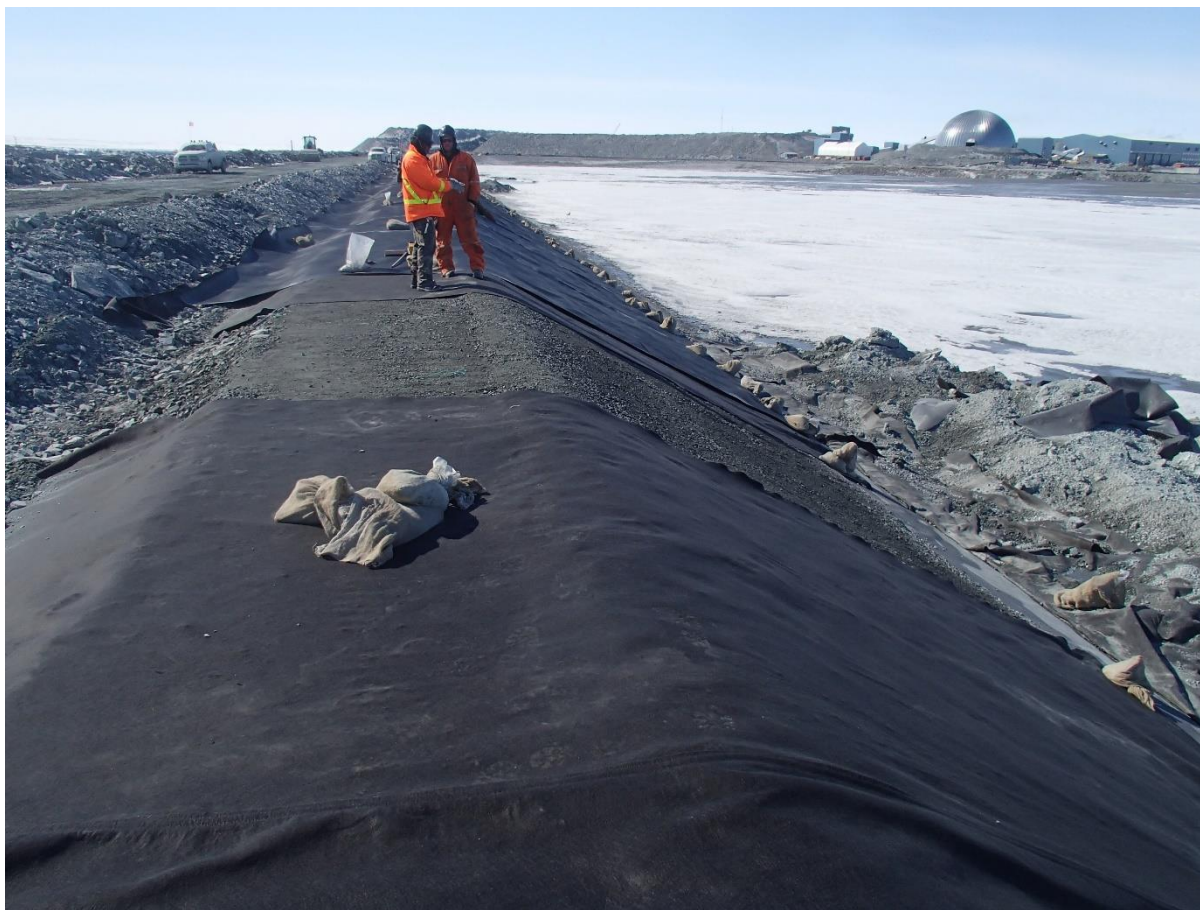
Photograph CD-1882: From Sta. 0+510/-25 m, looking S. View of the emplacement of the geotextile panel with a horizontal weld in the slope at Sta. 0+520 following its removal.
