QA DAILY REPORT

1897439-1576-TM-Rev0

QA DAILY REPORT FOR JUNE 5TH, 2018 – TSF SOUTH CELL CONSTRUCTION - MEADOWBANK (1897439)

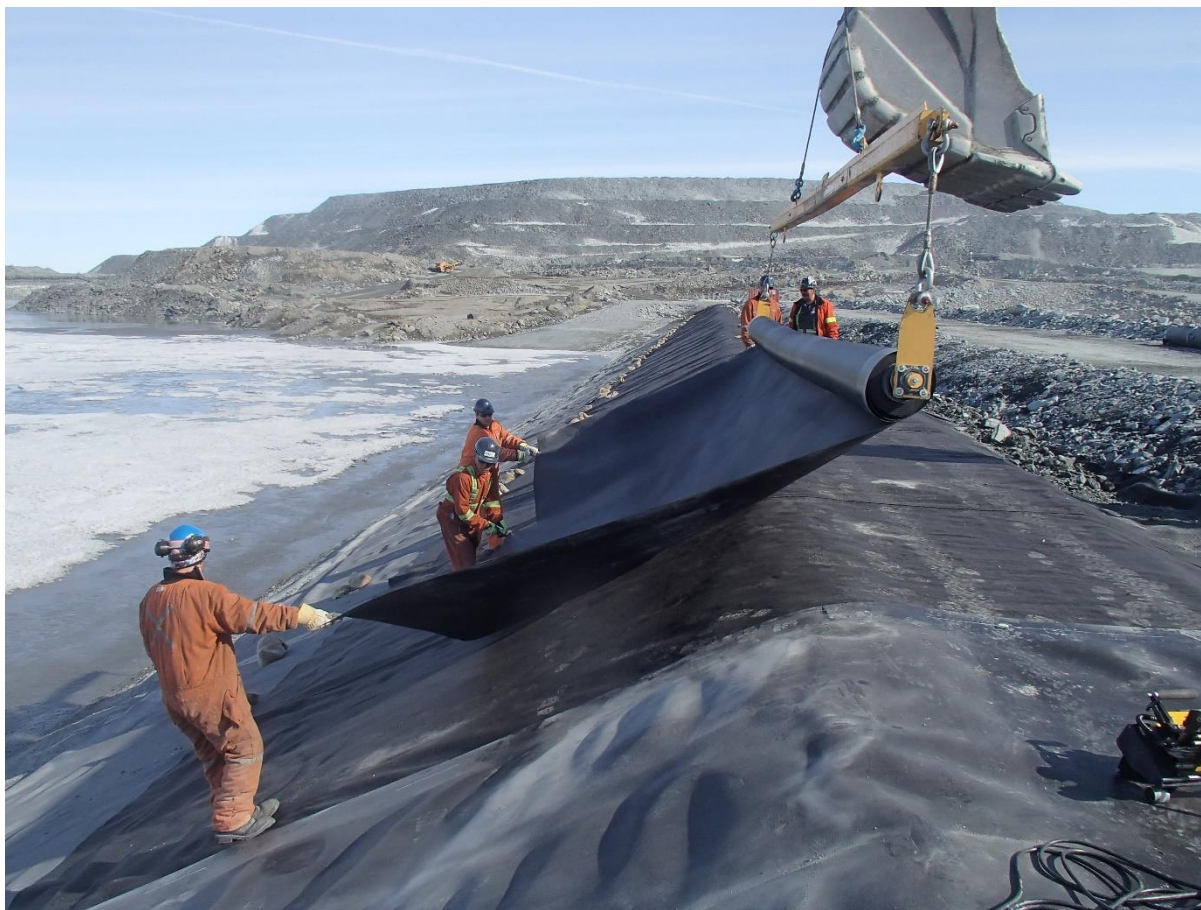
Photograph CD-1888: From Sta. 0+525/-26 m, looking N. Installation of the LLDPE liner on the upstream slope 2H:1V between El. 143 m and 145 m from Sta. 0+320 m to 0+150 m (panel numbers 911 to 933).

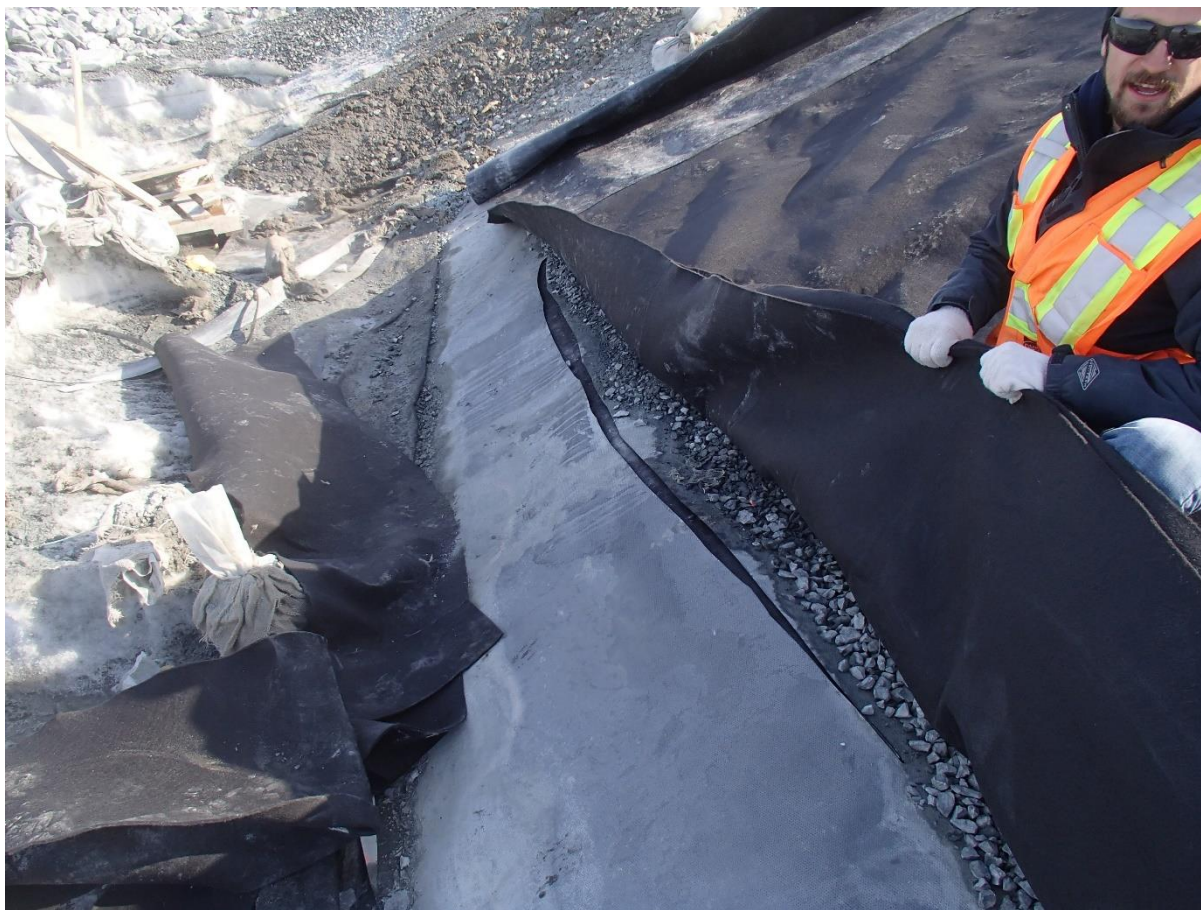
Photograph CD-1889: From Sta. 0+150/-28 m, looking N. View of the underlying liner that has been cut at around Sta. 0+160 m to drain the water.

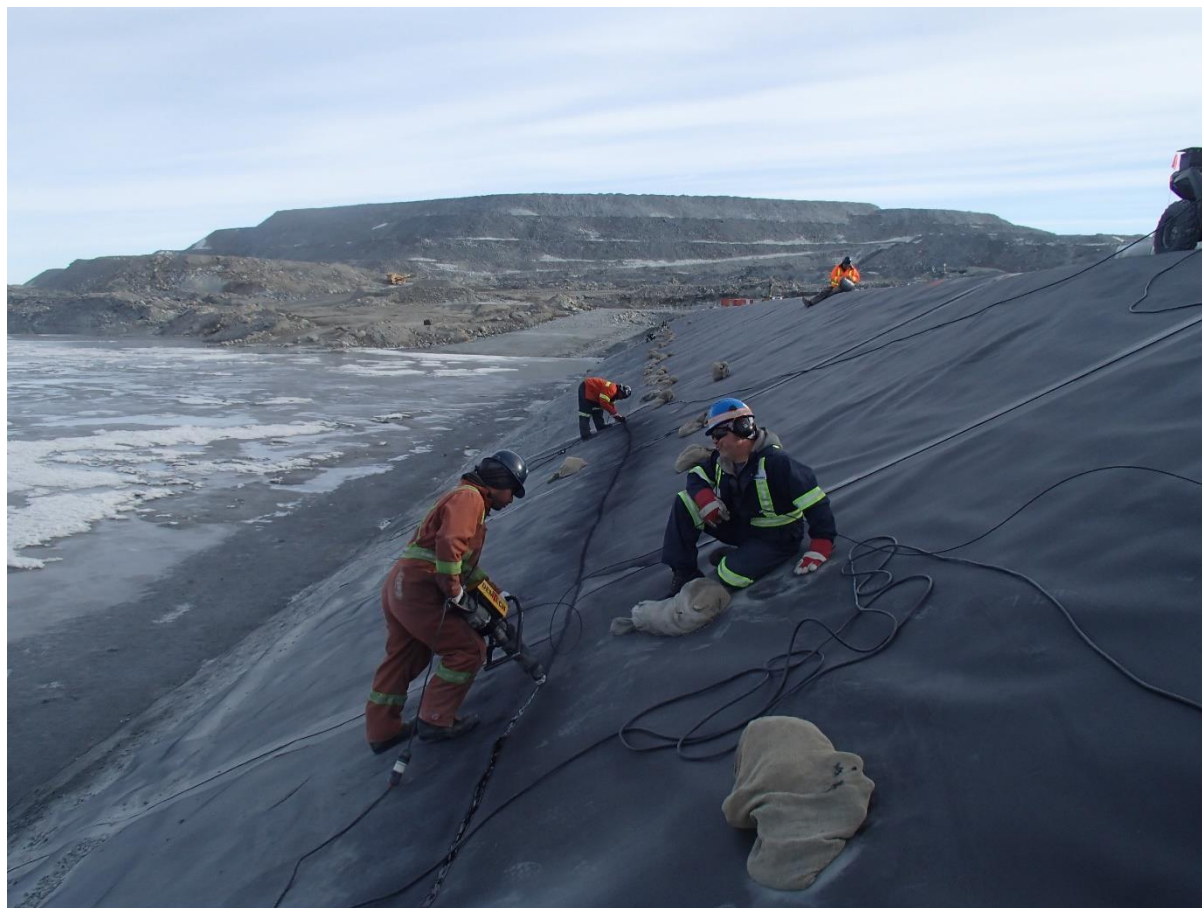
Photograph CD-1890: From Sta. 0+310/-26 m, looking N. View of the extrusion welding.

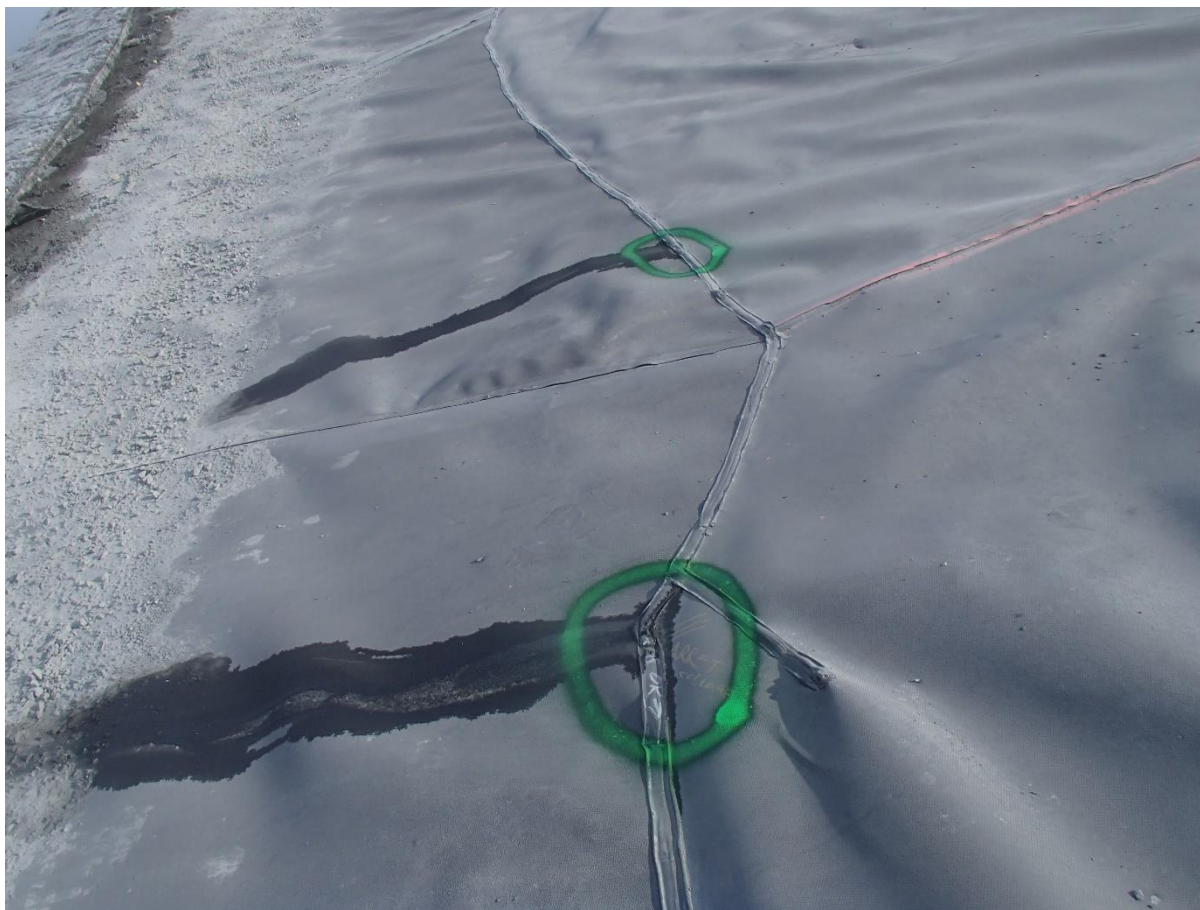
Photograph CD-1891: From Sta. 0+960/-28 m, looking N. View of leaking extrusion fillet seam before their repair on panel 816 and 818.

- The holes that were marked in paint yesterday by the QA Manager on the LLDPE liner panel 832, 833 and 834 were repaired and vacuum tested.
- Water leaking from extrusion fillet seams were noticed yesterday by the QA Manager at the bottom of panels 803, 807, 808, 810, 814, 815, 816 and 818. All leaks were marked in paint repaired and vacuum tested. The extrusion fillet seams at the bottom of panels 814 and 815 are still leaking water. They will be repaired and vacuum tested this week.

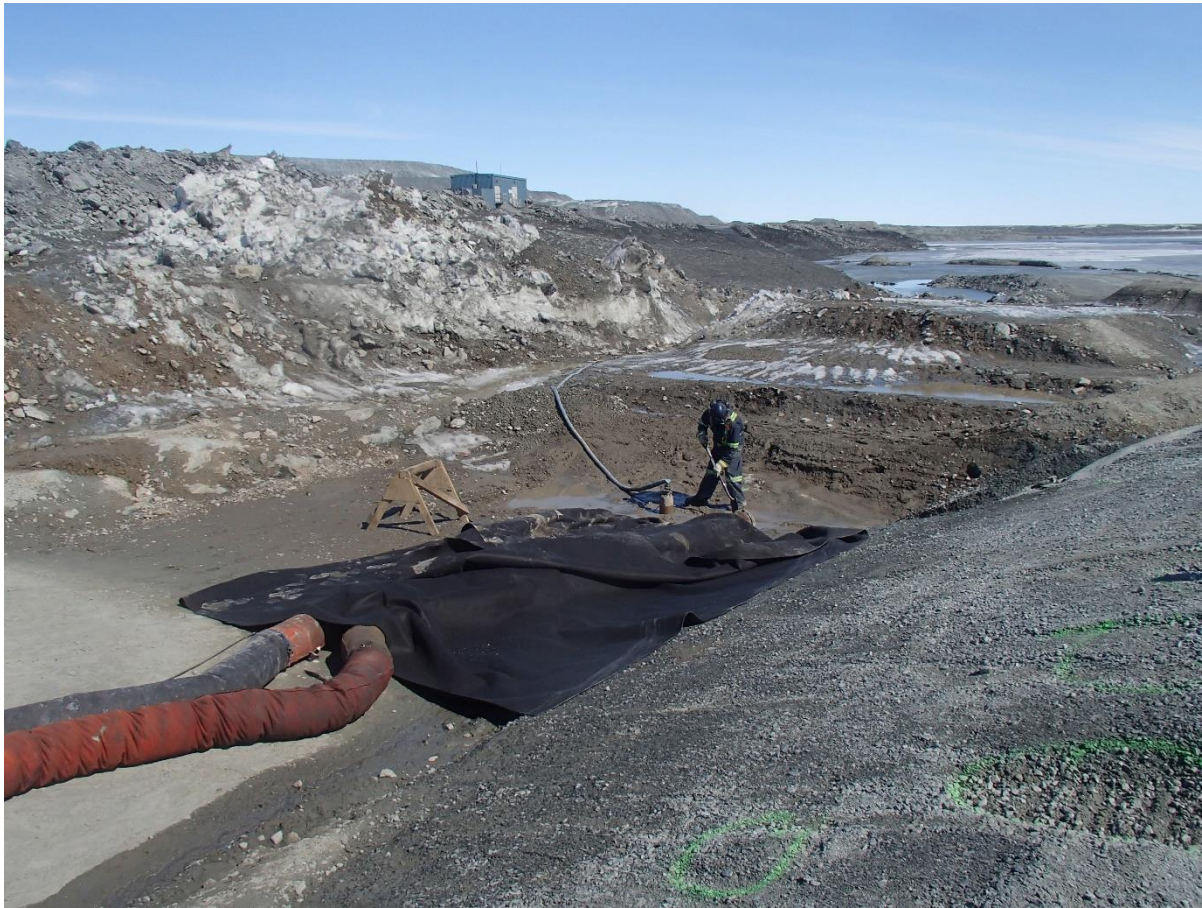
| Activity or Area | Comments |
|---|--|
| Water management | <ul style="list-style-type: none"> ■ The water ponding on the first compacted sieved till layer of the upstream toe liner tie-in at approx. Sta. 20+595 m was pumped. |

Photograph SD3-305: From Sta. 20+610/-48 m, looking NW. Dewatering of the water ponding on the first compacted sieved till layer of upstream toe liner tie-in. A Genset Frost-fighter is heating the sieved till layer and a pump is evacuating the water.

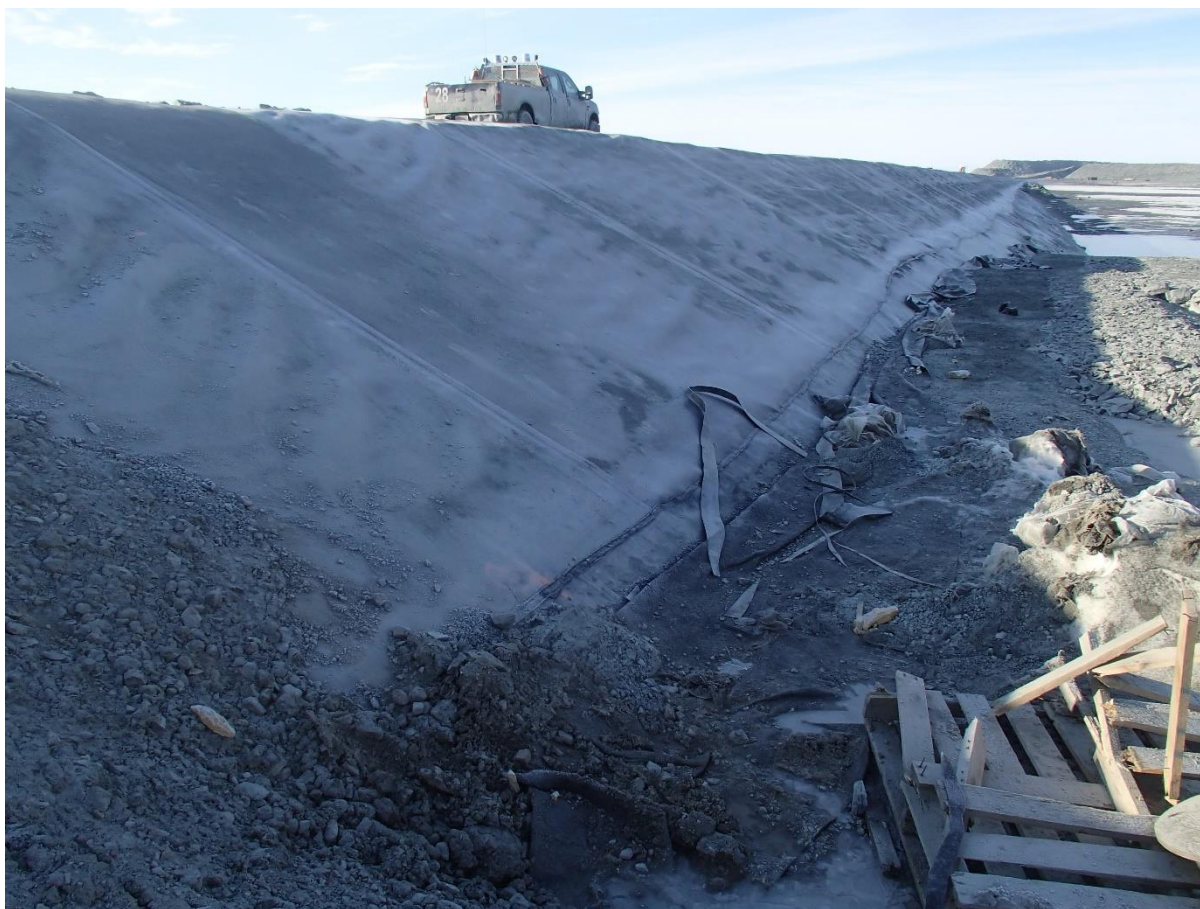
Photograph CD-1892: From Sta. 0+155/-32 m, looking S. View of the liner panel 933 overlapping the underlying liner that has been cut at around Sta. 0+160 m to drain the water.

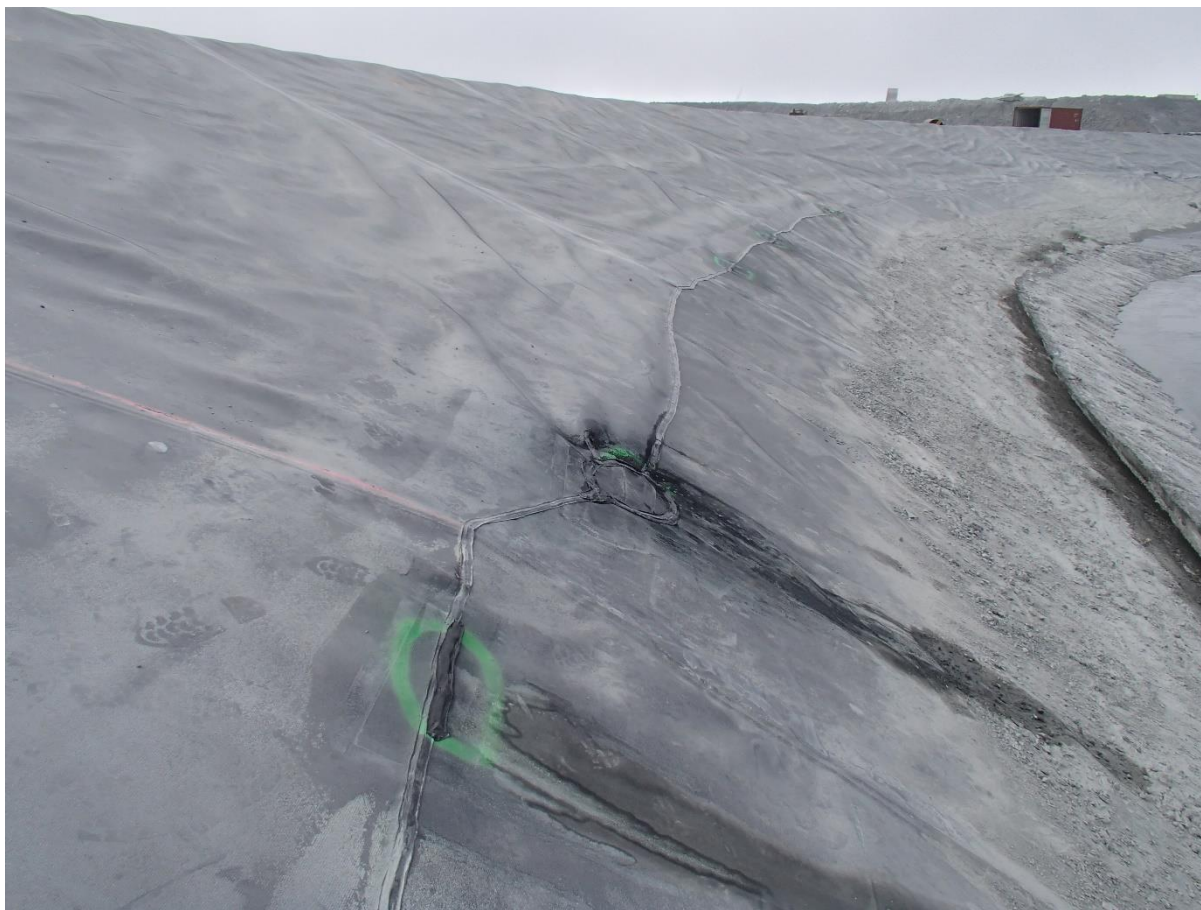
Photograph CD-1893: From Sta. 0+950/-27 m, looking SW. View of repair patches on the extrusion weld at the bottom of the panels 803, 807, 808, 810, 814, 815, 816 and 818.

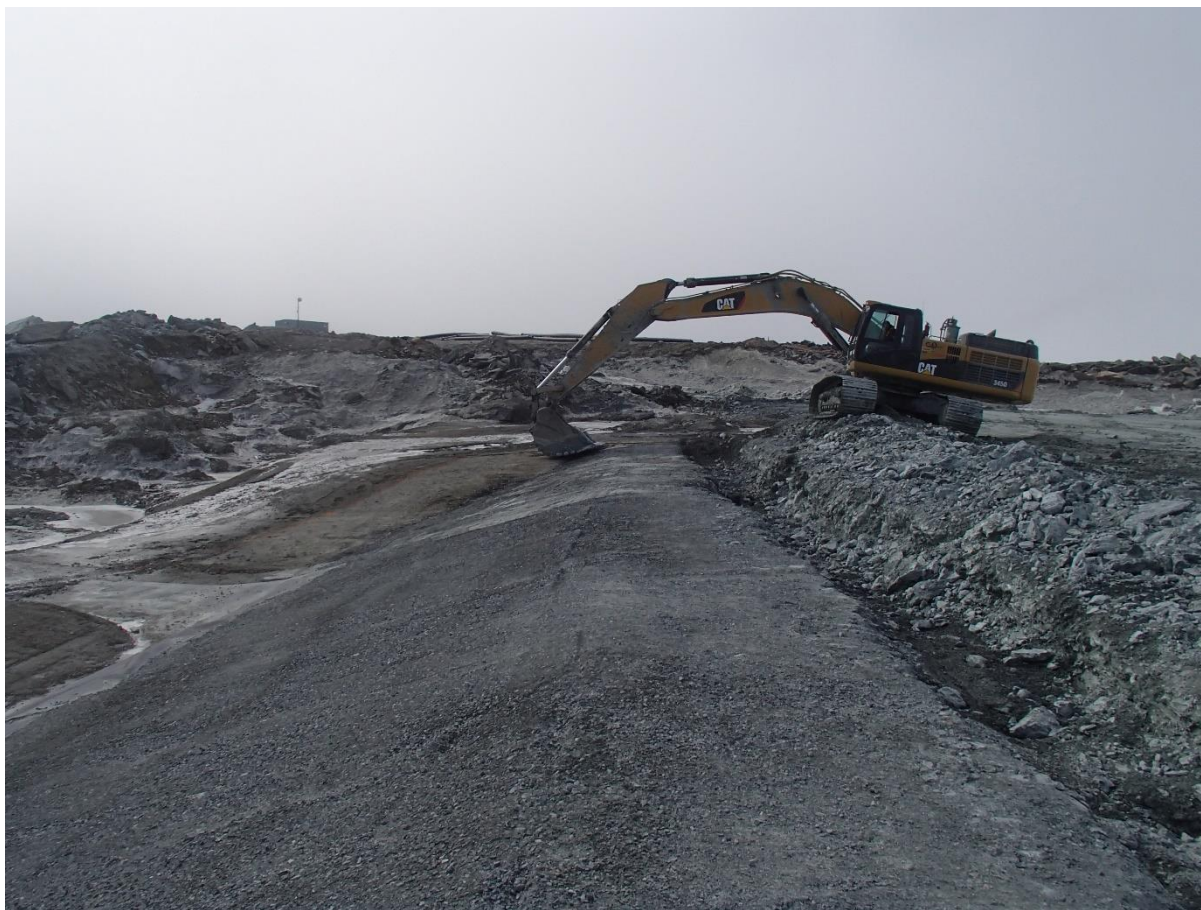
| Activity or Area | Comments |
|---|--|
| Upstream | <ul style="list-style-type: none"> ■ Correction of the surface of the fine filter in the upstream slope and the top of the first class compacted sieved till layer with an excavator from Sta. 20+803 m to 20+793 m. |

Photograph SD3-306: From Sta. 20+780/-25 m, looking S. Correction of the surface of the fine filter in the upstream slope and the top of the first class compacted sieved till layer with an excavator from Sta. 20+803 m to 20+793 m.

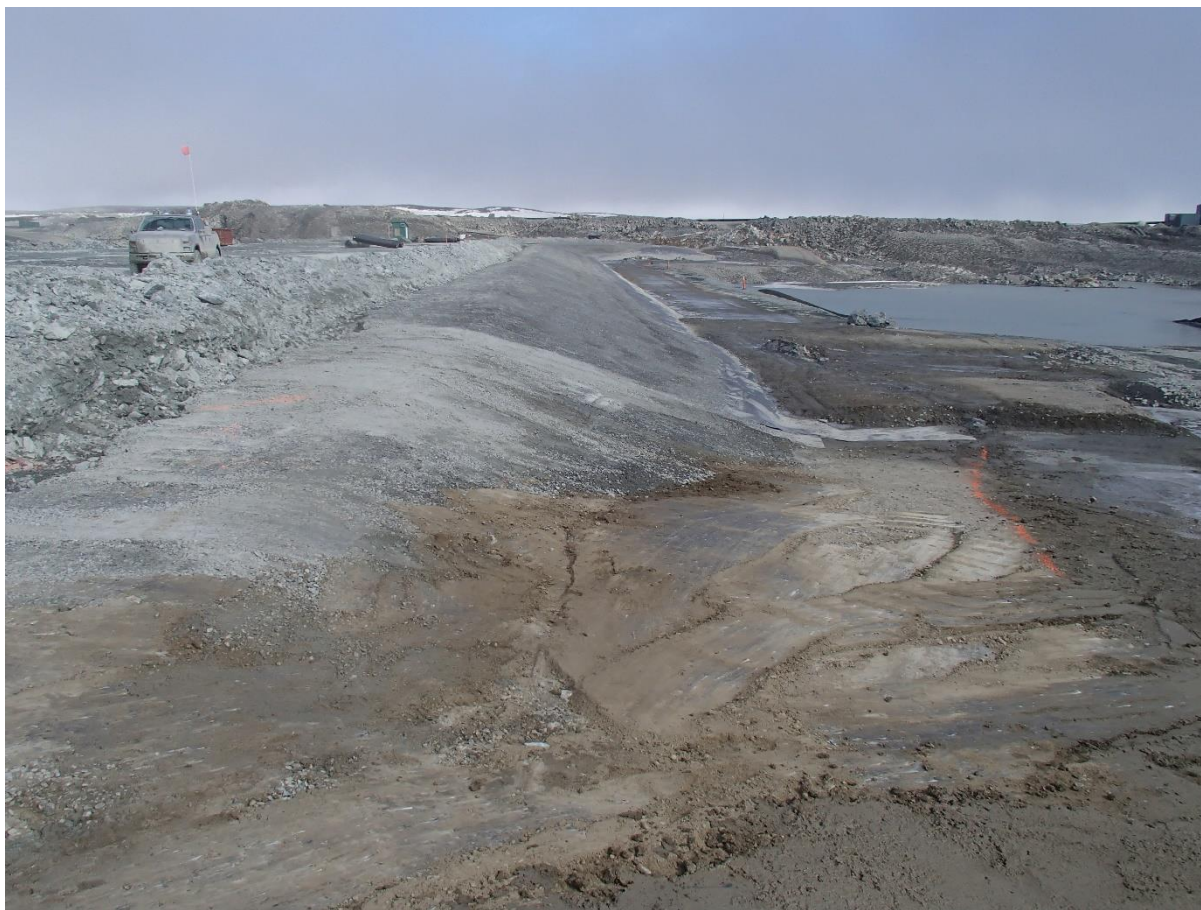
Photograph SD3-307: From Sta. 20+800/-25 m, looking N. View of the liner bedding ready for geosynthetics installation.

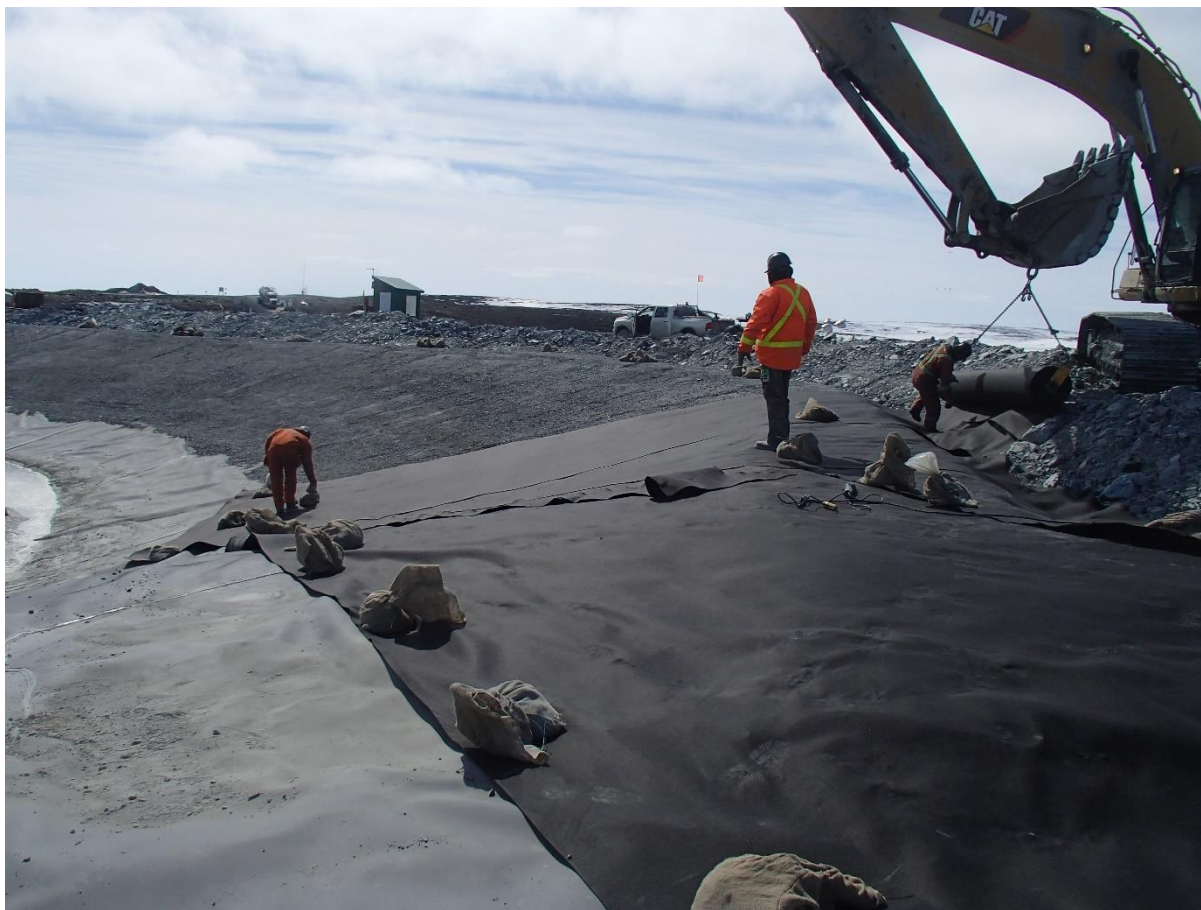
Photograph SD-308: From Sta. 20+620/-48 m, looking SW. Installation of the geotextile on the upstream slope 2H:1V between El. 143 m and 145 m from Sta. 20+620 m to 20+630 m.

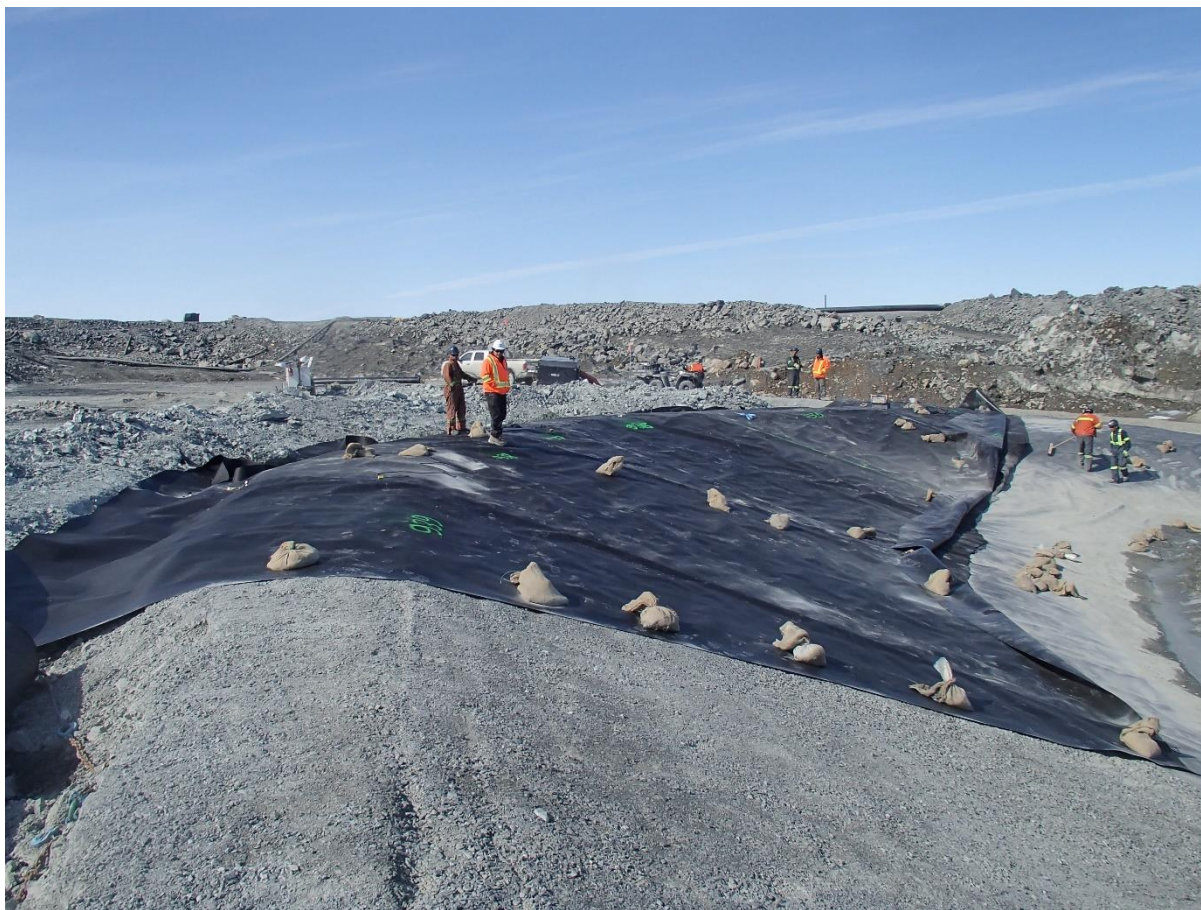
Photograph SD-309: From Sta. 20+640/-26 m, looking N. Installation of the LLDPE liner on the upstream slope 2H:1V between El. 143 m and 145 m from Sta. 20+620 m to 20+630 m (panel numbers 934 to 939).

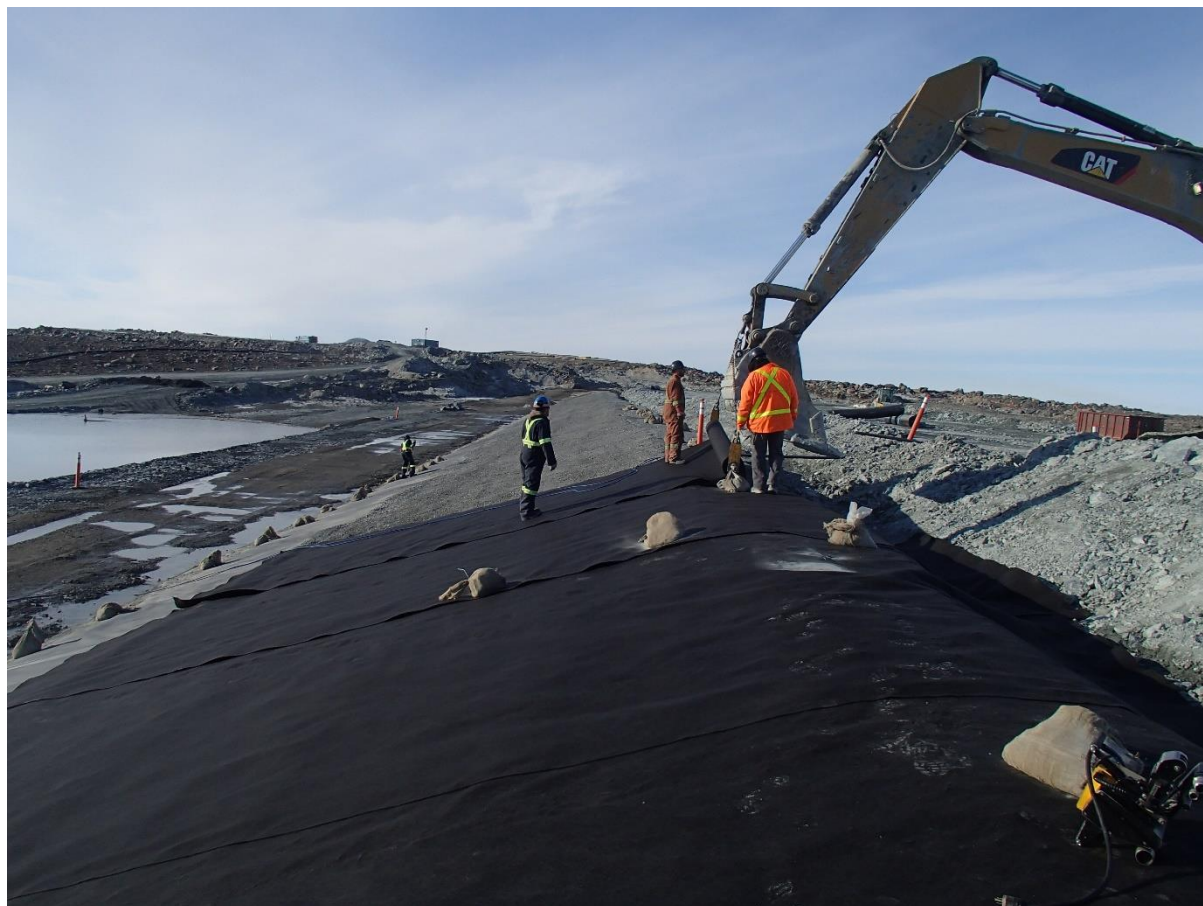
Photograph SD-310: From Sta. 20+635/-24 m, looking S. Installation of the geotextile on the upstream slope 2H:1V between El. 143 m and 145 m from Sta. 20+630 m to 20+800 m.

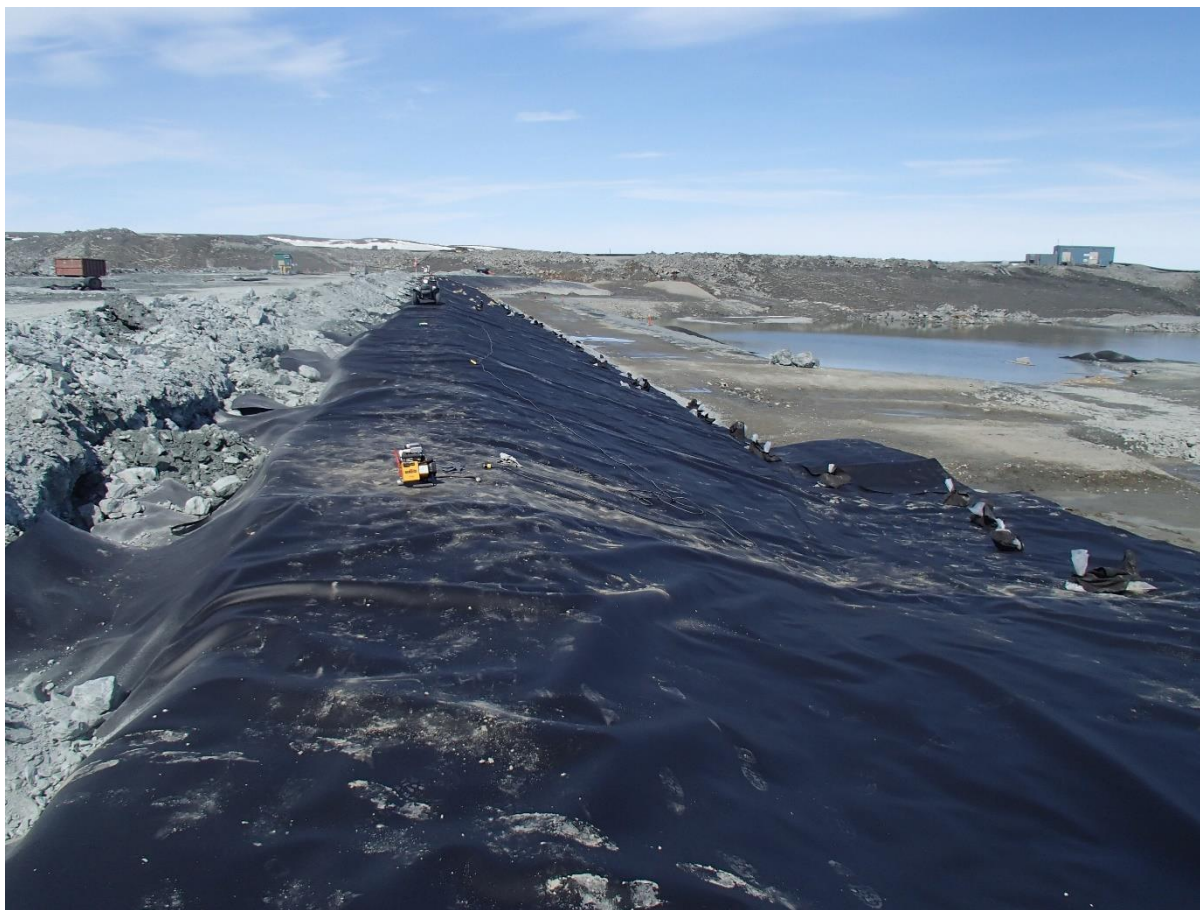
Photograph SD-311: From Sta. 20+810/-26 m, looking N. Installation of the LLDPE liner on the upstream slope 2H:1V between El. 143 m and 145 m from Sta. 20+630 m to 20+800 m (panel numbers 939 to 964).

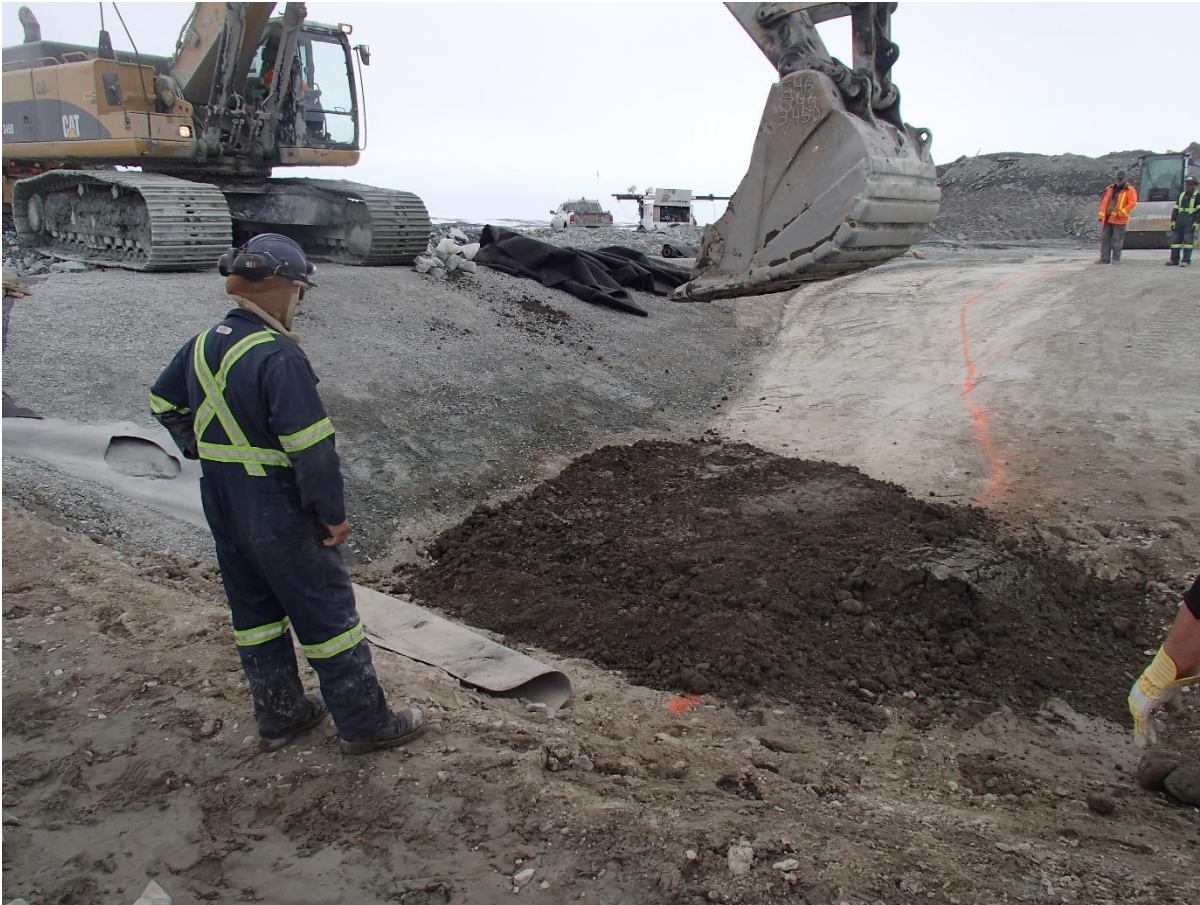
- The QA Manager observed a depression on the compacted sieved till layer of the upstream toe liner tie-in at approx. Sta. 20+595 m where the pump was evacuating the water for the last three days. The depression is approximately 3 m wide by 5m length and 0,15m deep. It was fill with compacted sieved till. As no portable nuclear gauge is present on site, a sample was taken for water content analysis and gradation and no compaction test could be done. Compaction tests will be required on the compacted sieved till before the next phase of construction for the installation of the LLDPE liner protection cover on SD3.

Photograph SD3-312: From Sta. 20+610/-48 m, looking W. Placement of a 0.15 m thick lift of compacted sieved till from Sta. 20+596.4 m to 20+601.6 m (o.s. -42.6 to -46.3 m) to fill the depression in the compacted sieved till layer.

| Activity or Area | Comments |
|---|---|
| Upstream toe liner tie-in | <ul style="list-style-type: none"> ■ Placement of a 0.15 m thick lift of compacted sieved till from Sta. 20+596.4 m to 20+601.6 m (o.s. -42.6 to -46.3 m) to fill the depression in the compacted sieved till layer. ■ Compaction of the 0.15 m-thick lift of compacted sieved till with a 10-tonne smooth-drum compactor without vibration from Sta. 20+596 m to 20+601 m. PNG tests were not conducted and will need to be conducted before the next step of construction. |

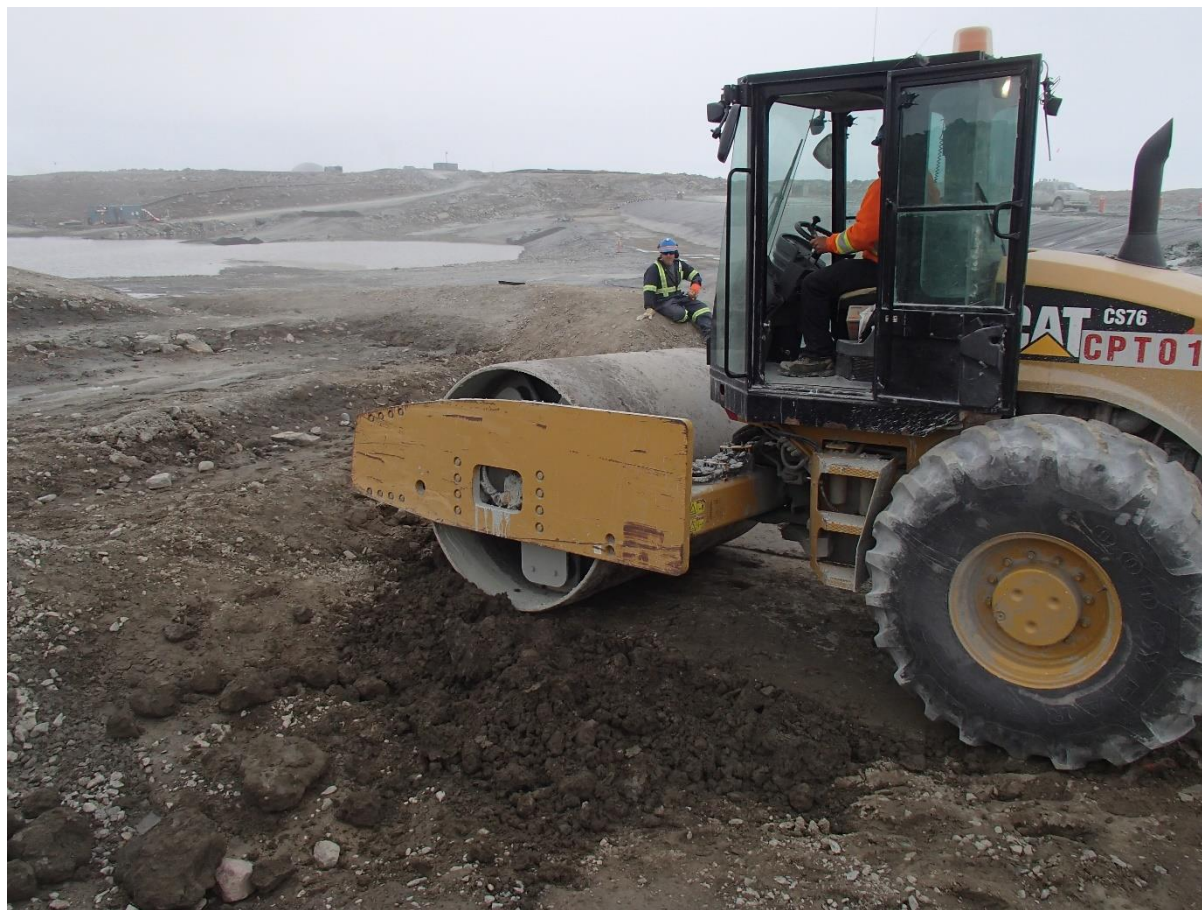
Photograph SD3-313: From Sta. 20+600/-52 m, looking S. Compaction of the 0.15 m-thick lift of compacted sieved till with a 10-tonne smooth-drum compactor without vibration from Sta. 20+596 m to 20+601 m.

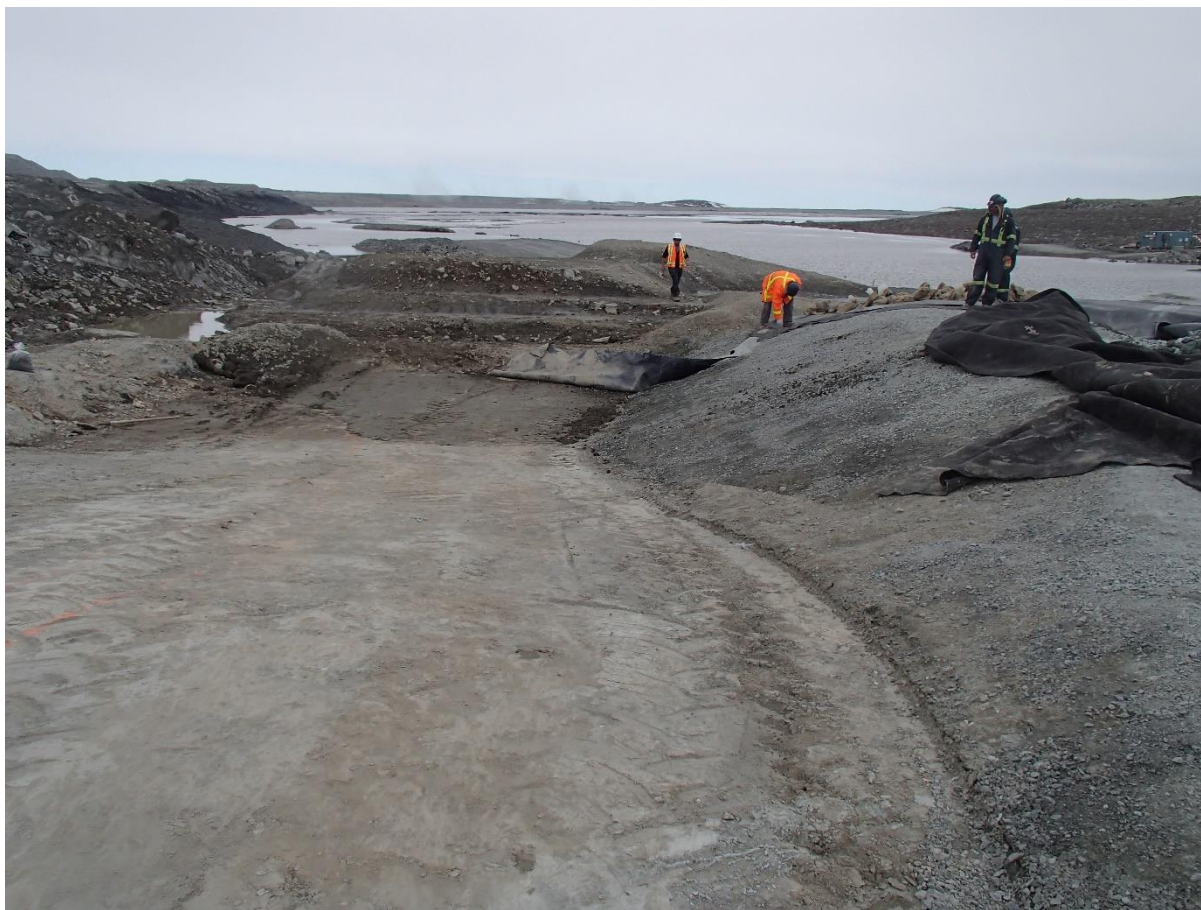
Photograph SD3-314: From Sta. 20+590/-32 m, looking E. View of the liner bedding ready for geosynthetics installation.

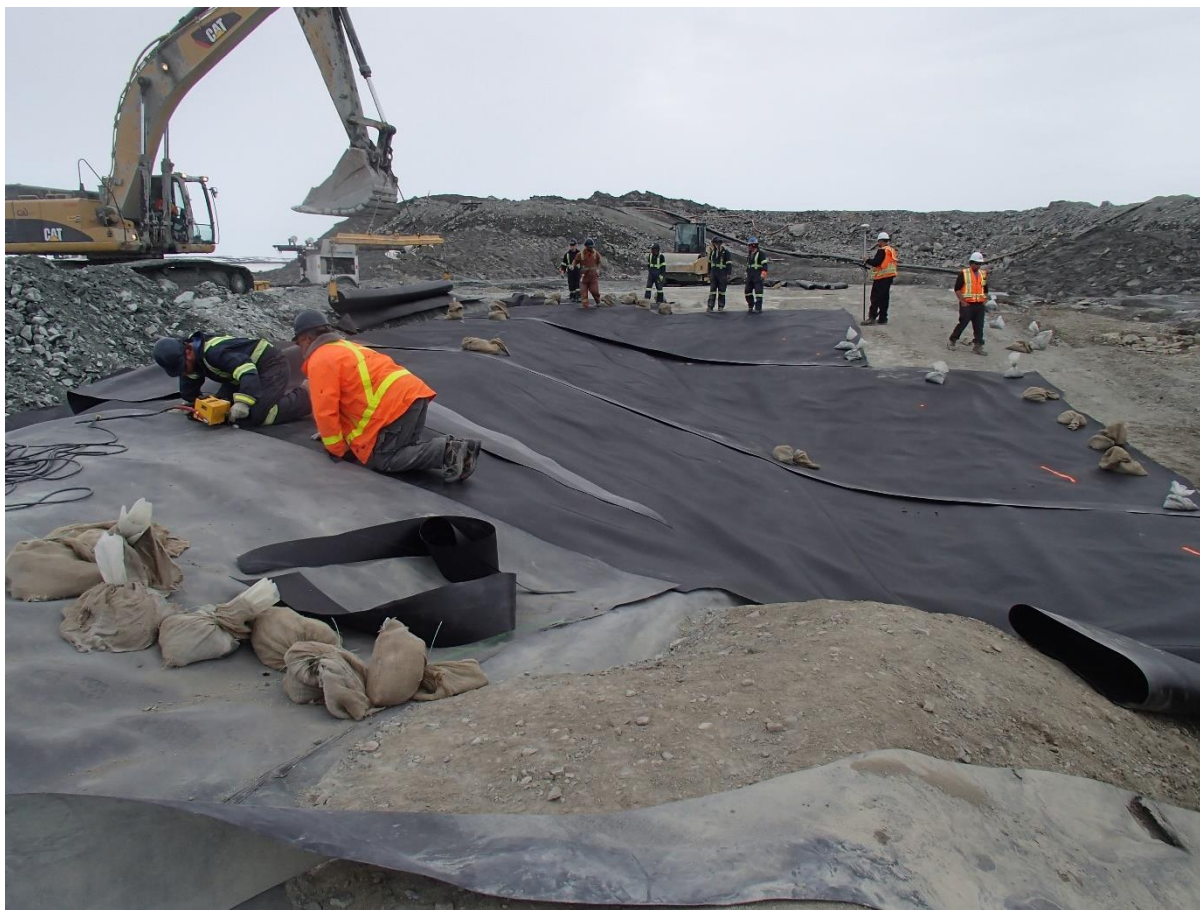
Photograph SD3-315: From Sta. 20+615/-46 m, looking W. Installation of the geotextile on the upstream slope 3H:1V between El. 143 m and 145 m from Sta. 20+593 m to 20+610 m and installation of the LLDPE liner on the upstream slope 3H:1V between El. 143 m and 145 m from Sta. 20+593 m to 20+610 m (panel numbers 965 to 967).

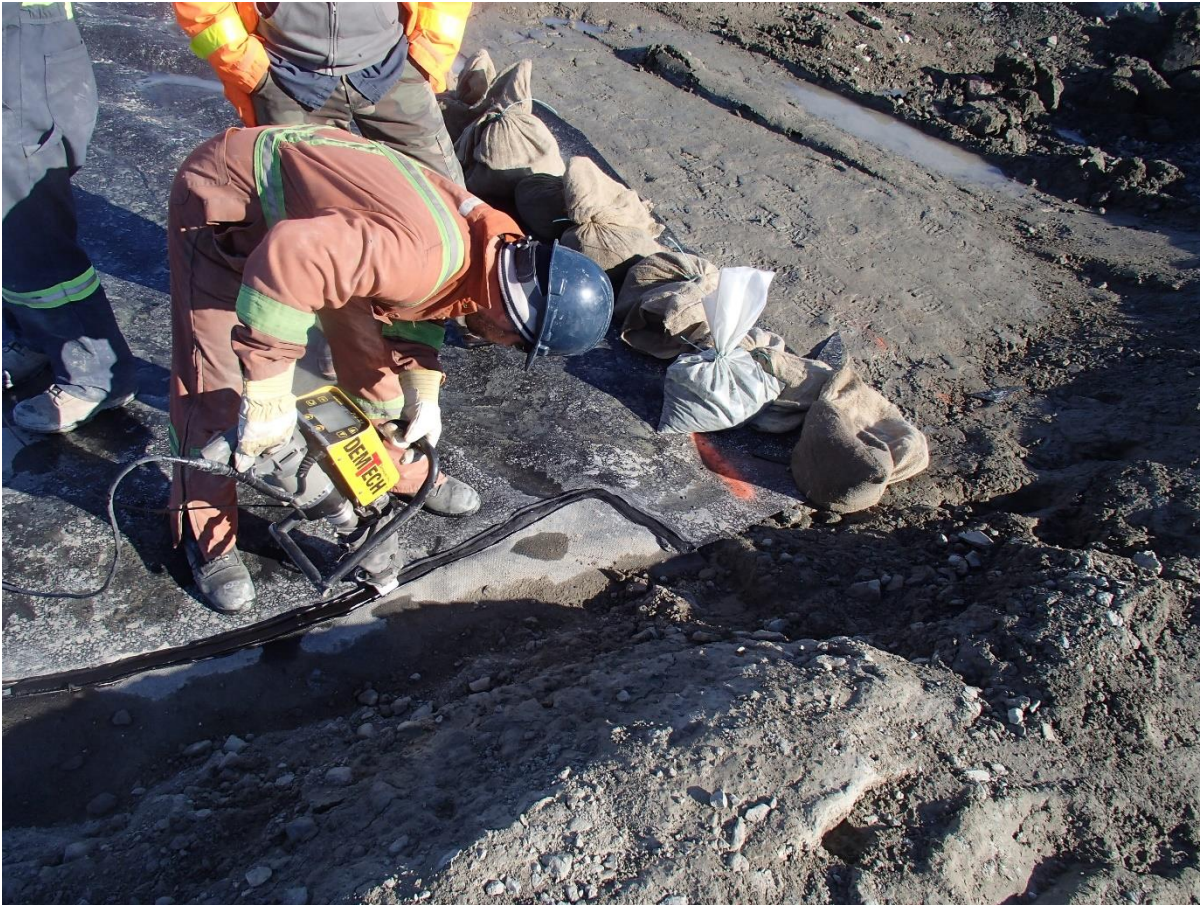
- The QA Manager observed bubbles in the extrusion seam between panel 965 and the existing LLDPE panel at Sta. 20+595 m (approx.). The seam was repaired and vacuum tested.

Photograph SD3-316: From Sta. 20+610/-45 m, looking NW. Repairs on the extrusion fillet seam between LLDPE panel 965 and the existing LLDPE panel at Sta. 20+600 m (approx.).

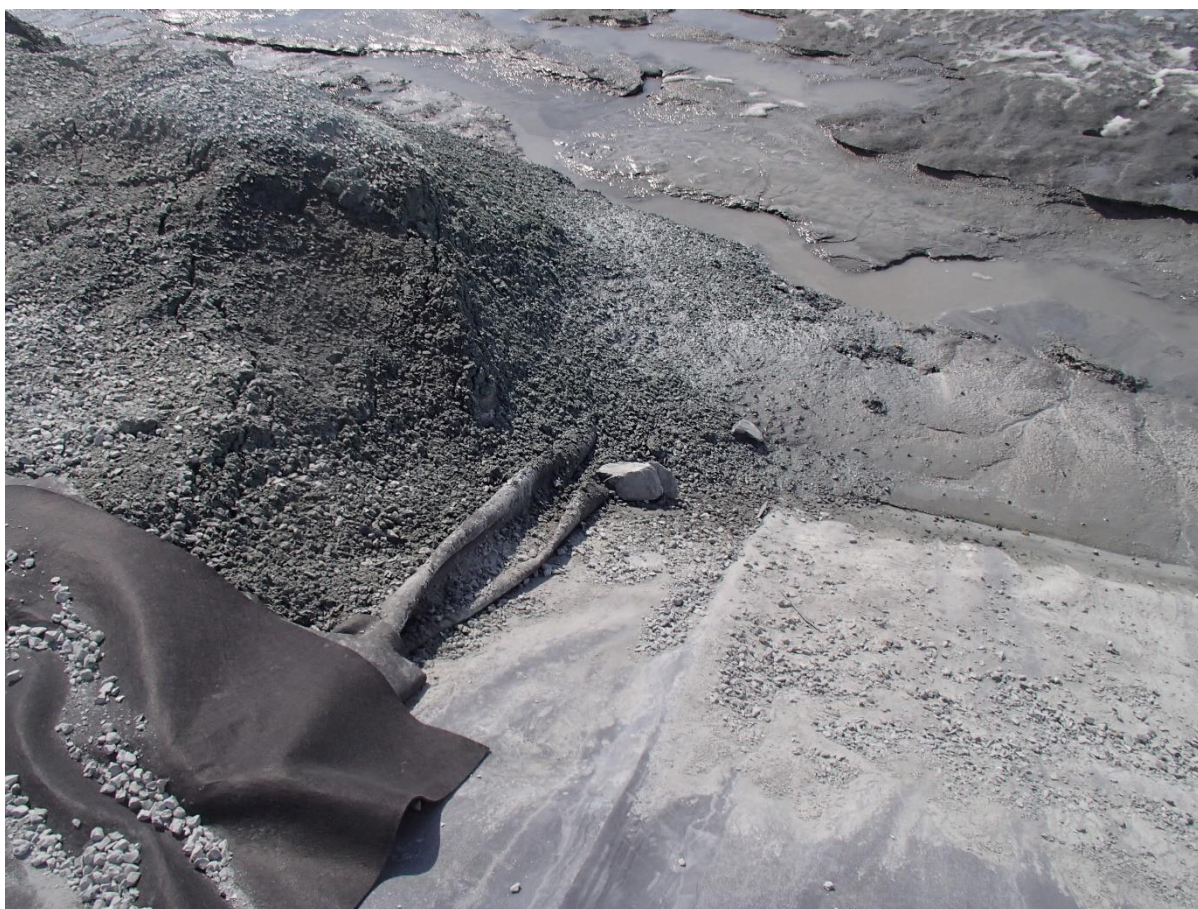
Photograph CD-1894: From Sta. 0+800/-28 m, looking E. View of a bloc in direct contact with the LLDPE liner following the construction of the deposition fingers on Central Dike.

- The QC Personnel observed that the compaction of the backfilling of the geosynthetics tie-in on Central Dike from approx. Sta 0+950 m to 1+050 m was inadequate and informed SANA foreman. It will be compacted tomorrow.
- The QA Manager reiterated that the mechanical properties of the TenCate Mirafi S1600 are inferior to those of the Texel 934, as required per the design change regarding the liner erosion protection cover on SD3. An alternative solution will need to be found with the agreement of the Designer.
- The QA Manager observed a few stones in direct contact with the liner following the construction of the deposition fingers on Central Dike and asked SANA foreman to remove them.
