QA DAILY REPORT

QA DAILY REPORT FOR JULY 7TH, 2018 – TSF SOUTH CELL CONSTRUCTION - MEADOWBANK (1897439)

Table 1: QA Observations for Saddle Dam 3

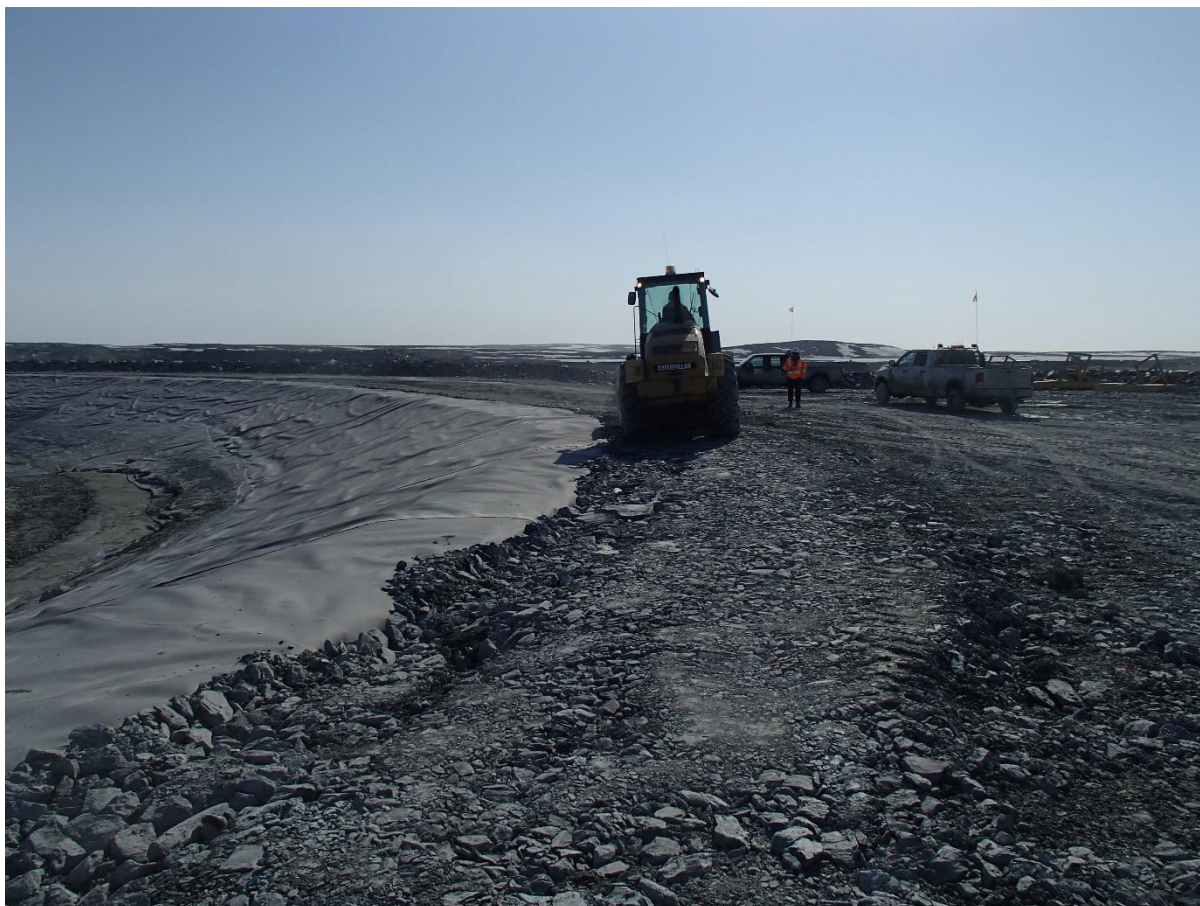
Photograph CD-1895: From Sta. 40+670/-15 m, looking E. Compaction of the geosynthetics tie-in material at El. 145 m with a 10-tonne smooth-drum compactor with vibration (4 passes) from Sta. 40+670 m to 0+950 m (approx.).

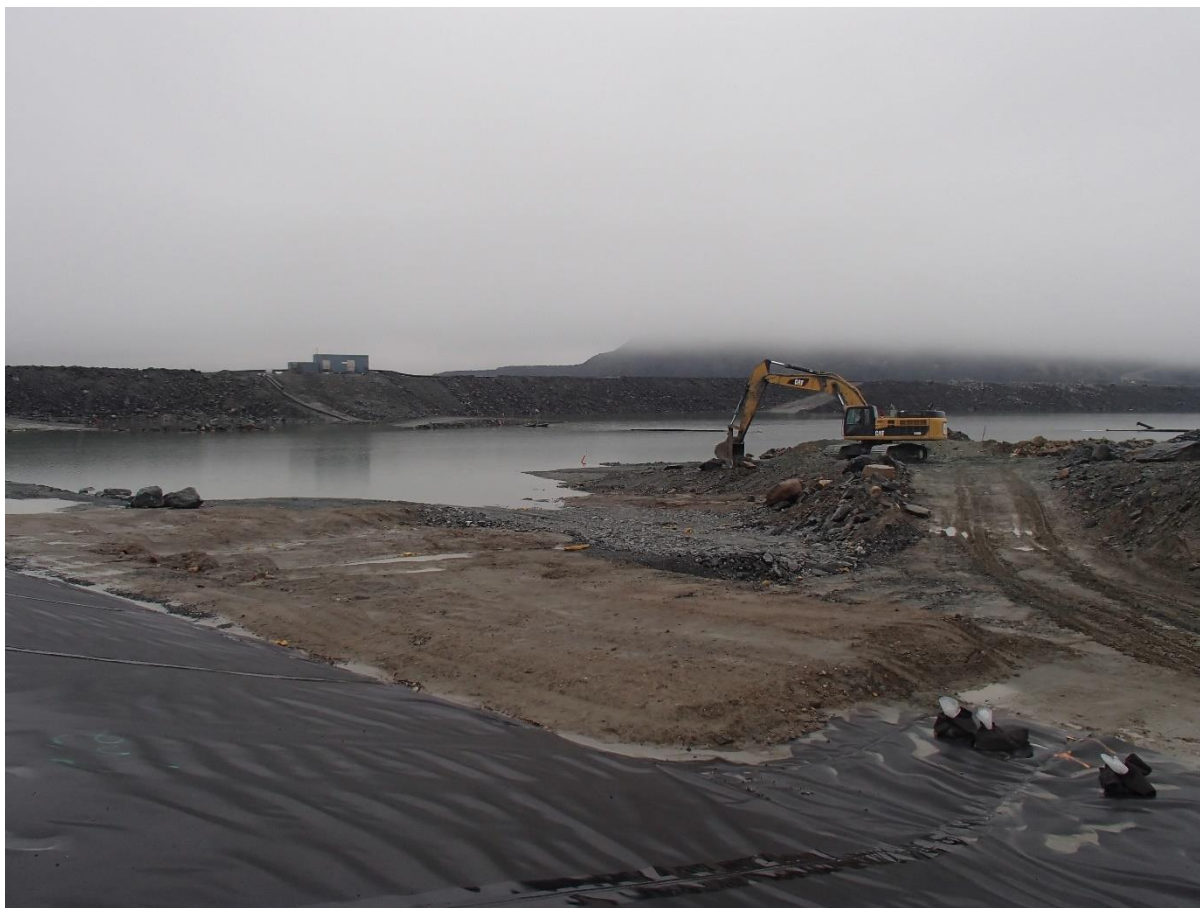
Photograph SD3-317: From Sta. 20+800/-22 m, looking E. Reworking of the access to SD3.

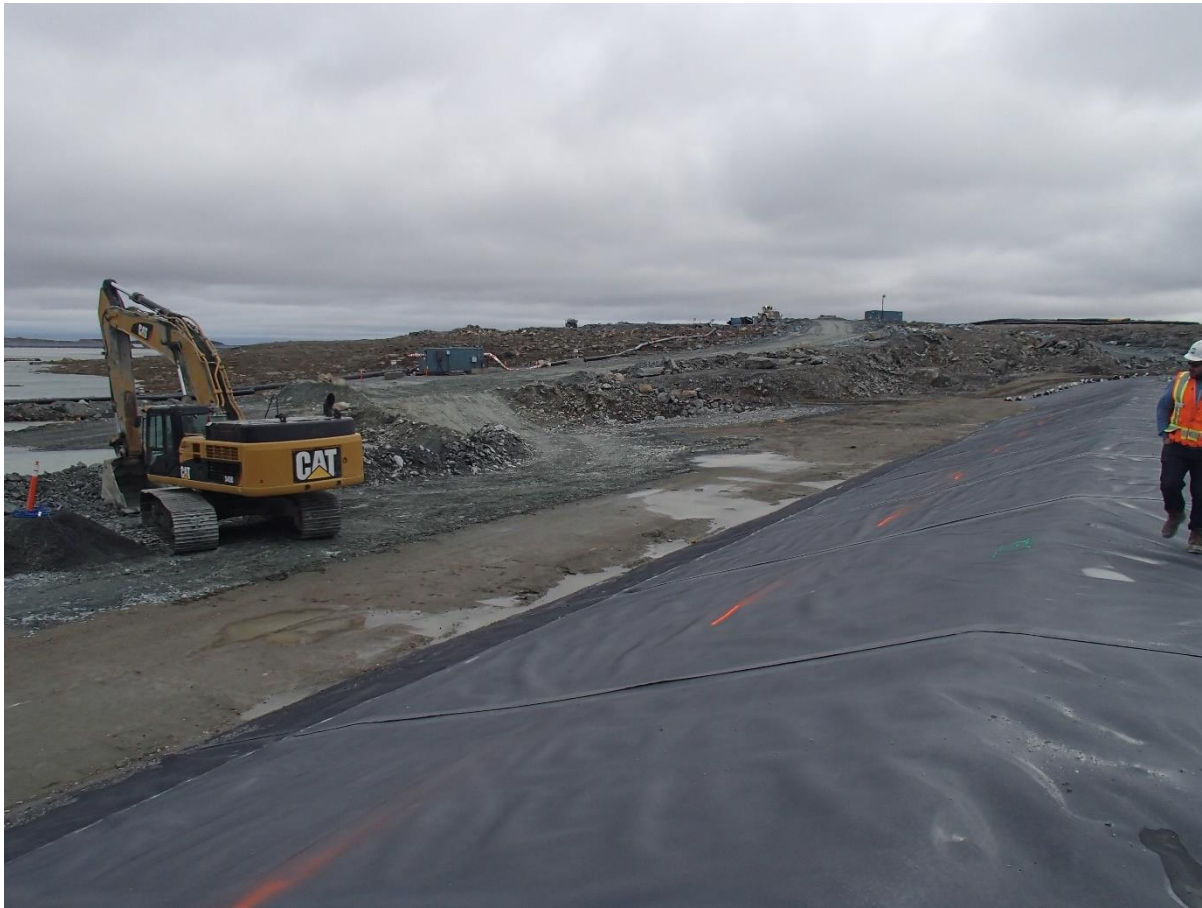
Photograph SD3-318: From Sta. 20+710/-24 m, looking SE. Placement of IV rockfill in the water up to El. 142m with an excavator from Sta. 20+785 m to 20+730 m, at the bottom of the upstream slope of SD3 to widen the rockfill layer and allow access to the erosion protection.

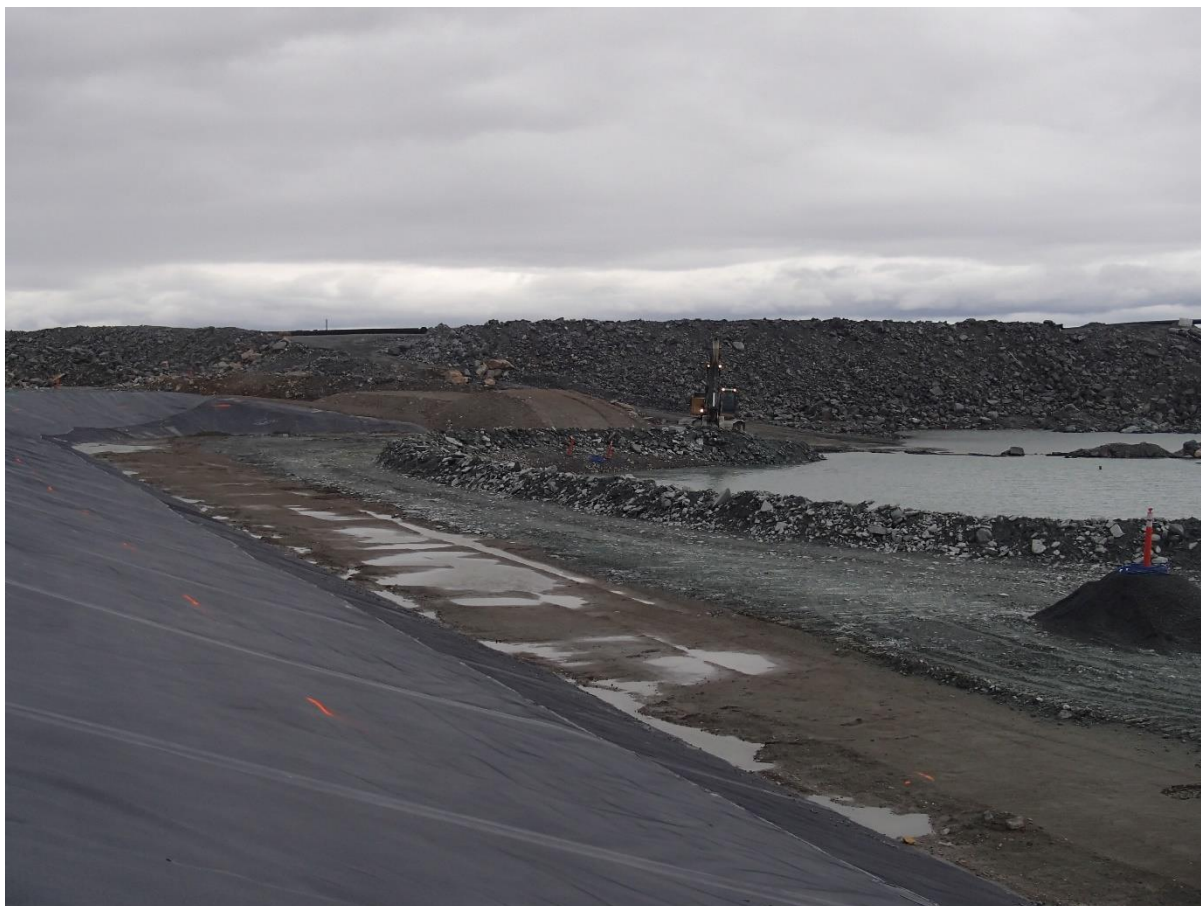
Photograph SD3-319: From Sta. 20+740/-31 m, looking SE. Placement of IV rockfill in the water up to El. 142m with an excavator from Sta. 20+730 m to 20+610 m, at the bottom of the upstream slope of SD3 to widen the rockfill layer and allow access to the erosion protection.

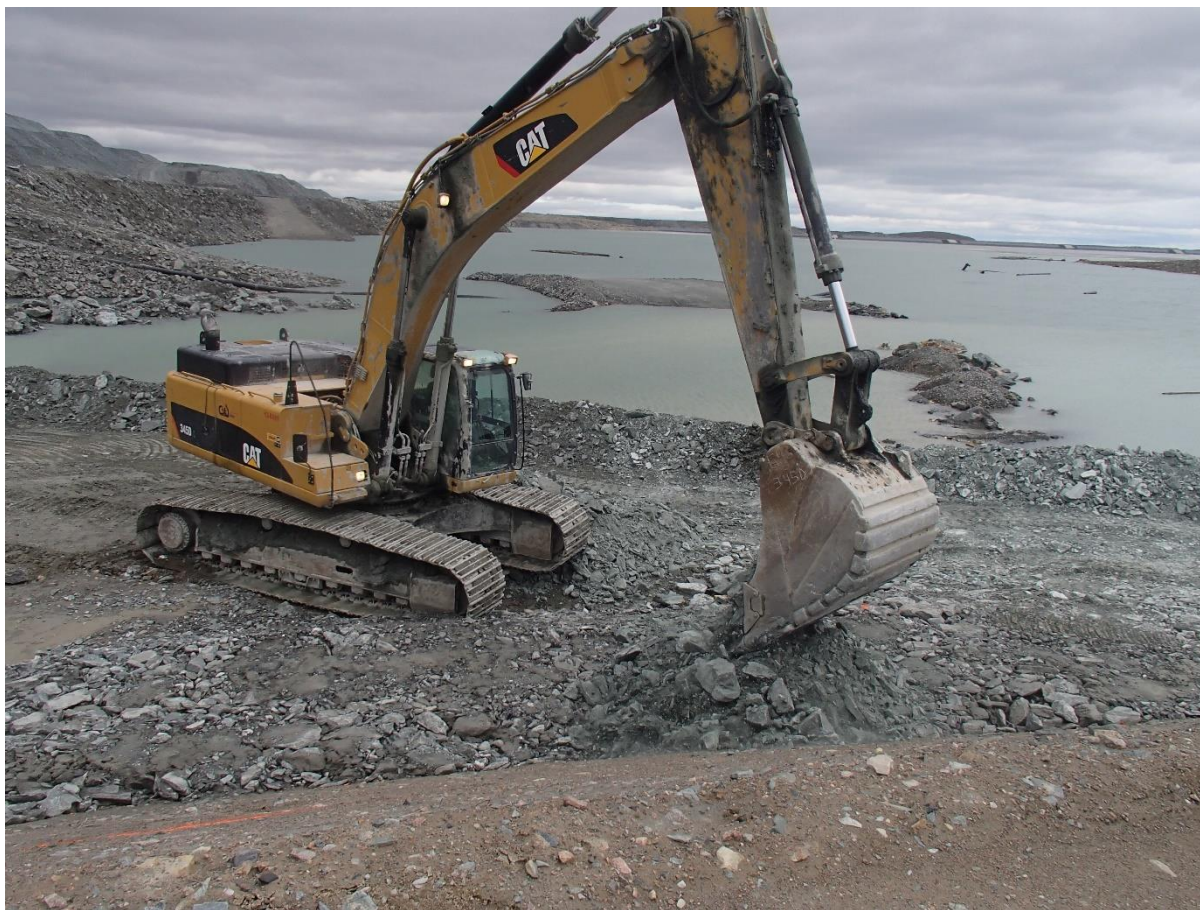
Photograph SD3-320: From Sta. 20+620/-67 m, looking E. Placement of a 1 m thick (approx.) lift of fine IV rockfill over the compacted till in the upstream slope from El. 142 m to 144 m with an excavator from Sta. 20+600 m to 20+610 m.

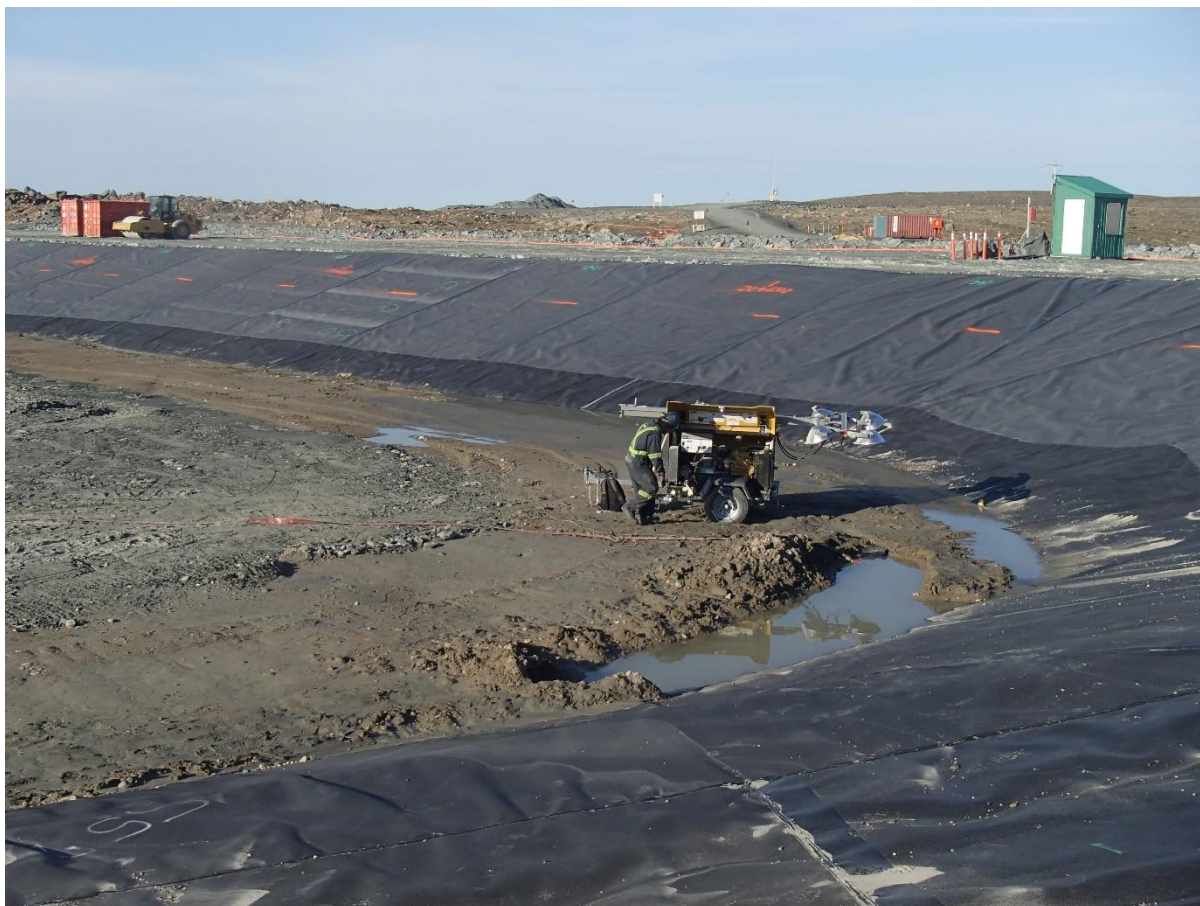
Photograph SD3-321: From Sta. 20+610/-56 m, looking SW. Water ponding at El. 142m on the compacted sieved till layer of the upstream toe liner tie-in at approx. Sta. 20+620 m to 20+630 m was pumped.

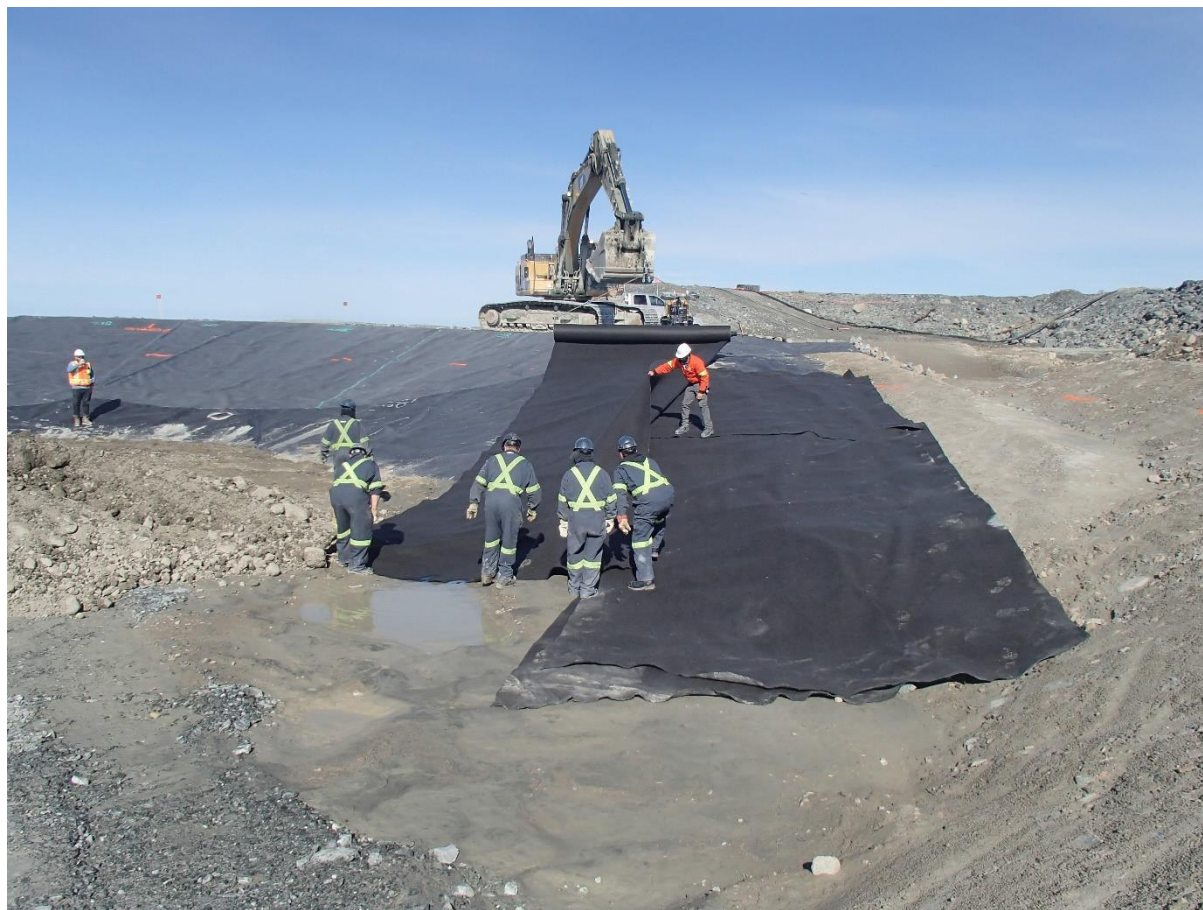
- The design change for the erosion protection cover on SD3 required geotextile type Texel 934 or equivalent. The mechanical properties of the only geotextile available on site, TenCate Mirafi S1600, are inferior to those of the Texel 934, thus it is not considered equivalent. The alternative that was accepted by the Designer to protect the LLDPE geomembrane was to replace the layer of Texel 934 by two layers of TenCate Mirafi S1600. It should be noted that the use of two layers of geotextile is not a recommended practice as the two layers may slip on each other.
- The QA Manager observed many particles larger than 300 mm in the low quality till sieved with the bucket of the excavator (0-50 mm) on SD3 at the beginning of the shift. It was reiterated that the sieving operation aims to remove particles of size over 50 mm. The bigger particles were removed with an excavator on SD3.

Photograph SD3-322: From Sta. 20+625/-63 m, looking W. Installation of two layers of geotextile on the upstream slope 3H:1V between El. 142 m and 143 m (approx.) from Sta. 20+610 m to 20+800 m.

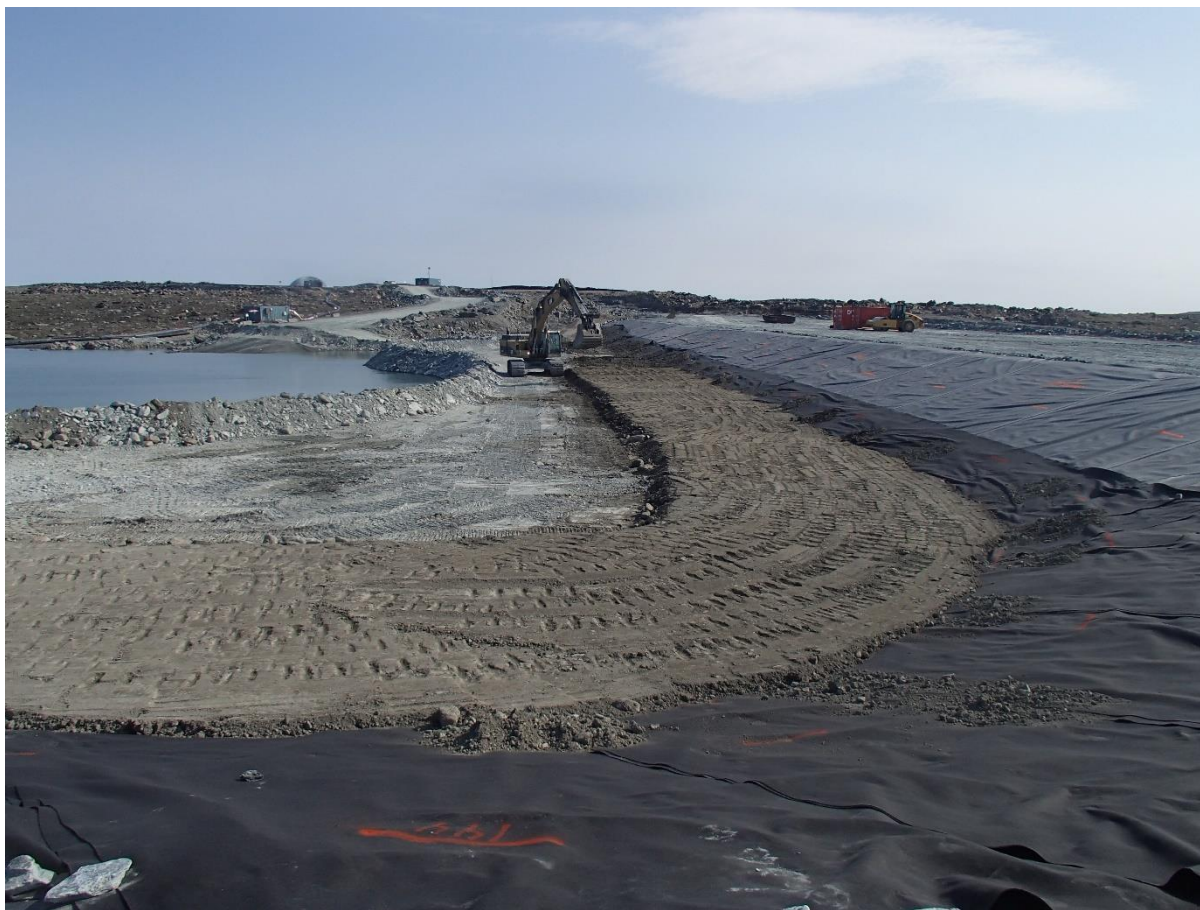
Photograph SD3-323: From Sta. 20+610/-43m, looking S. Placement of the first lift of low quality till (0-150 mm) from El. 142 m to 142.5 m from Sta. 20+610 m to 20+715 m.

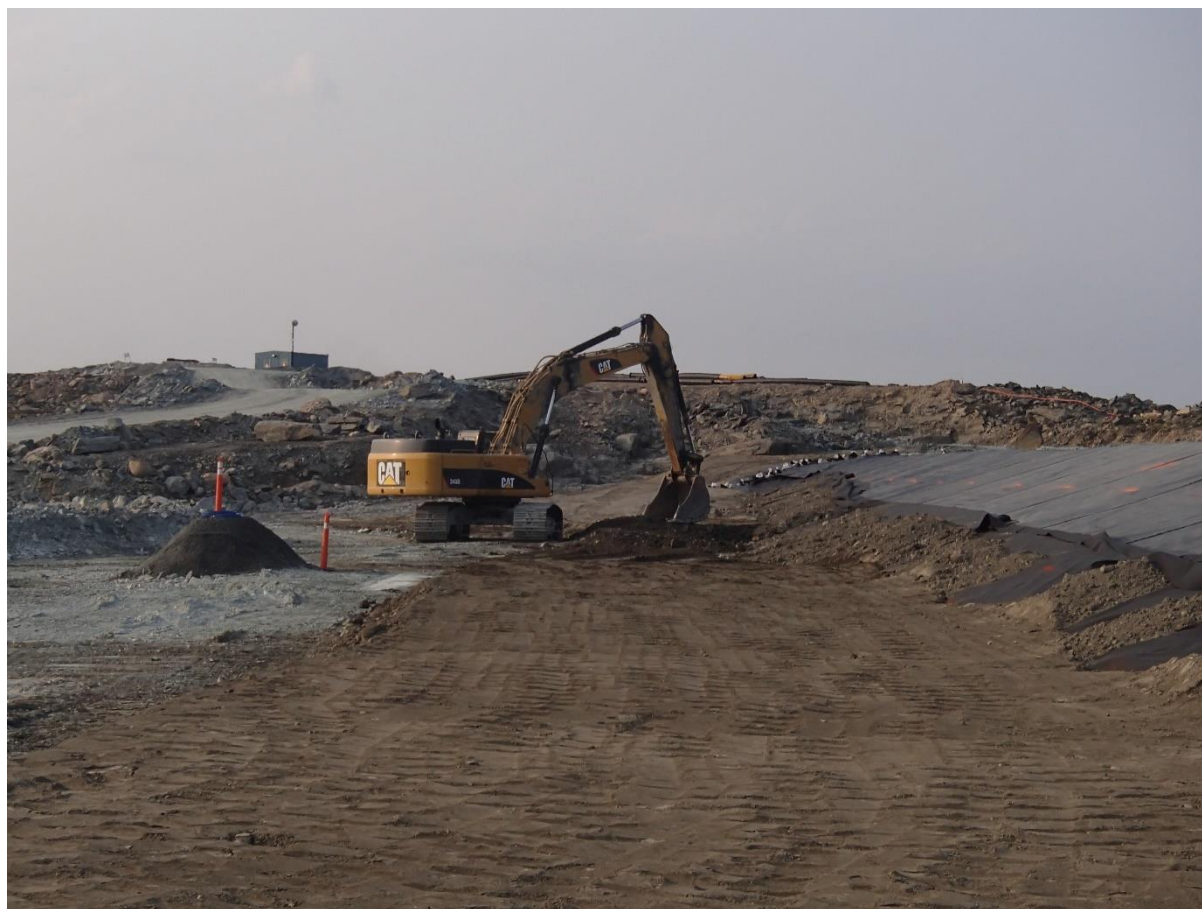
Photograph SD3-324: From Sta. 20+680/-39m, looking S. Placement of a 0.5 m thick lift of low quality till (0-150 mm) from El. 142 m to 142.5 m from Sta. 20+715 m to 20+760 m.

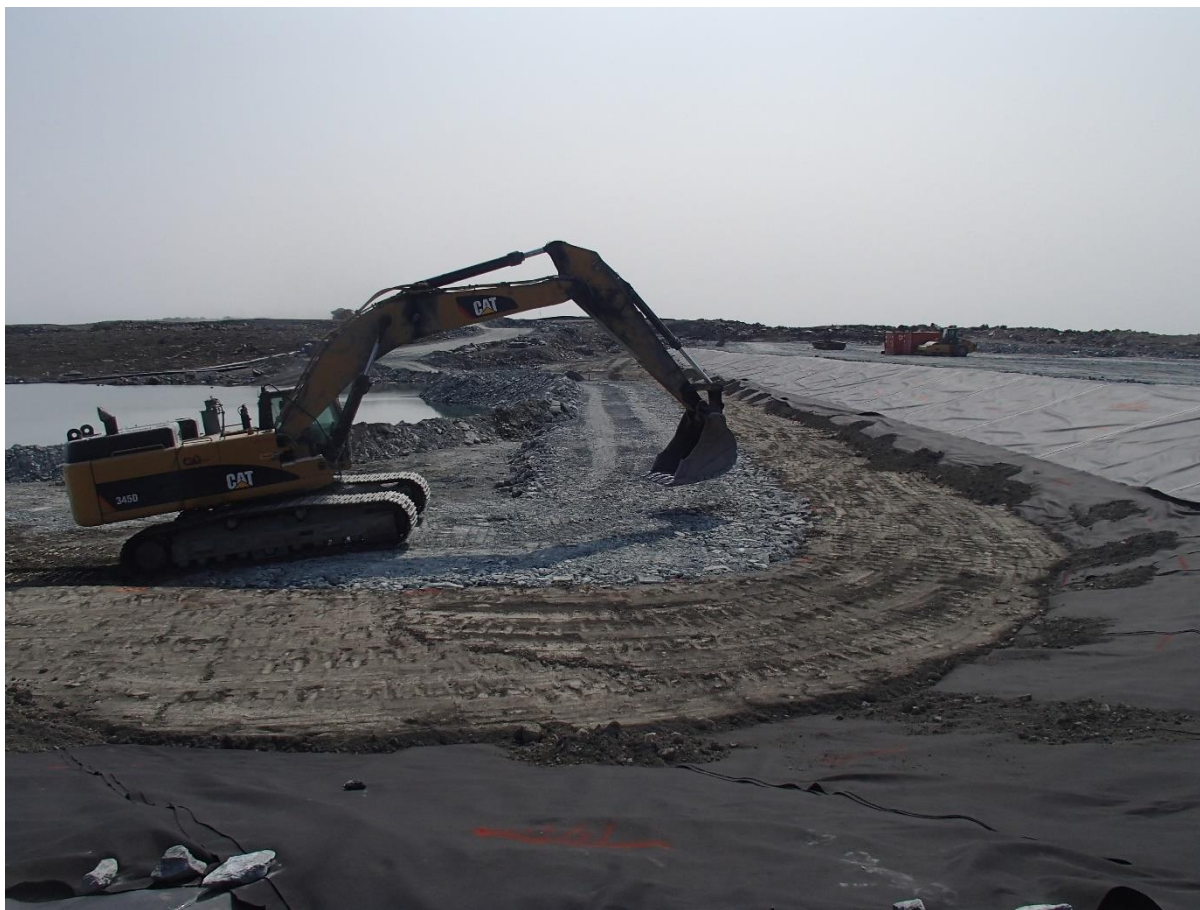
Photograph SD3-325: From Sta. 20+610/-43 m, looking S. Placement of a first 0.5 m thick lift of fine rockfill (0-500 mm) upstream of the low quality till from El. 142 m to 142.5 m from Sta. 20+610 m to 20+760 m.

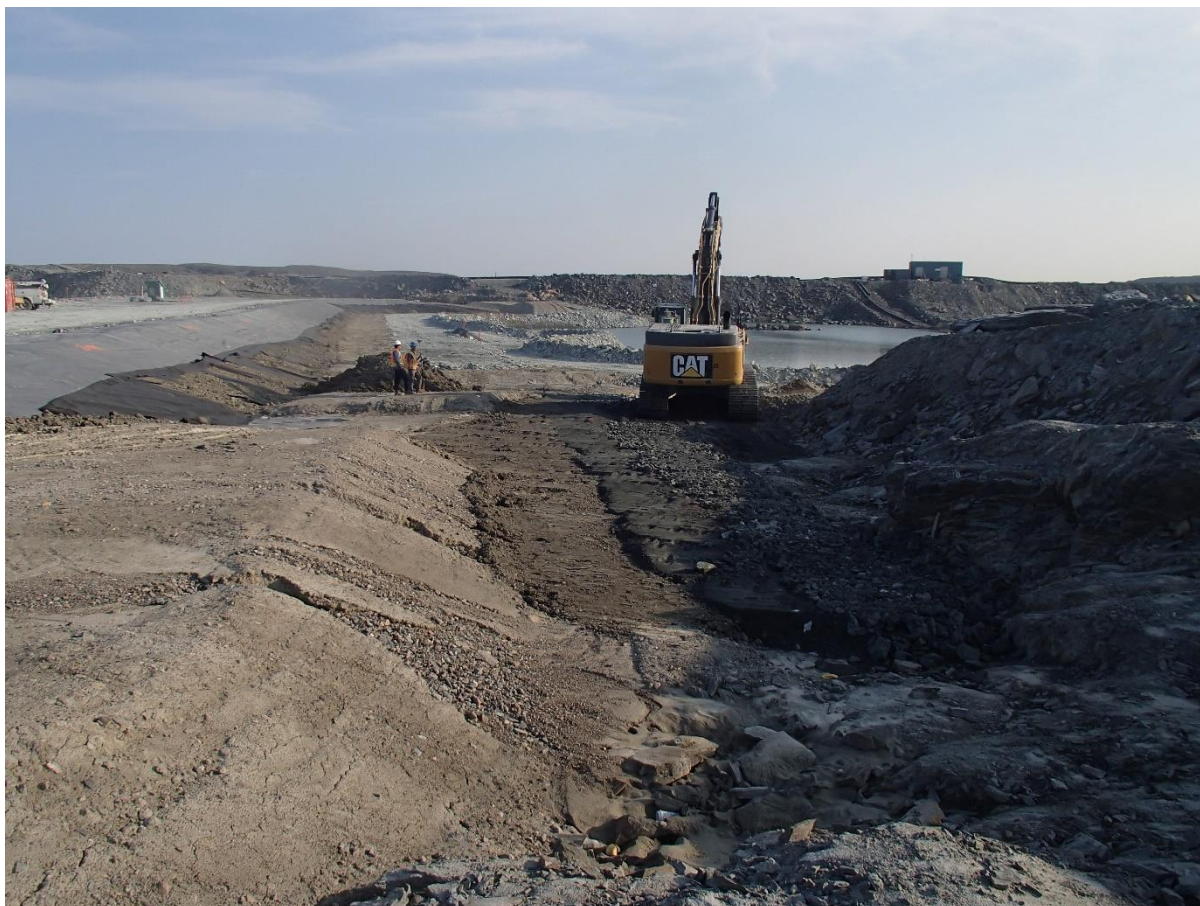
Photograph SD3-326: From Sta. 20+820/-34 m, looking N. Placement of the 0.5 m thick lift of low class till, fine filter, coarse filter and fine rockfill on the upstream slope of the upstream toe liner tie-in with an excavator from Sta. 20+780 to 20+810 m.

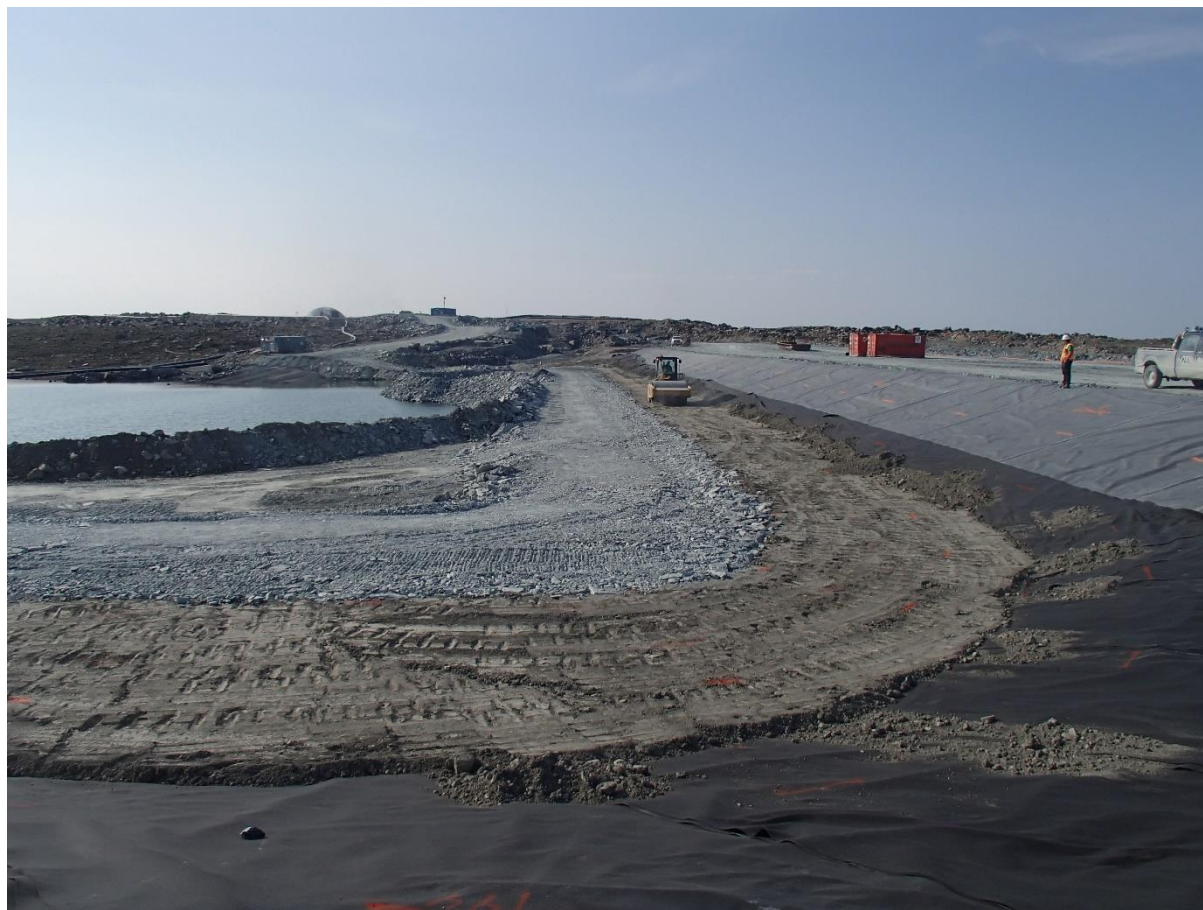
Photograph SD3-327: From Sta. 20+610/-43 m, looking S. Compaction of the 0.5 m lift of low quality till (0-150 mm) at El. 142.5 m with a 10-tonne smooth-drum compactor with vibration (4 passes) from Sta. 20+610 m to 20+615 m and from Sta. 20+635 m to 20+760 m.

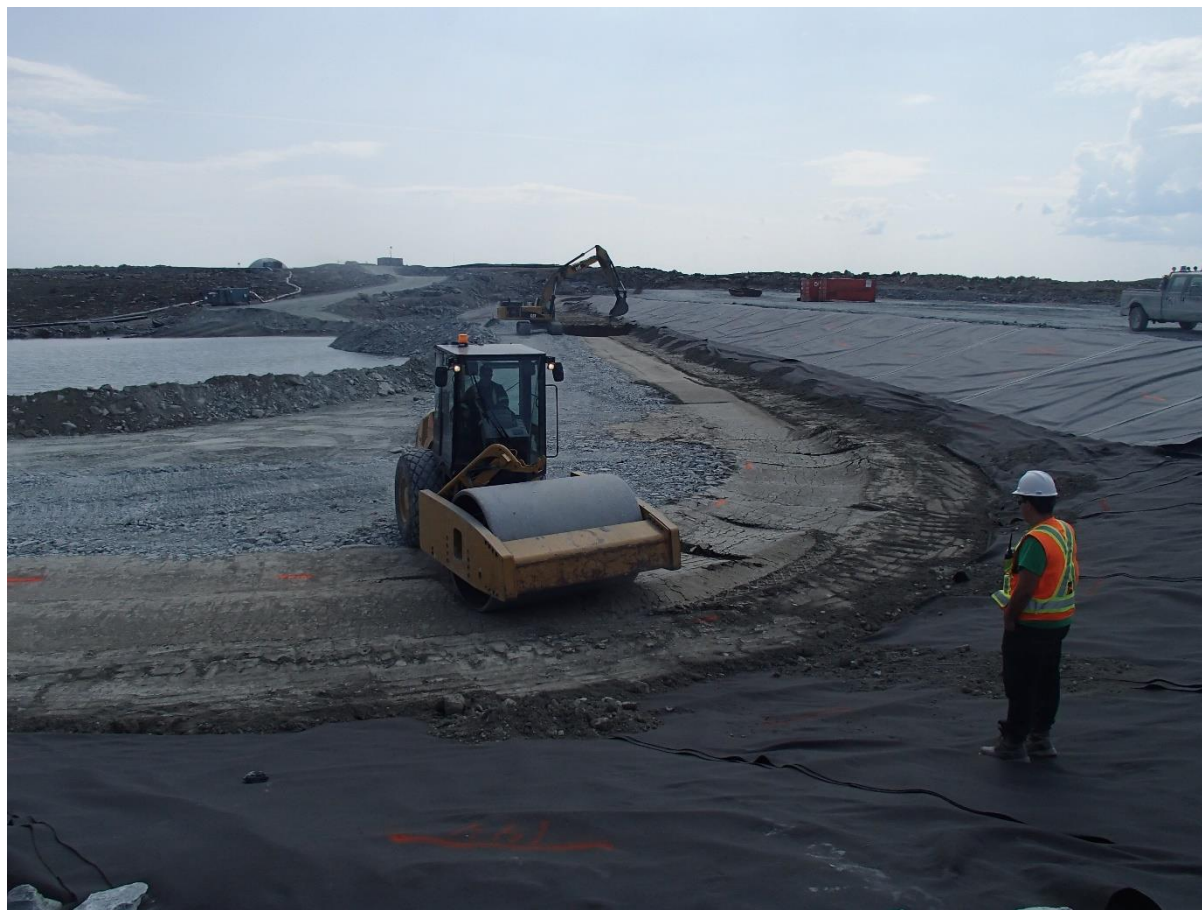
- The compactor was sinking in the low quality till at El. 142.5 m from sta. 20+615 m to 20+635 m, when turning to follow the curve of Saddle Dam 3. As the water content measured with the portable nuclear gauge indicated a 6.1% water content, it was assumed that it was the underlying compacted sieved till layer that was too soft. Following discussion with the Designer, it was decided not to excavate the underlying till layer to prevent damaging the LLDPE geomembrane below the compacted sieved till. The surface of the low quality till at El. 142.5 m was corrected with the excavator and was then compacted with a with a 10-tonne

smooth-drum compactor without vibration. The compaction was carried out perpendicularly to the longitudinal axe of Saddle Dam 3 to avoid the necessity to turn on the low quality till for the compactor.

Photograph SD3-328: From Sta. 20+610/-43 m, looking S. Compaction perpendicularly to the longitudinal axis of Saddle Dam 3 of the 0.5 m lift of low quality till (0-150 mm) at El. 142.5 m with a 10-tonne smooth-drum compactor without vibration (4 passes) from Sta. 20+615m to 20+635 m.

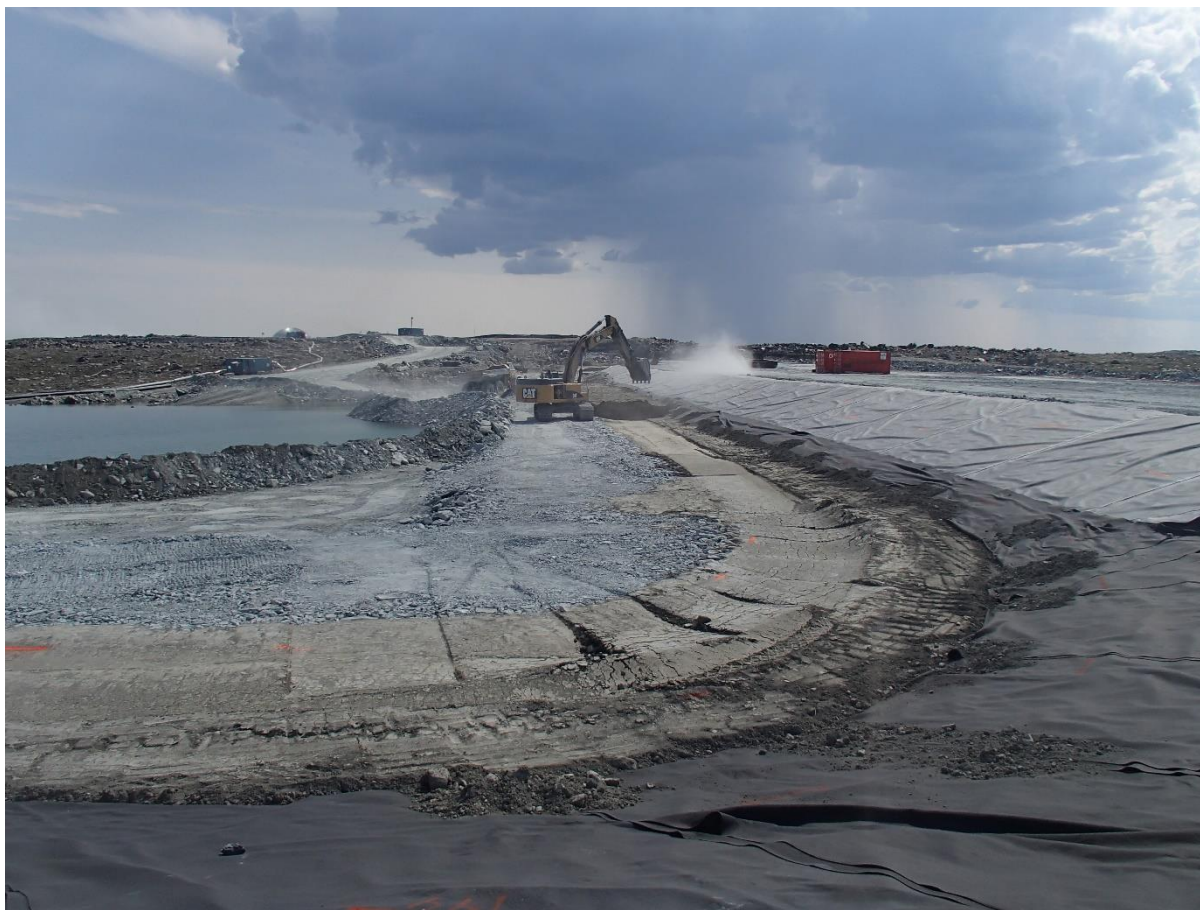
Photograph SD3-329: From Sta. 20+610/-43 m, looking S. Placement of a 0.5 m thick lift of low quality till (0-150 mm) from El. 142.5 m to 143 m from Sta. 20+610 m to 20+760 m.

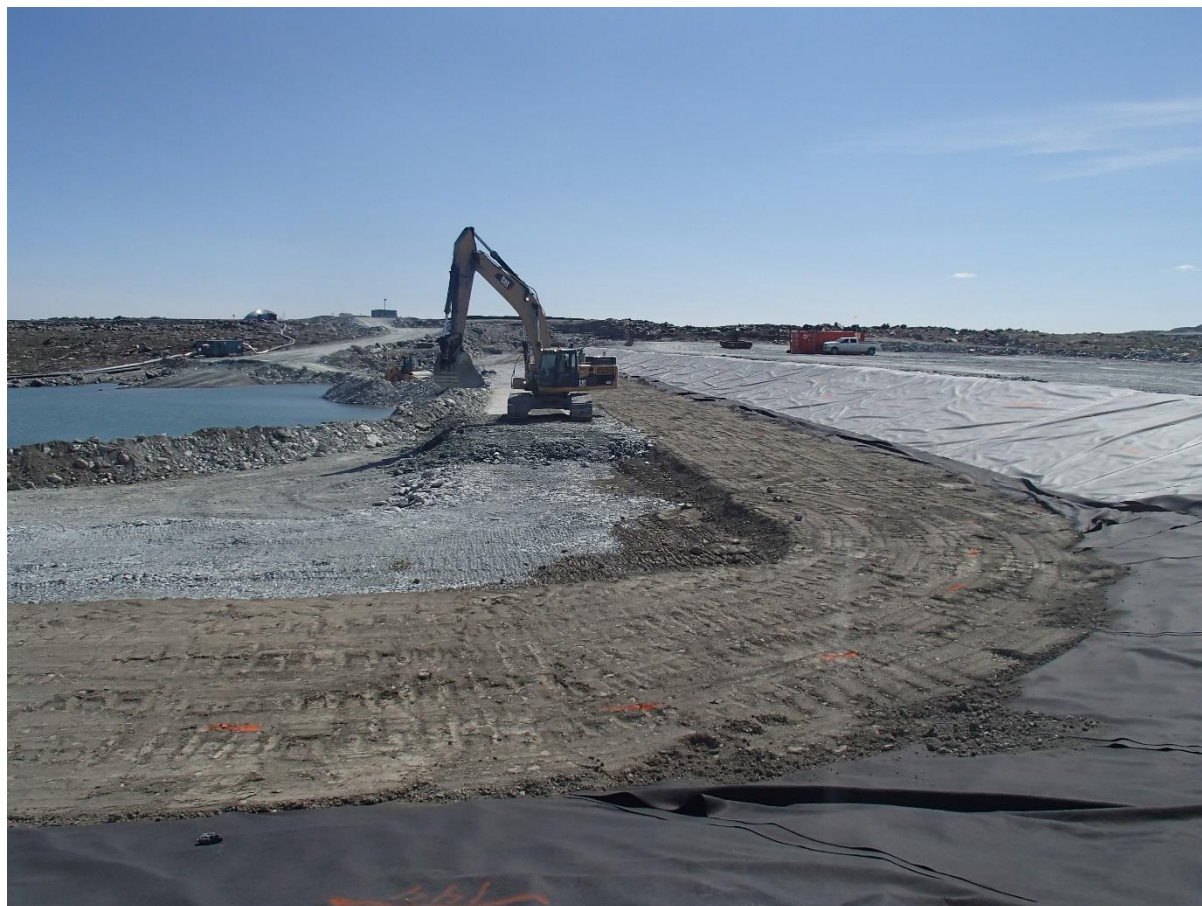
Photograph SD3-330: From Sta. 20+610/-43 m, looking S. Placement of a second 0.5 m thick lift of fine rockfill (0-500 mm) upstream of the low quality till (0-150mm) from El. 142.5 m to 143 m from Sta. 20+610 m to 20+760 m.

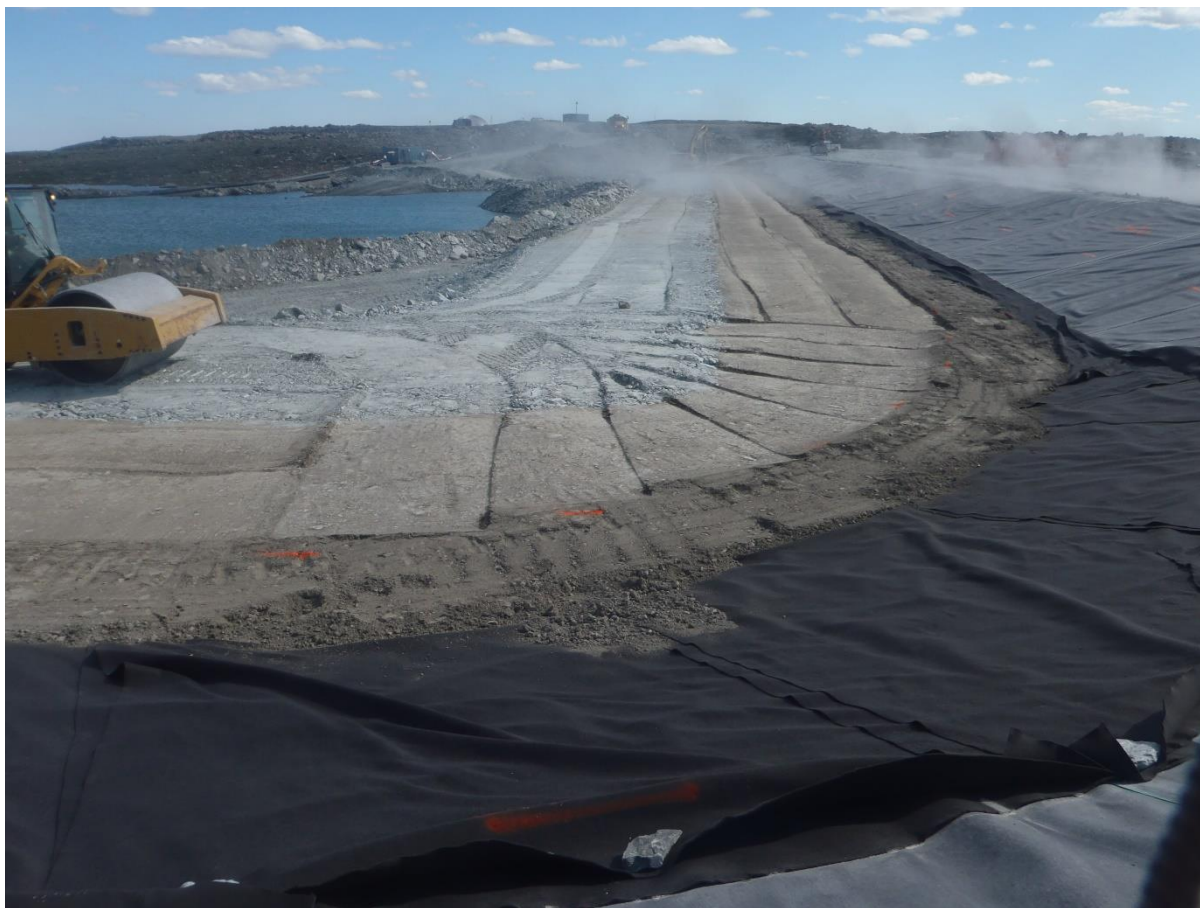
Photograph SD3-331: From Sta. 20+610/-43 m, looking S. Compaction of the 0.5 m lift of low quality till (0-150 mm) at El. 143 m with a 10-tonne smooth-drum compactor with vibration (4 passes) from Sta. 20+610 m to 20+760 m.

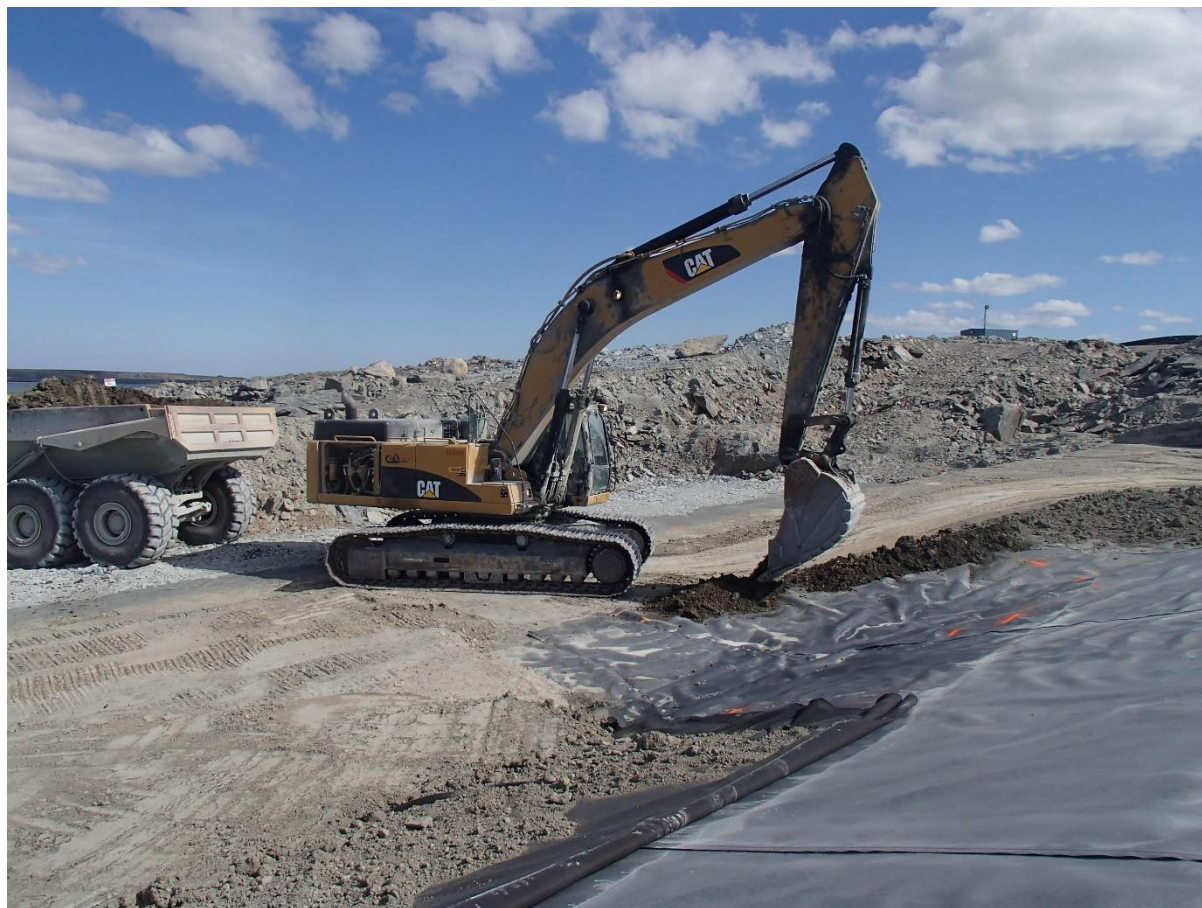
Photograph SD3-332: From Sta. 20+775/-23 m, looking SE. Placement of a first 0.5 m thick lift of compacted sieved till over the LLDPE geomembrane on the upstream toe liner tie-in with an excavator from Sta. 20+775 m to 20+800 m.

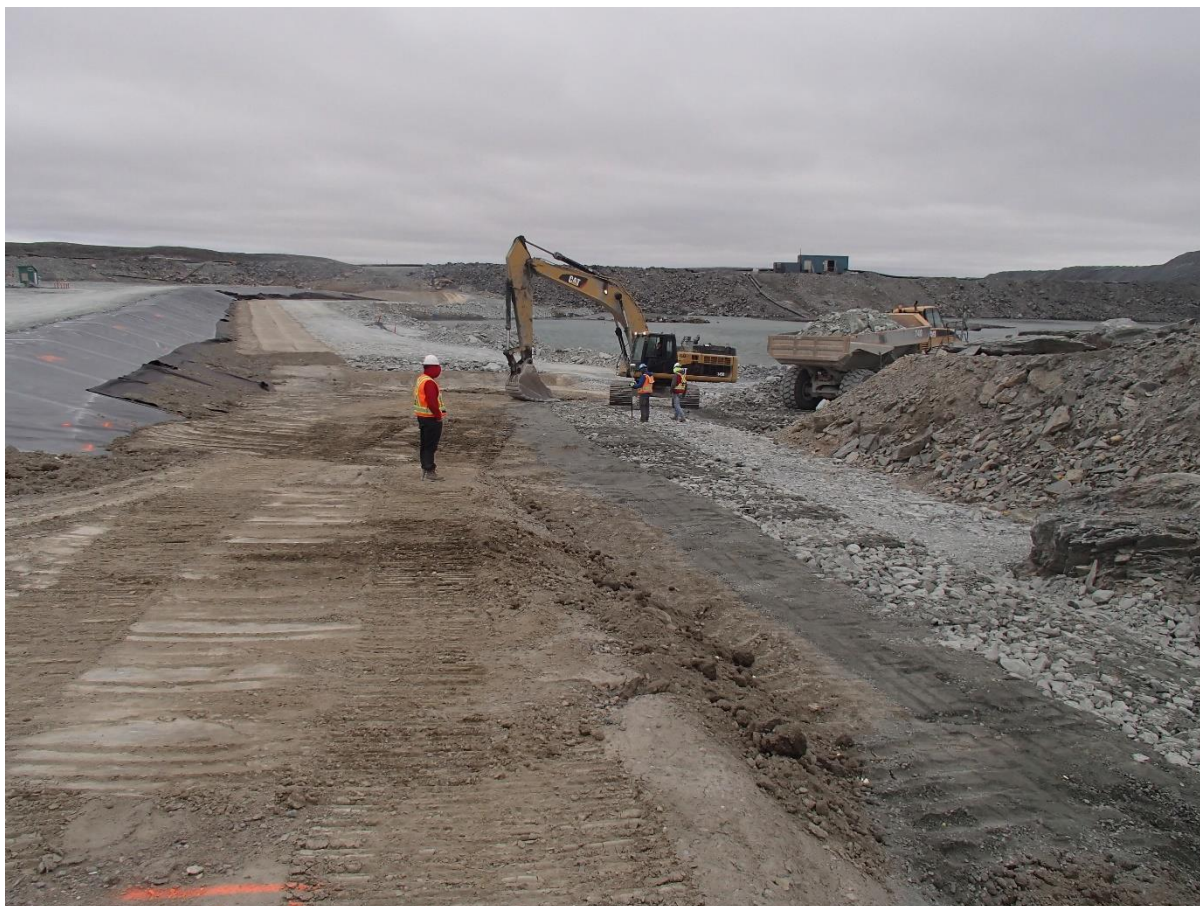
Photograph SD3-333: From Sta. 20+817/-29 m, looking N. Placement of a second 0.5 m thick lift of fine rockfill on the upstream slope of the upstream toe liner tie-in with an excavator from Sta. 20+775 m to 20+800 m.

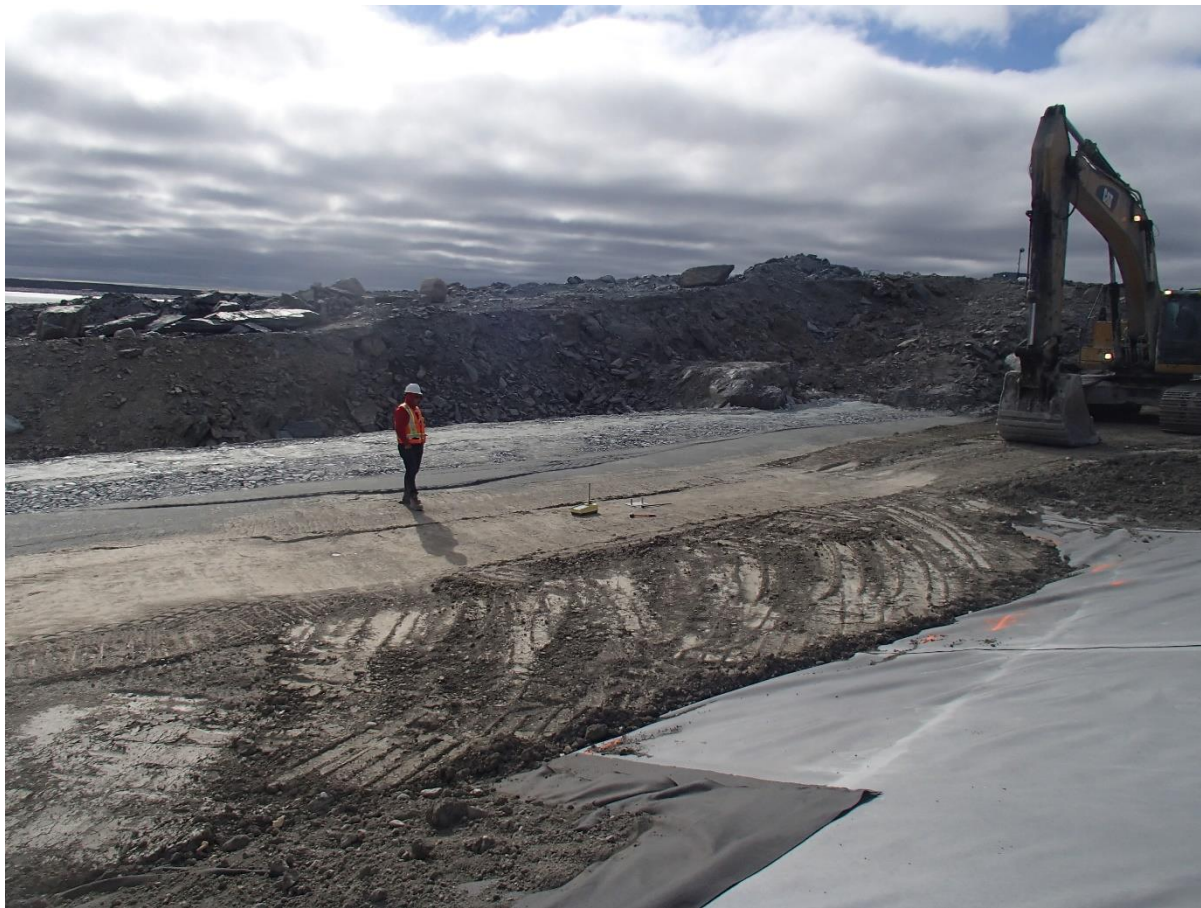
Photograph SD3-334: From Sta. 20+780/-26 m, looking SE. Compaction of the second 0.5 m thick lift of compacted sieved till and third lift of fine filter, coarse filter and fine rockfill of the upstream toe liner tie-in with a 10 tonne smooth-drum compactor with vibrations from Sta. 20+770 m to 20+800 m.
