QA DAILY REPORT

QA DAILY REPORT FOR JULY 7TH, 2018 – TSF SOUTH CELL CONSTRUCTION - MEADOWBANK (1897439)

Table 1: QA Observations for Saddle Dam 3

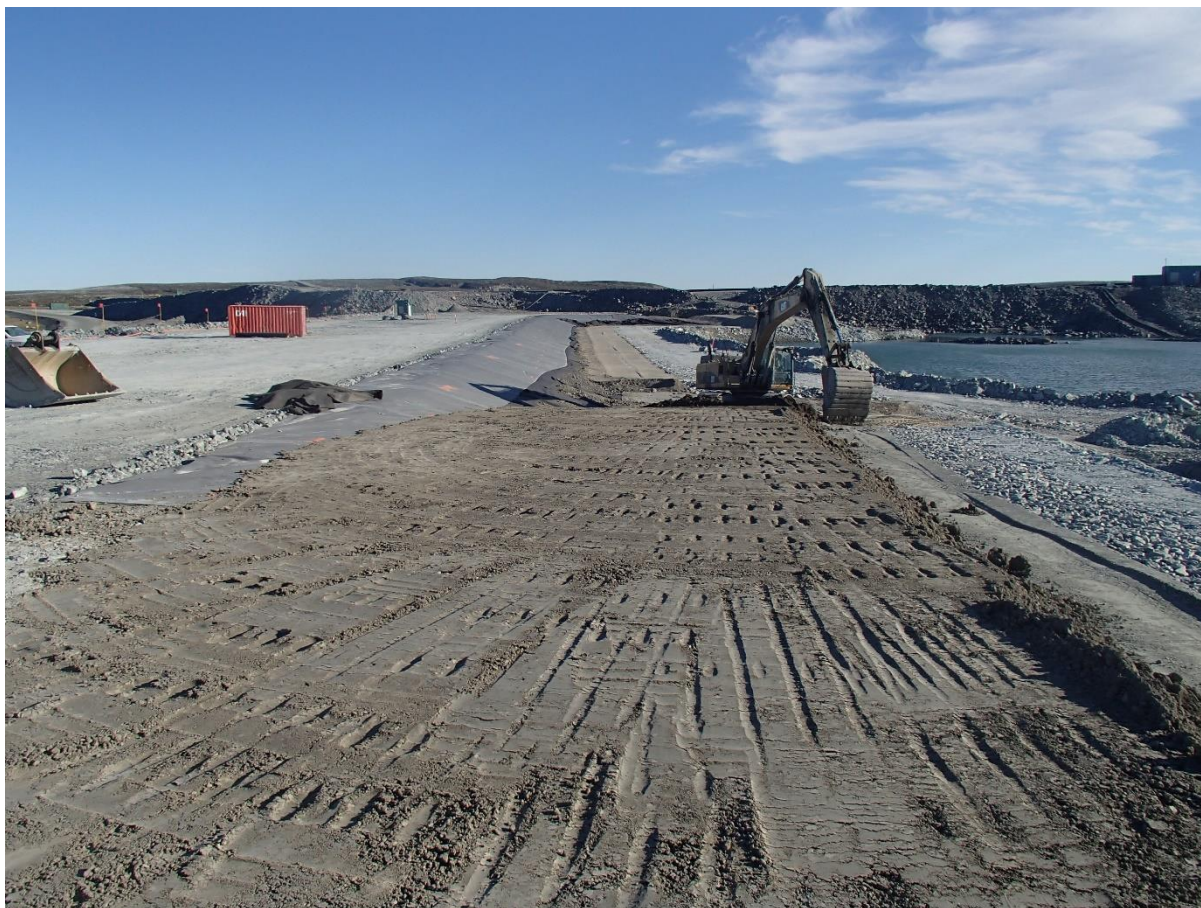
Photograph SD3-335: From Sta. 20+815/-27 m, looking N. Placement of a third 0.5 m thick lift of compacted sieved till on the upstream toe liner tie-in with an excavator from Sta. 20+760 m to 20+810 m.
