QA DAILY REPORT

1897439-1576-TM-Rev0

QA DAILY REPORT FOR JULY 15TH, 2018 – TSF SOUTH CELL CONSTRUCTION - MEADOWBANK (1897439)

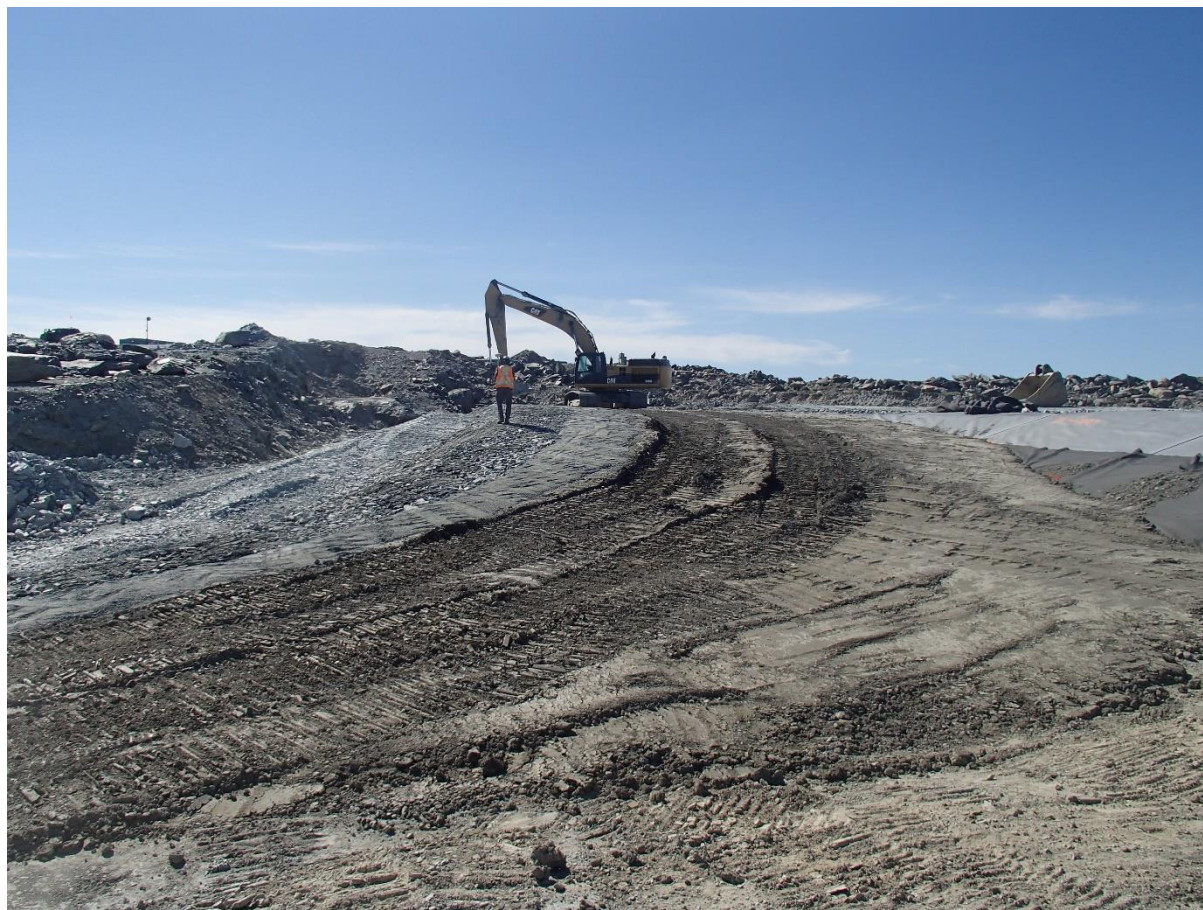
Photograph SD3-336: From Sta. 20+755/-48 m, looking S. Placement of a fourth 0.5 m thick lifts of fine filter, coarse filter and fine rockfill on the upstream slope of the upstream toe liner tie-in with an excavator from Sta. 20+770 to 20+800 m.

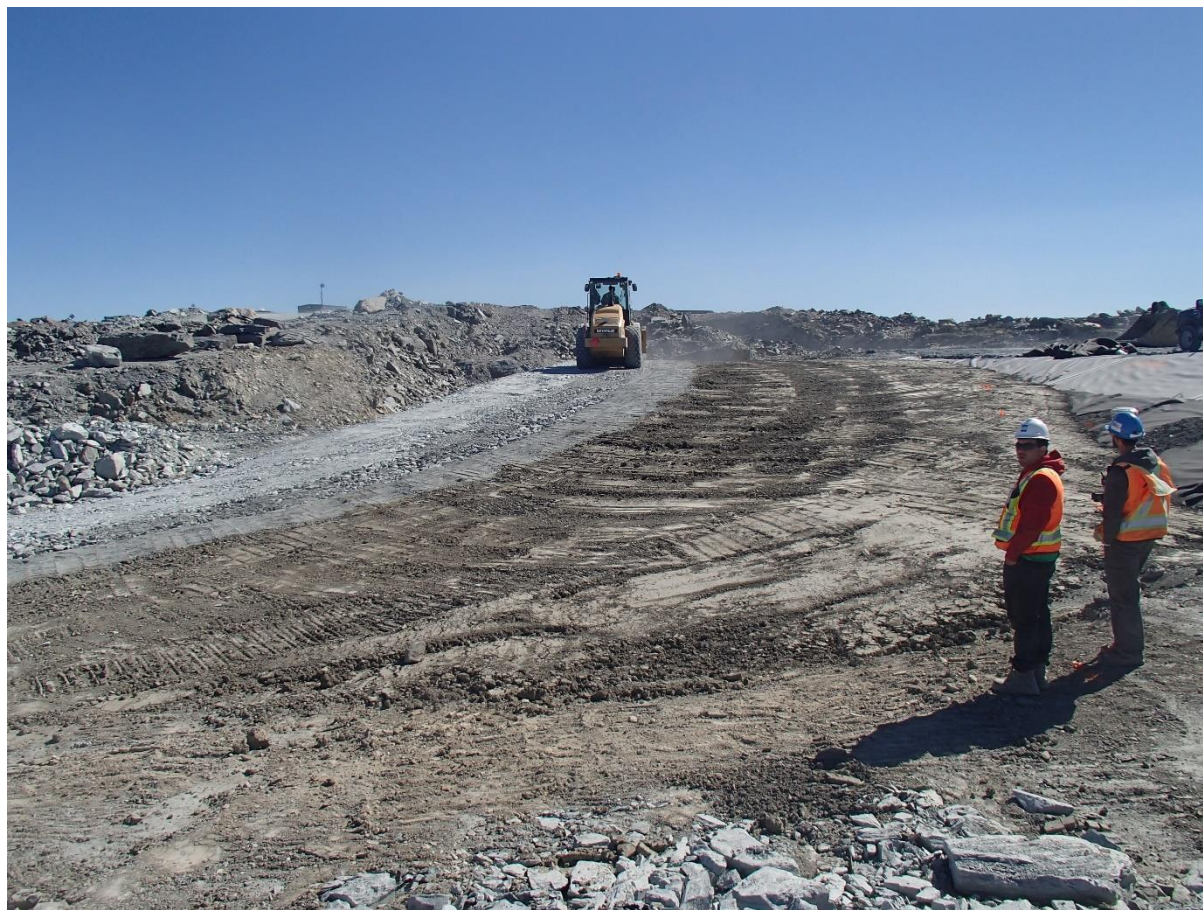
Photograph SD3-337: From Sta. 20+760/-37 m, looking S. Compaction of the fourth 0.5 m thick lifts of fine filter, coarse filter and fine rockfill on the upstream slope of the upstream toe liner tie-in with a 10 tonne smooth-drum compactor with vibrations (4 passes) from Sta. 20+770 to 20+800 m.

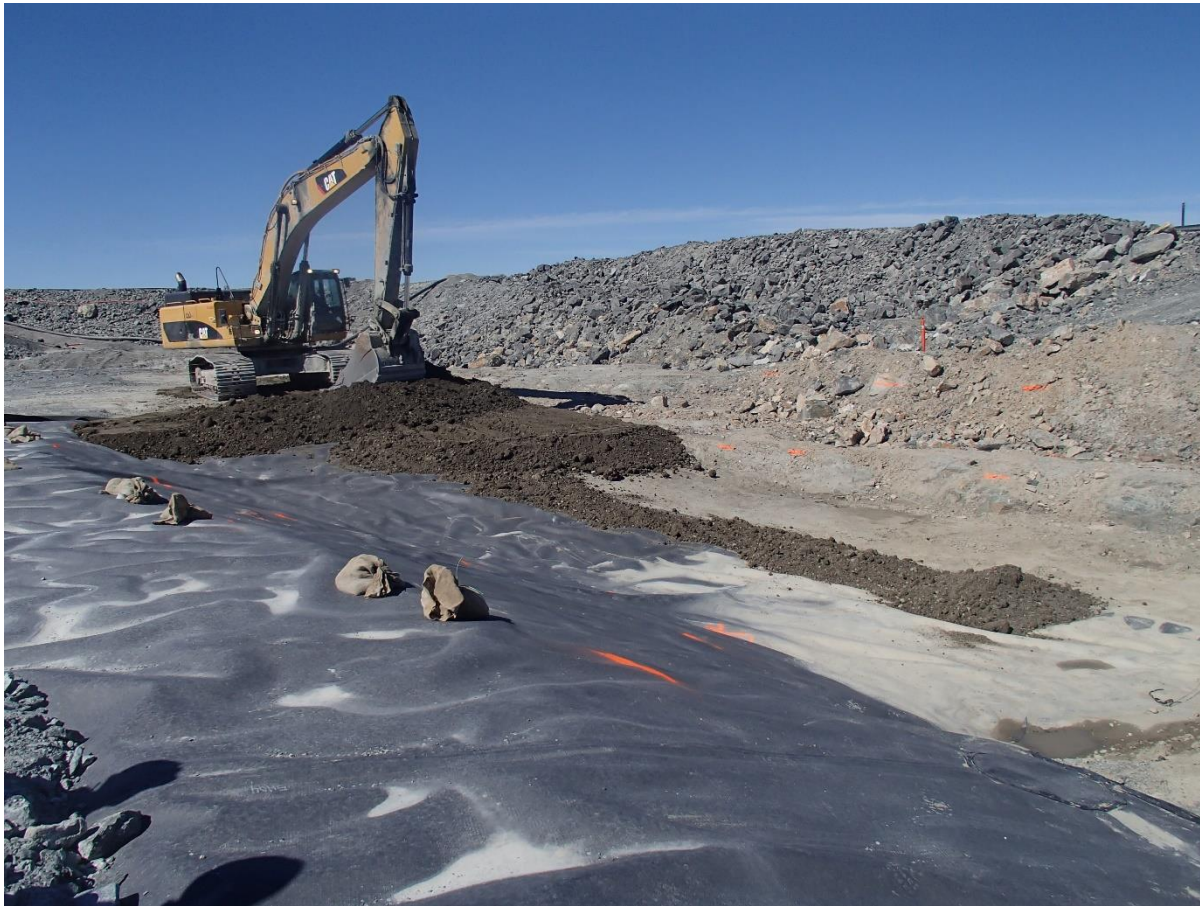
Photograph SD3-338: From Sta. 20+610/-43 m, looking NW. Placement of a first 0.5 m thick lift of compacted sieved till over the LLDPE geomembrane on the upstream toe liner tie-in with an excavator from Sta. 20+588 m to 20+599 m.

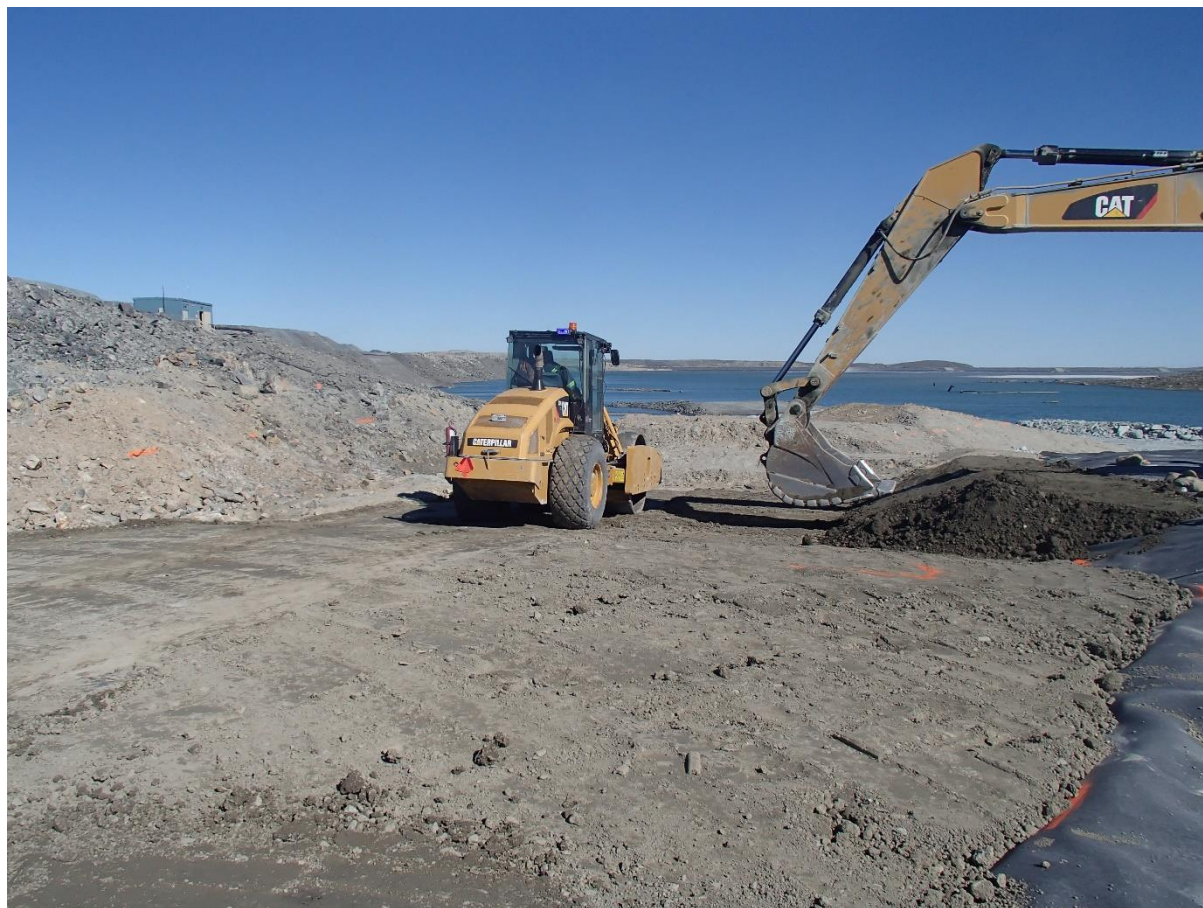
Photograph SD3-339: From Sta. 20+600/-29 m, looking E. Compaction of a first 0.5 m thick lift of compacted sieved till on the upstream toe liner tie-in with an excavator from Sta. 20+588 m to 20+599 m.

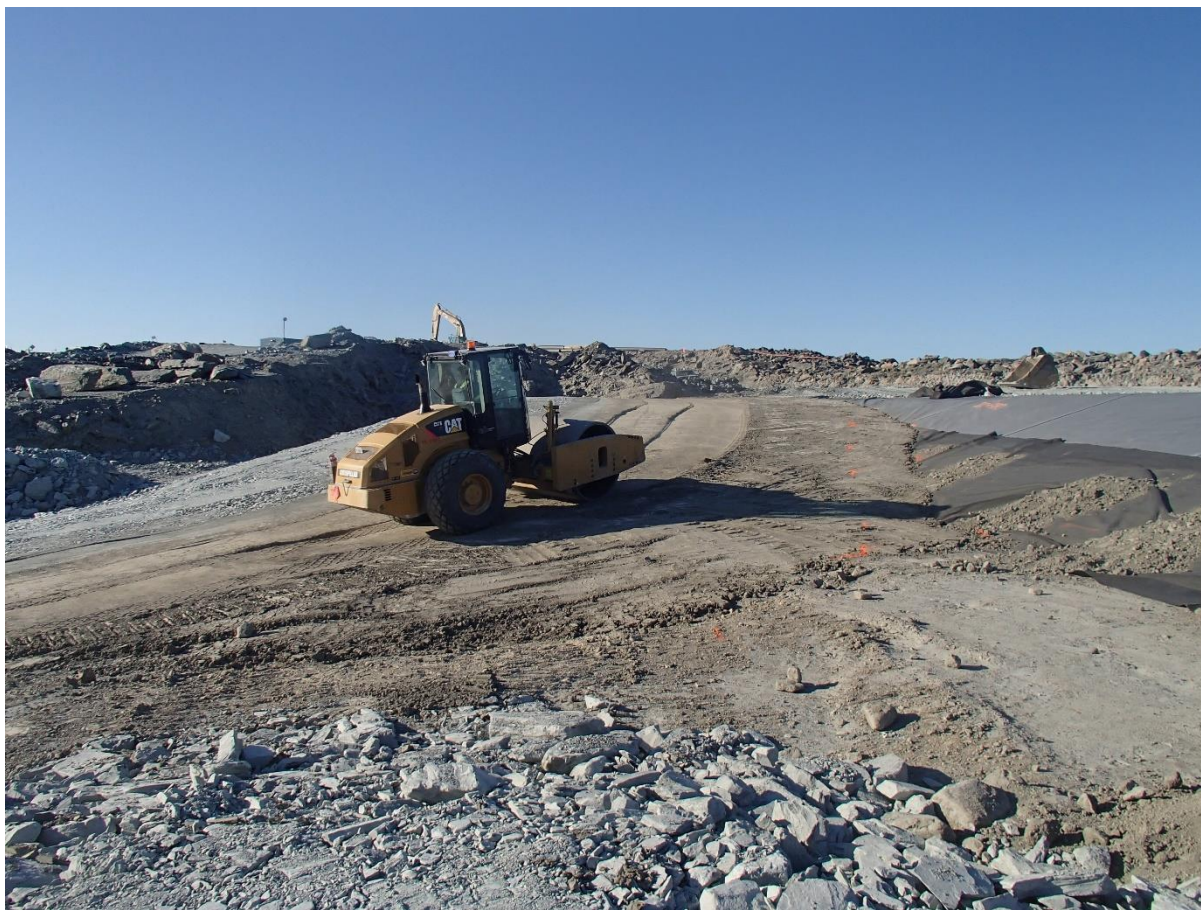
Photograph SD3-340: From Sta. 20+750/-40 m, looking S. Compaction of the third 0.5 m thick lift of compacted sieved till on the upstream toe liner tie-in with an excavator from Sta. 20+760 m to 20+820 m.

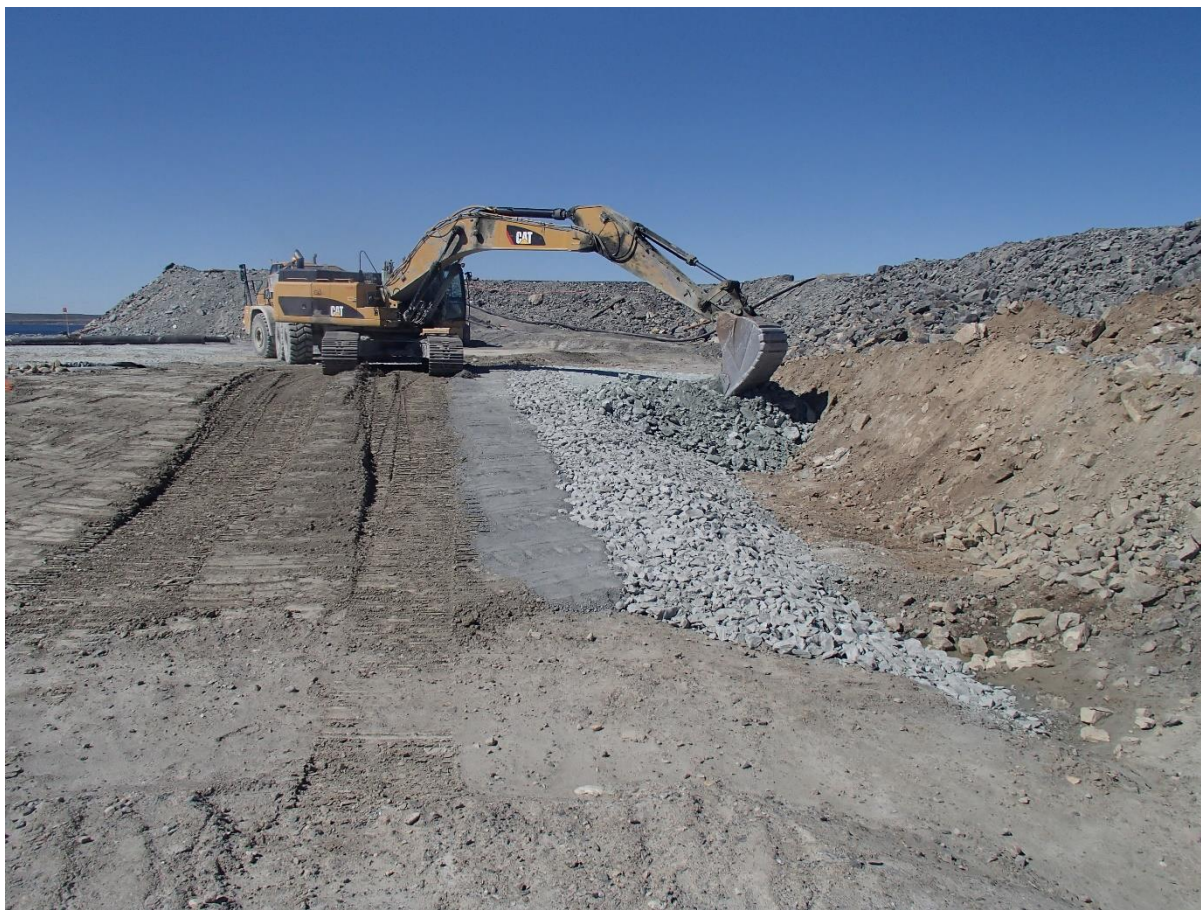
Photograph SD3-341: From Sta. 20+600/-58 m, looking W. Placement of a first 0.5 m thick lift of fine rockfill on the upstream slope of the upstream toe liner tie-in with an excavator from Sta. 20+588 m to 20+599 m.

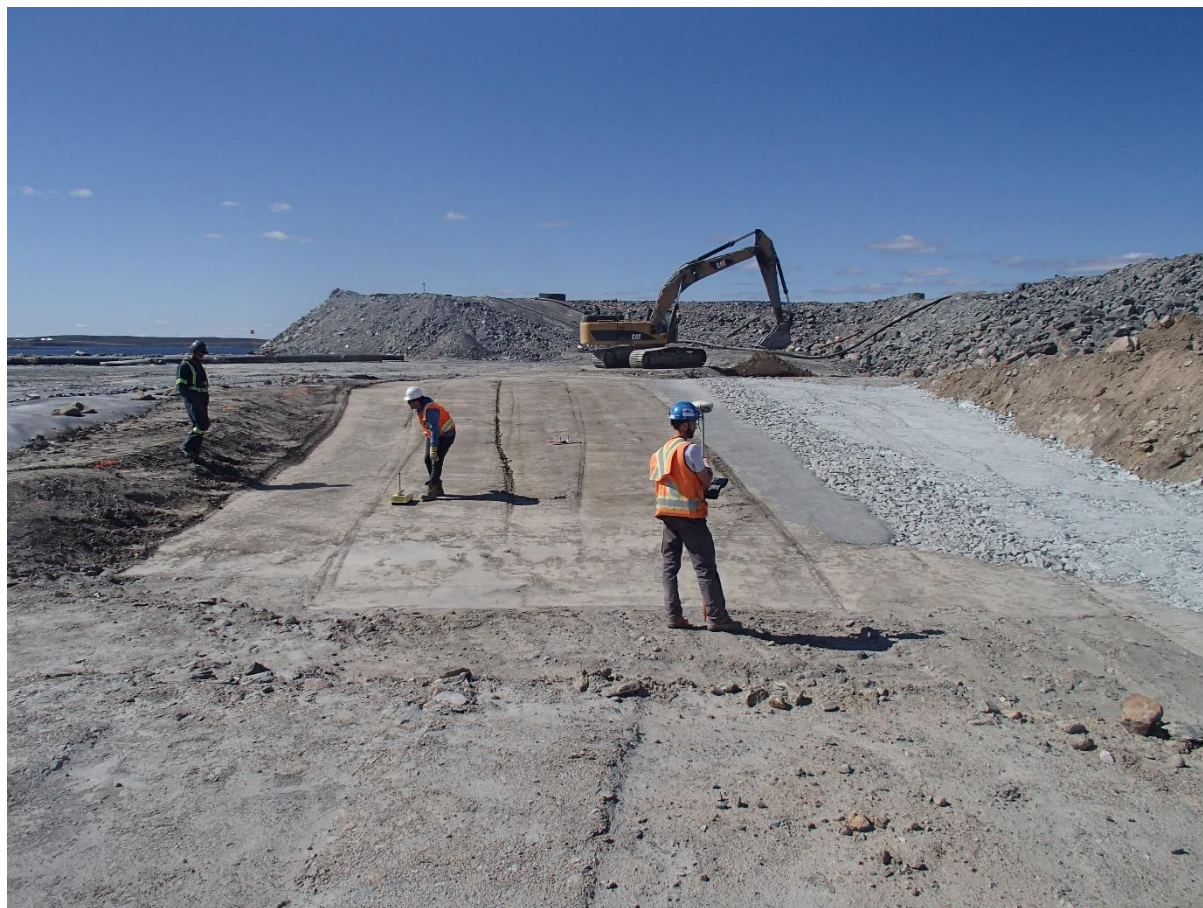
- The depressions in the surface between SD2 and SD3 are being filled with low quality till up to El. 145 m to limit water pounding and runoff in this area during freshet.

Photograph SD3-342: From Sta. 20+600/-57 m, looking W. View of the compaction test and view of the filling of the depression between SD2 and SD3 with low quality till up to El. 145 m.

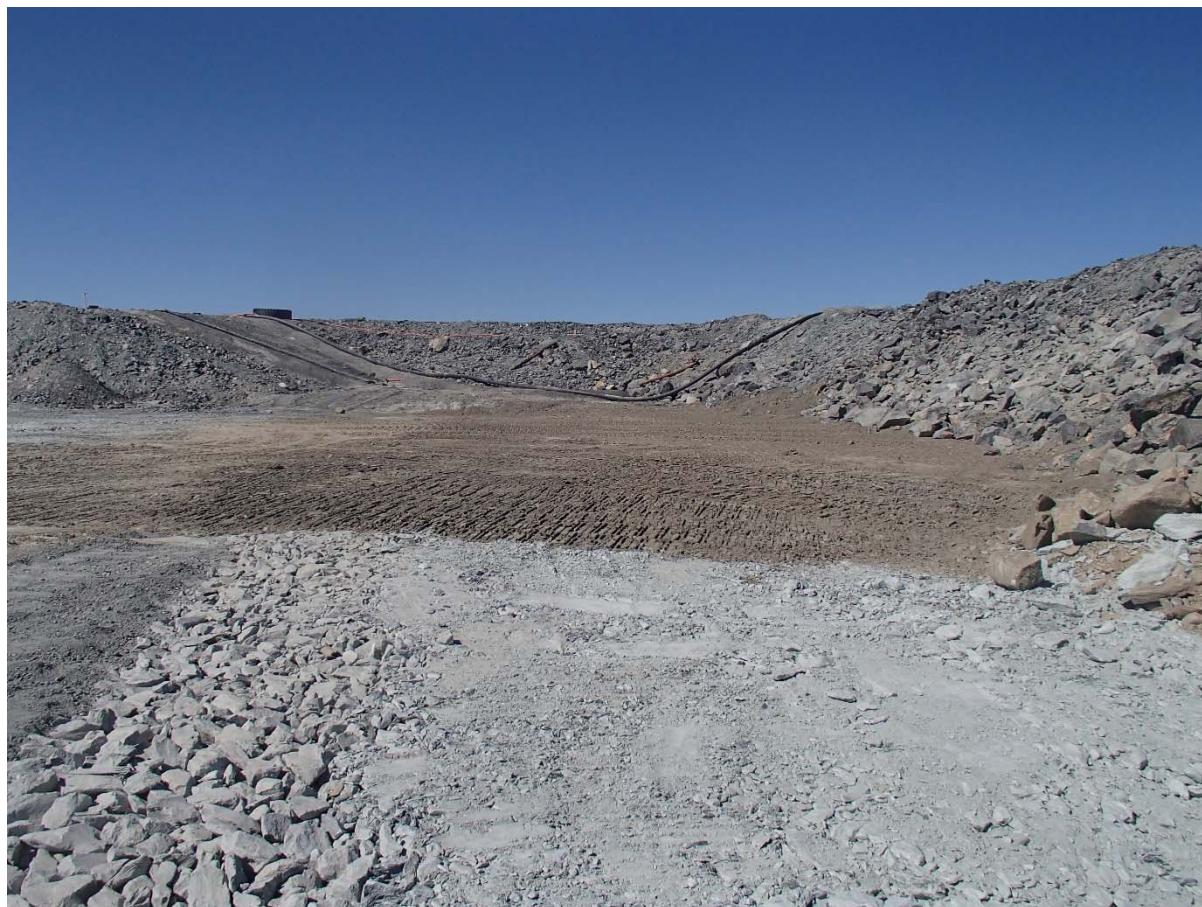
Photograph SD3-343: From Sta. 20+590/-40 m, looking NW. View of the depression between SD2 and SD3 backfilled with low quality till up to El. 145 m.

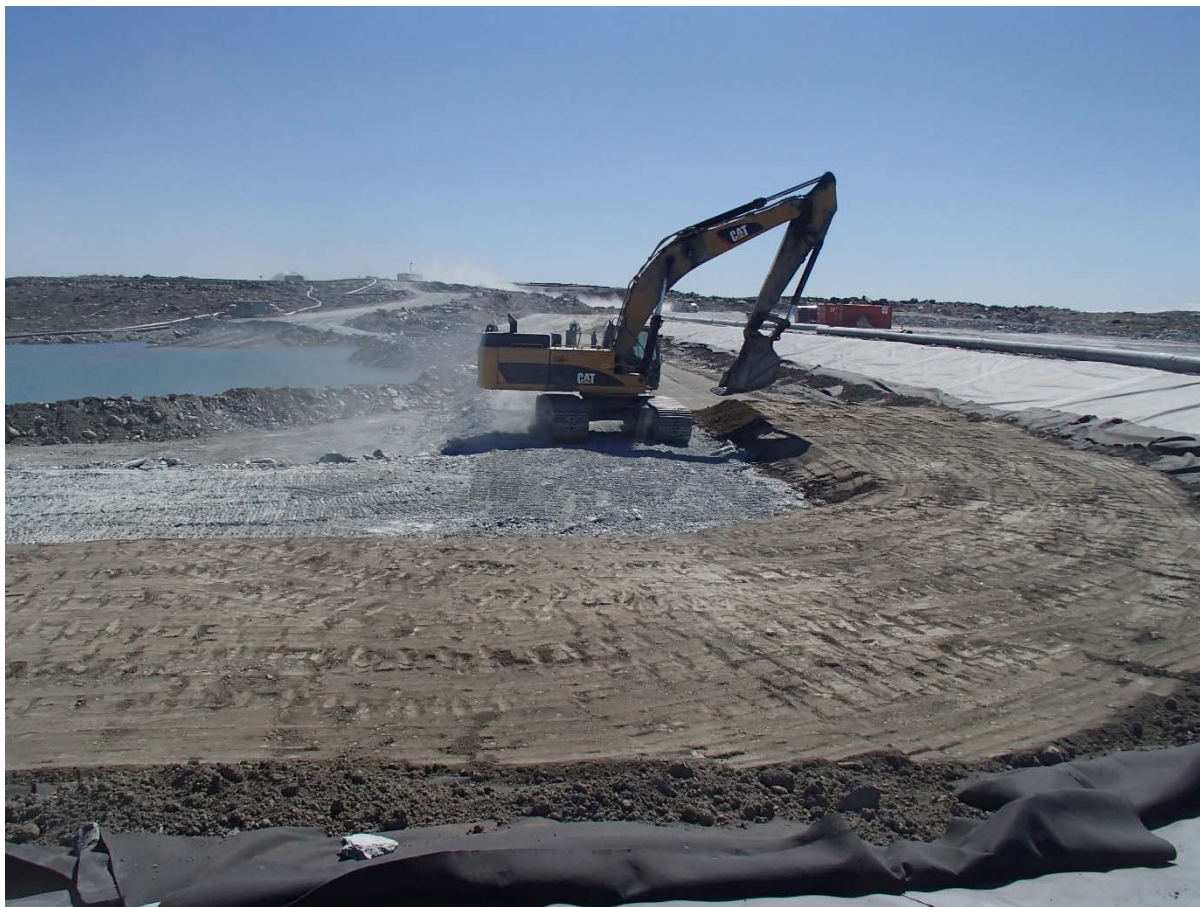
Photograph SD3-344: From Sta. 20+610/-43 m, looking S. Placement of a third 0.5 m thick lift of low quality till (0-150 mm) from El. 142.5 m to 143 m from Sta. 20+570 m to 20+590 m.

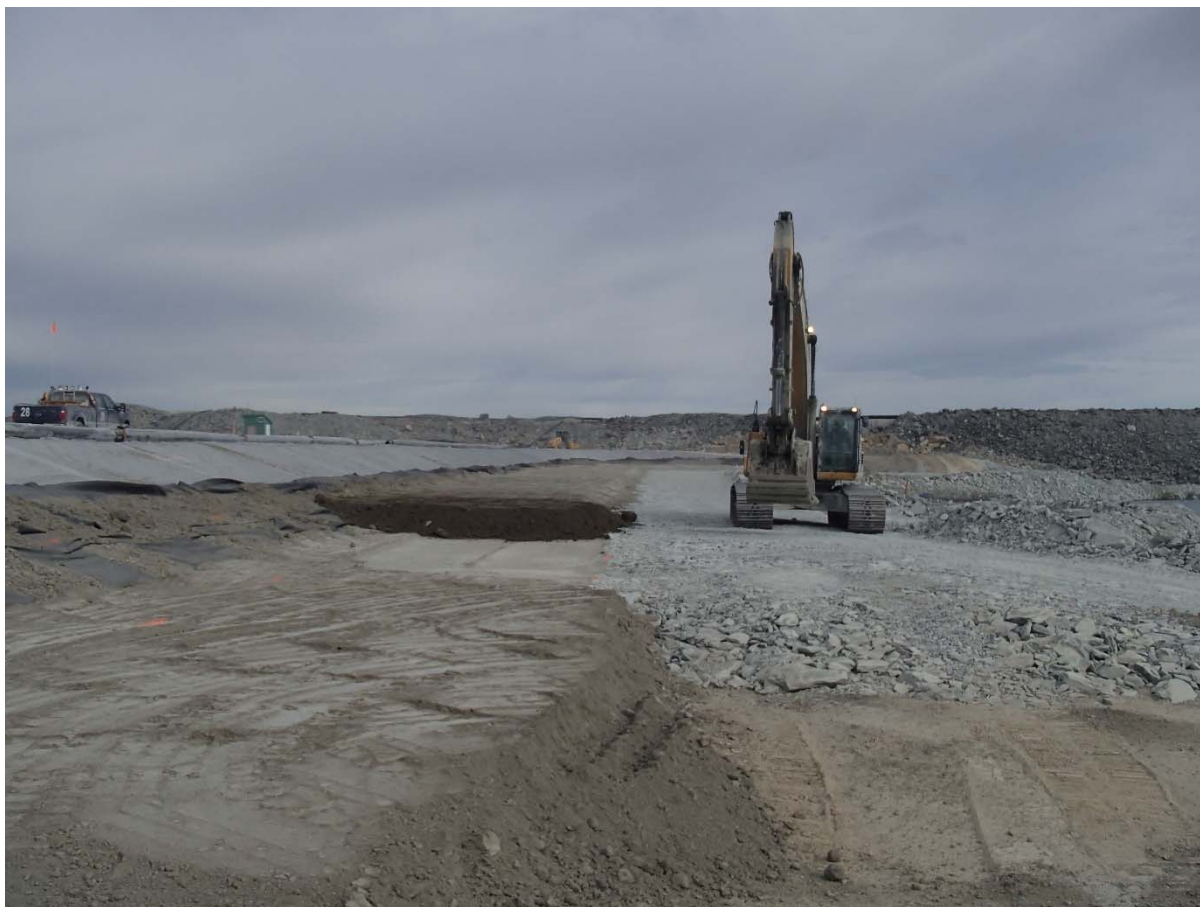
Photograph SD3-345: From Sta. 20+760/-42 m, looking NW. Placement of a fourth 0.5 m thick lift of low quality till (0-150 mm) from El. 143 m to 143.5 m from Sta. 20+619 m to 20+777 m.

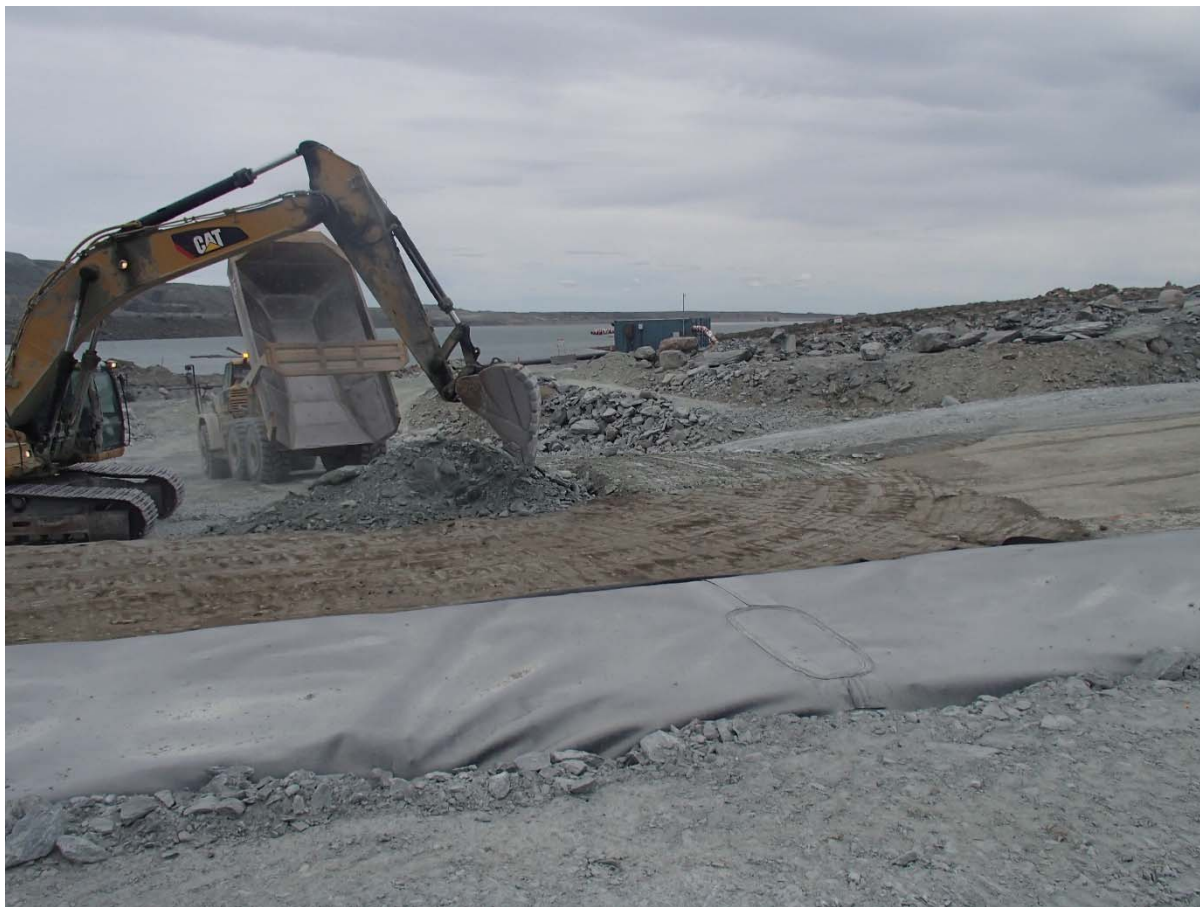
Photograph SD3-346: From Sta. 20+760/-21 m, looking E. Placement of a third 0.5 m thick lift of fine UM rockfill (0-500 mm) upstream of the low quality till (0-150mm) from El. 143 m to 143.5 m from Sta. 20+668 m to 20+777 m.

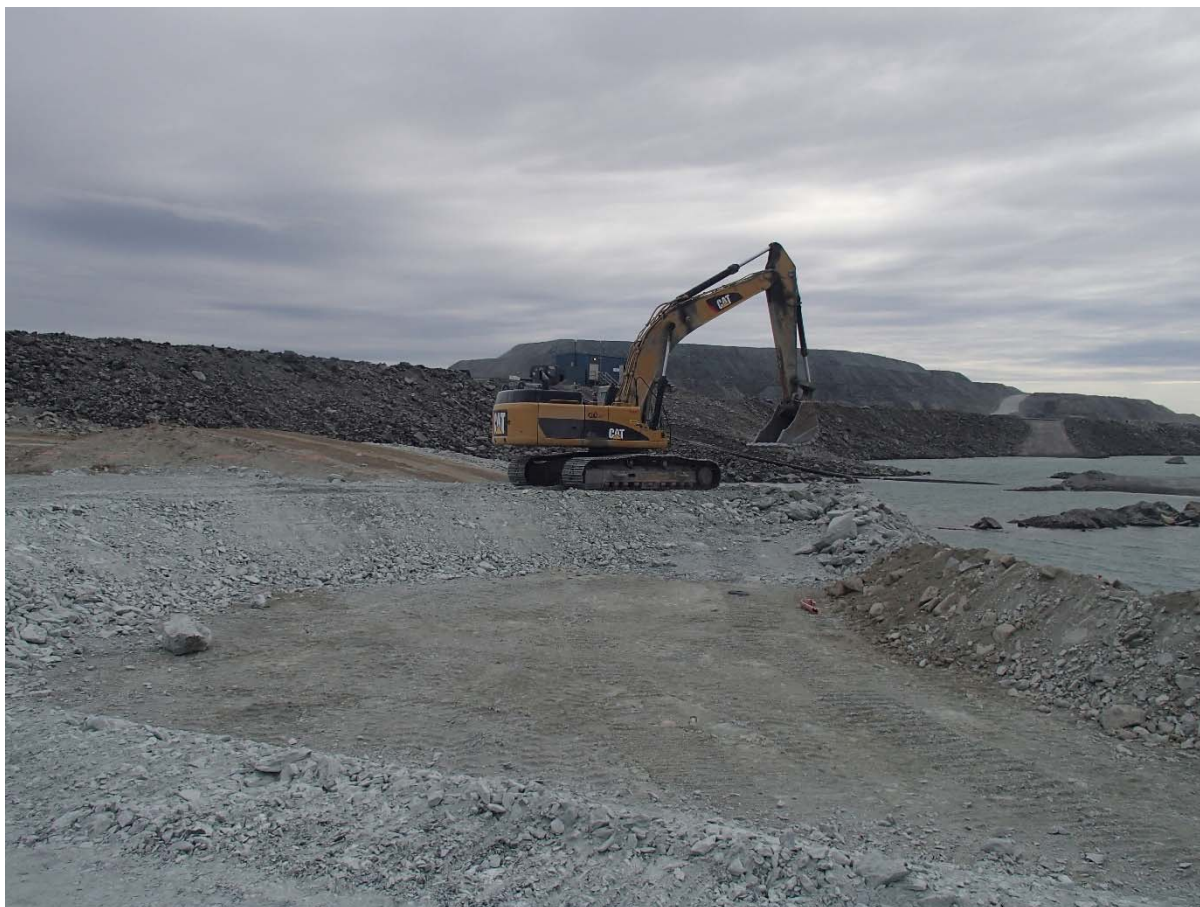
Photograph SD3-347: From Sta. 20+640/-41 m, looking W. Placement of a third 0.5 m thick lift of fine UM rockfill (0-500 mm) upstream of the low quality till (0-150mm) from El. 143 m to 143.5 m from Sta. 20+688 m to 20+619 m.

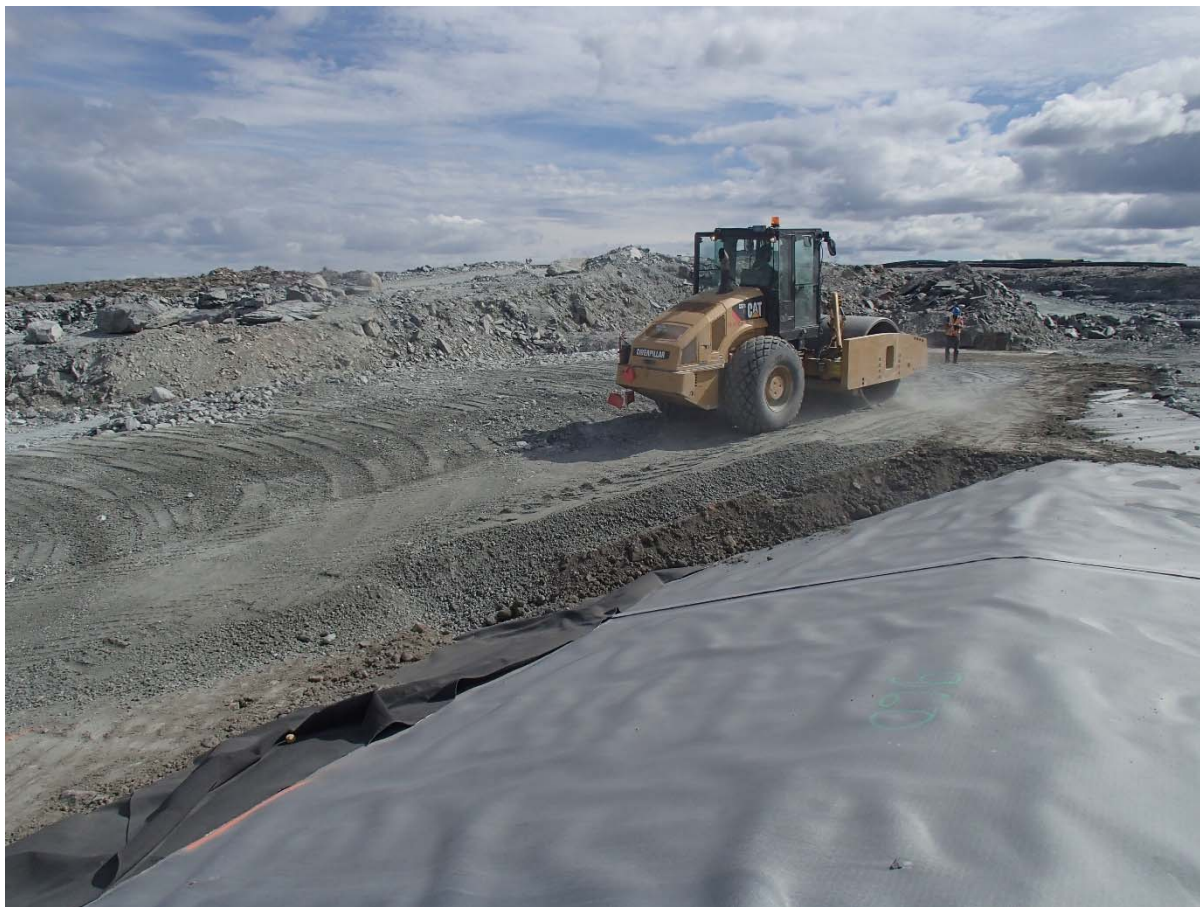
Photograph SD3-349: From Sta. 20+765/-29 m, looking SE. Compaction of the 0.5 m thick lift of fine filter on the top of the upstream toe liner tie-in with a 10 tonne smooth-drum compactor with vibration (4 passes) from Sta. 20+777 m to 20+807 m.

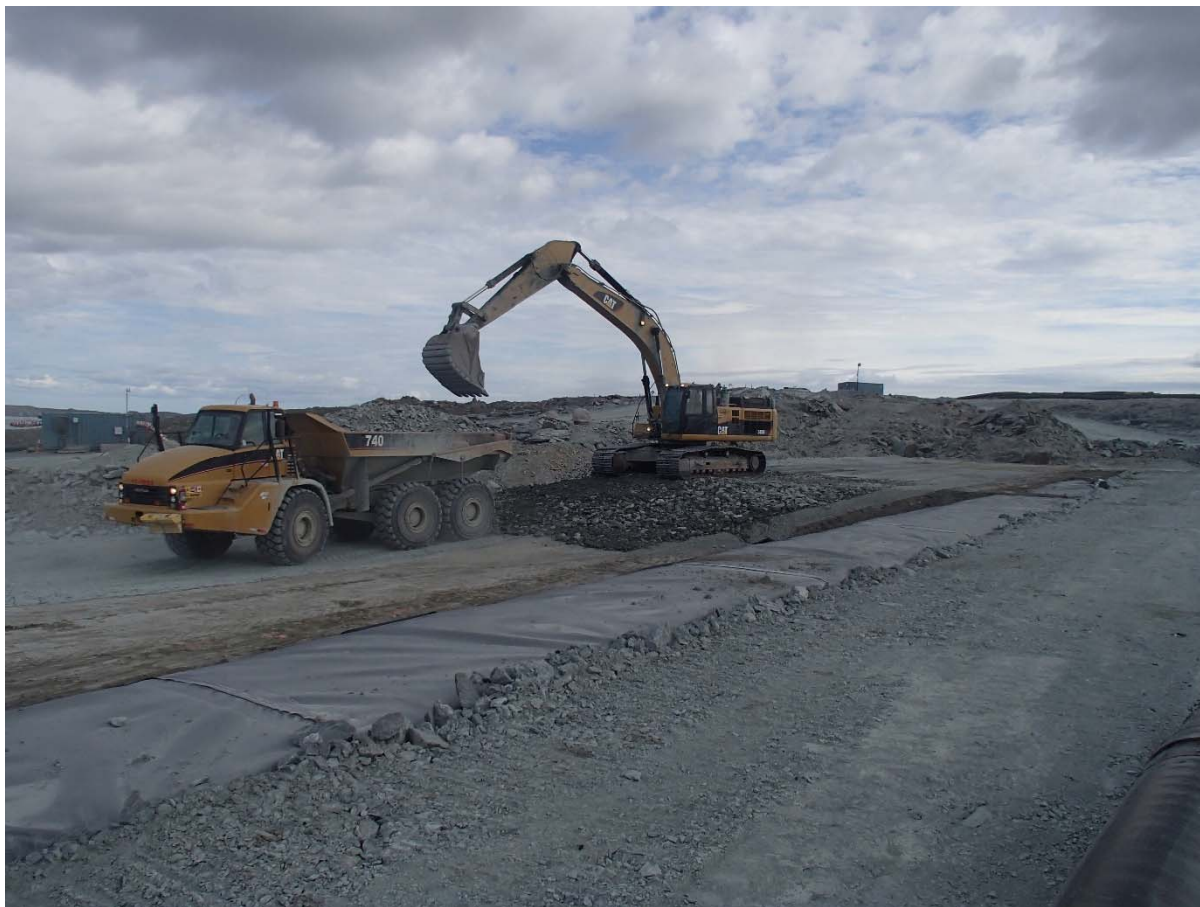
Photograph SD3-350: From Sta. 20+740/-24 m, looking SE. Placement of a 0.5 m thick lift of coarse filter on the top of the fine filter on the upstream toe liner tie-in with an excavator from Sta. 20+777 m to 20+807 m.

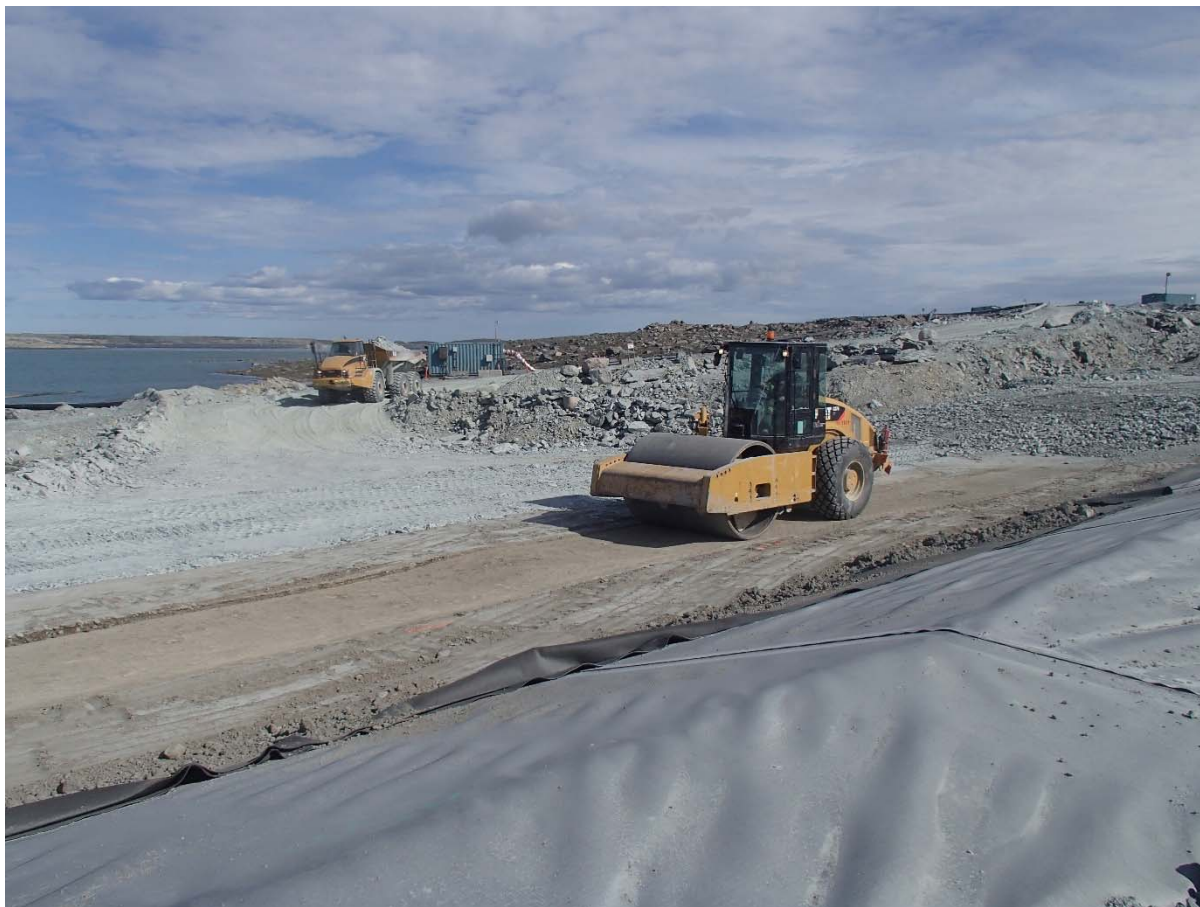
Photograph SD3-351: From Sta. 20+740/-24 m, looking SE. Compaction of the 0.5 m lift of low quality till (0-150 mm) at El. 143.5 m with a 10-tonne smooth-drum compactor with vibration (4 passes) from Sta. 20+619 m to 20+777 m.

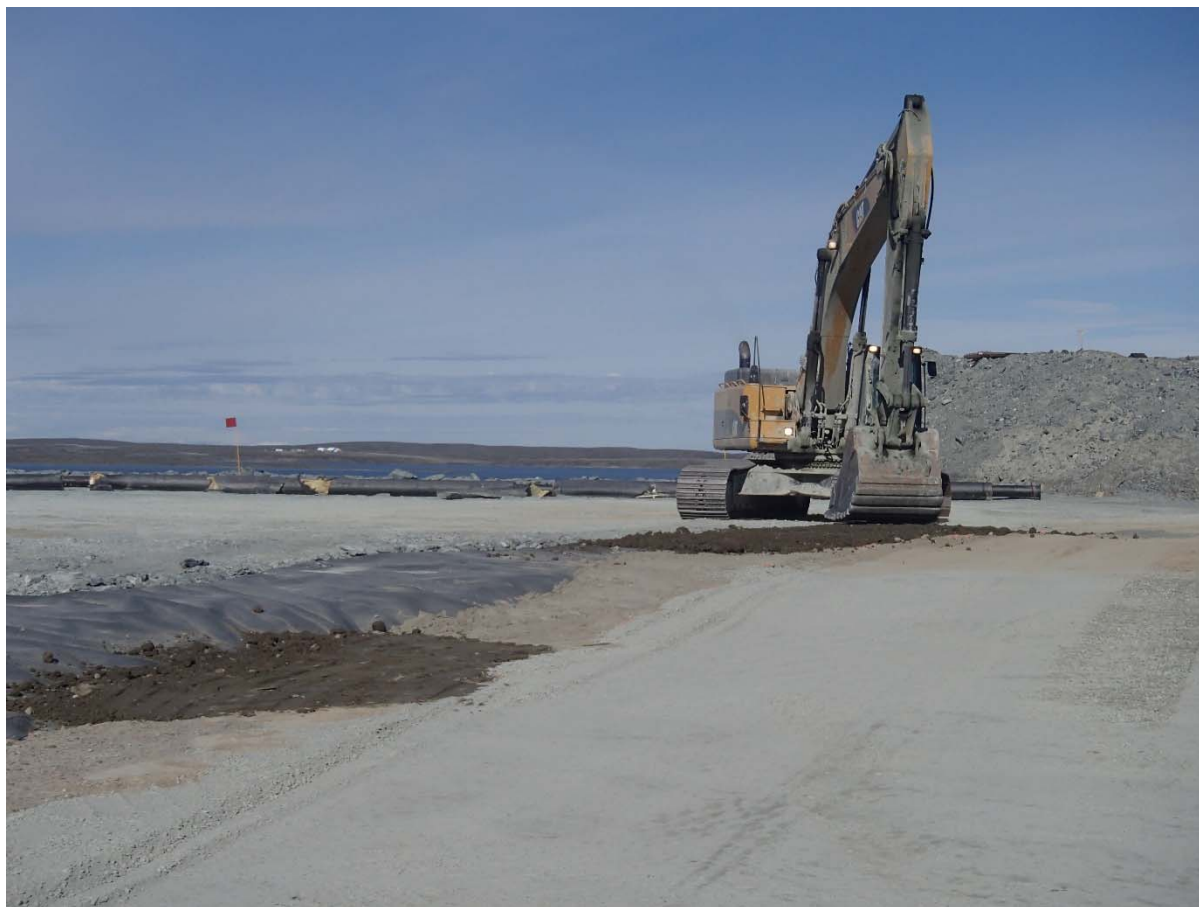
Photograph SD3-352: From Sta. 20+600/-59 m, looking SW. Corrections to the layer of compacted sieved till placed against the upstream slope from Sta. 20+599 m to 20+613 m.

Activity or Area	Comments
Upstream toe liner tie-in – north abutment	<ul style="list-style-type: none"> ■ Corrections to the layer of compacted sieved till placed against the upstream slope from Sta. 20+599 m to 20+613 m. ■ Completion of the compaction of the 0.5 m thick lift of fine filter on the top of the upstream toe liner tie-in with a 10 tonne smooth-drum compactor with vibration (4 passes) from Sta. 20+599 m to 20+613 m.

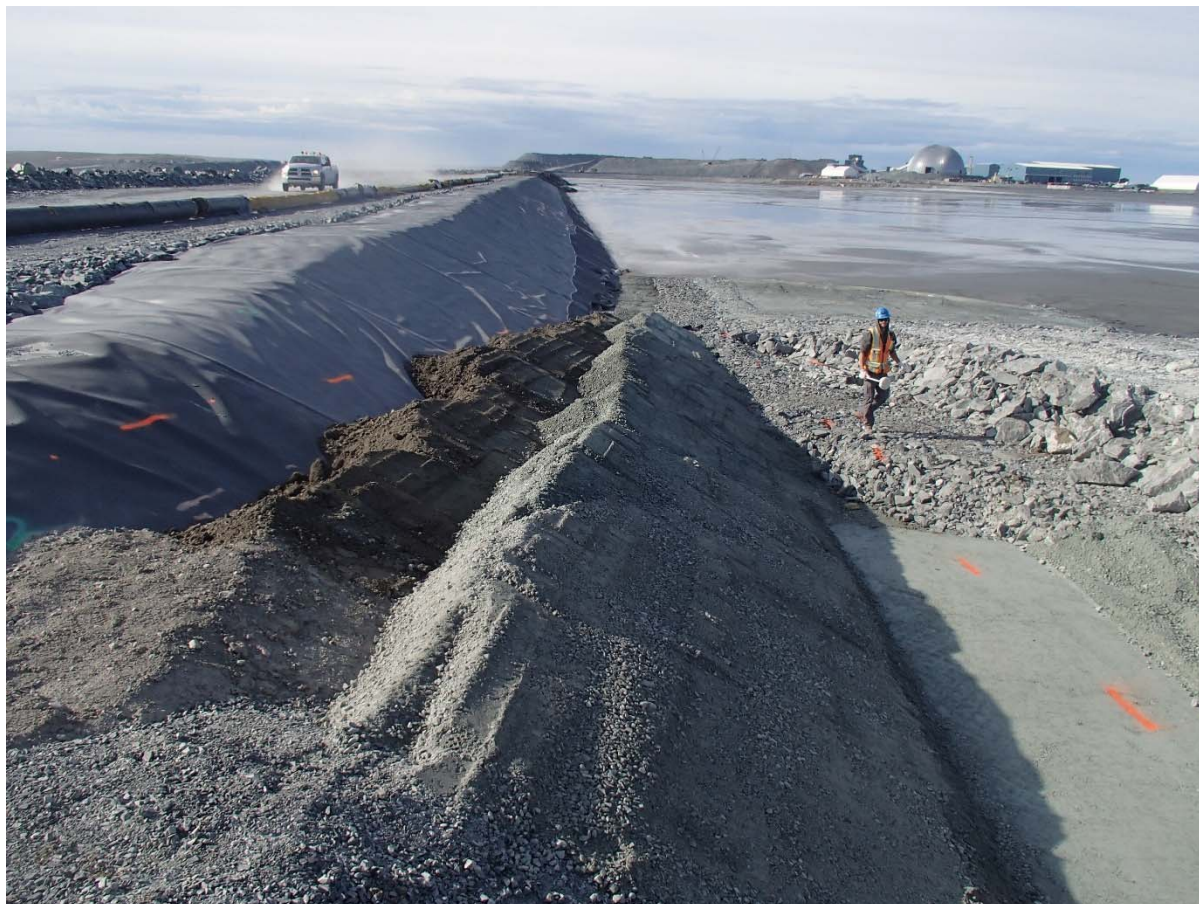
Photograph CD-1896: From Sta. 0+140/-30 m, looking S. Placement of 0.5 m thick layers of compacted sieved till and fine filter on the upstream slope of Central Dike with an excavator from Sta. 0+147 m to 0+177 m.

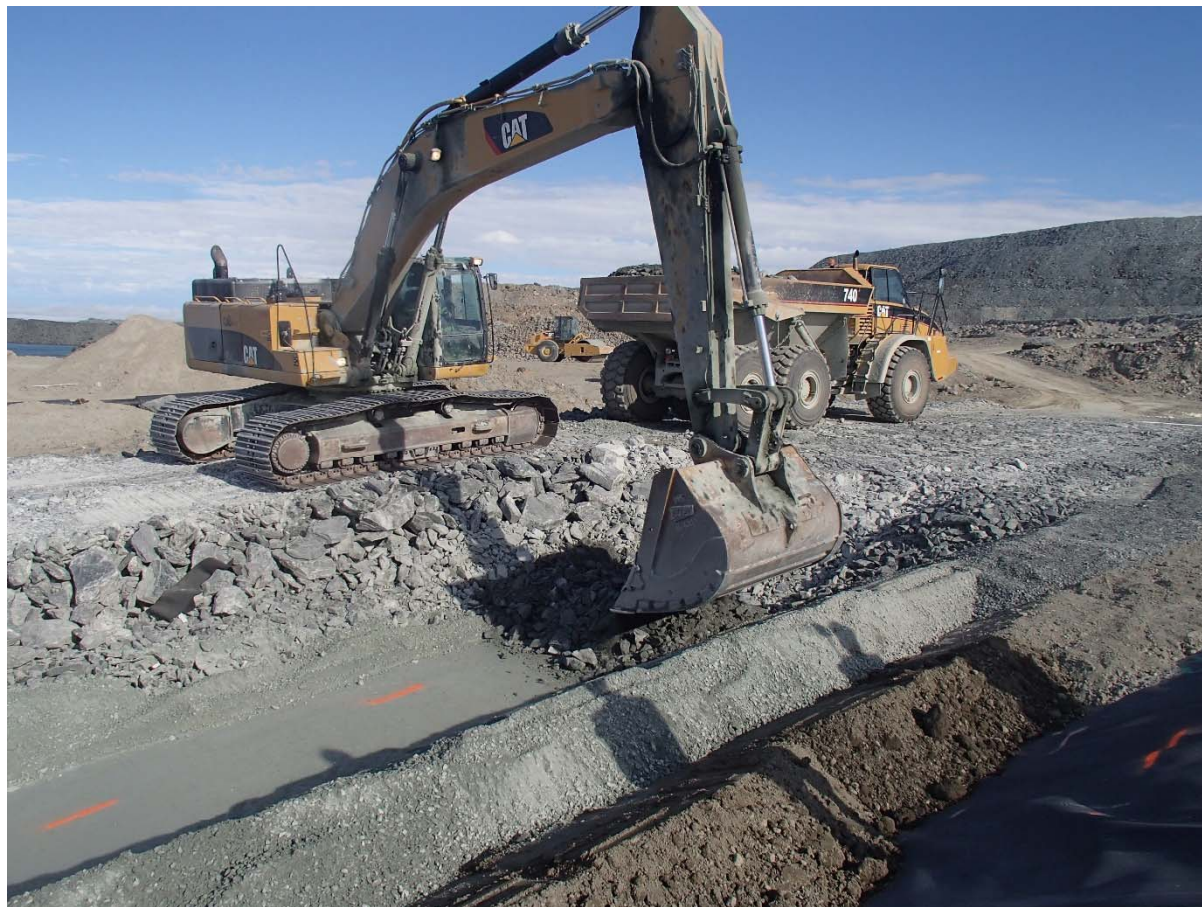
Photograph CD-1897: From Sta. 0+145/-30 m, looking NW. Placement of a 0.5 m thick lift of coarse filter on the top of the fine filter on the top of the upstream toe liner tie-in and on the upstream slope with an excavator from Sta. 0+147 m to 0+177 m.

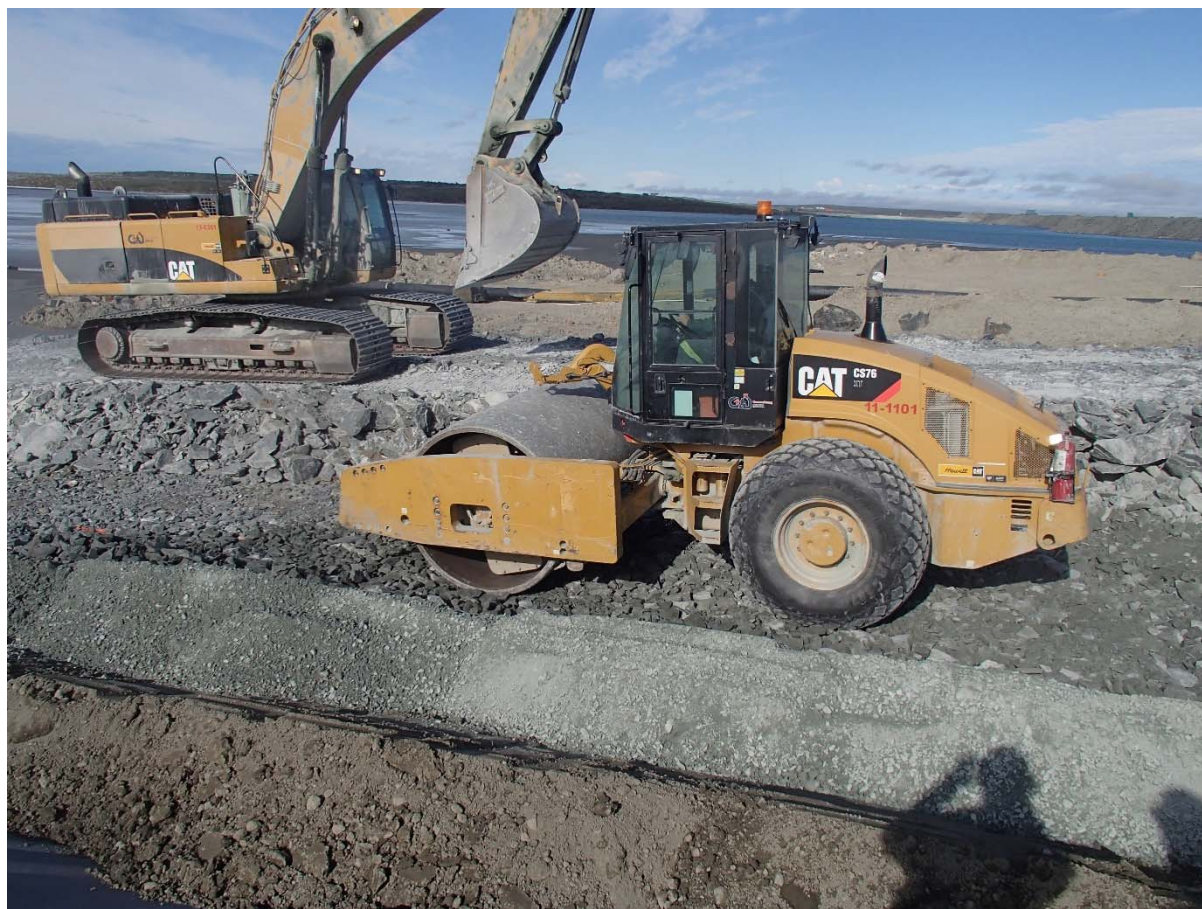
Photograph CD-1898: From Sta. 0+145/-30 m, looking W. Compaction of the 0.5 m thick lift of coarse filter on the top of the fine filter on the top of the upstream toe liner tie-in and on the upstream slope with a 10 tonne smooth-drum compactor with vibration (4 passes) from Sta. 0+147 m to 0+177 m.

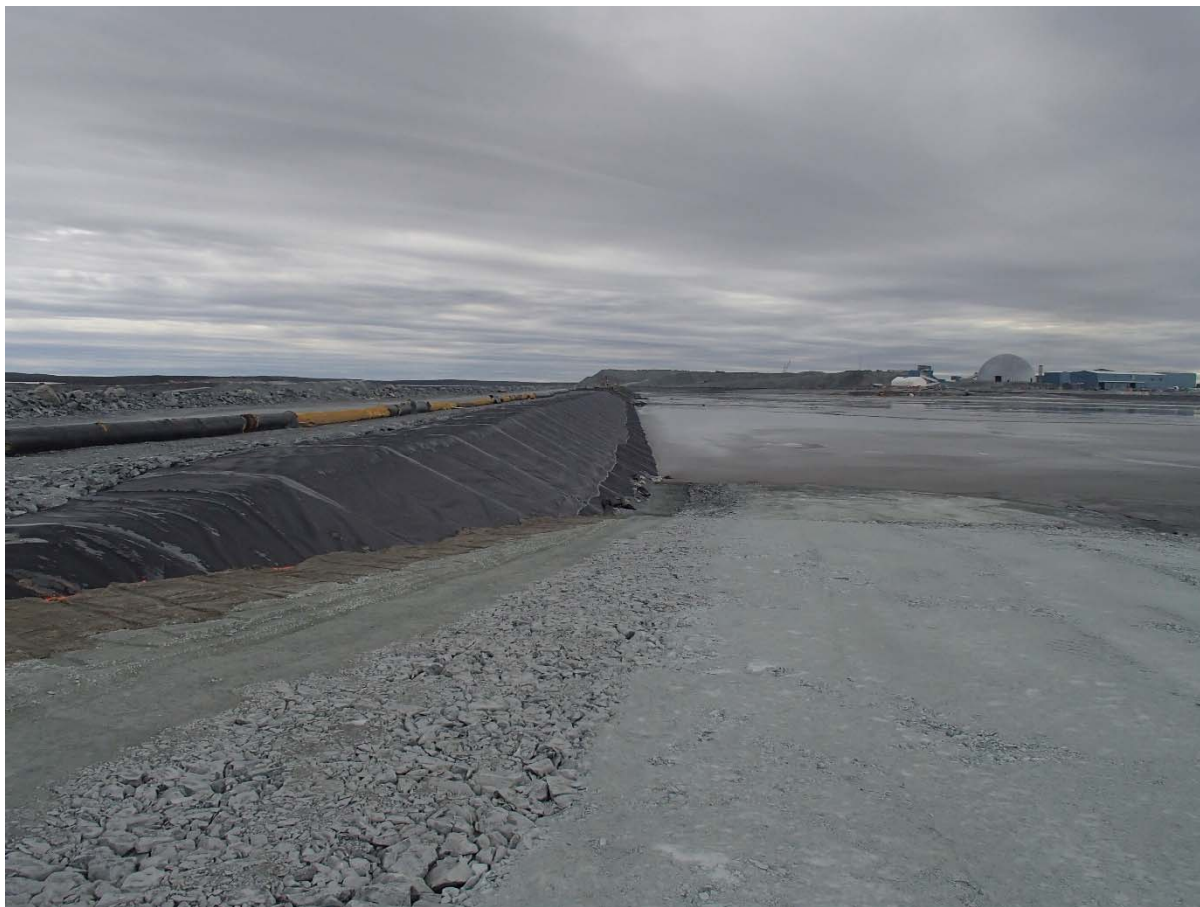
Photograph CD-1899: From Sta. 0+140/-33 m, looking S. View of Central Dike at the end of the 2018 construction phase.
