QA DAILY REPORT

1897439-1576-TM-Rev0

QA DAILY REPORT FOR JULY 15TH, 2018 – TSF SOUTH CELL CONSTRUCTION - MEADOWBANK (1897439)

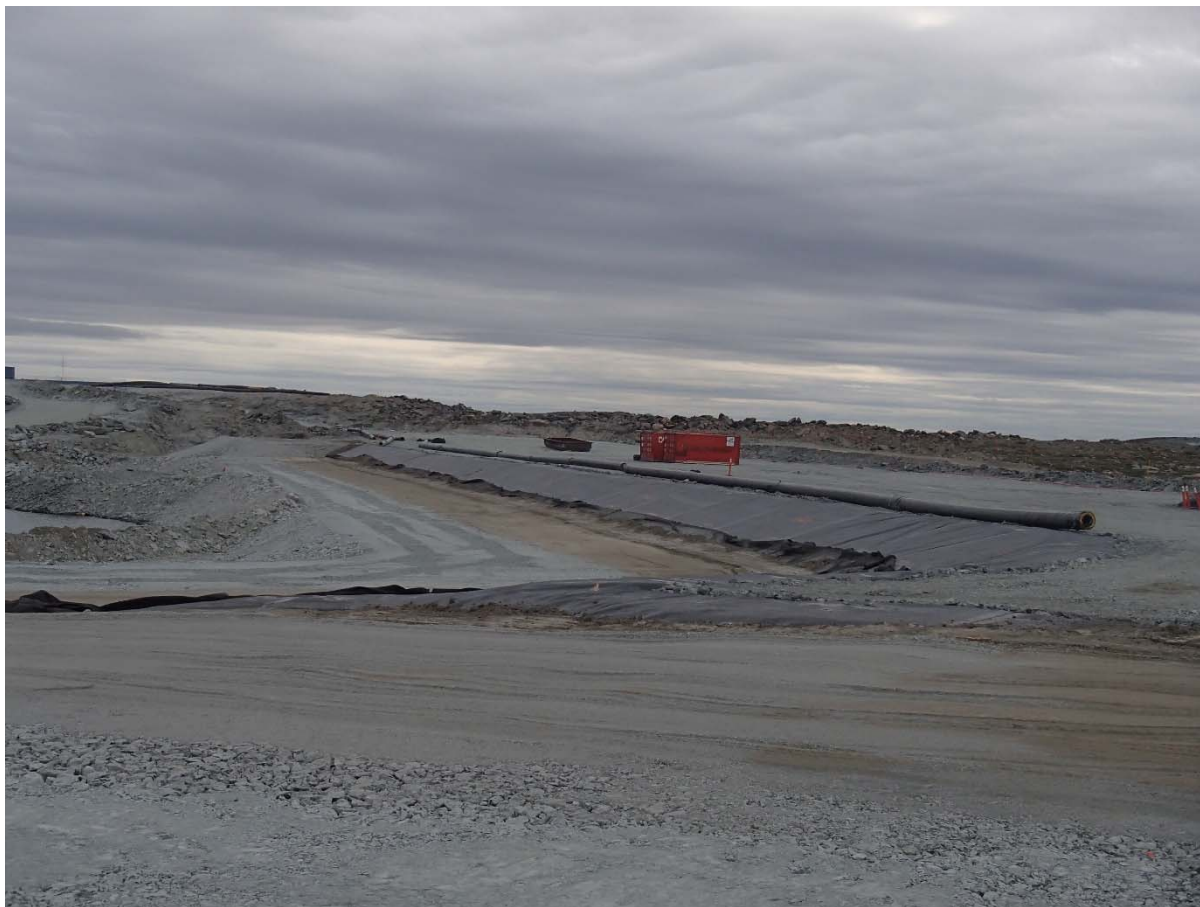
Photograph SD3-353: From Sta. 20+580/-49 m, looking SW. View of SD3 at the end of the 2018 construction phase.

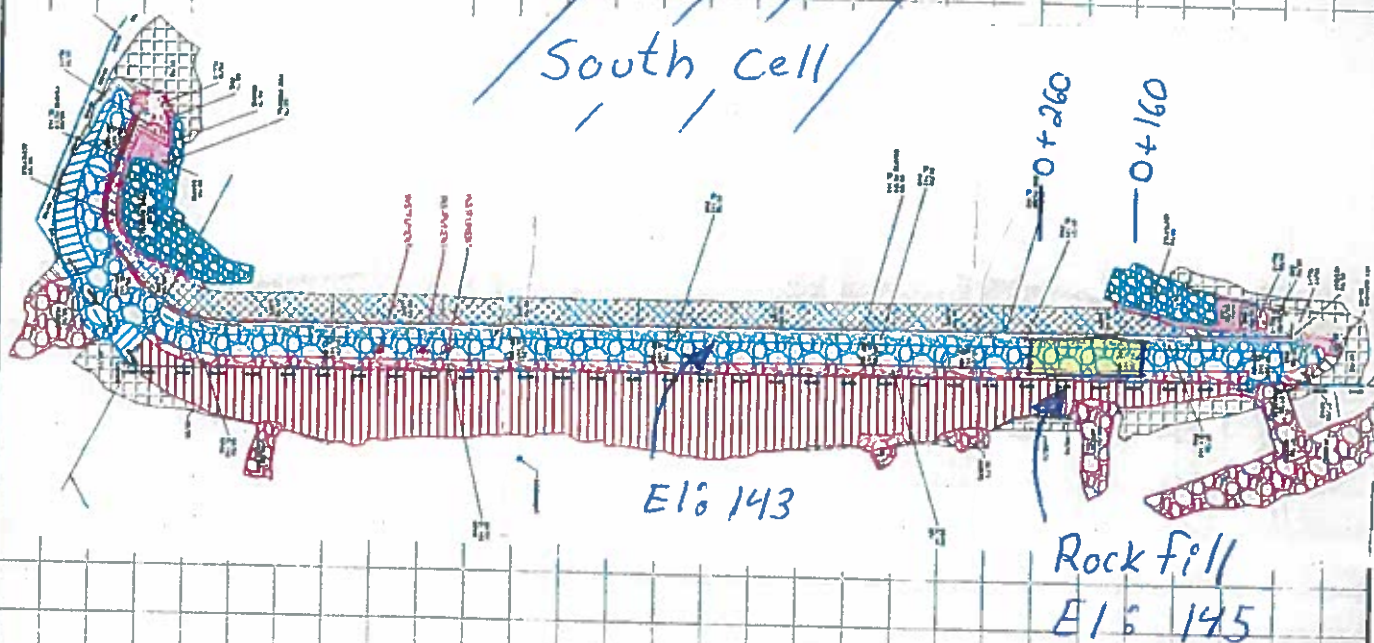
- Rockfill on Central Dyke at El: 145 (0+160 à 0+260). (see sketch join to the report)
- Clear snow and scarification at El: 143 on Central Dyke. (see sketch join to the report)
