Projet: *Saddle dam # 3, 4 & 5*
Central Dyke

QC INSPECTOR'S DAILY REPORT
CENTRAL DIKE
AGNICO-EAGLE MEADOWBANK

Date: 26-Apr-18 Inspector - Day/Night: Cedrick Fillon Tremblay, Day shift
 Weather : sunny (-15°C)
 Project: Increase the final level of Central Dike at El: 145 Contractor: Sana

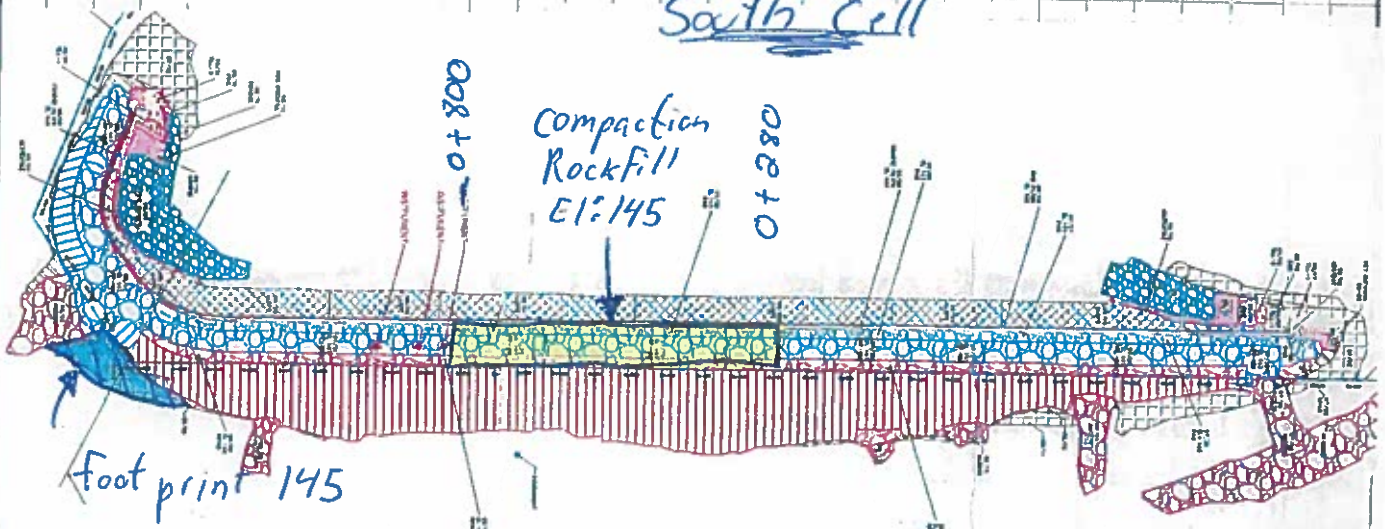
-Finish to made the foot print 145 on Central Dike down stream at south. (see sketch join to the report)

-Rebuild the acces road at south of Central Dike for E l: 145. (see sketch join to the report)

-Rockfill placement around the two casing at 0+850. (see sketch join to the report)

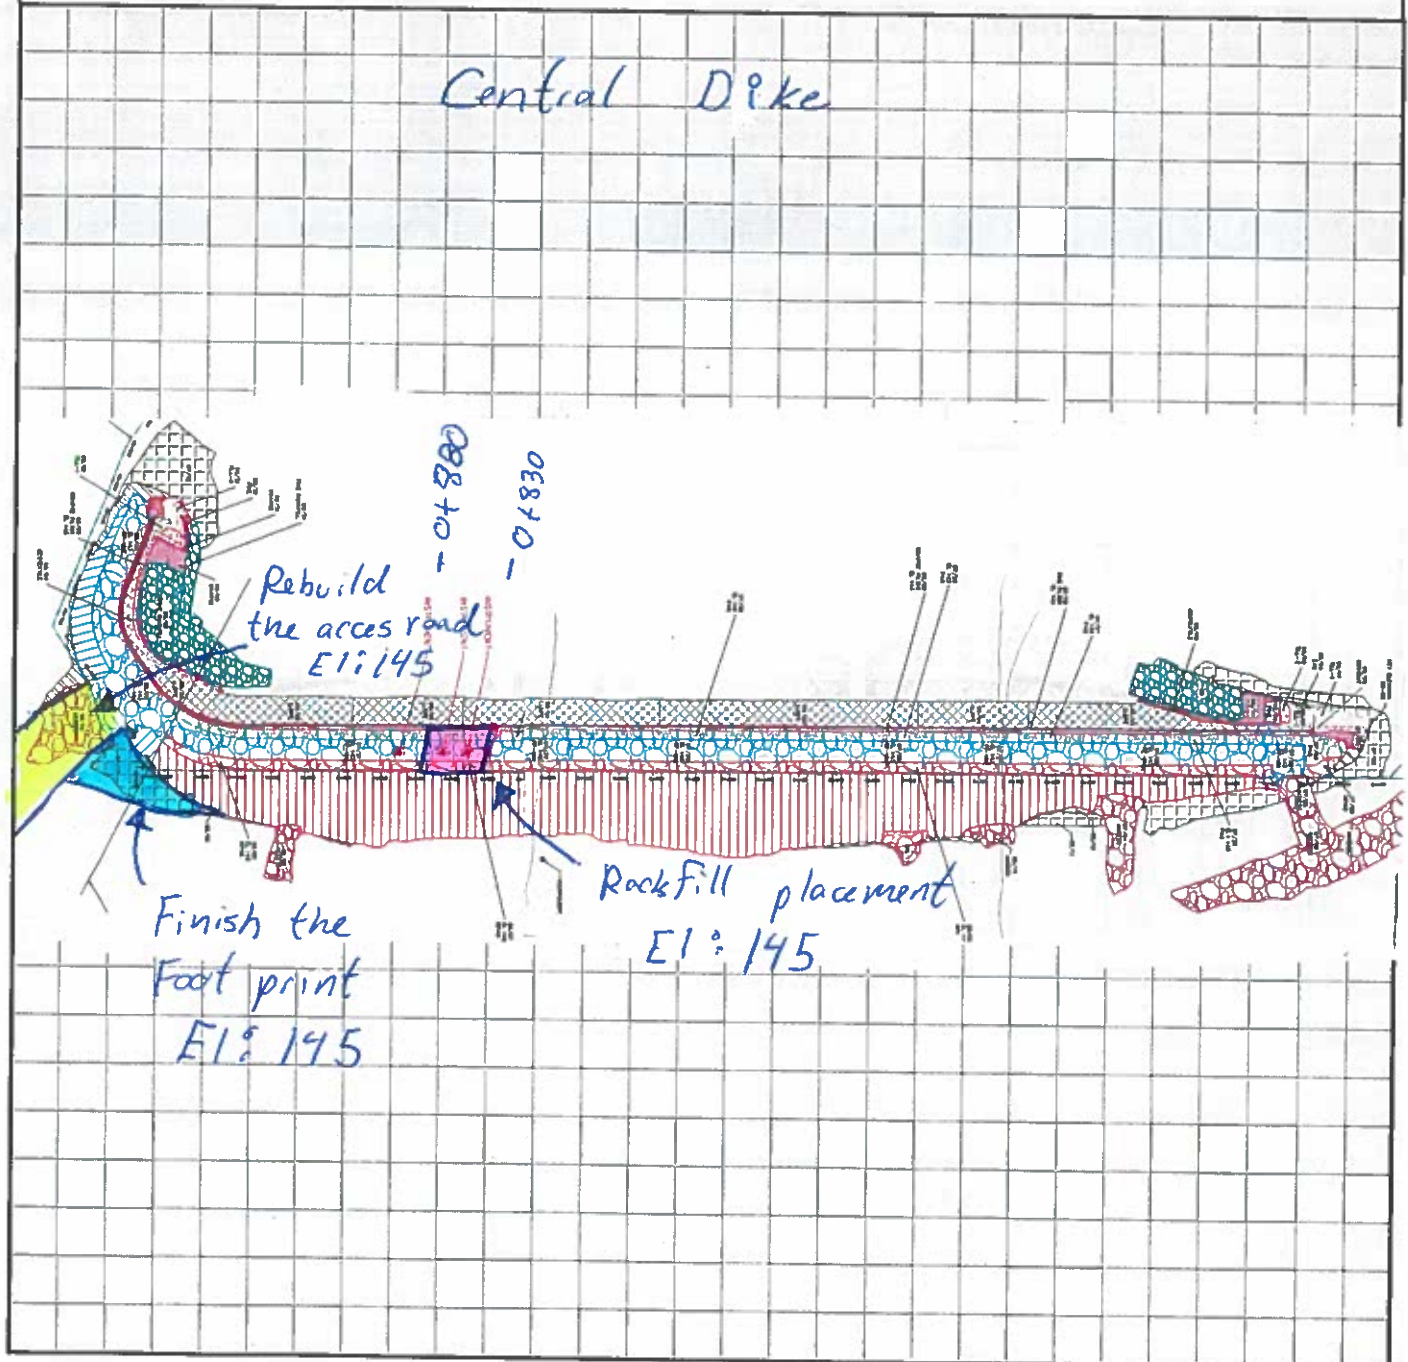
- Make the connection of Central Dike with Saddle Dam 5 at El: 145. (see sketch join to the report)
- Start the slope down stream on north of Central Dike at El: 145. (see sketch join to the report)
- Clean with backhoe, a little accumulation of snow on foot the berms. (see sketch join to the report)

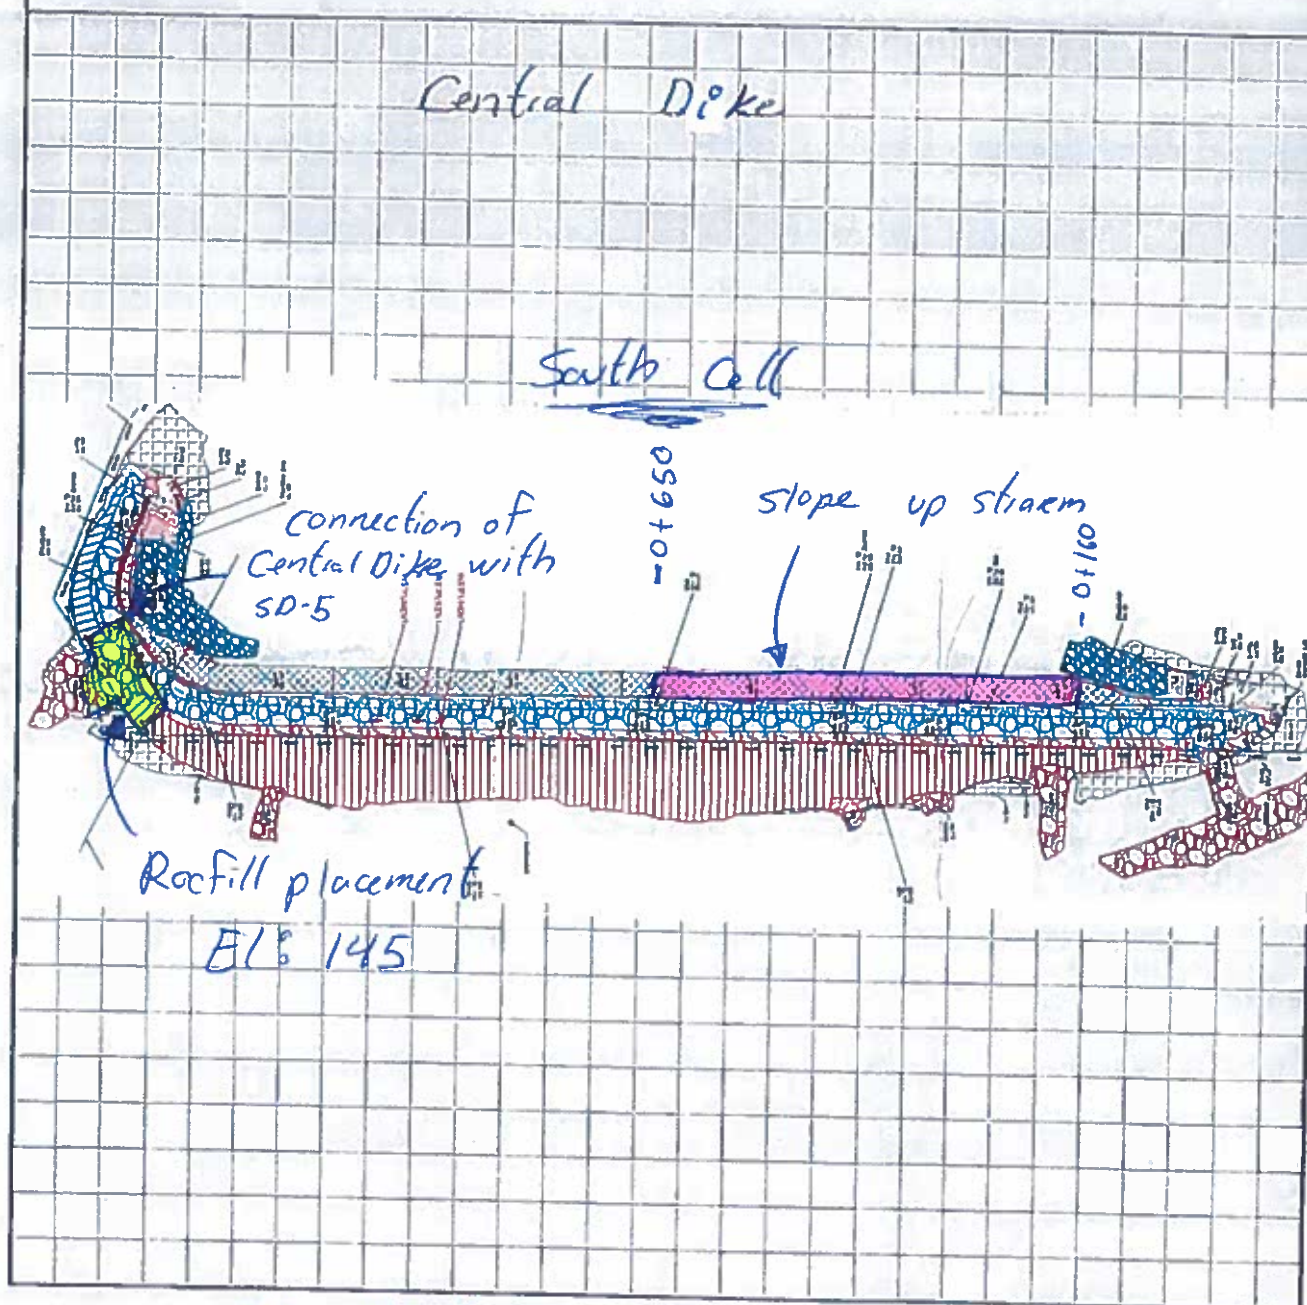
- Rockfill placement on south of Central Dike at E 1: 145. (see sketch join to the report)
- Make the slope up stream on middle and south of Central Dike at E 1: 145. (see sketch join to the report)
- Start the slope down stream on north of central Dike at E 1: 145. (see sketch join to the report)

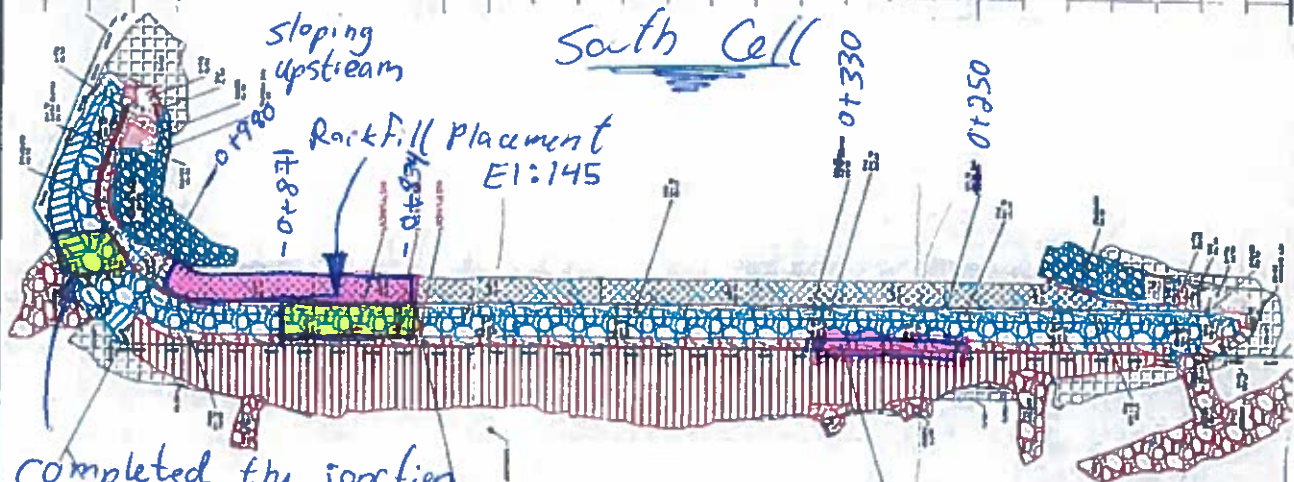
*Completed the junction
of central dike and saddle dam 5.
at E1:145*

*- The rock fill placement on central dike is
Finish.*

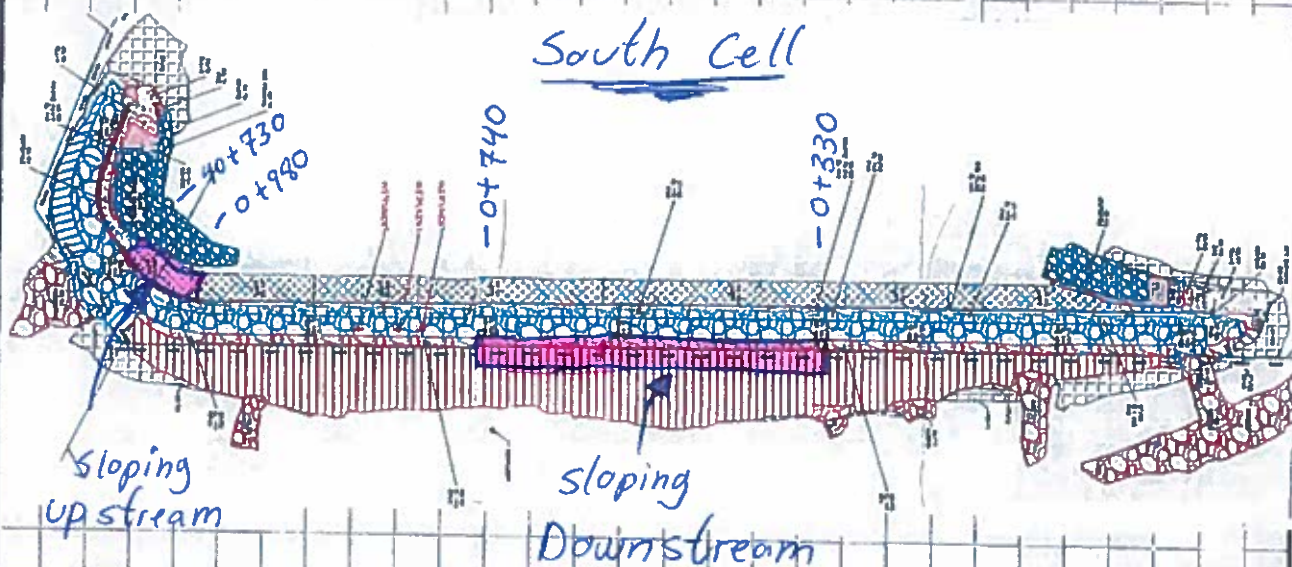
-Try to thaw the finger on north of central Dike with two frost fight. (see sketch join to the report)

*thaw the
finger with
frost fighter*

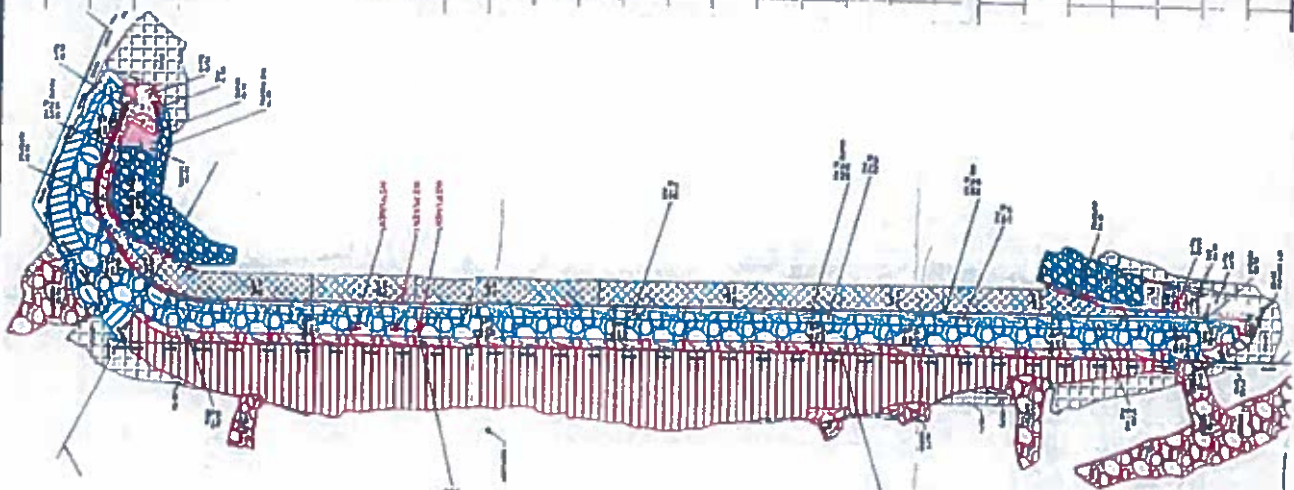
0+730 ← 1st lift compacted → 0+880 0+490 ← 1st lift compacted → 0+880

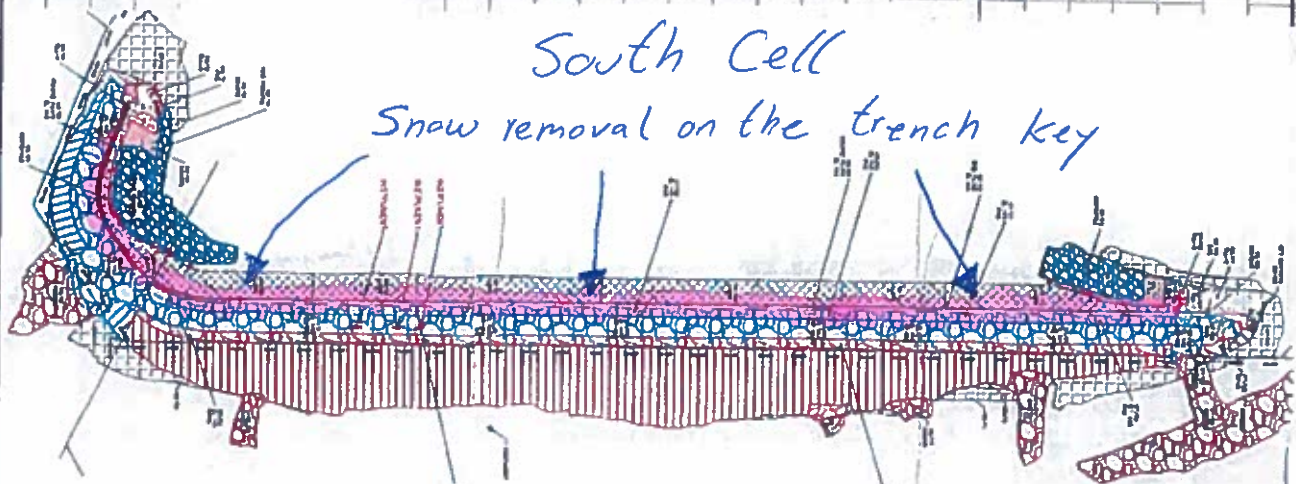
Snow removal on the trench key

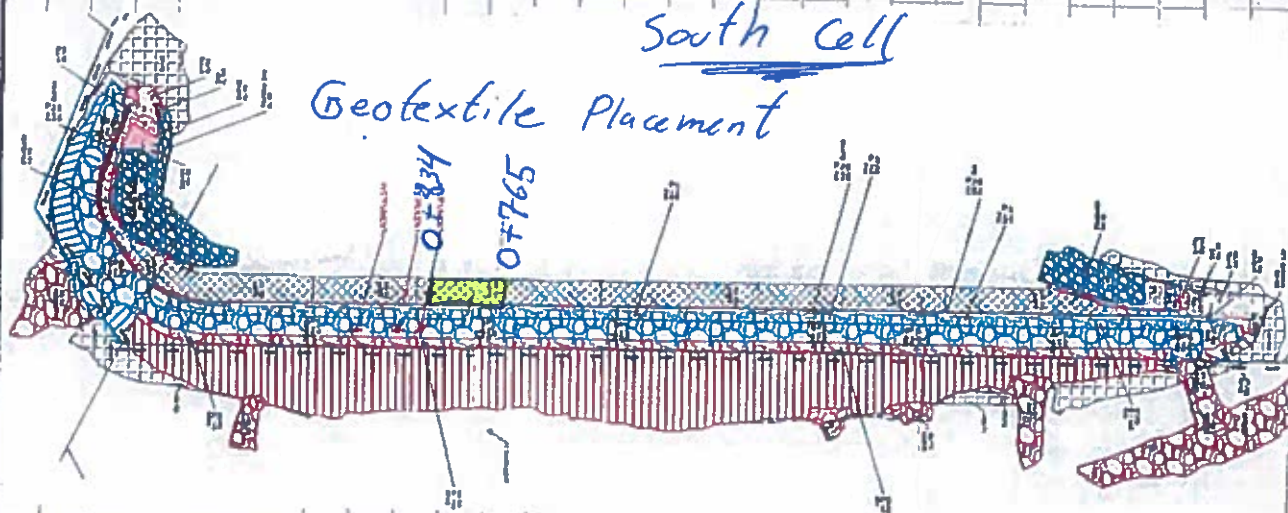
Geotextile Placement

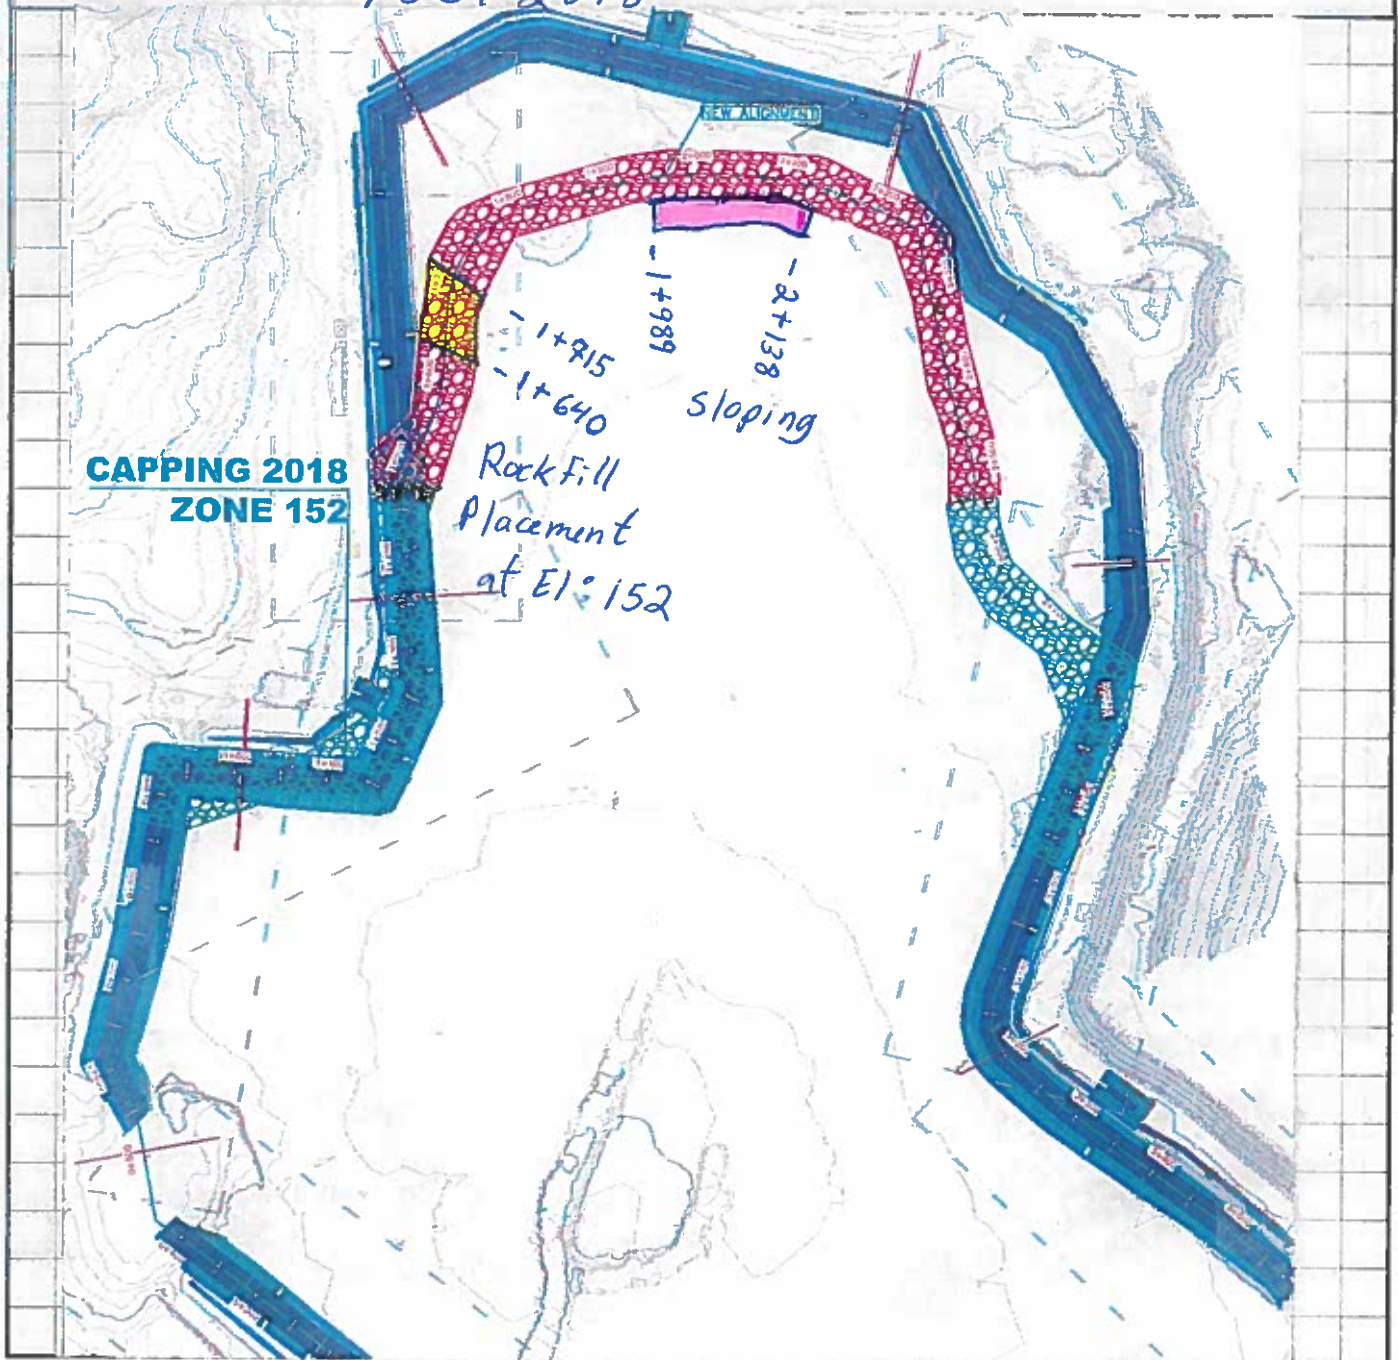
- Sloping upstream on north cell capping. (see sketch join to the report)
- Due to some problem with water presence on LLDPE, the bottom horizontal weld needs to be repaired at many places. (see sketch join to the report)
- Continue installing the LLDPE on south of Central Dike. (see sketch join to the report)
