QA WEEKLY REPORT

DATE July 30th 2018

QA WEEKLY REPORT FROM JULY 23RD TO JULY 29TH– TSF NORTH CELL CONSTRUCTION MEADOWBANK (1897439)

This document summarizes QA activities performed by Golder from July 23rd to July 29th, 2018 inclusively, related to the construction activities of the North Cell Internal Structure at the Meadowbank mine site.

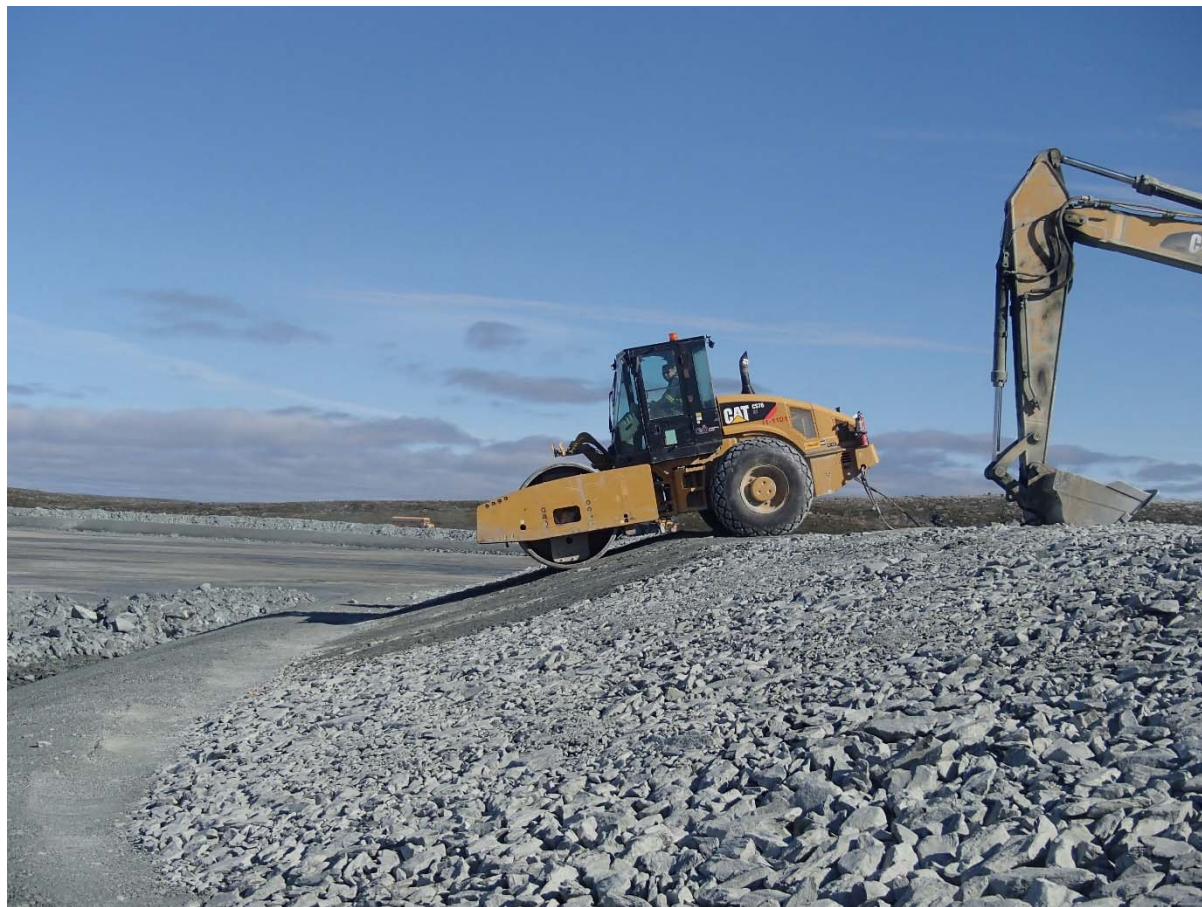
Photograph NCIS-105: From Sta. 2+630/-34 m (approx.), looking NW. Compaction of the 0.5 m lift (approx.) of coarse filter between El. 152 m and 154 m with a 10-tonne smooth-drum compactor with vibration (4 passes) in the upstream slope from Sta. 2+710 m to 2+411 m.

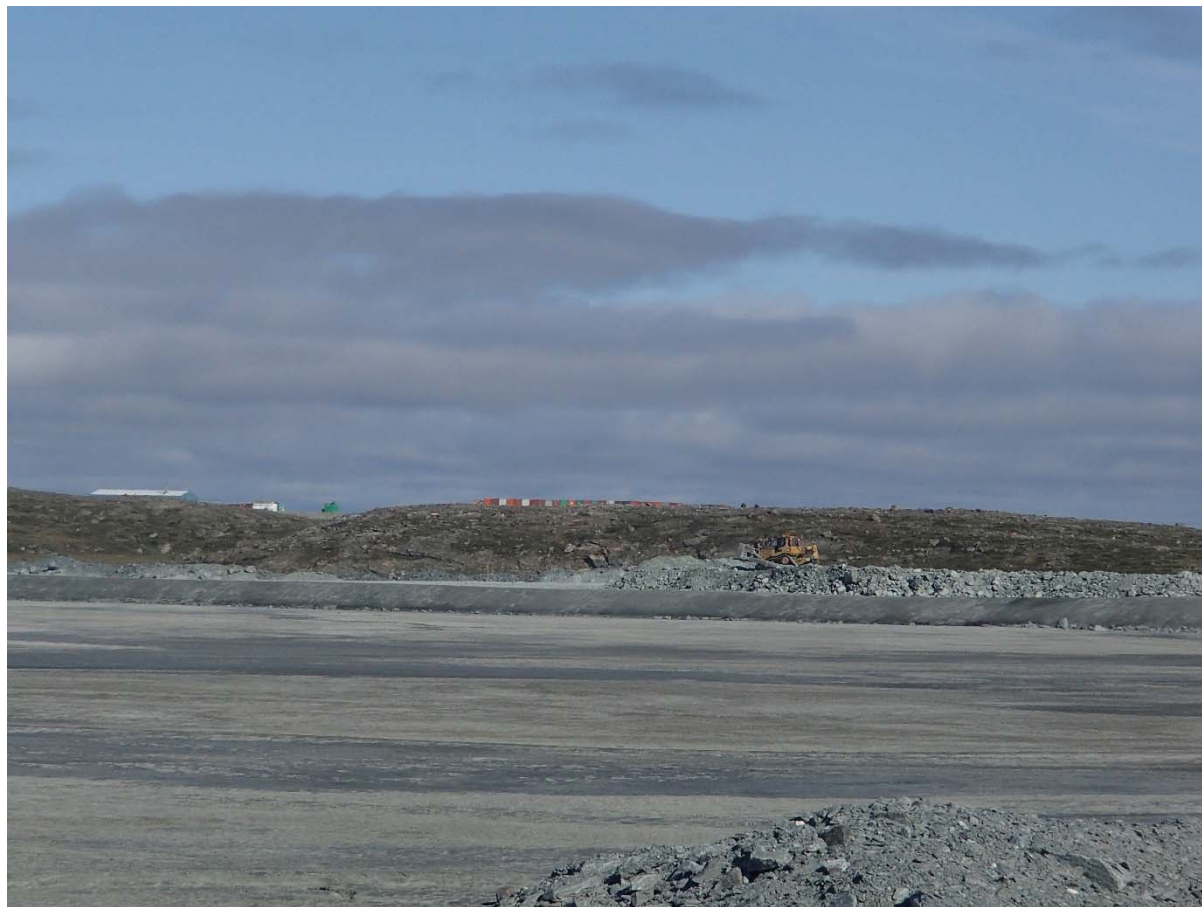
Photograph NCIS-106: From Sta. 2+620/-35 m (approx.), looking NW. Placement of a 2 m thick (approx.) lift of UM rockfill from El. 152 m to El. 154 m (approx.) with a dozer from Sta. 1+947 m to 1+863 m (+14 m to -26 m). The material is of good quality and is well graded.

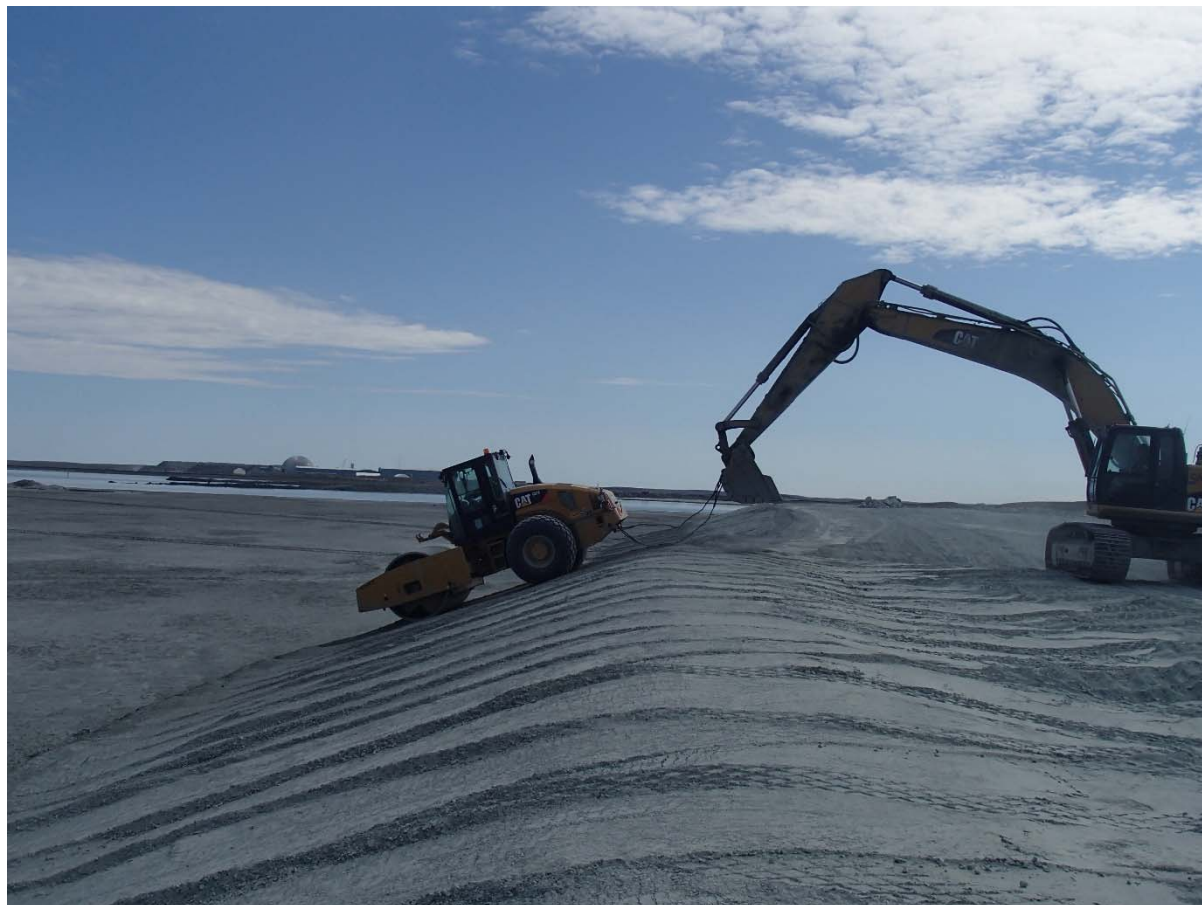
Photograph NCIS-107: From Sta. 1+380/-38 m (approx.), looking S. Compaction of the 0.5 m lift (approx.) of fine filter between El. 150 m and 152 m with a 10-tonne smooth-drum compactor with vibration (4 passes) in the upstream slope from Sta. 1+251 m to 1+1+660 m.

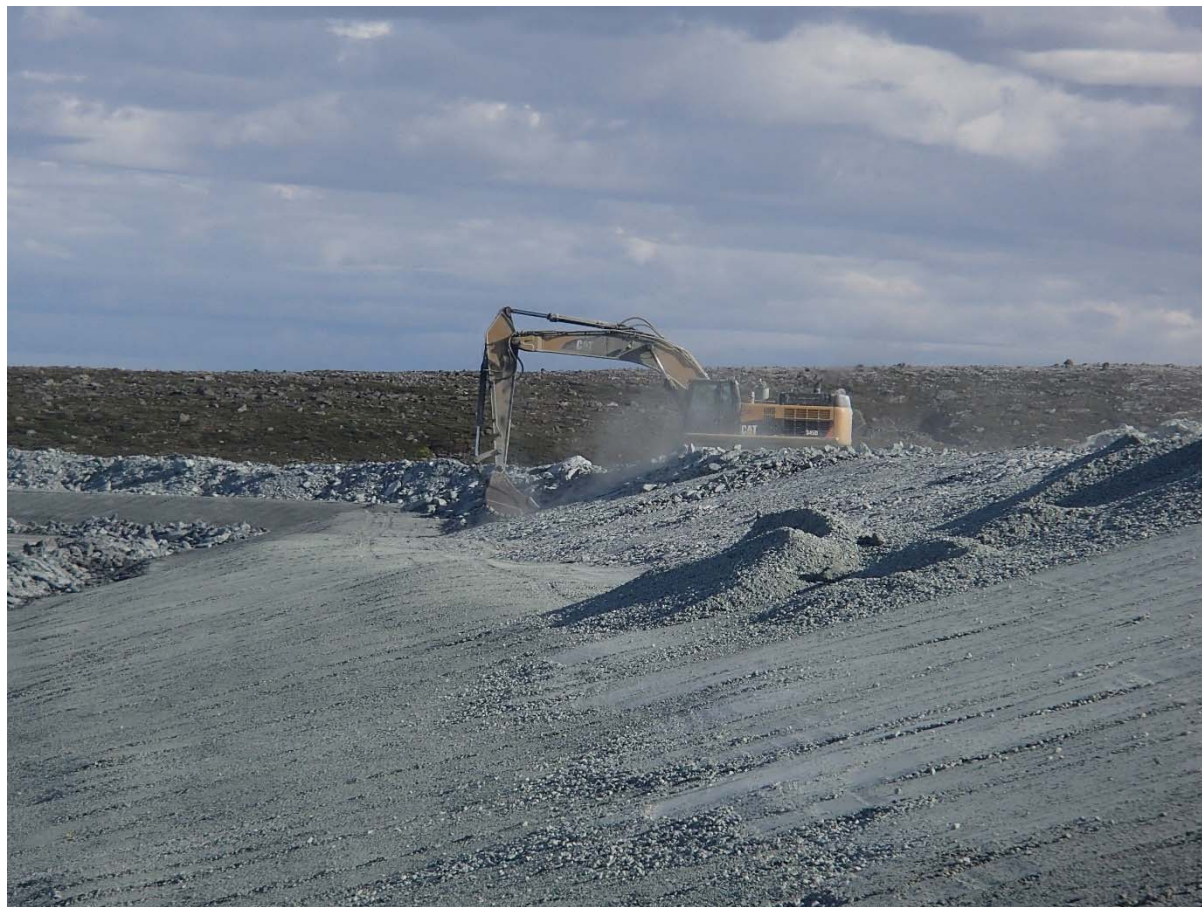
Photograph NCIS-108: From Sta. 2+490/-32 m (approx.), looking N. Profiling of the upstream slope (3H:1V) from El. 152 to 154 m with an excavator from Sta. 2+159 m to 2+409 m.

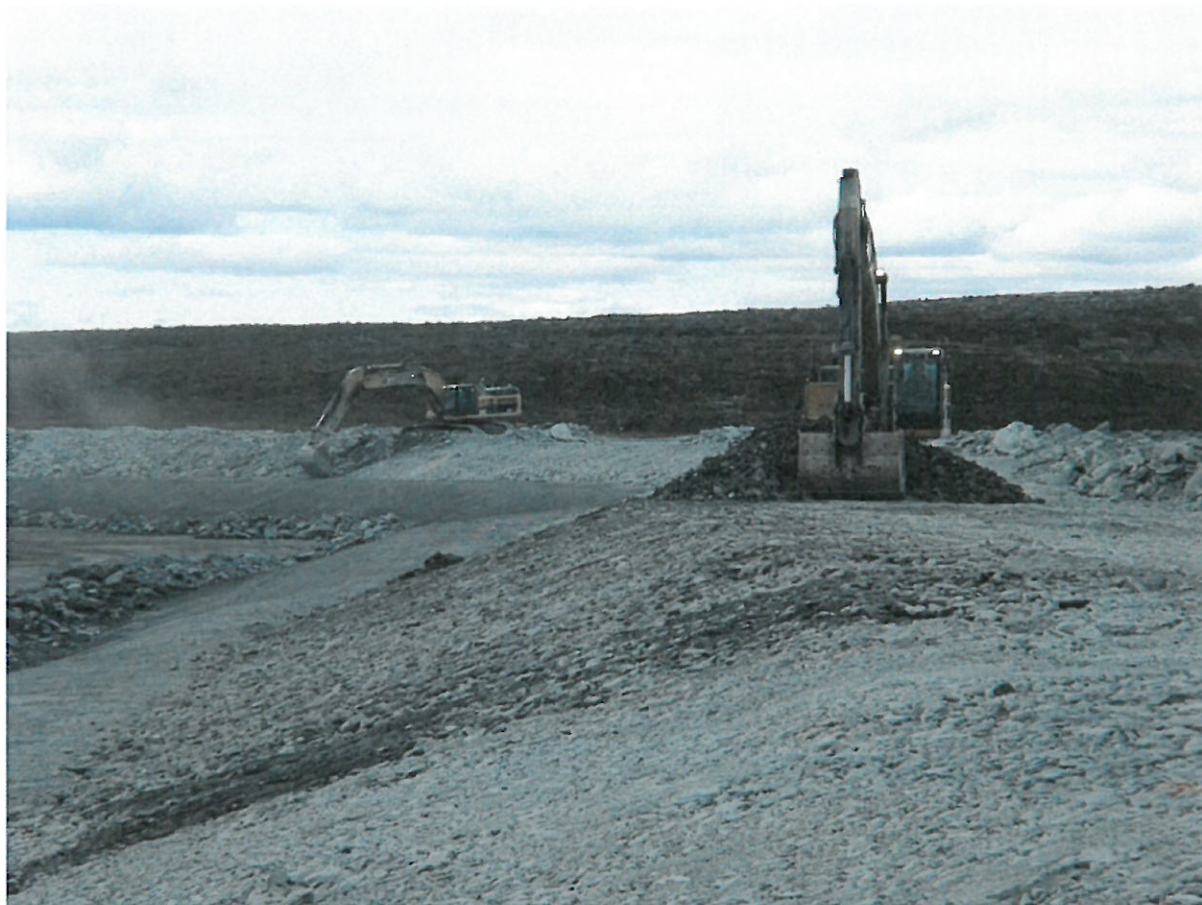
Photograph NCIS-109: From Sta. 2+450/-21 m (approx.), looking N. Placement of a 0.5 m thick lift of coarse filter in the upstream slope from El. 152 m to 154 m with an excavator from Sta. 2+293 m to 2+411 m.

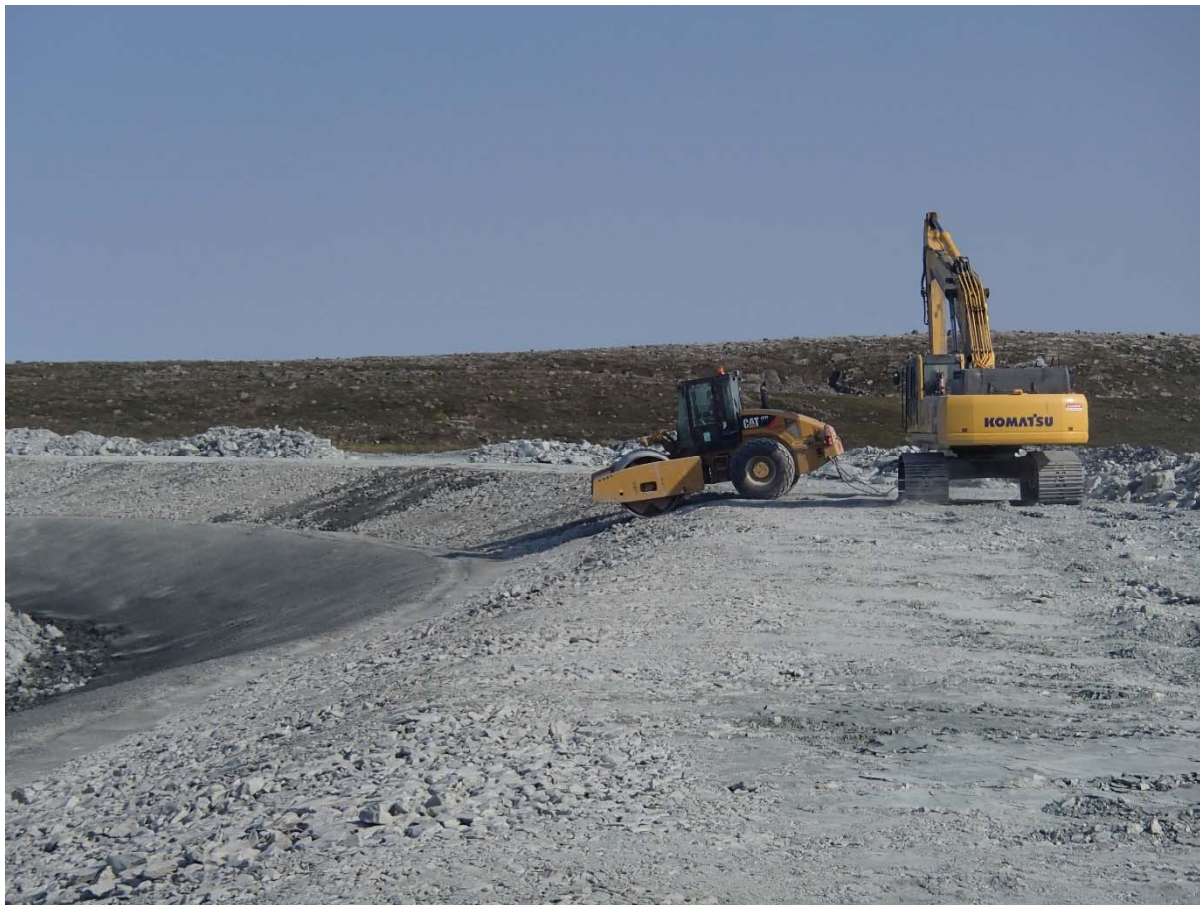
Photograph NCIS-110: From Sta. 2+320/-22 m (approx.), looking N. Compaction of the 0.5 m lift (approx.) of coarse filter between El. 152 m and 154 m with a 10-tonne smooth-drum compactor with vibration (4 passes) in the upstream slope from Sta. 2+293 m to 2+080 m.

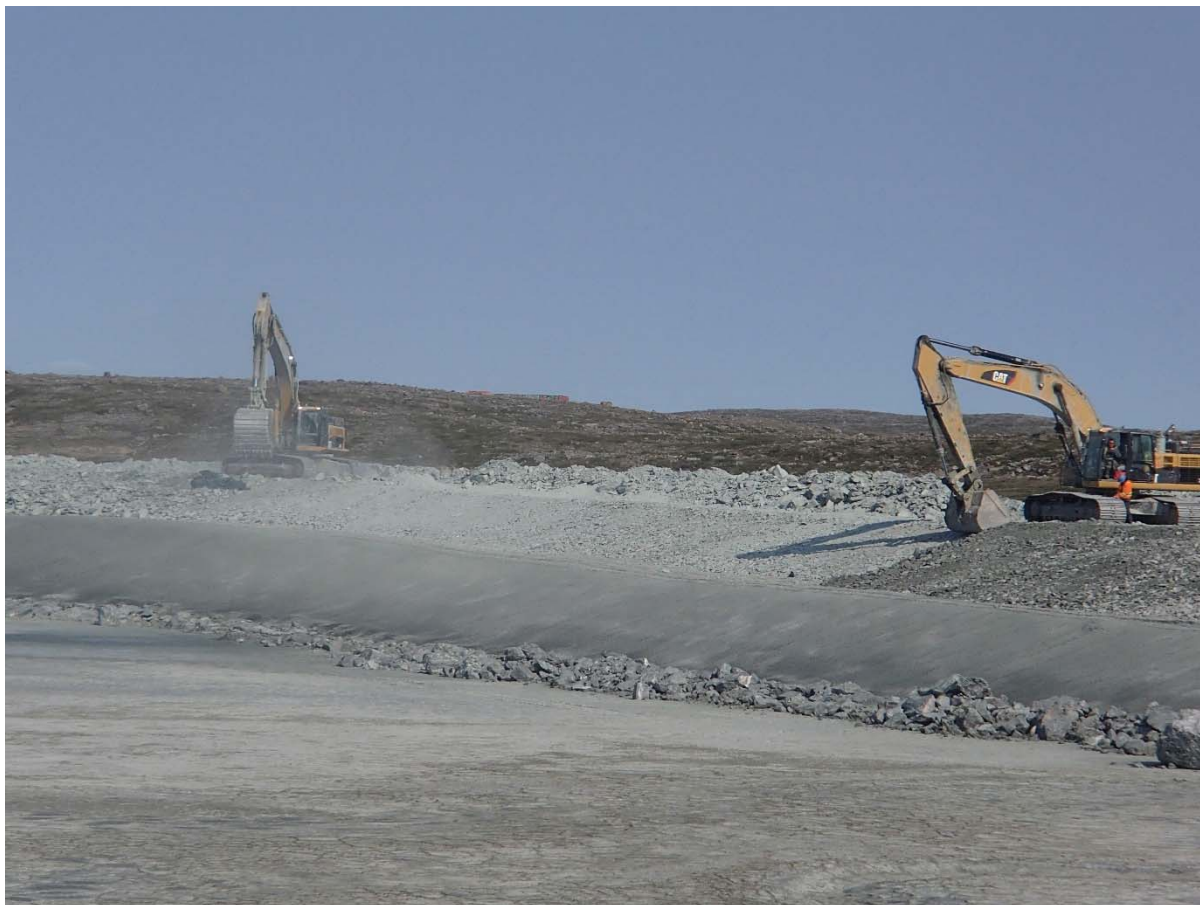
Photograph NCIS-111: From Sta. 2+320/-22 m (approx.), looking NW. Profiling of the upstream slope (3H:1V) from El. 152 to 154 m with an excavator from Sta. 2+159 m to 2+000 m and placement of a 0.5 m thick lift of coarse filter in the upstream slope from El. 152 m to 154 m with an excavator from Sta. 2+293 m to 2+080 m.

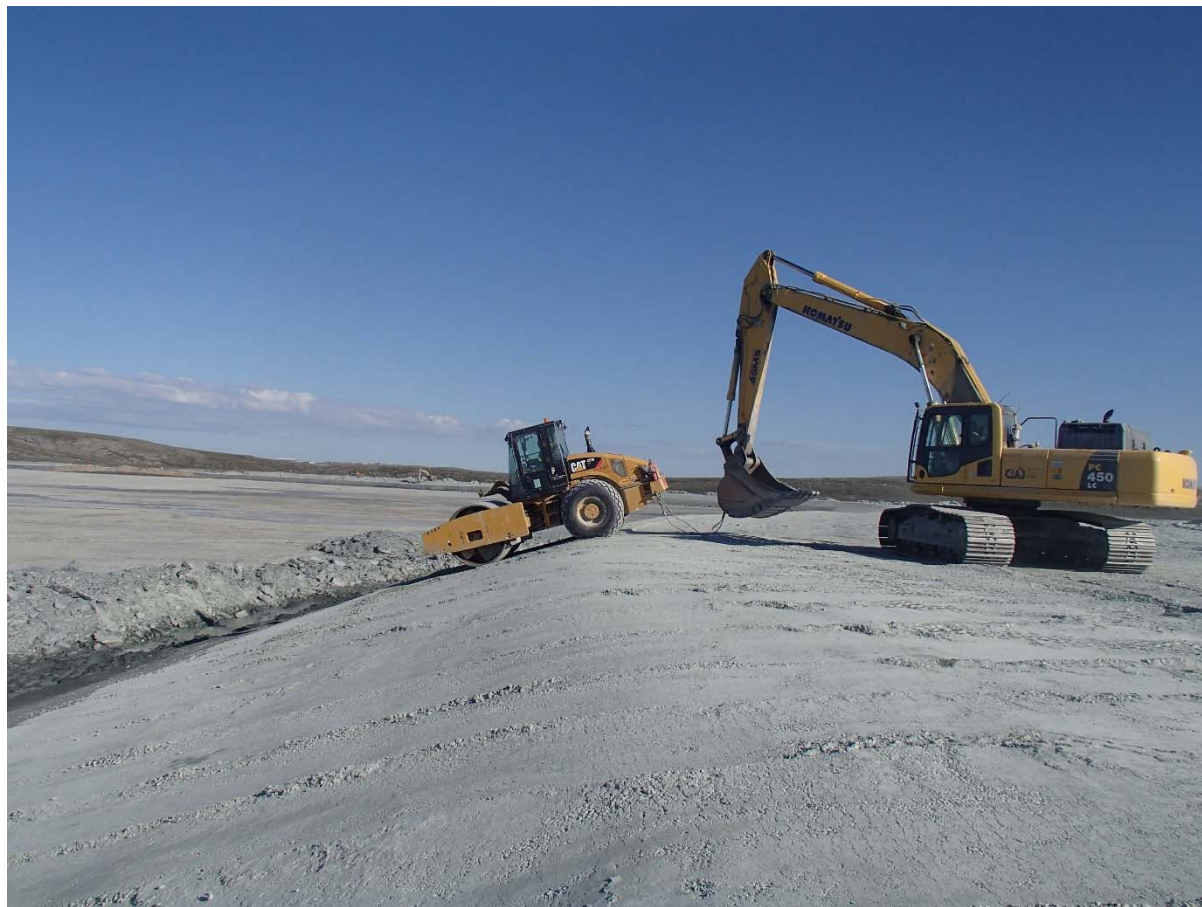
Photograph NCIS-112: From Sta. 2+610/-29 m (approx.), looking N. Compaction of the 0.5 m lift (approx.) of coarse filter between El. 152 m and 154 m with a 10-tonne smooth-drum compactor with vibration (4 passes) in the upstream slope from Sta. 2+080 m to 2+000 m.

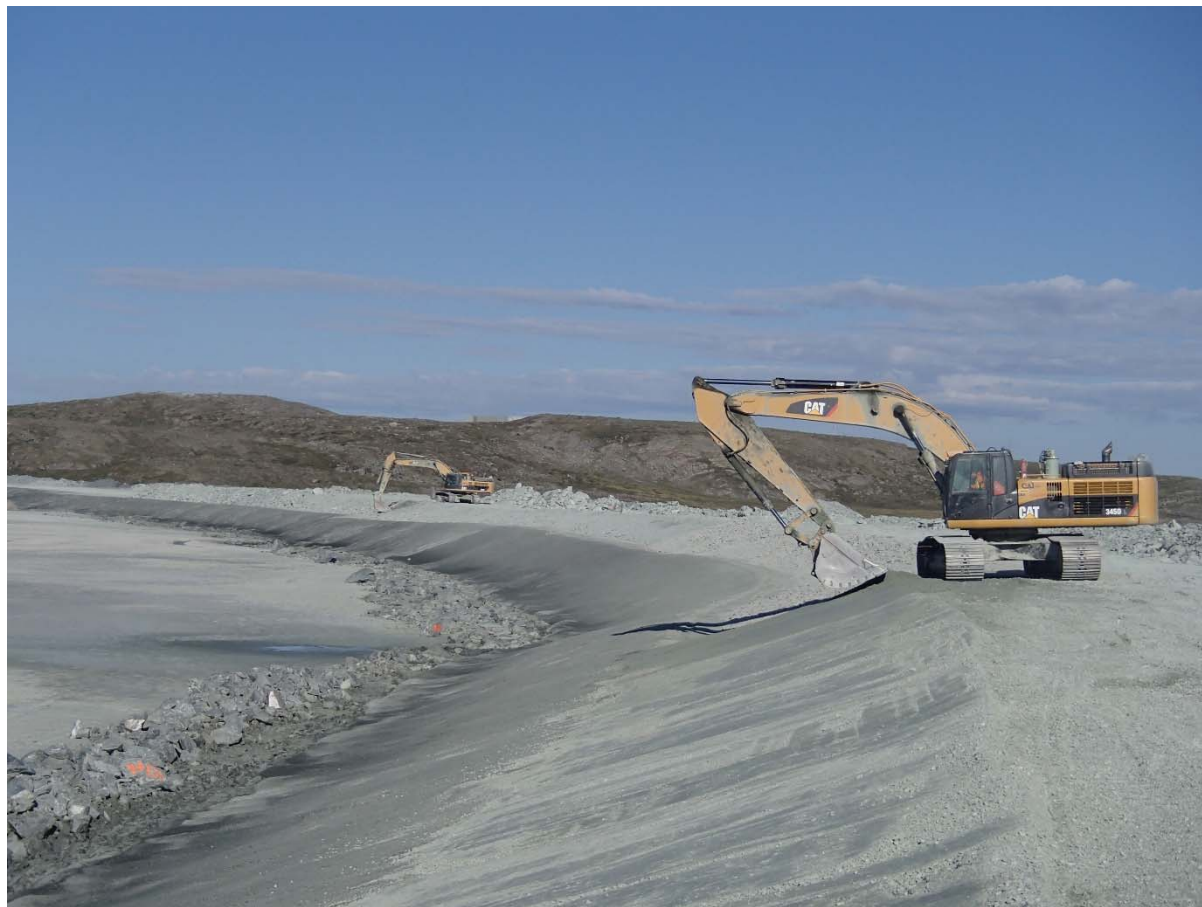
Photograph NCIS-113: From Sta. 2+220/-26 m (approx.), looking SW. Profiling of the upstream slope (3H:1V) from El. 152 to 154 m with an excavator from Sta. 2+000 m to 1+185 m and placement of a 0.5 m thick lift of fine filter in the upstream slope from El. 152 m to 154 m with an excavator from Sta. 2+300 m to 2+090 m.

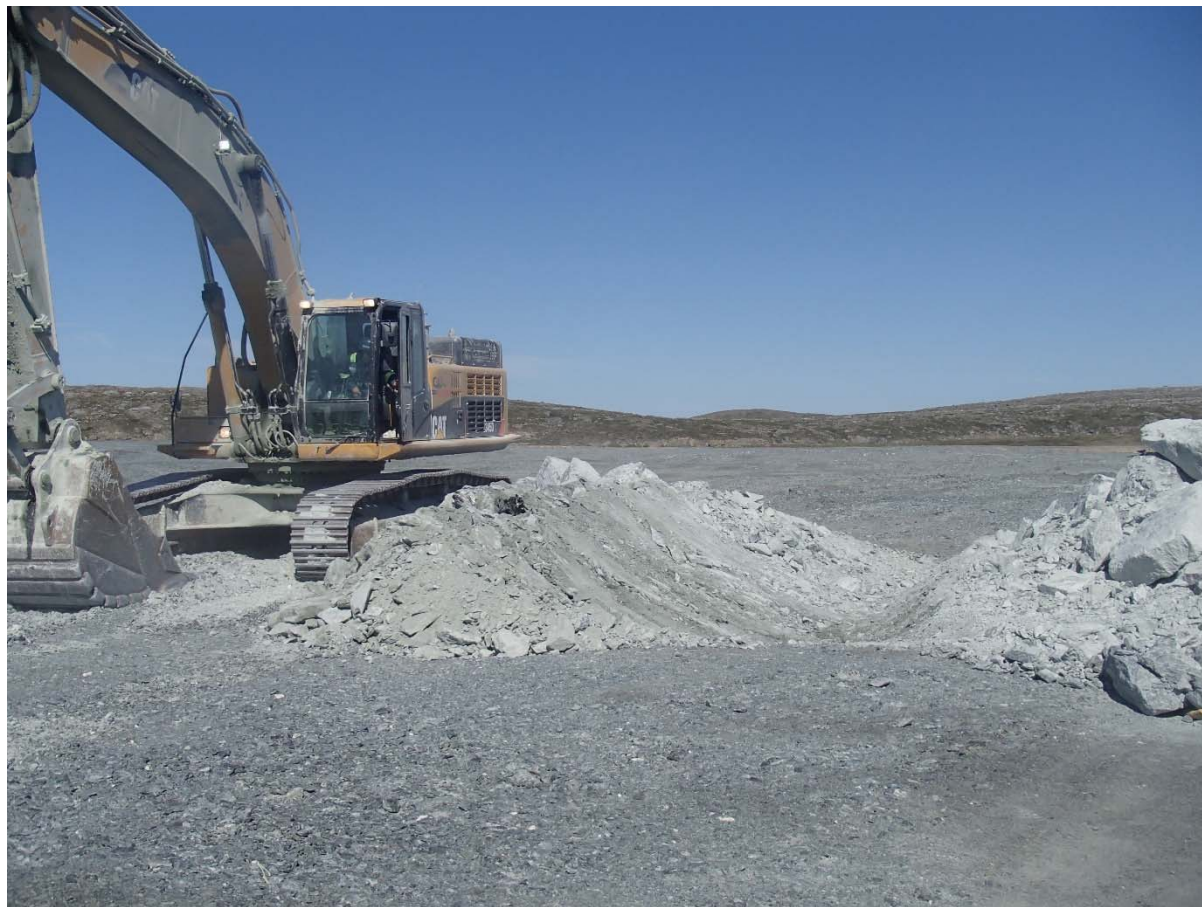
Photograph NCIS-114: From Sta. 1+700/-34 m (approx.), looking N. Excavation of a 0.8 m (approx.) deep, 1 m wide shallow ditch in the rockfill capping with an excavator from Sta. 1+500 m to 1+650 m.

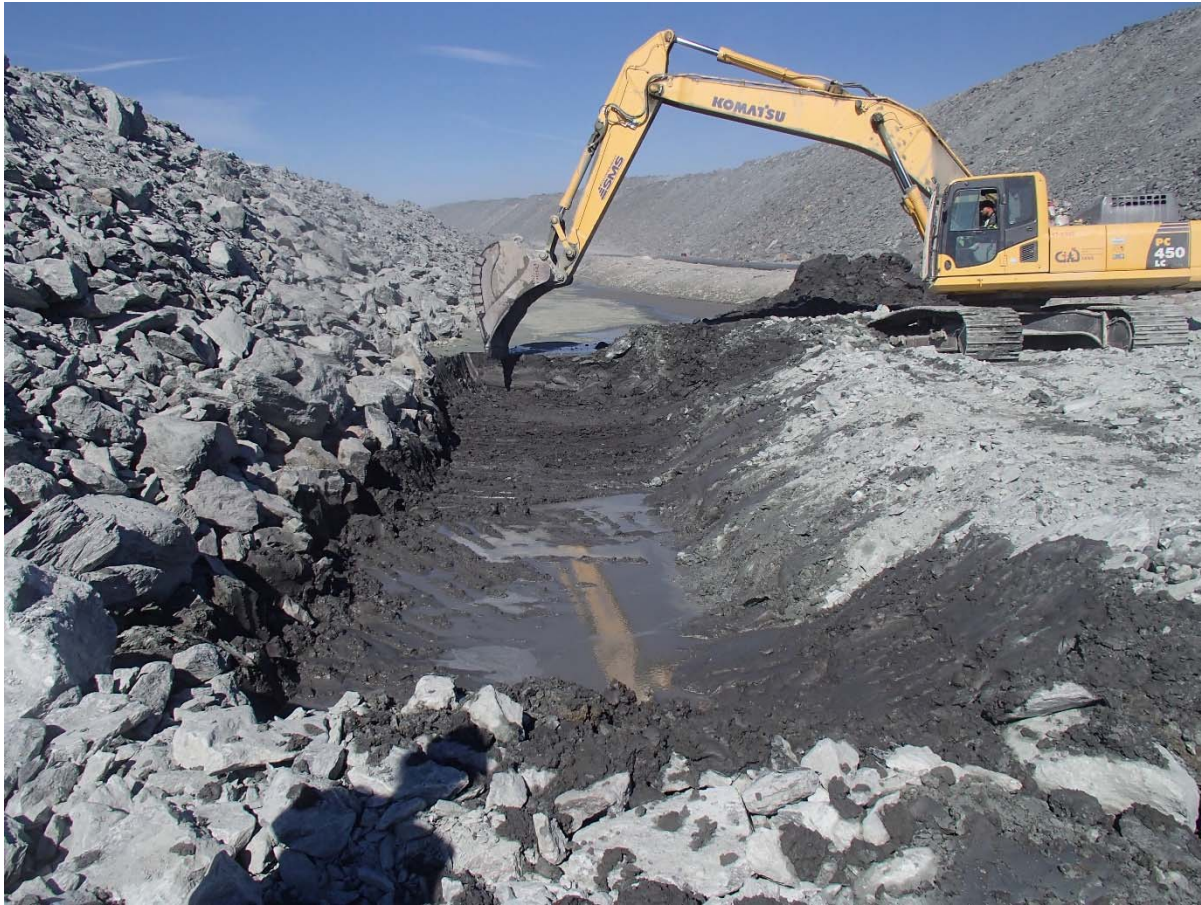
Photograph NCIS-115: From Sta. 3+040/-33 m (approx.), looking NE. Excavation of a 1 m (approx.) sump in the tailings with an excavator from Sta. 3+010 m to 3+030 m (o.s. +27 to +30 m). The bottom of the excavation was frozen.

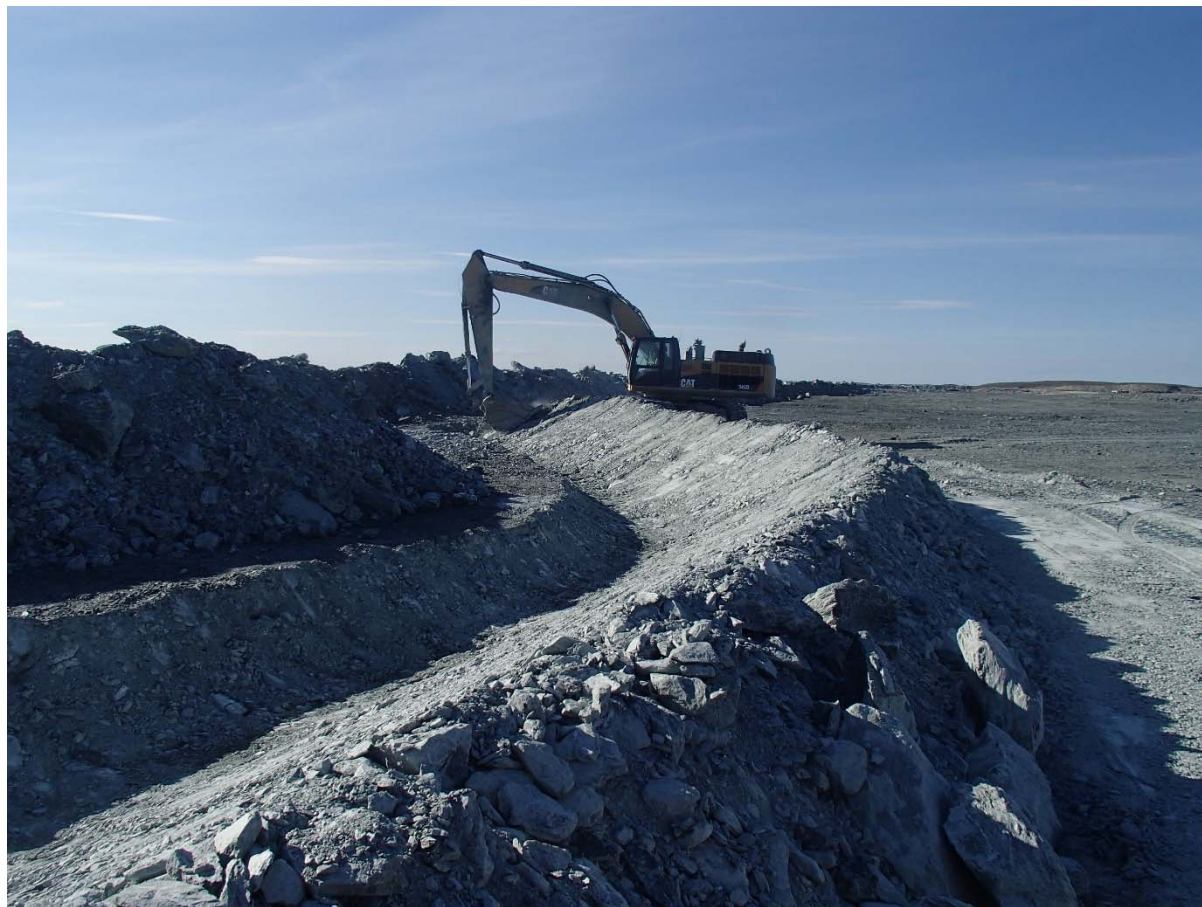
Photograph NCIS-116: From Sta. 1+700/+37 m (approx.), looking SE. Excavation of a 0.8 m (approx.) deep, 1 m wide shallow ditch in the rockfill capping with an excavator from Sta. 1+500 m to 1+455 m.

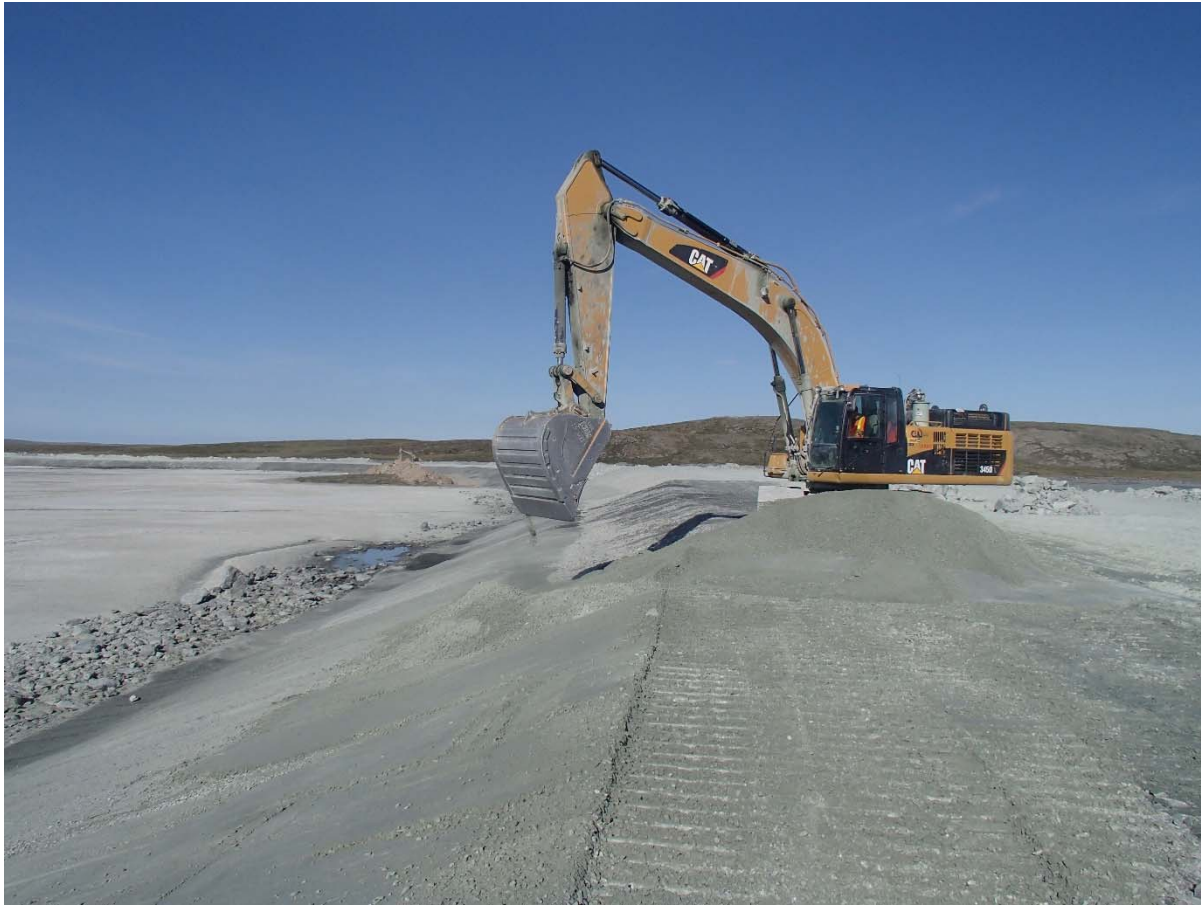
Photograph NCIS-117: From Sta. 2+050/-25 m (approx.), looking SW. Placement of a 0.5 m thick lift of fine filter in the upstream slope from El. 152 m to 154 m with an excavator from Sta. 2+090 m to 1+890 m.

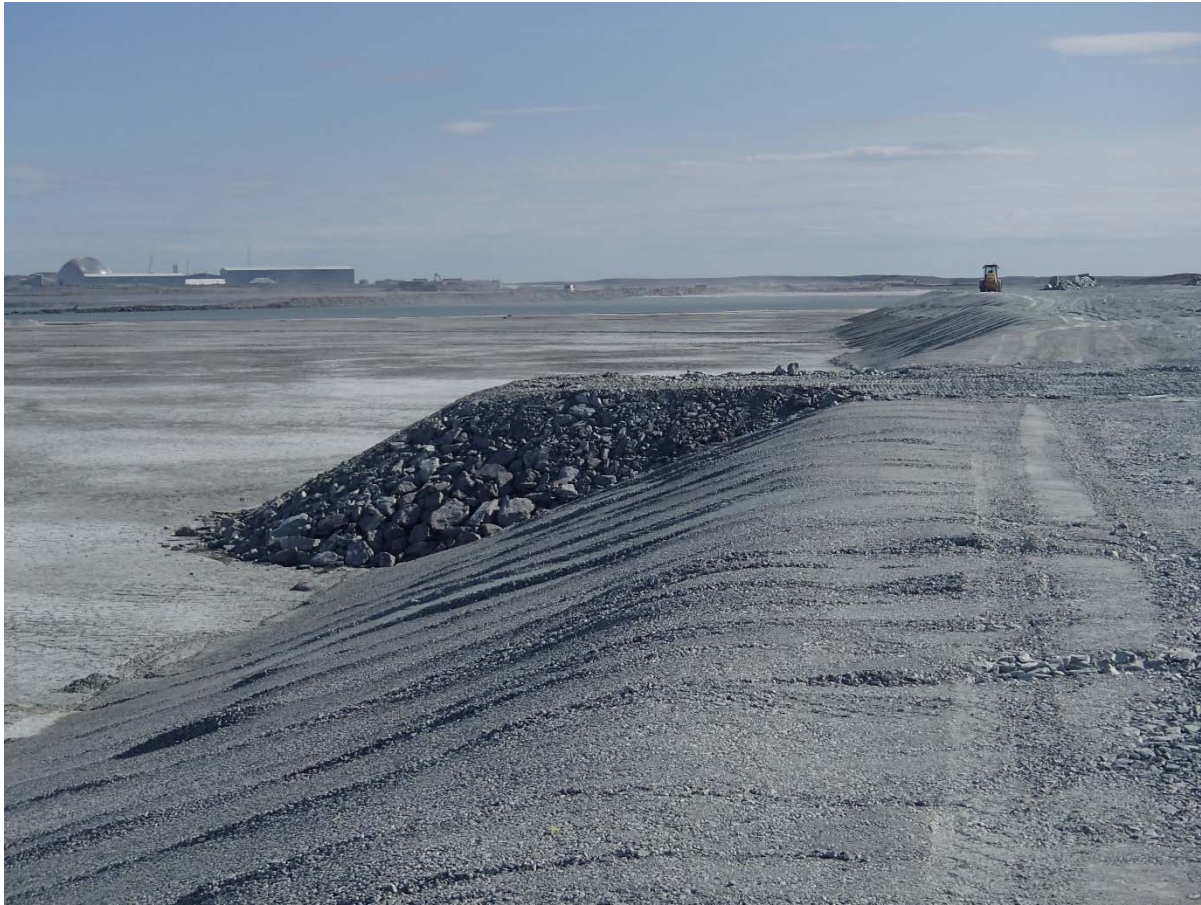
Photograph NCIS-118: From Sta. 1+500/-37 m (approx.), looking S. View of a deposition point.

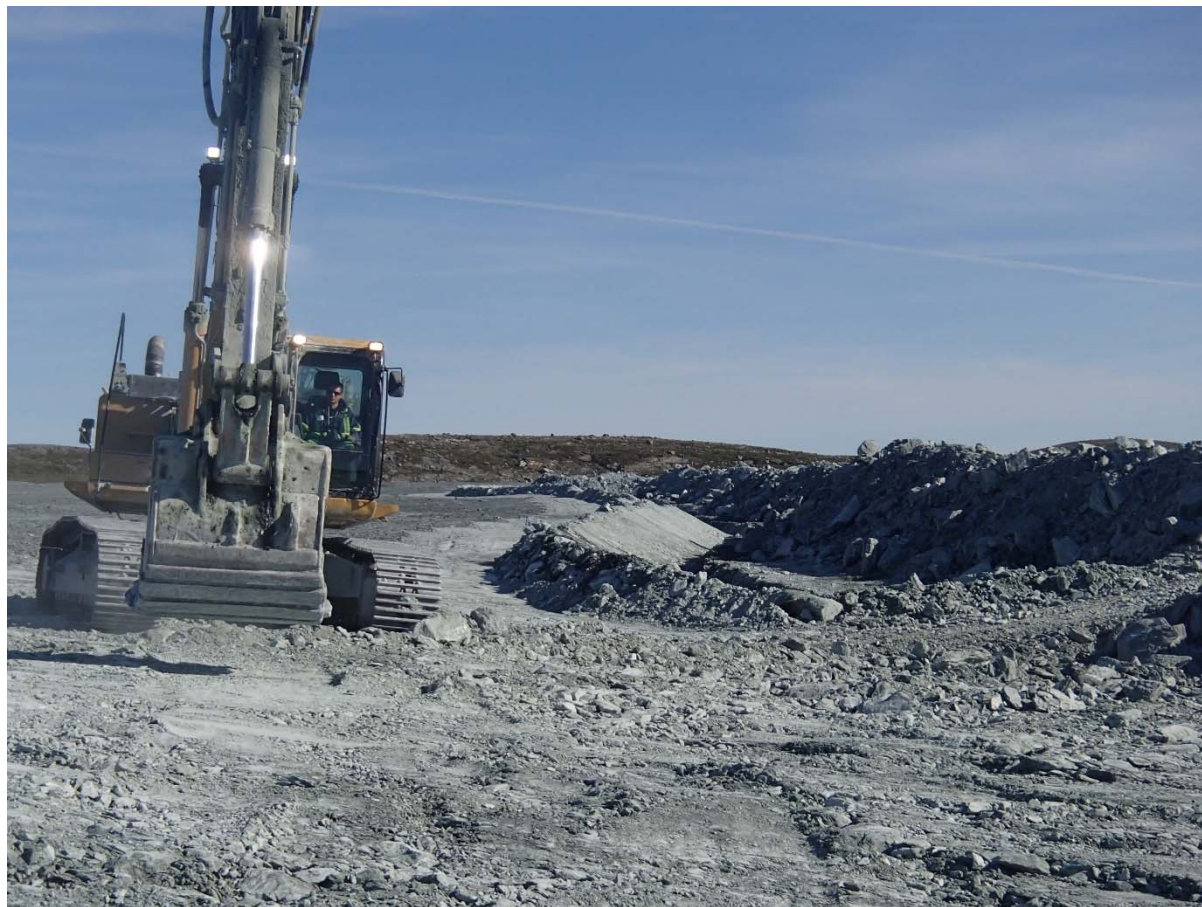
Photograph NCIS-119: From Sta. 1+430/-22 m (approx.), looking N. Excavation of a 0.8 m (approx.) deep, 1 m wide shallow ditch in the rockfill capping with an excavator from Sta. 1+455 m to 1+400 m.

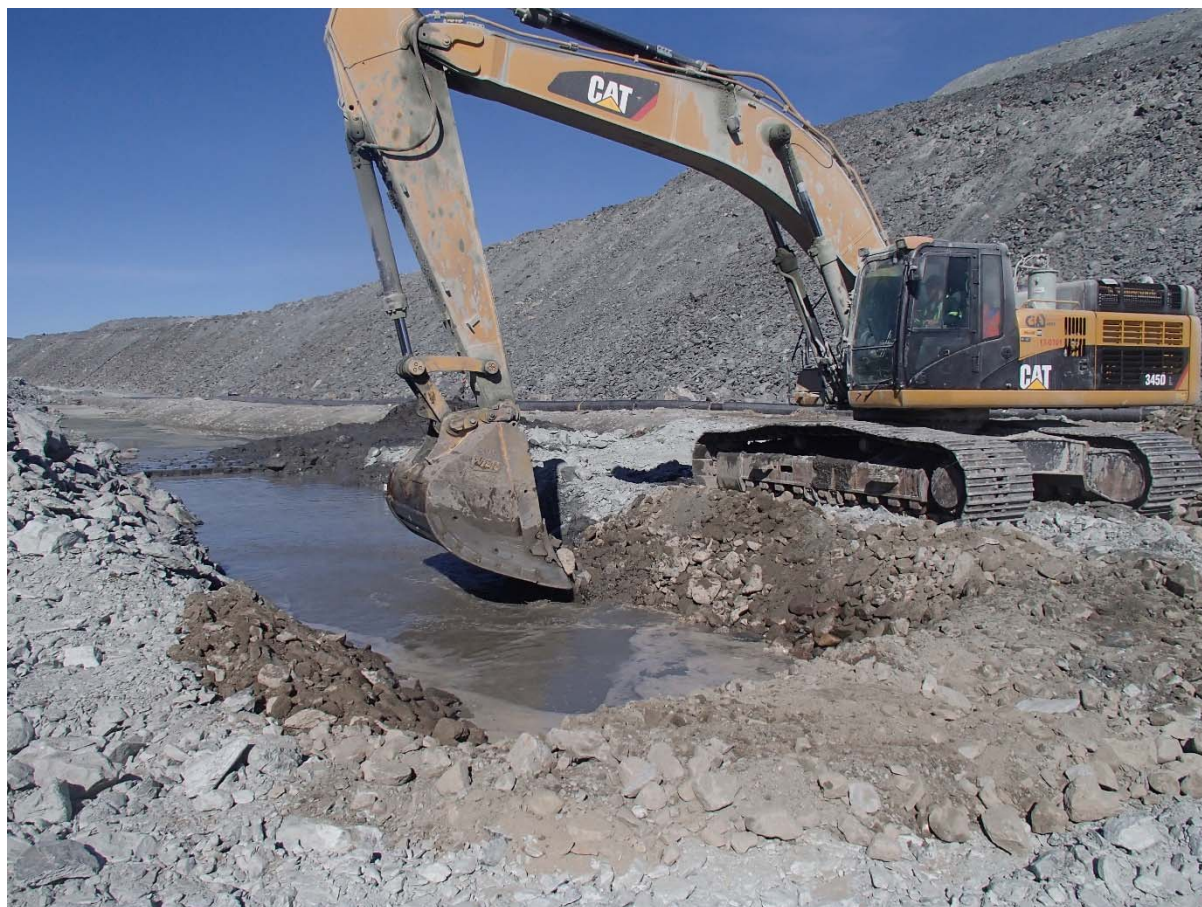
Photograph NCIS-121: From Sta.3+050/+26 m (approx.), looking NE. Placement of a 0.3 m thick (approx.) layer of till sieving reject material on the bottom and on the slopes of the sump.

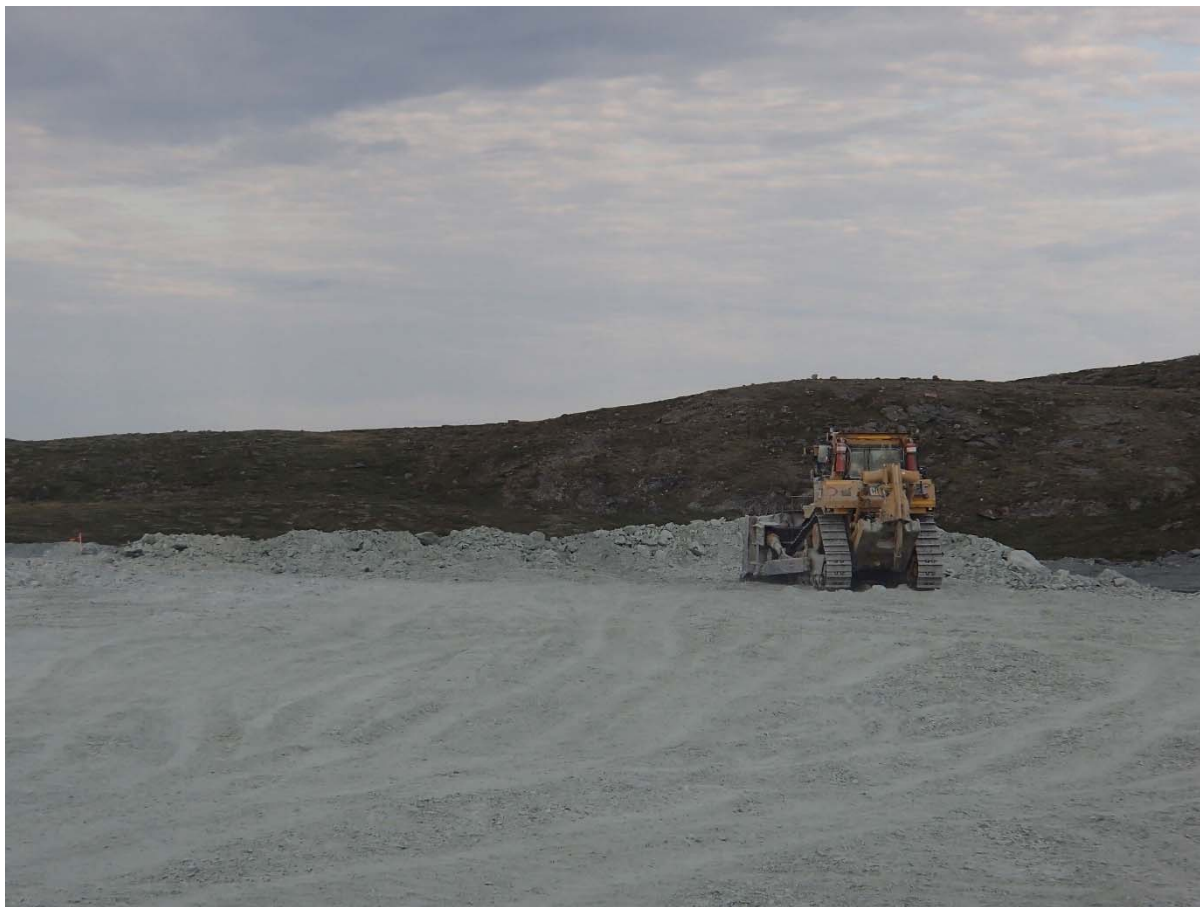
Photograph NCIS-122: From Sta. 1+960/-6 m (approx.), looking W. Placement of a 2 m thick (approx.) lift of UM rockfill from El. 152 m to El. 154 m (approx.) with a dozer from Sta. 1+830 m to 1+860 m (+8 m to -23 m).

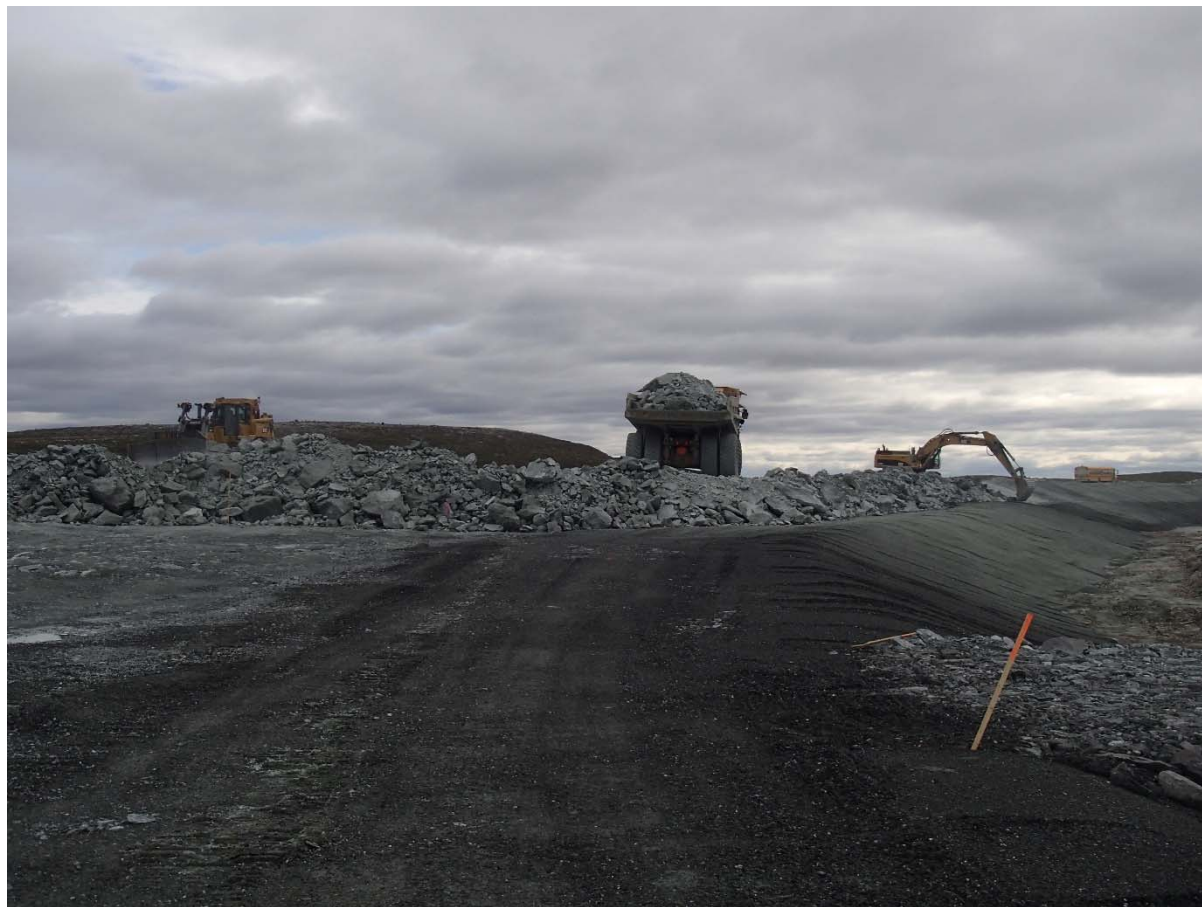
Photograph NCIS-128: From Sta. 1+680/-42 m (approx.), looking NE. Placement of a 2 m thick (approx.) lift of UM rockfill from El. 152 m to El. 154 m (approx.) with a dozer from Sta. 1+830 m to 1+660 m (+8 m to -31 m) and profiling of the upstream slope (3H:1V) from El. 152 to 154 m with an excavator from Sta. 1+880 m to 1+780 m.

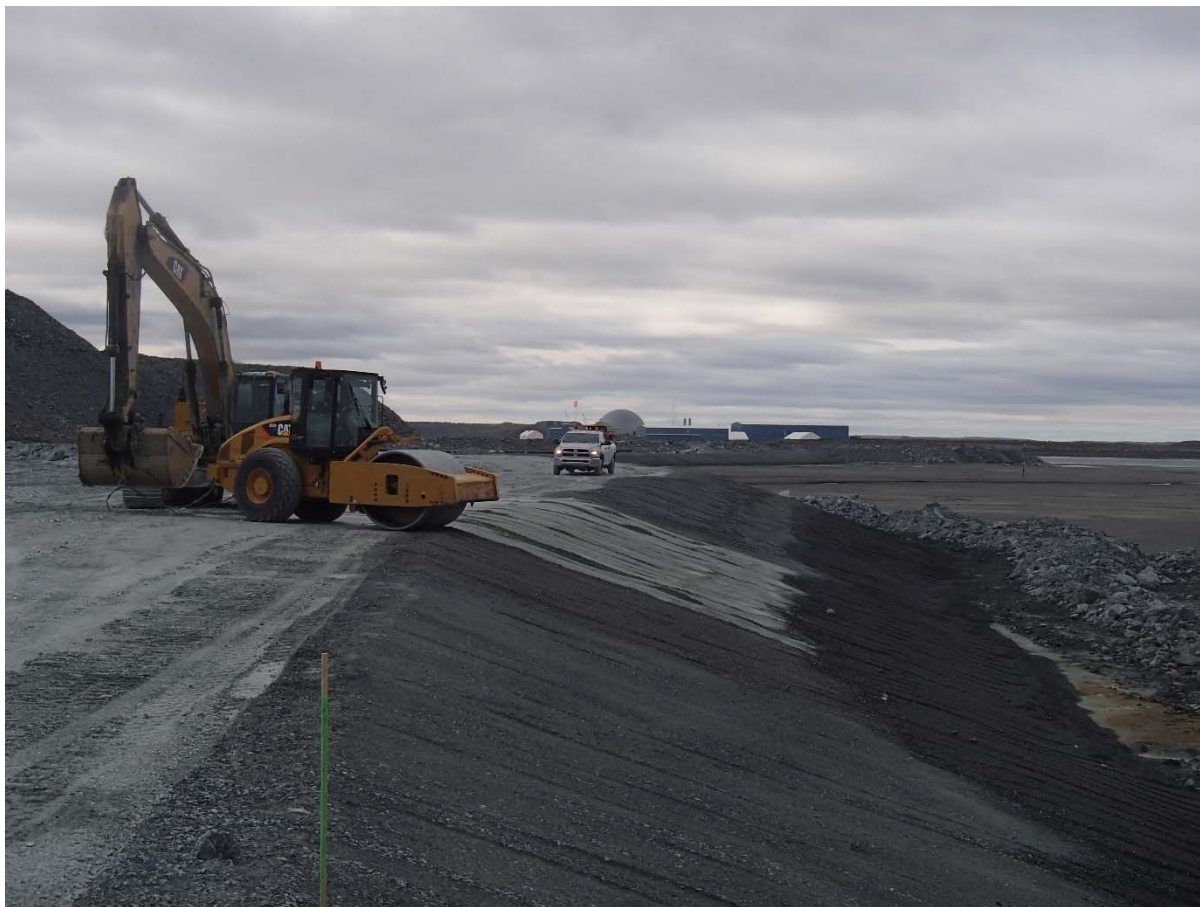
Photograph NCIS-129: From Sta. 2+450/-21 m (approx.), looking S. Compaction of the 0.5 m lift (approx.) of fine filter between El. 152 m and 154 m with a 10-tonne smooth-drum compactor with vibration (4 passes) in the upstream slope from Sta. 2+220 m to 1+940 m.

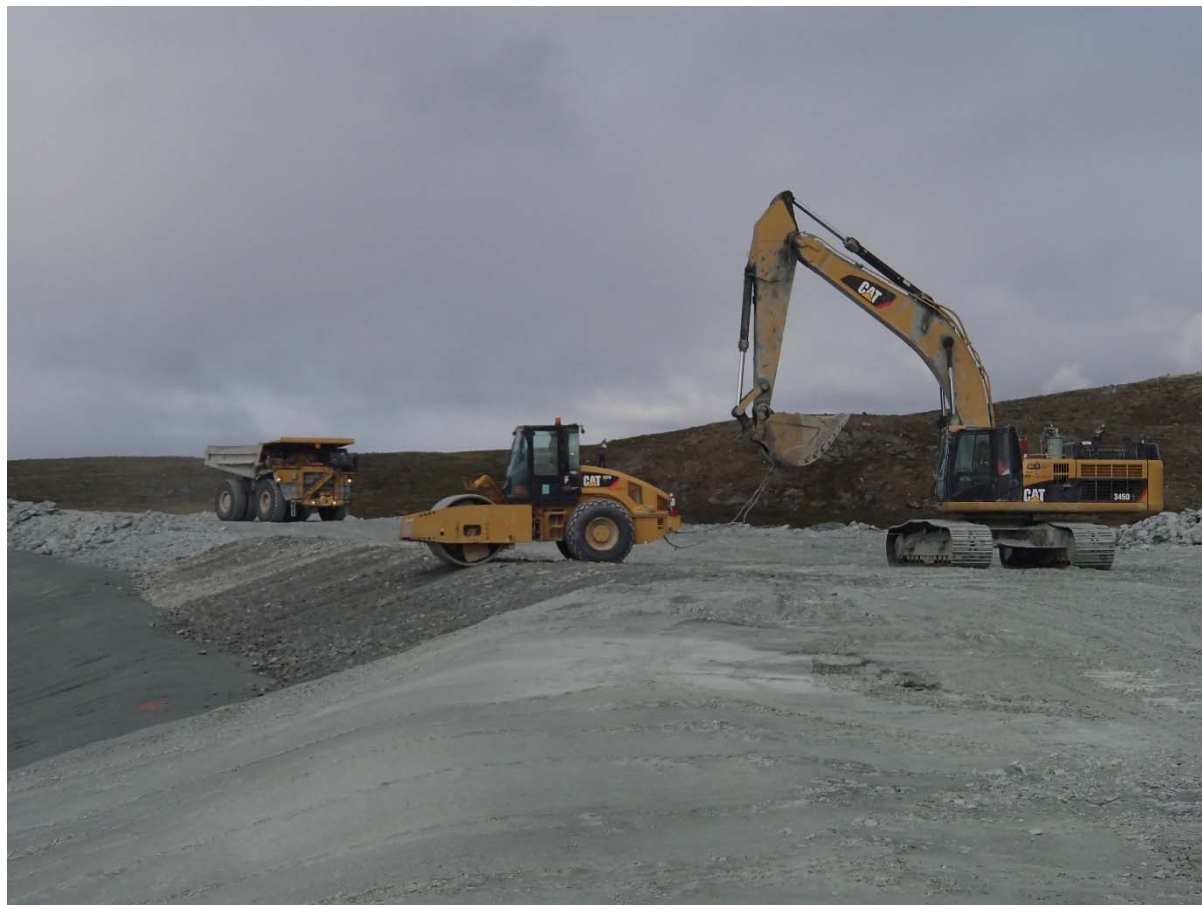
Photograph NCIS-131: From Sta. 1+940/-20 m (approx.), looking W. Compaction of the 0.5 m lift (approx.) of coarse filter between El. 152 m and 154 m with a 10-tonne smooth-drum compactor with vibration (4 passes) in the upstream slope from Sta. 1+890 m to 1+826 m.
