QA WEEKLY REPORT

DATE July 30th 2018

QA WEEKLY REPORT FROM JULY 23RD TO JULY 29TH– TSF NORTH CELL CONSTRUCTION MEADOWBANK (1897439)

This document summarizes QA activities performed by Golder from July 23rd to July 29th, 2018 inclusively, related to the construction activities of the North Cell Internal Structure at the Meadowbank mine site.

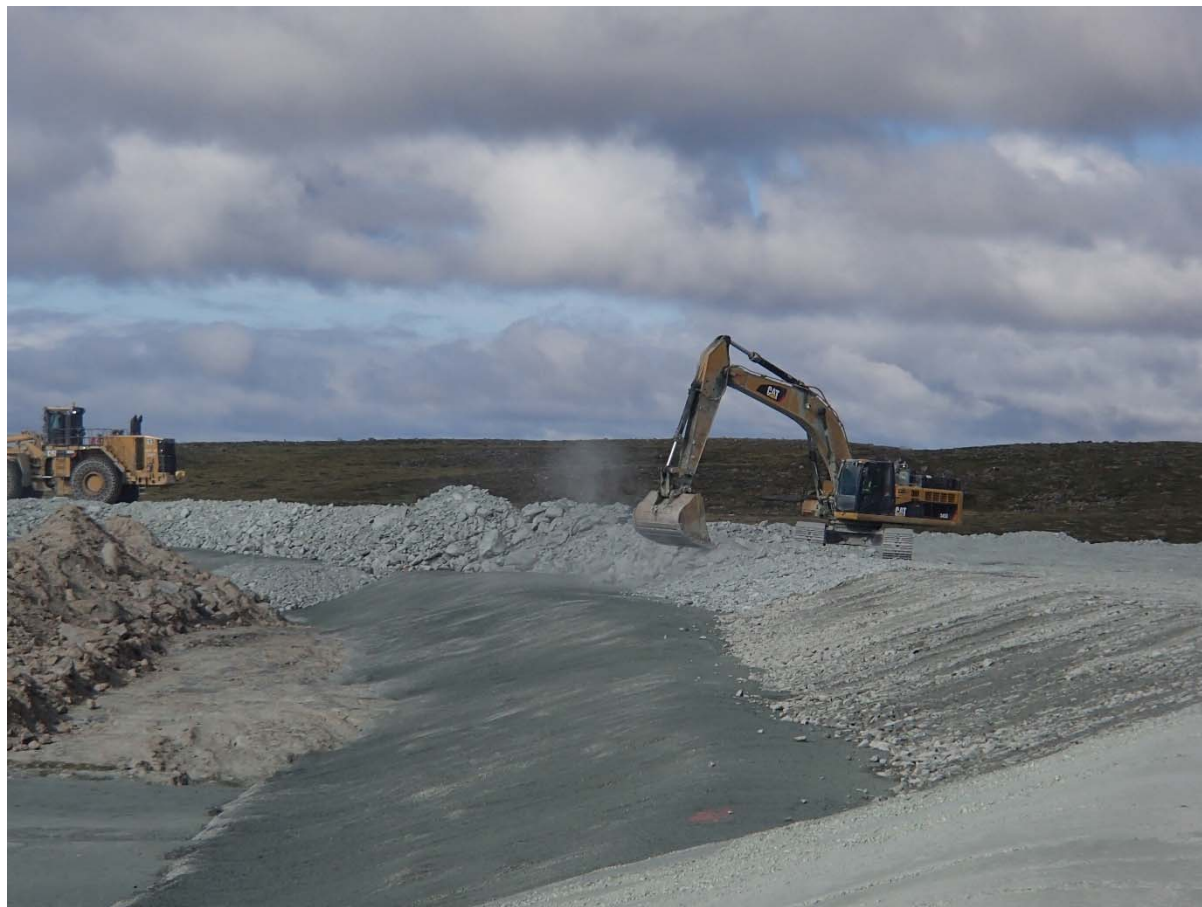
Photograph NCIS-132: From Sta. 1+940/-20 m (approx.), looking W. Profiling of the upstream slope (3H:1V) from El. 152 to 154 m with an excavator from Sta. 1+780 m to 1+660 m.

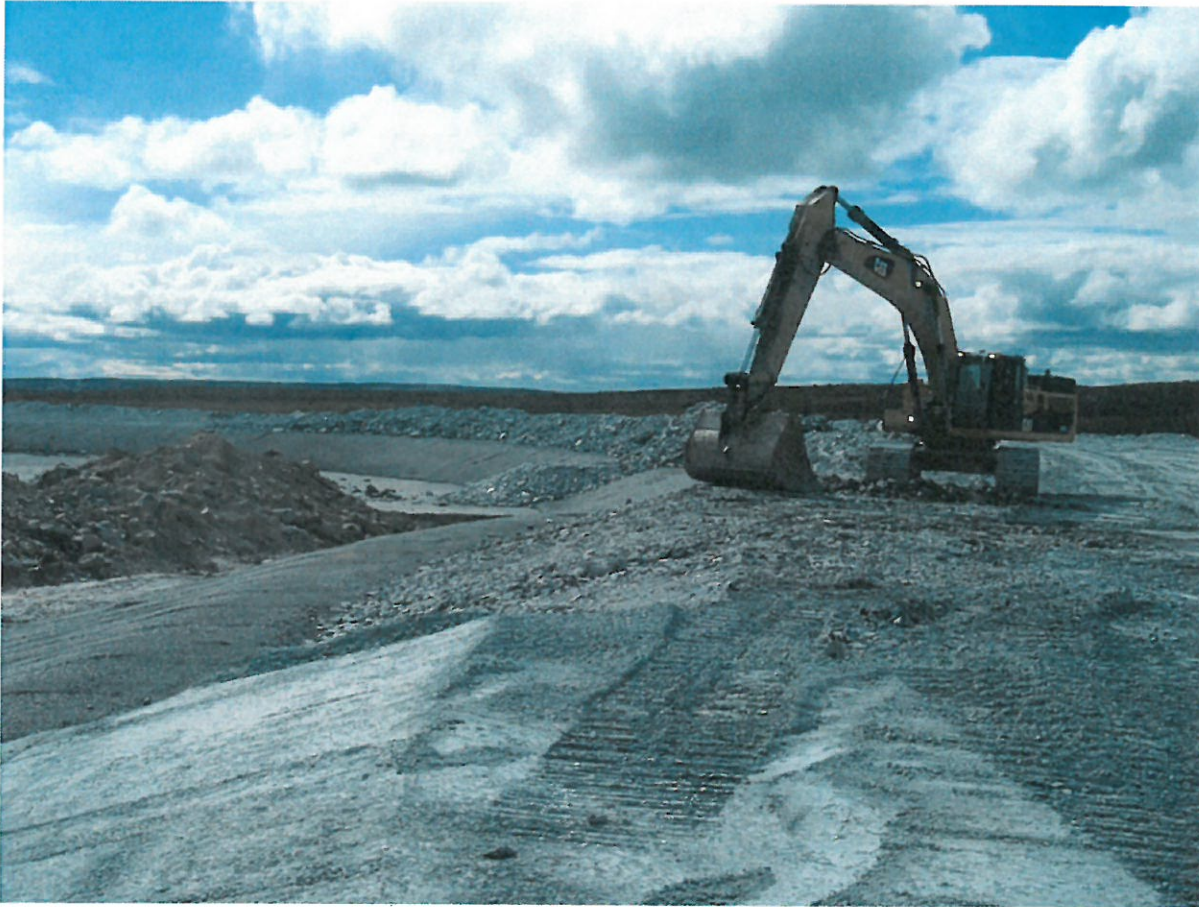
Photograph NCIS-133: From Sta. 1+820/-28 m (approx.), looking W. Placement of a 0.5 m thick lift of coarse filter in the upstream slope from El. 152 m to 154 m with an excavator from Sta. 1+890 m to 1+826 m.

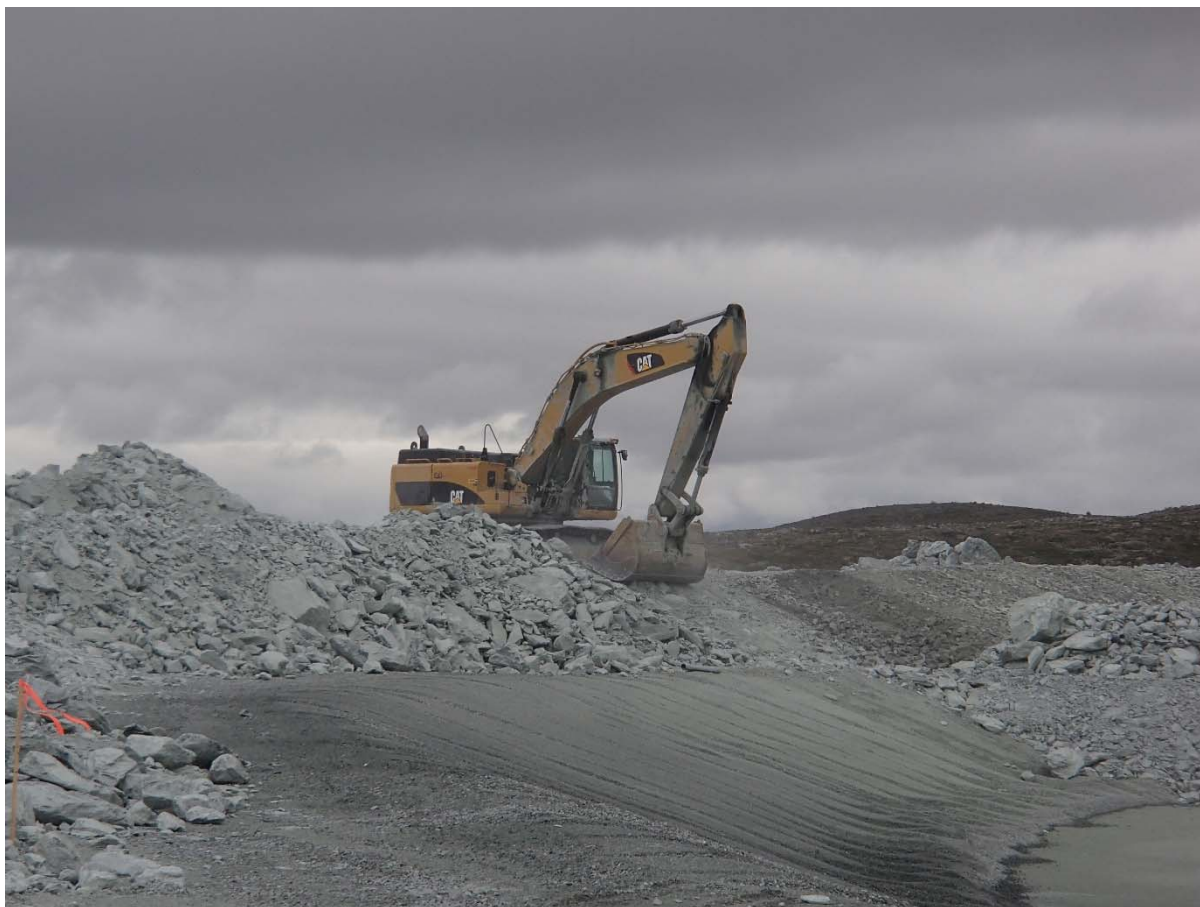
Photograph NCIS-134: From Sta. 1+630/-32 m (approx.), looking NE. Completion of the profiling of the upstream slope (3H:1V) from El. 152 to 154 m with an excavator from Sta. 1+700 m to 1+660 m.
