November 4, 2008

Mr. Dennis Gourde, P.Eng.
General Manager
Agnico – Eagle Meadowbank Division
Baker Lake Office

Re: Meadowbank Dike Review Board (MDRB)
Trip Report – Dr. Andrew M Robertson – October 31, 2008

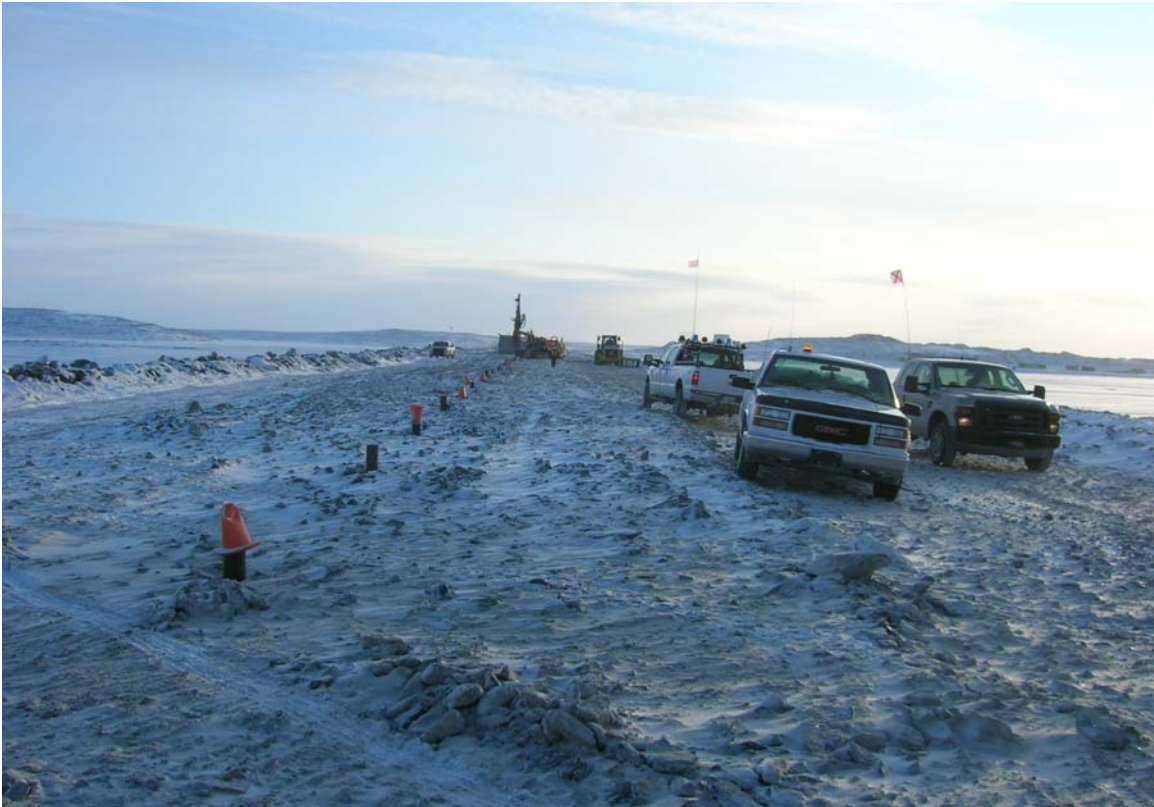
October 31: Travel from Baker Lake to mine site. During the morning Mr Gaston Blanchette presented a review of the overall project dike requirements, investigations, designs and design changes, and construction progress. In the afternoon the East Dike was inspected (Photo 1) including the grouting installations and partially excavated trial grout area (Photos 2 to 4 and 7), and returned to Baker Lake. In the evening Gaston Blanchette completed the review presentation of the materials submitted for MDRB review during Meeting No 1.

Photo 1 – East Dike crest with Primary holes grouted in casings protruding

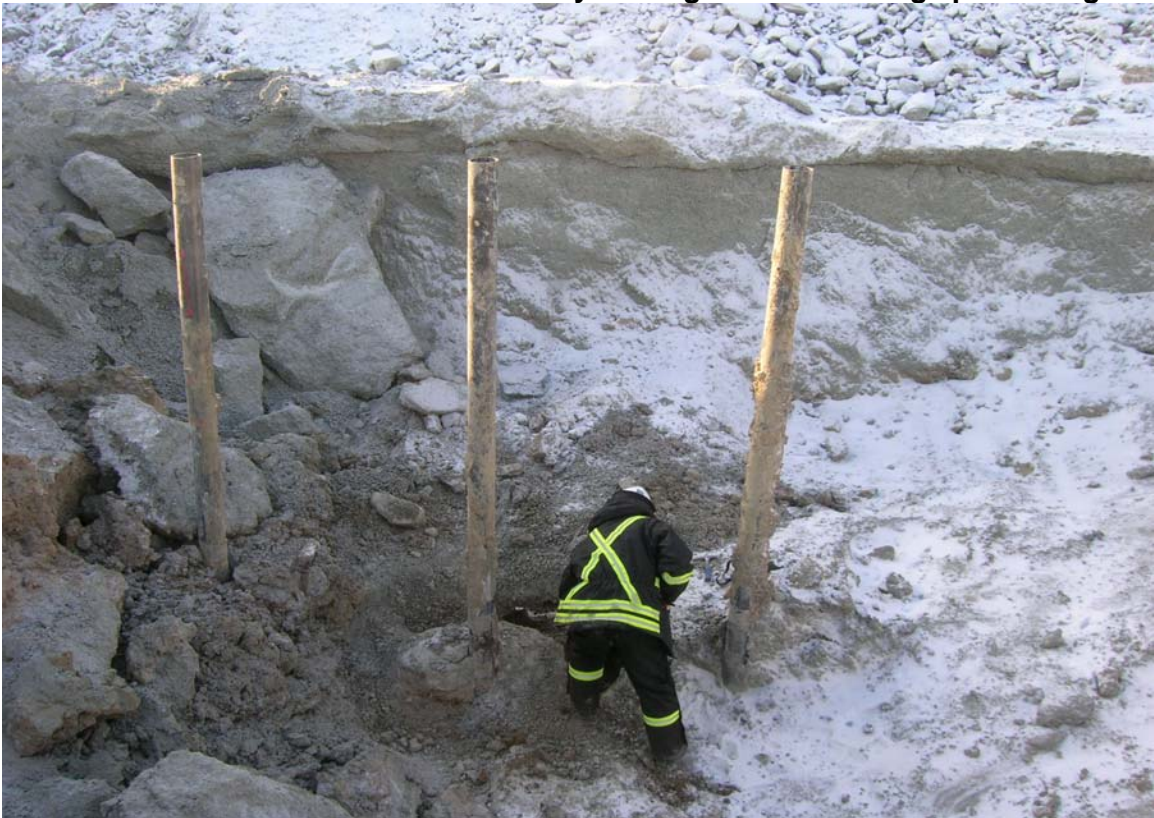
A grouting test had been completed where both the 'grouted in casing' (GIC) and "tube-a-manchette" (TAM) methods had been applied at a location where excavation of the grout bulbs for inspection was possible. At the time of the visit the grout bulb for one of the GIC trials was being excavated (Photo's 2 to 4). The TAM trial for which the white grout casing is seen in Photo 7 had not been excavated.

Photo 2 – Excavated grouted in casings and grout bulb at slurry wall rock contact

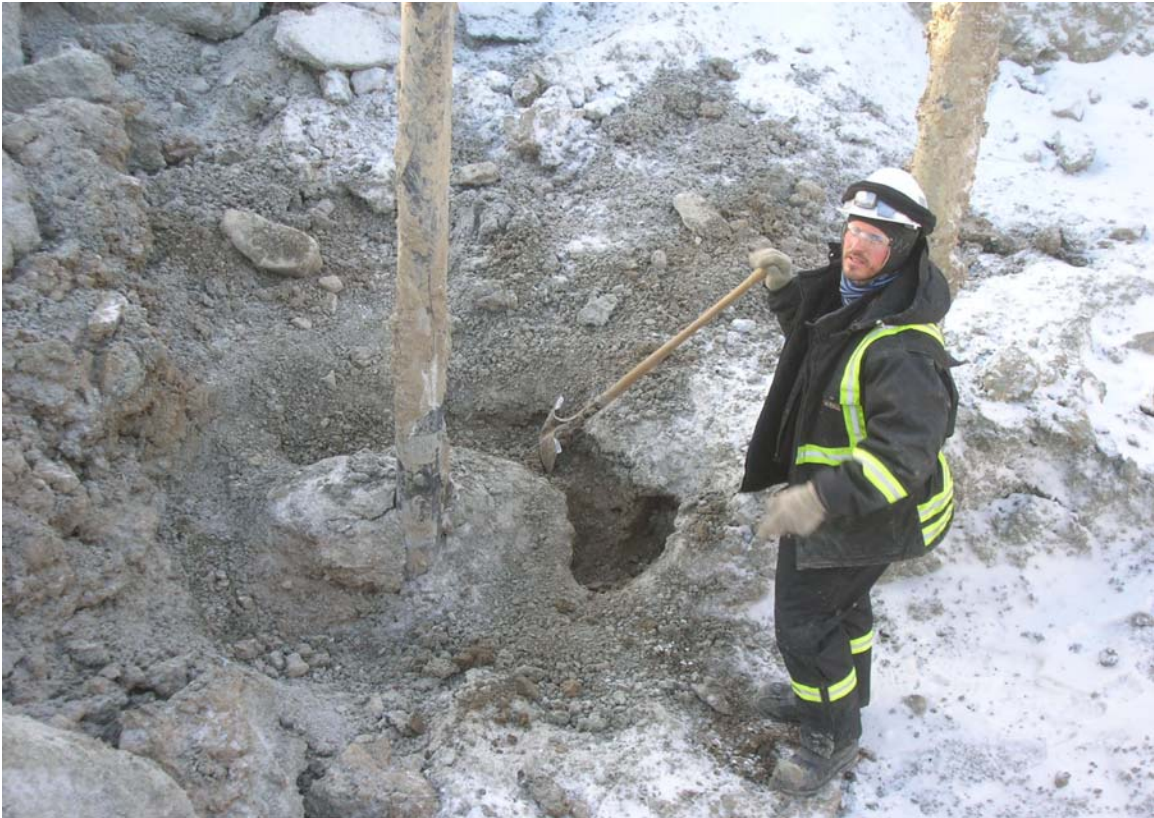
The grouting trial excavation indicated the presence of loose ungrouted 'crush' fill at the base of the cutoff wall fill material. This is apparent in the deeper 'hole' excavation seen in Photo 3. The grout bulb achieved by the GIC grouting trial clearly indicates the presence of open matrix crush prior to grouting. Reliable grouting of the toe of the cutoff wall is a necessity to prevent rapid seepage through such crush fill. Grouting of the rock below the upper surface could not be inspected.

The grouted bulb produced by cement grout intrusion from the GIC trial showed effective penetration of grout into the crush but for a limited distance (about 35 cm for the bulb seen in Photo 3. The conventional cement grout penetrates the crush well (see Photos 5 and 6) and the cement particle size does not appear to be a constraining factor.. It seems unlikely that the use of microfine cement will increase the radius of penetration significantly.

Photo 3 – Grout bulb with excavated ungrouted ‘crush’ fill adjacent

Should the TAM not result in a considerably improved grout seal, and the GIC method is selected, it is appears likely that a very close spacing of grout holes will be required to reliably and continuously grout the cut-off wall toe.

It is prudent to develop a clear and reliable understanding of the grouting effectiveness of the alternative methods if a secure sealing of the toe of the cut-off wall is to be achieved in the most efficient and expeditious manner. Additional trials and testing may be warranted.

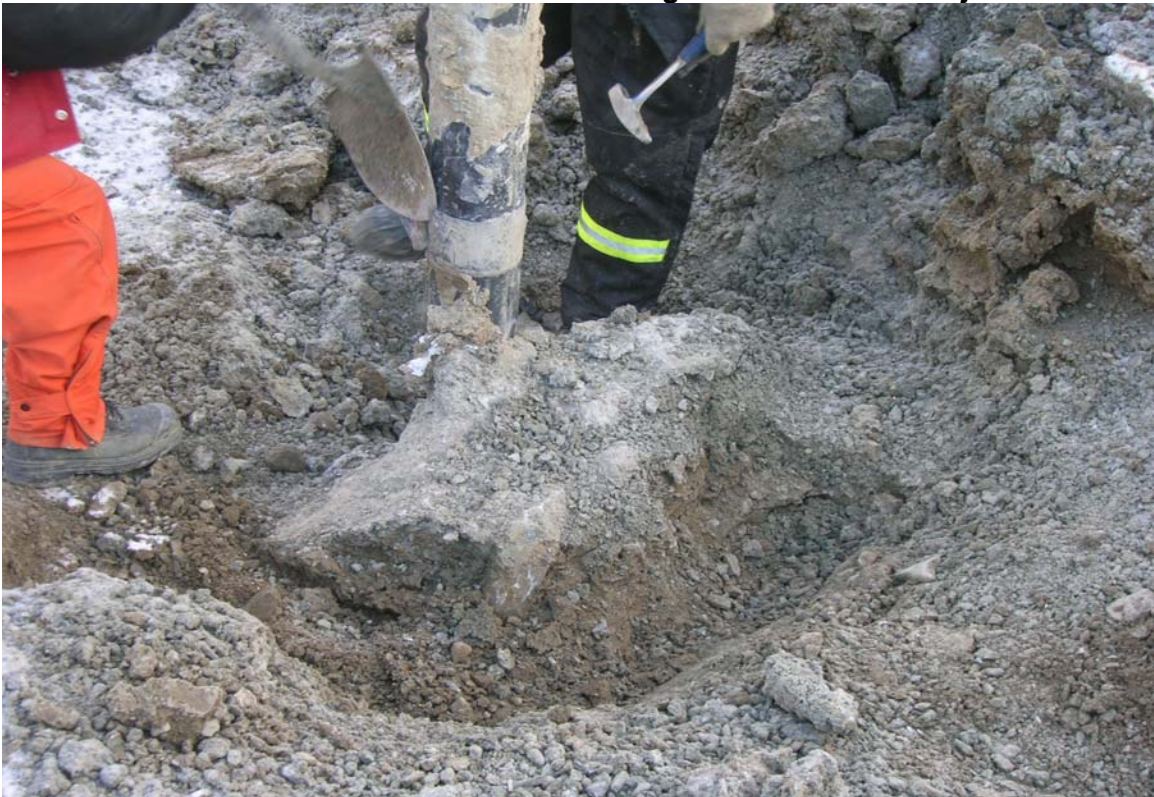
Some of the grout – particularly at the limits of the grout bulb – was very weak and some appeared not to have 'set' after 8 days. The unset grout would be readily erodible. The cold ground temperatures may be extending the set time the need for an accelerator should be considered, particularly if early dewatering is required.

Photo 4 – Limited extent of grout bulb. Injection port sleeve at tip of spade.

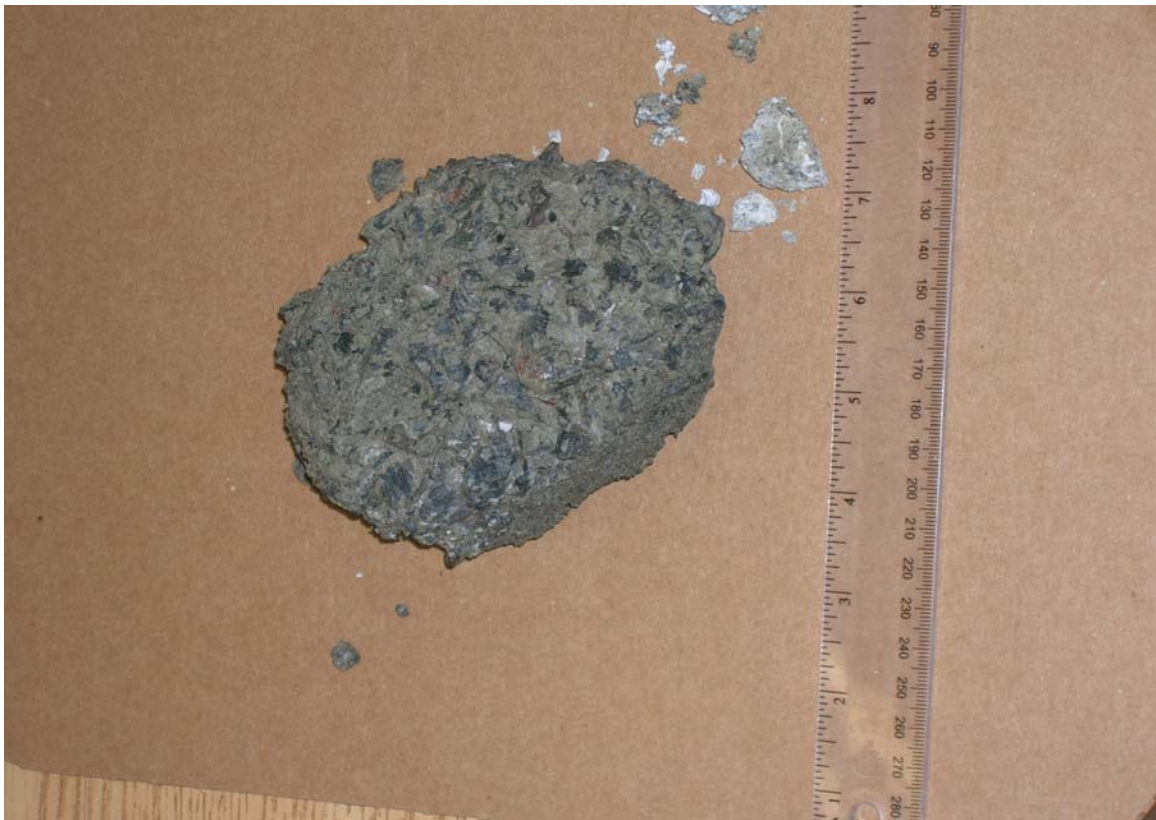
A sample of the grouted crush was inspected closely (Photo's 5 and 6).

Photo 5 – Sample of grouted crush

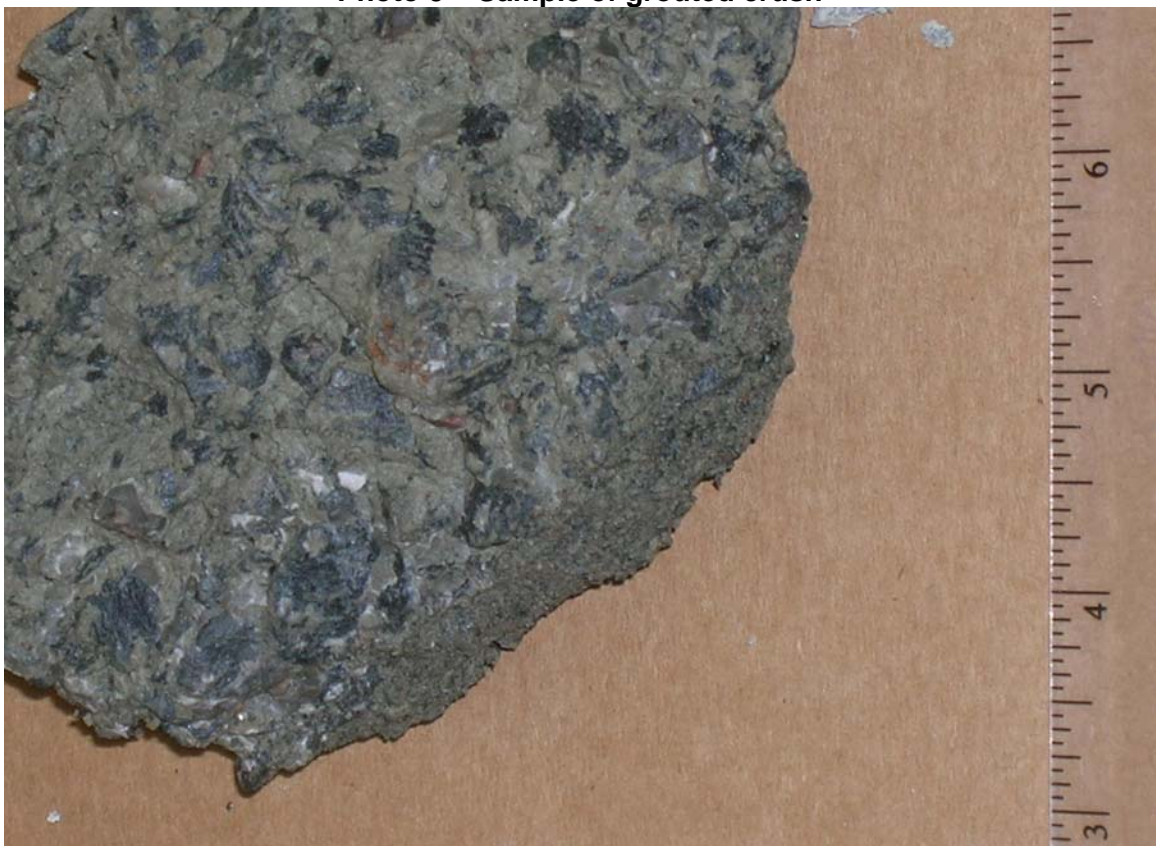
Photo 6 – Close-up of part of grouted crush sample

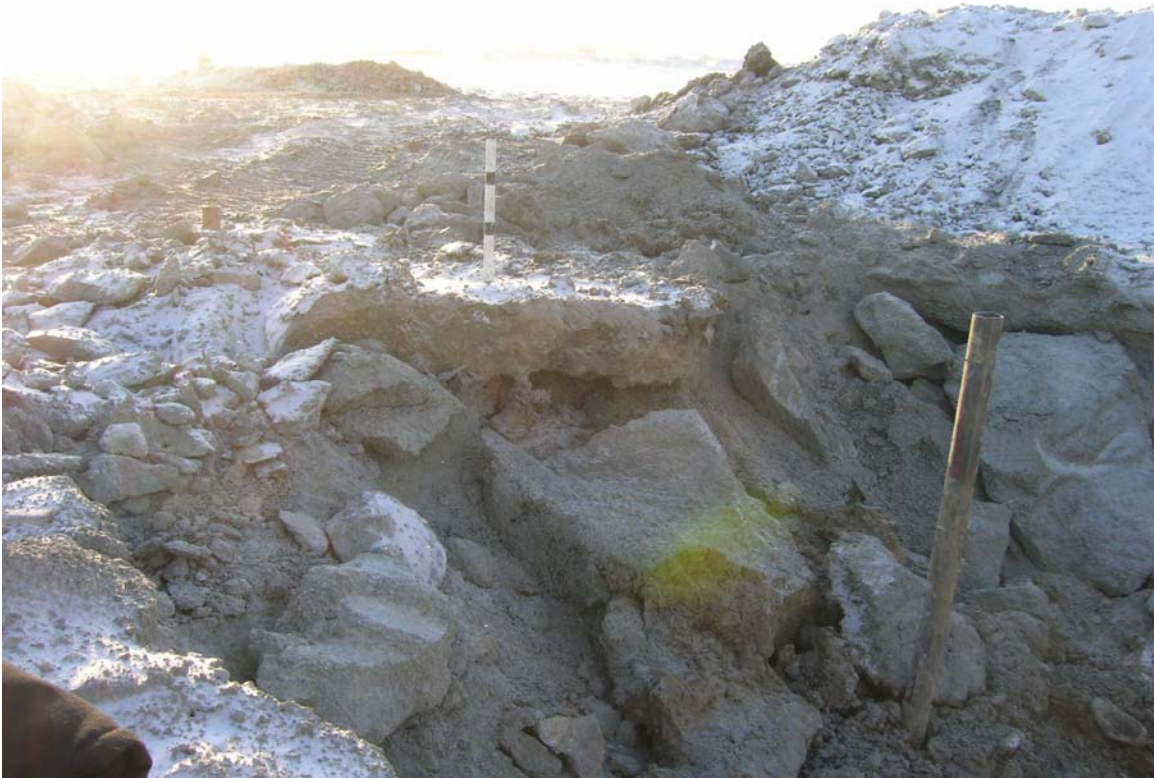
East dyke earthfill and slurry cut-off wall had been completed (Photo 7) together with installation of every second primary 'grouted in casing' in preparation for cut-off wall toe grouting. The grouting crew was off site waiting on a decision on which of two grouting procedures to implement.

Photo 7 - "tube-a-manchette" (TAM) grouting tube (white) in test zone still to be excavated
