APPENDIX A

Construction Photographs

1.0 NORTHERN PORTION – 2009 CONSTRUCTION

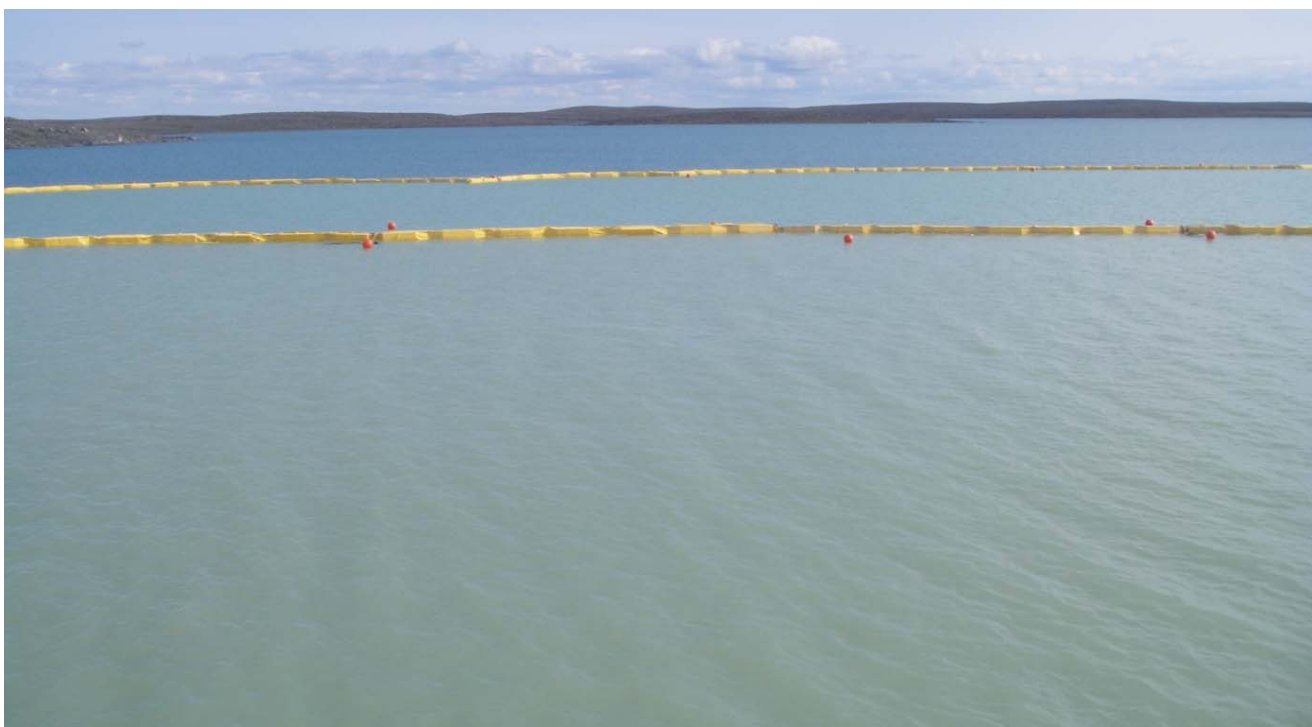
Photograph 1: Turbidity barriers functioning during rockfill placement - August 1, 2009

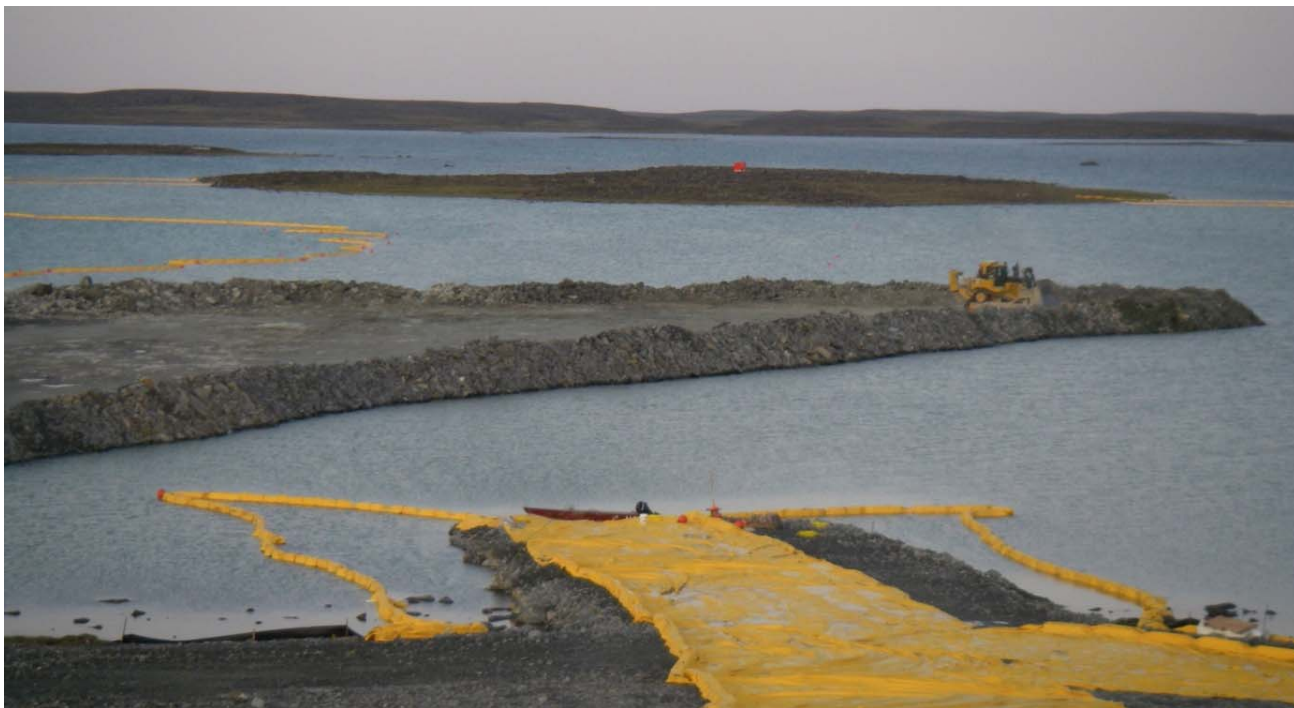
Photograph 3: Rockfill placement at approximately Sta. 30+366. Rockfill placement from the downstream (pit side) to the upstream to push lakebed sediments away from the dike centerline. Turbidity barrier installation in foreground - August 3, 2009

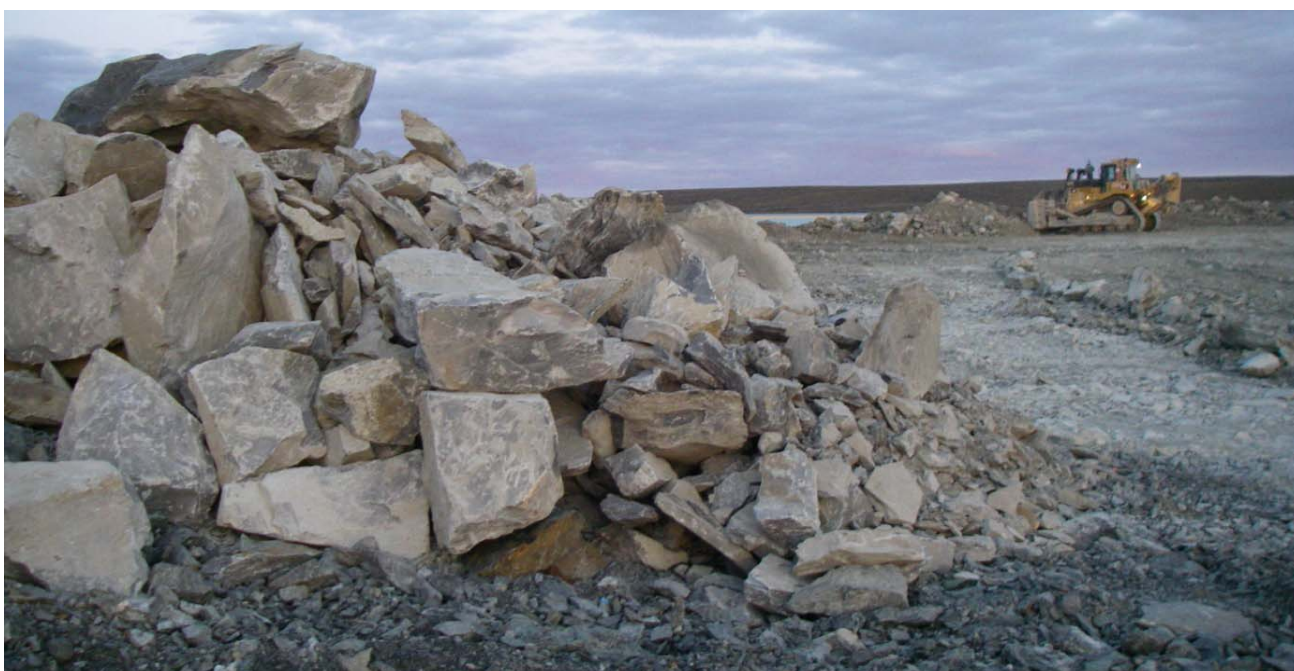
Photograph 4: Oversize rockfill is being placed on the sides of the dike platform – August 4, 2009

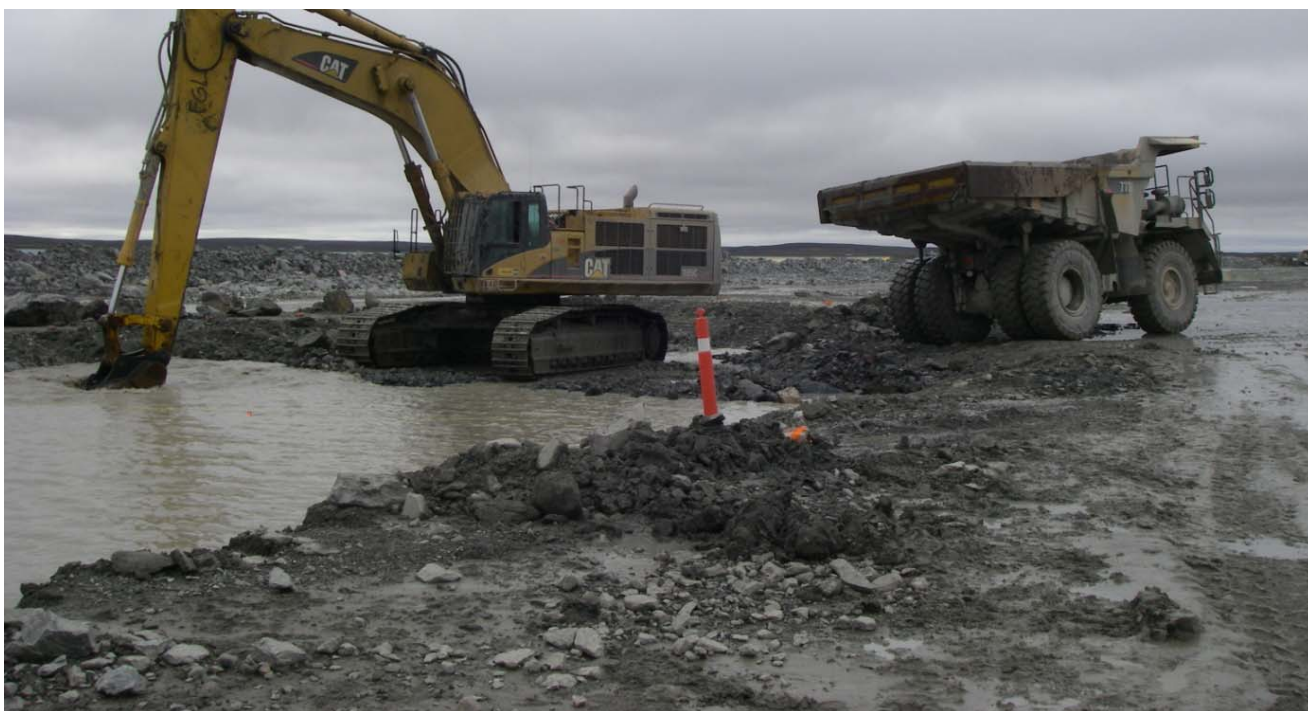
Photograph 6: Excavation of rockfill as part of the initial trench excavation, Sta. 30+200 - August 13, 2009

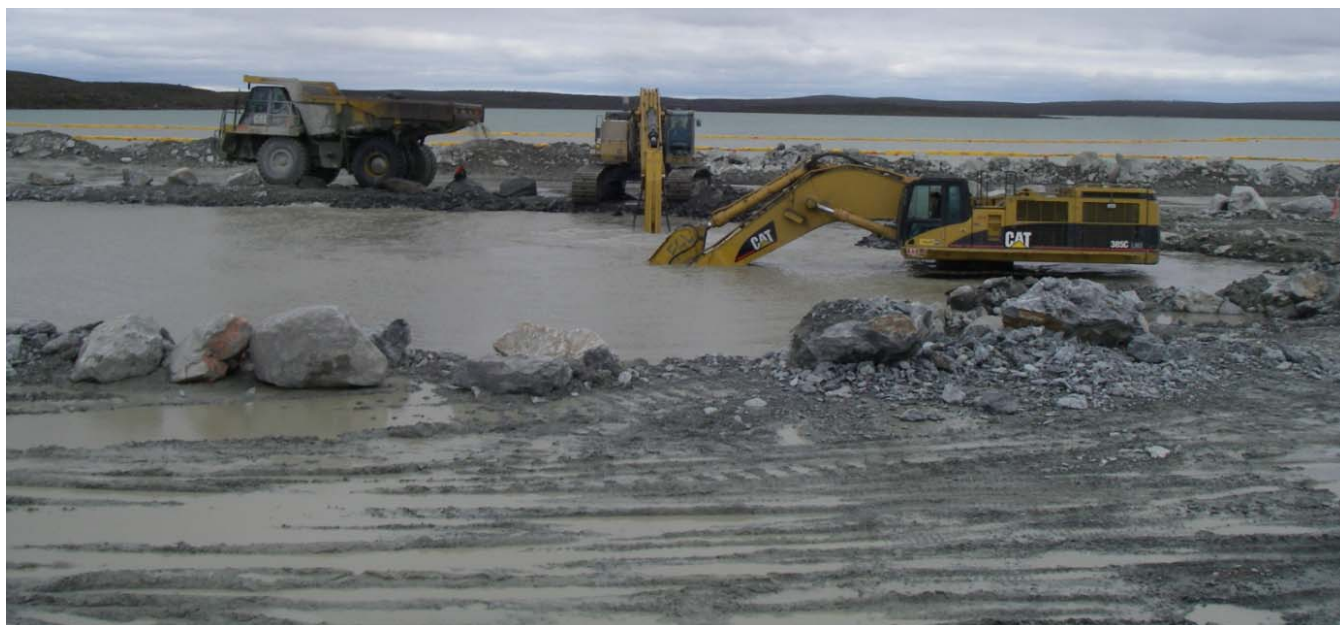
Photograph 7: Initial trench excavation at Sta. 30+400, excavation was at a depth of 10 m, excavator was sitting on a lower bench - August 20, 2009

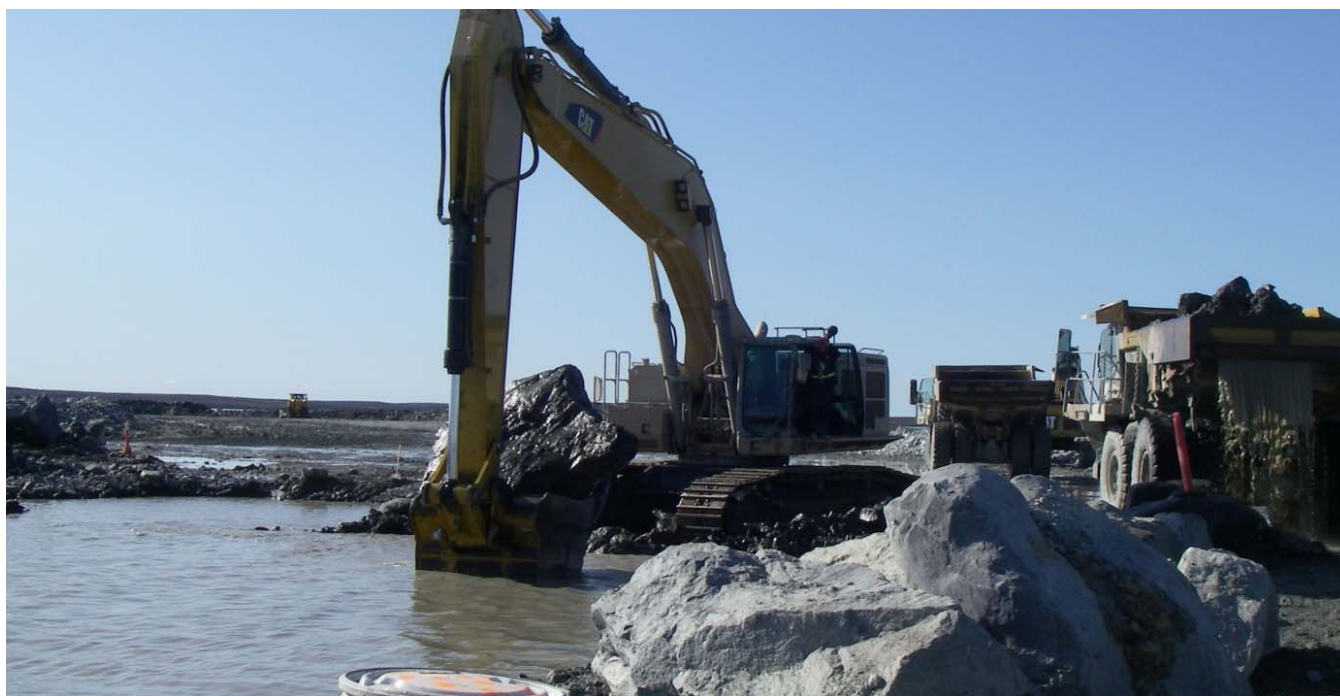
Photograph 8: A boulder of approximately 3 m diameter excavated from the centreline at Sta. 30+440 - August 24, 2009

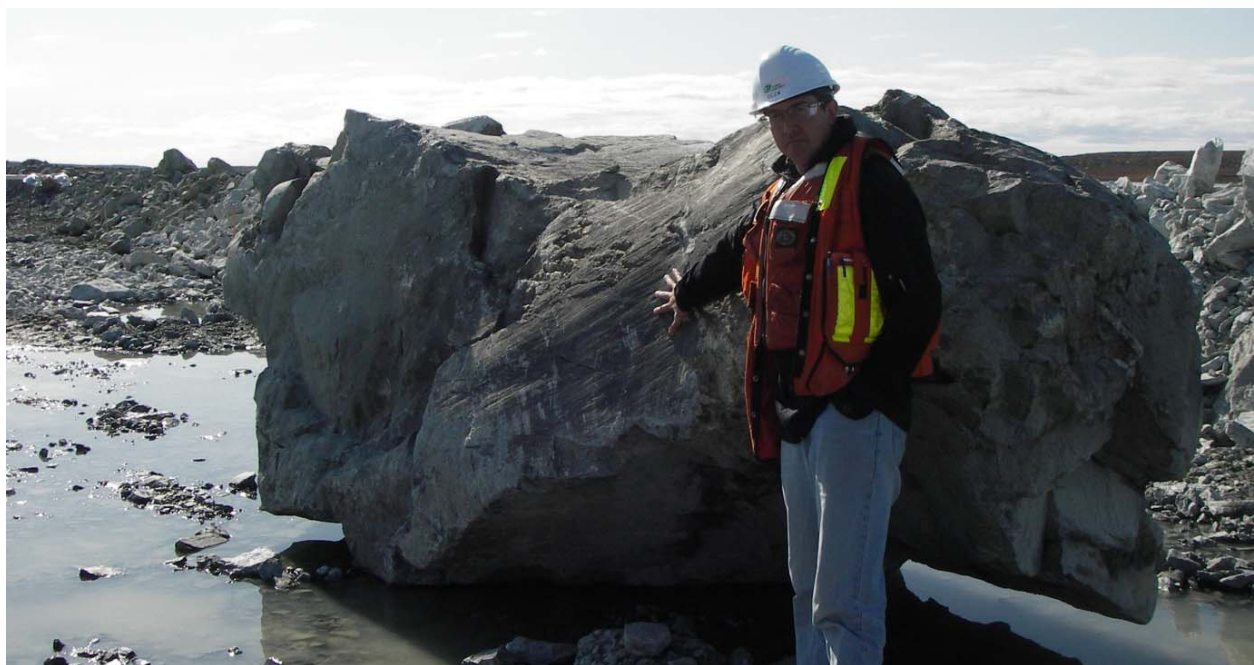
Photograph 9: A bedrock boulder of approximately 3 m diameter excavated from base of trench at Sta. 30+490 - August 28, 2009

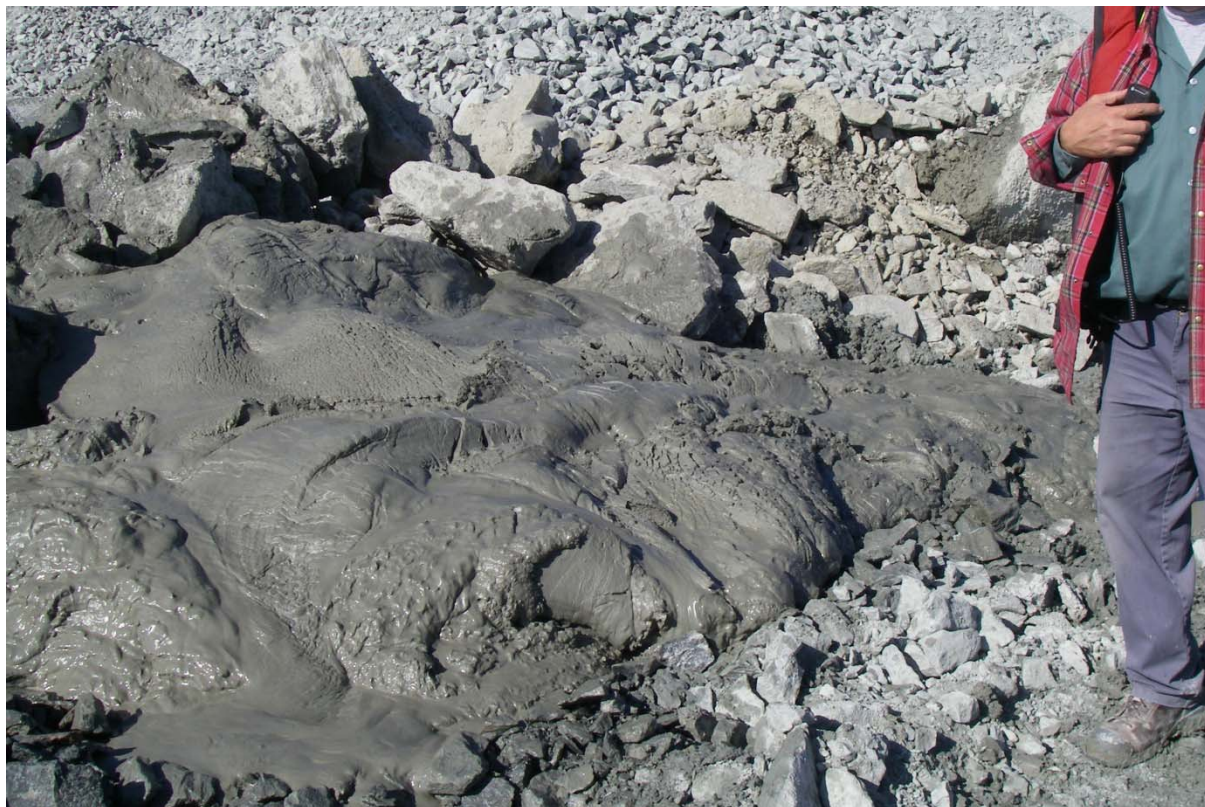
Photograph 10: Sediments excavated from base of initial trench at Sta. 30+362 - August 24, 2009

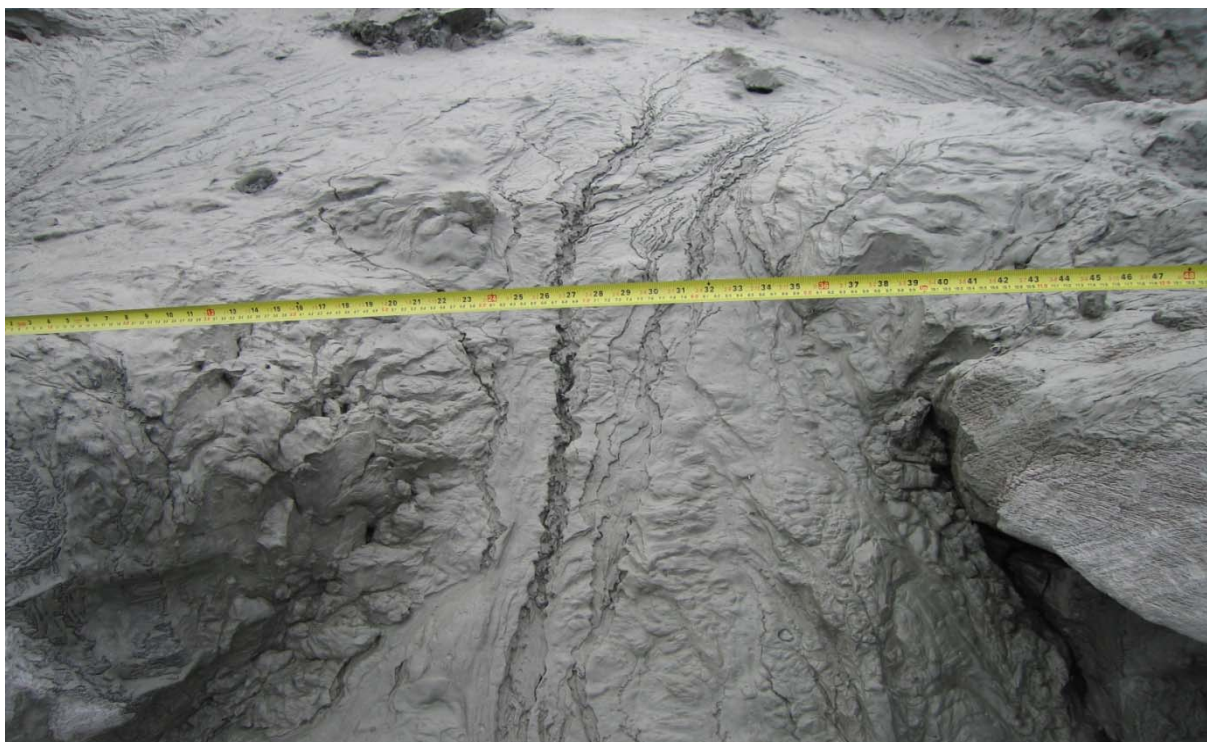
Photograph 11: Lakebed sediments excavated during initial trench excavation at Sta. 30+615 - September 5, 2009

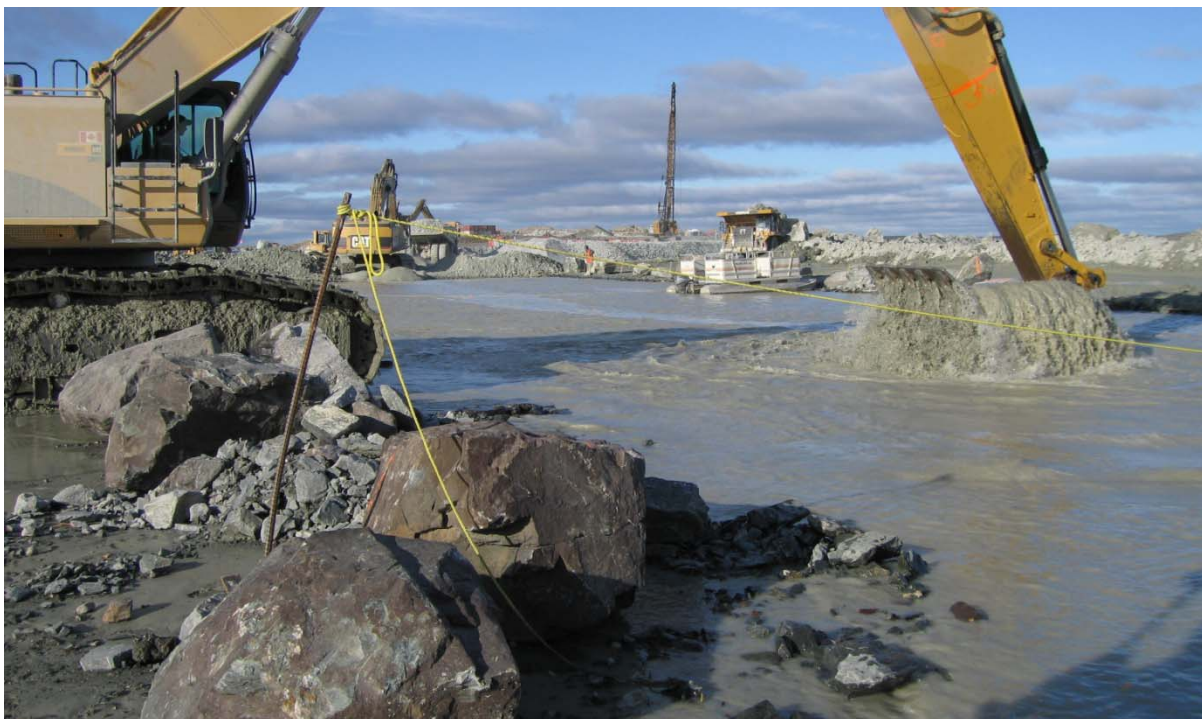
Photograph 12: Excavator bucket being used to investigate trench bottom at Sta. 30+570 - September 5, 2009

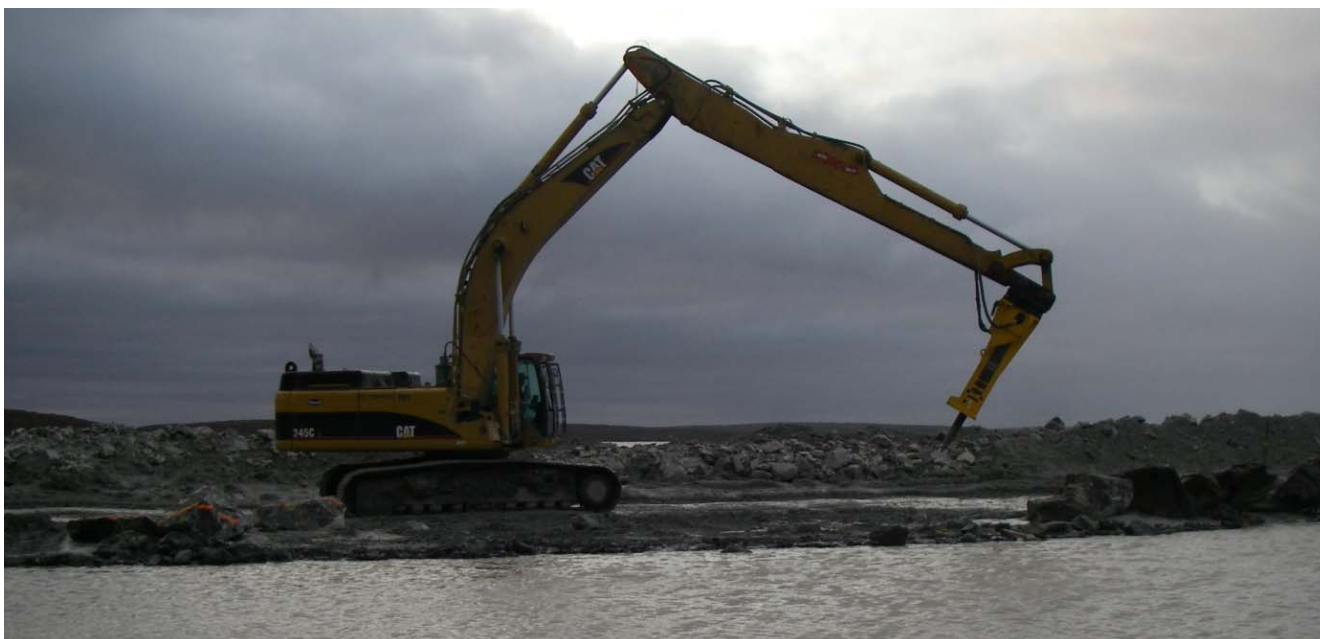
Photograph 13: CAT 345 excavator with long boom and breaker attachment used to smooth bedrock surface where irregularities were noted - September 6, 2009

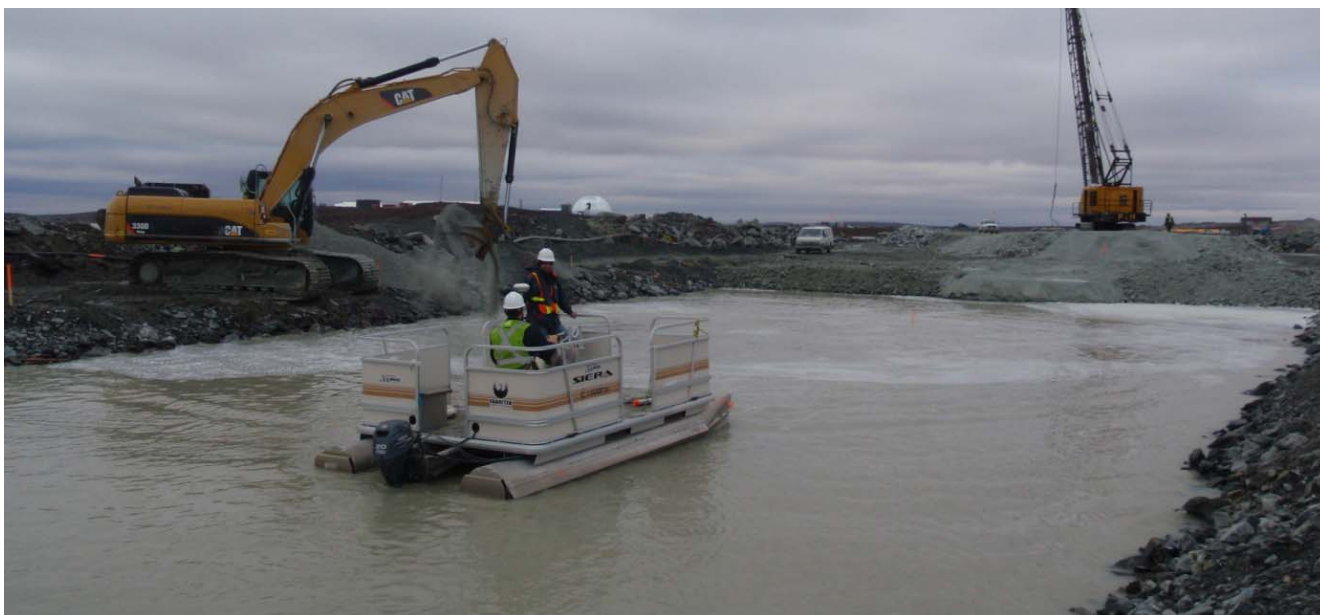
Photograph 14: Bathymetry survey by FGL between Sta. 30+800 and 30+860. Core Backfill placement on the downstream side and dynamic compaction of the core backfill - September 12, 2009

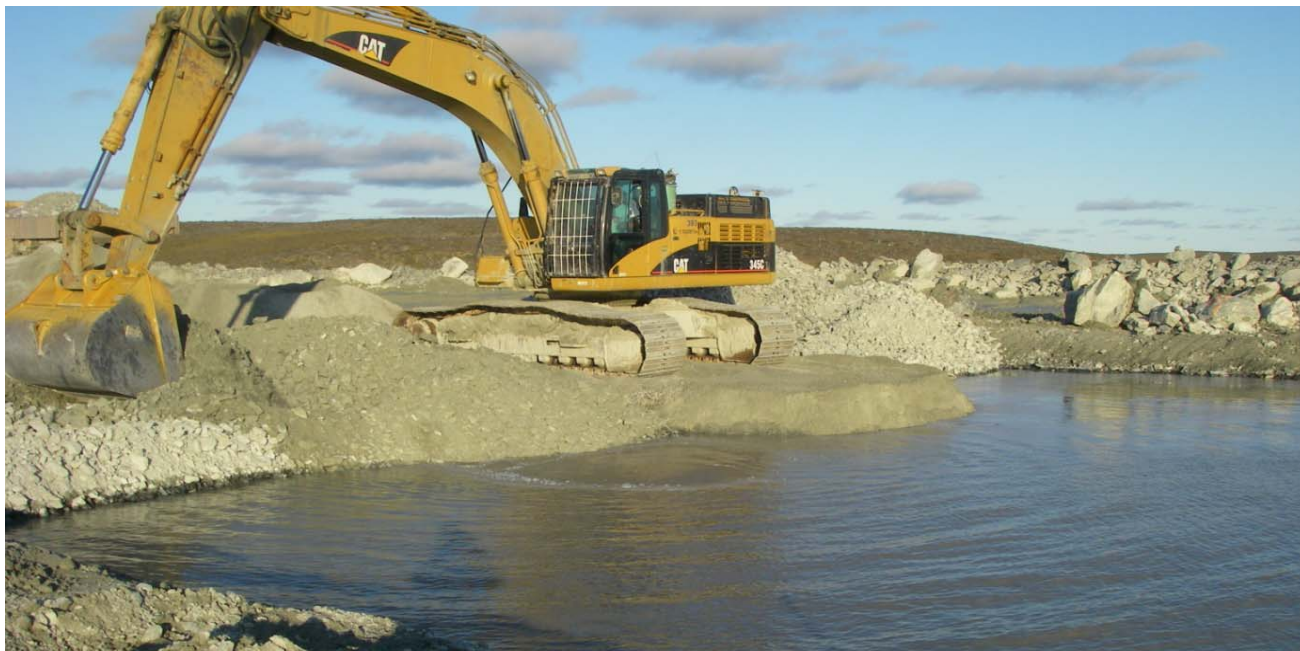
Photograph 15: Core Backfill and Coarse Filter placement at Sta. 30+310 - August 22, 2009

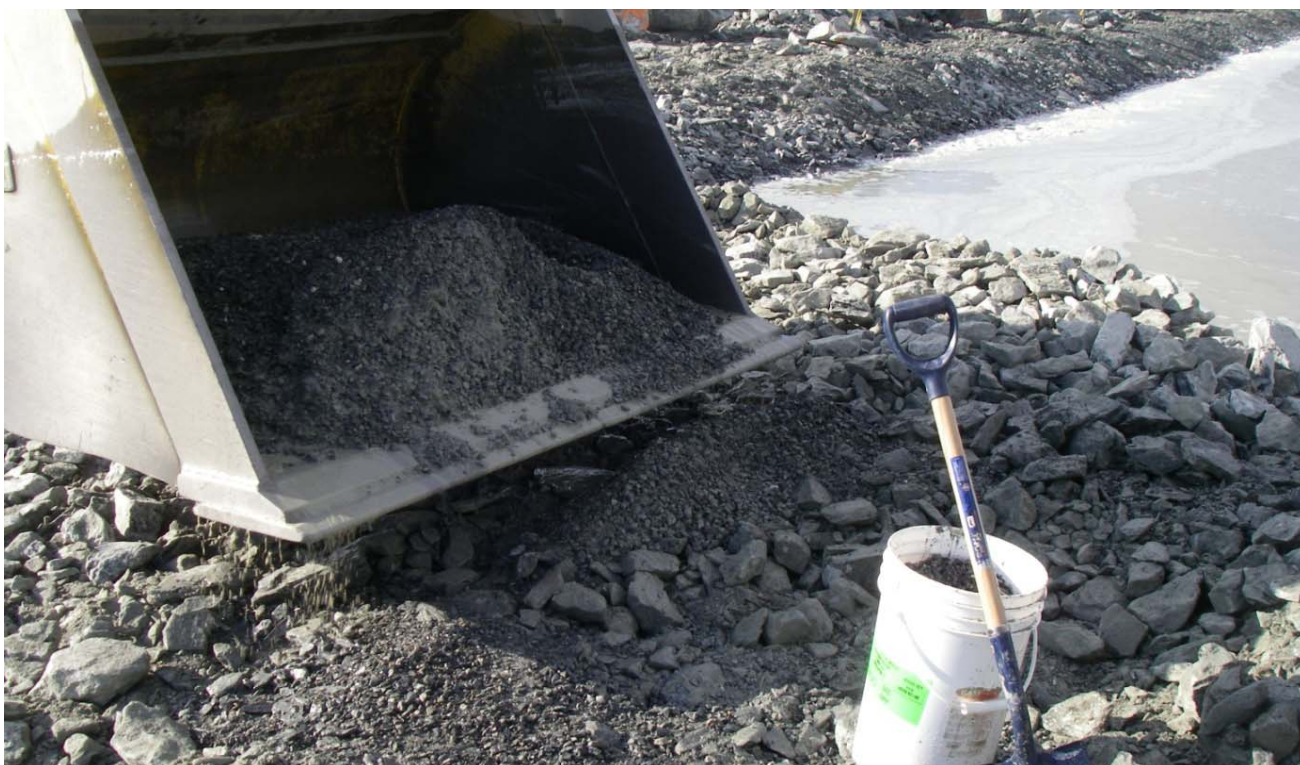
Photograph 16: In-situ sampling of the Core Backfill taken from Sta.30+284 - August 22, 2009

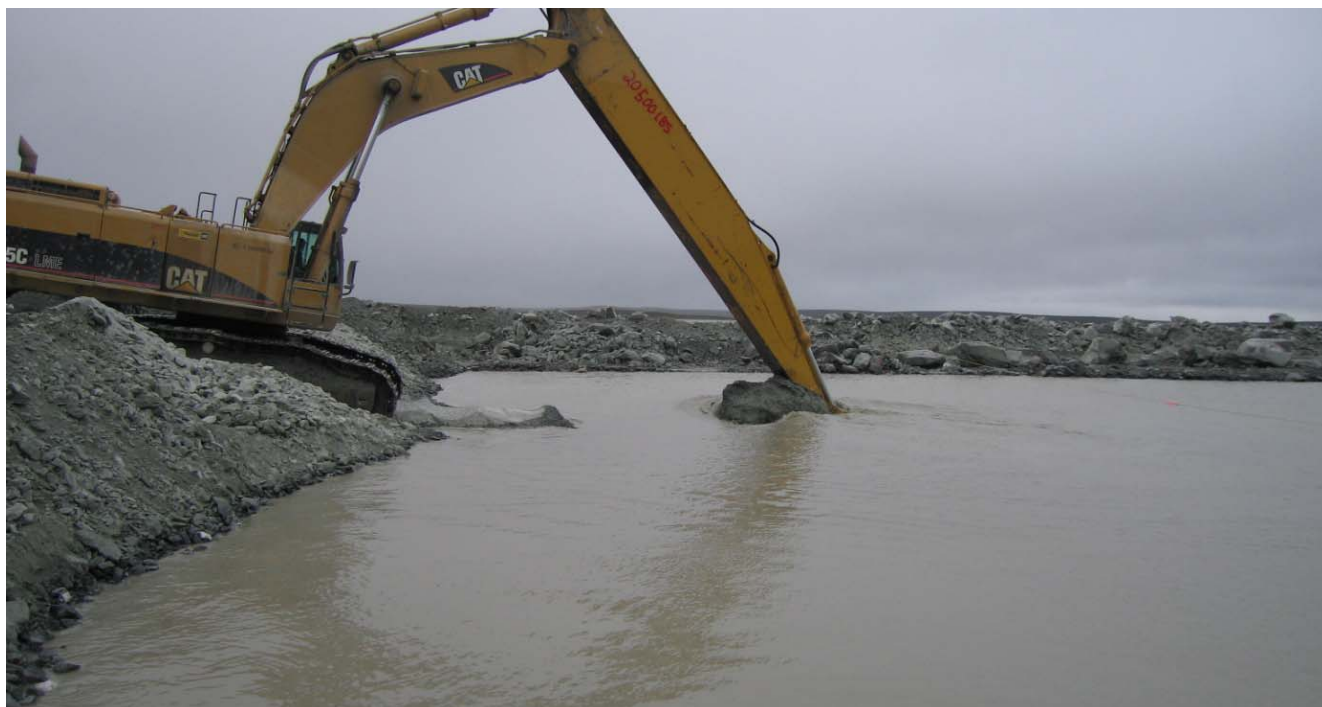
Photograph 17: Sediment at the bottom of the trench excavated prior to Core Backfill and Coarse Filter placement at Sta. 30+450 - September 3, 2009

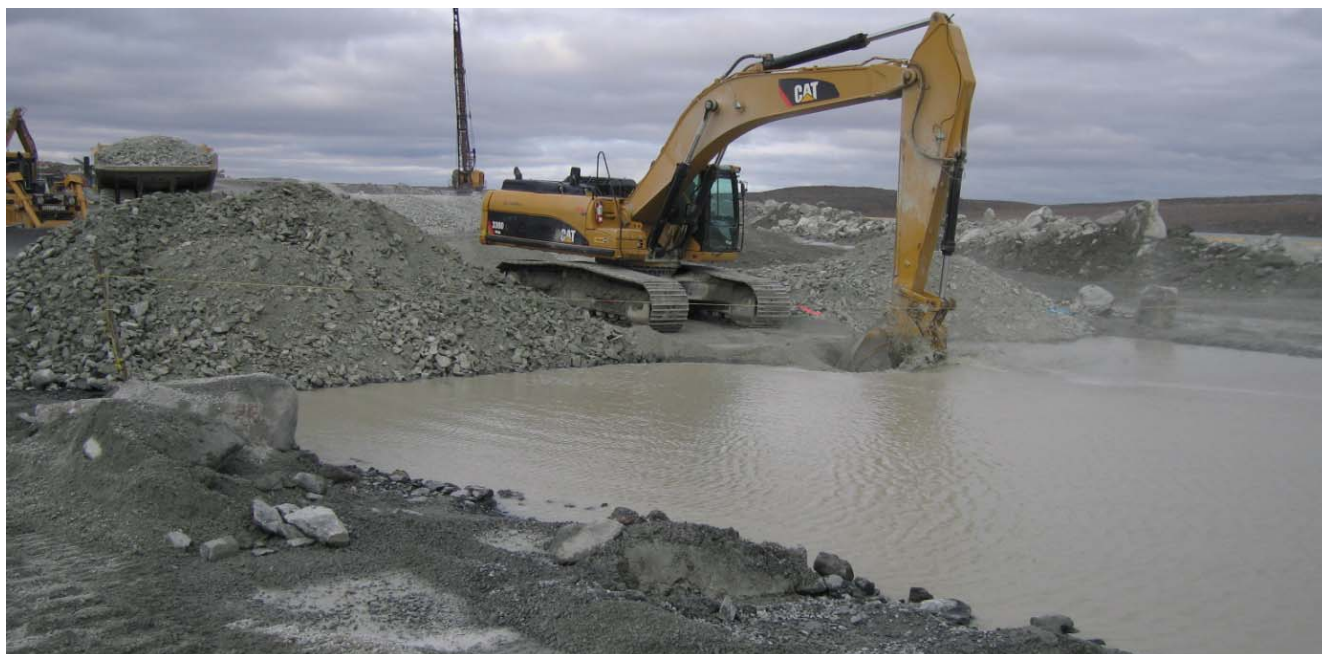
Photograph 18: Placement of the Core Backfill material by pushing the Core Backfill forward and down to minimize segregation, Sta. 30+500 - September 5, 2010

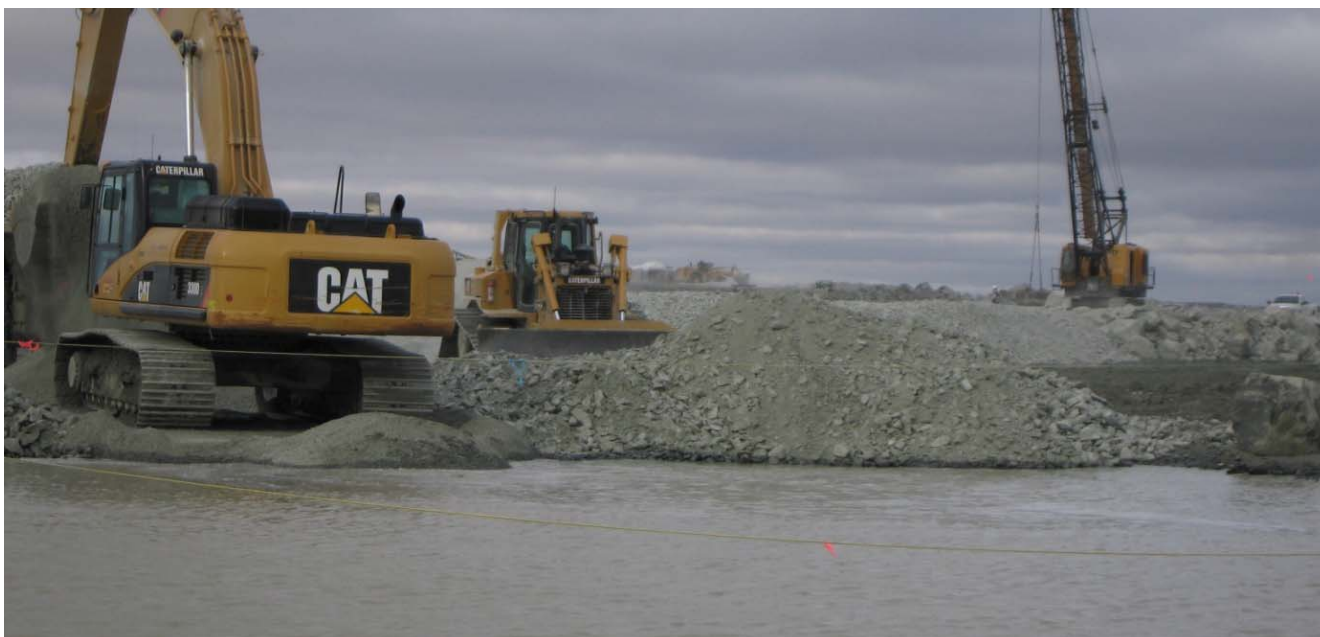
Photograph 19: Placement of the Coarse Filter upstream of Core Backfill by pushing forward with a dozer onto already placed material to minimize segregation, Sta. 30+500 - September 5, 2009

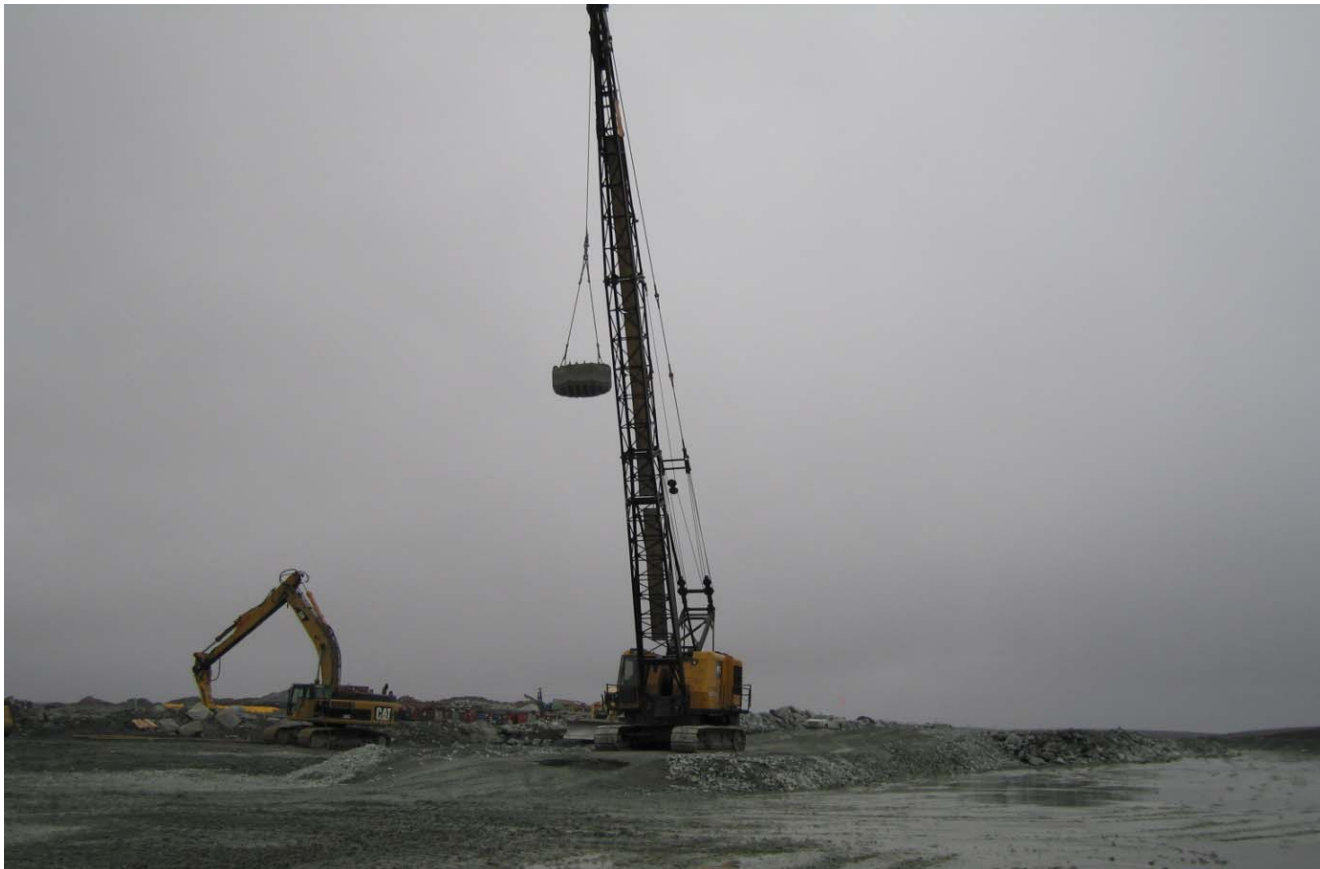
Photograph 21: Dynamic Compaction at Sta. 30+375 - September 2, 2009

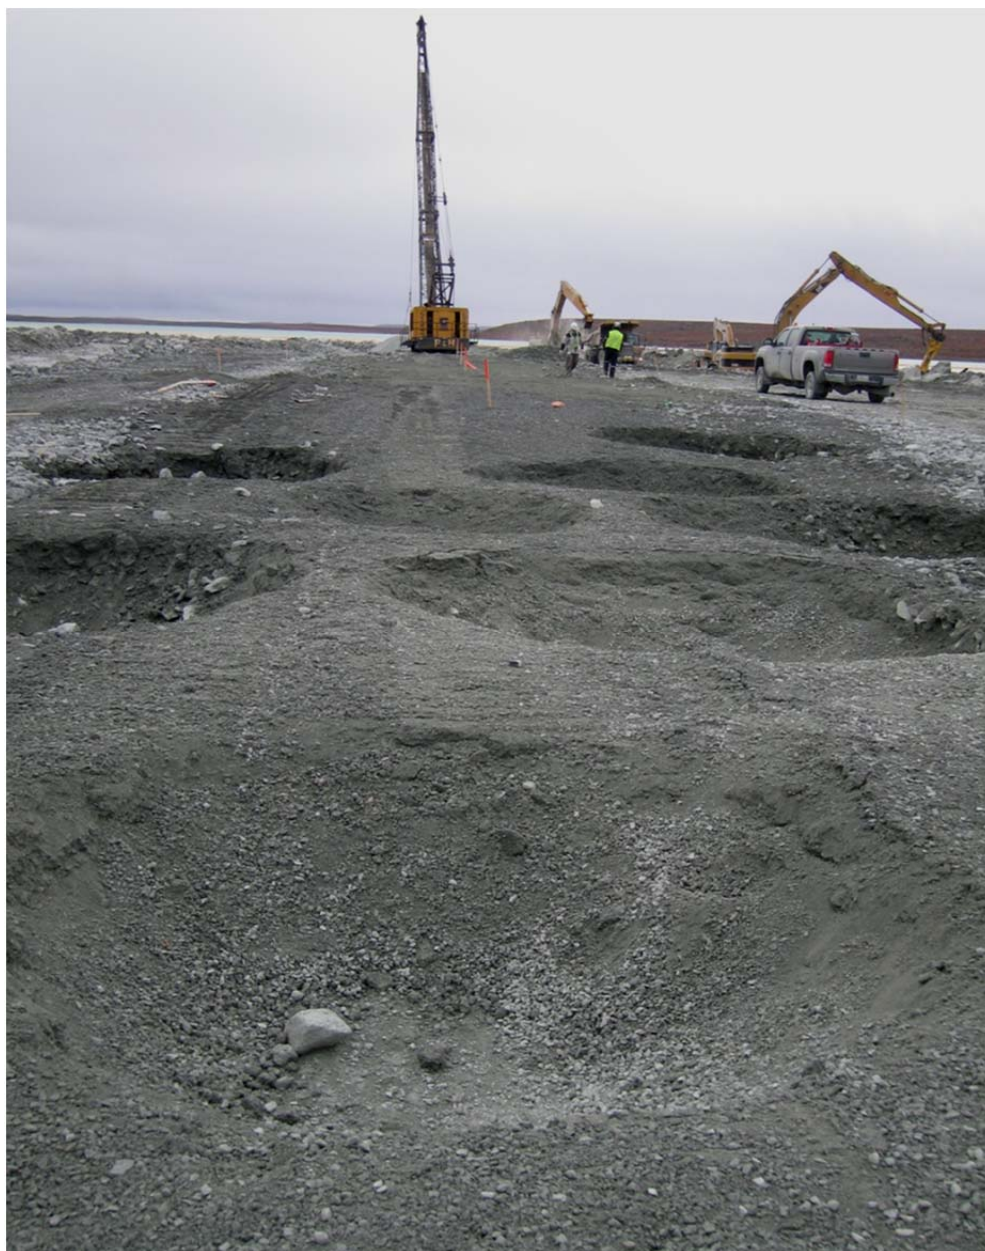
Photograph 22: Craters formed within the Core Backfill Zone following dynamic compaction, Sta. 30+230 looking north - September 2, 2009

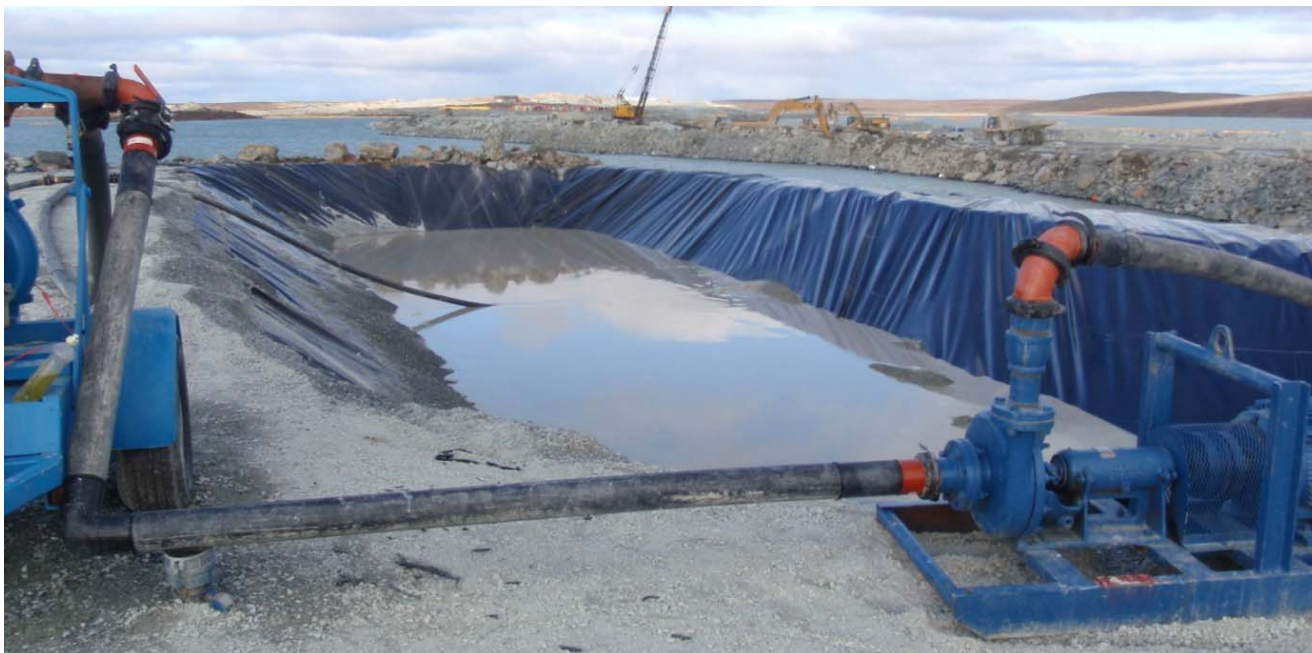
Photograph 25: Bentonite slurry pond constructed on Goose Island - September 10, 2009

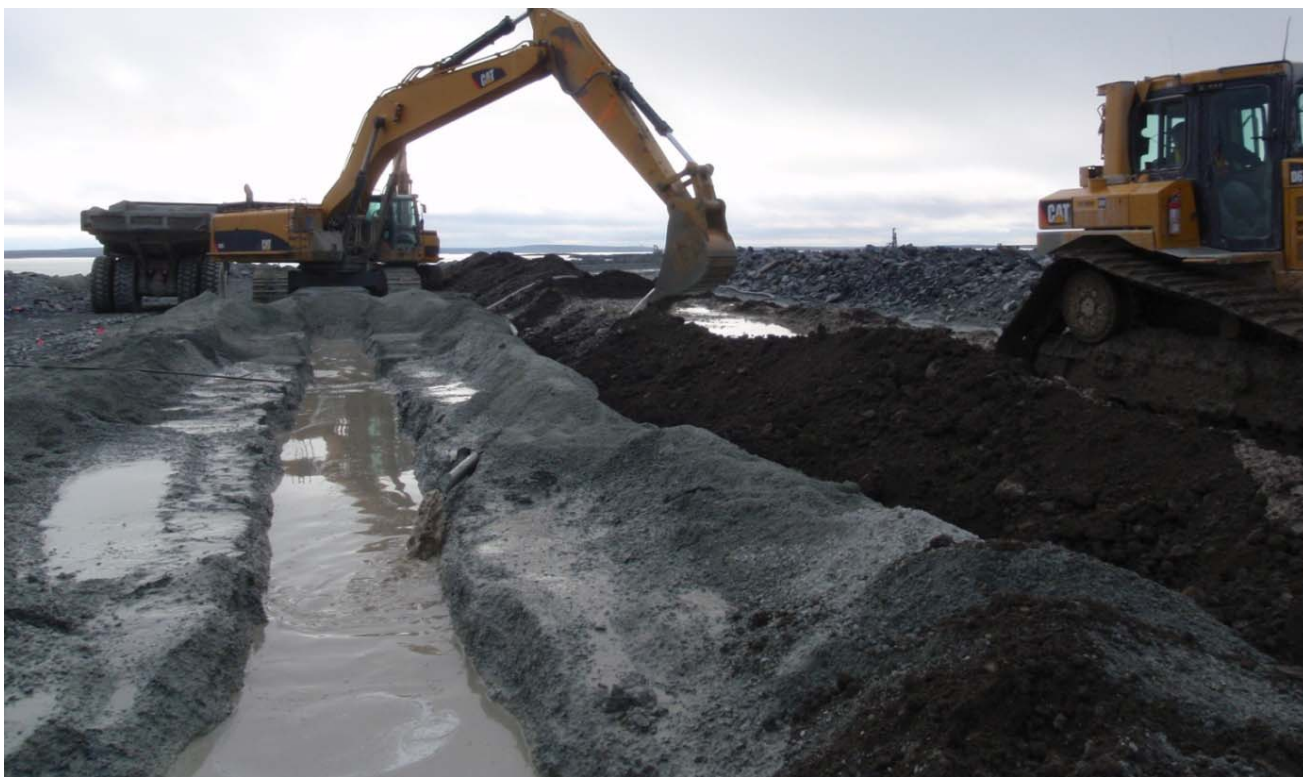
Photograph 27: Bentonite slurry is pumped into the cutoff trench excavation to provide trench support through the pipe visible in the foreground, Sta. 30+075. The excavator takes slurry from the trench to mix with the till and bentonite stockpile adjacent to the trench. The dozer is then used to mix the till to create the soil bentonite (SB) for placement in the trench - September 12, 2009

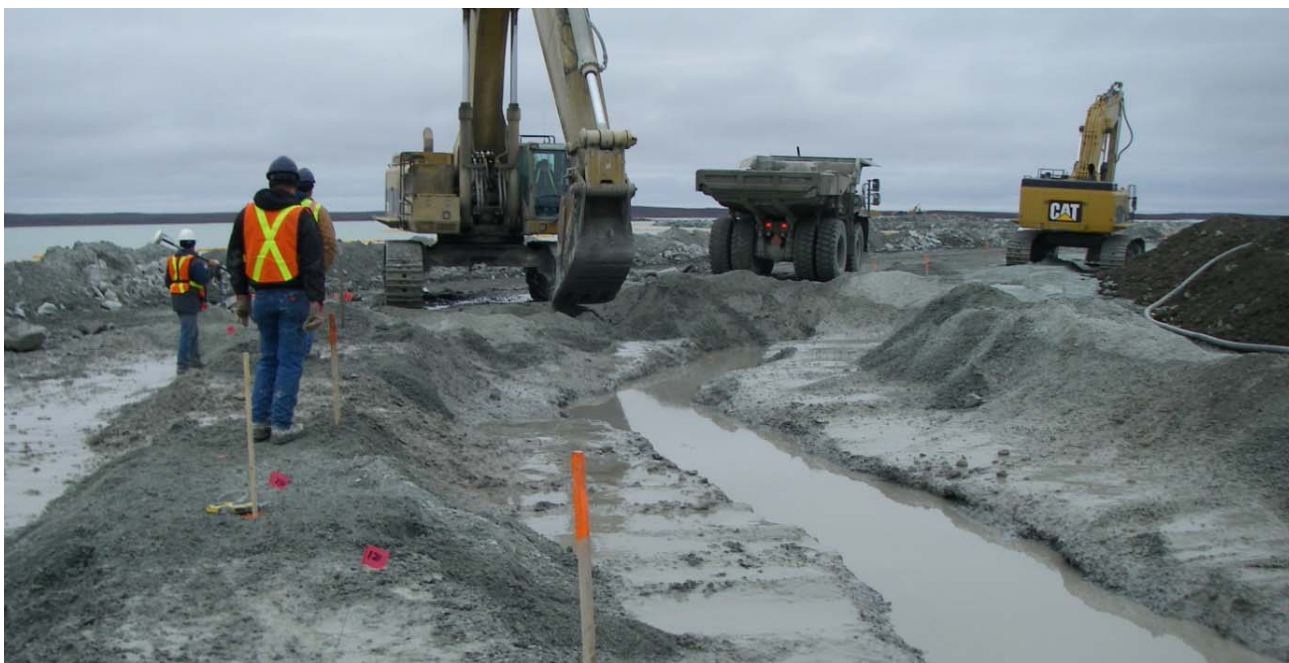
Photograph 29: Excavation of the cutoff trench and widening at the bends, Sta. 30+140 - September 13, 2009

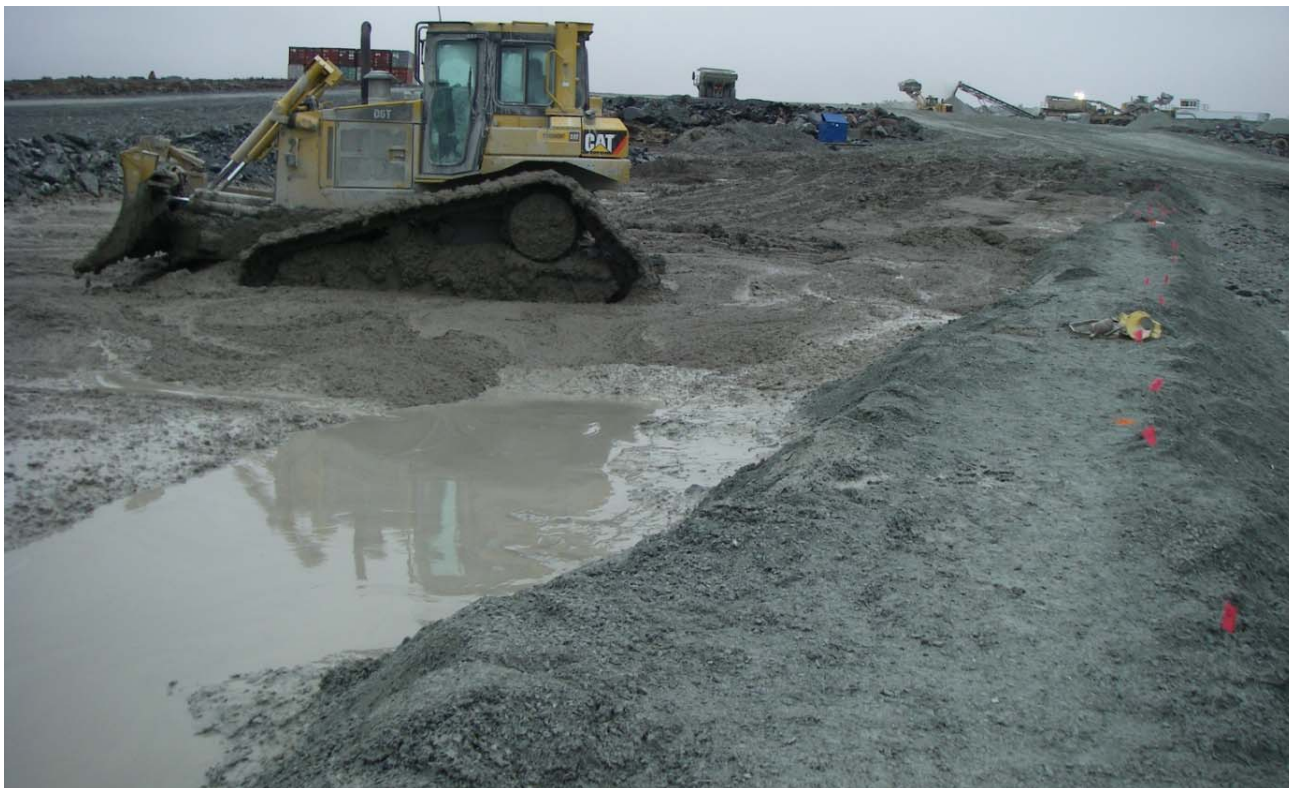
Photograph 30: Placement of the soil bentonite mix within the cutoff trench by a dozer, Sta. 30+106 - September 14, 2009

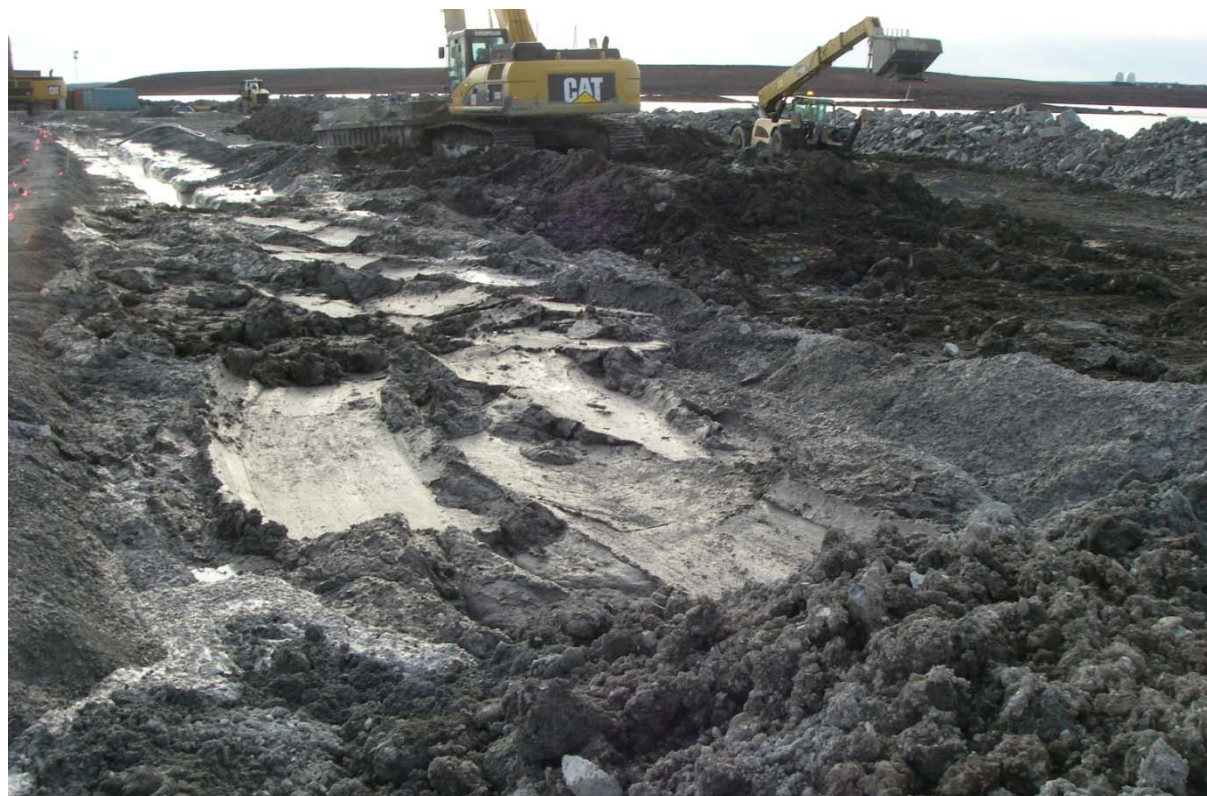
Photograph 32: Cement soil bentonite backfill within the cutoff trench - September 19, 2009
