APPENDIX A

Construction Photographs

1.0 NORTHERN PORTION – 2009 CONSTRUCTION

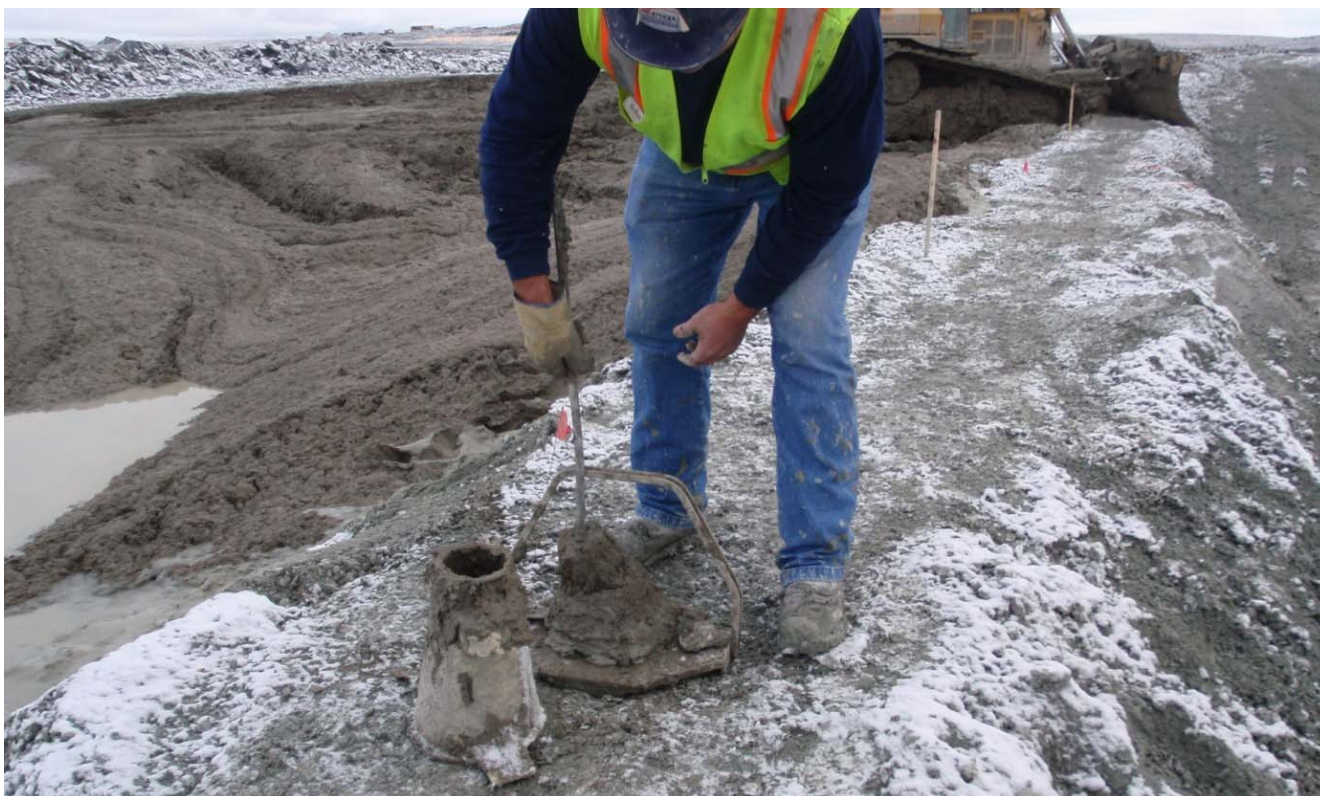
Photograph 33: Slump test carried out on a sample of soil bentonite taken from Sta. 30+455 - September 22, 2009

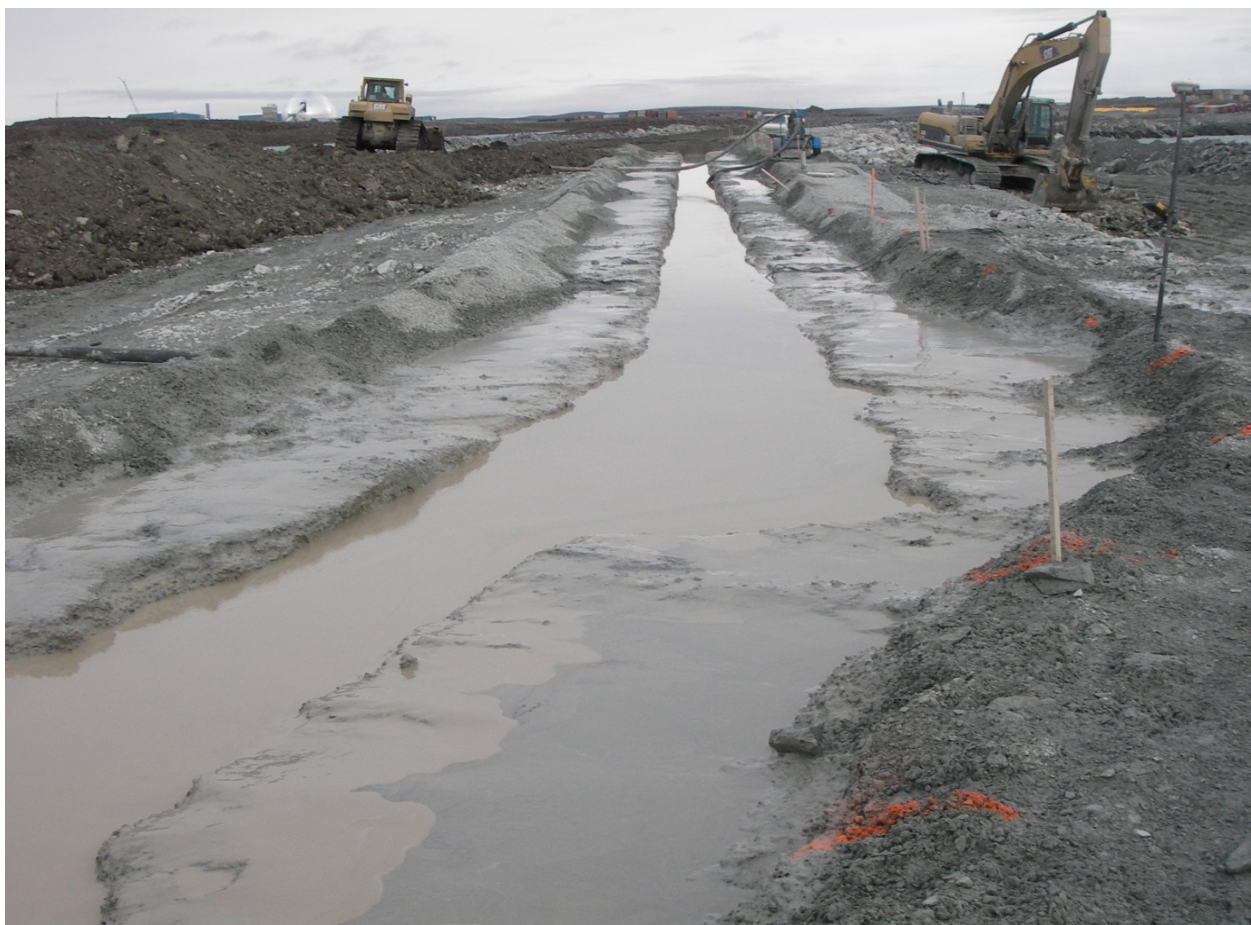
Photograph 35: Cutoff trench excavation widened at the bends, Sta. 30+725 - September 24, 2009

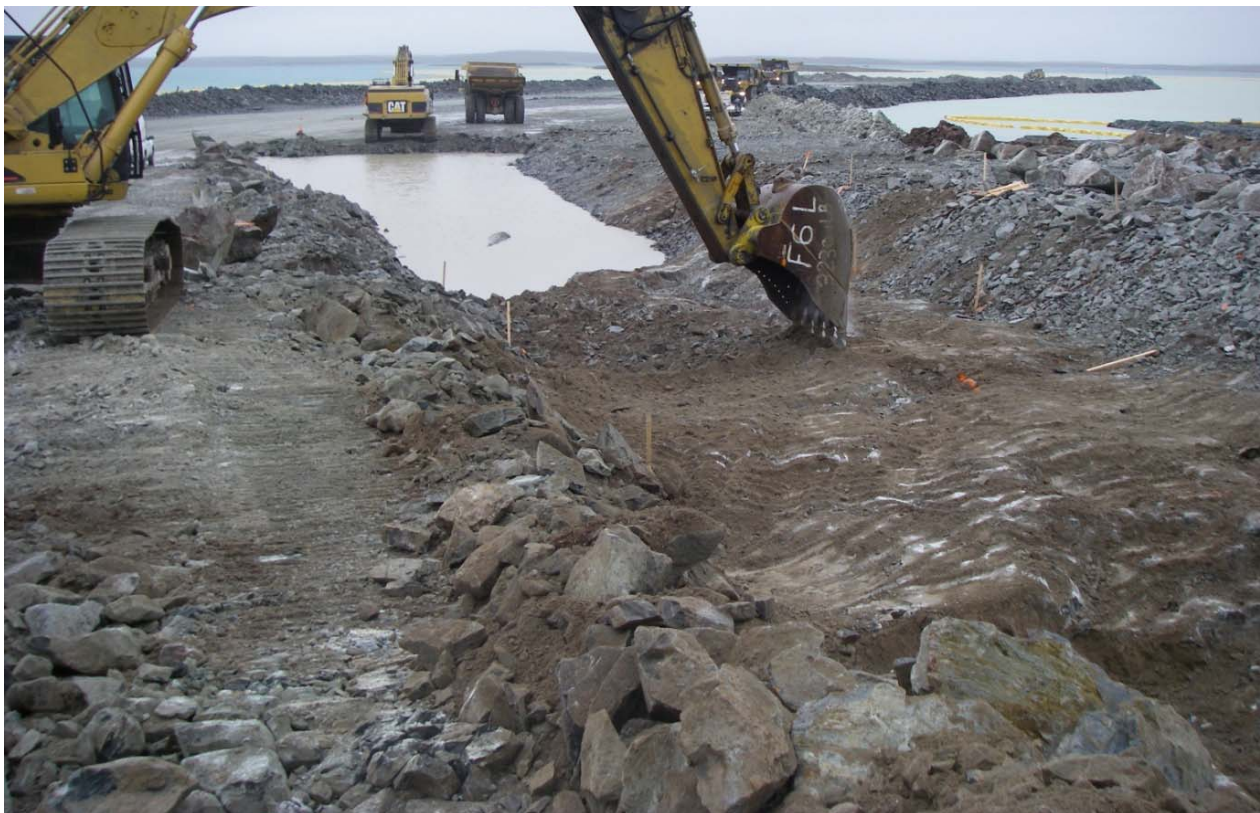
Photograph 37: Cleaning of the bedrock surface on the north abutment between Sta. 30+000 and 30+050 - August 12, 2009

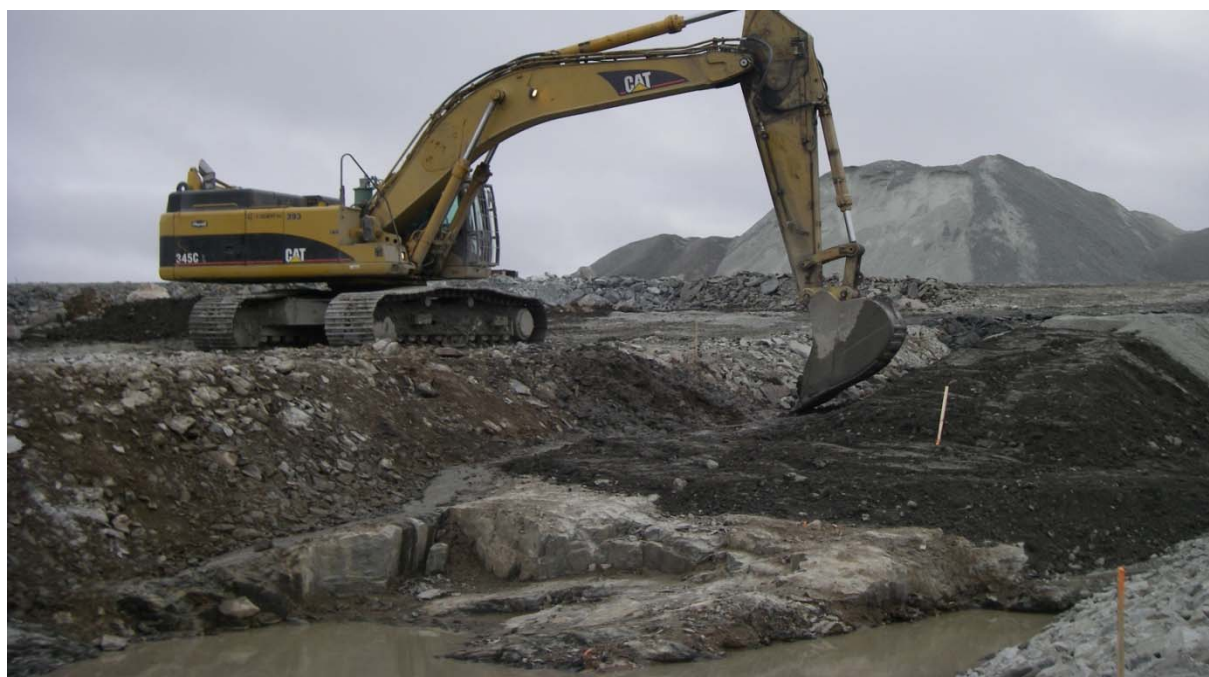
Photograph 39: Placement of till to form the north abutment cutoff between Sta. 30+000 and 30+050 - August 14, 2009

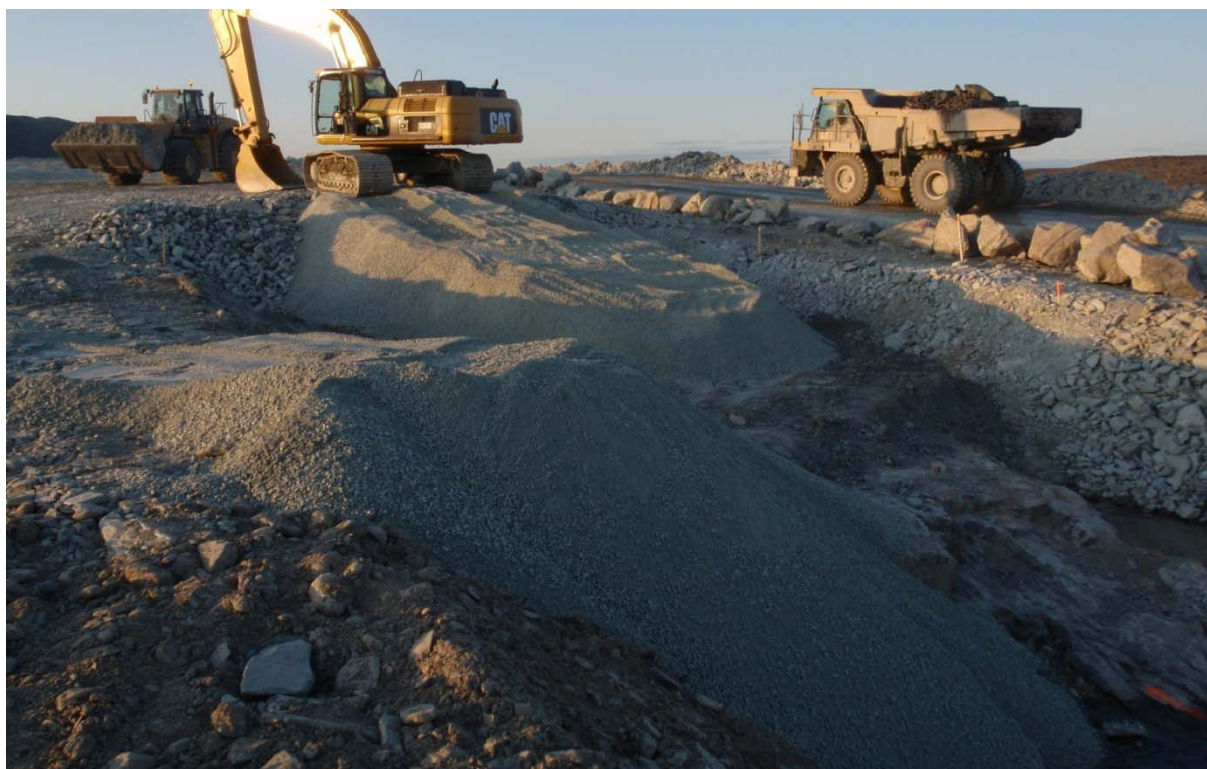
Photograph 40: Placement of 19 mm minus Core Backfill over the till placed on the north Abutment, Sta. 30+045 looking North - August 15, 2009

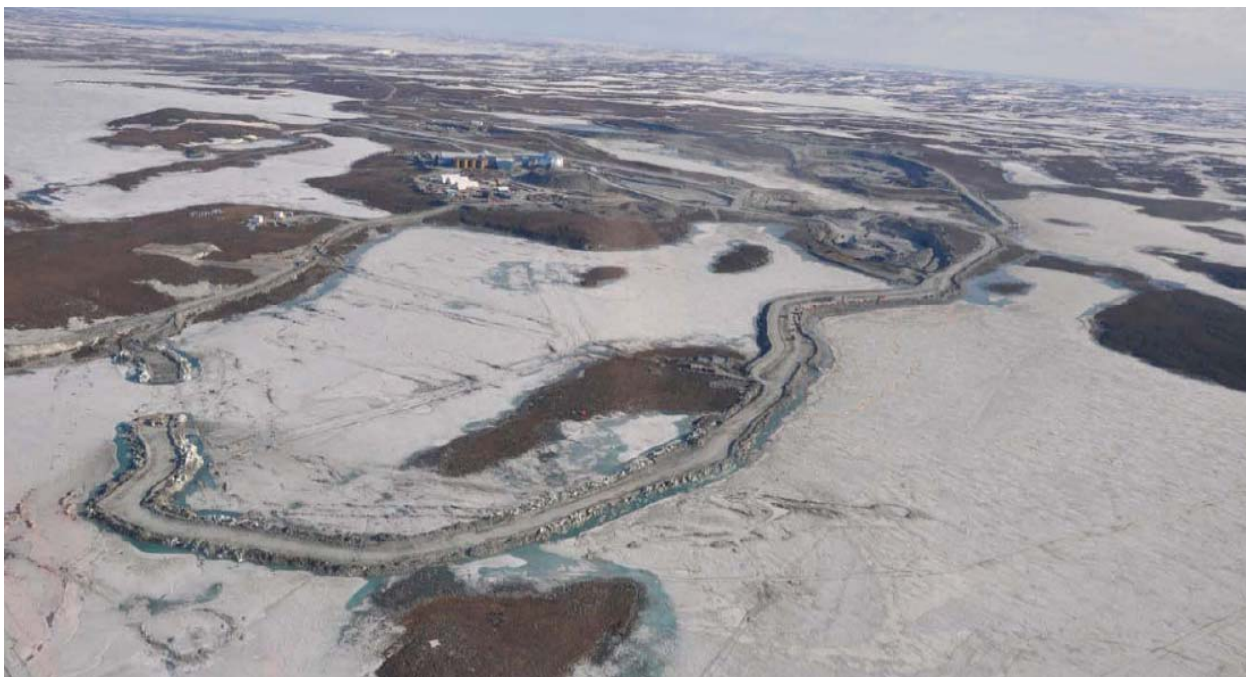
Photograph 41: Rockfill causeway construction from Goose Island to South Camp Island during winter 2010, to provide structure for anchoring turbidity barriers to for the remainder of the summer construction program - June, 2010

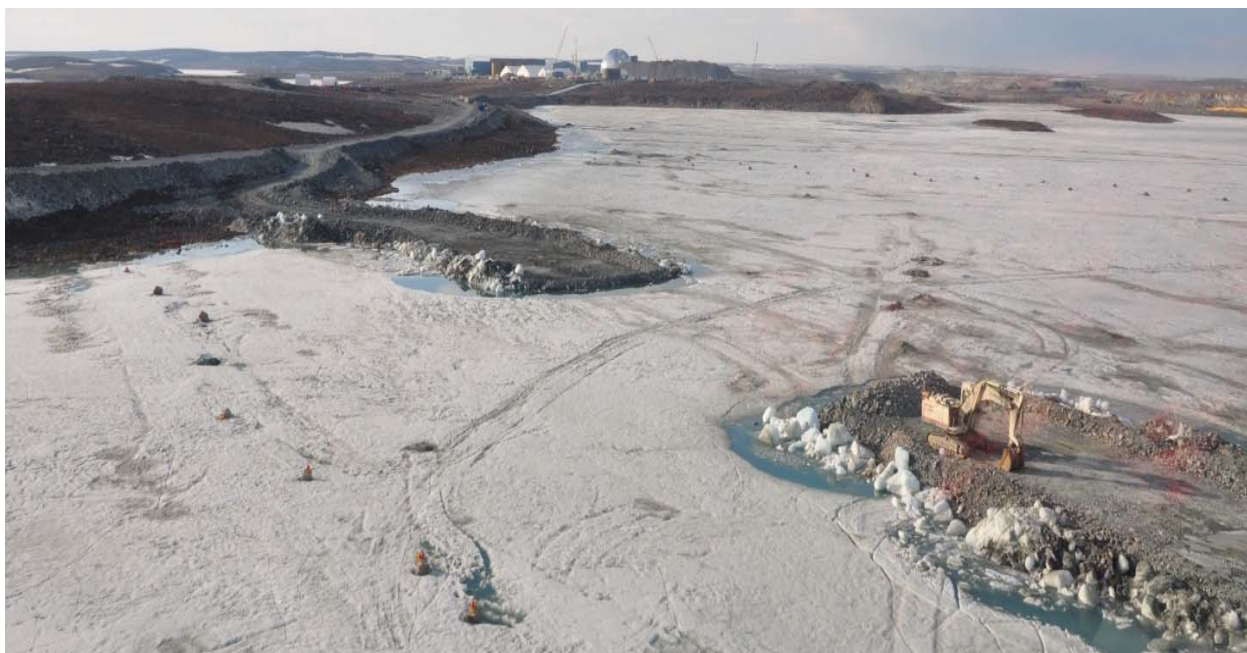
Photograph 42: Rockfill placement as part of the causeway construction at Sta. 31+950 - June 2010

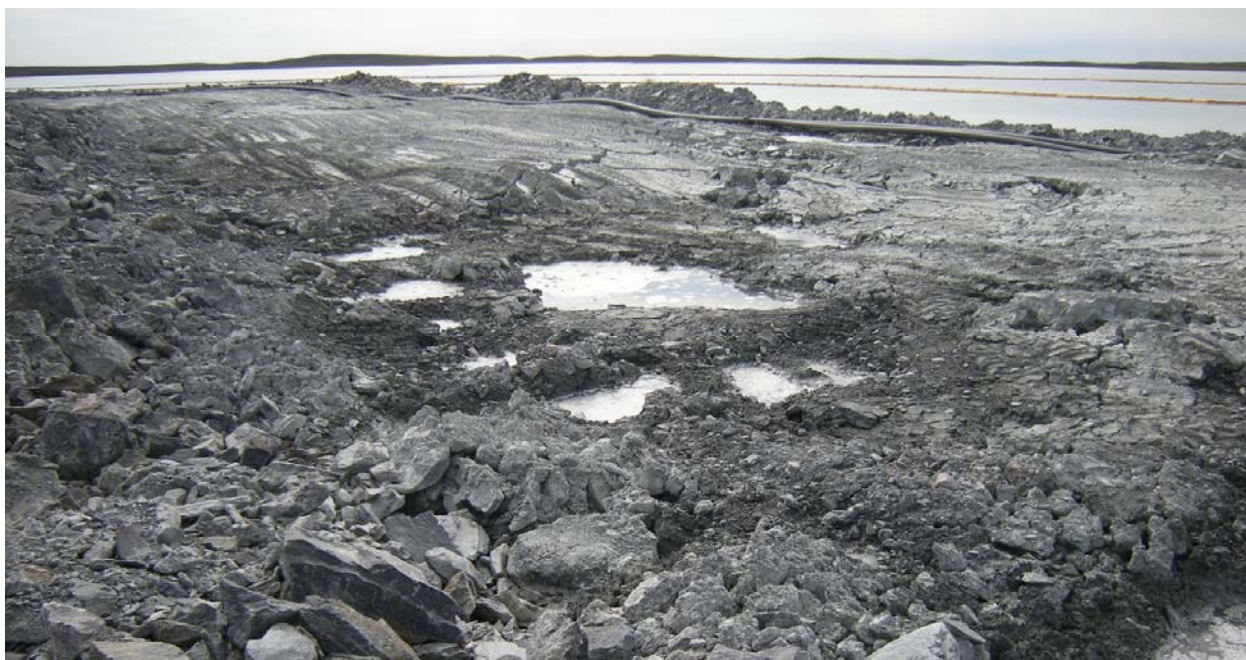
Photograph 43: Depression observed on causeway surface at Sta. 31+680, due to thawing of ice trapped in rockfill during winter causeway construction – July 23, 2010

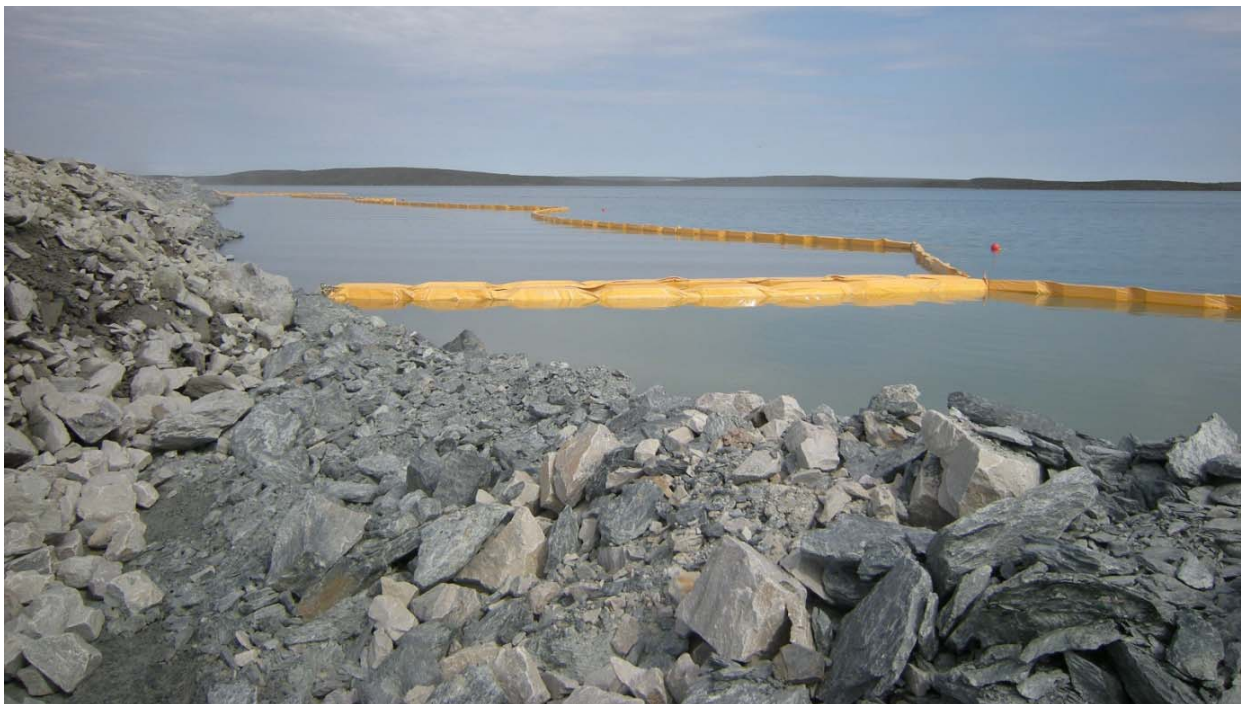
Photograph 44: Turbidity barriers on upstream side of causeway at Sta. 31+350, barriers placed as small cells and anchored to the causeway - July 23, 2010

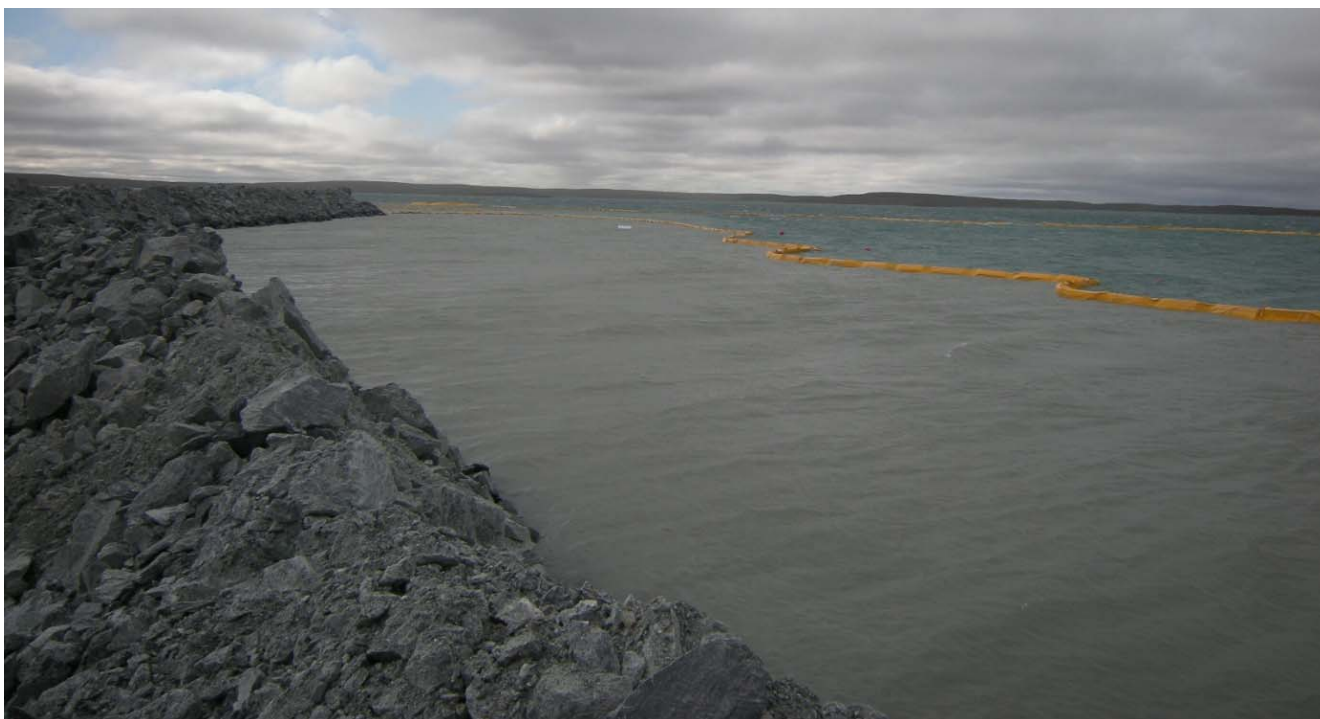
Photograph 45: Upstream turbidity barriers functioning during rockfill placement, Sta. 31+780 - August 4, 2010

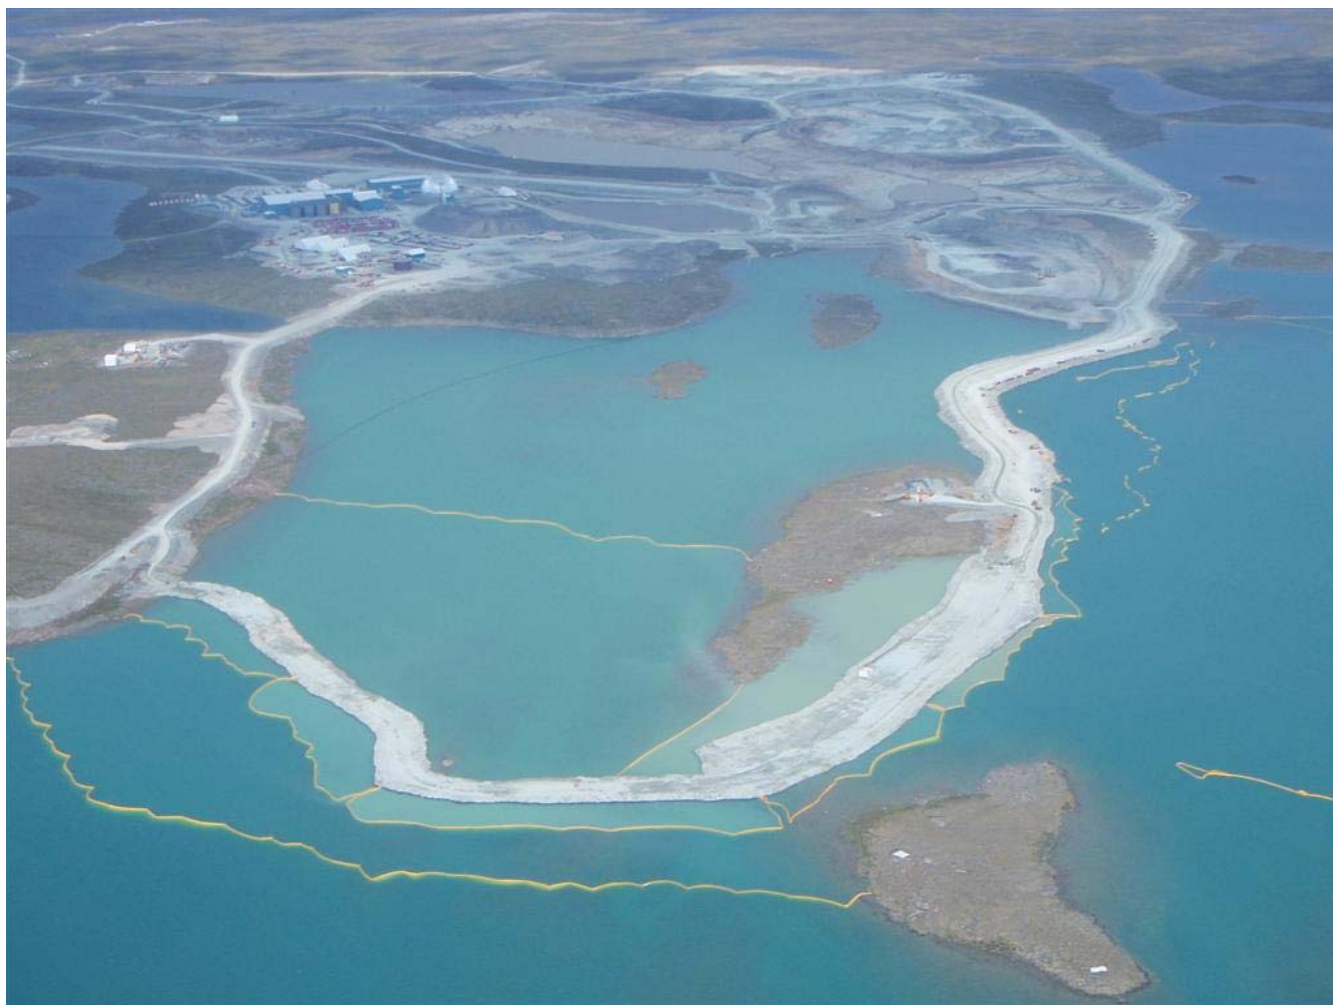
Photograph 47: Turbidity barriers and rockfill placement to widen causeway - August 2010

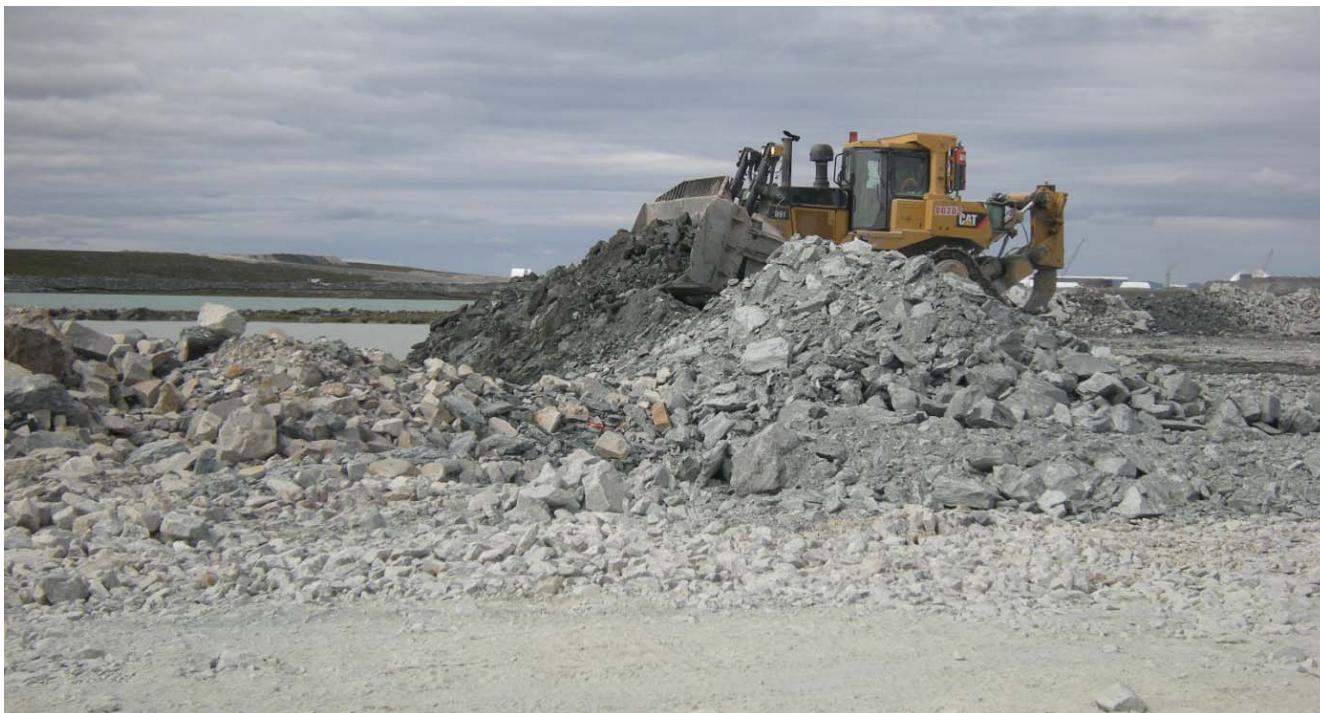
Photograph 48: Rockfill placement to widen causeway at Sta. 31+200 - July 22, 2010

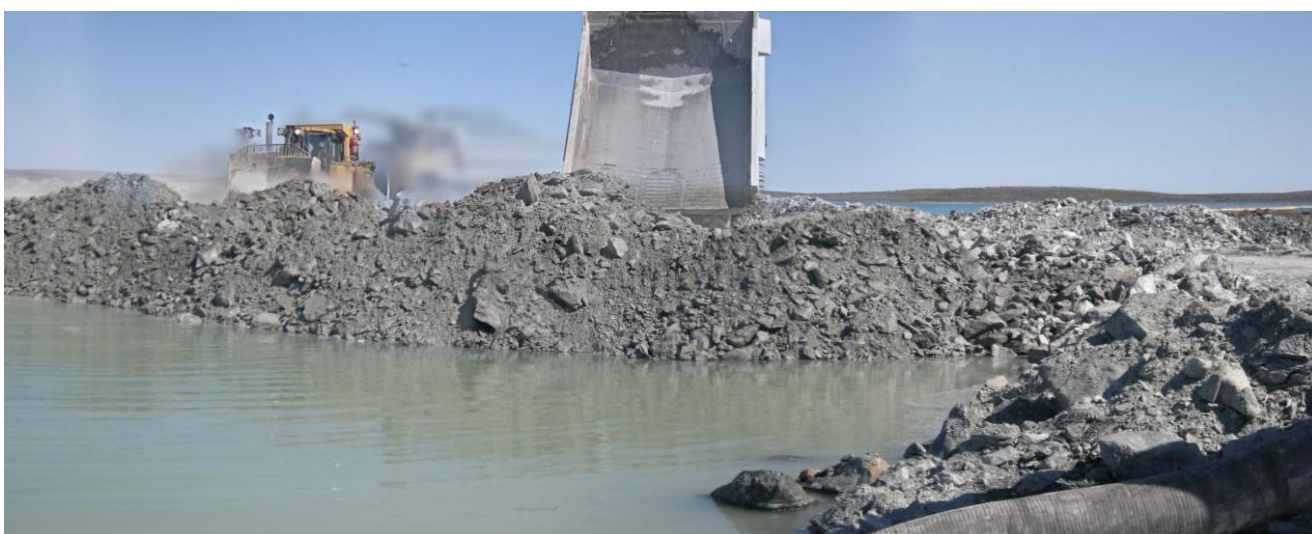
Photograph 49: Rockfill placement at Sta. 31+460 - July 24, 2010

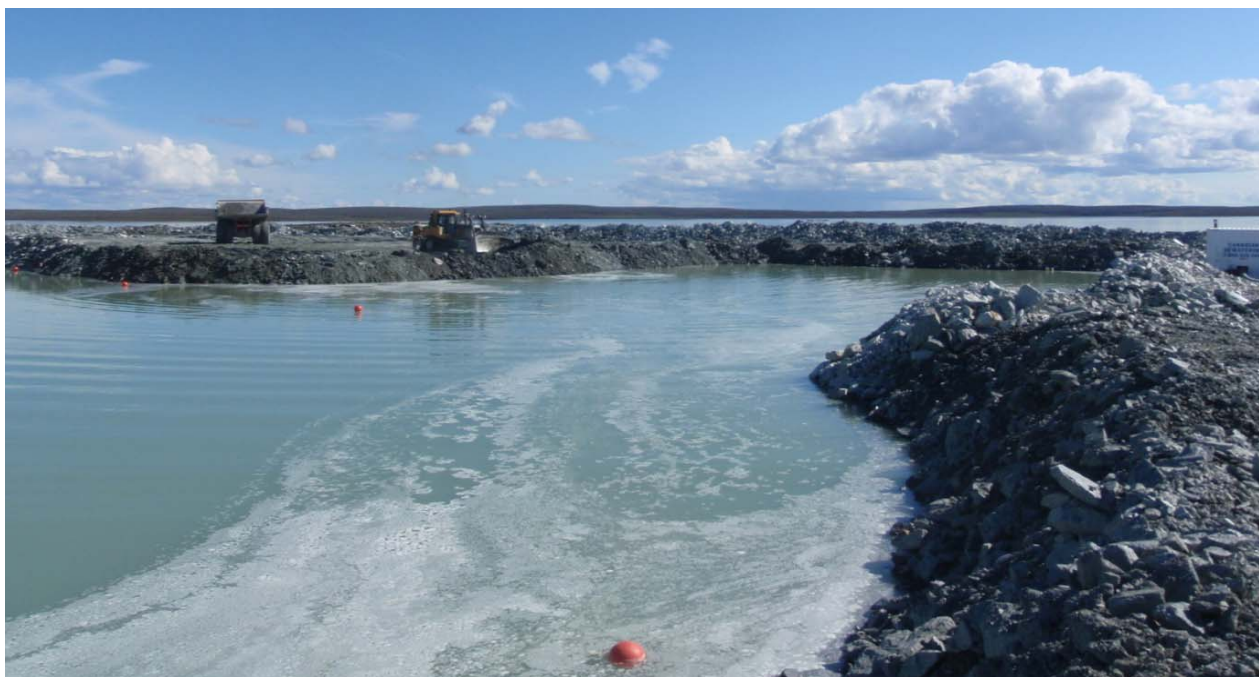
Photograph 50: Rockfill placement at Sta. 31+580 to connect to rockfill placement front 2 - August 1, 2010

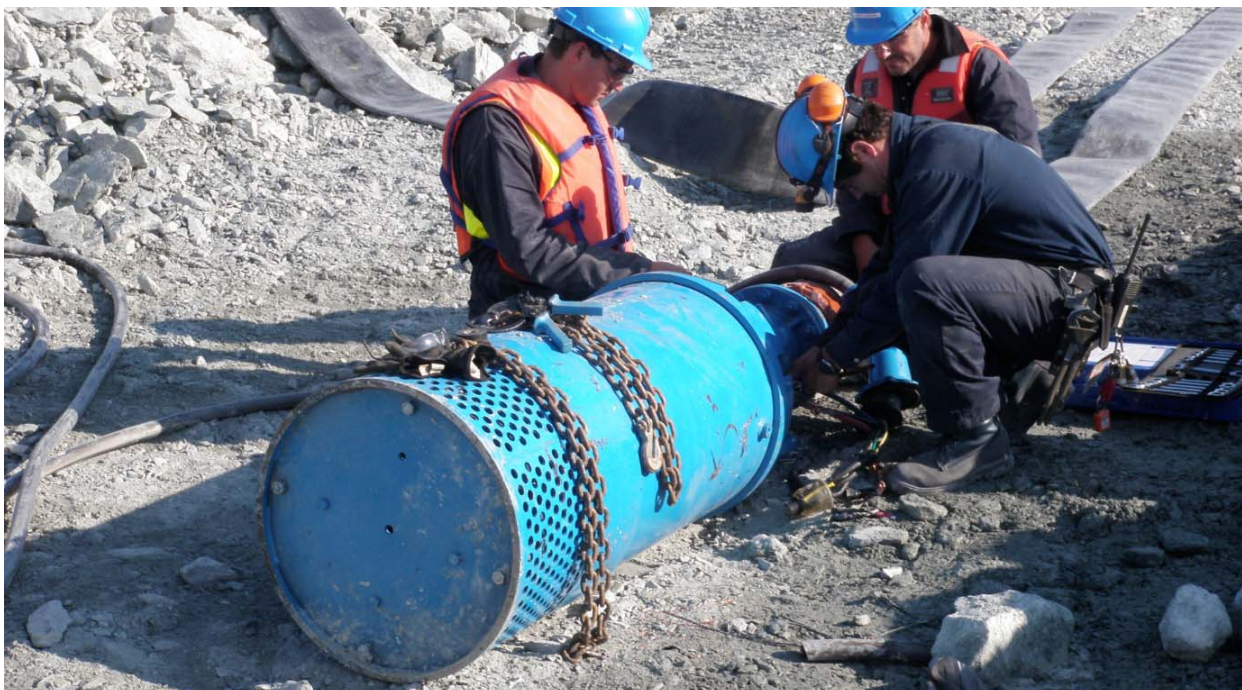
Photograph 51: Pump to be installed in excavation trench to pump water from trench to water management pond. Purpose was to try and reduce outward pressure on turbidity barriers through equalizing volumes of water being removed with those being displaced during material placement within trench - July 27, 2010

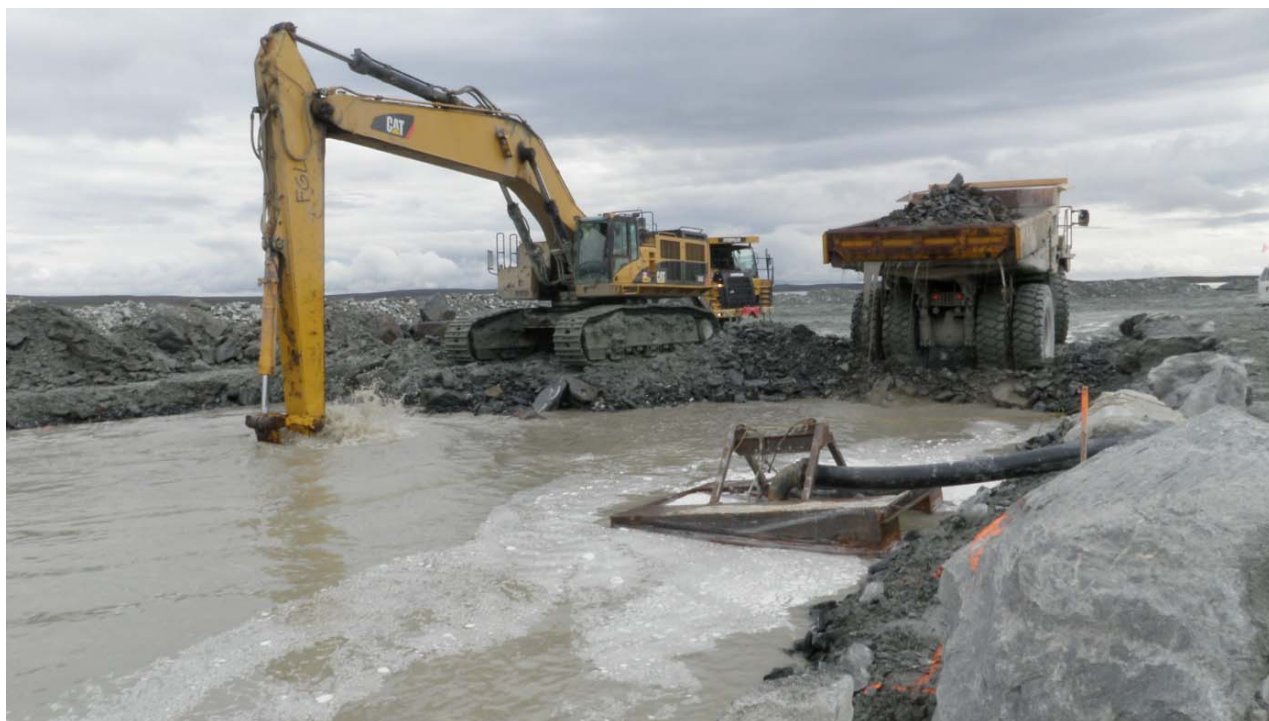
Photograph 52: Initial trench excavation with CAT 385 excavator at Sta.31+330. Pump installed on downstream side of trench – July 31, 2010

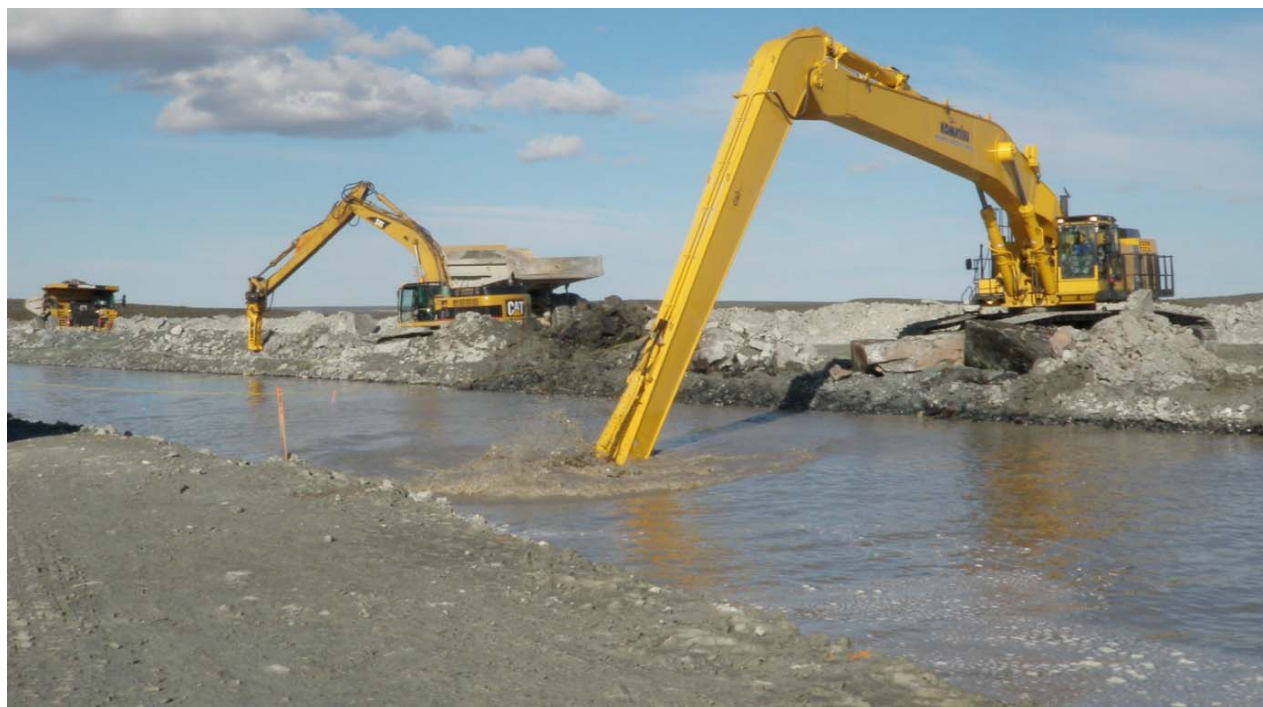
Photograph 53: Komatsu 1250 excavator removing loose material after CAT 385 excavator with breaker attachment shaped bedrock surface at Sta. 31+348 - August 1, 2010

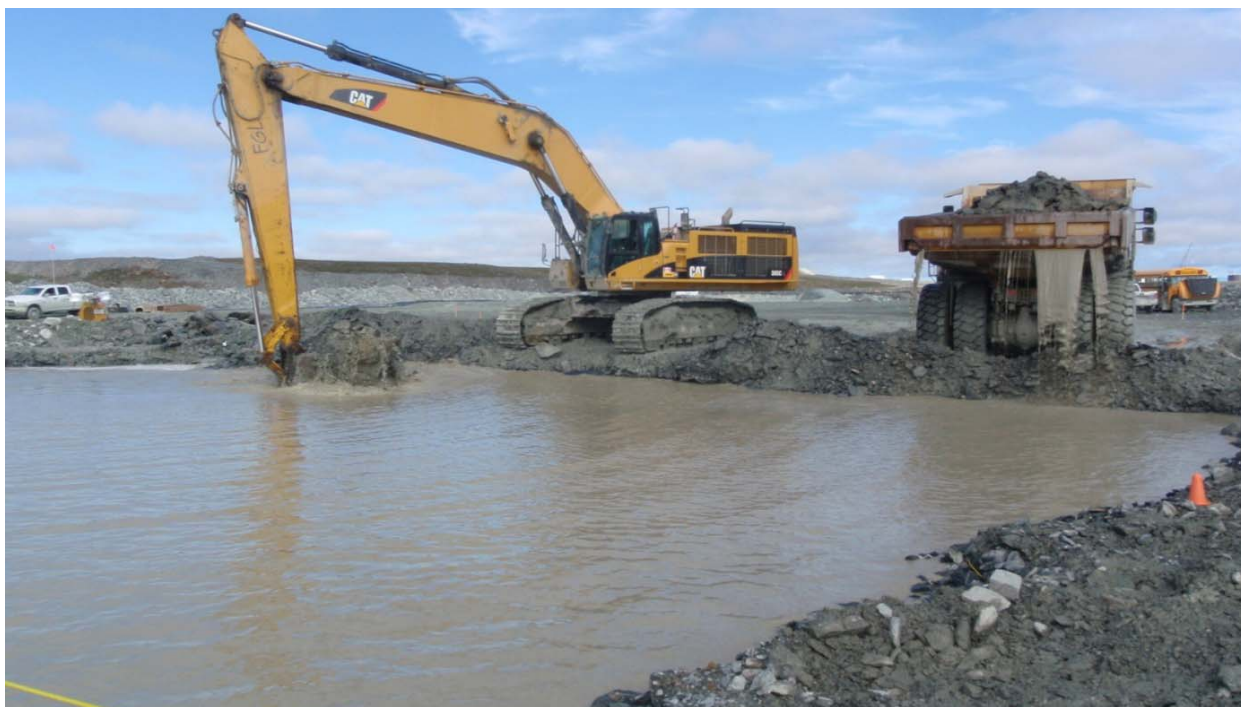
Photograph 54: Initial trench excavation at Sta. 31+700 - August 1, 2010

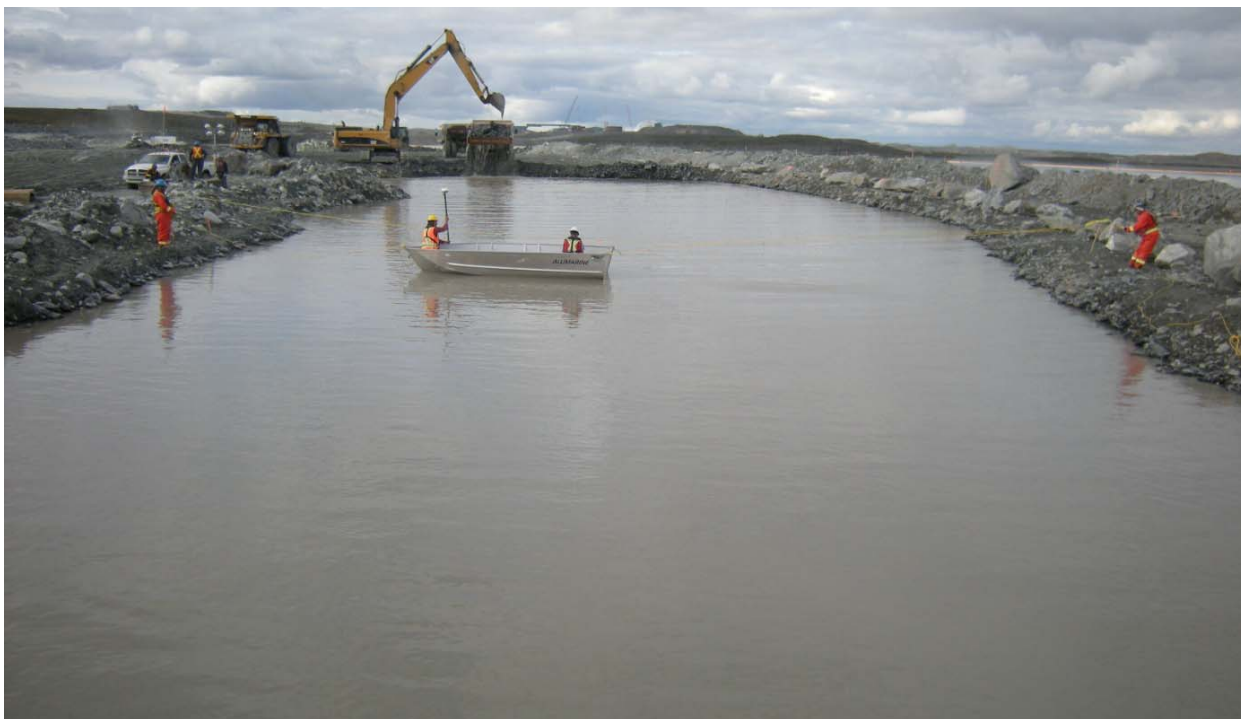
Photograph 55: Manual sounding and centreline marking in preparation for core backfill placement, Sta. 31+680 - August 3, 2010

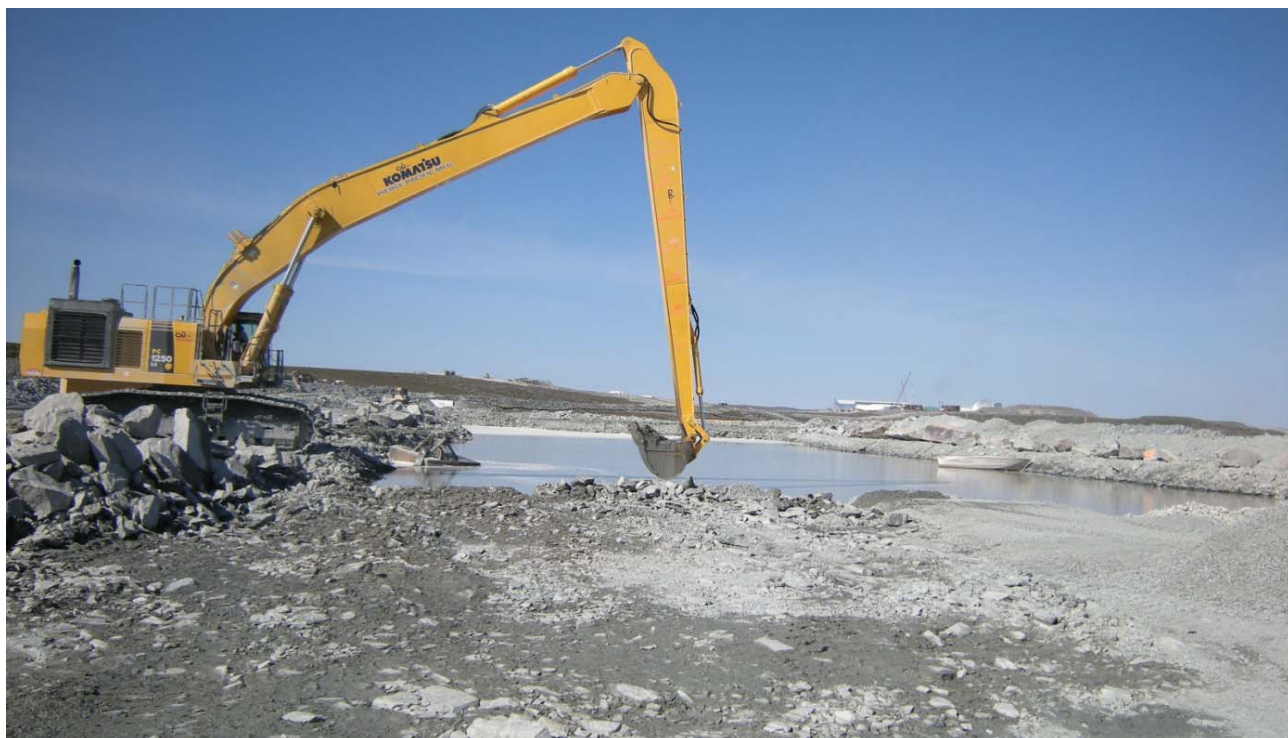
Photograph 56: Komatsu 1250 excavator removing sediments prior to core backfilling of initial trench - August 7, 2010

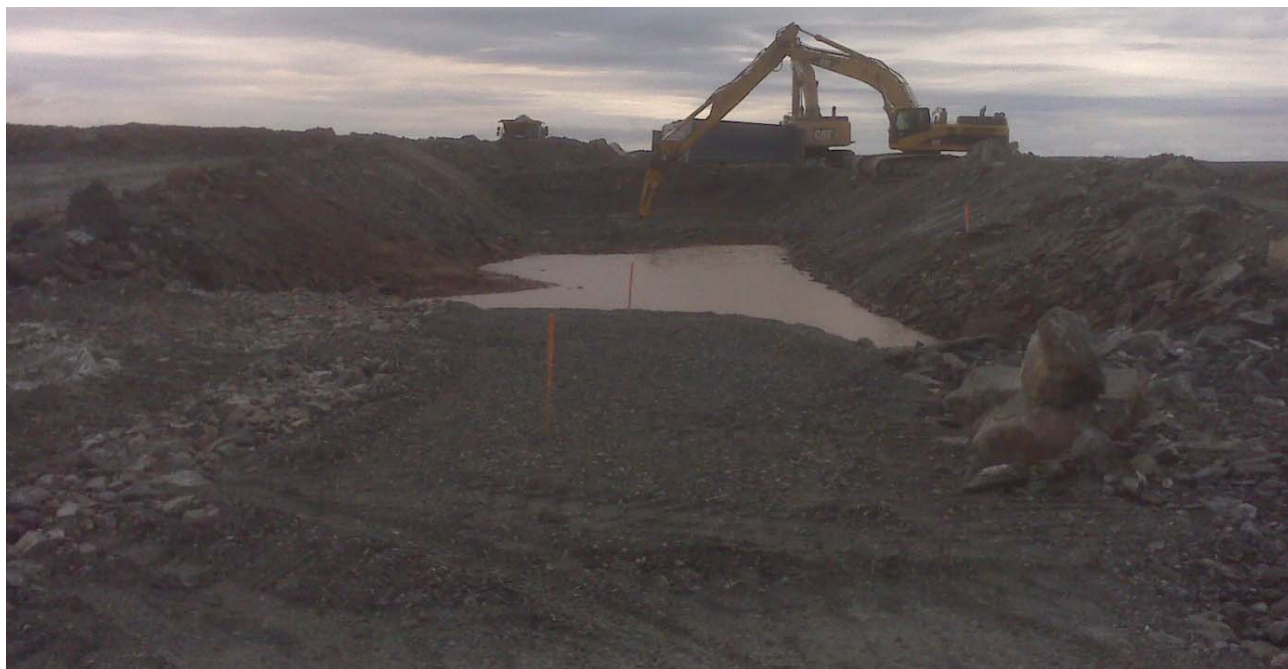
Photograph 57: Excavation of rockfill and frozen core backfill at tie-in of the north portion of the cutoff wall to the south portion, Sta. 30+850 - August 12, 2010

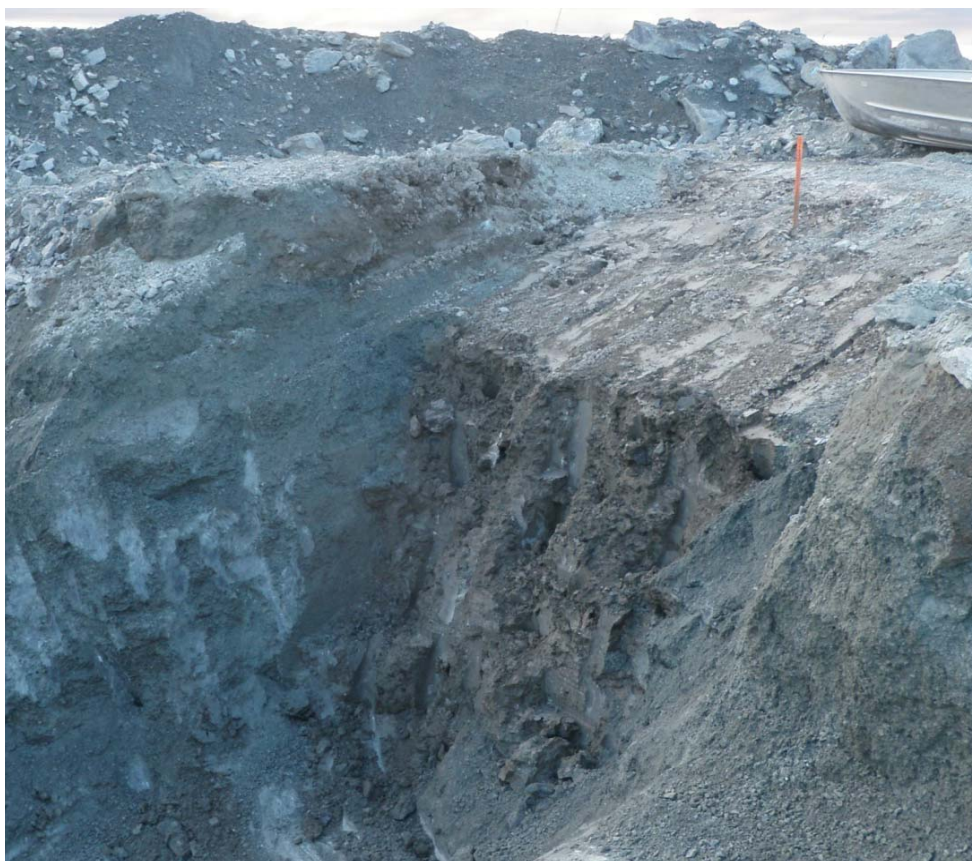
Photograph 58: Core backfill and CSB excavation at north portion tie-in, approximately Sta. 30+860 - August 12, 2010

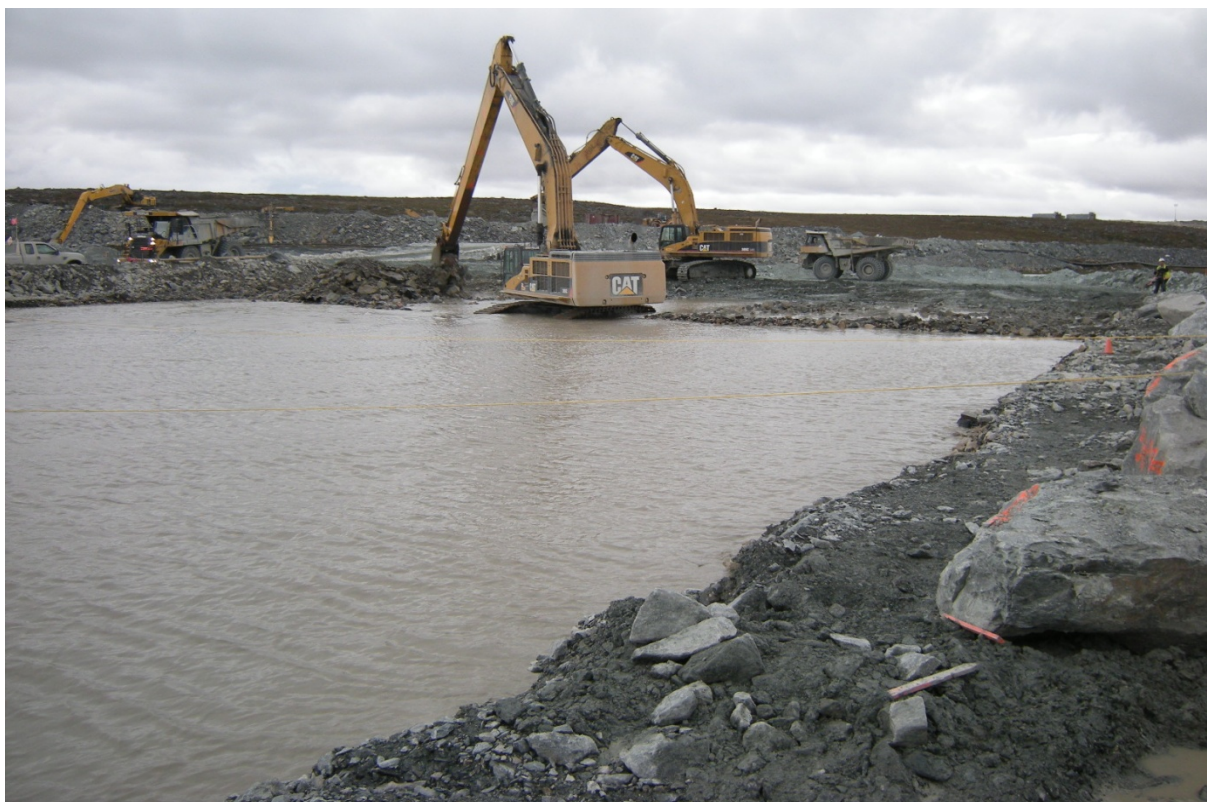
Photograph 60: Initial trench excavation, Sta. 32+007 - August 25, 2010

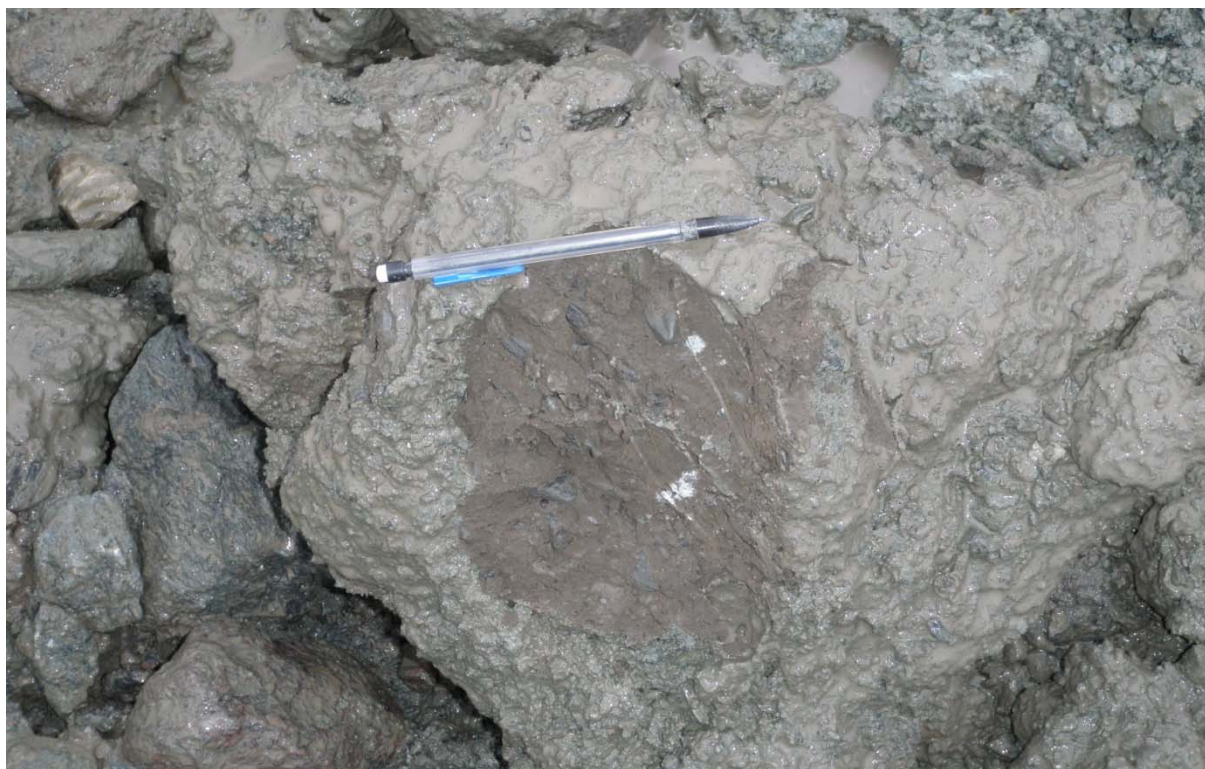
Photograph 62: Sample of competent till excavated at Sta. 32+062 - September 11, 2010
