APPENDIX A

Construction Photographs

1.0 NORTHERN PORTION – 2009 CONSTRUCTION

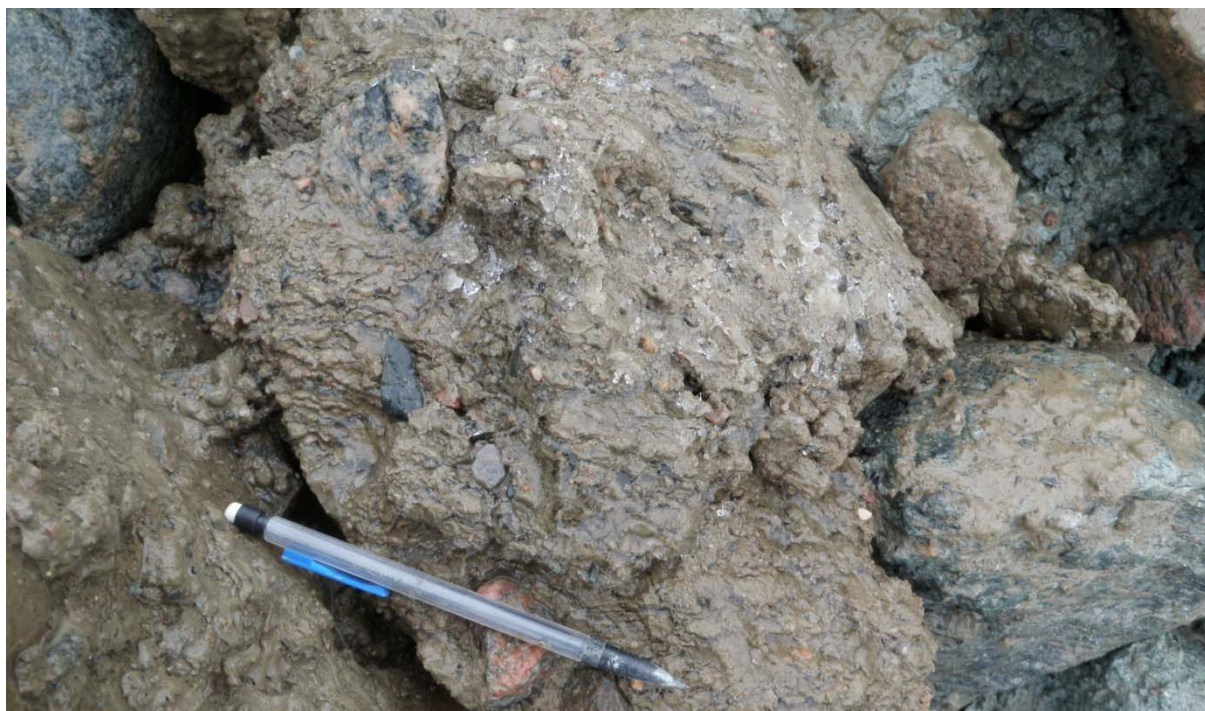
Photograph 63: Sample of ice-rich till excavated at Sta. 32+127 - September 14, 2010

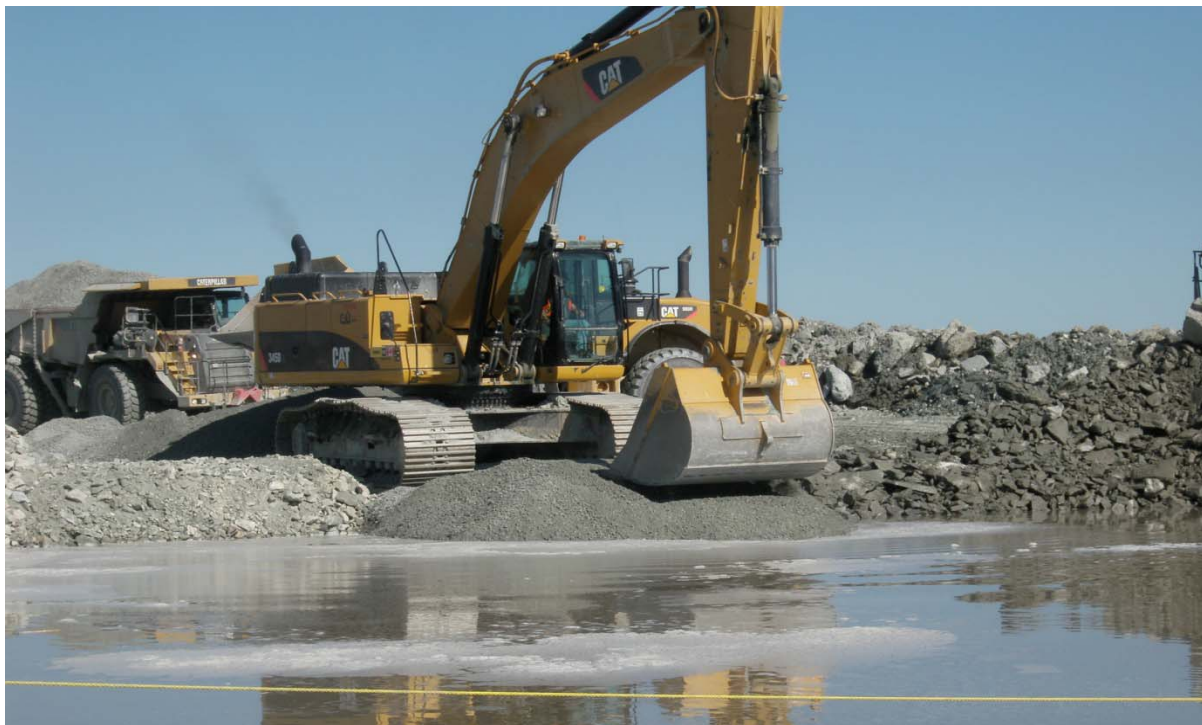
Photograph 64: Core backfill placement at Sta. 31+390 - August 7, 2010

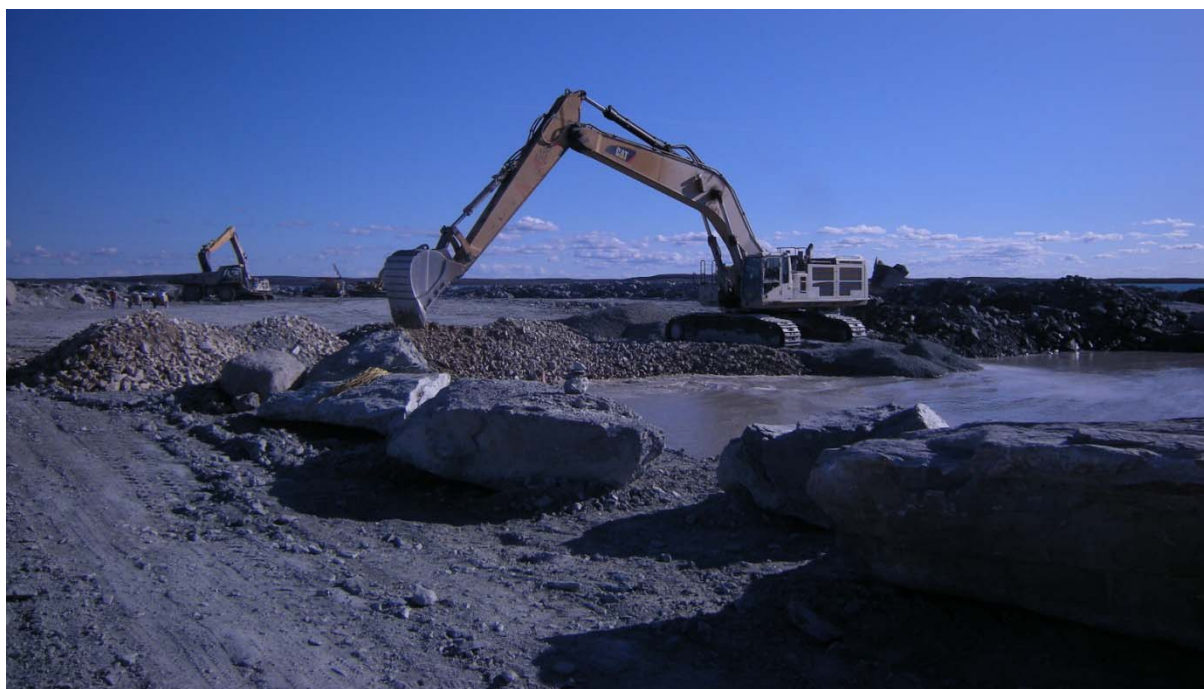
Photograph 65: Core backfill, coarse filter and fine rockfill placement at Sta. 31+835 - August 10, 2010

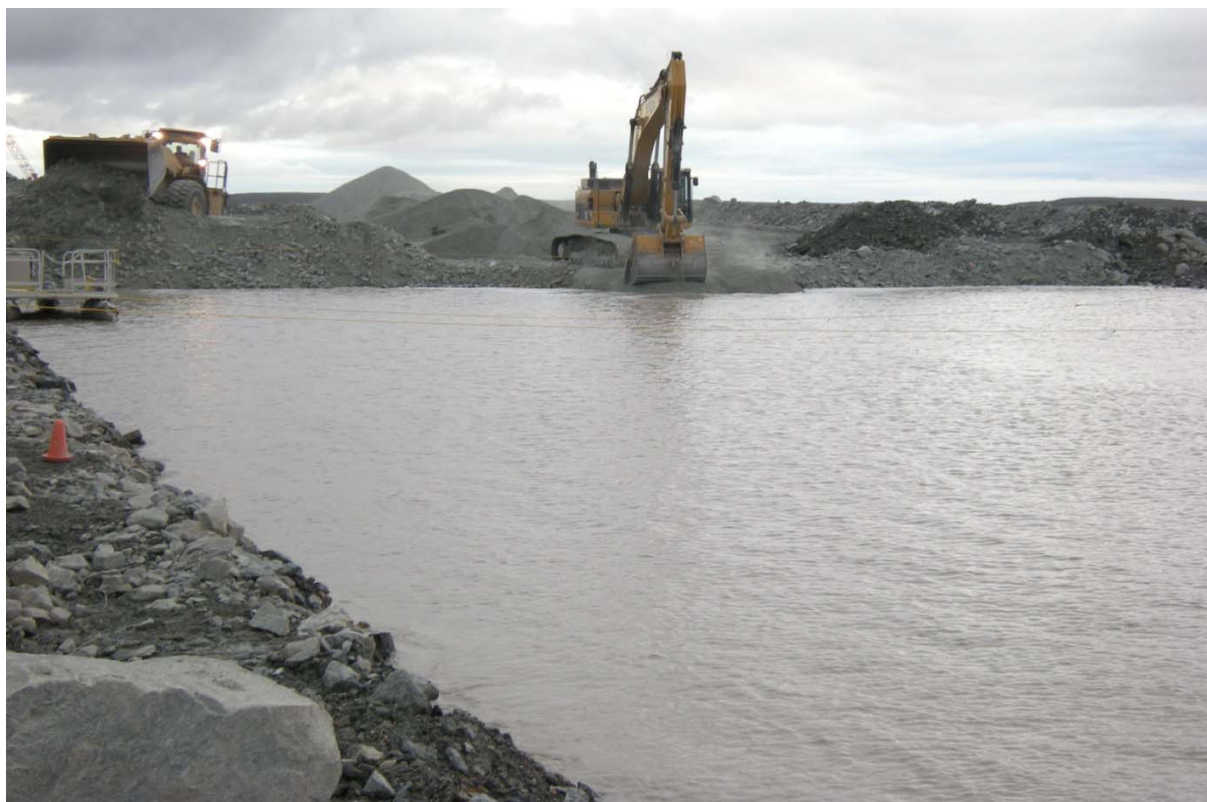
Photograph 67: Placement of core backfill material by pushing the core backfill forward and down. Coarse filter wing advanced with dozer on downstream side, Sta. 31+975 - August 25, 2010

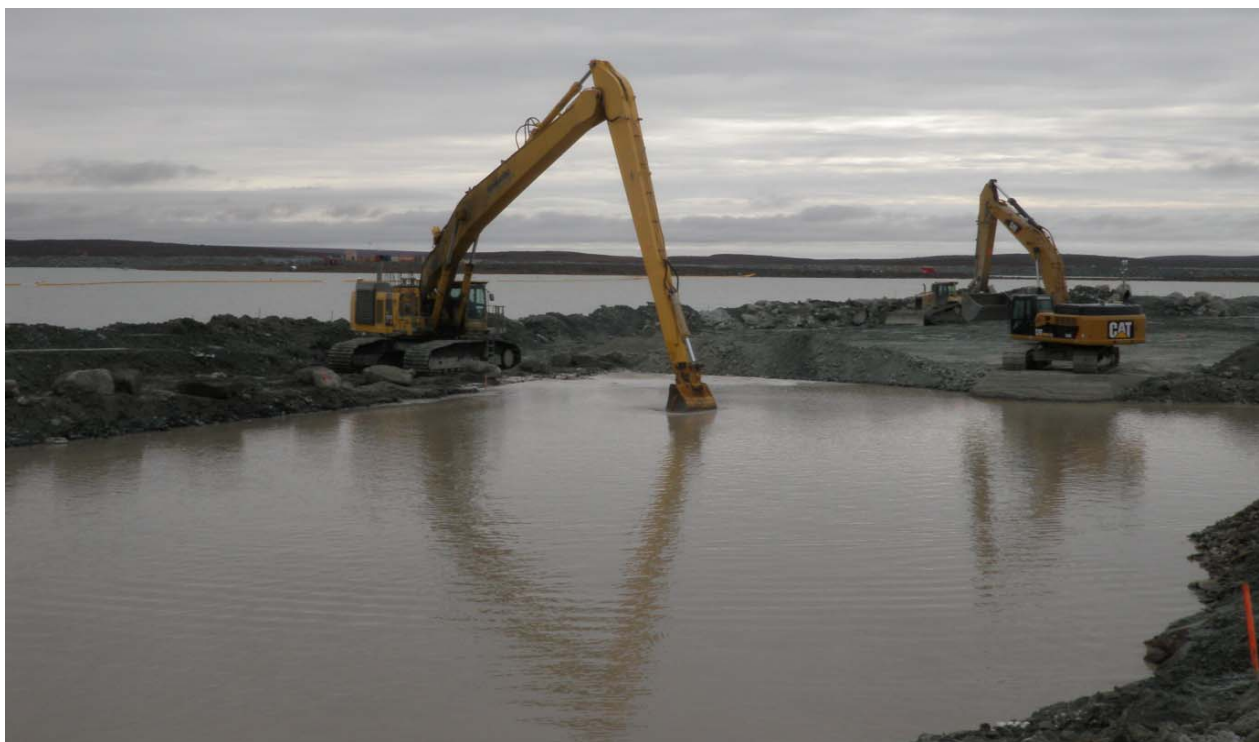
Photograph 68: Placement of core backfill material on downstream side slope of trench – September 14, 2010

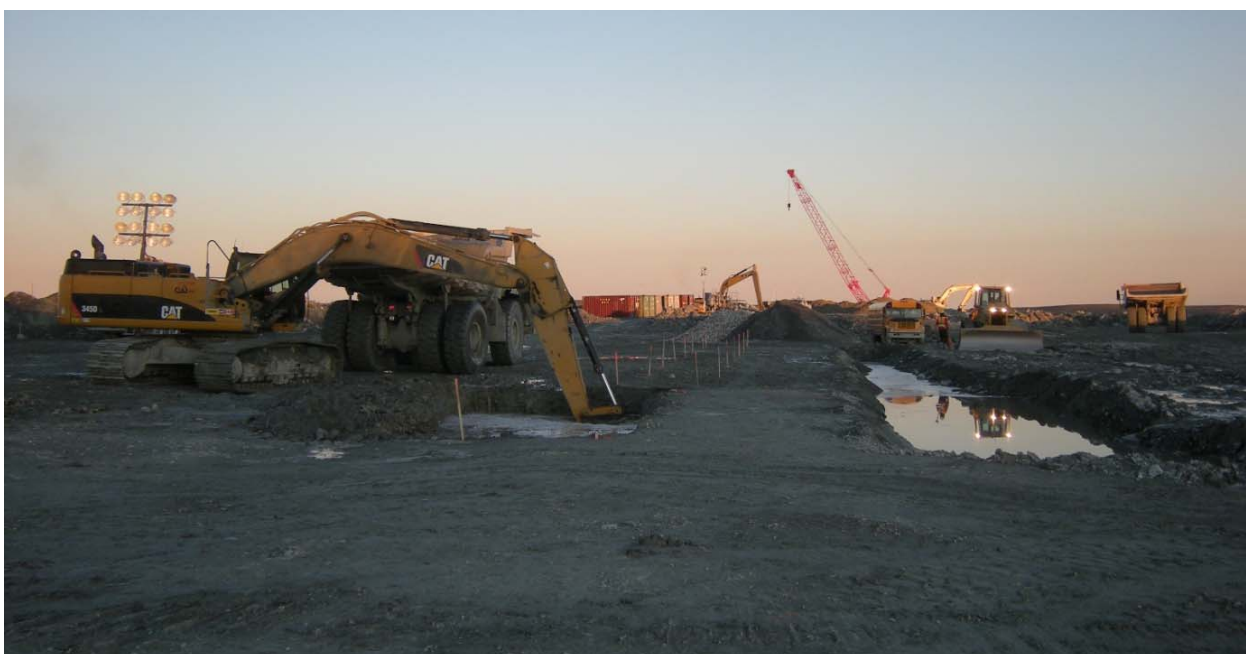
Photograph 69: Excavation of coarse filter and fine rockfill to widen core backfill for vibro-densification, Sta. 31+820 - August 23, 2010

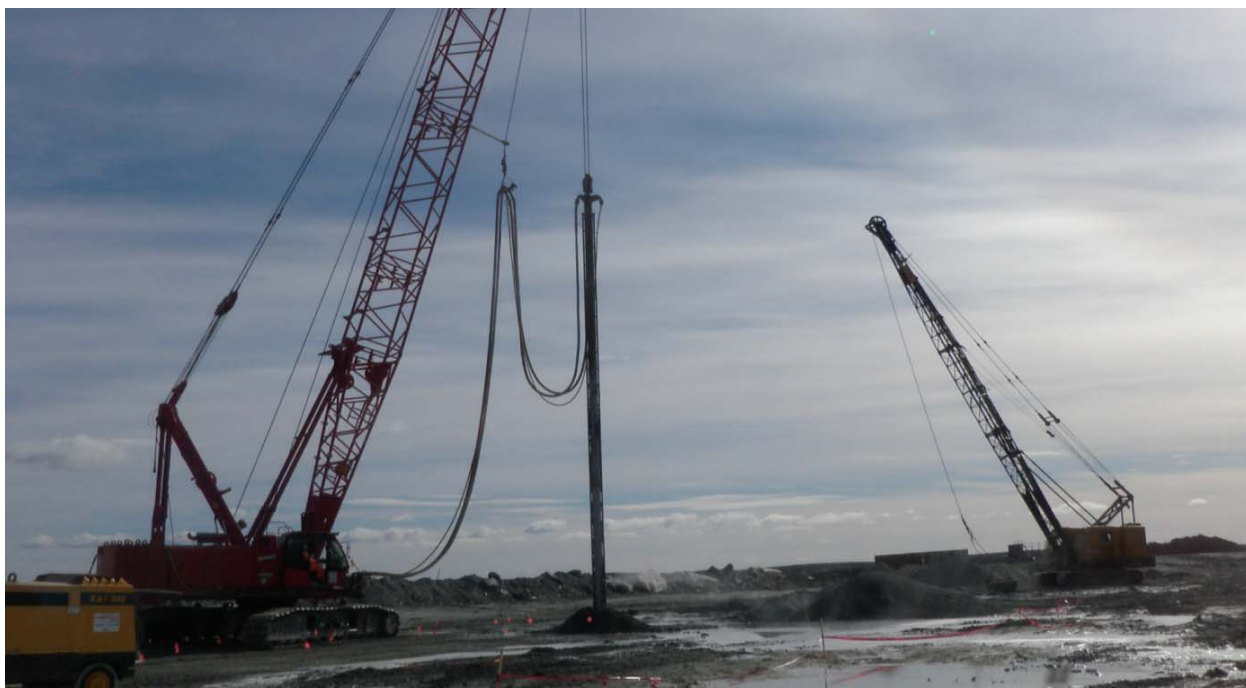
Photograph 70: Vibro-densification of core backfill - September 1, 2010

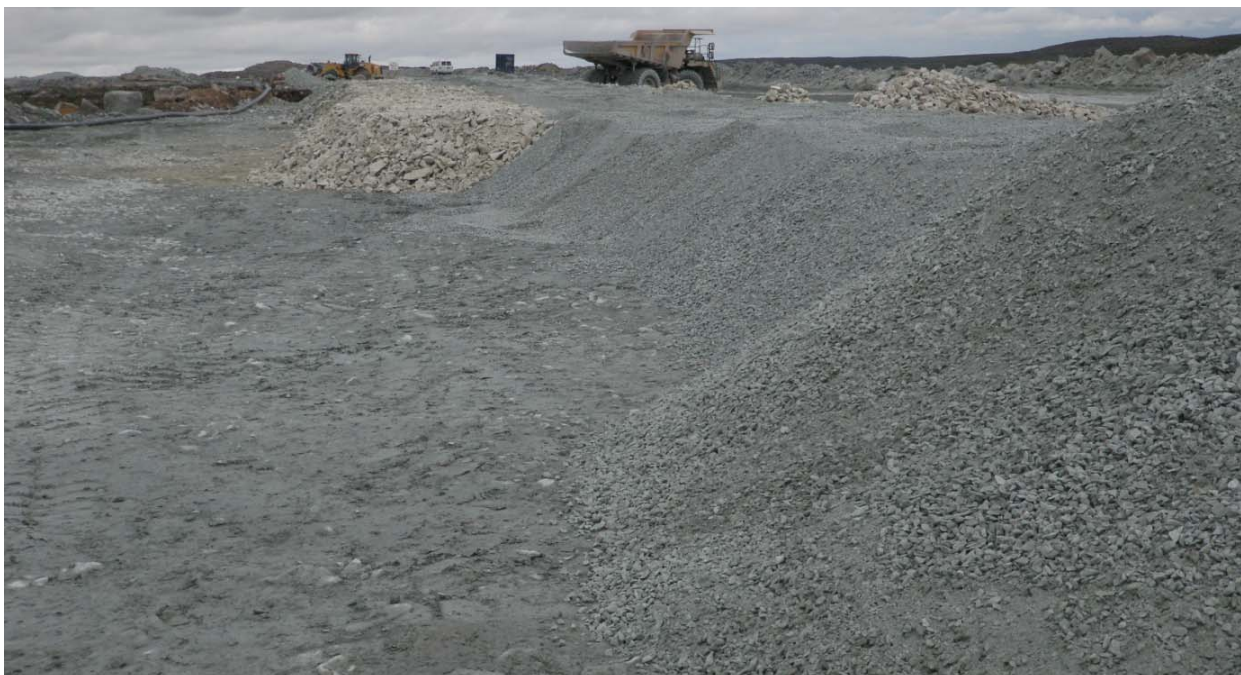
Photograph 71: Downstream side of densification platform at Sta. 31+100. Core backfill and coarse filter downstream wing - August 2, 2010

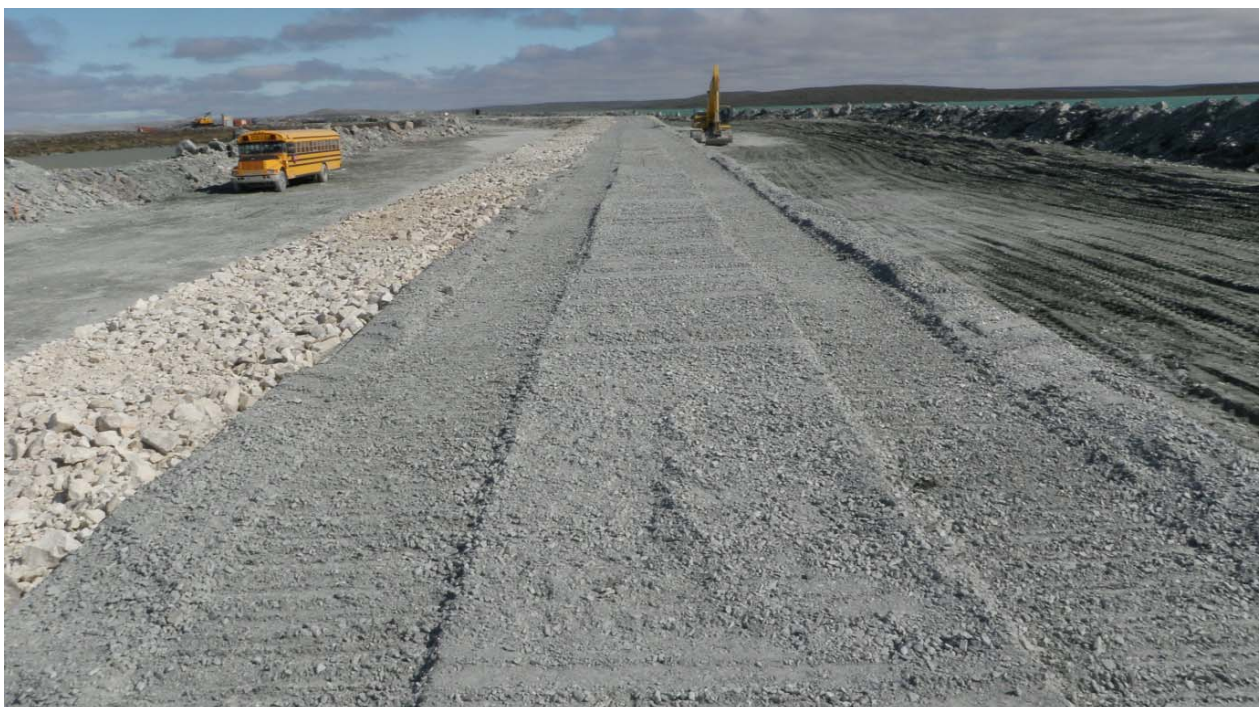
Photograph 72: Densification platform surface at Sta. 31+310. Coarse filter material placed on downstream side of platform - August 4, 2010

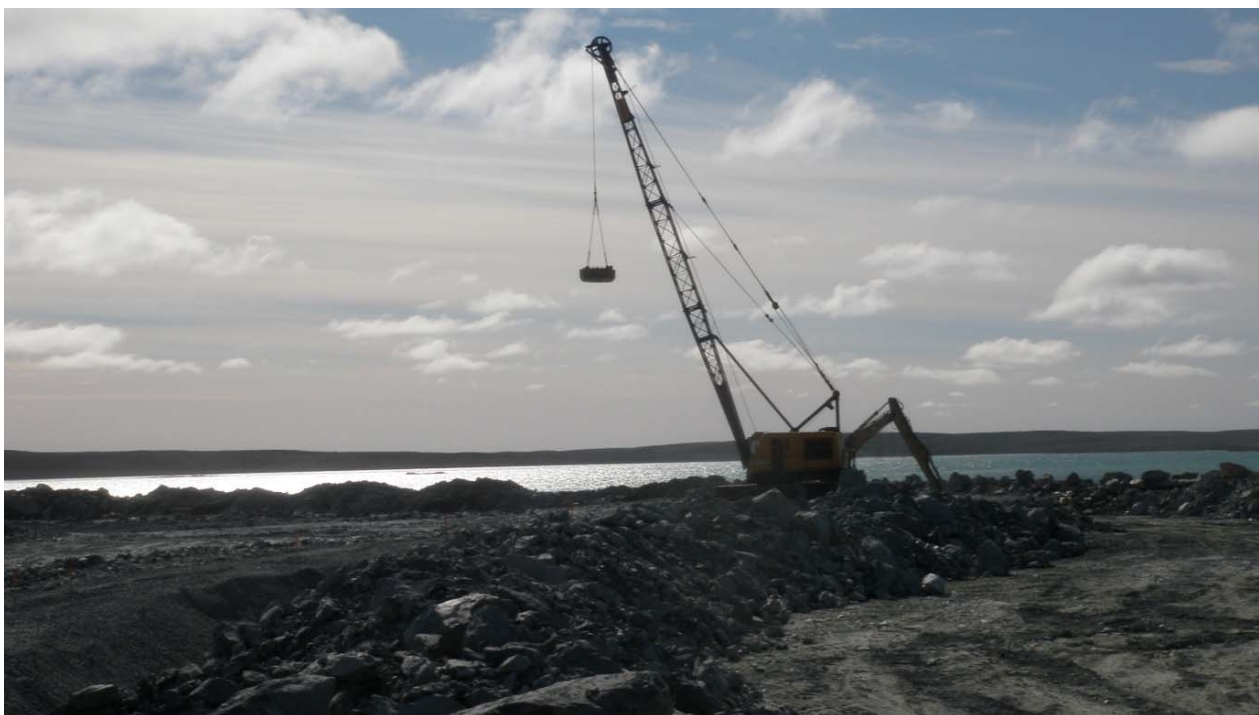
Photograph 73: Dynamic compaction of core backfill at Sta. 31+650 - August 15, 2009

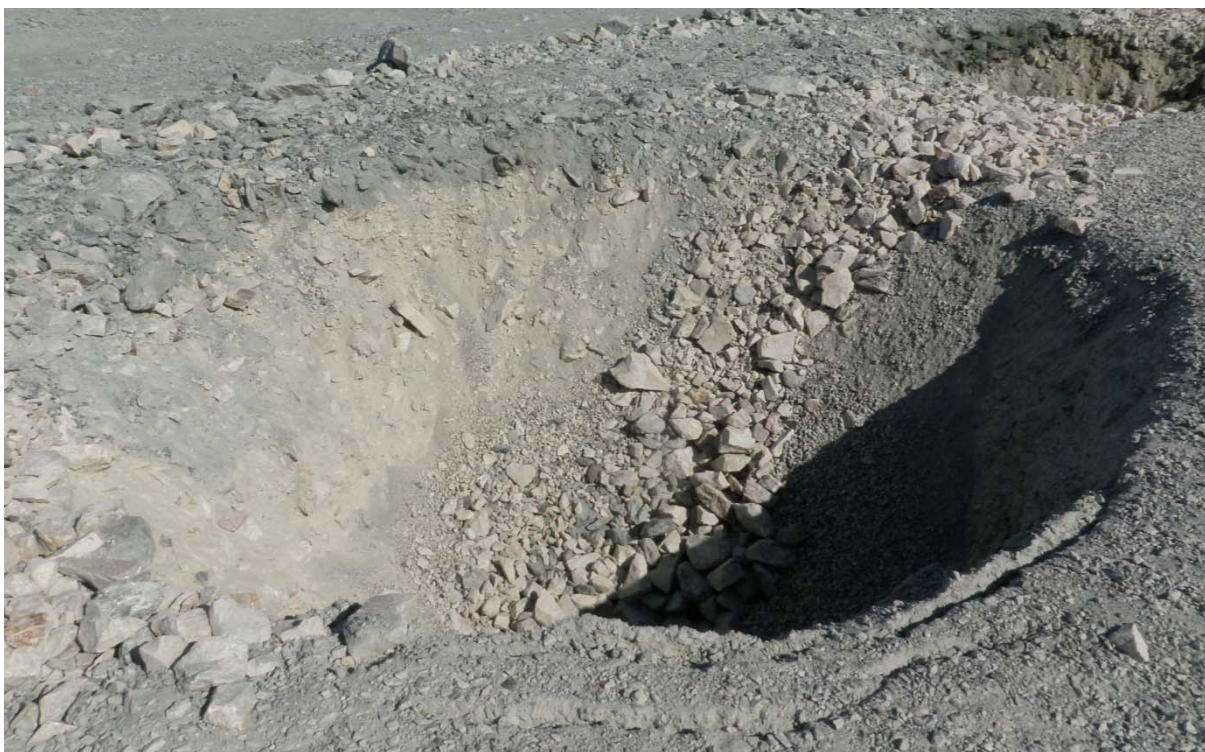
Photograph 74: Crater formed following dynamic compaction, Sta. 31+670 – August 15, 2010

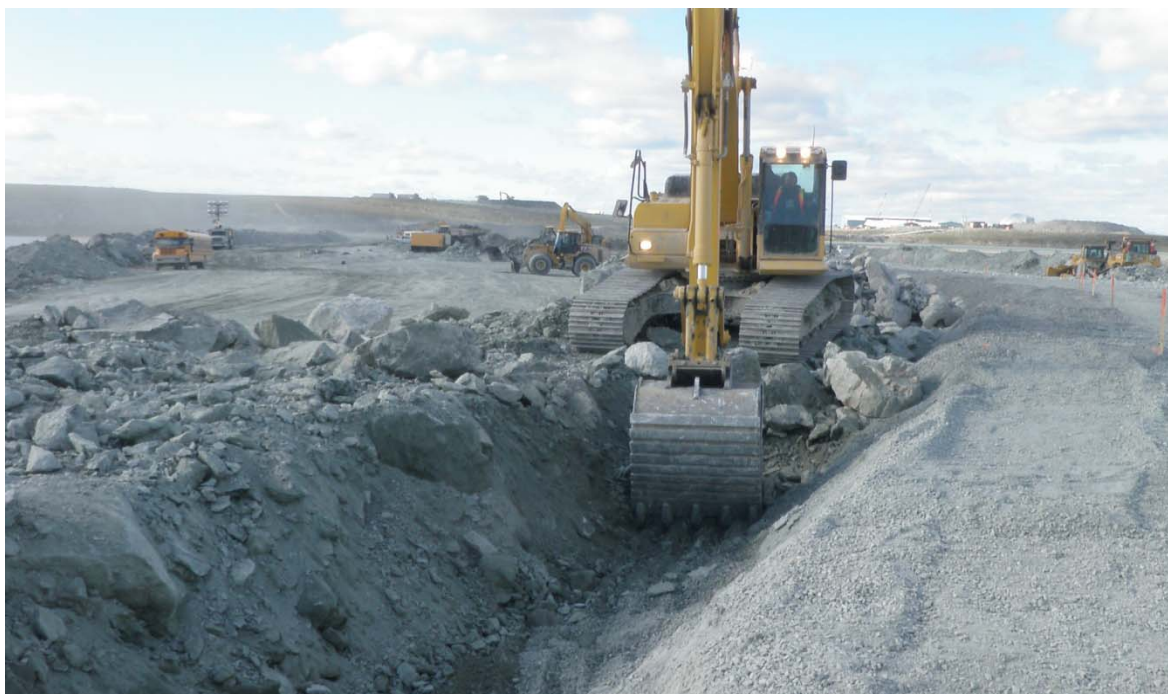
Photograph 75: Excavation of oversized fine rockfill on upstream side of densification platform in preparation for dynamic compaction - August 15, 2010

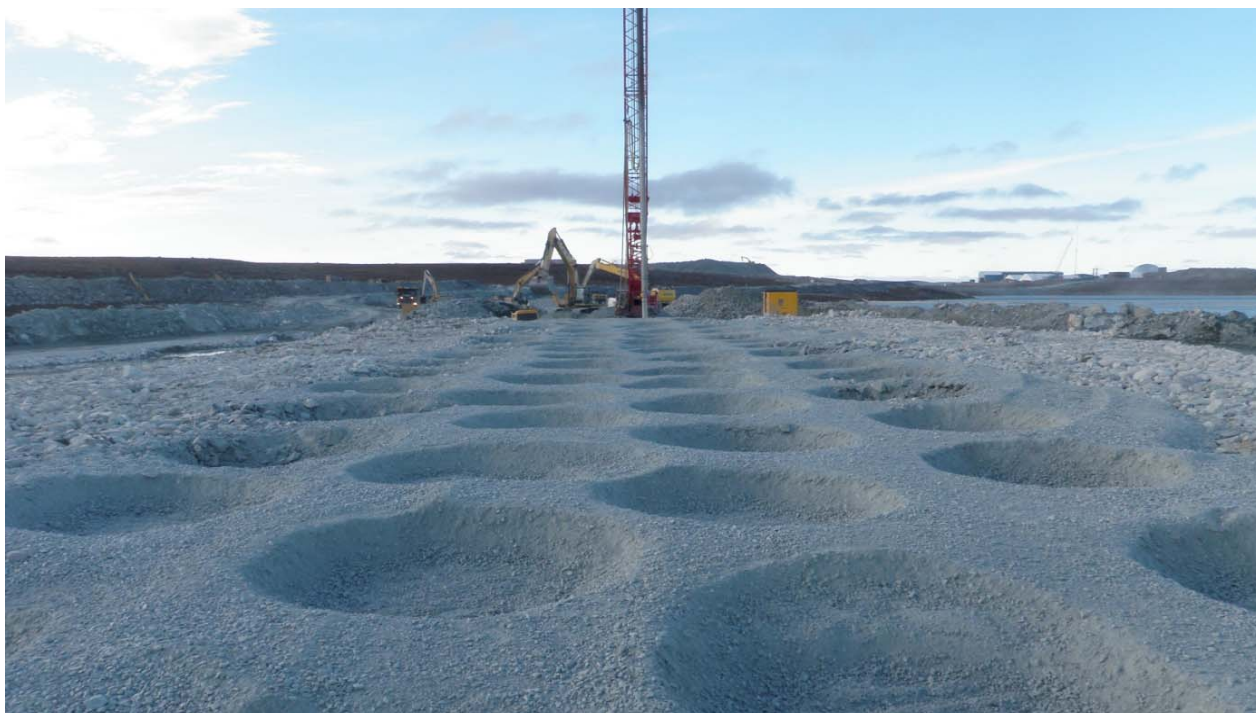
Photograph 76: Craters formed within the central core backfill zone following dynamic compaction, Sta. 31+841 to 31+930 - September 7, 2010

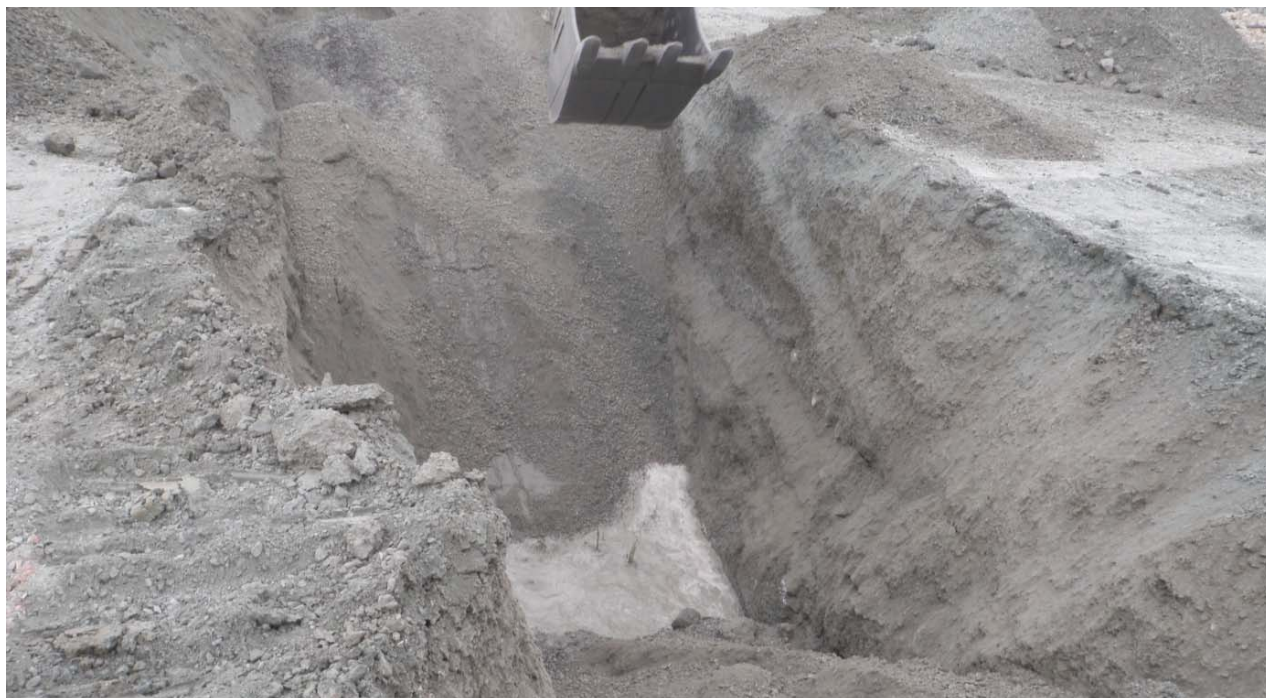
Photograph 77: Excavation of core backfill previously compacted with dynamic compaction at channel 3 in preparation for vibro-compaction – September 21, 2010

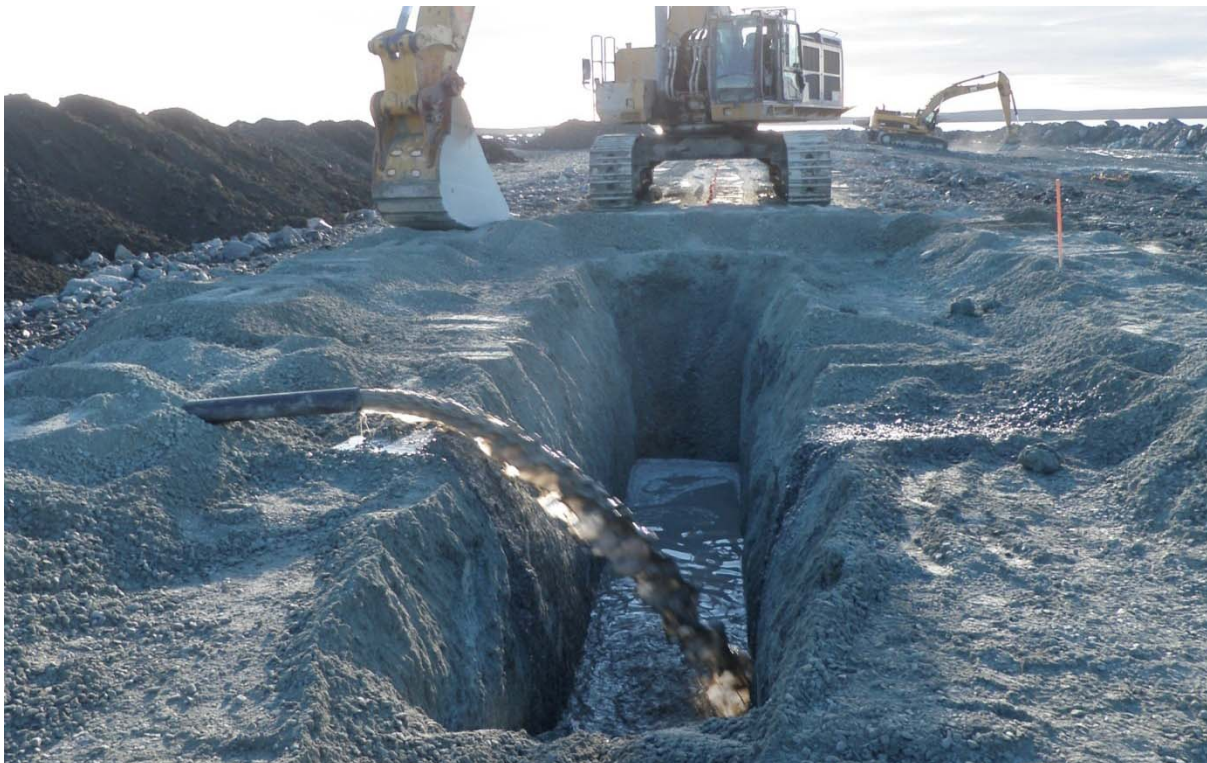
Photograph 78: Cutoff trench excavation and bentonite slurry placement – August 23, 2010

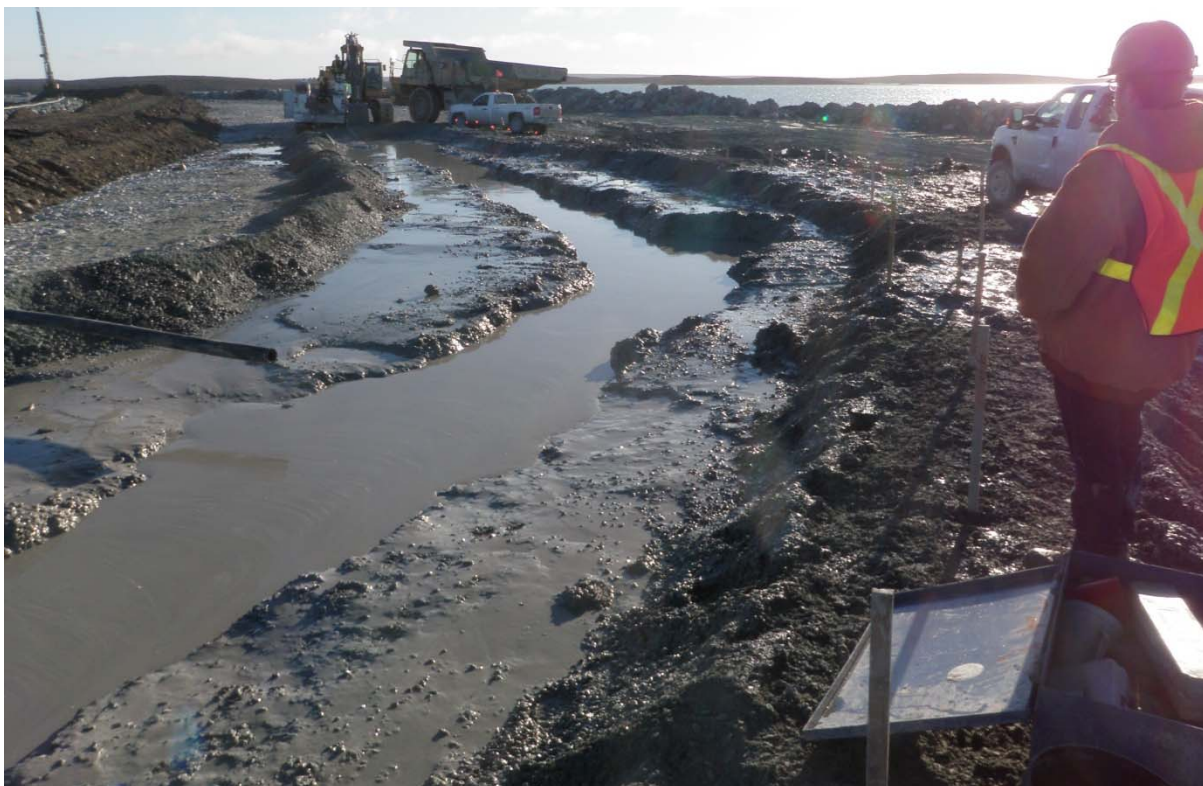
Photograph 81: Excavation of the cutoff trench and corner construction, Sta. 31+468 - August 27, 2010

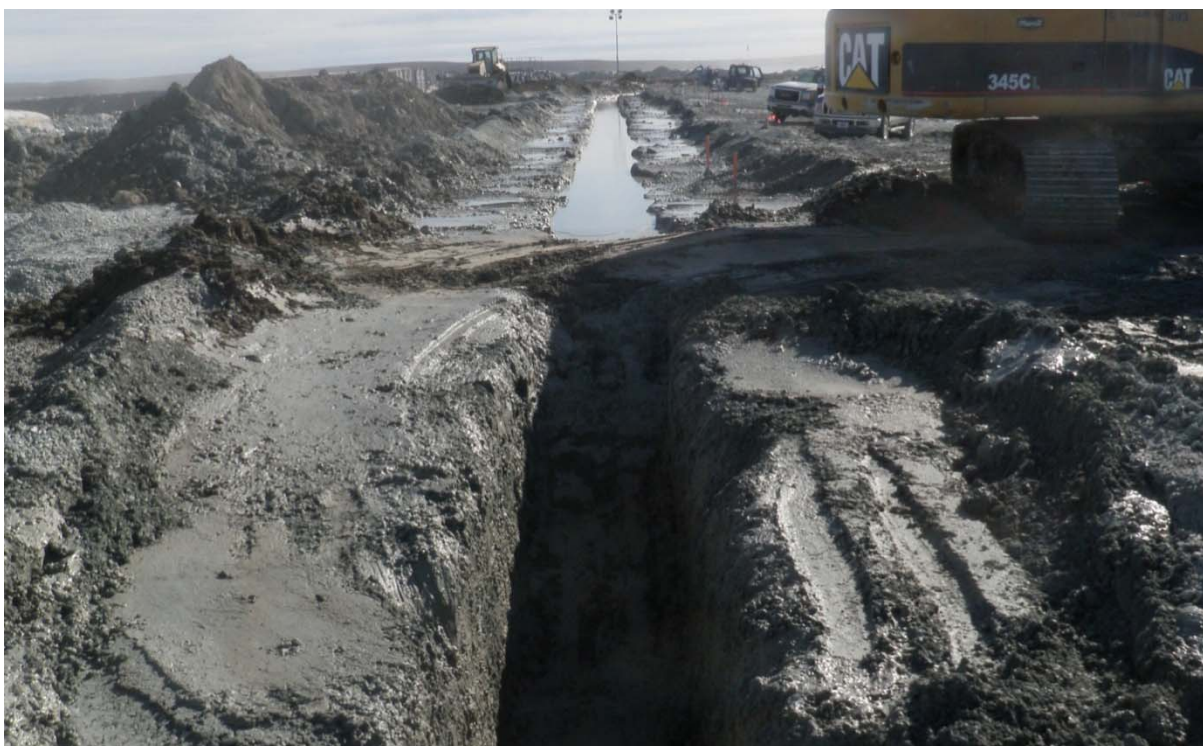
Photograph 83: From top to bottom: Cutoff trench with bentonite slurry, CSB plug at Sta. 31+806 and cutoff wall excavation – September 7, 2010

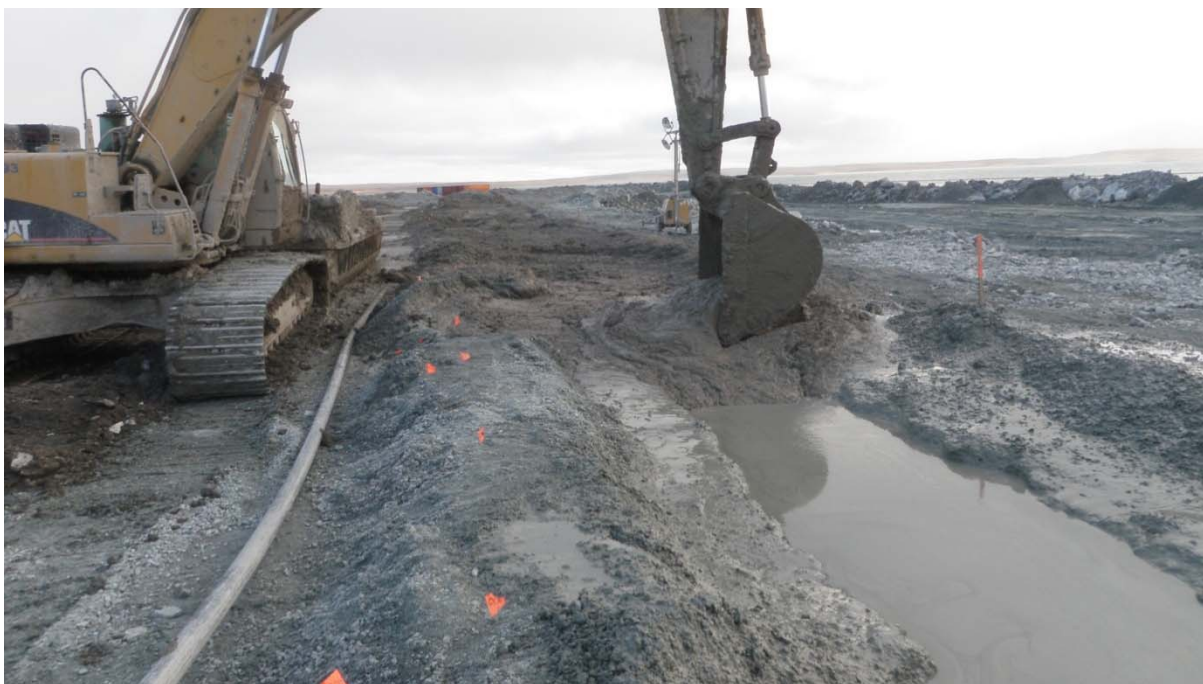
Photograph 84: Placement of cement soil bentonite mix within the cutoff trench, Sta. 31+900 - September 20, 2010

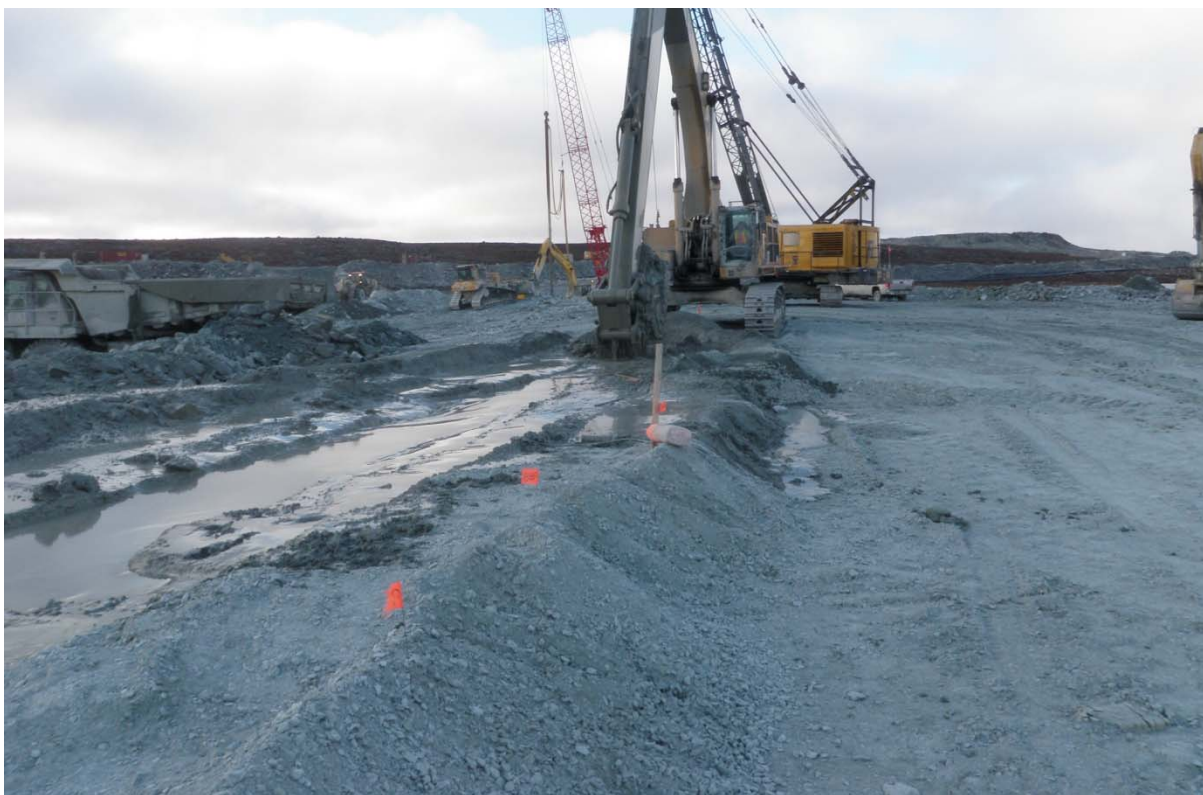
Photograph 85: Excavation of the cutoff trench at Sta. 31+984 – September 20, 2010

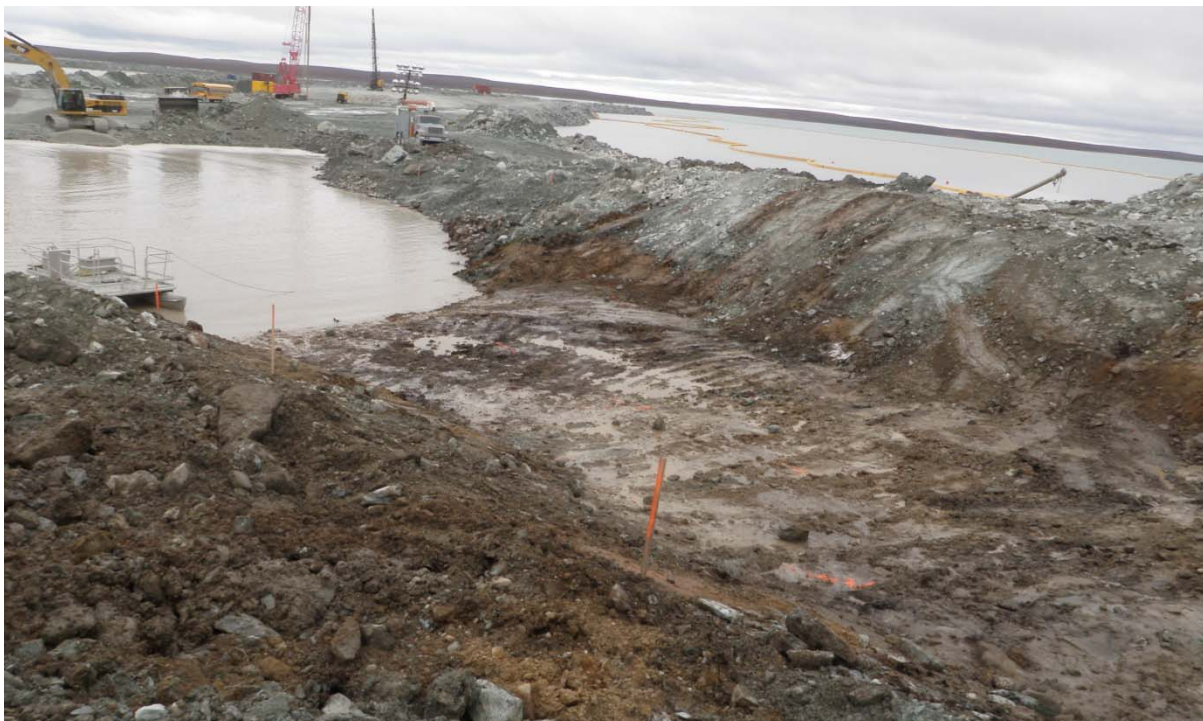
Photograph 86: South abutment foundation preparation. Ice rich material was left in place between Sta. 32+125 and 32+166 due to schedule constraints - September 14, 2010

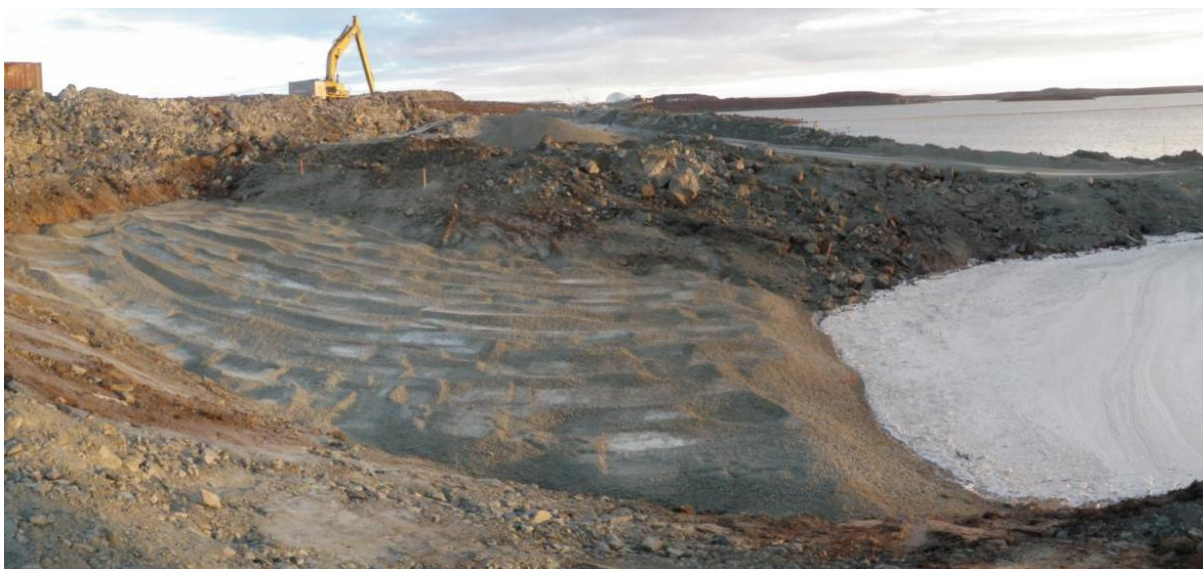
Photograph 87: Core backfill placement on top of ice-rich material at the south abutment, Sta. 32+140 to 32+166 - September 15, 2010

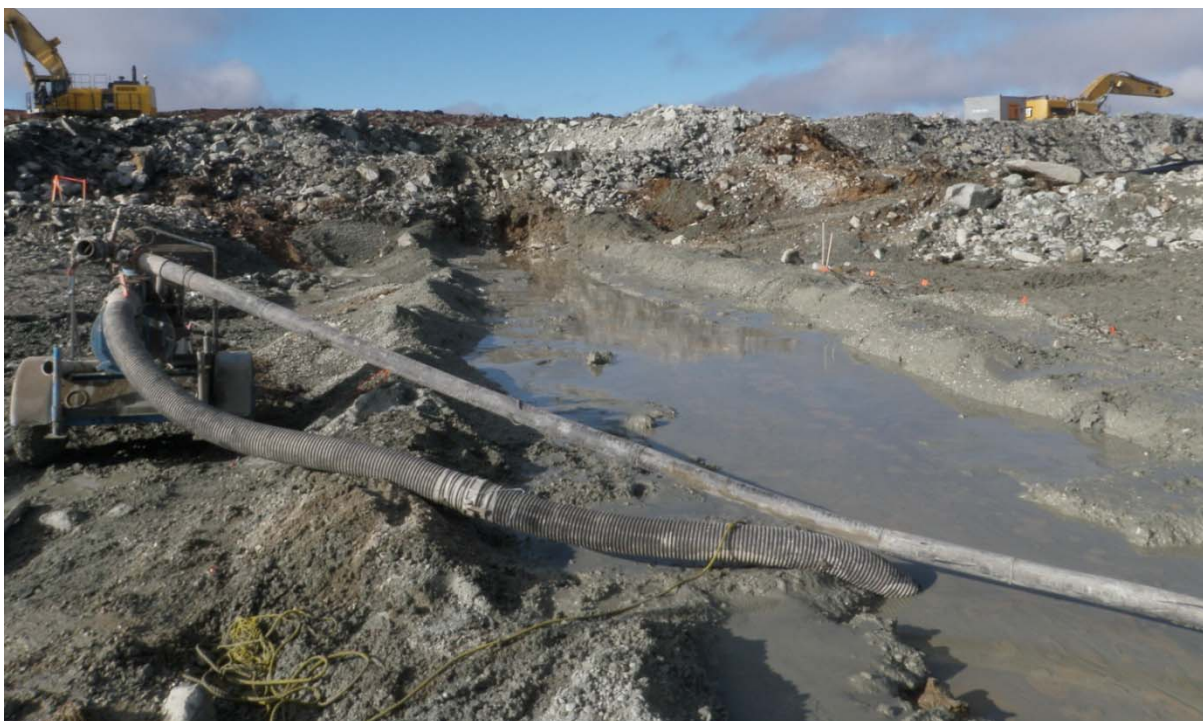
Photograph 88: Cutoff trench at south abutment, Sta. 30+140 - September 23, 2009
