# Construction Progress

# **SWD 2009 CONSTRUCTION PHOTOS**

**AGNICO EAGLE**

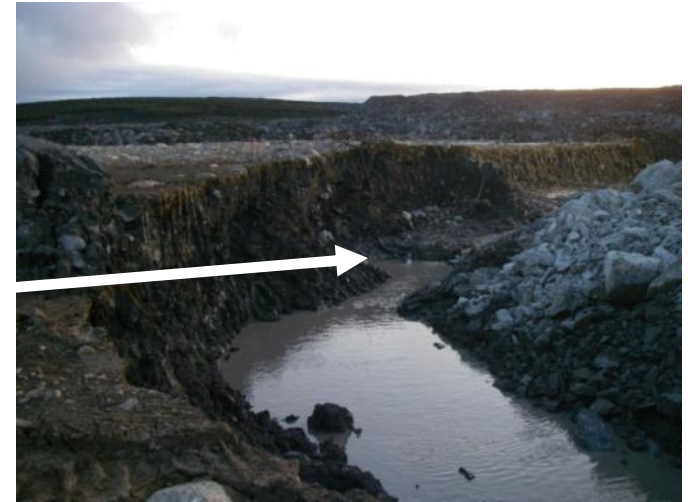
**Inflows and  
pumping**

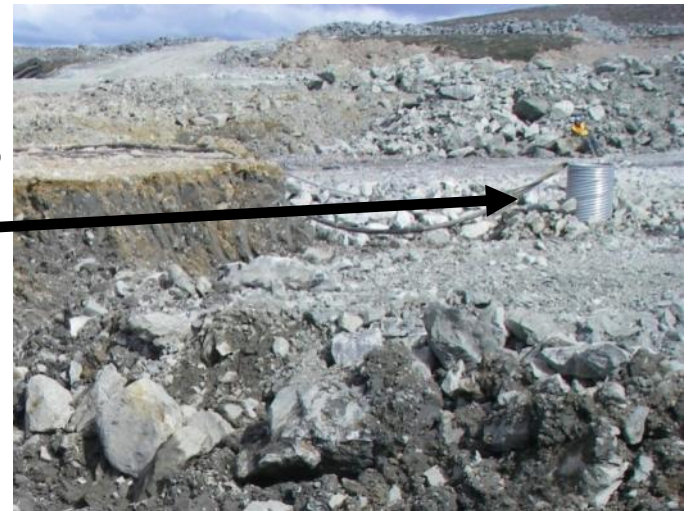
**Culvert  
placement to  
allow for  
dewatering  
during  
construction**

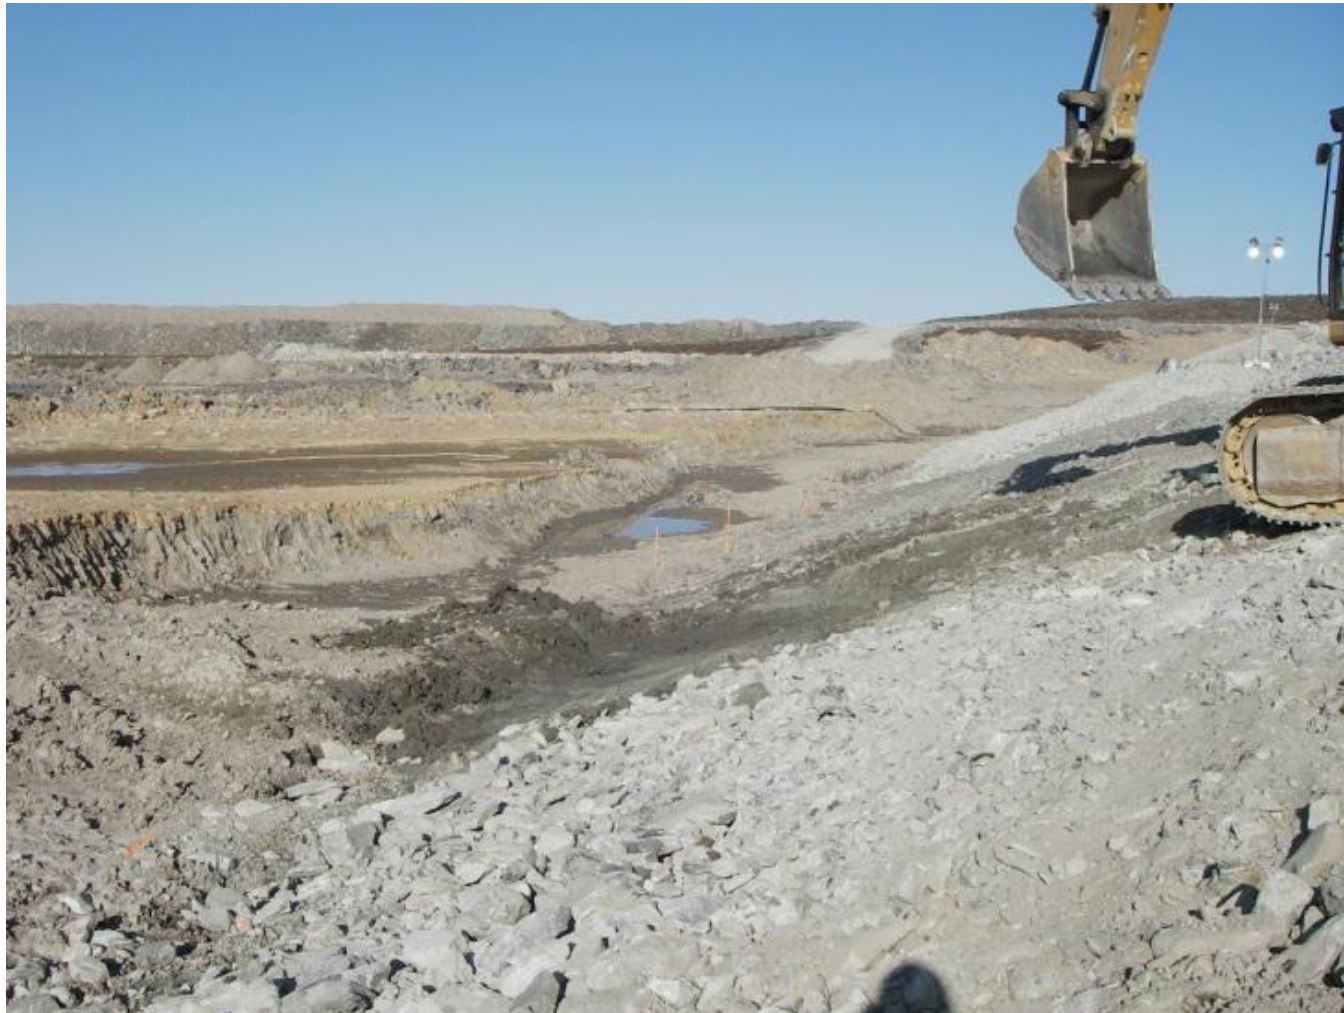
# SWD – SLOPING OF UPSTREAM SLOPE

Sloping rockfill to 3H:1V

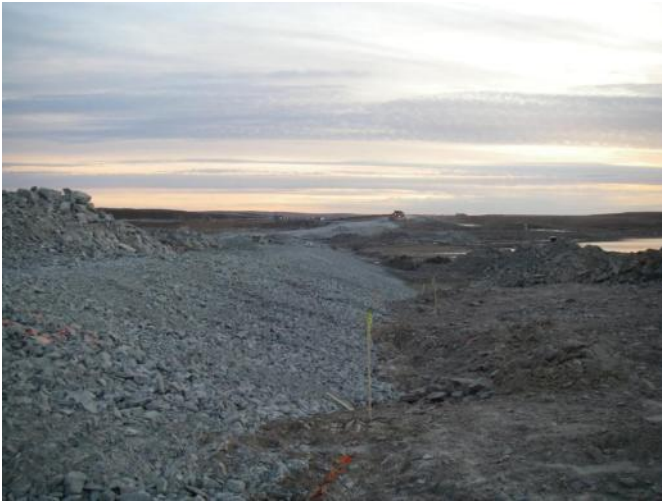
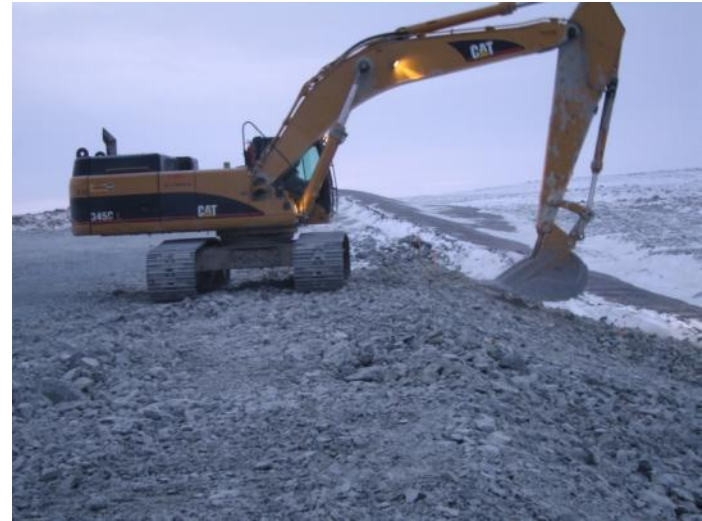
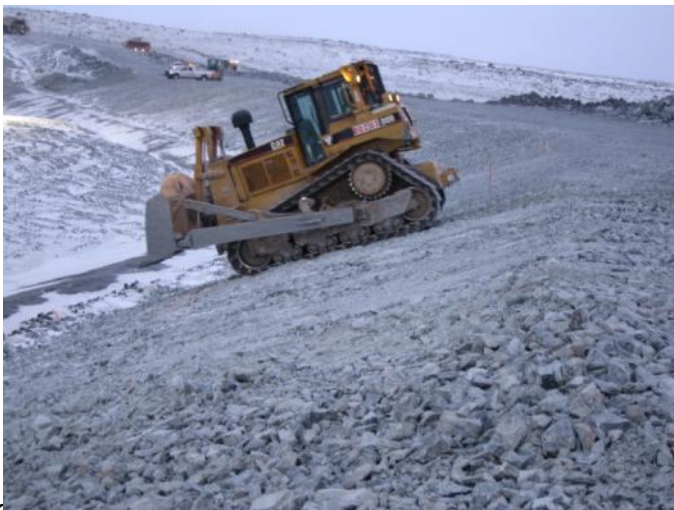
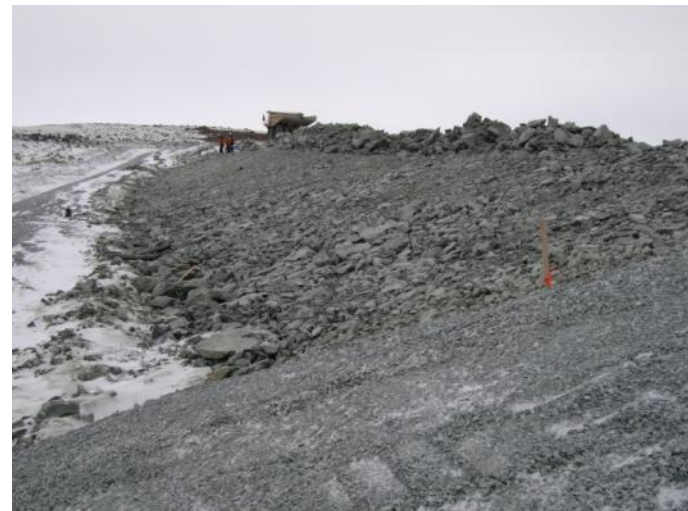
# SWD - BEDDING PLACEMENT

0-150 mm minus material placement and compacted with dozer

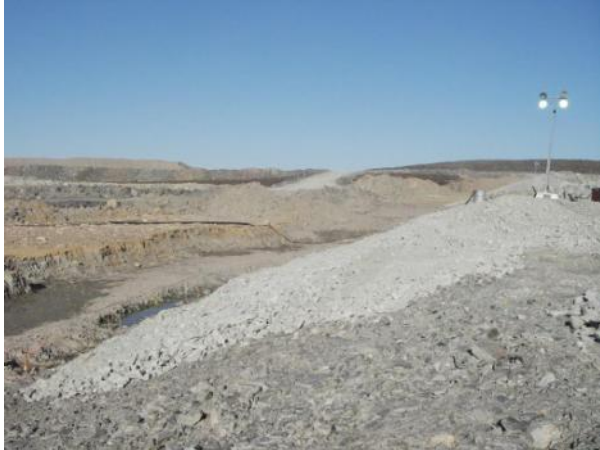
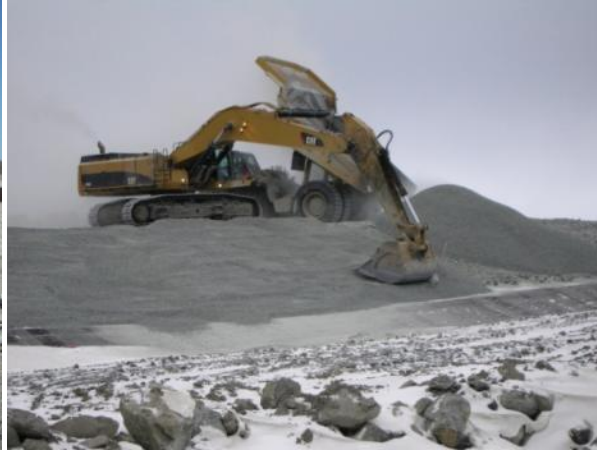
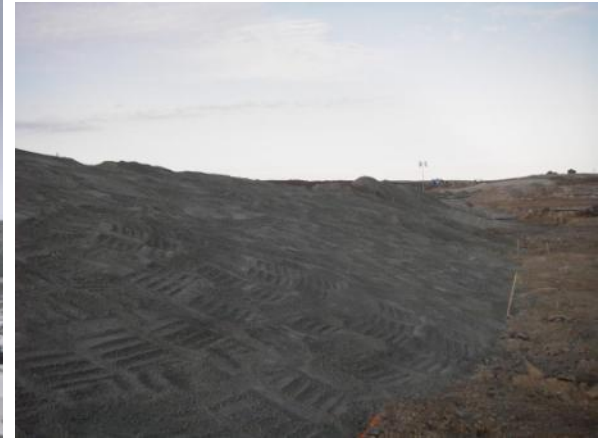
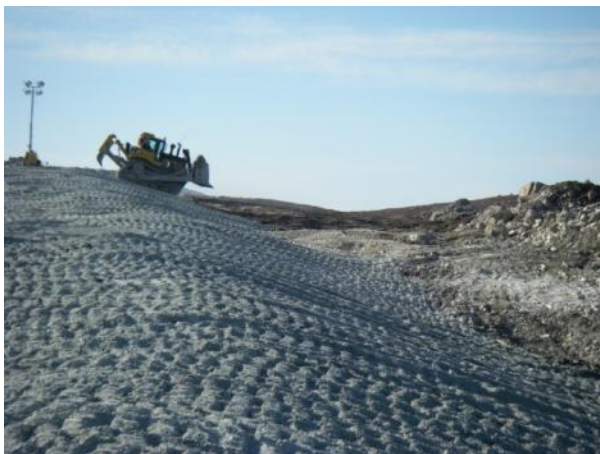
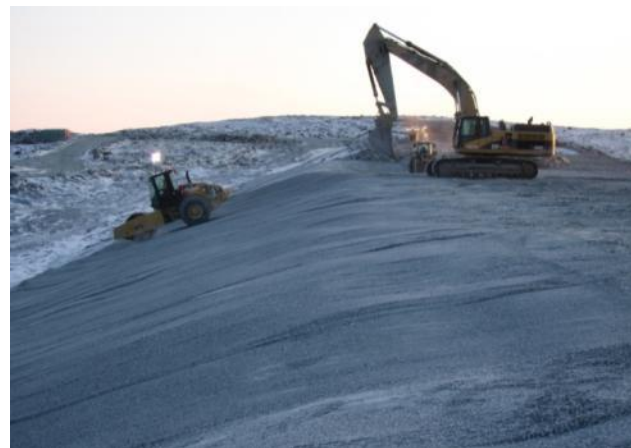
# SWD - BEDDING PLACEMENT

0-20mm minus material placement and compaction with excavator bucket, dozer and smooth drum compactor
