SWD 2011 CONNECTION CONSTRUCTION PHOTOS

AGNICO EAGLE

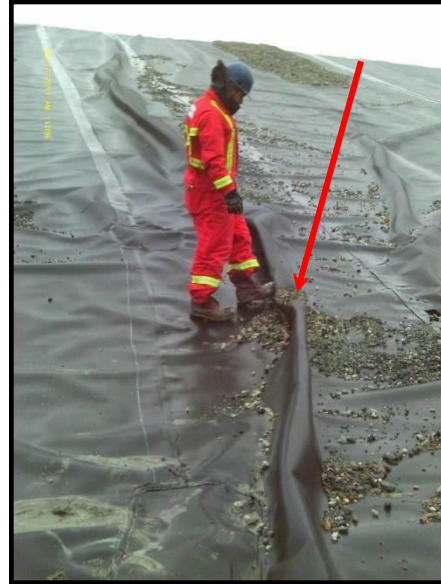
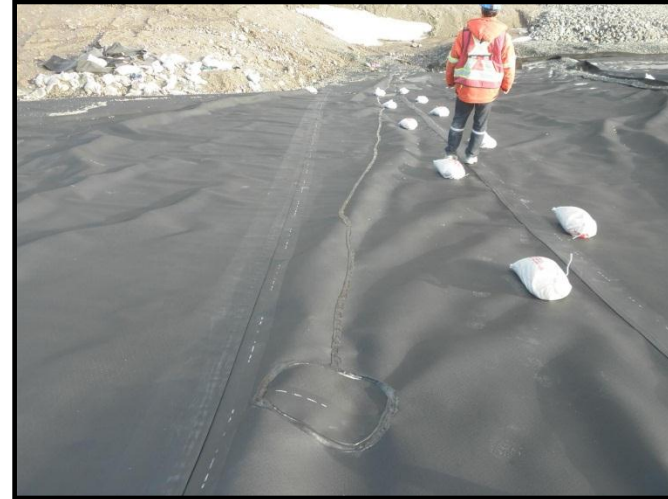
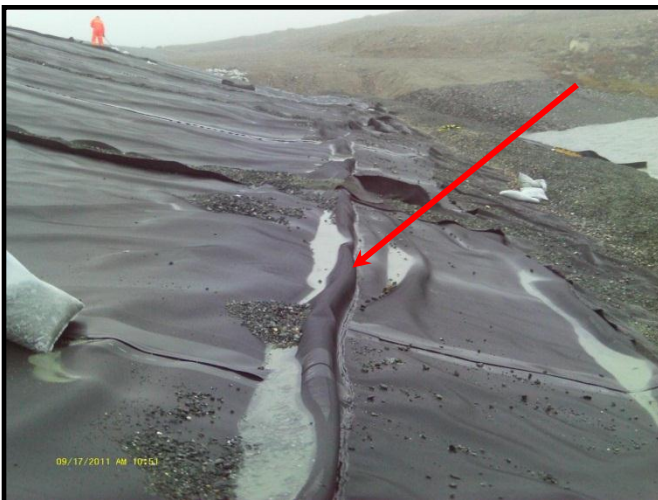
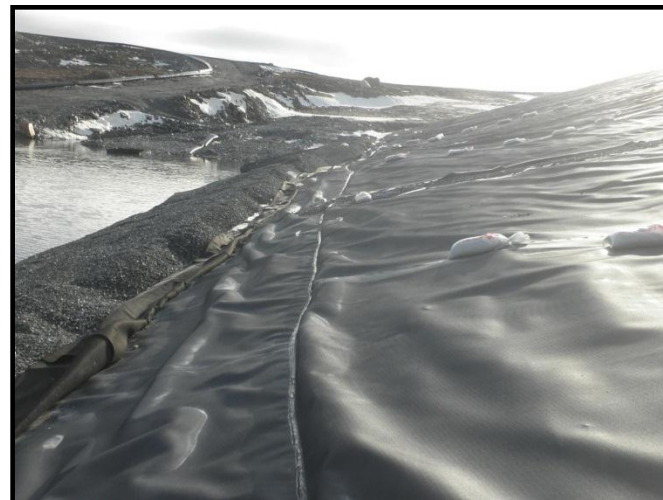
GEOMEMBRANE REPAIR PROCEDURE – SD1

Excessive
Wrinkles Cut
and Repaired
with
Extrusion
Weld

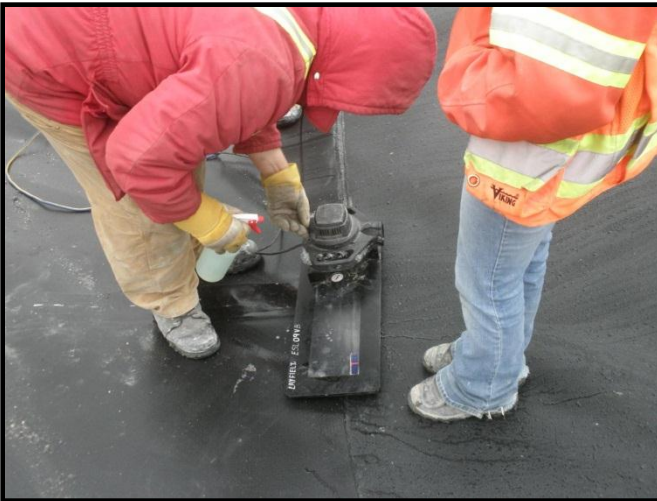
Vacuum Box Test

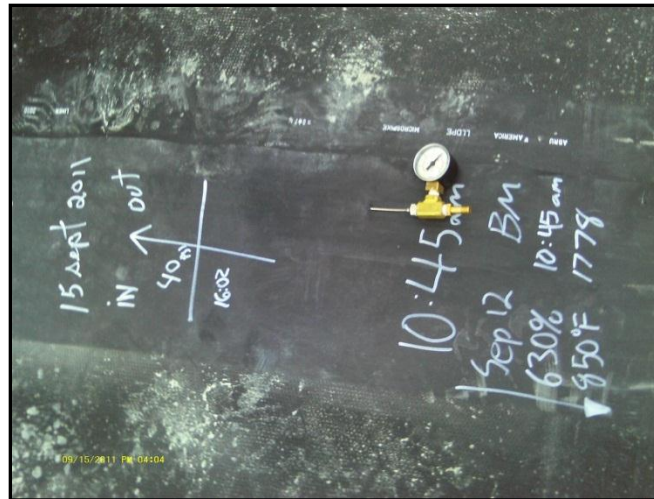
Air Pressure Test

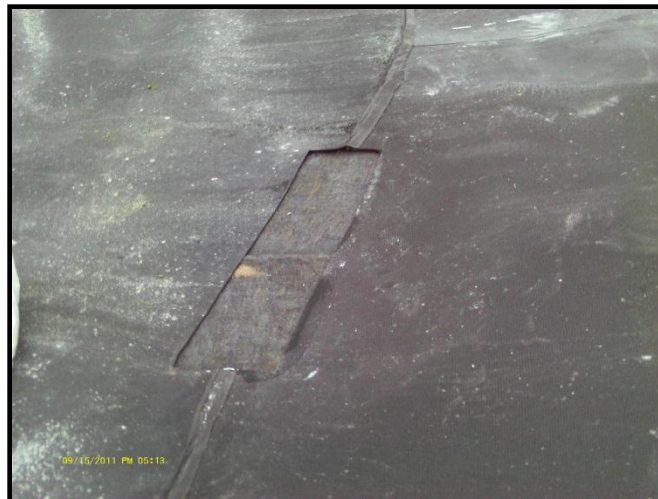
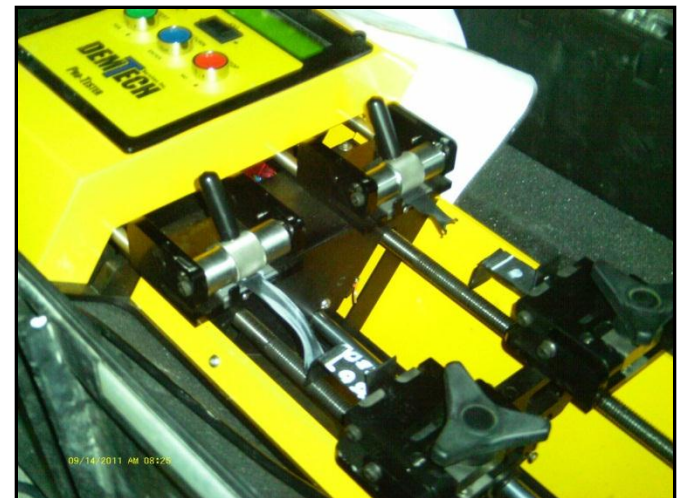
Destructive Test – Peel and Shear Strength
