PROJECT : Construction of Vault Dike  
PROJECT #: 6116/4 DATE: 2013-03-12  
DOCUMENT #: 2013 0312 - 01 CLIENT: OEM  
(YYYYMMDD-D1)

### CERTIFICATE OF ACCEPTANCE OF LINER CONDITION - VAULT DIKE

**AGNICO-EAGLE, MEADOWBANK VAULT DIKE  
ANICO-EAGLE MINE LIMITED  
Baker Lake, Nunavut  
Texel Geosol Project No. C12259**

**QUALITY CONTROL FINAL REPORT  
BY TEXEL GEOSOL INC.**

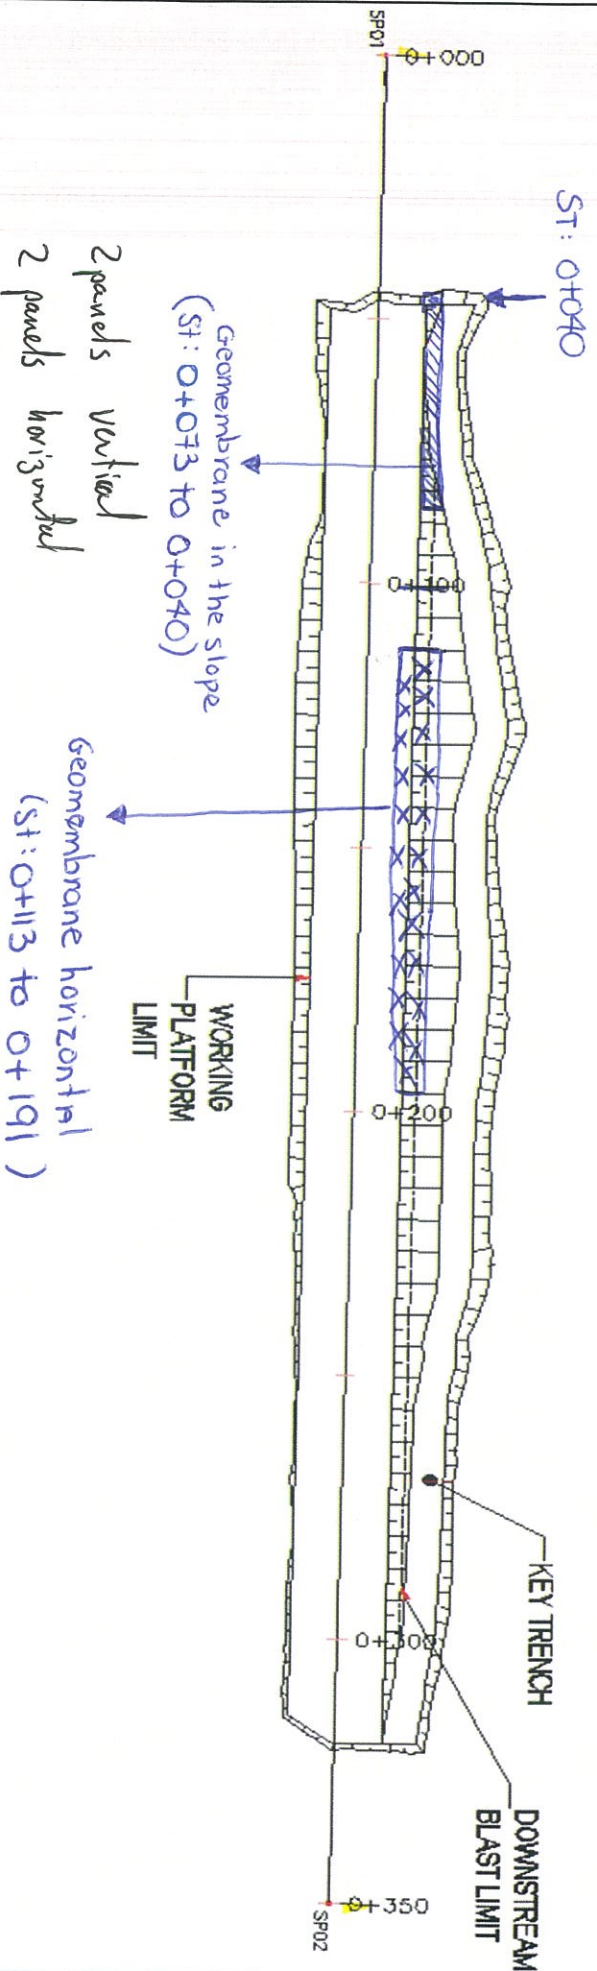
Figure 1 - Approximate approved liner area

Station: 0+073 to station: 0+040

Station: 0+113 to station: 0+191

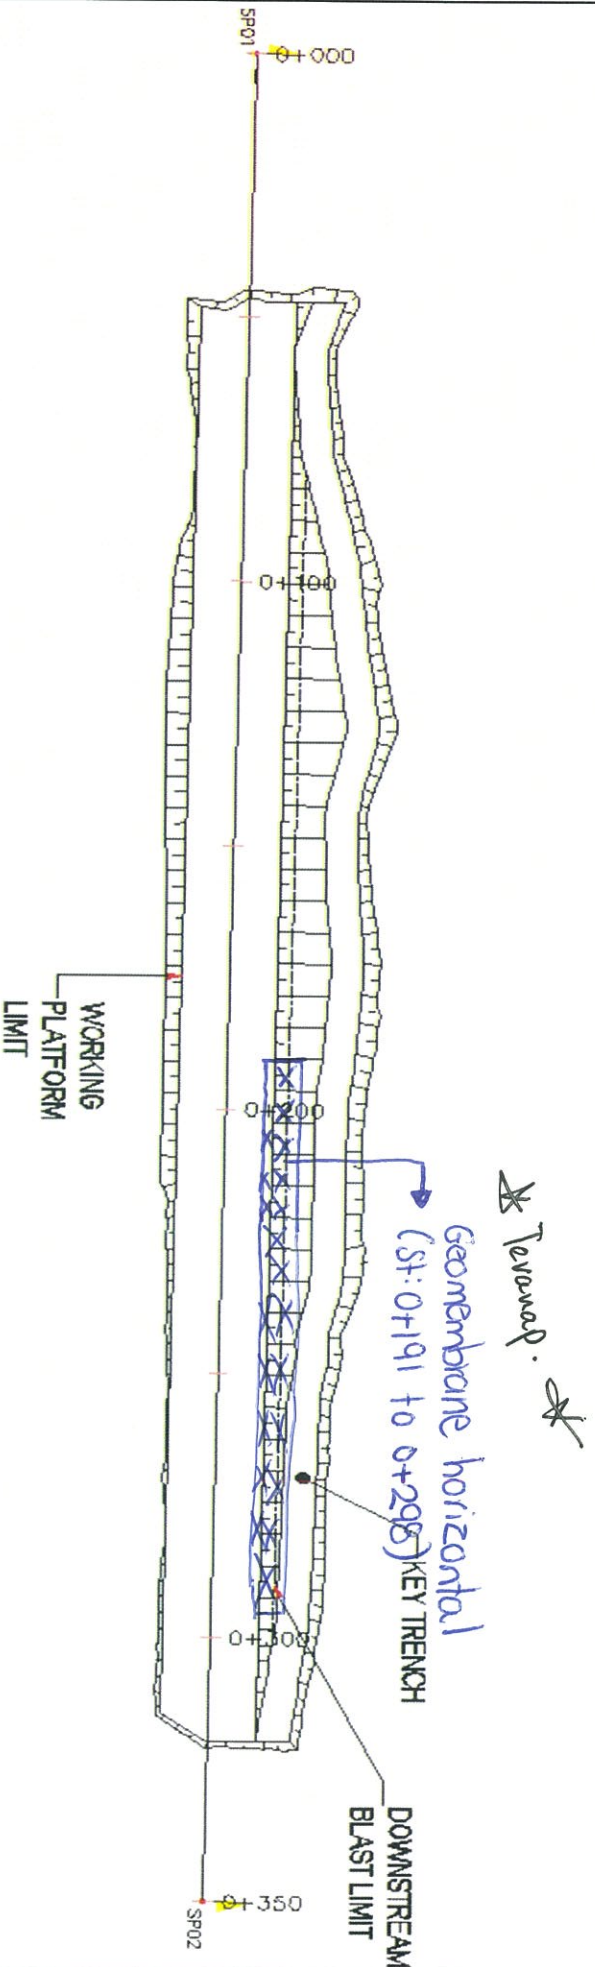
Figure 1 - Approximate approved foundation area

Station: 0+191 (~~Offset~~): \_\_\_\_\_ To Station: 0+298 (Offset): \_\_\_\_\_
