**CONSTRUCTION SUMMARY REPORT
ROCK STORAGE FACILITY – INTERIM TILL PLUG**

**AGNICO-EAGLE MINES LIMITED
MEADOWBANK GOLD PROJECT**

OCTOBER 30TH, 2013

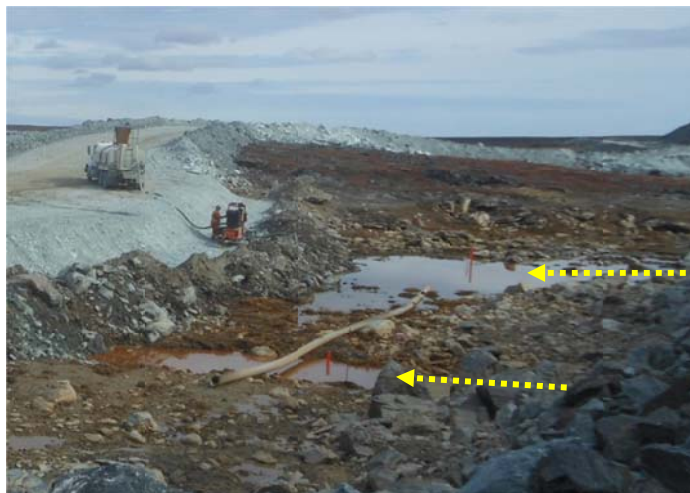
Figure 3: view of the 2 main channels and the pumping station after the completion of the works.

The first step prior to all works in the area is to pump the seepage water from the two main channels out of the till plug area. In order to control the water level through the entire construction period, a water truck from SANA was hauling (as needed) 14,000 litres of seepage water and disposed of it in the tailings pond over the Stormwater dike. A 3" diesel pump (model Godwin CD103) was placed within the 2 main deepest channels to keep them as empty as possible to allow the working area to be as dry as possible for the beginning of the excavation. The pump was moved as the work progresses.

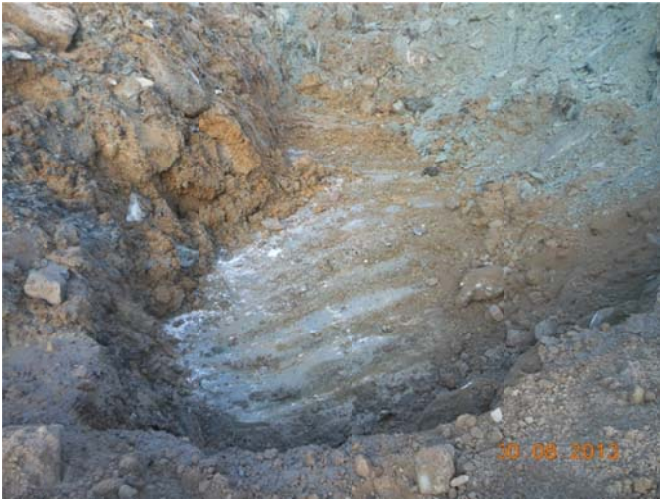
Figure 1: Excavation of the active layer until reaching the permafrost. Between 0.5 and 3.8 m were required to reach proper foundation.

Excavation of the unfrozen deleterious material was realized with a CAT 345 excavator. The excavation depth was adapted according to the material encountered. Unfrozen tundra, soft till and/or sediments were removed until refusal either on frozen till or bedrock. The foundation exposed was then cleaned and approved by AEM representative before further works performed. The excavation depth over the entire length of the road was ranging from 0.5 to 2.5 m deep (averaging around 1.3m). The deepest portions that had been excavated were the 2 main seepage channels and the shallowest were the eastern and western abutments that were directly over bedrock. As suggested by the Environment department, the excavation debris was put in front of the trench to act as a first barrier against any extraordinary event that might happen in the

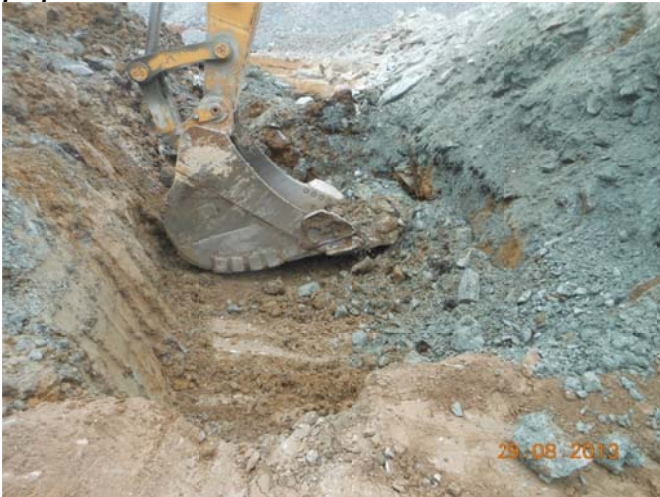
Figure 2: excavation of the foundation to permafrost / bedrock). The width of the trench at the bottom was at least one bucket wide. Note the excavated material is discarded on the upstream side.

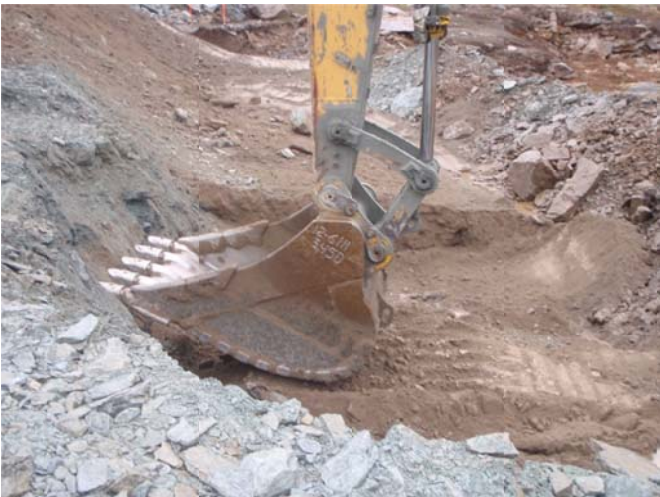
Figure 3: till placement with the excavator bucket and compaction.

Once a zone of 4-5m wide was excavated and the foundation exposed and approved by the AEM representative, a till layer of at least 500mm was placed in the excavation and compacted with the shovel bucket. The selected till was chosen to meet the specifications presented in section 3.1.3. The till was coming from a stock pile that was built in 2012 for Central dike construction, hauled with 50T trucks and dumped in the slope where it was pick up and spread with the excavator. Prior to any till placement, all the material coarser than 150mm was automatically discarded by the operator.

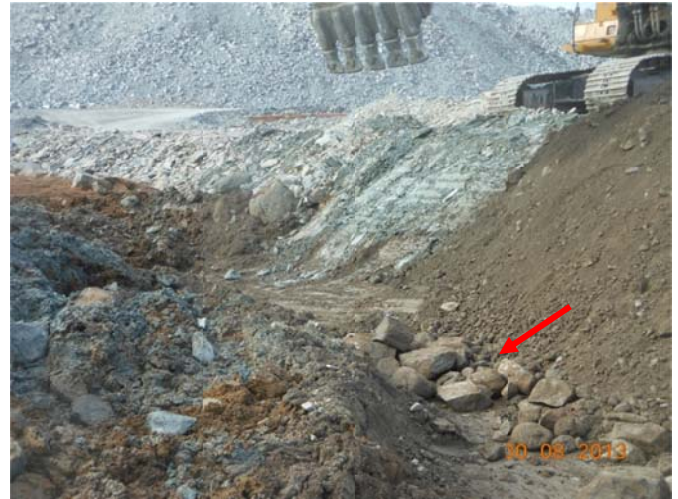
Figure 4: preparation of the transition NPAG on the roadside. Once excavation completed, soapstone was flattened and compacted before any till placement. Note the coarser material discarded from the till (red arrow).

According to the design, a transition layer 1A needs to be put in place prior to the excavation and till placement along the entire upstream side of the road (on the RSF side). As the primary constituent material of the road was already fine NPAG soapstone, the 1A layer was replaced by remodeling the in-situ material. The coarser material encountered was removed from the slope and the remaining finer soapstone was flattened and recompacted with the excavator bucket to create a 2 in 1 slope. The preparation of the road upstream slope began 1m above the high water marks left on the tundra after freshet, on both eastern and western abutments of the natural topographic low.

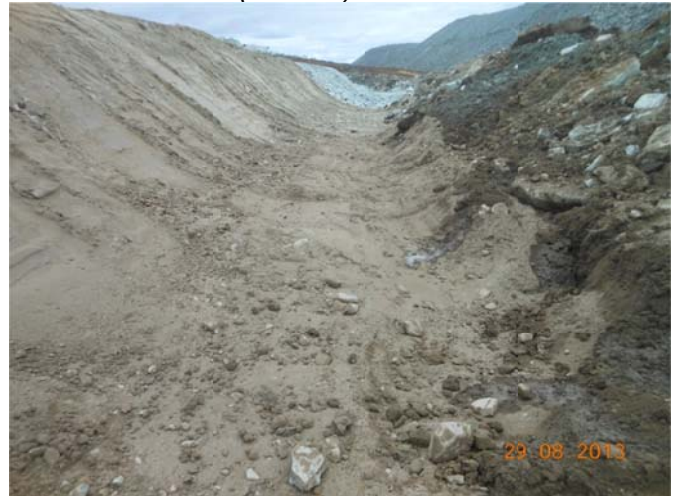
Figure 5: final till placement over an entire section after 1 day of work. The till is flattened and compacted before any rockfill placement.

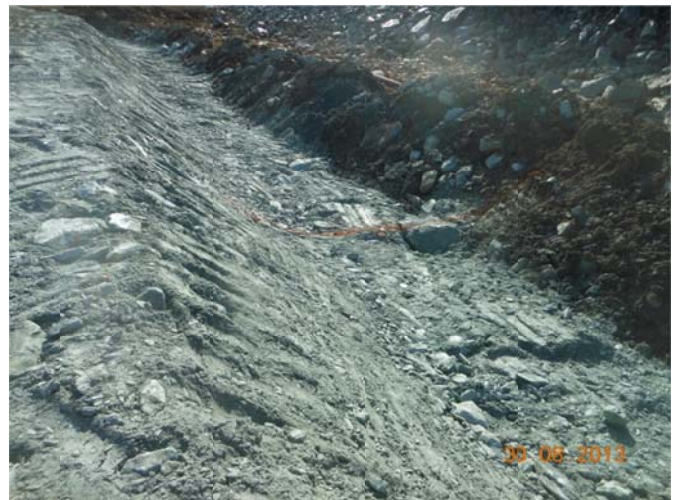
Figure 6: Final placement of soapstone rockfill protective layer (1A) over the till, once compacted.

Once the till layer was completed, a protective layer of fine filter has to be put in place to prevent any erosion of the layer. The selected material was fine soapstone that was hauled with 50T trucks from SANA. The rock was coming from Goose pit and dumped over the till blanket to be spread, placed and compacted by the excavator bucket. Every boulders or rocks over 500mm was discarded by the operator. The thickness of the protective layer was at least 500mm and has been adapted to the topography of the excavation.

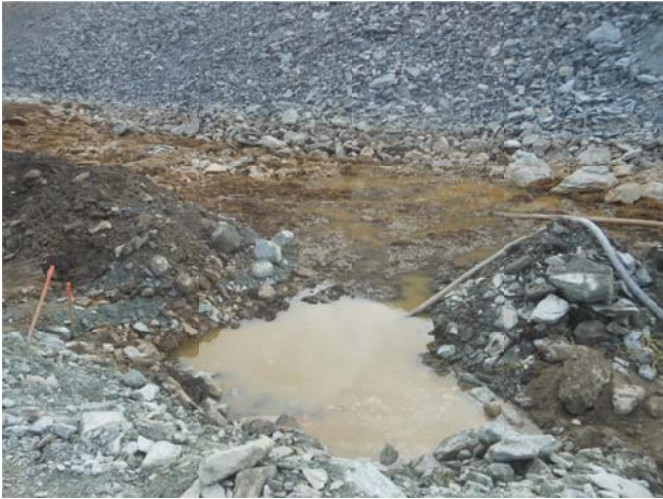
Figure 7: water accumulation along the side of the road before works begin. View of the eastern channel.

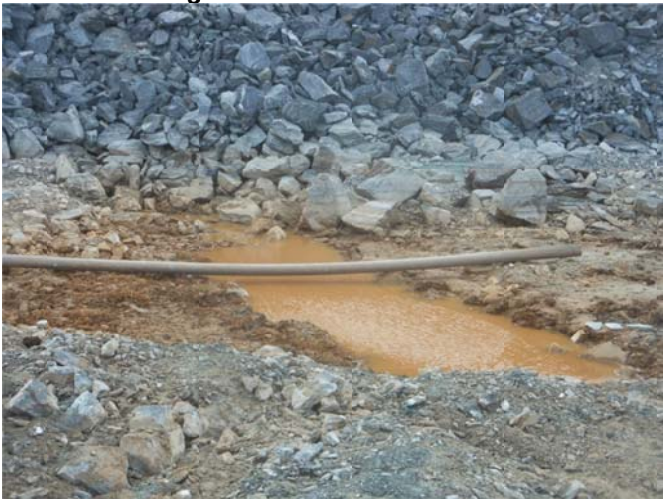
Figure 8: water accumulation along the side of the road before works begin. View of the western channel.

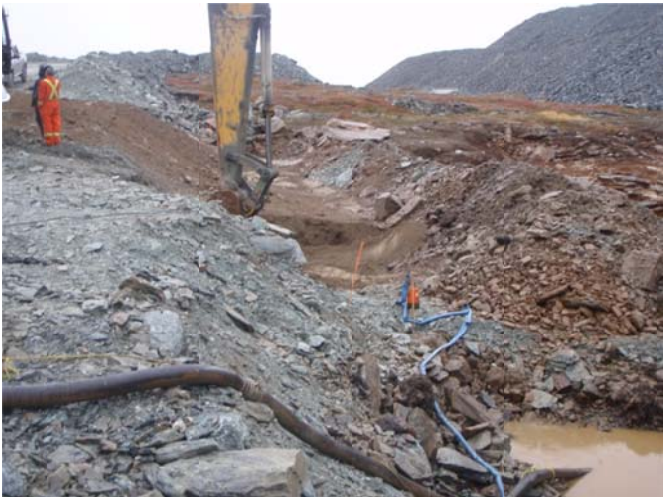
Figure 9: water control during the construction. A small 3" electric pump and a 3" diesel pumps were used.

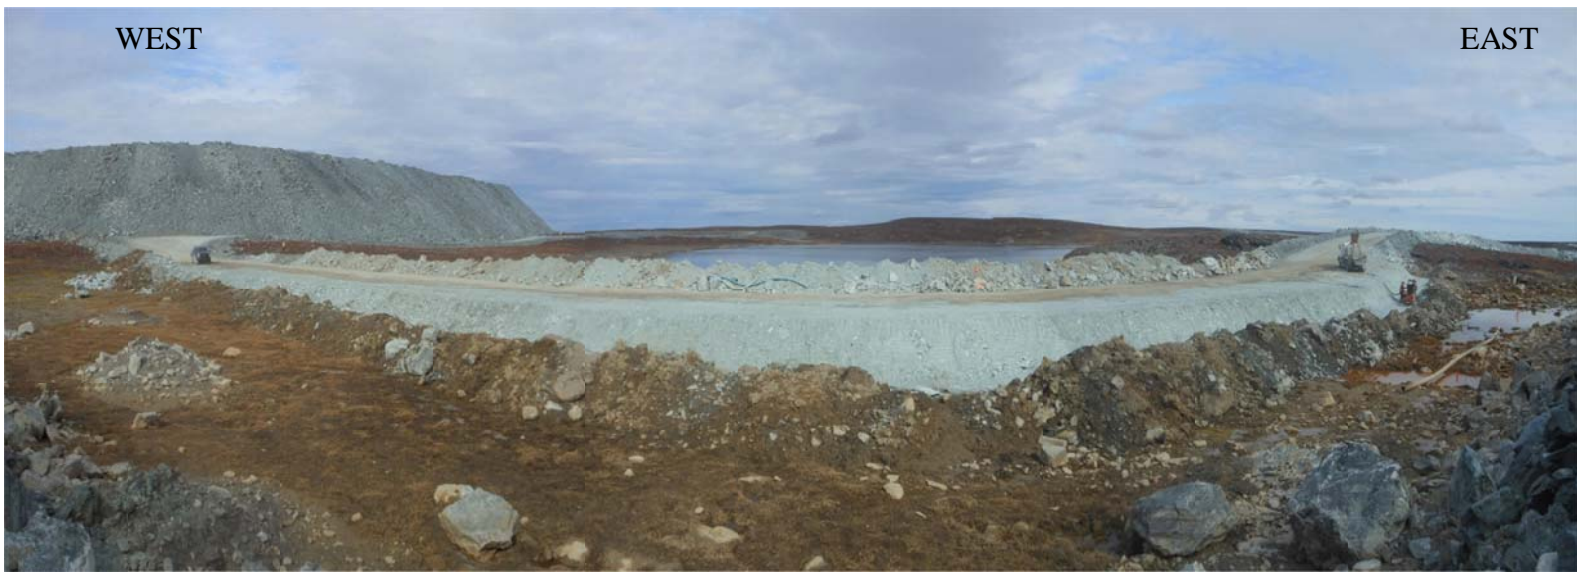
Figure 10: photo of the final result of the entire till plug from West to East. The actual pumping station and the 2 active seepage channels are visible on the eastern abutment.
