Meadowbank Division

Environment Department

Spill at km 34

Dated: August 19, 2011

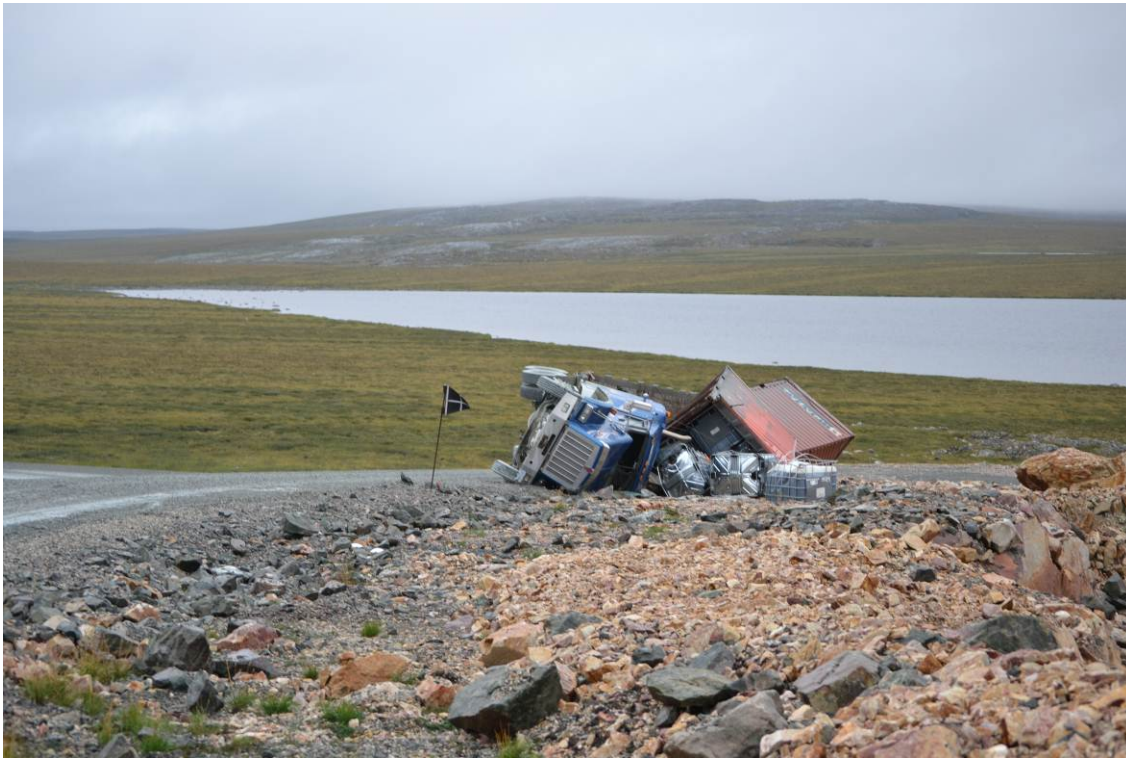
On August 19, around 20:00 o'clock, a tractor trailer loaded with two sea cans of oil flip on his side (see picture #1). The first sea can was containing 18 totes (1,000 L) of engine oil (Ralube 40) and the second one was containing 9 totes of engine oil (Ralube 40) and 8 skid of pails (20L) of roc drill oil ARDEE 32. In total, 32,760 L of oil was in the two sea cans. The material in the sea-cans were damage and leaked out of there containment. The environmental department helped by Emergency Response Team when on site to manage the situation.

Picture #1 Accident before intervention

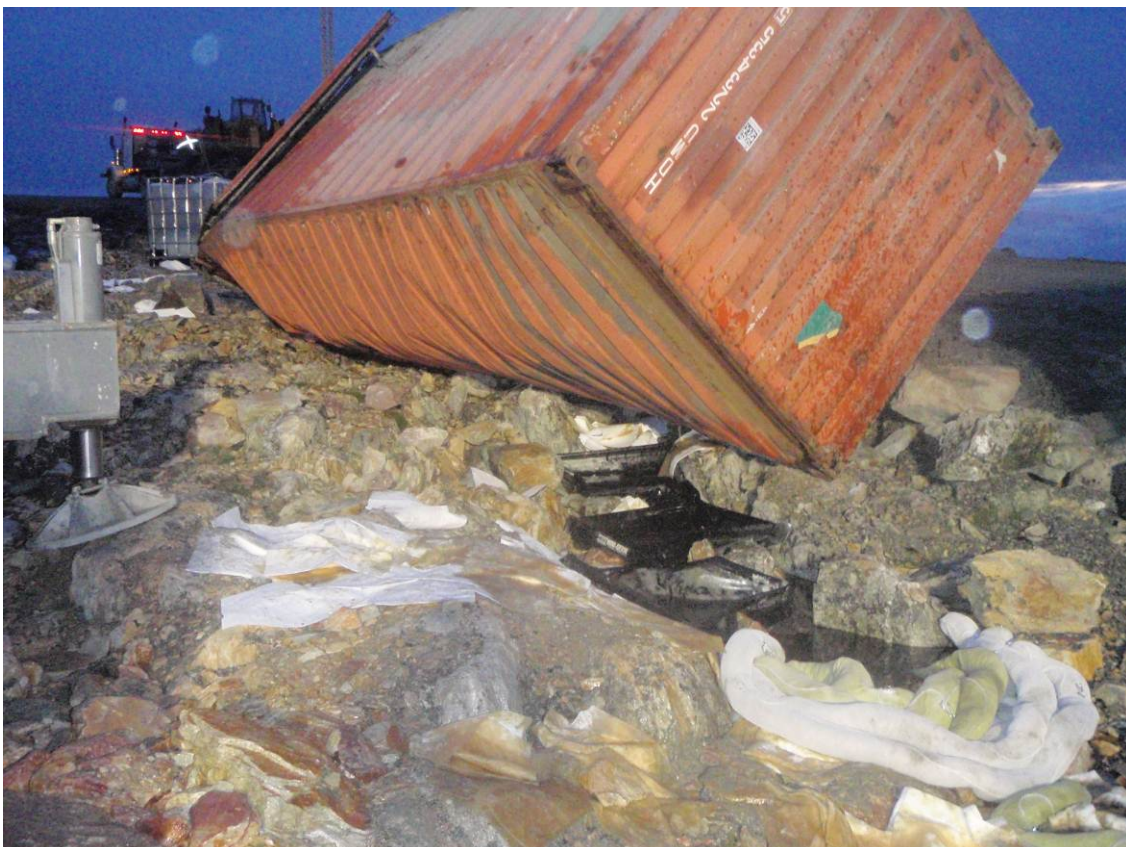
Picture #2 Leaking contained with secondary containment and absorbent booms

The first responders arrived on site secured the location and contained the spreading of the oil with secondary containment and absorbent boom. Most of the oil was recuperated with pales and transfer into drums. Once the crane arrived on site, we put the sea-cans back up on big secondary containments. Then, the oil from the damage totes (cubic meter totes) and pales got transfer with pumps and compressors into adequate containments and put in another sea-can for transportation. We recuperated 21,700L of oil. During that time, other people were cleaning up the contamination with absorbent rags (picture #2 and #3). We estimated that 11,060L of oil were spill on the ground. No water body was affected by this spill.

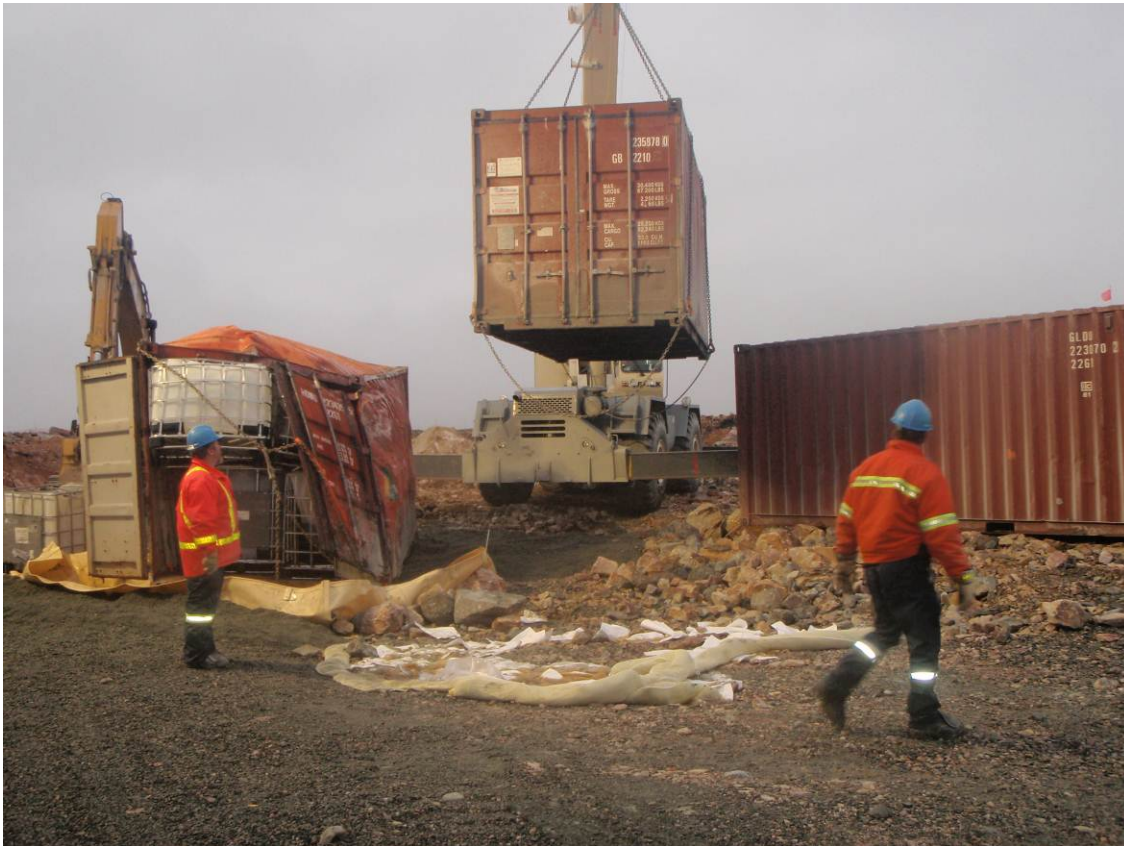
Picture #3 Damage sea-can put on the big secondary containment

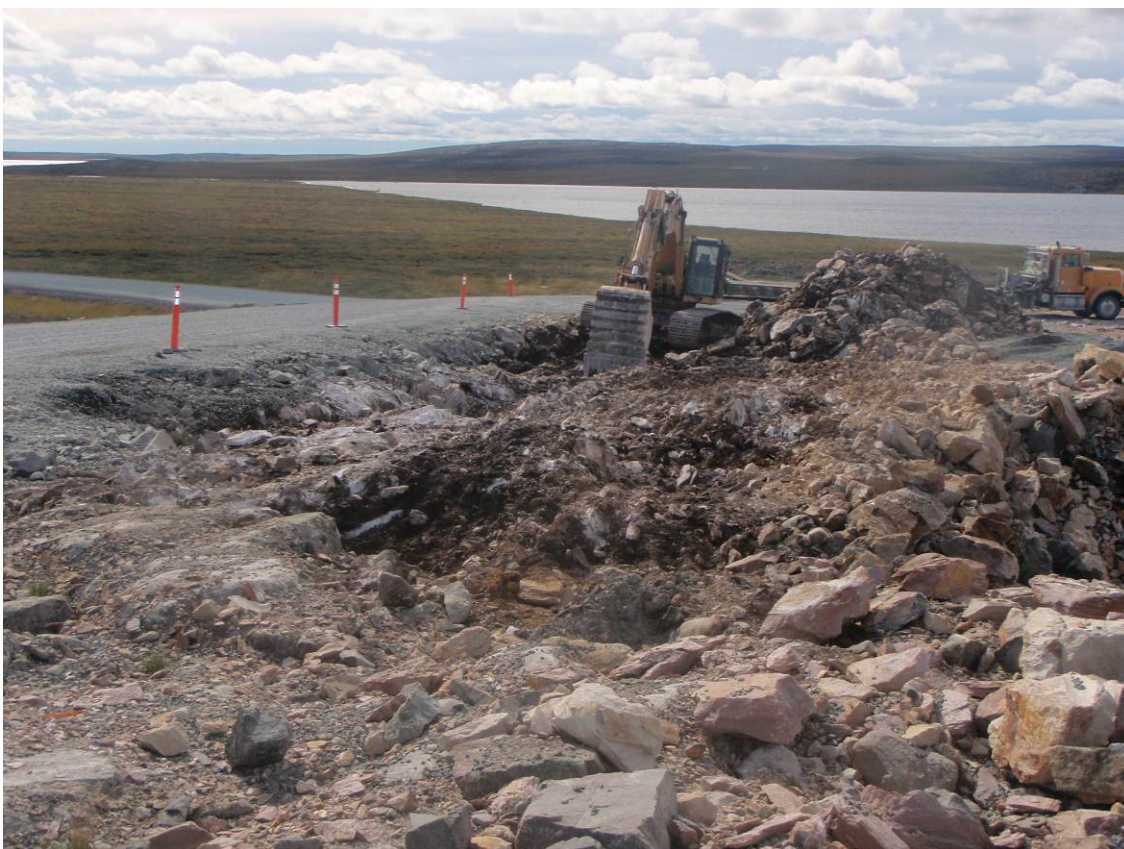
Picture #4 Excavation of the material

Once the material got picked-up and shipped, the environmental team started the excavation of the contaminated soil with a 345 shovel and a loading unit. Because of the thickness of the oil, most of the material got stuck at the surface. The hydraulic shovel dogged into the roc until no contamination could be found (picture #4 and #5). Around 100 m3 of contaminated material got ship in the quarry 5 and store in onto tarps (see picture #6).

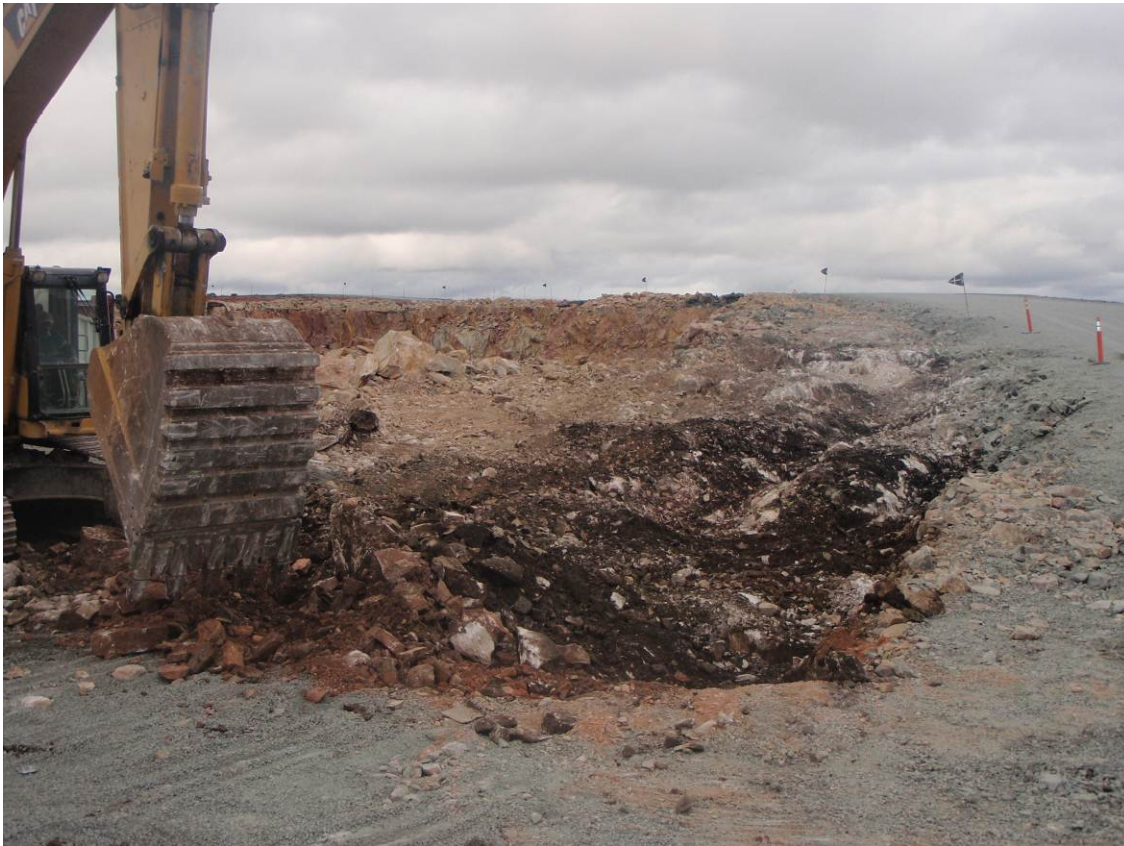
Picture #5 Excavation of the material

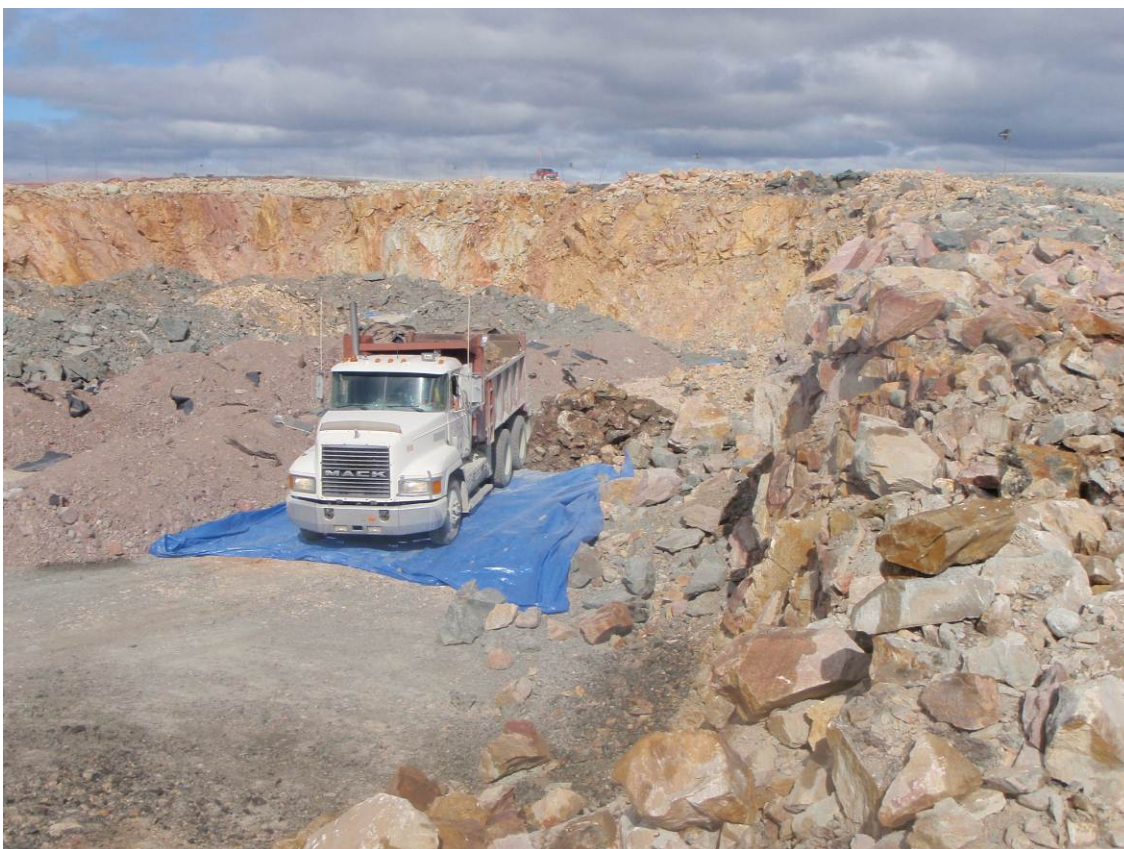
Picture #6 Storage of the contaminated soil on tarps
