## November 11th Spill

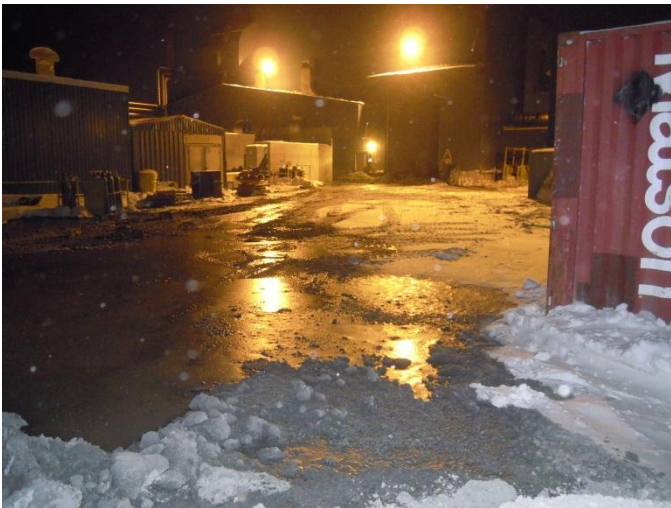
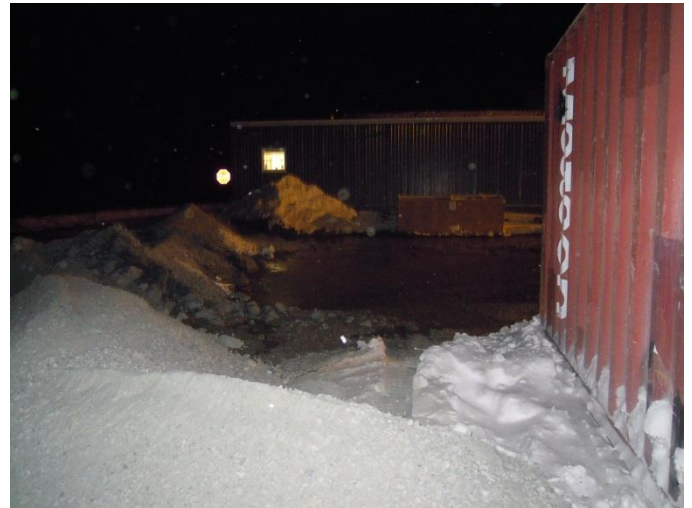
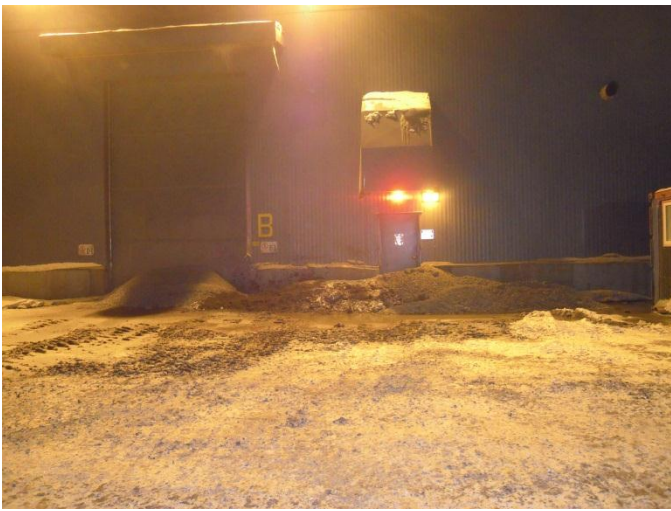
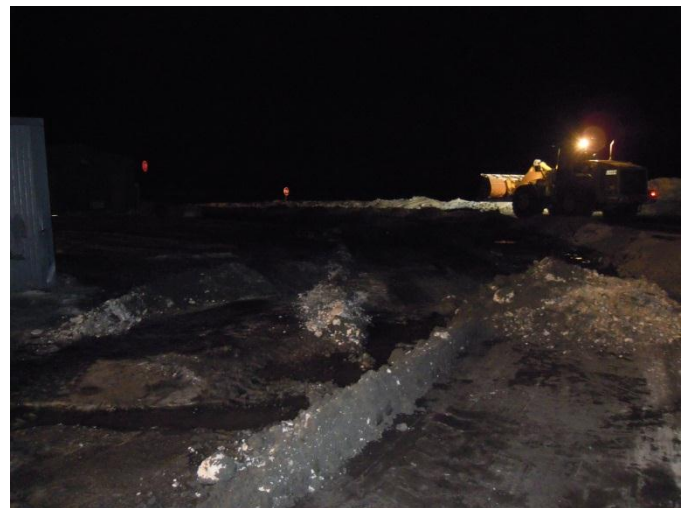
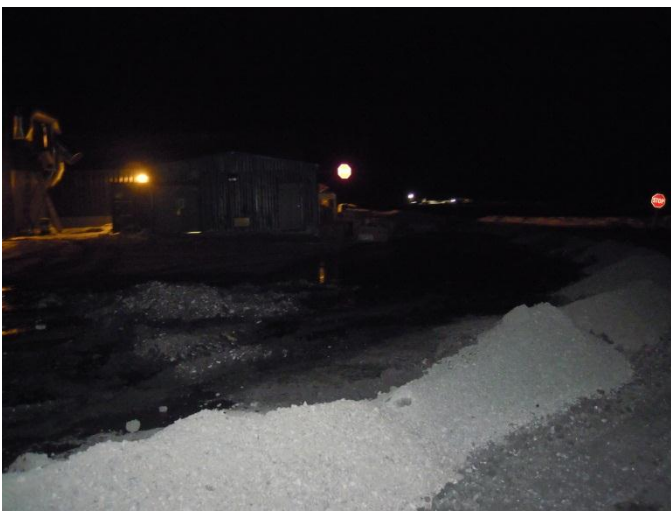
Pictures of response

Power failure at the Mill, all compressor were stop and no air available to close the Leach Gate #8. The slurry continued to feed the CIP tank with no pump running to pump it out. The pump box overflowed and flooded the Mill and eventually seeped out of the Mill. Site services and the environment crew blocked the seeping doors with material and then built berms to contain the slurry.

Final calculation of spilled quantity was at 2500L. There were no off site impact or discharge to any receiving watercourse.

- 1) Make sure there is a body jack available near the leach gallery to help closing the valve.
- 2) Installation of a pitch valve on the line that feed the CIP inside the Mill to allow us to stop the flow if unable to close the valve.
- 3) Have a gasoline generator and a compressor to be able to close the valves during power failure.

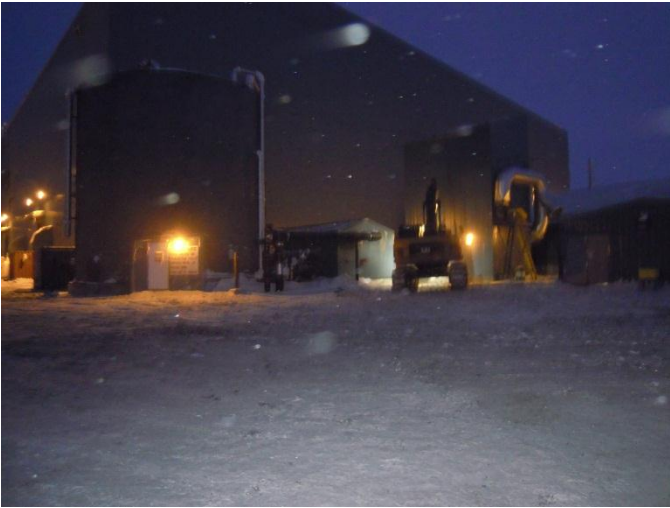
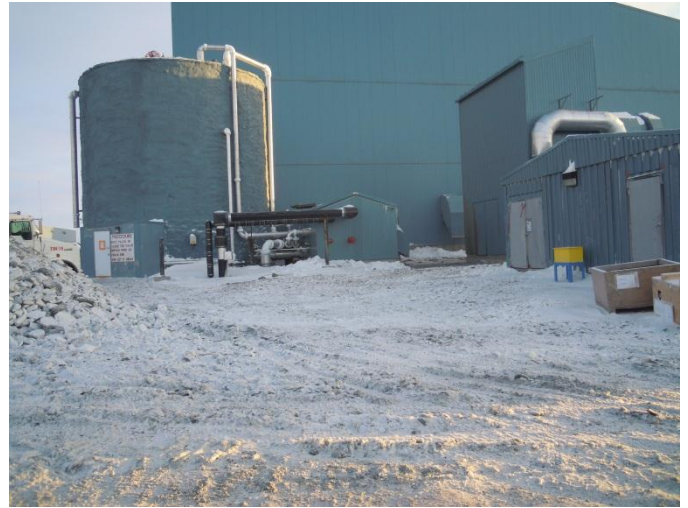
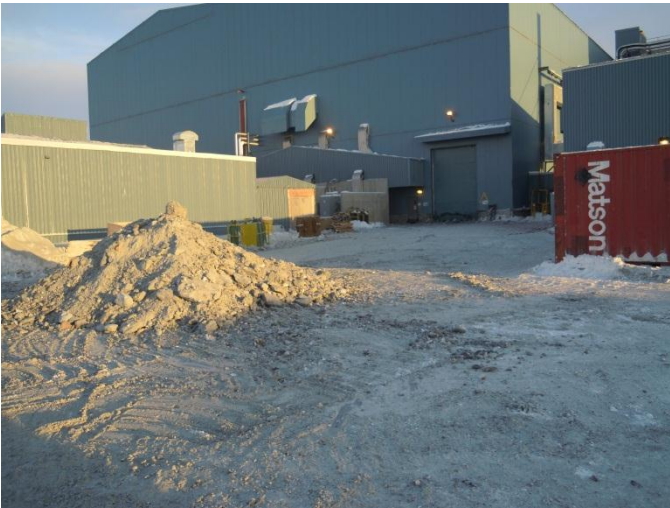
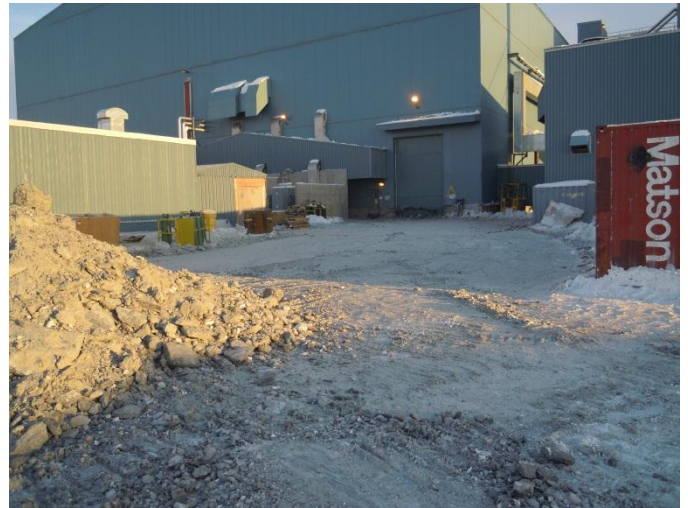
Pictures after clean up

The berms kept the material in place, making it freezing. We used two loaders to contain the material out of the road. Once everything was frozen, we used a shovel to scrap all the material and finally, grader completed the job.

Material removed was estimated at 115 m<sup>3</sup>. Everything was sent at the tailing storage facility.
