RE: Update to Meadowbank Spill – Report #13-379 – Assay Lab Road Seep

This letter is intended to give a resume of the spill report GN Spill Report 13-379 that was submitted on November 8, 2013

Mill Leakage Investigation

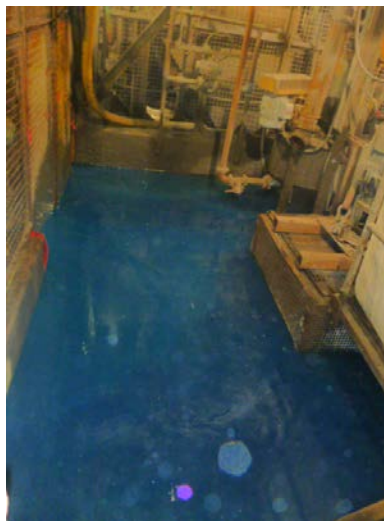
- To try and determine the source of the leakage, water was added to the sumps with tracer dye within the Mill. By doing this, the location of the seepage was determined to be in the CIP sump.

- The seepage area increased due to the testing of the sumps and water seeped out of the previous reported location as well as an adjacent area at the base of the assay lab road. Another containment berm was immediately constructed, this water was sampled (CN WAD taken at our on-site assay lab = 4.23ppm Copper = 2.55, Iron = 1.64). Please note the attached diagram for reference. Additional samples will be sent to our off site accredited lab on Monday Nov 18. Samples were also taken in Third Portage Lake using AEM's on site assay lab. Results to date indicate "no detect" in the lake. See attached table of sample results and location.
- Crews removed any build of ice in this area and continue to remove it on a regular basis.

- AEM is now working on a plan to properly seal the CIP sump, in the meantime all water has been removed from this sump to prevent any further seepage and allow for repairs.
- The bermed containment area is to prevent access to wildlife and unauthorized personnel.

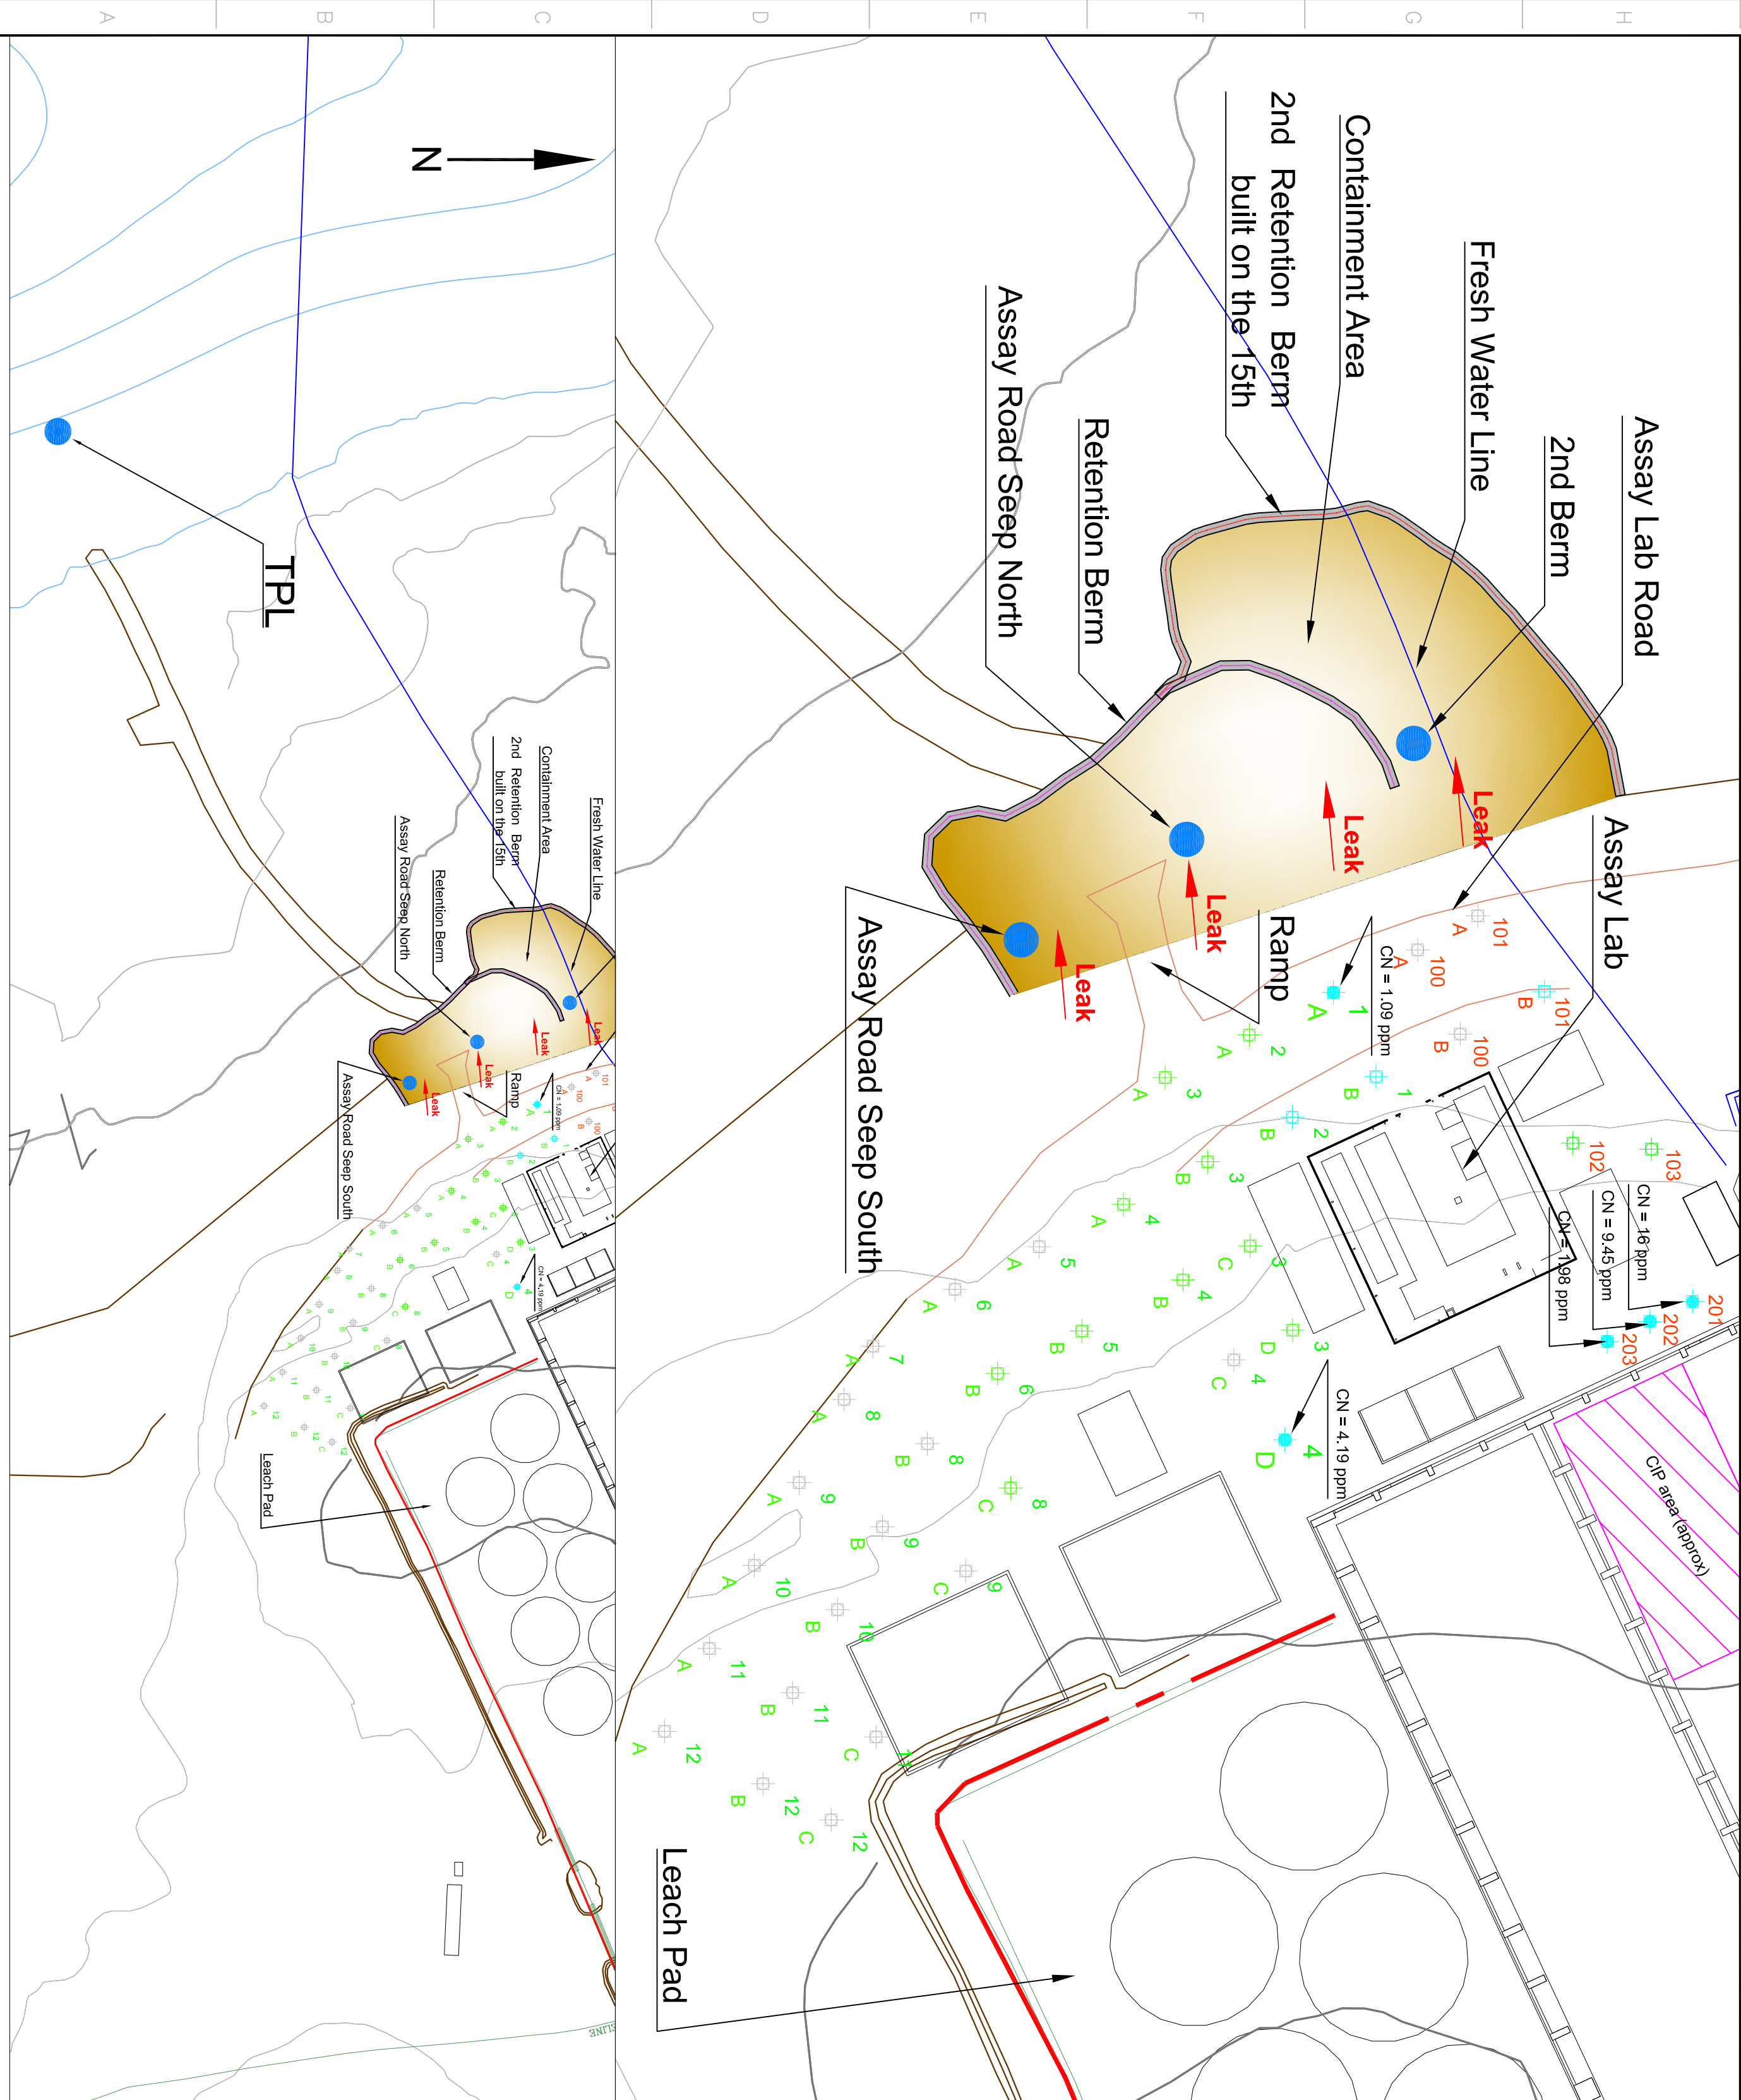
- No process water has reached lake (contain in the berm area)
- Investigations took place through-out the mill area to determine where the source of process water was leaking from
- A drilling campaign took place Nov 15 – 17, with a total of 21 holes being drilled the seep location and the mill area (see figure 1). Out of the 21 holes,
 - 4 holes were wet and sample water was obtained (blue)
 - 4 holes were drilled and wet and no sample could be obtained
 - 13 holes were drilled dry (green)
