July 4, 2015 Spill

Please find the following information as a follow up to the Spill report submitted February 18th, 2015 by Agnico Eagle Meadowbank division. This detailed report is submitted to the Inspector in compliance with the conditions under the Nunavut Water Board License 2AM-MEA0815, Part H, Item 9c.

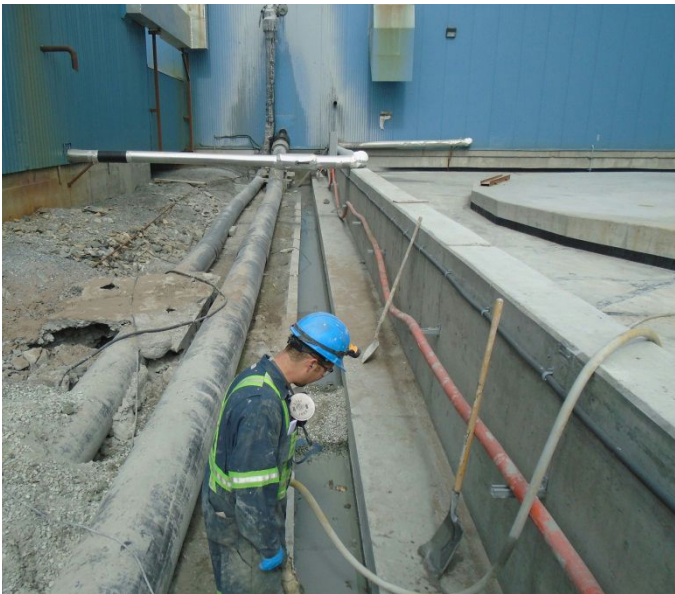
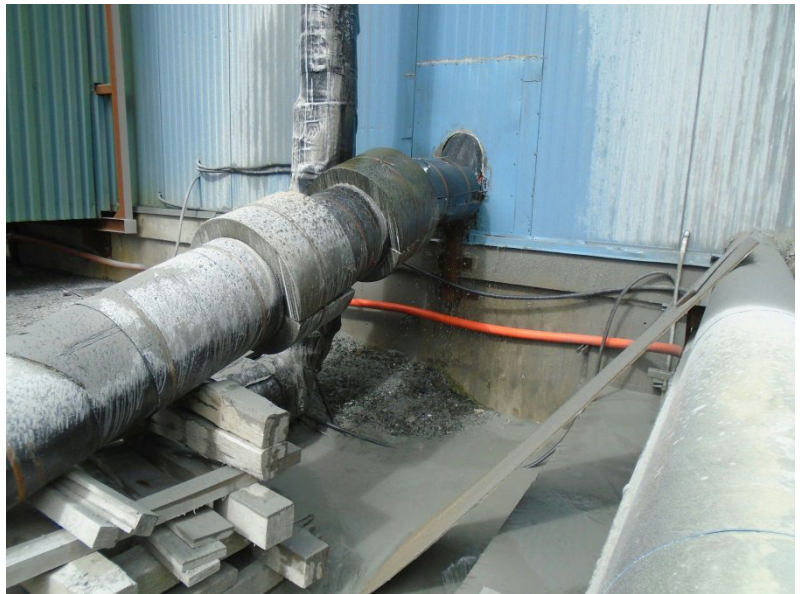
After investigation it was found that the weld of the plastic "Y" broke. No significant wear was noted on the piping outside the mill. Movement of the pipe attributed to the failing of the weld.

Clean up was immediately initiated by shovelling and pumping the slurry back into the leach pad containment. The “Y” that broke was replaced, and tailings deposition recommenced.

The Mill maintenance group has added a better support to the location in which the “Y” is located. In addition, as part of the preventative maintenance program, the “Y” will be inspected annually and changed if any irregularities are noted.

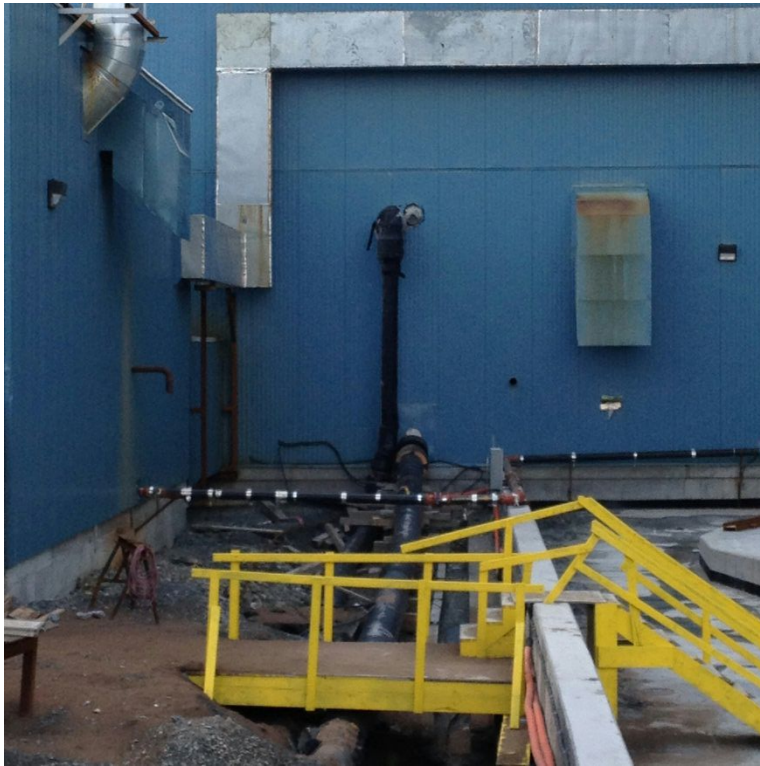
All spilled slurry was contained in the tailings line ditch. There was no threat to any receiving waters.
