## **July 24th, 2015 – Tailings Spill RF1, TSF**

Please find the following information as a follow up to the spill report submitted July 25<sup>th</sup>, 2015 by Agnico Eagle Meadowbank division, related to the tailings spill that occurred on July 24<sup>th</sup>, 2015 at the tailings storage facilities (TSF). This detailed report is submitted in compliance with the conditions under the Nunavut Water Board License 2AM-MEA0815, Part H, Item 9c.

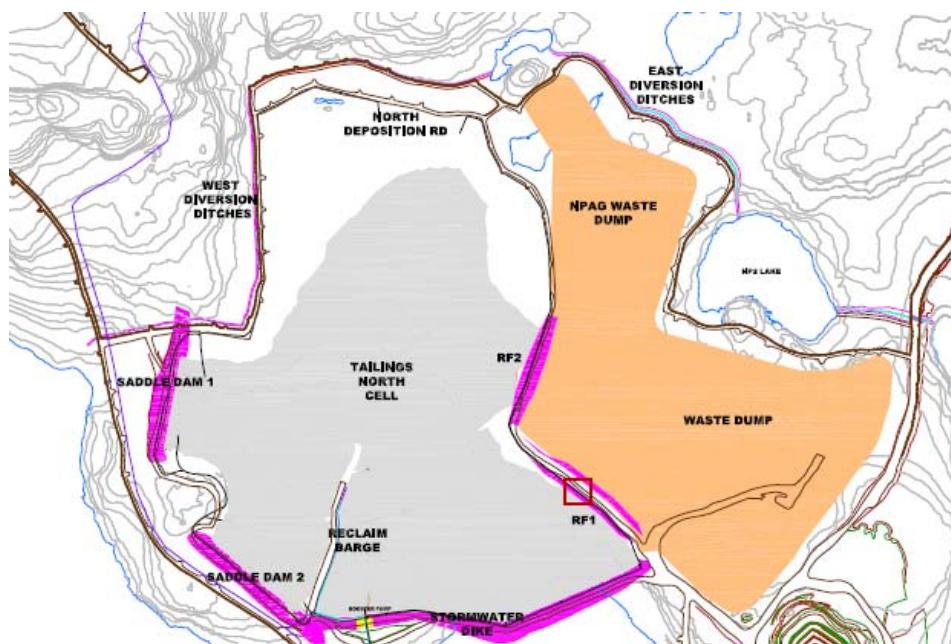
The spill occurred on July 24<sup>th</sup>, 2015 at 9h50 am (CT). The spill occurred during the change of tailings deposition point to E13 along the Rock Fill Road 1 (RF1) in the North tailings Cell (TSF). Shortly after the tailings slurry was sent to point E13, a leak was identified on the tailings pipe. The pipe was damaged during the winter time and the crack was located under the pipe, below the pipe insulation layer. The damage was not observed during the pipe inspection prior to the spill as it was under the insulation layer. Figure 1 presents the approximate location of the spill and Photo 1 presents the pipe damage.

**Figure 1 – Approximate location of the tailings slurry spill on RF1 from July 24<sup>th</sup>, 2015**

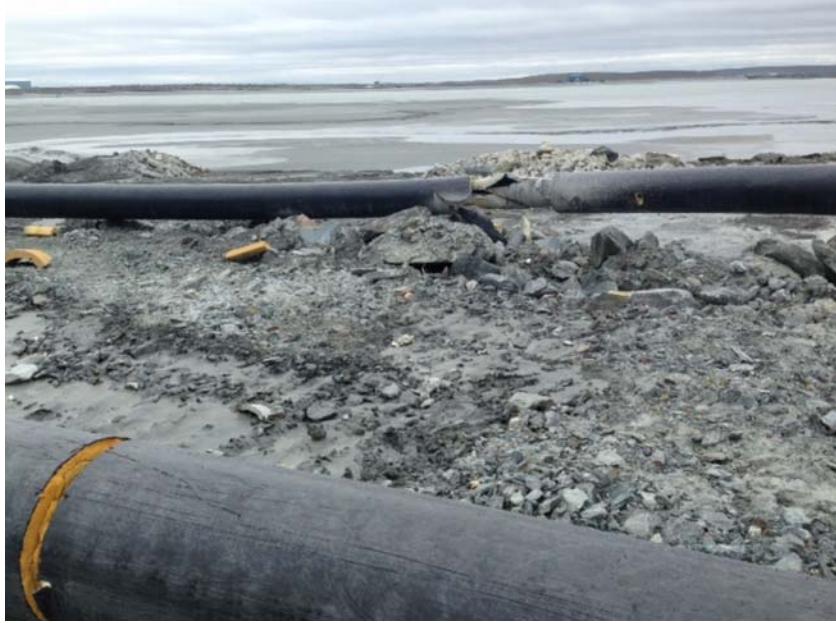
**Photo 1 – Pipe damage after the removal of insulation cover**

In the future the Dike & Dewatering Team (in charge of the tailings deposition) will thoroughly inspect the piping prior to further deposition point moves and use the air compressor to identify any possible leaks on the pipe. The pipe was likely damaged during the winter by equipment used for snow plowing. Prior to next winter, equipment operators will be met to emphasize the importance of reporting incidents when the pipe is touched or damaged by equipment.

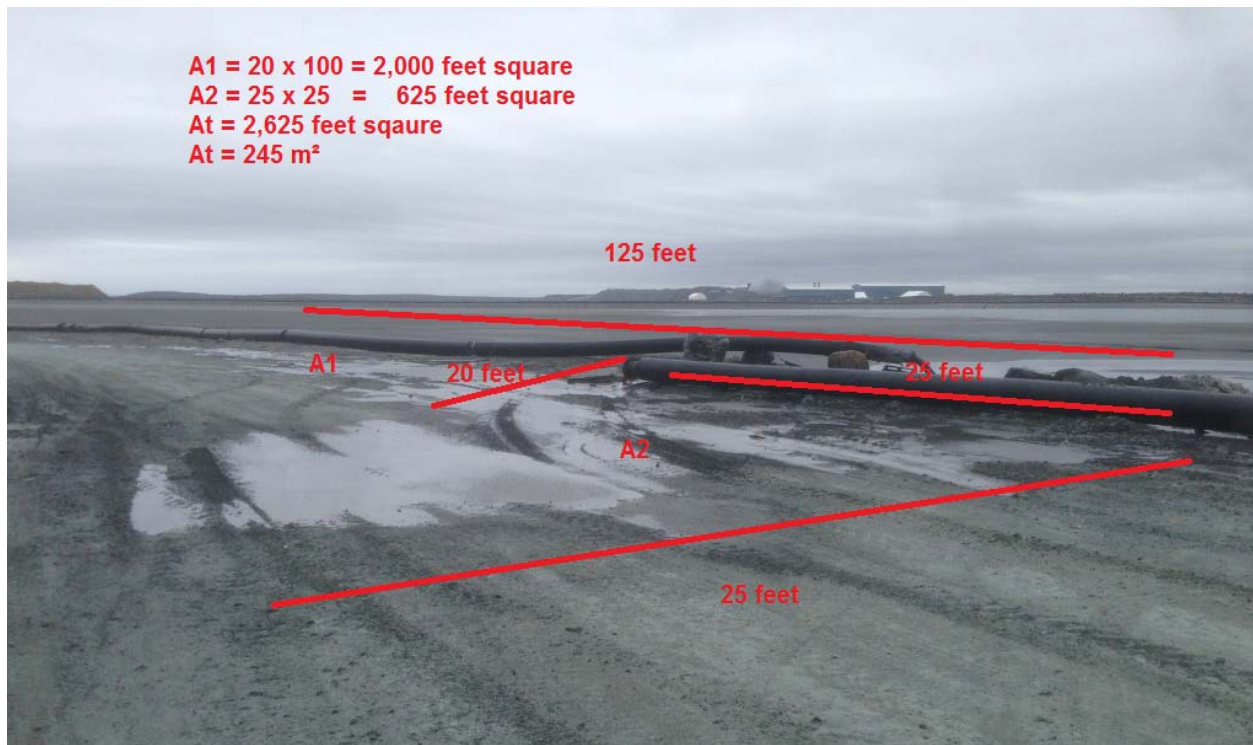
The slurry went over the surface of the RF1 and also on the slope towards the TSF impoundment. An area of approximately  $245 \text{ m}^2$  on the surface of the RF1 was contaminated with tailings slurry, as presented on Figure 2.

**Figure 2 - An area of approximately 245 m<sup>2</sup> on the surface of the RF1 was contaminated**

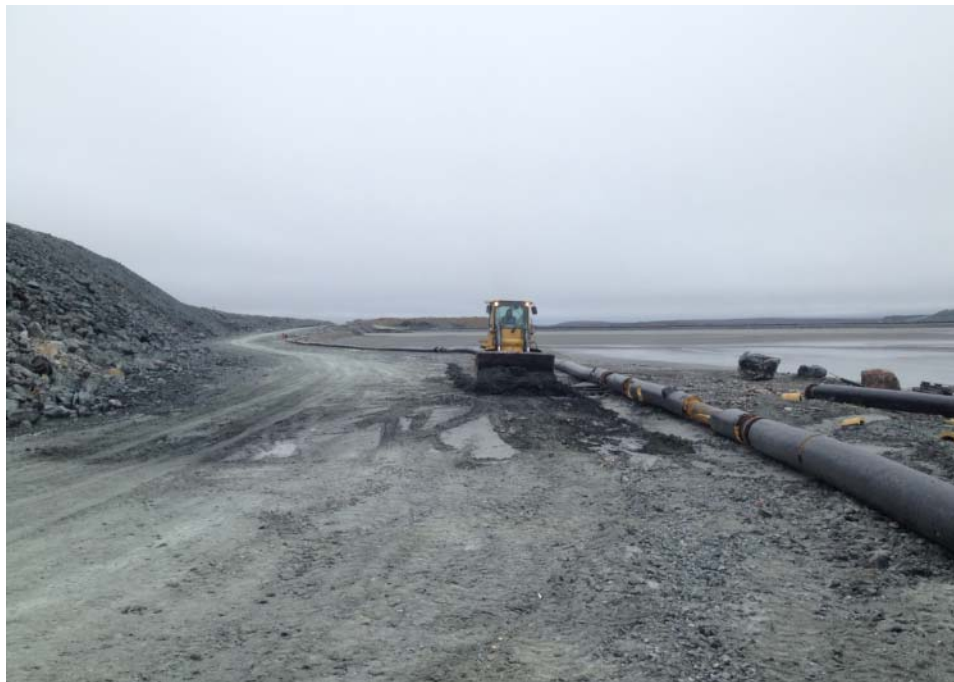
**Photo 2 – Cleaning of the RF1 contaminated surface with the loader**

Clean up was started on the morning of July 25<sup>th</sup>, 2015. As presented on Photo 2, the loader scraped the contaminated surface of RF1 to remove all the tailings slurry and contaminated soil. The contaminated material was then disposed in the Tailings storage facility impoundment by the loader, as presented on Photo 3. Clean aggregates were then placed on the surface of the road. Photo 4 shows the surface of the RF1 after the cleanup was completed.

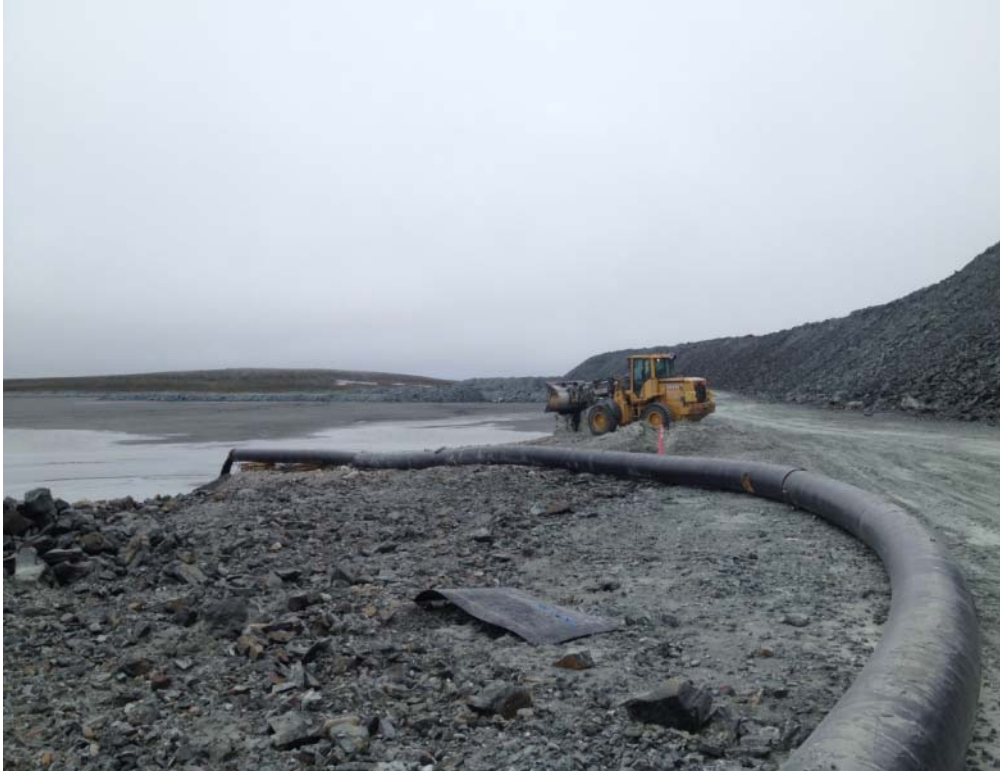
**Photo 3 – Disposal of the contaminated soil in TSF**

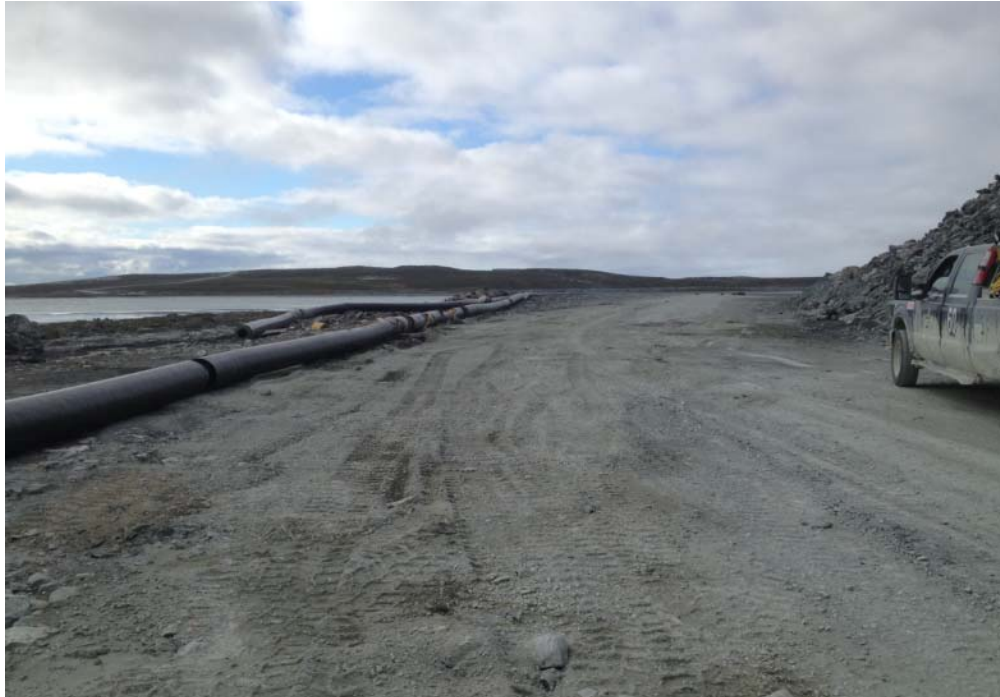
**Photo 4 – RF1 surface after cleanup activities**
