Spill September 18th, 2015 – Follow Up Action Report

Please find the following information as a follow up to the Spill report submitted September 19th, 2015 by Agnico Eagle Meadowbank division. This detailed report is submitted to the Inspector in compliance with the conditions under the Nunavut Water Board License 2AM-MEA1525, Part H, Item 8c.

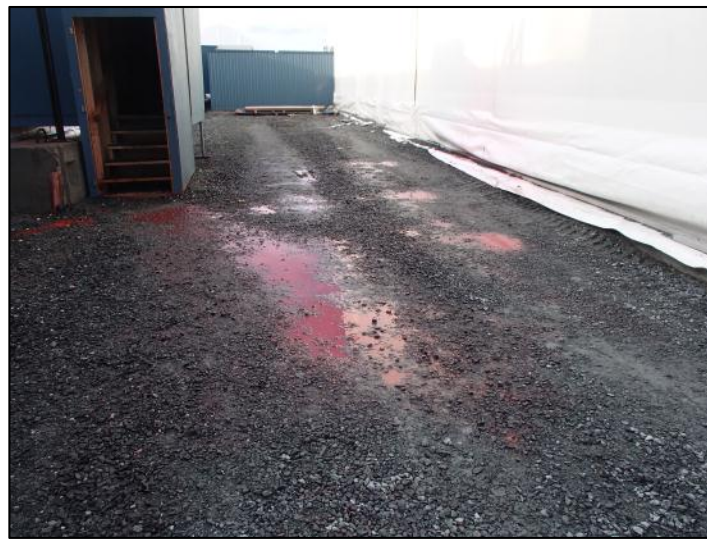
On September 18th 2015, when moving a pallet of material between the Arctic Corridor (corridor between the Service Building and the Mill, see Figure 1) and the Warehouse Dome, a loader damaged the glycol pipe of the heating glycol system, resulting in a spill of glycol. Quickly the valve of the system was closed to prevent any more spillage. Absorbent pads were immediately put on the ground to absorb glycol. Approximately 900 liters of glycol were spilled on the ground and along the building. The quantity was determined based on the amount of glycol used to refill the heating system after the spill. The contaminated area is approximately 60 m² along the building. Photo 1 shows the contaminated area after the spill. The spill occurred in an area at approximately 375 meters from the closest watercourse and there is no threat to any receiving watercourse.

Photo 1 – Contaminated area, September 18th 2015

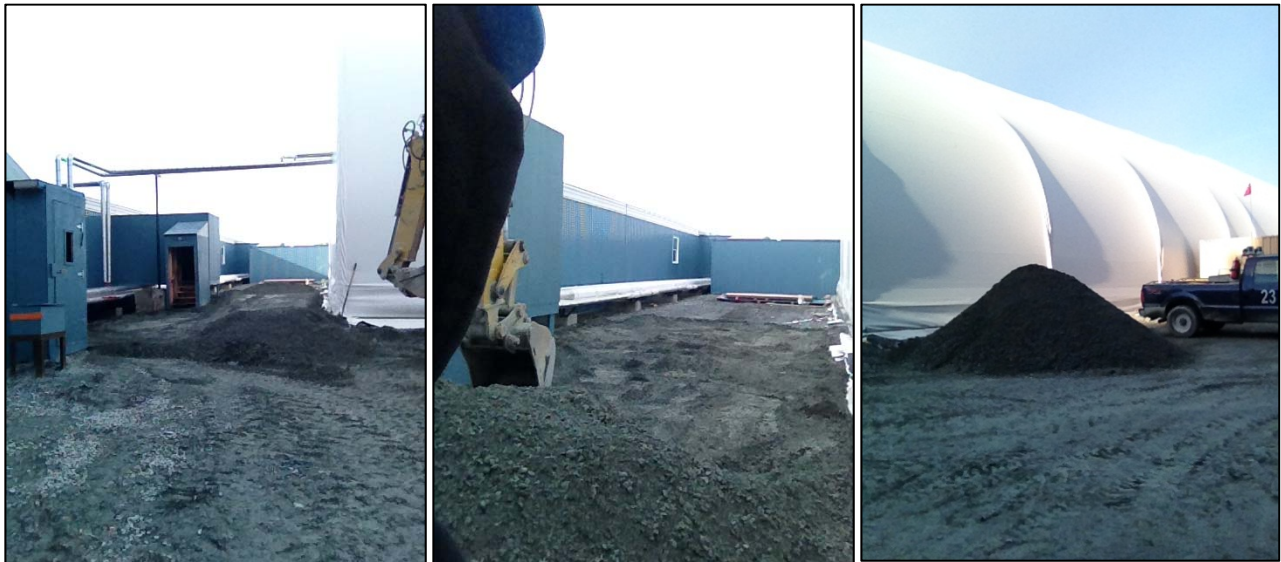
Photos 2, 3, 4 – Clean-up and contaminated soil excavation, September 19th 2015

On September 19th, the contaminated area along the Arctic Corridor was cleaned. Contaminated material has been removed from the area with an excavator. It is possible that some spillage may have migrated downward to an electrical cable corridor and/or along the building foundation. The area was cleaned as much as possible

and all the contaminated material was placed in one pile. Approximately 2.5 m³ of material was excavated. This contaminated material was placed in a roll-off bin and disposed in the North Cell tailings pond area. See Photos 2 to 4 showing the clean-up work, and Photo 5 showing the area after clean-up. Absorbent pads have been disposed in Hazmat storage.

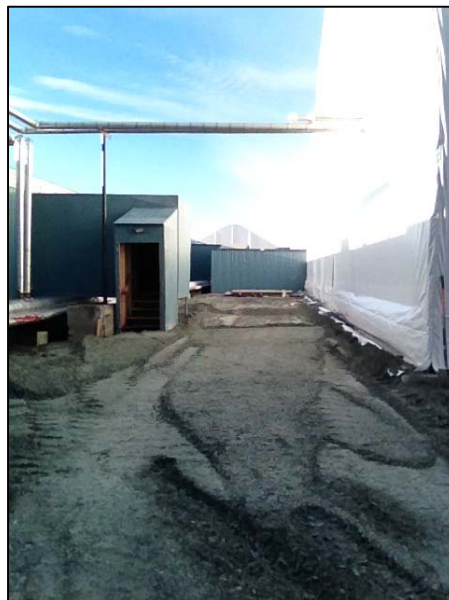
Photo 5 - Area after clean-up action, September 19th 2015

At closure, after the site buildings have been dismantled, this area will be reassessed to determine if any residual remains. If so, further clean up activity will ensue.
