<u>Spill September 4th, 2015 – Follow Up Action Report</u>

Please find the following information as a follow up to the Spill report submitted September 4th, 2015 by Agnico Eagle Meadowbank division. This detailed report is submitted to the Inspector in compliance with the conditions under the Nunavut Water Board License 2AM-MEA1525, Part H, Item 8c.

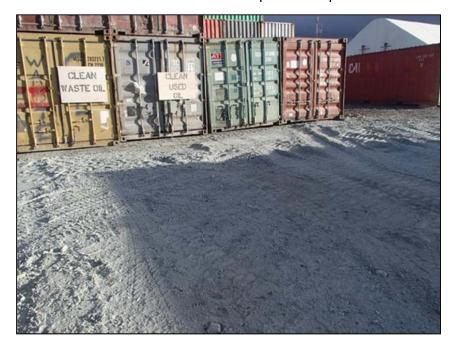
Photo 1 - Area after clean-up action

The waste oil left in the broken tote was pumped into another empty container. The contaminated soil in the area was quickly collected with a loader and put in a roll-off bin to be brought at our landfarm area at Meadowbank. The Photo 1 shows the area after the clean-up was completed.
