## October 11th, 2015 – Tailings Spill RF2, TSF

Please find the following information as a follow up to the spill report submitted October 11<sup>th</sup>, 2015 by Agnico Eagle Meadowbank division, related to the tailings spill that occurred on October 11<sup>th</sup>, 2015 at the tailings storage facilities (TSF). This detailed report is submitted to the Inspector in compliance with the conditions under the Nunavut Water Board License 2AM-MEA1525, Part H, Item 8c.

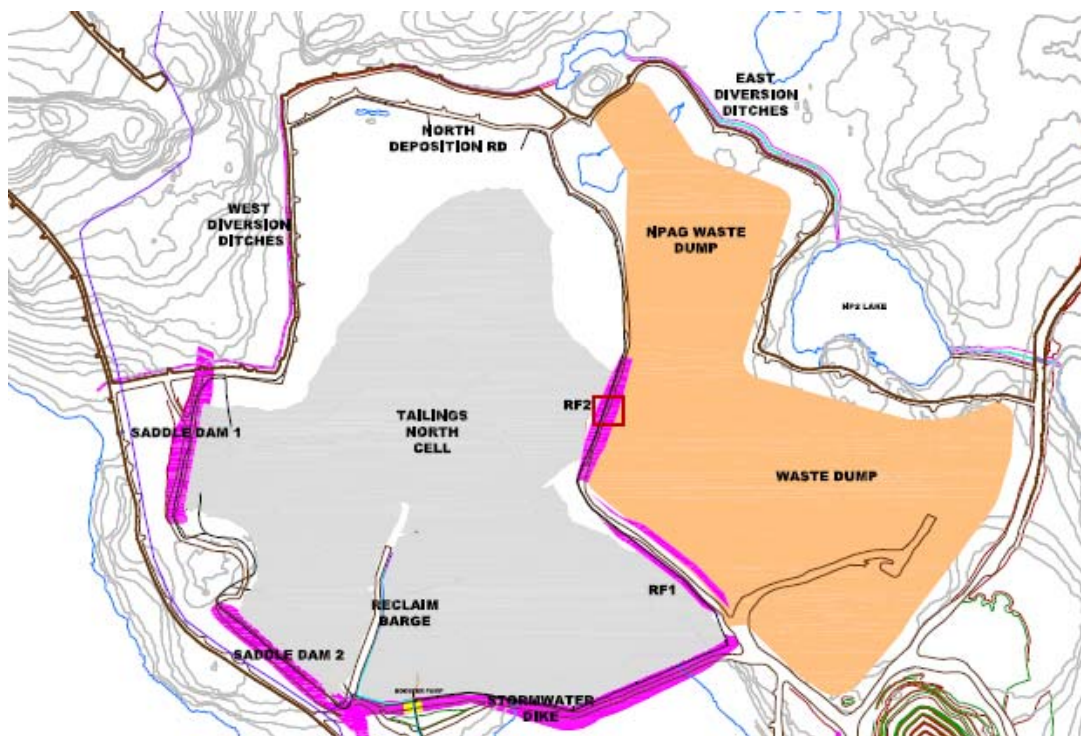
While switching the tailings deposition point in the North Tailings Cell, a spill of approximately 500L of tailings slurry occurred on RF2 (Rockfill Road 2). RF2 is a peripheral structure of the North Tailings Cell. After the deposition point change, while unflanging (separating) the inactive tailings pipe to complete the pipe clean up, some residual slurry left in the pipe spilled on the road surface, as the other extremity of the pipe was located at a higher elevation.

Figure 1 – Approximate location of the tailings slurry spill on RF2 (TSF) from October 11<sup>th</sup>, 2015

In the future the Dike & Dewatering Team (in charge of the tailings deposition) will inspect and ensure that the tailings pipe is clean and does not contain tailings slurry that could spill when unflanging (separating) the pipe, especially if one extremity of the pipe is located in a higher elevation.

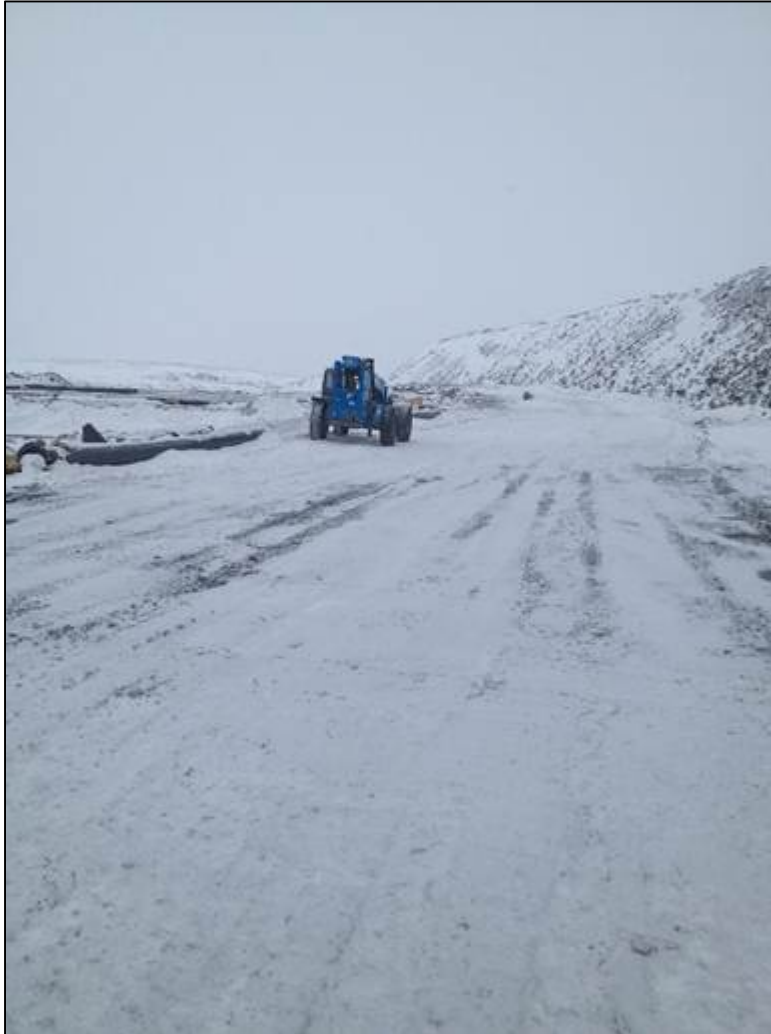
The slurry was confined over the RF2 structure and within the tailings facility area. An area of approximately 10 m<sup>2</sup> was contaminated by the tailings slurry. Immediately after the spill occurred on October 11<sup>th</sup>, 2015, the slurry and the contaminated material were collected with a loader. The loader scraped the contaminated surface of RF2 to remove all the tailings slurry and contaminated soil. The contaminated material was then disposed in the Tailings storage facility impoundment by the loader. Photo 1 shows the area after the completion of the clean-up.

**Photo 1 – RF2 surface after cleanup activities, October 11<sup>th</sup> 2015**
