November 26, 2015 Vault hydraulic spill (2015-478)

Please find the following information as a follow up to the Spill report submitted November 26th, 2015 by Agnico Eagle Meadowbank division. This detailed report is submitted to the Inspector in compliance with the conditions under the Nunavut Water Board License 2AM-MEA1525, Part H, Item 8b.

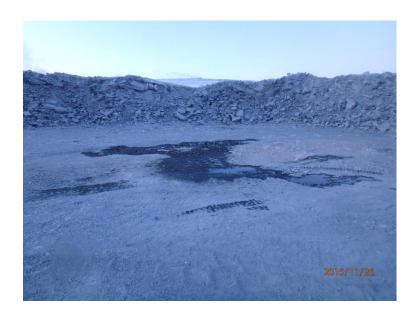
In the process of removing oil from the tank of Loader 13, the spring loaded valve for draining did not release. And therefore could not close. The mechanics had the valve closed again as quickly as he could.

Upon closure of the valve, the mechanic notified his supervisor. The loader was removed from the area and the spill contained on location. An estimated amount of 300 liters of oil was calculated to be spilled, using the volume added to the equipment after it was moved.
