Remediation

Prevention

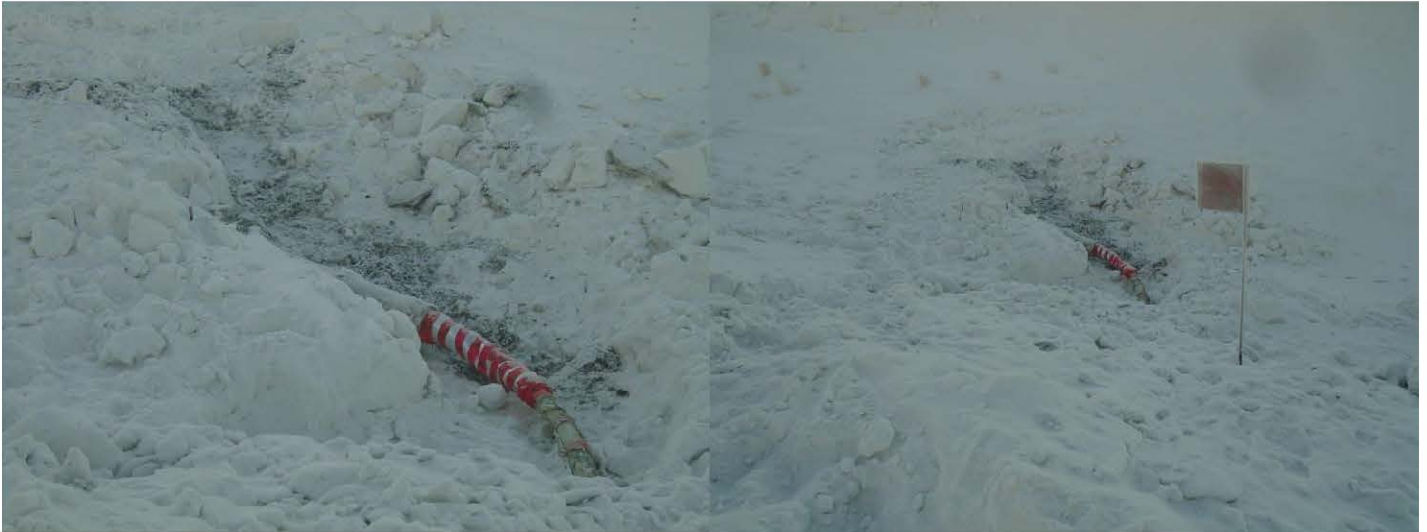
A vacuum truck was used for approximately an hour to remove the sewage. The ground was frozen so the sewage remained on surface. The ground was clean after the use of the vacuum truck. Electrical cables and pipes are also located in this area, which made clean-up more difficult.

The joint was completely taken apart, reinstalled and checked for leaks after reinstallation. It was also inspected frequently on the subsequent days by the STP operator and plumber. The pipe will also be visually checked when it will be completely accessible.
