## December 18, 2015 Laydown spill

Please find the following information as a follow up to the Spill report submitted December 18<sup>th</sup>, 2015 by Agnico Eagle Meadowbank division. This detailed report is submitted to the Inspector in compliance with the conditions under the Nunavut Water Board License 2AM-MEA1525, Part H, Item 8b.

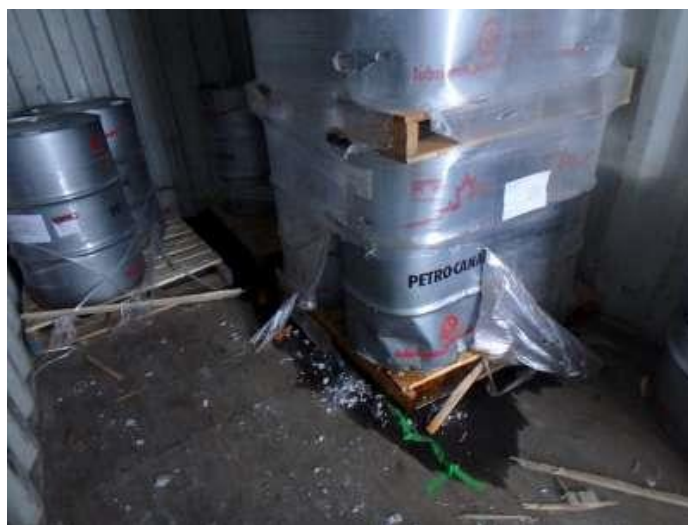
When a warehouse operator entered the c-can to get a drum of Endurex EP150 oil for delivery for use on site, he noticed that one drum was empty and some spilled oil was visible on the floor. After investigation, it was found that the drum was probably punctured in a previous handling of the material inside the c-can without being noticed. Puncture occurred when the forks of zoom-boom went through drums that were behind the ones being handled.

Procedure for handling and use of zoom-boom was reviewed by warehouse crew. Emphasis was also put on Supervision Formula used on site, specially the inspection phase.

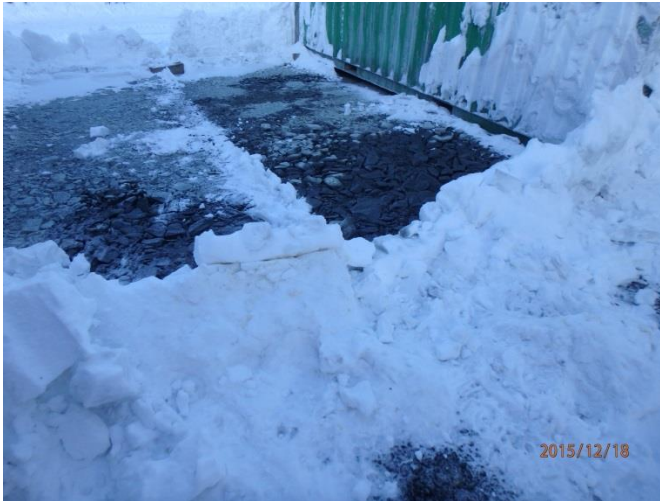
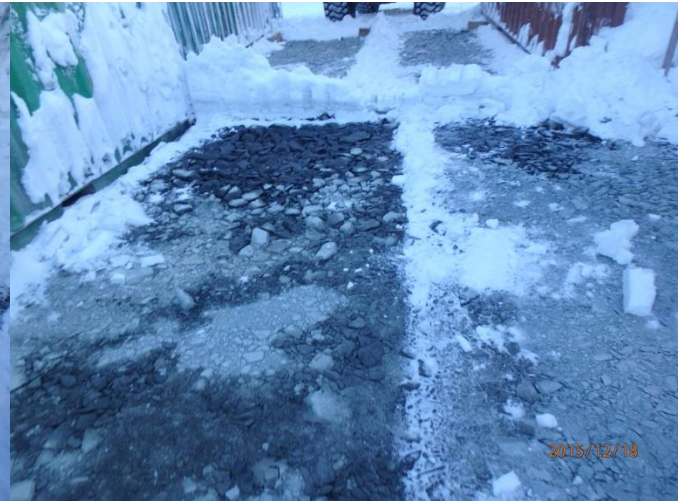
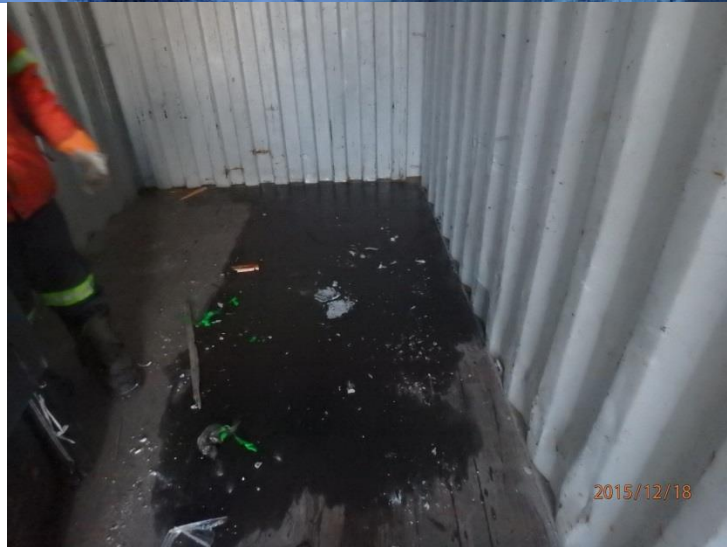
Upon noticing the drums, warehouse proceeded to empty the c-can to assess if any oil spilled outside. Upon being emptied and moved to the side, some oil was observed on the ground. From the 205 liters capacity of the drums an estimated 150 liters went on the ground with the remaining 55 liters staying inside the c-can.
