January 23rd, 2016 Pit E3

Spill Description

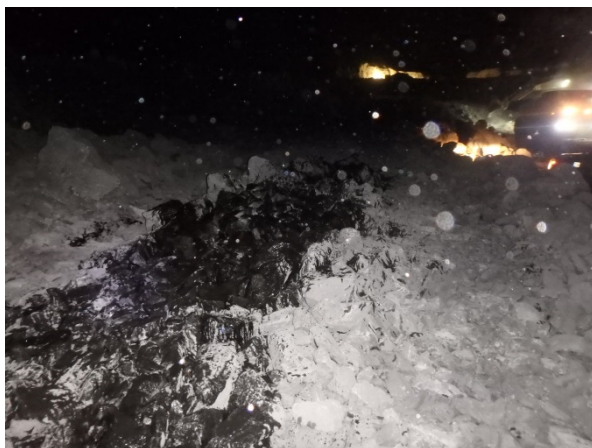
On January 23rd 2016, the main hydraulic hose on backhoe #8, working in Pit E3, failed and caused hydraulic oil to be spilled on the ground. The quantity of hydraulic oil spilled was 300 liters, and the area of contamination was 30 m² after the equipment was moved for clean-up. The spill was contained on location the hose was repaired.

Hydraulic hose on backhoe #08 failed while working in Pit E3 mainly due to cold weather conditions.
