January 25th, 2016 Vault Pit

Spill Description

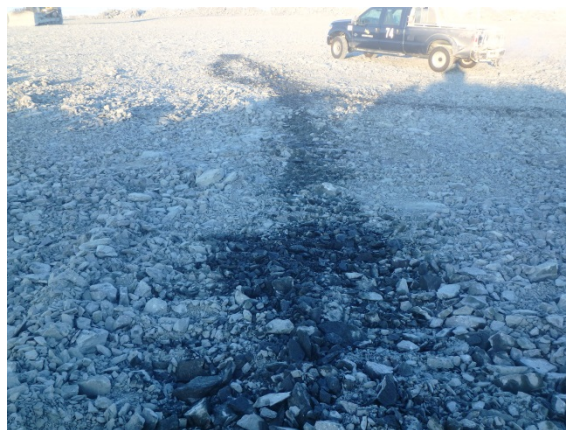
On January 25th 2016, one of the major coolant hoses had a failure and the coolant system flushed on the ground while going uphill on the Vault hauling road. Truck proceeded to empty load and then stopped so repairs could be safely done. The quantity of diesel fuel spilled was 250 liters, and the area of contamination 500 m².

Main coolant hose failure on haul truck related to cold weather conditions.

The area was cleaned using a grader and contaminated soil was collected and brought to the Meadowbank Tailings Storage Facility. An estimated volume of 40 m³ of contaminated material was collected and brought to the TSF.
