Cause of Spill

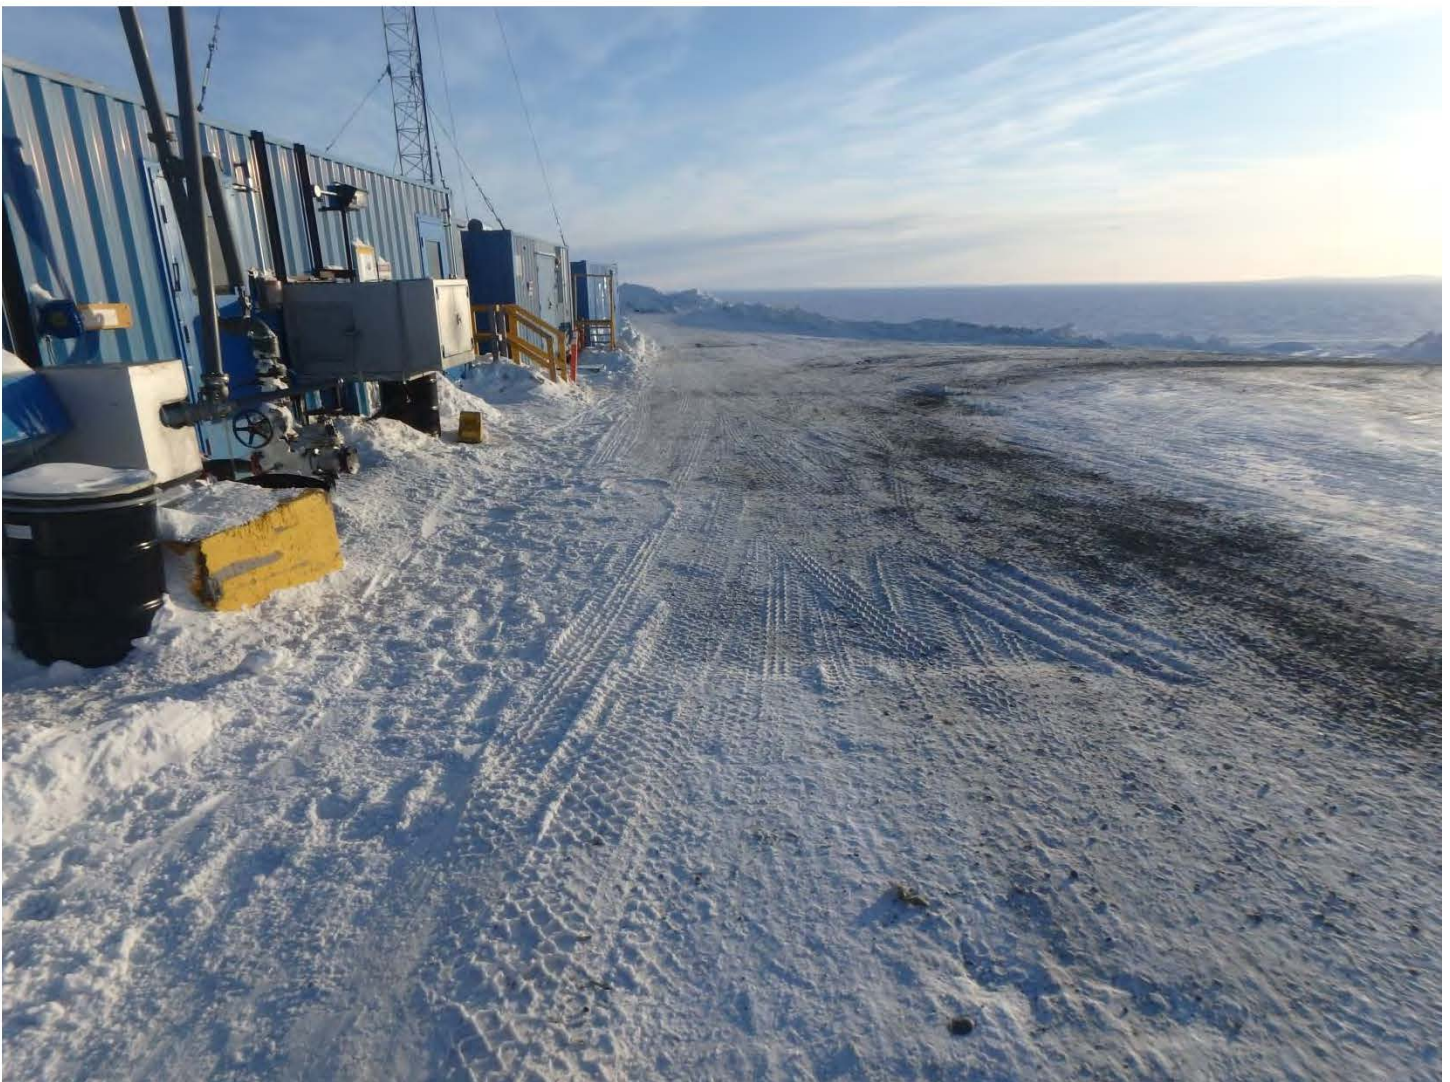
A miscalculation was made on the tanker compartment capacity by the driver. After investigation (report included in appendix 1) it was found that the Fuel arm was hooked on compartment #2 (capacity of 5000 liters) instead of #1 (capacity of 15 000 liters).

A containment was placed underneath the overfill pipe on the tanker. Spill absorbents were placed on the ground to absorb fuel. The area was then cleaned with a loader. The Environment department proceeded to on-field sampling using a PID meter. Area was scanned and deemed satisfactory.

Contaminated soil was brought to the Landfarm and contaminated snow will be disposed at the TSF at the Meadowbank Mine Site.
